The Characterization of Stress Corrosion Cracking in the AE44 Magnesium Casting Alloy Using Quantitative Fractography Methods

Abstract: In this work an assessment of the susceptibility of the AE44 magnesium alloy to stress corrosion cracking in a 0.1M Na₂SO₄ environment is presented. The basic assumed criterion for assessing the alloy behavior under complex mechanical and corrosive loads is deterioration in mechanical properties (elongation, reduction in area, tensile strength and time to failure). The AE44 magnesium alloy was subjected to the slow strain rate test (SSR) in air and in a corrosive environment under open circuit potential (OCP) conditions. In each variant, the content of hydrogen in the alloy was determined. The obtained fractures were subjected to a quantitative evaluation by original fractography methods. It was found that under stress corrosion cracking (SCC) conditions and in the presence of hydrogen the mechanical properties of AE44 deteriorated. The change in the mechanical properties under SCC conditions in a corrosive environment was accompanied by the presence of numerous cracks, both on fracture surfaces and in the alloy microstructure. The developed metho

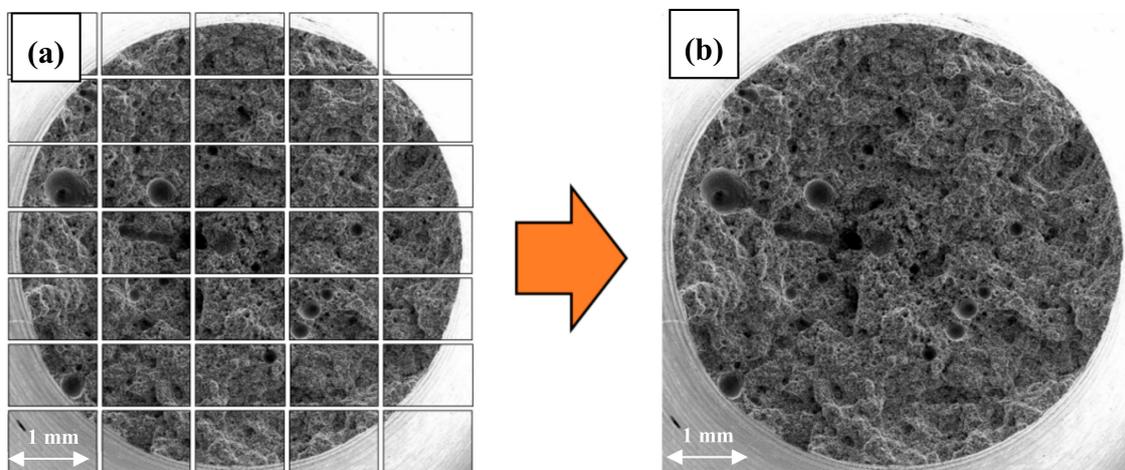
Figure 1. Scheme of the image merging operation (SE) into the image of high resolution (HR) of the fracture surface of the sample using the scanning electron microscope (SEM): (a) scheme of systematic scanning operations of the real surface of the fracture - C_{ij} matrix of images, (b) image of the total area surface of the fracture after combining images from the C_{ij} matrix.

The quantitative fractography analysis covered entire fracture surfaces. The use of the systemic scanning method (a series of photographs showing the entire fracture surface) and the subsequent arrangement of the images into one high-resolution photograph (Figure 1) enabled the assessment of details on a micrometer scale.

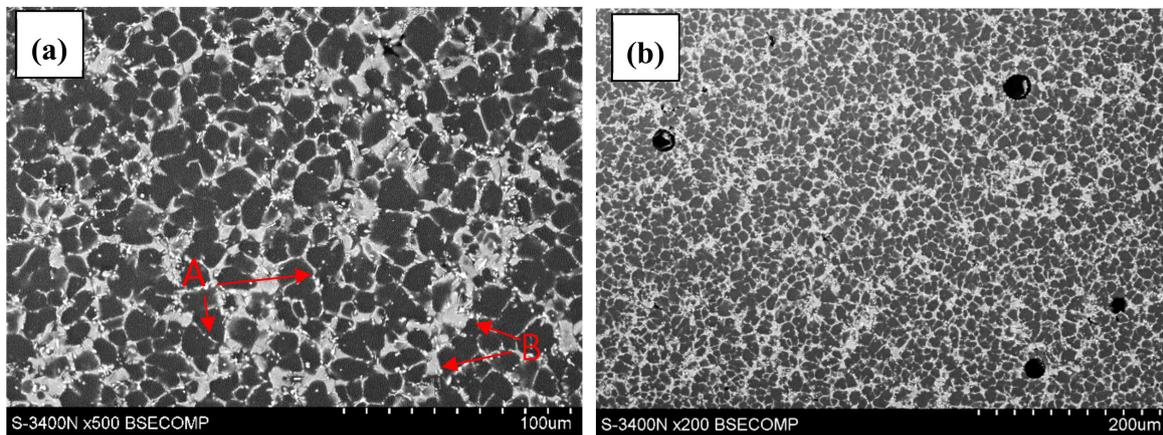
Figure 2. Microstructure of magnesium alloy AE44 in initial state: (a) cross-section perpendicular to the axis of the sample; (b) casting pores.

The microstructure of as-cast AE44 is characterized by the presence of fine grains with phase precipitates present mainly at grain boundaries (Figure 2). Moreover, few pores of various sizes are also observed in the structure (Figure 2b).

SEM observations (Figure 2) revealed typical microstructure of diecast AE44 alloy consisted of fine grains of α -Mg matrix and two sorts of tiny precipitates [21]. The first one was with lamellar morphology (phase type A, Figure 2). The second was coarse with globular shape (phase type B, Figure 2). Micro-zone compositions analysis was performed on these white phases by energy dispersive spectrometer (EDS), and the results show that they contain aluminum and rare earth elements, cerium, lanthanum and neodymium. In our research, it was confirmed, according to [21], that these particles are precipitates of $Al_{11}RE_3$ and Al_2RE , respectively.

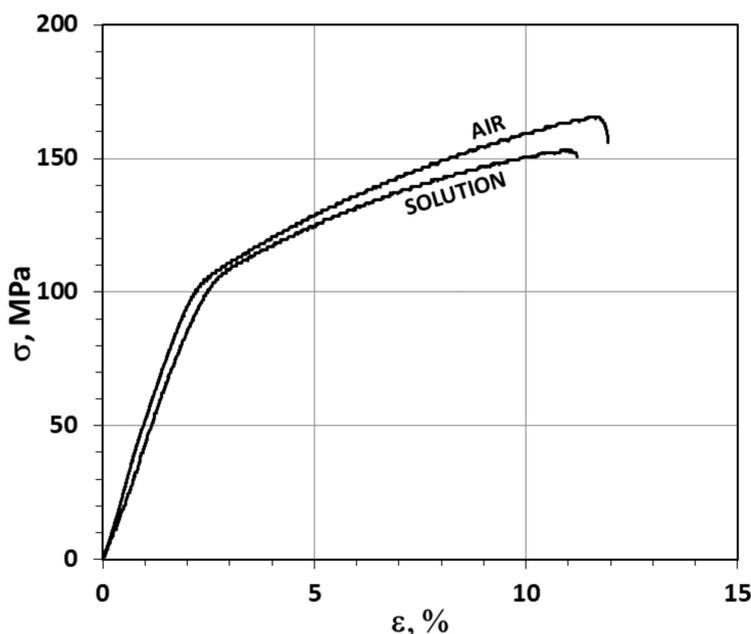
Figure 3. Stress–strain curves ($\dot{\epsilon} = 9 \times 10^{-7} \text{ s}^{-1}$) for samples of magnesium alloy AE44 deformed in air and in a corrosive environment under open circuit potential (OCP) conditions.

The stress–strain curves obtained as a result of the two SSR test variants for the AE44 samples are shown in Figure 3. They have a normal shape, with an elastic and plastic strain zone, but with no distinct yield point. The highest ultimate tensile strength (UTS \approx 166 MPa) is recorded for the material subjected to strain in air.

The samples subjected to strain with simultaneous exposure to the corrosive solution under OCP conditions were characterized by lower strength (UTS \approx 153 MPa). The best plasticity (ϵ , Z) was displayed by the samples tested in air (Figure 3, Table 1). The elongation recorded for these samples was $\epsilon = 11.9\%$ and the reduction in area was $Z = 7.8\%$. For samples subjected to strain in a corrosive environment under OCP conditions, a slightly lower elongation ($\epsilon = 11.2\%$) and a noticeably smaller reduction in area ($Z = 4.0\%$) were recorded (Figure 3, Table 1).

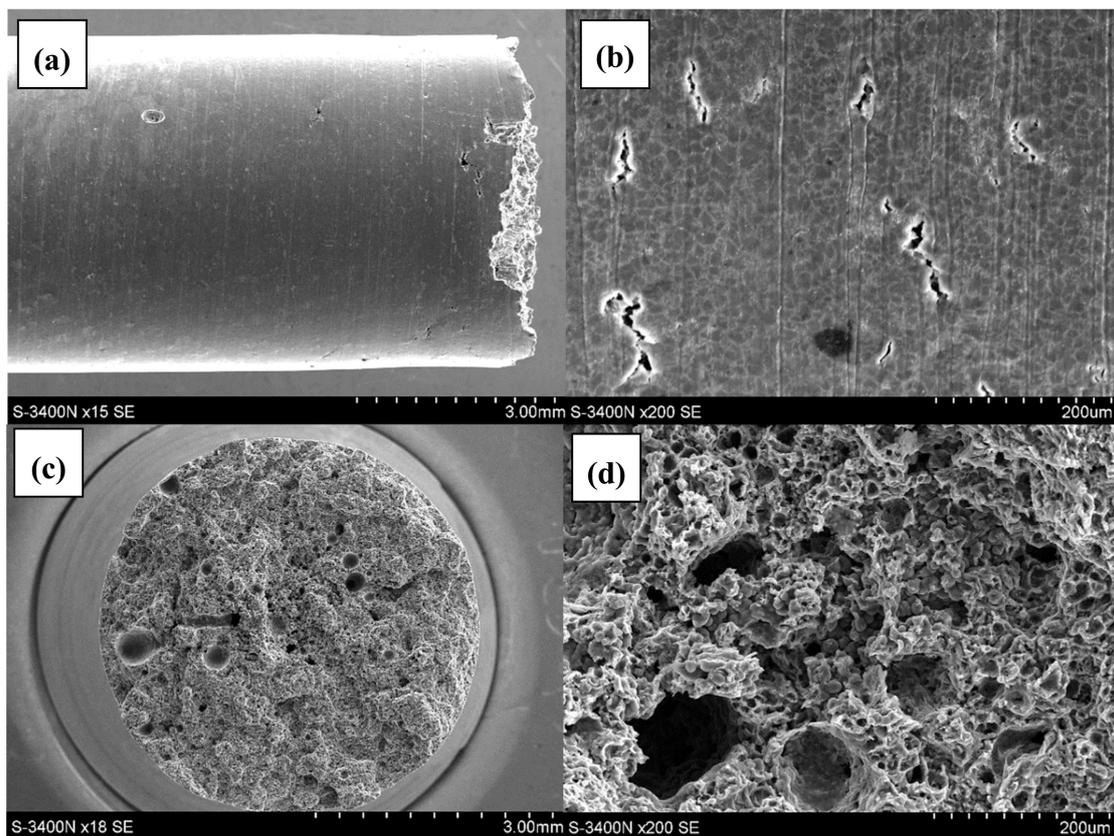
Figure 4. Lateral and fracture surface of the sample after SSR test in air: (a) macroscopic image of lateral surface; (b) magnified image of the lateral surface; (c) macroscopic image of fracture surface; (d) magnified image of fracture surface.

The analysis of the AE44 sample surfaces and fracture surfaces after the SSR tests in air and in the corrosive environment showed major differences. There were a few cracks on the side surfaces of the AE44 sample subjected to strain in air (Figure 4a,b). Their propagation direction was perpendicular to the force applied during the strain test.

On the main fracture surface (Figure 4c,d), there are numerous pores that formed during the casting process, of various sizes reaching even several hundred micrometers (Figure 4c).

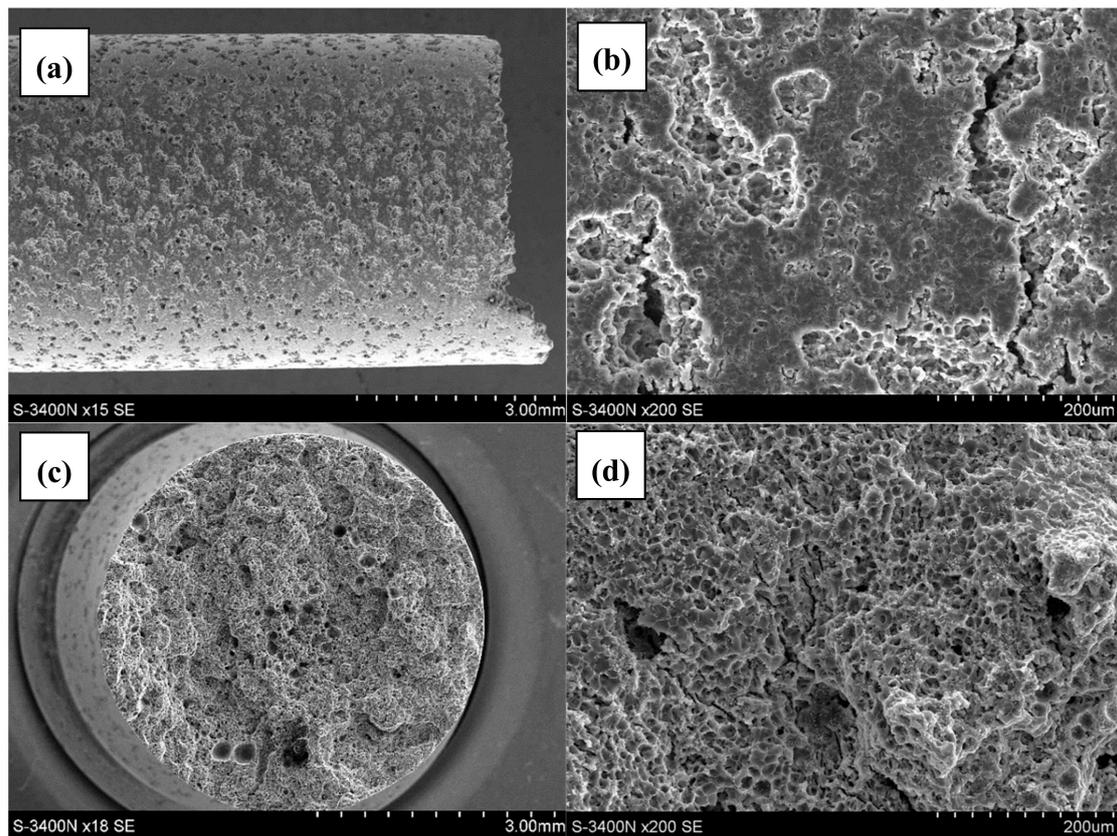
Figure 5. Lateral and fracture surface of the sample after SSR test in corrosive solution under OCP conditions: (a)—macroscopic image of lateral surface; (b)—magnified image of the lateral surface; (c) macroscopic image of fracture surface; (d) magnified image of fracture surface.

In the case of the specimen subjected to strain in the corrosive environment under OCP conditions, there are cracks and very numerous but shallow corrosion pits on its surface side (Figure 5a,b). On the main fracture surface (Figure 5c,d), there are pores of various sizes (Figure 5c) and numerous cracks (Figure 5d). However, there are also areas free of cracks. The morphology of the fracture surface of the AE44 alloy after the air test is typical—a ductile fracture with numerous pores, the elongated shrinkage porosity and spherical gas (air) porosity. It is comparable with the results of other authors [24].

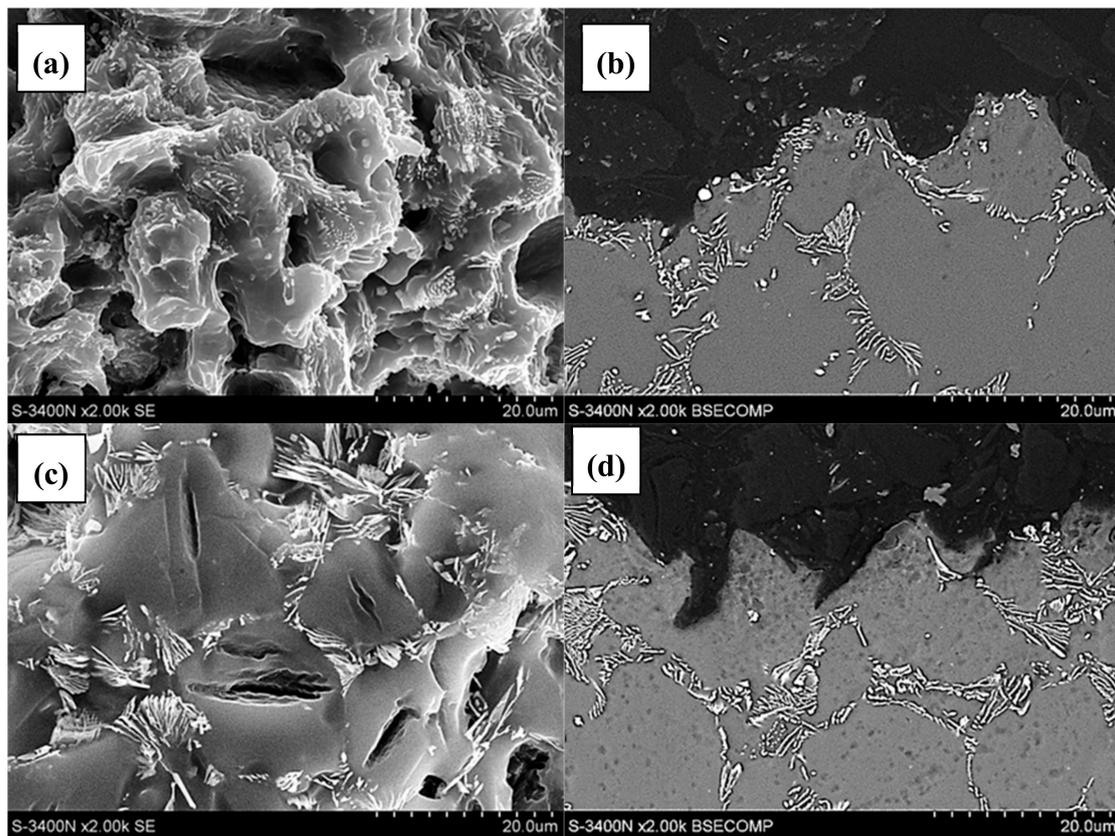
Figure 6. Surface and profiles of AE44 magnesium alloys obtained as a result of the slow strain rate test (SSRT): (a,b)—air, intergranular fracture; (c,d)—solution, transgranular fracture, and secondary cracks in the volume of the solid solution α -Mg.

A detailed analysis of the fracture surface of the AE44 specimens subjected to strain in air revealed that the fracture was intercrystalline. There were also many intermetallic phase precipitates on the fracture surfaces (Figure 6a), which were located along grain boundaries in AE44. Cracking along grain boundaries was also observed on the fracture profiles (Figure 6a,b). The analysis of the fracture surfaces of the AE44 specimens subjected to strain in the corrosive solution under OCP conditions revealed a significantly larger number of cracks. Moreover, areas of a transcrystalline nature were observed on the specimen surfaces (Figure 6c,d). According to Atrens et al. [31] fracture surface after SSC of Mg alloy is intergranular (IG-SSC) or transgranular (TG-SSC). A continuous or nearly continuous second phase, typically along grain boundaries, causes IG-SSC by microgalvanic corrosion of the adjacent Mg-matrix. IG-SSC is expected in all such alloys. TG-SSC is most likely caused by interaction of hydrogen with the microstructure. Hydrogen strongly interacts with rare earth elements (RE) in magnesium alloy AE44 to form hydrides with them. It is commonly recognized that transgranular SCC (TGSCC) of Mg alloys is a type of HE. HE models involve hydrogen-enhanced decohesion, hydrogen-enhanced localized plasticity, adsorption-induced dislocation emission, and delayed hydride cracking. The presence of hydride (MgH_2) phase on the fracture surface designates the DHC mechanism for a friction-stir welded magnesium alloy AZ31 [32].

Analysis of the places of occurrence of cracks on fracture surfaces indicates that in the AE44 alloy these cracks occurred in the areas of α -Mg solid solution after SSRT tests in corrosive environment and they were not accompanied by the separation of intermetallic phases (Figure 6). No such cracks were found after testing SSRT in the air. At the same time, it should be remembered that in the presence

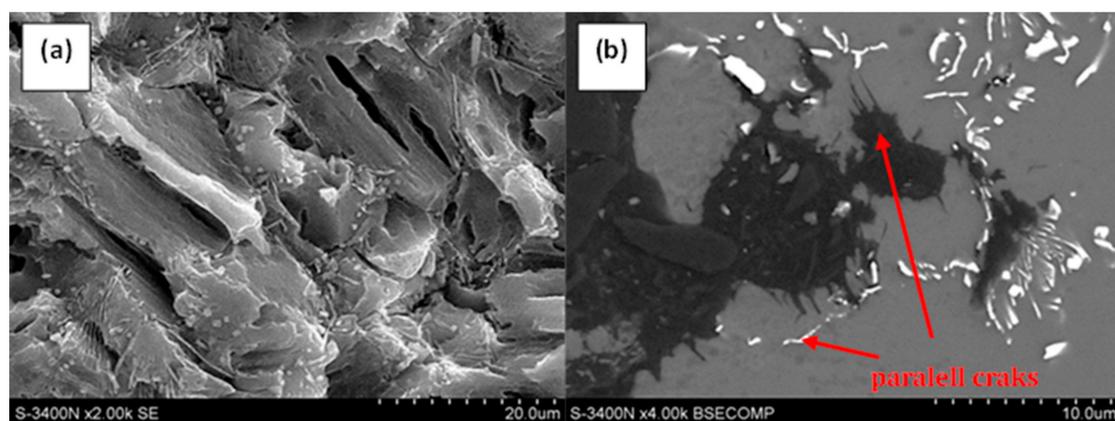
Figure 7. Series of parallel cracks in the AE44 magnesium alloy as a result of SSRT in a corrosive environment under OCP conditions: (a) on the fracture surface; (b) on the profile of fracture.

Cracks were also identified in the alloy matrix (α -Mg), where very often they propagated on parallel crystallographic planes (Figure 7). At the same time, it was observed that in the corrosive environment, the cracking occurred not only through the growth of the main crack, but also through the growth of secondary cracks, which together formed more complex crack configurations (Figure 7a).

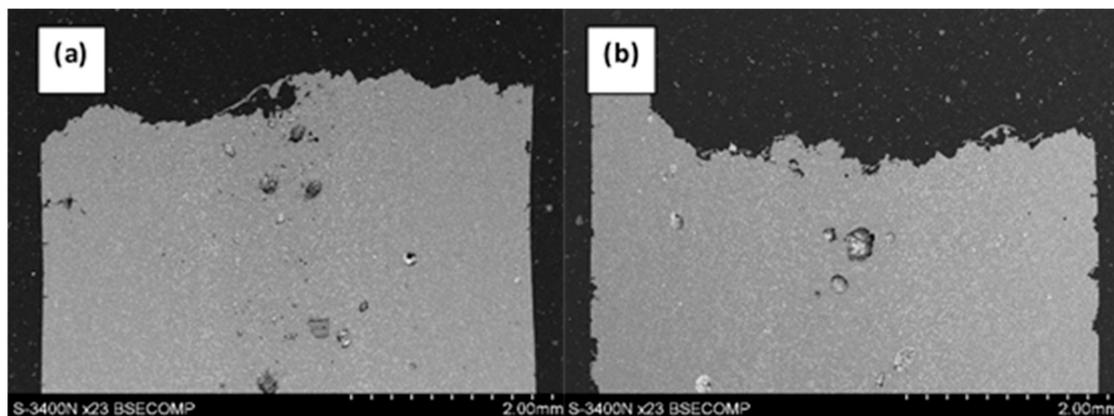
Figure 8. Profile of the fracture in magnesium alloy AE44 after SSRT: (a) in the air; (b) in solution.

On fracture profiles, porosity is observed in the entire volume of the specimens, with the pores being located mainly near the specimen axis (Figure 8). This is typical behavior for pores forming during the casting process.

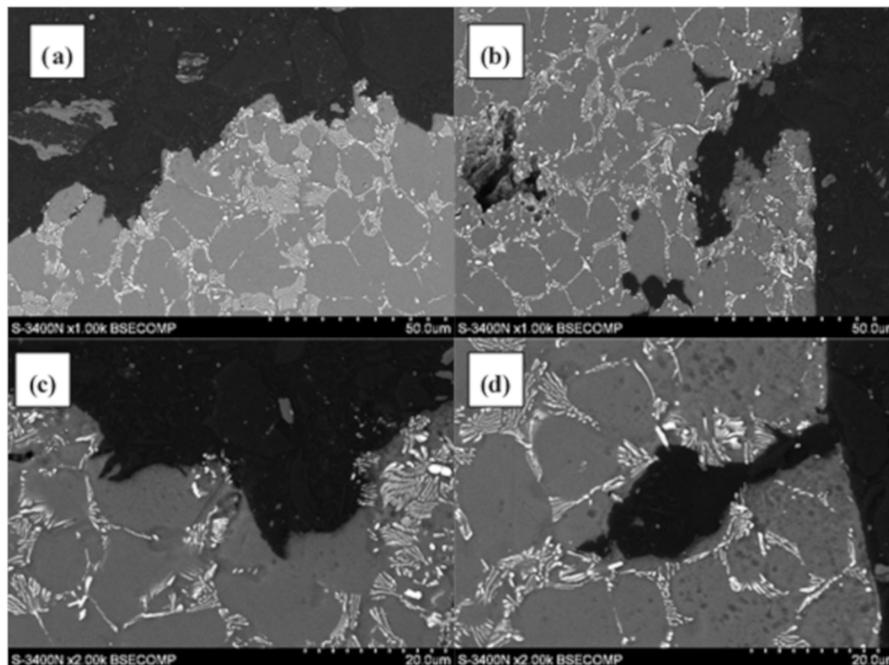
Figure 9. Profile of the fracture in AE44 magnesium alloy after SSRT in the air: (a)—fracture surface; (b)—lateral surface of the sample and after SSRT in solution: (c)—fracture surface; (d)—lateral surface of the sample.

The presence of local cracks propagating from the side surface deeper into the specimen was detected on the side surfaces of all the AE44 specimens (Figure 9b,d).

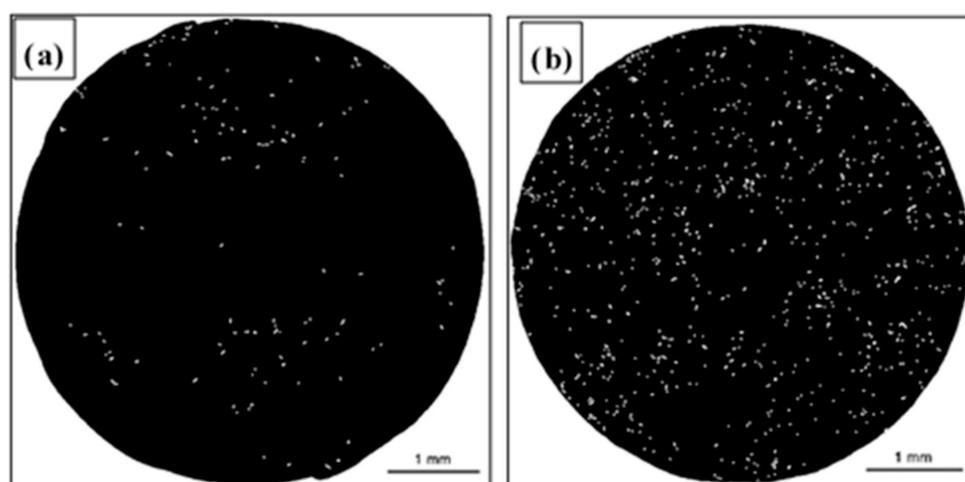
Figure 10. Binary image of cracks on the fracture surfaces of AE44 magnesium alloy after SSRT tests: (a) in the air and (b) in solution.

The basis for the quantitative evaluation of cracks on the AE44 fracture surfaces were binary images of total fracture surfaces with marked cracks (Figure 10).

The results of the quantitative evaluation of cracks on the fracture surfaces (Figure 10, Table 2) show major differences in the numbers and lengths of cracks depending on the SSR test conditions—in air and in the corrosive solution under OCP conditions.

The fracture surface of the specimen subjected to strain in air is characterized by the smallest number of cracks (141). Their distribution was uneven – the cracks formed small clusters (Figure 10a). Moreover, the cracks are characterized by the greatest average length ($34.5 \mu\text{m}$). The most numerous group of cracks present on the surfaces of the specimens tested in air were cracks that were $20\text{--}30 \mu\text{m}$ long—they accounted for 37.6% of all cracks. No cracks shorter than $14 \mu\text{m}$ were found. The longest crack found in these specimens was $114 \mu\text{m}$ long. Detailed information concerning the crack length distribution on the fracture surface of the AE44 specimen subjected to strain in air is shown in the form of a histogram (Figure 11a). The quantitative analysis of the cracks present on the fracture surface of the specimen tested in the corrosive environment under OCP conditions revealed that they were

much more numerous than in the case of the specimen tested in air—there were 900 cracks. They were evenly distributed on the fracture surface (Figure 10b). Their average length was 21.3 μm . The most numerous group of cracks was in the range of length of 10–20 μm . They accounted for 54.3% of all cracks present on the fracture surface. No shorter cracks were found. The longest crack was 139 μm long and this value was greater than that recorded for the specimens tested in air.

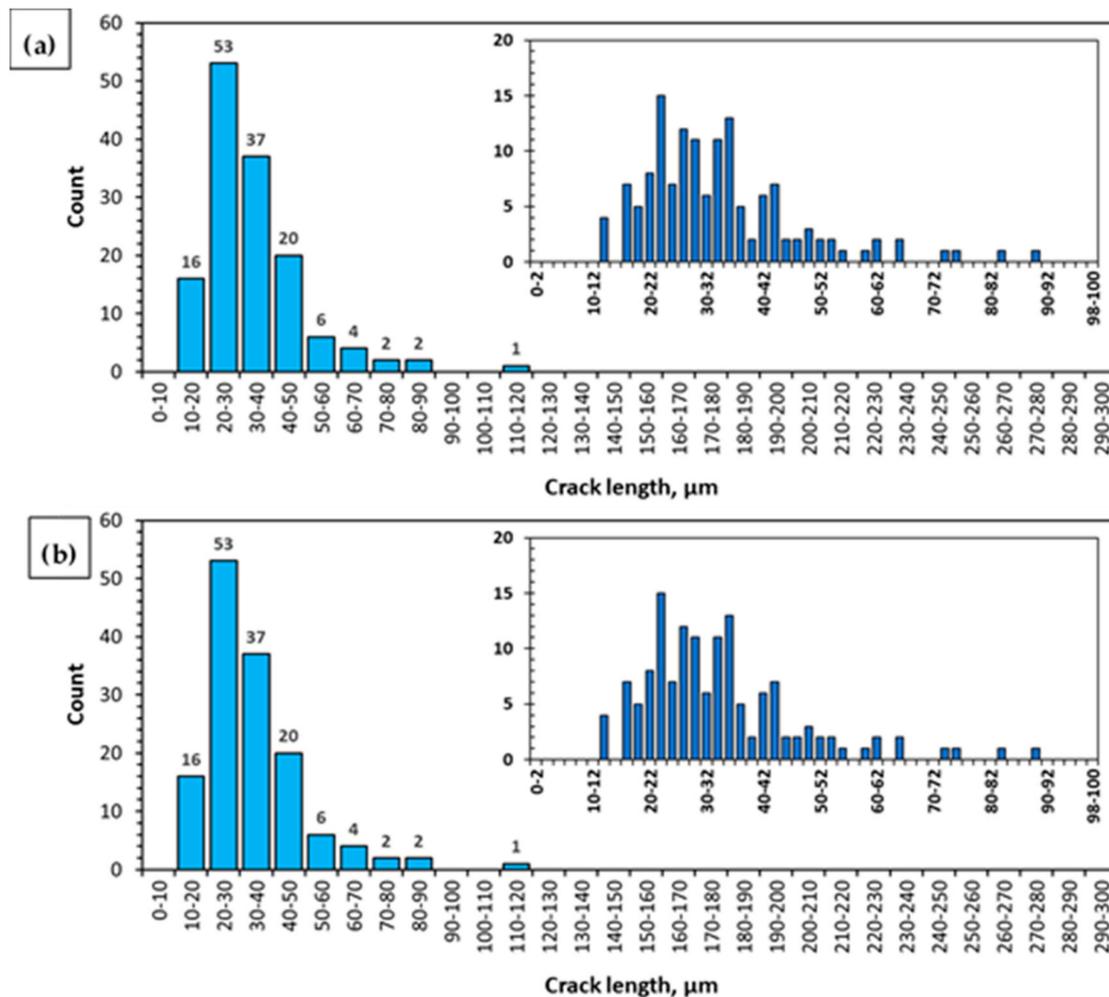
Figure 11. Histogram of the length of cracks occurring in the binary image of cracks present on the fracture surface of the AE44 magnesium alloy after SSRT in the air (a) and in solution (b).

The distribution of cracks on the fracture surface is shown Figure 11b. These results indicate that the presence of the corrosive environment resulted in a greater number of cracks, however, the cracks were shorter and thus their average length was also smaller. An important feature of the method presented in this work is that it covers the entire fracture area (resulting from the final specimen failure) and all cracks (taking into account the image resolution) of very different sizes, and the results obtained can be used to assess the susceptibility of an alloy to the action of a corrosive environment.
