Identification of the Destruction Model of Ventilated Facade under the Influence of Fire

Abstract: Ventilated facades are becoming an increasingly popular solution for external part of walls in the buildings. They may differ in many elements, among others things: claddings (fiber cement boards, HPL plates, large-slab ceramic tiles, ACM panels, stone cladding), types of substructures, console supports, etc. The main part that characterizes ventilated facades is the use of an air cavity between the cladding and thermal insulation. Unfortunately, in some aspects they are not yet well-standardized and tested. Above all, the requirements for the falling-off of elements from ventilated facades during a fire are not precisely defined by, among other things, the lack of clearly specified requirements and testing. This is undoubtedly a major problem, as it significantly affects the safety of evacuation during a fire emergency. For the purposes of this article, experimental tests were carried out on a large-scale facade model, with two types of external-facade cladding. The materials used as external cladding were fiber cement boards and large-slab ceramic tiles. The model of large-scale te

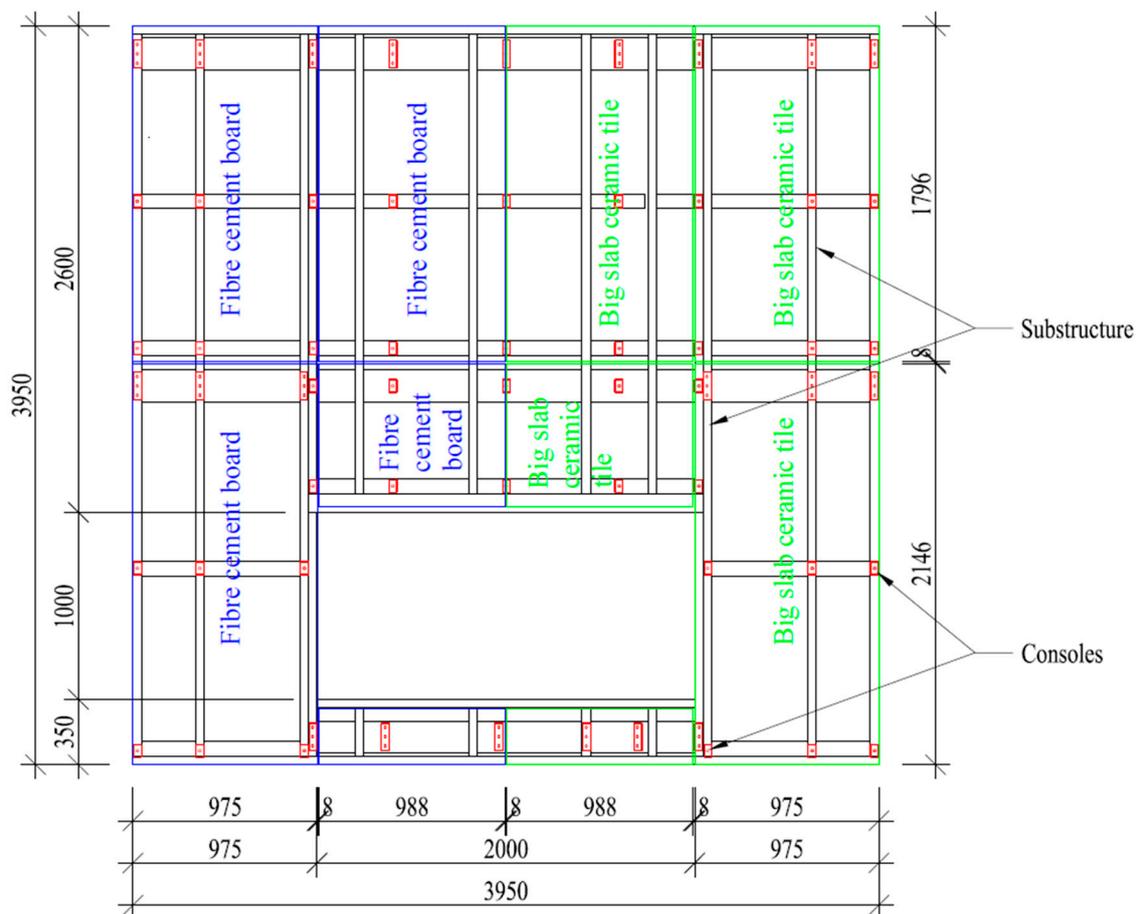
Figure 1. Scheme of the aluminum substructure, console arrangement, external cladding panels arrangement and material indication.

The layout of the aluminum substructure and the consoles transferring loads from the aluminum substructure to the system skeleton wall is shown in Figure 1.

The external cladding of the ventilated facade consisted of fiber cement boards with a thickness of 8 mm and density of 1700 kg/m^3 and large-slab ceramic tiles with a thickness of 5.6 mm and density of 2855 kg/m^3 . The external facade claddings attached to the aluminum grate were made with the use of the system adhesive technology and additionally with the use of steel mechanical connectors, i.e., perforated steel tapes attached to the substructure. The dilatation between individual boards was 8 mm. Figure 1 shows the division scheme of the external cladding and indicates the material of which they were made, namely, the fiber cement boards in the left part and the large-slab ceramic tiles in the right part.

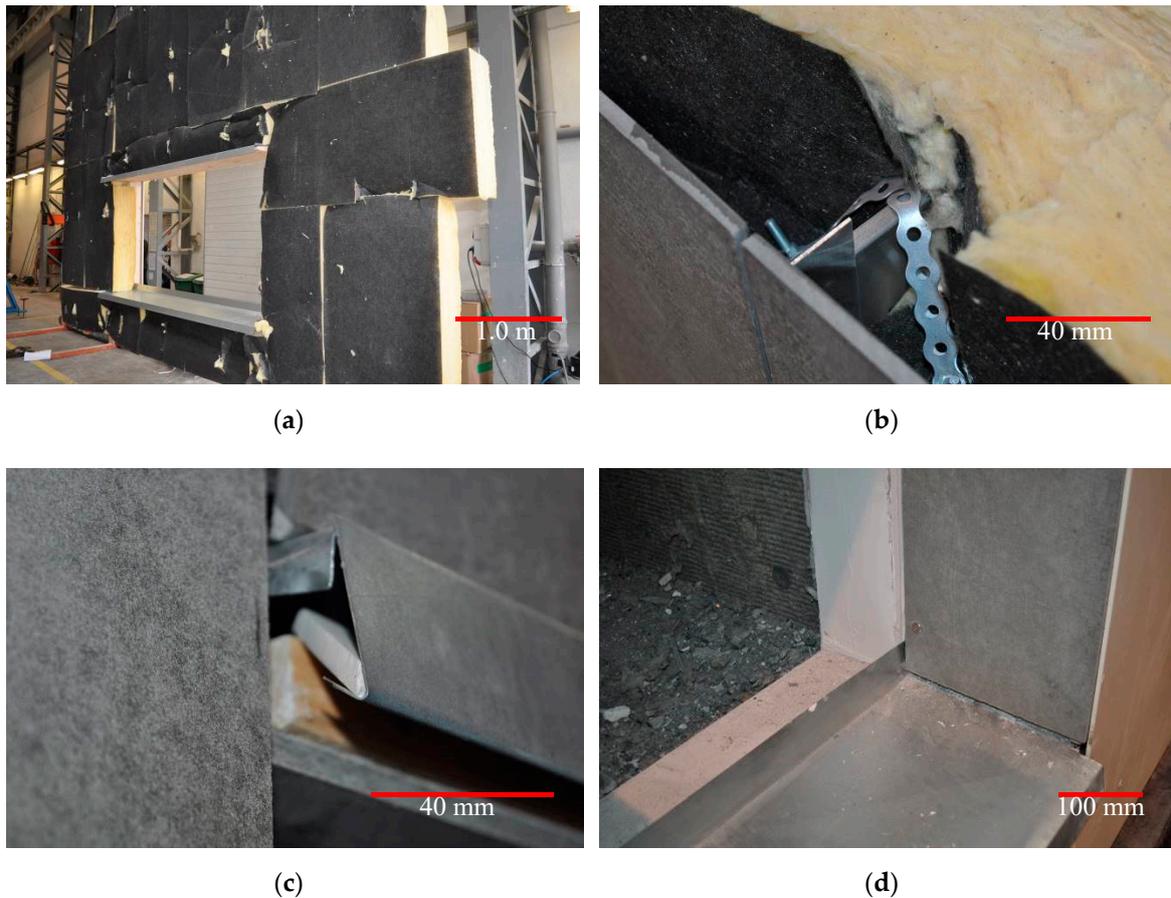
Figure 2. Selected details of the ventilated facade model under test: (a) thermal insulation system; (b) the detail of perforated tape connection with the console; (c) the detail of closing sheet above the window opening; (d) the detail of sill system.

Selected details of the tested ventilated facade are shown in Figure 2. Total dimensions of the tested model of ventilated facade were $3950 \text{ mm} \times 3950 \text{ mm}$, air gap width 38 mm, dimensions of fire hole $2000 \text{ mm} \times 1000 \text{ mm}$.

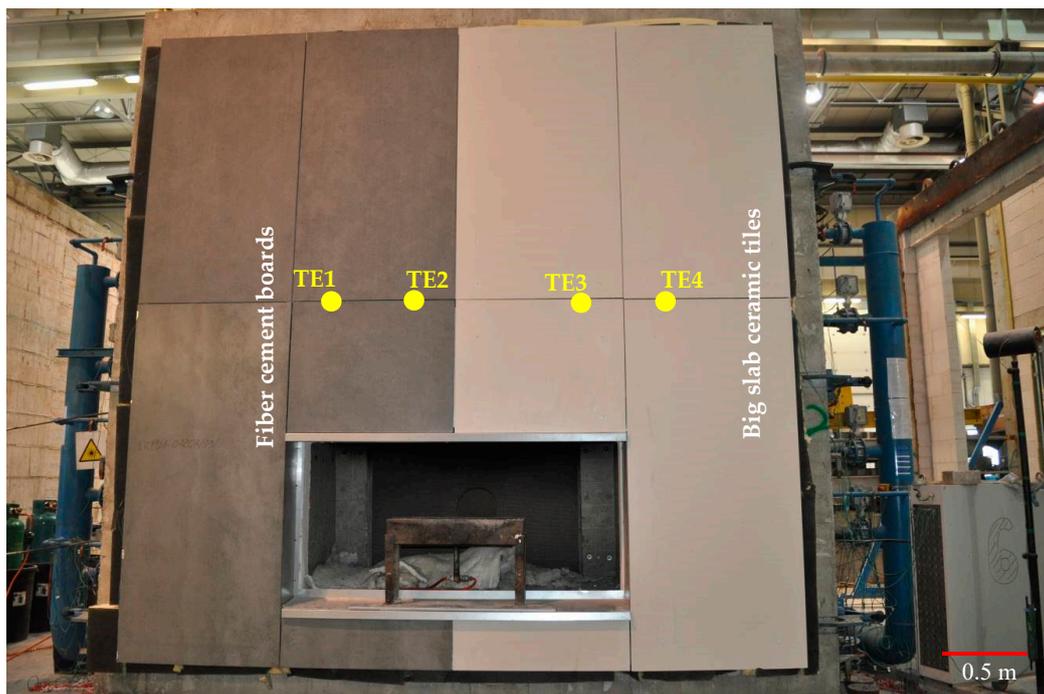
Figure 3. Ventilated facade model with location of thermocouples.

The scenario of the ventilated facade fire assumed that the flames would escape through a window opening from a room located directly behind the facade, inside the building. In order to map the room from which the flame was emitted, a recess was made in the model of the facade where the source of fire was placed. The burner parameters were selected in such a way as to reproduce the standard fire in the room, defined in the fire resistance test standard [20]. The fire was mapped with a gas burner releasing propane-butane gas at the speed of 3.8 m/s. The air from the recess in which the so-called sand burner was placed, supplied by the furnace installation had the possibility of inflow from the side of the opening, through a technical solution ensuring laminar air inflow, the so-called vent. In order to verify and identify damage to the external cladding, four thermocouples were installed. Thermocouples send information regarding temperatures as a function in time. Influence of high temperature was one of the negative external environmental effects on buildings elements. Thermocouples were placed in the gaps between the panels: two in the part of fiber cement boards and two in the part of large-slab ceramic tiles. The location of the thermocouples is shown in Figure 3. A ventilated facade with open joints was made, where additional gaps (gaps between individual external cladding panels) can provide air circulation.

The results of temperature measurement from the thermocouples located in the part of the fiber cement boards, as shown in Figure 3, are presented as a function of time in Figure 6 for thermocouples TE1 and TE2. On the other hand, the results for TE3 and TE4 thermocouples located in the part of large-slab ceramic tiles are shown in Figure 7. The results presented for TE1 and TE2 thermocouples show high instability and temperature variations. This was due to the high development of degradation over time of fiber cement boards, especially after full development of the fire. The locations of the greatest temperature fluctuations in Figure 6 can be associated with cracking or detachment of external cladding elements.

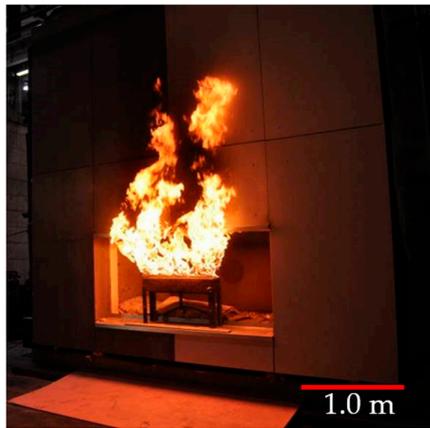
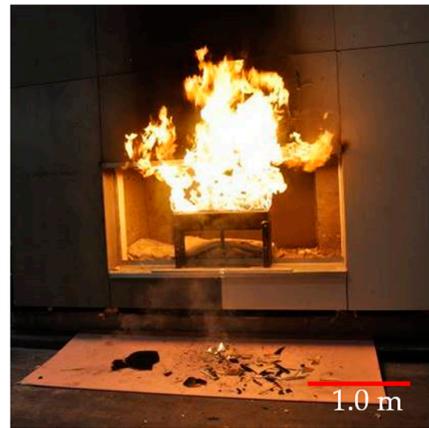
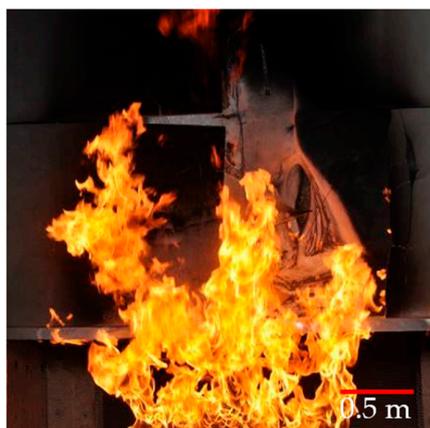
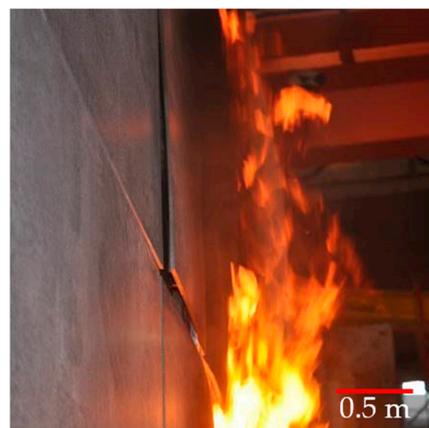
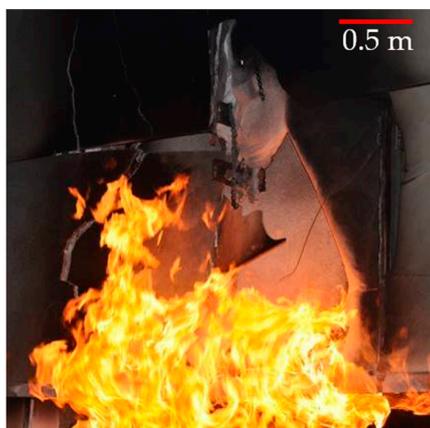
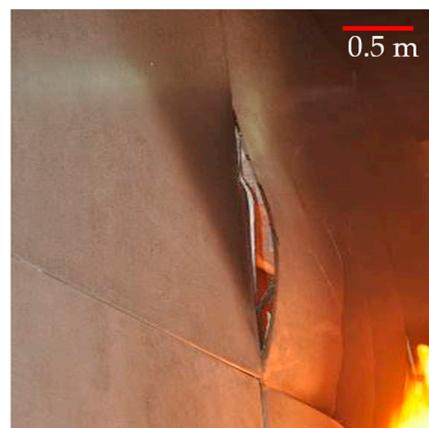
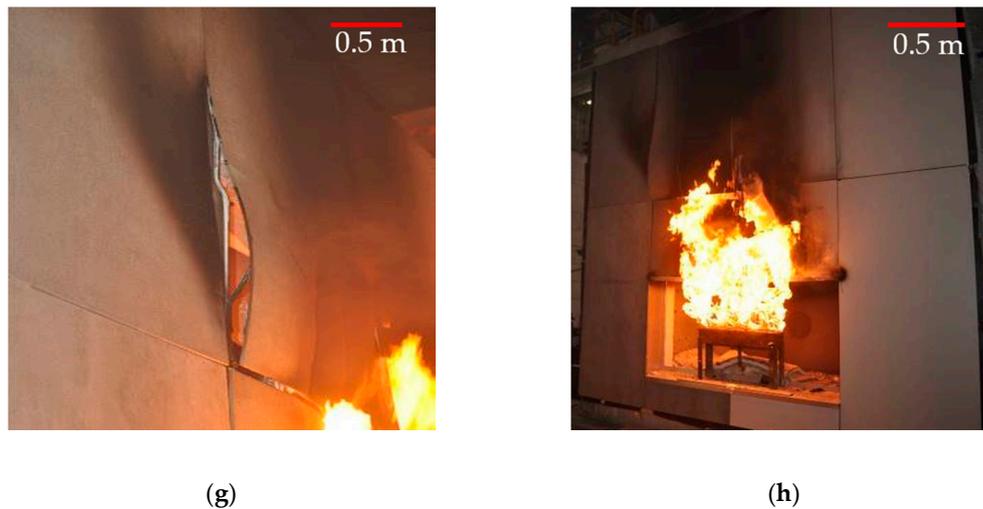
Figure 4. Ventilated facade model view in subsequent test minutes.: (a) 1st minute of the test; (b) 6th minute of the test; (c) 11th minute of the test; (d) 21st minute of the test; (e) 31st minute of the test; (f) 41st minute of the test; (g) 56th minute of the test; (h) 61st minute of the test.

The test was carried out in a closed hall, with an ambient temperature of 18.9 °C and relative humidity of 60.7%. The test started with setting the burner and calibrating the gas release. The first 5 min of the fire revealed smoke/charring of the external cladding, no falling-off of the external cladding elements (Figure 4a).

The first falling-off of elements were observed in the 6th minute of the test, i.e., large-slab ceramic tiles elements started to fall off (Figure 4b). The subsequent minutes of high temperature impact caused greater destruction of the external cladding, particularly visible in the part where large-slab ceramic tiles were located. On 11th minute, the degradation of fiber cement boards started significantly. Figure 4c shows the initial stages of expansion of the fiber cement boards. The destruction of the large-slab ceramic tiles slowed down around 20th minute. The places where the temperature impact was highest were destroyed, and in the remaining places, large-slab ceramic tiles “tolerated” high temperatures quite well. Large-slab ceramic tiles had the greatest degradation in the first several minutes of fire. No further degradation of ceramic sinters was noticed.

Thermocouples TE3 and TE4, as opposed to thermocouples located in a part of fiber cement boards, initially showed higher temperature increase. The power of the fire was constant, the difference in temperature was caused by the heating of the elements. In 6–7 min, TE3 thermocouples showed high stability—large-slab ceramic tiles were quickly destroyed in the central part above the fire recess. TE4 thermocouple initially showed high instability and temperature fluctuations. This was caused by the influence of lower temperature on large-slab ceramic tiles in this part of the facade. TE4 thermocouple became stable in about 15th minute when the ceramic sinters were no longer damaged by high temperature. The damage is shown in Figure 4c. This state or a slightly altered state, was maintained practically until the end of the test.

high resistance—the first few minutes or so. About 11 min, the first signs of degradation of fiber cement boards are visible (Figure 4c). Then the state of the degradation was deepened until the final destruction. Fiber cement boards have exhausted their load-bearing capacity during high temperature exposure. They were held on the structure only by perforated steel tapes. The authors wanting to refer the results from large-scale test to testing on samples by Szymków [1], had to specify the method of reference of the results. The temperature in the large-scale test was much higher than in Szymków's research [1], the time function will be not representative. The authors determined that as the most reflecting value will be function of integral.

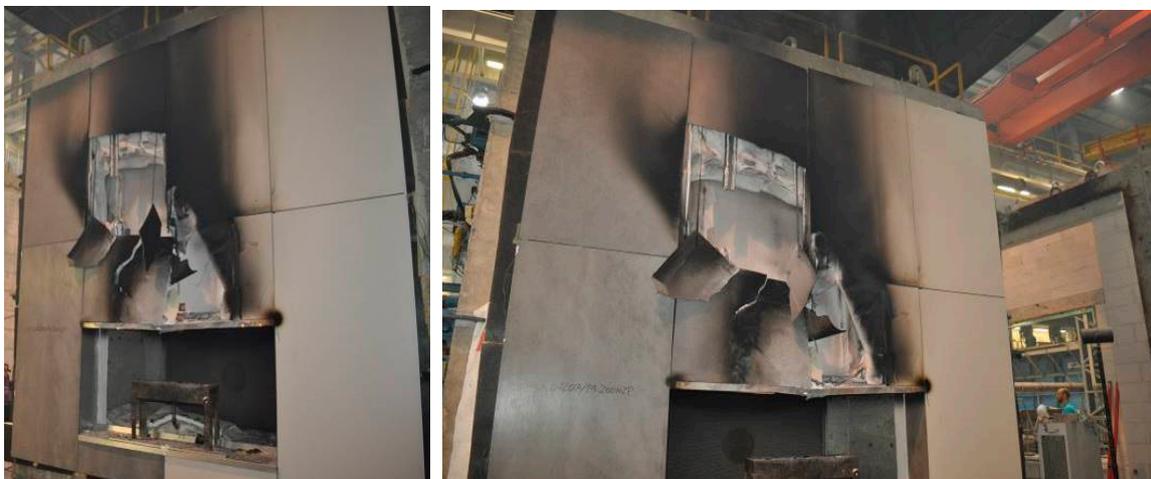
Figure 5. Ventilated facade model view after the fire source was extinguished and the test was completed.

The horizontal upper splay, made of 0.5 mm thick steel sheet, deformed, but its location has not changed. The aluminum grate directly above the recess with the fire source, except in places directly sheltered by the steel top splay was burnt at a height of up to 1660 mm. Glass mineral wool was melted directly above the recess at a height of up to 1400 mm. The steel fasteners and consoles remained in place, as did the lower splay. Figure 5 shows the condition of the facade after the fire source was extinguished.

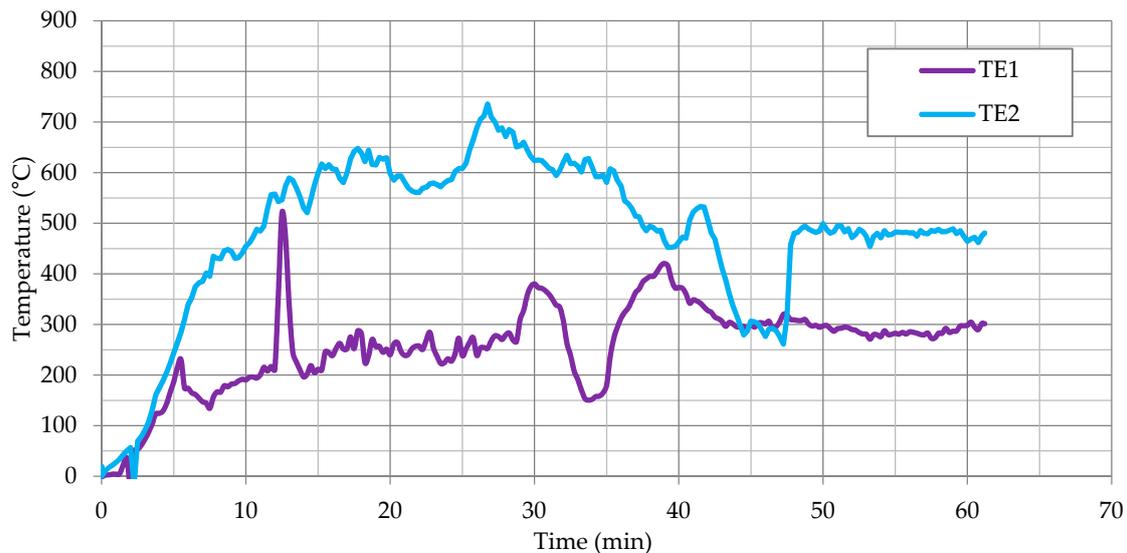
Figure 6. Temperature measurement results for TE1 and TE2 thermocouples.

The next research steps, helping to better solve the problems of ventilated facades and to increase their safety, should, according to the authors, concern the samples of fiber cement panels tested at a temperature closer to the actual fire, i.e., about 550–650 °C (Figure 6). Such tests should also be carried out for ceramic sinters, which have not yet been described in the literature.

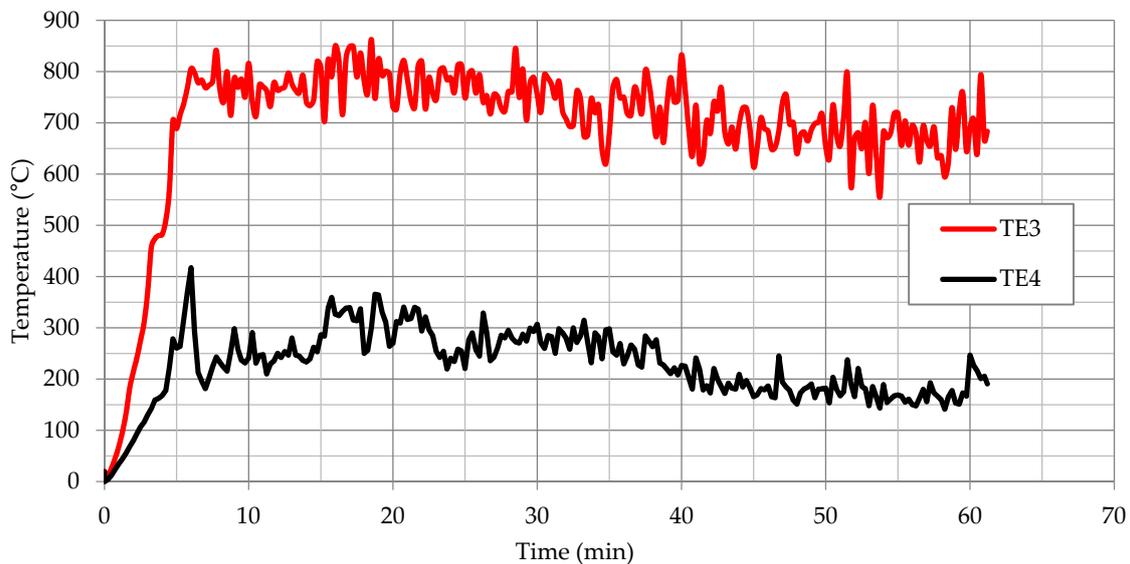
Figure 7. Temperature measurement results for TE3 and TE4 thermocouples.

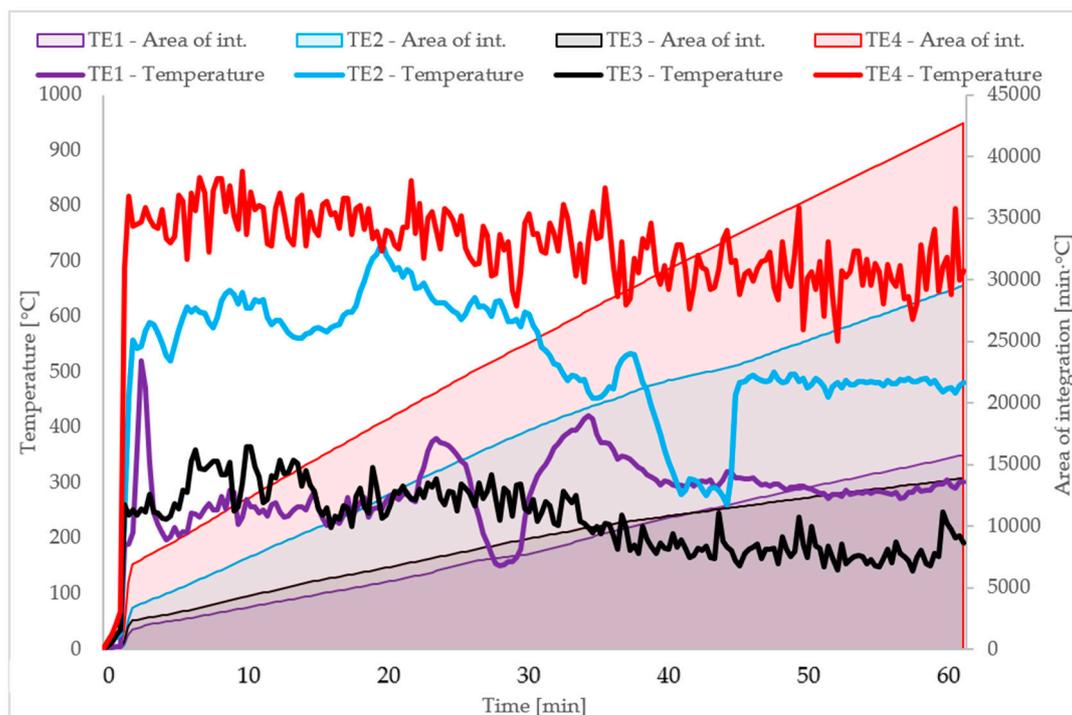
Figure 8. Temperature measurement results for thermocouples and the increasing integral for the temperature-time function.

- the integral for TE1 ($^{\circ}\text{C} \times \text{min}$) was 15,745.0 ($^{\circ}\text{C} \times \text{min}$);
- the integral for TE2 ($^{\circ}\text{C} \times \text{min}$) was 29,475.1 ($^{\circ}\text{C} \times \text{min}$);
- the integral for TE3 ($^{\circ}\text{C} \times \text{min}$) was 42,686.2 ($^{\circ}\text{C} \times \text{min}$);
- the integral for TE4 ($^{\circ}\text{C} \times \text{min}$) was 13,912.0 ($^{\circ}\text{C} \times \text{min}$).

These results are shown in Figure 8 together with temperature diagrams for all thermocouples: TE1, TE2, TE3, TE4. In this graph we can observe a linear growth pattern of the integral for TE3 and TE4 thermocouples (thermocouples placed in a part of the cladding made of large-slab ceramic tiles). In addition, in the part with ceramic sinters the fire force was much higher. The maximum temperature for TE3 was 862.7°C and for TE2 thermocouple measuring the temperature in the area of fiber cement boards it was 735.5°C . The much higher temperatures in the large-slab ceramic tiles area were caused by the much faster destruction of this material, the “release” of access to the thermocouples. The falling-off of large-slab ceramic tiles made easier way to burn mineral wool, this allows maintain higher temperature. In addition, it was likely that ceramic sinters insulate thermocouples much worse than fiber cement boards. The temperature course for TE1 and TE2 thermocouples contains much more disturbances and significant faults. In addition, the integral function has a visible refraction in 34th and 39th minutes for TE1 thermocouple and 42nd and 48th minutes for TE2 thermocouple.

For the purpose of further analyses, the average value of the function integral for all series was assumed to be 3800 (°C × min). The average value of the function integral for all series corresponds to the increasing integral for TE1 thermocouple in about 20.5 min and the increasing integral for TE2 thermocouple in about 12.75 min. This is reflected in Figure 6; Figure 8. The time of 12.75 min approximately coincides with the point of significant fault in the temperature graph for TE1 thermocouple. This corresponds to the beginning of the destruction in 11th minute of the tested model (Figure 5). Fiber cement boards detach into parts, probably obscuring the TE1 thermocouple. Then the fiber cement panels were continuously destroyed until the end of the test. This corresponds to integral 42,686.2 (°C × min). The tests shown in [16] end with the integral value of 6000 (°C × min). The results obtained during the test in question indicate identical tendencies to the behavior of the samples presented in [16].
