# Experimental and Numerical Investigation of Intact, Defective and Repaired Countersunk Composite Joints under Tensile Loading

**Abstract:** Bolted joints are commonly used for assembling carbon fiber/resin composite structures. Since drilling may generate defects at hole edges which affect mechanical properties, it is of great engineering significance to develop proper repair methods to restore the mechanical properties of the defective parts. However, there are few studies on hole edge defects and their repair methods. Therefore, a novelty short fiber filling repair method was proposed to repair defective holes in this study. The mechanical properties of intact, defective and repaired countersunk composite joints were compared and investigated. Experimental tensile tests showed that defective joints had lower initial stiffness and failure loads compared to intact joints, while the mechanical properties were effectively restored after repair. Three-dimensional finite element models were also established to analyze the damage process of the joints. Results of numerical modelling were consistent with the experimental results. The simulations showed that changes in contact behavior

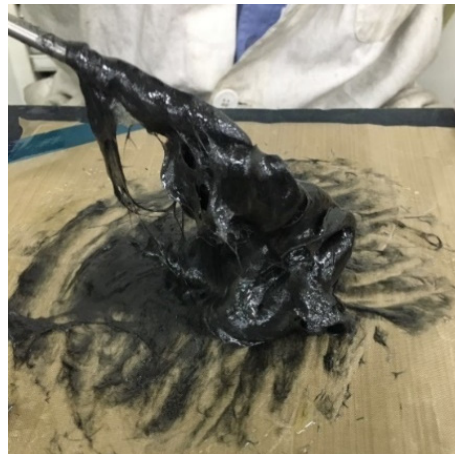
The short fiber composite material was prepared using a mixture of T700 short fibers and DG-3 epoxy adhesive (made in China), as shown in Figure 3.

**Figure 3.** Short fiber composite materials before curing.

The lengths of the short fibers were 2 to 3 mm, and the fiber fill fraction in the mixture was 3%. The fibers and DG-3 epoxy adhesive were well mixed to produce a mixture with randomly oriented fibers. Before filling the defective hole with the short fiber composite, the surface of the hole was cleaned with alcohol. The laminate samples with repaired holes were vacuumed to  $-0.8$  MPa using a vacuum system and cured at room temperature ( $26$  °C) for 48 h. After curing, the filler material had an elastic modulus of 10 GPa, Poisson's ratio of 0.36, and compression strength of 290 MPa (measured by basic mechanical tests and shown in Table 2).
