First Conclusions on Damage Behaviour of Recycled Carbon Staple Fibre Yarn Using X-ray and Acoustic Emission Techniques

Abstract: This paper presents the first results on the characterisation of the damage behaviour of recycled carbon fibre (rCF) rovings manufactured into unidirectionally (UD) reinforced plates. In the first step, the mechanical properties of several material combinations were determined by mechanical tests (tensile, flexural, compression). This proves the usability of the material for load-bearing structures. For example, a tensile modulus of up to 80 GPa and a tensile strength of 800 MPa were measured. Subsequently, the fracture surface was analysed by scanning electron microscopy (SEM) to characterise the fibre–matrix adhesion and to obtain first indications of possible failure mechanisms. Despite the high mechanical properties, poor fibre–matrix adhesion was found for all matrix systems. In situ X-ray microscopy tests were then performed on smaller specimens under predefined load levels as transverse tensile and bending tests. The results provide further predictions of the failure behaviour and can be compared to the previous test results. The three-dimensiona

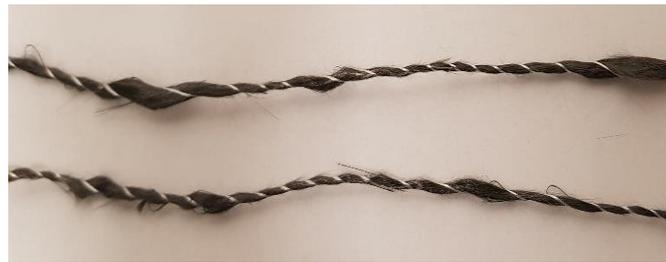
Figure 1. rCF roving with binding yarn leading to undulation and inhomogenisation of fibre thickness; a few protruding fibres can be seen.

The staple fibre yarn used from Wagenfelder Spinnereien GmbH (Wagenfeld, Germany) (Figure 1) consists of 60–80 mm long individual fibres that are twisted in a carding and spinning process (similar to rope production) and then fixed by a polyamide 6 (PA6) thread (binding yarn) [15,22]. In addition, PA6 filaments of the same size as the rCF fibres are inserted. This allows for a variation in the rCF/PA6 ratio. In this work, a 90/10 (rCF/PA6) yarn was used. In the following, this rCF yarn is referred to as roving. According to the manufacturer, the rCF fibres used come partly from production waste, but also from end-of-life components that have been shredded and pyrolysed. The peculiarity of the roving due to the manufacturing process is that it does not have a straight alignment but an

undulated shape (Figure 1). This undulation has a theoretical influence on the mechanical properties in the processed state, as deviations in the fibre orientation lead to a decrease in the mechanical properties. To counteract this effect, attempts were made to pre-tension the rovings during the manufacturing process (filament winding) to compensate for the undulation and to align the fibres. Micrographs and fibre orientation analyses using X-ray CT scans are shown in Chapter 3. To achieve the best possible alignment during the filament winding process, tensile tests were first carried out on the dry, unimpregnated rovings. This was performed using a tape tensile tester developed at the IVW that, by deflecting the tapes for the purpose of restraint, reduces excess stress in the restraint and determines the pure tensile strength of the tape [31]. This effect can also be used for the rovings.

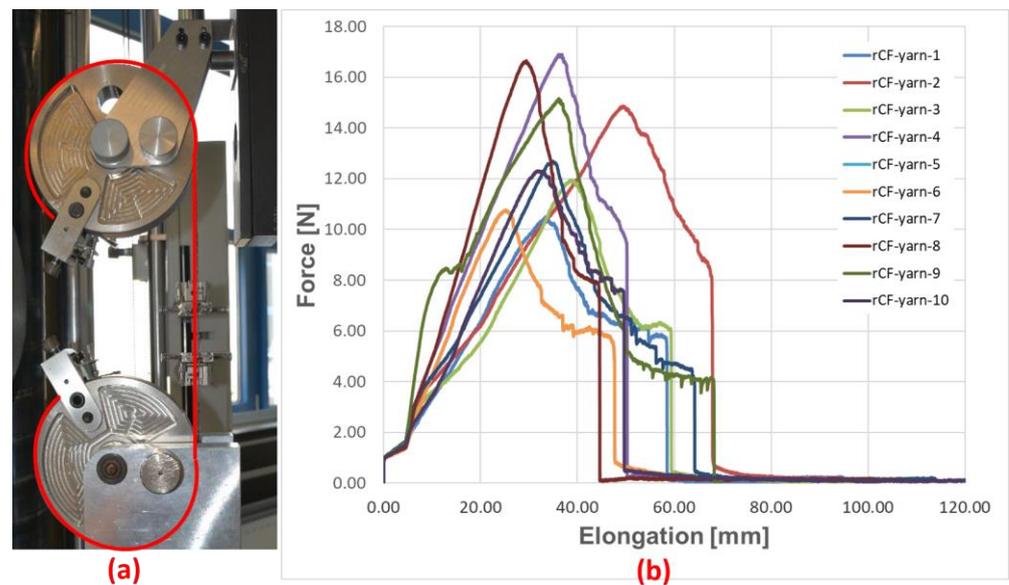
Figure 2. Dry tensile tests on rCF rovings: test setup with tape clamping system and clamping of roving (red line) (a); force–displacement diagram (b).

The test setup and the determined force–elongation curves are shown in Figure 2.

Due to the inhomogeneity of the rovings, the resulting tensile strength (in N) is widely scattered between 10 and 18 N. Therefore, the lower limit of 10 N was used as the pre-tensioning force for the subsequent panel production to avoid possible cracking or slipping of the rovings.

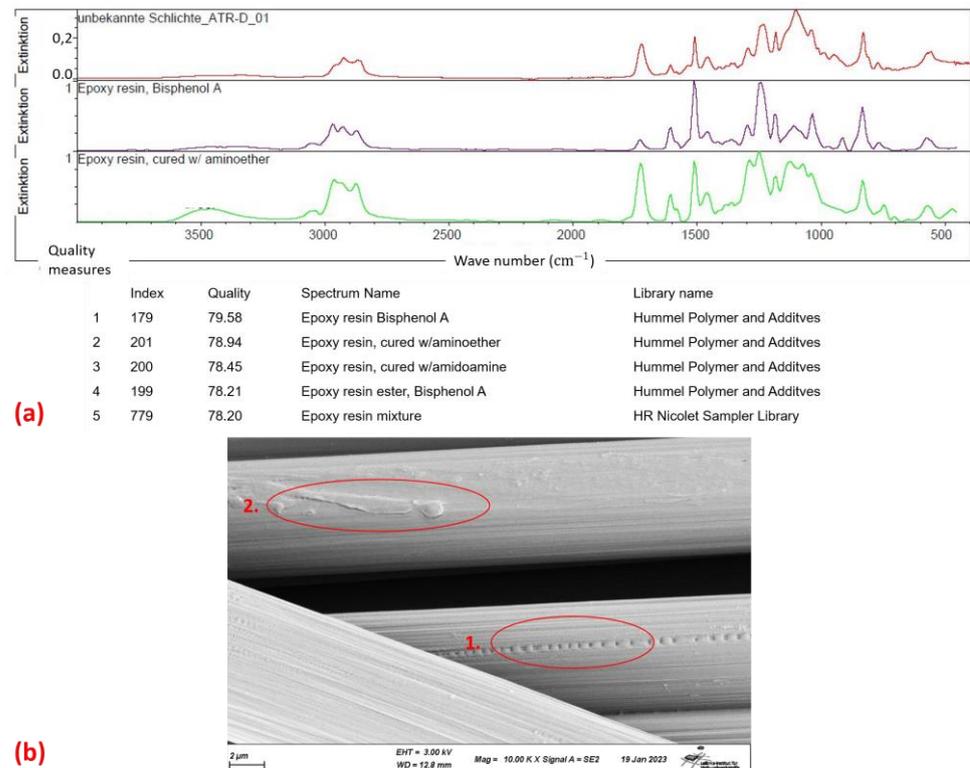
Figure 3. Analysis of dry rCF roving: FTIR analysis of residues on fibres (a) and SEM images of fibre surface with film attachment (1) and damages on fibre (2) (b).

shown in Figure 3. The FTIR analysis showed a 70–80% match with an epoxy sizing. This is a first indication that the fibres used are either not pyrolysed or have been re-coated with a new sizing. Unfortunately, there is no reliable information from the manufacturer.

A film can be clearly seen on the fibre when looking at the SEM image (Figure 3(b1)). This again indicates that there is no untreated fibre. In addition to the film, damage is also visible on the fibre, possibly caused by the carding process (Figure 3(b2)). Such pre-damage may have a negative effect on the subsequent mechanical properties, but has not been considered further below.

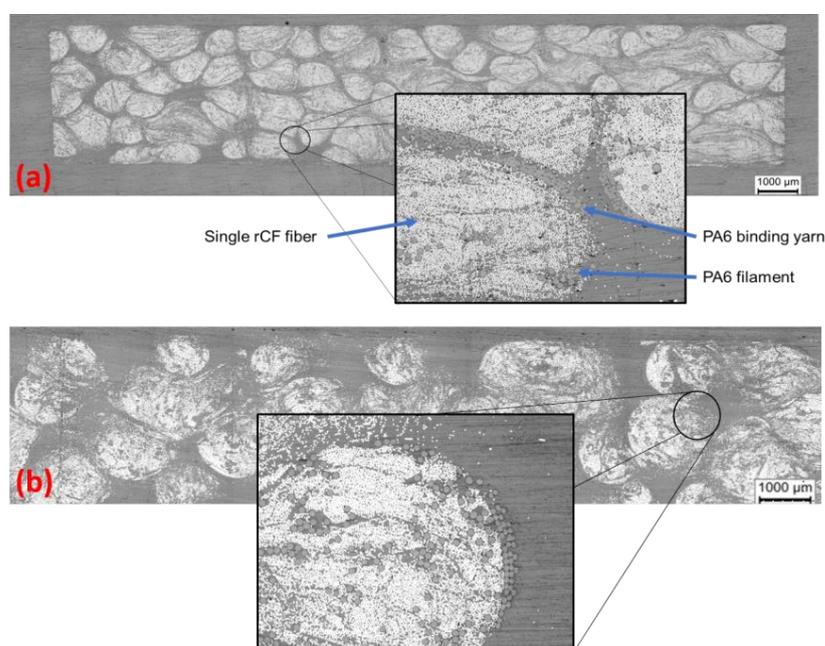
**Figure 4.** Microsection of the Bio-rCF (a) and EP-rCF (b). Typical microstructure with matrix, single rCF fibres, binding yarn and PA6 filaments visible.

The first step is to examine the microstructure of the plates produced by micro-sectioning. The impregnation quality, possible pore content and fibre volume content are to be determined approximately. The impregnation of the EP-rCF, PA6-rCF and the Bio-rCF specimens is of good quality (cf. Figure 4). There are no large defects or pore accumulations that could affect the mechanical properties. The fibre volume content differs slightly between the two samples (Bio-rCF \approx 37% and EP-rCF and PA6-rCF \approx 30%), which is due to the different processing methods. This must be taken into account when interpreting the results.

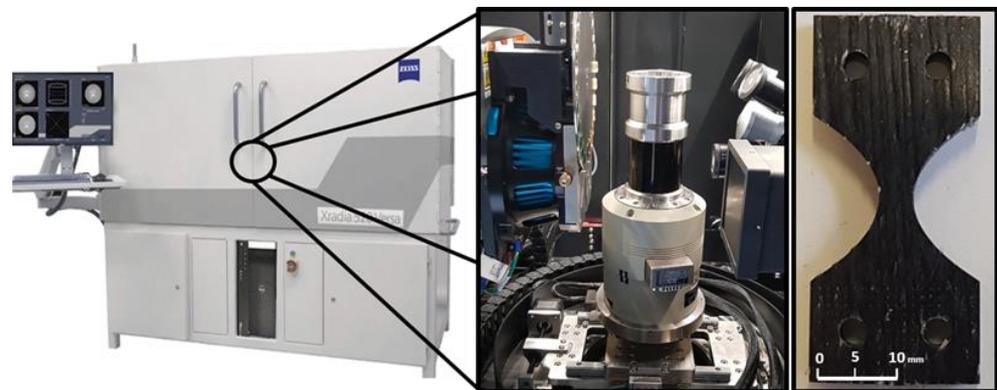
Figure 5. X-ray Microscope Zeiss Xradia 520 Versa with in situ Module Deben CT 5000 and used sample geometry.

The test set-up for the in situ tests is shown in Figure 5. A material testing device from Deben UK Ltd. (Bury Saint Edmunds, UK), specifically designed for in situ computed tomography (CT) testing, was used [35]. It can be used for static and low-cycle tensile, compression and bending tests up to a maximum load of 5 kN. This device was built into the ZEISS Xradia (Oberkochen, Germany) 520 Versa X-ray microscope [36]. Special optics inserted in the beam path allow resolutions of up to 200–300 nm to be achieved. In the in situ experiments carried out in this work, measurements were made with a resolution of 1.5 μm .

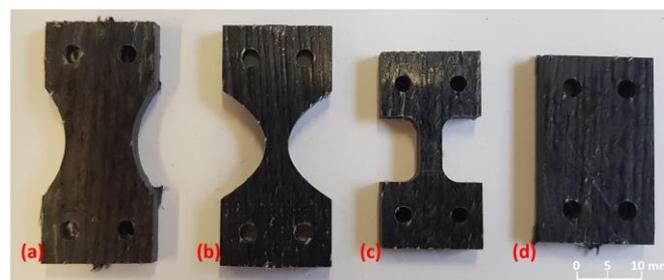
Figure 6. Different sample geometries tested in situ: (a) tapered sample with large region of interest (ROI), (b) tapered sample with small ROI, (c) nearly straight ROI sample and (d) rectangular sample.

The first step was to design a specimen geometry that would not exceed the maximum load to failure, but would also achieve the required resolution while still containing sufficient material structure (at least one complete roving). Different geometries were milled from a wound rCF plate and tested (cf. Figure 6). The sample geometry in Figure 6b showed the best conditions due to its resolution and failure behaviour. However, the maximum load in the fibre orientation (0° orientation) was challenging for all specimen geometries. Unfortunately, the 0° tests resulted in increased failure in the clamping as well as slipping in the clamping (clamping force could not be increased due to the associated damage to the specimen). Therefore, at this stage, only tensile tests transverse to the fibre orientation could be carried out. In the discussion in Chapter 4, the first approaches to solving the problem are listed, which can also be solved by the installation of the AE measurement technology.

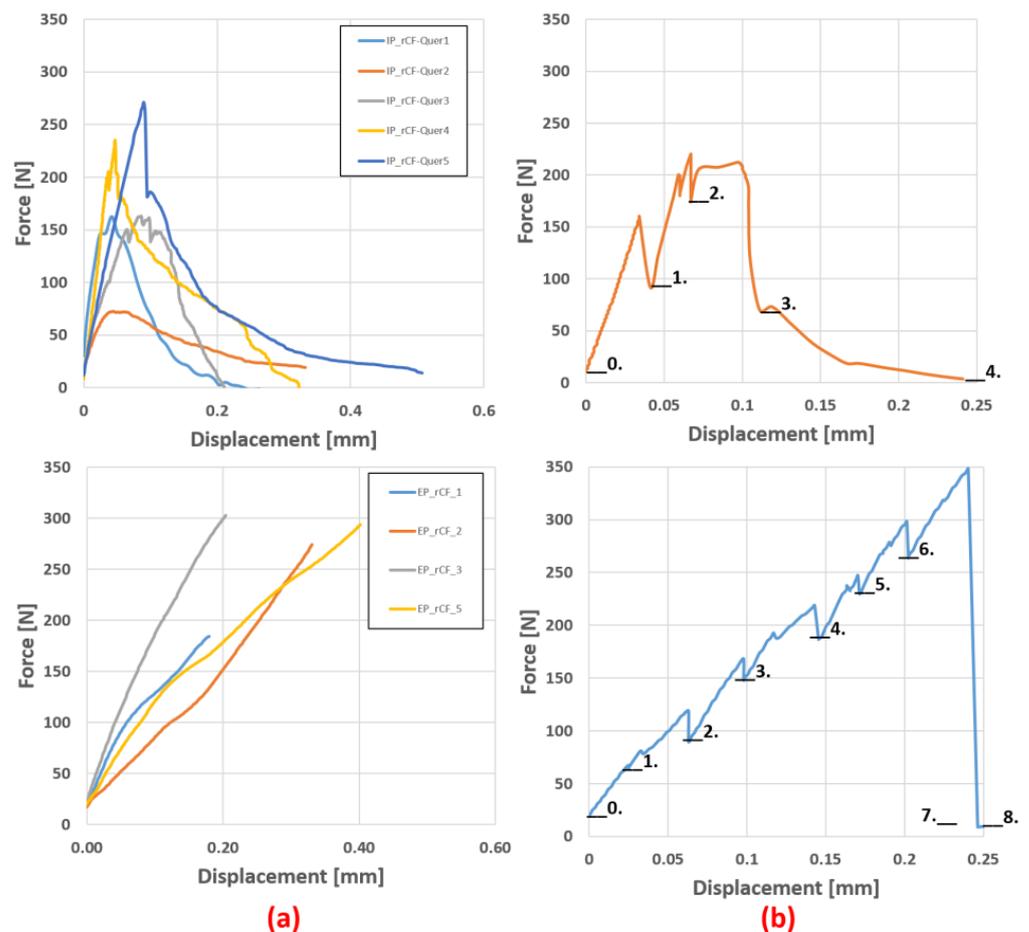
Figure 7. (a) Force–displacement diagram from the pre-tests of the rCF in situ samples Bio-rCF (top) and EP-rCF (bottom) normal to the fibre orientation. (b) Measurement diagram during in situ experiments with load levels; relaxation of sample visible.

At first, the tensile properties of the in situ samples were measured ex situ with the in situ test device to determine the load levels for the actual measurements. This is important for finding relevant points, where the actual CT scan can be started to detect the failure mechanism. It is also important to find the relaxation time of the specimen at certain load levels in order to reduce specimen movement during the CT scan [37]. The results for both materials are shown in Figure 7a and the diagram of the in situ measurement with the corresponding load steps is shown in Figure 7b. The relaxation time for both materials was approximately 30 min after reaching the target load. No further changes in load were measured after this time. Relaxation in the Bio-rCF tests was different at all load levels. This could be due to the small number of load steps and the therefore greater differences in applied loads from one step to another. In the EP-rCF tests, the relaxation was around 10–15% of the target load (except for load step 2 at 30%).

The same behaviour can be detected in the EP-rCF sample. In this test series, eight load steps were performed. This resulted from the difference in applied load on the sample in the in situ measurement and the pre-tests. Relaxation processes during the CT measurement (load drop can be seen in Figure 7 bottom) and the resulting stress relief in the material are causal for this increase in load steps because failure occurs at a later state. The increase of 40% from the mean value of pre-tests (16% from max. value) can be seen in Figure 7b. For comparison purposes, only the last 4 load levels are shown in Figure 12, which illustrates the failure behaviour for the EP-rCF.

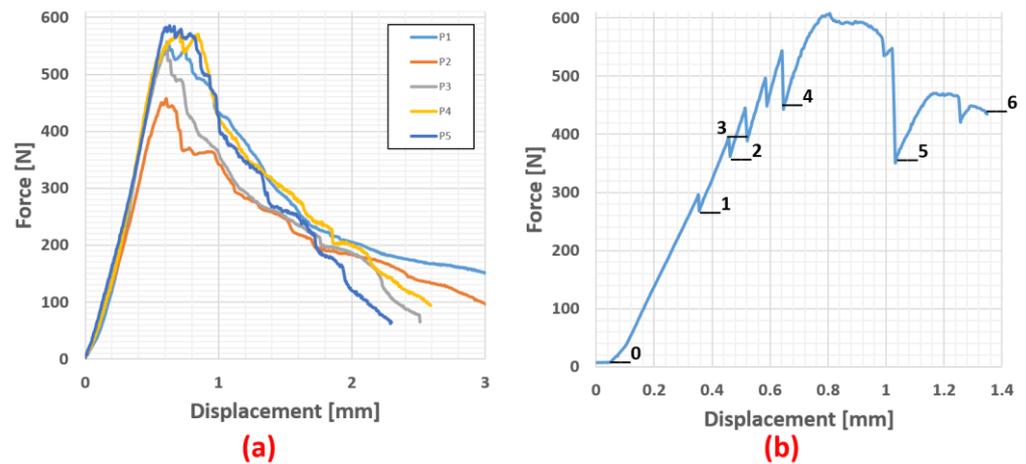
Figure 8. (a) Force–displacement diagram of the Bio-rCF bending pre-test and (b) measurement diagram during in situ bending experiment.

The same procedure was followed for the bending specimens (Figure 8). The specimen geometry was a rectangular specimen with dimensions of $25 \times 3 \times 2$ mm (length \times width \times height) and a support width of 20 mm. Seven load levels were set to give a better overview of fibre movement, likely delamination or crack initiation.

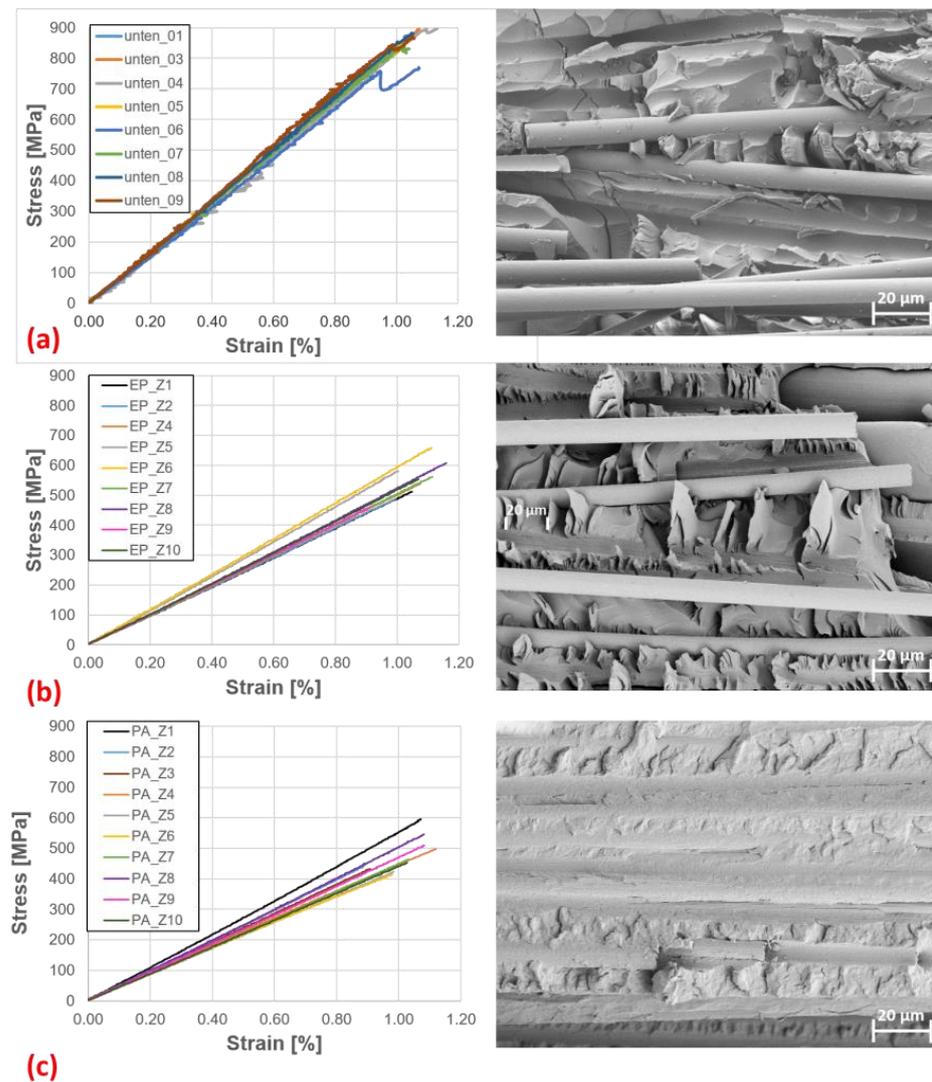
Figure 9. Tensile tests: Stress-strain diagrams and SEM images of fracture surfaces of (a) Bio-rCF, (b) EP-rCF and (c) PA6-rCF.

For the Bio-rCF and the EP-rCF samples, large fibre channels can be seen, which are due to pure fibre pull-out. In addition, no matrix attachment is visible on the exposed fibres. Gaps between the fibre and matrix are also visible on the visible embedded fibres. This could be due to delamination by the applied stresses. However, it is also possible that the matrix adhesion was not well established during the manufacturing process. In contrast, the fibre–matrix adhesion in the PA6-rCF is slightly better. Fibre channels are also visible, but more fibres are embedded and fibre–matrix adhesion is visible on the exposed fibres. The fibre–matrix adhesion is not ideal, but looks better than with the other system, which is in contrast to the FTIR results.

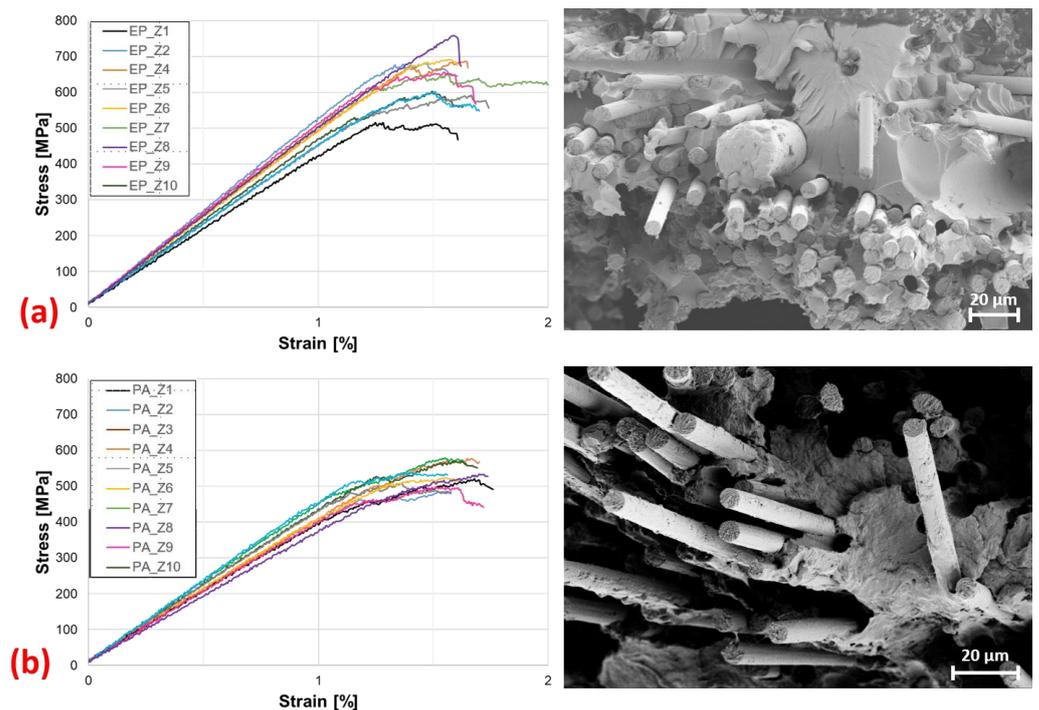
Figure 10. Bending test: stress–strain diagrams and SEM images of fracture surfaces of (a) EP-rCF and (b) PA6-rCF.

In the following, the flexural properties of the EP-rCF and PA6-rCF specimens are presented and their characteristic values are compared. The stress–strain diagrams (Figure 10) show an apparently linear course up to a strain of approx. 1.2%. After that, a decreasing slope of the graphs up to fracture is visible. This could be a consequence of the matrix influence of the composite, which is favoured by the mobility of the staple fibres in the material.

When looking at the SEM images (Figure 10) of the flexural specimens, similar characteristics to those present in the tensile specimens are noticeable. Fibre pull-out channels are evident in both materials, indicating poor fibre–matrix adhesion. The exposed fibre ends of the EP-rCF specimens do not exhibit matrix adhesion, again confirming this. In the PA6-rCF samples, however, isolated adhesions are visible, again indicating slightly better adhesion properties to the rCF fibre.

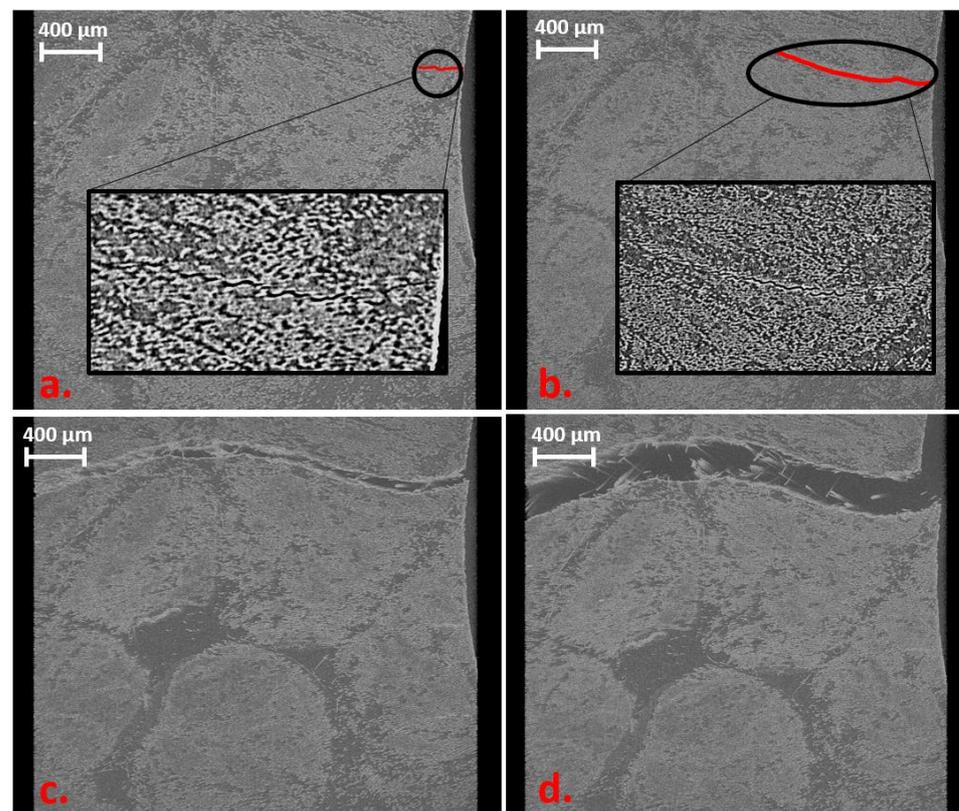
Figure 11. Volume rendering images of the different load levels (unloaded level not shown) of Bio-rCF sample. (a) 100 N: small crack (red line) at the edge. (b) 170 N: crack propagation (red line) between the fibres. (c) 220 N: failure of the sample. (d) Crack opening of 0.2 mm: some bridging fibres visible.

Beginning with the results of the testing of the Bio-rCF, the following behaviour, which can be seen in Figure 11, was detected.

In the first load step (100 N), a small crack (30 µm) appears at the edge of the specimen. This crack spreads through the matrix with a higher load (crack length of 124 µm at 170 N). It can be seen that the crack propagates between the roving structures. In addition, bigger resin pockets were not affected by crack initiation or propagation. At the third load level (220 N), a nearly horizontal crack through the whole specimen at the smallest diameter of the sample geometry can be observed. A reason for crack propagation from load level one to three is that the crack propagation is independent of the material structure (parts

of higher/lower fibre content) and the tailored shape of the specimen promotes a defined failure event at the middle of the sample. The sample geometry is therefore suitable for receiving a defined failure event at the centre plane and can be reliably detected in the region of interest in the X-ray microscope.

At the fourth load level, a crack opening of 0.1 mm was performed to reconstruct the fibre pull-out while post-failure. Here, it can clearly be seen that isolated fibres cross the crack and connect the two separated parts. A fibre pull-out because of free fibre ends in the crack zone cannot clearly be detected because of the small elongation of the sample (overlapping length of the fibres up to 50 mm). This will always lead to a compromise: by increasing the field of view to detect a larger pull-out length, the resolution will downgrade and single fibres cannot be detected. Only an estimation can be made with the in situ tests and it has to be proved in standard tensile tests.

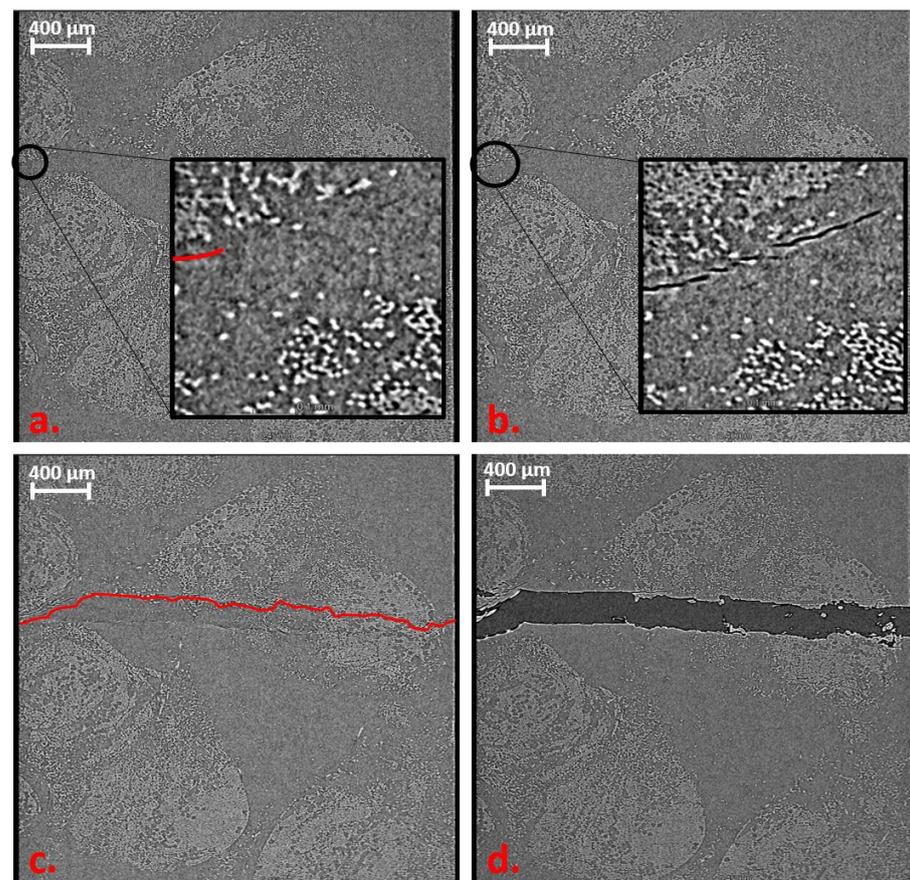
Figure 12. Volume rendering images of in situ tensile test of EP-rCF. (a) 220 N: small crack (red line) at the edge of sample. (b) 250 N: crack propagation between the fibres. (c) 300 N: failure of the sample. (d) Crack opening of 0.2 mm.

Here too, the damage behaviour is similar to that of the Bio-rCF. In Figure 12a, a slight crack is visible (marked in red for better visualisation). The crack initiation starts within a roving that is slightly above the narrowest part of the specimen (normally, the maximum

stress under tensile load is in the narrowest part of the tapered specimen). When the load is increased to 300 N, the crack continues to expand through the roving (Figure 12b). In Figure 12c at 350 N, failure of the specimen takes place. It can be seen that the crack that penetrates the entire specimen is not identical to the crack seen at the previous load levels. This suggests that micro-cracks are already present in the previous load levels that were not visible in the CT scan but lead to failure due to the stress maximum at the narrowest point. Figure 12d shows post-failure, where the crack has widened by 0.1 mm. It can be seen that individual filaments bridge the crack and thus maintain the structural cohesion of the specimen (“fibre bridging”). No more load is applied to the specimen (constant load at 20 N) and only fibre pull-out from the interconnected fracture surfaces takes place. This behaviour can also be verified by SEM images of the failed specimens from the quasi-static mechanical tests, where fibre bridging also occurred (cf. fibre channels visible)

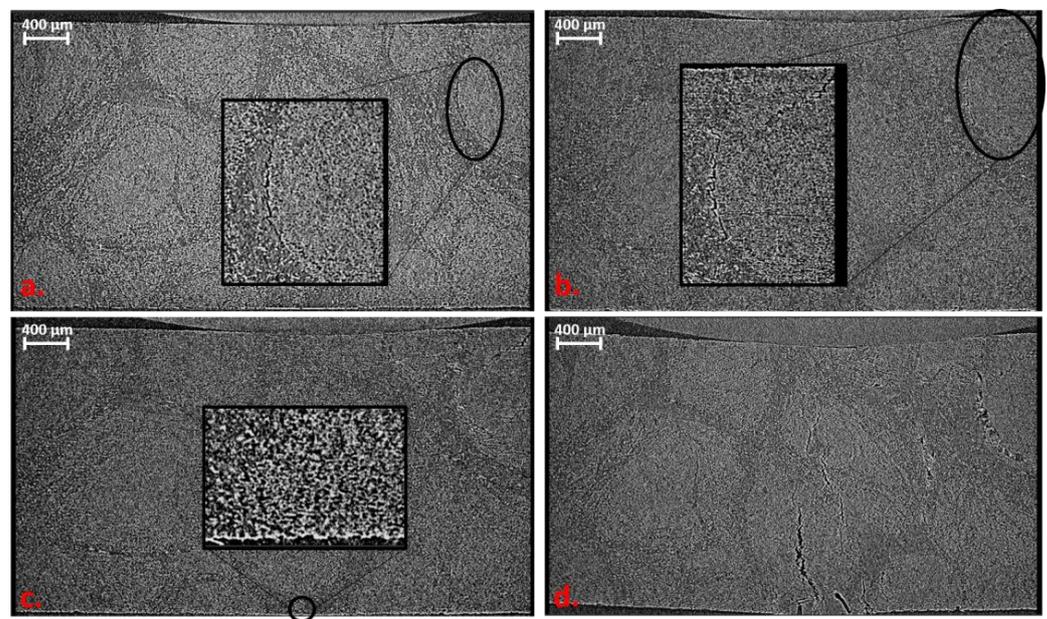
Figure 13. Volume rendering images of in situ bending test of Bio-rCF. (a) 400 N: small crack at border to the pressure fin. (b) 500 N: crack propagation between the fibres. (c) 550 N: crack initiation on tension side of sample. (d) 600 N: failure of sample before load drop.

Figure 13a shows that a crack initially forms on the upper side of the sample near the pressure fin, starting from the surface. Since the crack runs diagonally through the material, the crack can only be shown in a 2D sectional image for this paper (image resolution in which the connection to the surface is not visible). In Figure 13b, this connection is now visible due to the crack growth. At both load levels, pure compression failure near the compression fin can be concluded. Only at load level 4 (Figure 13c) can the first cracks be detected on the tension side of the specimen, which are due to tensile stresses. At load level 6 (Figure 13d), it can clearly be seen that the cracks from both the top and bottom of the specimen propagate in a straight line through the material, leading to the failure of the specimens. Delamination and shear failure are not visible.

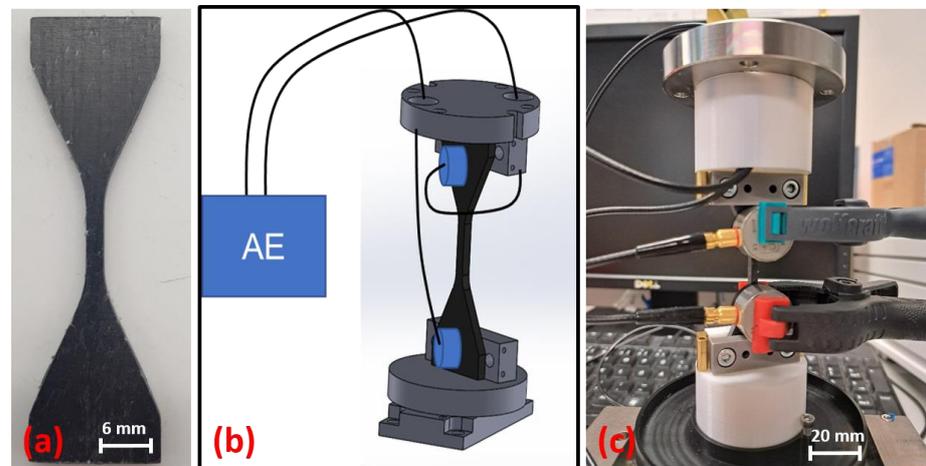
Figure 14. Integration of AE sensors into in situ Deben CT 5000: (a) adapted sample geometry, (b) construction drawing of setup and (c) first integration try with in situ test device.

In order to integrate the sensors of the acoustic emission (AE) apparatus into the Deben CT 5000 in situ module, new clamps must first be developed that allow the sensors to be guided through the closed construction into the interior. The clamps were designed in

such a way that a new sample geometry can be used [38]. The setup including the specimen can be seen in Figure 14.

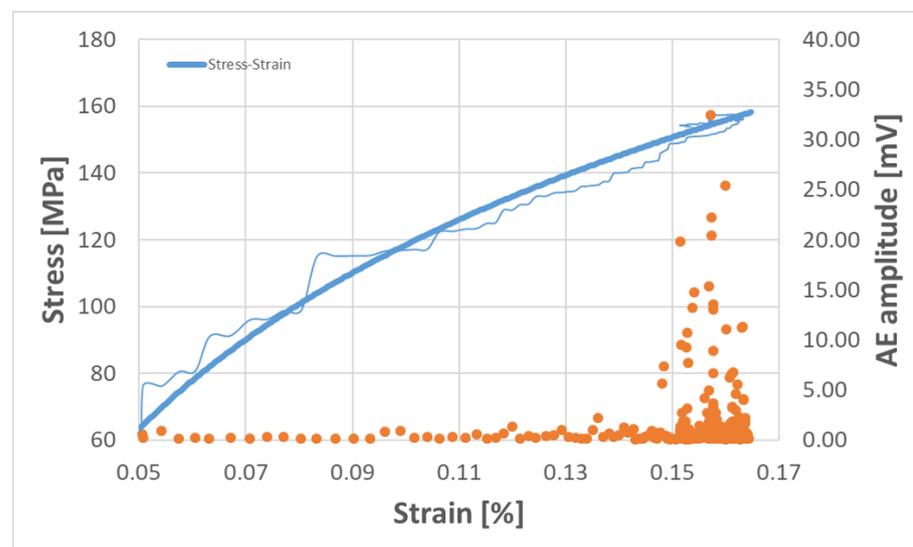
Figure 15. Example of stress–strain diagram (blue lines; bright line average value) of Bio-rCF sample with AE signal distribution (orange dots).

The typical stress–strain curve for the rCF material (blue line) is shown. The orange dots represent the recorded AE events, which provide clues to events in the material. Here, it can be seen that, up to an elongation of 0.13%, no conspicuous signals were recorded. From there on, not only does the number of recorded events increase (increase in point density), but there is also a clear increase in the amplitude of the signals, especially from 0.15% strain. This increase correlates with the onset of damage and ultimately the failure of

the specimen at 0.17% strain in the tensile test. This in turn means that the acoustic signals have detected initial damage in the material.

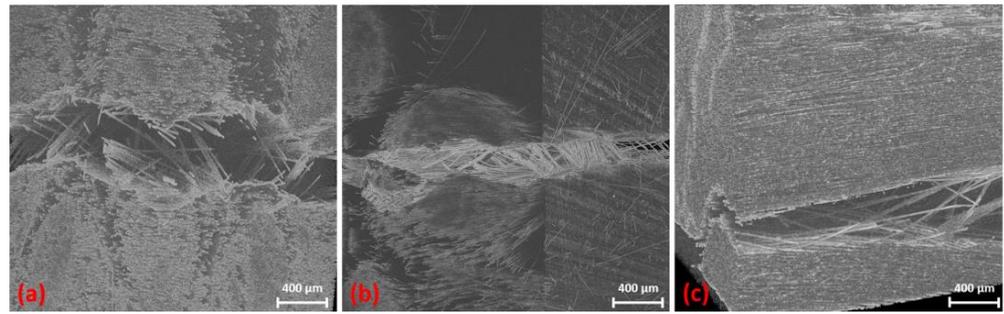
Figure 16. Good-natured post-failure behaviour with bridging fibres detected in in situ tests: Bio-rCF tensile test (a), EP-rCF tensile test (b) and Bio-rCF bending test (c).

The failure that occurs can be described as good-natured, as individual fibres or rovings bridge the fracture and thus there is no complete structural failure (Figure 16a,b). The post-failure behaviour is characterised by a forceless fibre pull-out of the bridging fibres (due to the lack of fibre–matrix adhesion). This means that, depending on the length of the bridging fibres, the elongation of the specimen after failure can be up to 50% of the individual fibre length (here, between 30 and 40 mm) until structural failure occurs.

The effect of good-natured failure was also demonstrated in the in situ bending tests (Figure 16c). In addition, the failure behaviour (failure under compression and tensile load as a function of the fin arrangement) from the classic bending tests could be verified.
