Article

Comparison of Repair Methods for Cracked Titanium Alloy Aircraft Structures with Single-Sided Adhesively Bonded Composite Patches

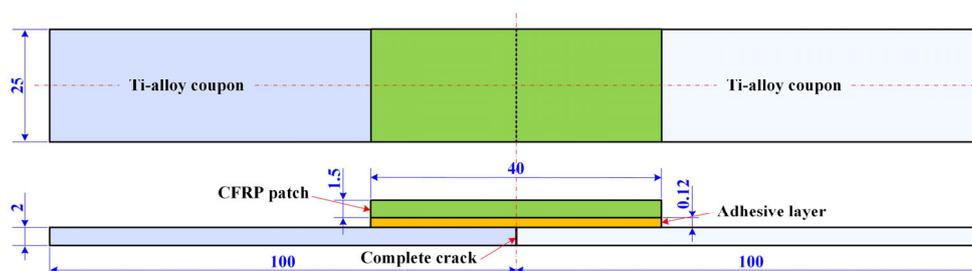
Figure 1. Geometrical configurations of repaired Ti-alloy specimens with single-sided composite patches (unit: mm).

A butt joint containing two Ti-alloy coupons and one single-sided composite patch bonded with adhesive film was employed as the test configuration to investigate the efficiency of three distinct repair methods applied to fully cracked metallic structures, as illustrated in Figure 1. Differing from the semi-cracked specimens in previous work [18,19], this configuration excluded the influence of residual stiffness and the strength of cracked metallic components on the repair performance so that only the effects of the repair methods were involved. The Ti-alloy coupon was made from Ti6Al4V with a geometry of 100 mm × 25 mm × 2 mm and provided by Shanghai Luhao Metal Co., Ltd., Shanghai, China. The adhesive film was SY-24C structural adhesive with a thickness of 0.12 mm and was provided by the Beijing Institute of Aerial Materials (Beijing, China). As for the patch, there were four different specifications, namely pre-cured unidirectional laminate, unidirectional (UD) prepreg, plain weave (PW) prepreg and wet-layup patches that corresponded to pre-curing, prepreg and wet-layup methods. For simplicity, the specimens repaired with pre-cure, UD prepreg, PW prepreg and wet-layup patches are represented by cases A, B, C and D, respectively. These patches were made from T300 carbon fibers and 7901 epoxy matrix resin provided by Shanghai Cedar Composites Technology Co., Ltd. (Shanghai, China). The main ingredient of the 7901 matrix was phenolic resin with a reactive flame retardant. The geometry of the patches was set to 40 mm × 25 mm × 1.5 mm. Each UD prepreg or dry fiber cloth thickness was about 0.15 mm, thus there were 10 plies in a composite patch and the total nominal thickness was 1.5 mm in cases A, B and D. As for the PW prepreg in case C, the single ply was 0.2 mm in thickness, with only 7 plies employed to obtain the total nominal thickness of 1.4 mm. The adhesive film and the composite prepreg were covered with anti-adhesive paper on both sides to prevent contamination prior to their use. The mechanical properties of the Ti-alloy coupon, film adhesive, cured UD and PW composite laminas are listed in Table 1.

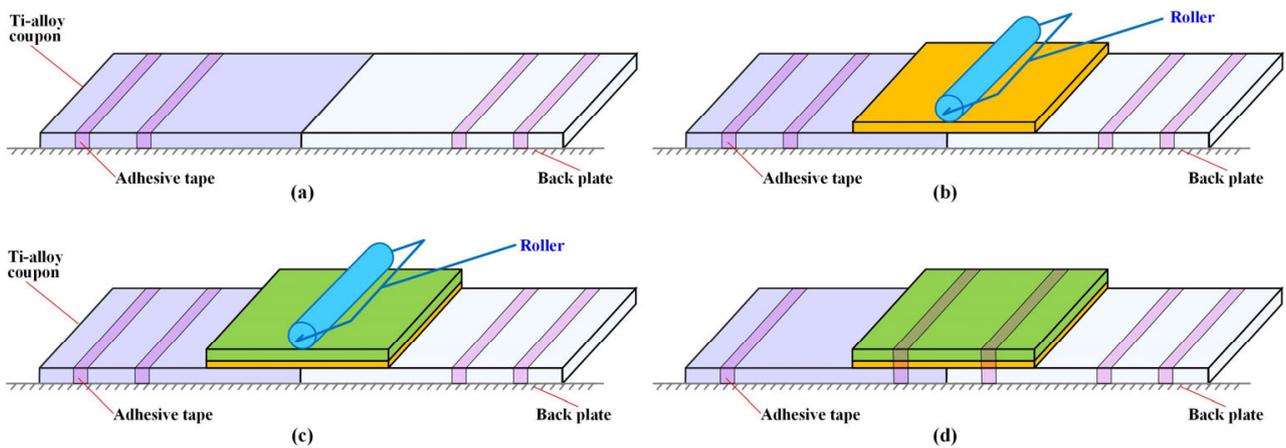
Figure 2. Preparation for cracked Ti-alloy specimen repaired with a composite patch. (a) Fixation of Ti-Alloy coupons, (b) adhesive film layup, (c) composite patch layup, (d) fixation of well-prepared specimen.

The repair bonding process where the composite patch was applied to the cracked Ti-alloy component is presented in Figure 2. Firstly, two Ti-alloy coupons were fixed to a steel back plate with thin adhesive tape to form a butt joint (Figure 2a). Then, adhesive film was cut to the required size and pasted on to the butt zone after its bottom paper was uncovered. A roller was used to press the upper surface of the adhesive film to remove bubbles and gaps in order to make it firmly bond to the Ti-alloy coupons (Figure 2b). Thirdly, the prepared composite patch was overlaid on the adhesive film with a designed 0° fiber orientation after the papers on both mating surfaces were removed. Again, the roller was used to consolidate the patch, wet all the fibers, release air, and to conform to the coupons. The latter two steps were strictly repeated if more than one layer of prepreg was needed for repairing specimens in the cases of B, C and D in the prepreg and wet-layup methods (Figure 2c). Finally, the patch zone was bundled up with thin adhesive tape and fixed to the backing plate to avoid relative movement in the upcoming cure process (Figure 2d).

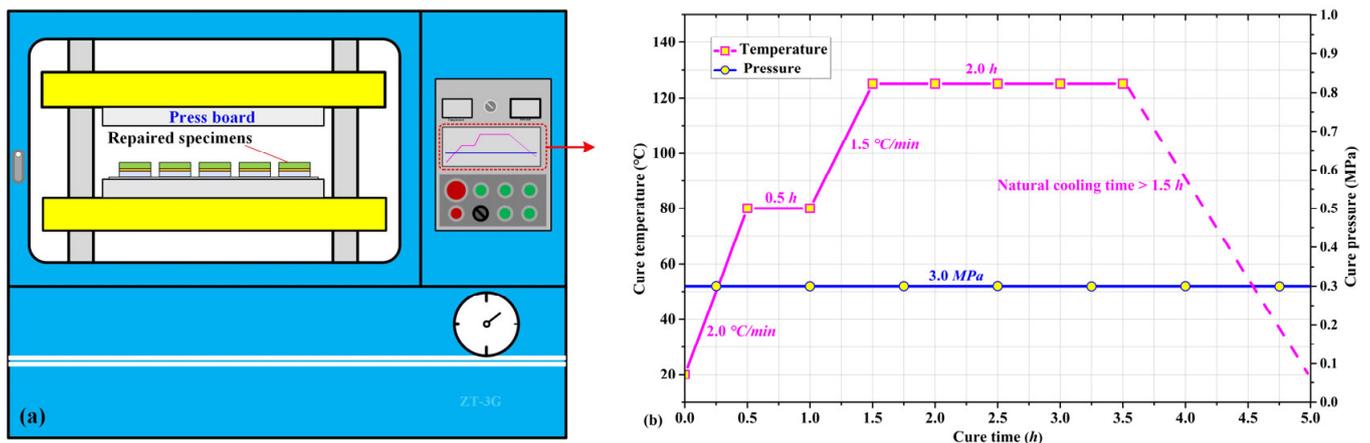
Figure 3. Cure process for cracked Ti-alloy specimens repaired with composite patches, (a) repaired specimens placed in automatic pressure precision machine, (b) curing temperature and pressure curves.

The four preformed repair specimen specifications were cured in an automatic pressure precision machine (ZG-3T, Dongguan, China) as shown in Figure 3a. The curing temperature and pressure curves are presented in Figure 3b. Since the SY-24C adhesive film and 7901 epoxy resin had the same curing temperature and duration, it was reasonable to choose these two materials for repair research. In the pressure machine, the preformed repair specimens together with the backing plates were placed between two parallel pressure boards with a predetermined cure pressure of 0.3 MPa applied to the specimens (Figure 3a). The specimens were first heated up from room temperature to 80 °C in 0.5 h, followed by a

0.5-h maintenance at this temperature for the initial cure. Then the cure temperature rose to 125 °C in 0.5 h and was kept at that temperature for 3 h for a thorough cure (Figure 3b). The specimens were naturally cooled through opening the air-tight door to release the residual stress caused during the curing process. The spilt prepreg and adhesive on both lateral sides of the repaired specimens were cut out to make their final dimensions. It should be noted that although the UD patches in cases A, B and D were 0.1 mm thicker than the PW patches in cases C, the former were easily flattened due to them lacking lateral constraints to the longitudinal fiber bundles. Fiber bundles and epoxy resin spilt out easily under the cure pressure, resulting in a reduced thickness than the nominal value. However, it was not the case for the PW patch since the fiber bundles of warp yarn and weft yarn constrained mutually, making them hard to spill out. Thus, the final thickness difference between UD and PW patches was much smaller than 0.1 mm and its influence on repair efficiency and failure mode could be ignored.

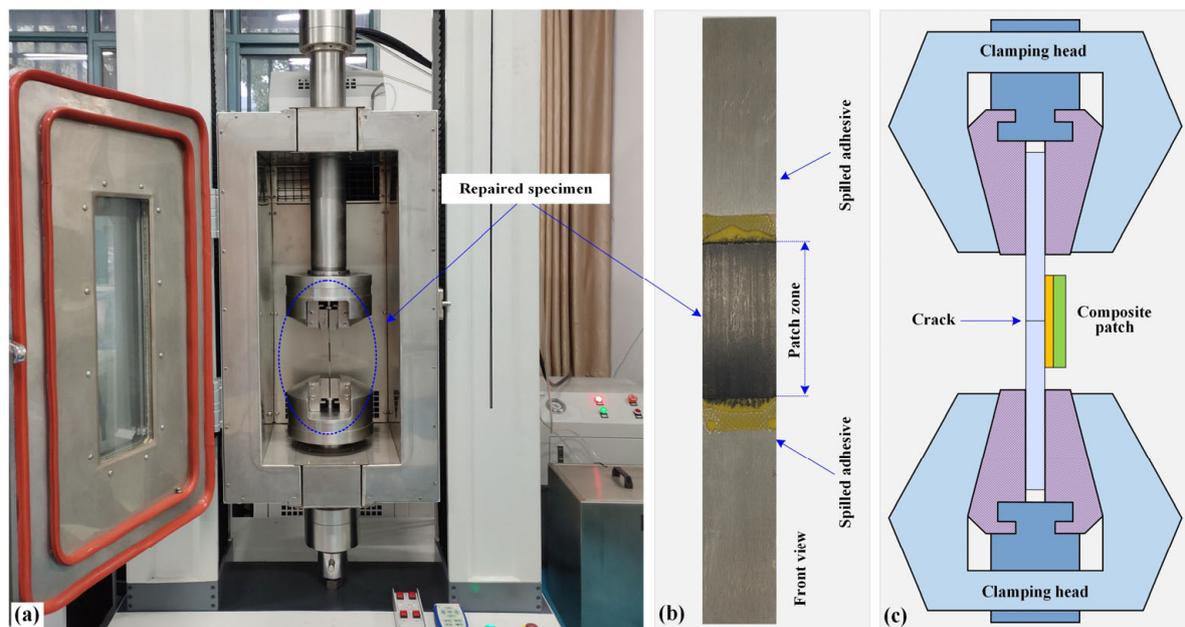
Figure 4. Test setups for repaired specimens: (a) testing machine with clamped specimen, (b) front view of repaired specimen, (c) hydraulic gripping fixture with clamped specimen.

The specimens repaired with different methods were statically loaded to evaluate their repair effectiveness. The quasi-static tensile tests were conducted in a universal testing machine (Pootae 100GDW-60, Dongguan, China) with a load capability of 100 kN, as shown in Figure 3a. The relative error of force-displacement measurement and control

accuracy was within $\pm 1\%$. Before testing, two ends of the repaired specimen were held with hydraulic clamping fixtures at a distance of 30 mm as shown in Figure 4a. Then, all the tests were performed with a constant displacement rate of 1.0 mm/min during which the data of load–displacement curves were continuously recorded. Loading stopped when the repaired specimens ruptured and the load–displacement curves drastically dropped. Each specimen specification was repeated at least five times. After testing, the damage morphology and failure mode of the broken specimens were elaborately observed and analyzed. It is worth mentioning that for each patch specification, the five specimens were made in two batches (see Section 2.2): three in the first and two in the second to evaluate the stability of repair process.

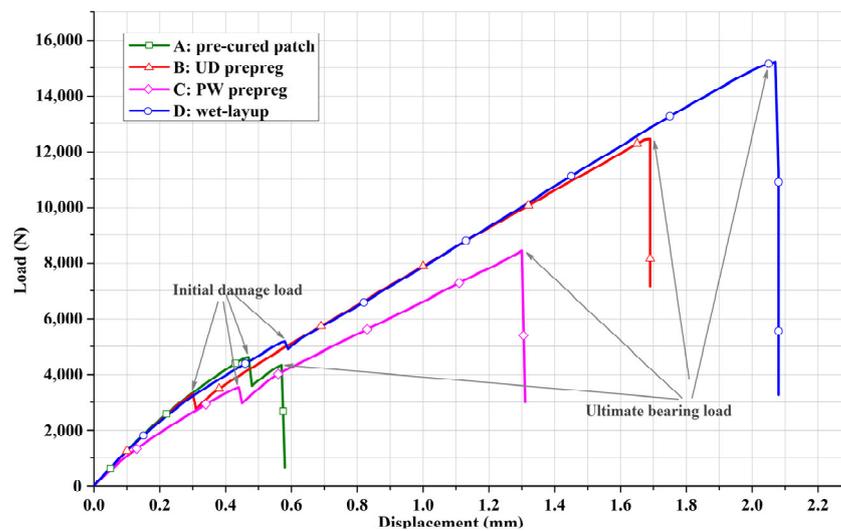
Figure 5. Typical load-displacement curves of four repaired specimen specifications.

The typical load–displacement curves of the four specimen specifications from the three repair methods are presented in Figure 5. Generally, all the curves went through three phases: elastic–linear, damage propagation and complete fracture regardless of their final bearing capacity. For each load–displacement curve, these three phases were divided into two key points: the initial damage load point and the ultimate bearing load point. Commonly, the value of the former was smaller than that of the latter since the repaired structure continued to bear load increments after damage initiated and propagated in the repaired zone. There is, however, an exception to the pre-cured method or case A, where the phase of damage propagation was very short and the ultimate peak value was visibly smaller than that at the damage initiation point. This unique phenomenon indicated that the failure mechanism of the pre-cured method was different from the prepreg and wet-layup methods since it was adhesively bonded, while the other two were essentially co-cure joined. It should also be noted that the curve slope and ultimate bearing load of the PW prepreg patch in case C were much smaller than those of the UD prepreg patch in case B although they were prepared with the same carbon fibers and epoxy resin; this gap cannot be ascribed to the small thickness difference but to the difference of the 0° fiber content in the loading direction.

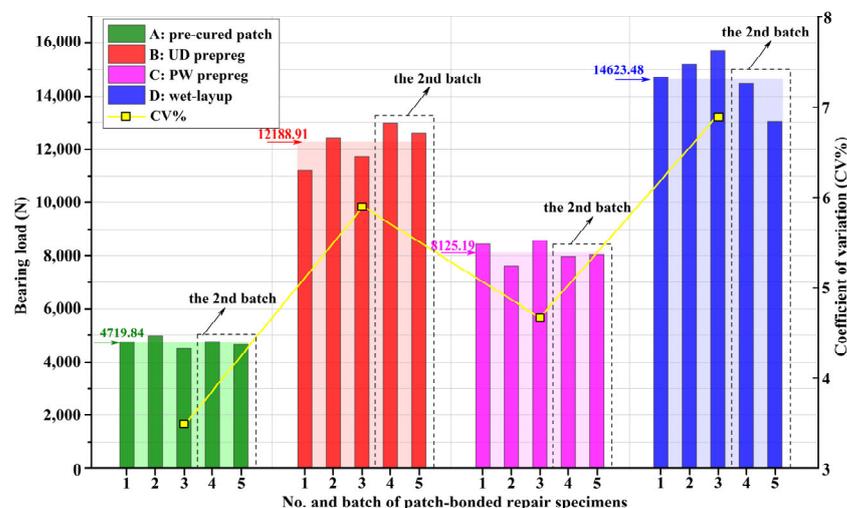
Figure 6. The ultimate bearing loads and the corresponding coefficients of variation (CV) of all repaired specimens from two separate preparation batches.

In order to evaluate the processing stability of the three repair methods, five repaired specimens in each patch specification were fabricated in two separate batches as mentioned earlier. The ultimate bearing loads of all the repaired specimens and their corresponding coefficients of variation (CV) are presented in Figure 6. It can be observed that for the specimens with the pre-cured and the WP patches in cases A and C, respectively, the ultimate bearing loads of the second batch were roughly the same as those in the first one. The CV of case A was only 3.51%, which was smaller than that of case C, which was about 4.67%. For the UD prepreg patch in case B, the ultimate bearing loads of the second batch were visibly greater than those of the first batch and because of this, the CV was larger than the PW patch in case C, at about 5.91%. As for the wet-layup patch in case D, the ultimate bearing loads of the second batch were obviously smaller than the first, thus the CV was the greatest of all at about 6.89%. Therefore, it can be concluded that the process stability of the pre-cured method was the best, followed by the PW and UD prepreg patches in the prepreg method. The wet-layup method presented the most unstable repair process because applying the matrix resin to unidirectional dry fiber cloth to form wet and sticky patch plies at the repair site was hard to standardize, and depended heavily on personal experience.

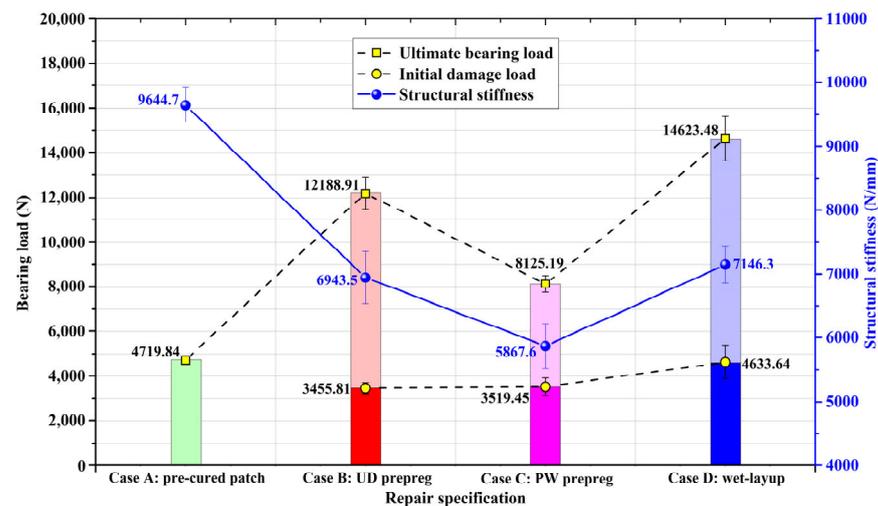
Figure 7. Structural stiffness, initial damage, and ultimate bearing loads of repaired specimens from four patch specifications.

The average structural stiffness, initial damage, and the ultimate bearing loads of four repaired specifications abstracted from their load-displacement curves are presented in Figure 7 to evaluate the repair effectiveness. Although the pre-cured patch in case A, UD prepreg patch in case B and wet-layup patch in case D have the same amount of 0° plies in loading direction, the repaired specimens in case A possessed the highest structural stiffness among them, about 9644.7 N/mm, followed by cases D and B in sequence, about 7146.3 N/mm and 6943.5 N/mm, respectively, which evidences that the repair method could partly determine the final stiffness of repaired structures. Since the 0° fiber content of PW prepreg patch in loading direction in case C was half of that in cases A, B and D, its stiffness was only 5867.6 N/mm, demonstrating that the architecture of composite patch could also affect the structure stiffness. In terms of loading behavior, the repaired specimens in case D possessed the highest ultimate bearing load of 14,623.48 N, closely followed by the repaired specifications of case B and then case C, about 12,268.91 N and 8125.19 N, separately. The ultimate bearing load in case A was only 4179.84 N owing to the bad bonding interface. As for initial damage load, it was 4633.64 N in case D, which was nearly equivalent to the ultimate bearing load of case A. In contrast, the initial damage load of prepreg method was much smaller, about 3455.81 N and 3519.45 N for case B and C, individually. It can be concluded that the on-site prepared wet-layup patch can achieve better interfacial binding force than the readymade prepreg patches because of the rich matrix resin. However, the sufficient resin applied to the fiber cloth could not distribute evenly and fill out the space between all of the fibers, which conversely pushes up the CV in patch preparation process.

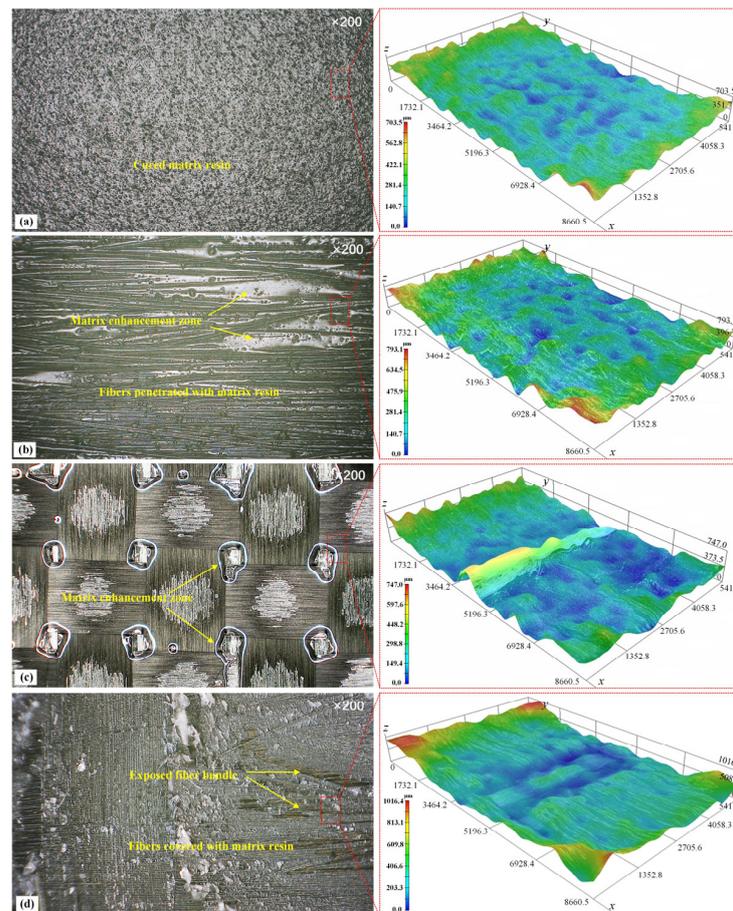
Figure 8. Surface morphology of composite patches made via different methods: (a) pre-curing method, (b) unidirectional prepreg patch, (c) weave prepreg patch, (d) wet-layup method.

The surface morphologies of the composite patches made from four repair specifications were observed with an automatically zoomed 3D surface measurement instrument (NT1100, Veeco Wyko, Tucson, AZ, USA) to figure out the mechanism of interfacial bonding behaviors in different cases (Figure 8). In the pre-cured patch, the fibers were covered with cured epoxy resin which formed a light-reflecting and low-energy surface. The surface roughness was within $351.7 \mu\text{m}$, which was too smooth to be infiltrated with a structural adhesive to generate a mechanical engagement force on the bonding interface (Figure 8a). In the UD prepreg patch, the fiber bundles together with the striped matrix resin enrichment zones were easily observed. The undulated side-faces of the fibers and the uncured matrix resin formed a relatively coarse and sticky surface for repair bonding, which greatly improved the interface binding force (Figure 8b). The PW prepreg patch was similar to the UD patch. The difference was that the intertwined warp and weft fiber bundles formed a

squared and uneven surface with a roughness of $597.6 \mu\text{m}$. The resin enrichment zones were coincidentally at the intersection points of the warp and weft yarns, whereas the resin deficiency zones were in the center of the squares (Figure 8c). In the wet-layup patch, the fiber bundles were bound loosely with a thermal fuse to form waved, unidirectional fiber cloth in which sufficient gaps or space were reserved for the penetration of the applied matrix resin. The prepared wet-layup patches with the flexible fiber bundles and abundant epoxy resin fitted the Ti-alloy coupons seamlessly, making a well-bonded interface to restore the structural load transfer path (Figure 8d).

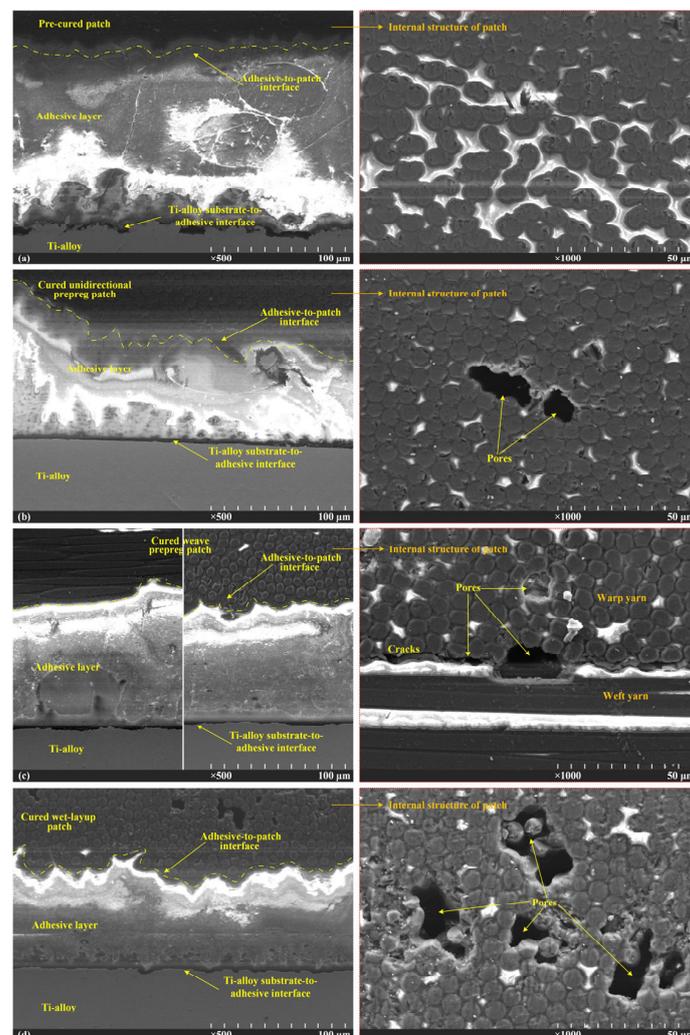
Figure 9. The microstructures of the bonding interfaces between Ti-alloy coupons and composite patches: (a) pre-curing method, (b) unidirectional prepreg patch, (c) weave prepreg patch, (d) wet-layup method.

The microstructures of the bonding interfaces between the Ti-alloy and the four composite patch specifications were inspected via a scanning electron microscope (JEOL SEM5600LV, Tokyo, Japan), as seen in Figure 9. All of the bonding interfaces contained five layers: the Ti-alloy substrate, the Ti-alloy-to-adhesive interface, the adhesive layer, the adhesive-to-patch interface, and the patch substrate; their thickness and micromorphology varied with the distinct repair methods. For the pre-cured patch interface in case A, the adhesive layer was wide because it could only be squeezed out of the bonding area via the pre-cured laminate patch instead of penetrating into it; there was a clear demarcation interface between the adhesive layer and the composite patch. A high level of peeling stress was induced via the eccentric load patch in the wide adhesive layer and this resulted in cohesive failure [13]. The only advantage of the pre-cured method was that the composite patch was compact inside and no pore was observed (Figure 9a). For both the UD and the PW prepreg patches in cases B and C, the width of the adhesive layer was much narrower than that in case A. There was no apparent boundary between the adhesive layer and the prepreg patch. Instead, they integrated, penetrated, and even interlocked with each other,

forming a well-bonded interface. However, the disadvantage was that the pores were observed in the handmade patches, indicating that the air was not completely discharged during the rolling and curing, undermining the strength of the patches (Figure 9b,c). It should be noted that in case C, the pores often appeared near the intersection zone of the warp and weft fiber bundles of the PW prepreg patch and became the crack cores which developed into observable cracks when subjected to the external loading (Figure 9c). As for the wet-layup patch in case D, the fusion between the adhesive layer and the carbon fiber cloth immersed with epoxy resin was strengthened when compared with cases B and C. Thus, the interface between them presented highly jigsaw-like patterns which were regarded as good bonding interfaces. However, the pores were more prone to formation in the wet-layup patch since it was hard to ensure the uniformity of the manually immersed matrix resin in the dry carbon fiber cloth (Figure 9d). The repair methods in cases B, C and D using the co-curing process with soft uncured patches conformed more easily to the complex geometries of the cracked structures than the rigid pre-cured patch in case A. Comparatively, the prepreg method was a compromised choice that prevailed against the others in terms of the quality of the bonding interface, the patch compactness, and the compaction process that needs to be improved to reduce patch porosity.

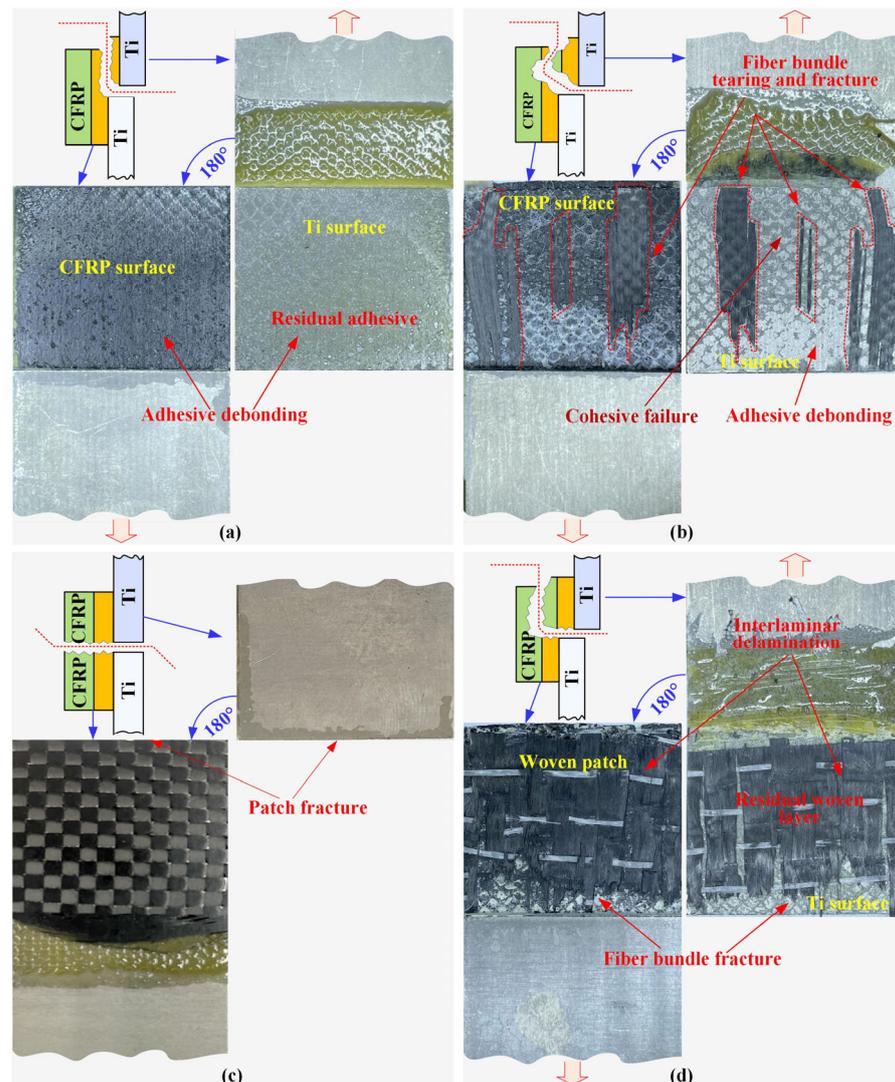
Figure 10. Failure morphology of repaired specimens with different repair methods: (a) pre-curing method, (b) unidirectional prepreg patch, (c) weave prepreg patch, (d) wet-layup method.

On the cracked Ti-alloy panel repaired with the composite patch, the external load was transmitted along the path from the Ti-alloy substrate, the Ti-alloy-to-adhesive interface, the adhesive layer, the adhesive-to-patch interface to the composite patch sequentially, during which, the weakest part in such a repair system determined the load carrying capacity of the repaired specimen. This weakest part was identified through observation of the failure modes in the broken repaired structures. The failure morphologies of the four repaired specifications are presented in Figure 10.

In case A, the pre-cured patch was entirely peeled off from the upper Ti-alloy coupon and attached to the lower one. The residual adhesive film mainly adhered to the upper Ti-alloy surface, while the mating surface of the composite patch was light-reflecting. The fractured mating surfaces exhibited an adhesive failure mode in the adhesive-to-patch interface, demonstrating that the pre-cured composite patch was not suitable for metallic repair (Figure 10a). In case B, the UD prepreg patch detached from the upper Ti-alloy coupon and presented three mixed failure modes. The clean and smooth zones on the surface of the upper Ti-alloy was adhesive or debonding failure on the Ti-alloy-to-patch interface which occupied about 20% of the fracture surface. Some fragments of the bottom ply were torn out from the UD prepreg patch and were tightly attached to the Ti-alloy

surface, presenting an adherend failure mode. The other 50% of the surface was a cohesive failure since the residual adhesive film was observed on the two uneven mating surfaces. It was a transitional stage where the failure mode transitioned from the adhesive failure to the prepreg ply failure, indicating that these vital layers had similar strength in the repair system (Figure 10b). In case D, the main failure mode was the interlaminar delamination of the wet-layup patch, accompanied by the fracture of the fiber bundles and the cohesive failure at the end of the upper Ti-alloy coupon; the adhesive strength was therefore much greater than the interlaminar strength of the wet-layup patch. Thus, the patch itself was the weakest part of the repair system and its interlayer performance must be purposefully enhanced (Figure 10d). The only distinctive failure mode occurred in case C, where the PW weave patch broke in half along the central crack. This failure of morphology was reasonable when considering that the 0° fiber content in the PW prepreg patch in the loading direction was only half of that of the UD patch. It is believed that the PU prepreg is not an ideal alternative to UD patches with a diverse stacking sequence when the same grade carbon fiber prepreg is employed for structural reparation. (Figure 10c).
