# Mechanical Performance Evaluation of Repair Materials Suitable for Mechanical Pressurizing Equipment for Cross-Sectional Repair of Concrete Box Structures

Abstract: This study entailed performance tests to confirm the bond performance of the proposed new repair material and the pressurization effect of the developed mechanical pressurizing equipment. The physical property changes of the new repair material were reviewed by varying the mixing ratio of high aluminate cement (HAC)-mixed mortar. Strength tests were performed according to the mixing ratios of polymer and silica fume to improve the bond performance. To improve water retention, the mixing ratios of the cellulose and nylon fibers were adjusted, and the change in water retention was measured. The proposed repair material mixing ratio yielded the best performance when pressure was applied to the repair surface. Comparing the existing repair materials and the new repair material prepared by adjusting the ratios of HAC-mixed mortar, cellulose fiber, redispersible powder resin, and other factors confirmed that the new repair material has a high bond strength.

**Keywords:** mechanical pressurizing equipment; high aluminate c

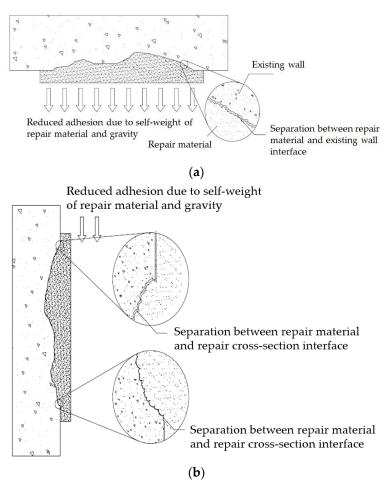
**Figure 1.** Separation of concrete structure. (a) Ceiling separation; (b) wall separation.

To solve the separation problems represented in Figure 1, this study developed mechanical pressurizing equipment (MPE, Seongnam-si, Republic of Korea), as shown in Figure 2. Figure 2a presents a detailed diagram of the MPE; the reinforcement support consists of easily movable wheels and a plate located below the angle adjustment element and supports and maintains the pressure generated in the main pressurization element. As shown in Figure 2b, the main pressurization element consists of the perforated plate (Figure 2c), main expansion member, and lower support plate. By forming an installation space with a rod that can maintain a gap with the perforated plate, it has sufficient contact with air when pressurizing the repair material. The contact area between the perforated plate and mortar was made of a flexible material, ensuring a uniform pressure was applied to the irregular repair surface. A pressure gauge and pressure controller were attached to the main expansion member, ensuring a constant pressure was applied, as shown in Figure 2d.

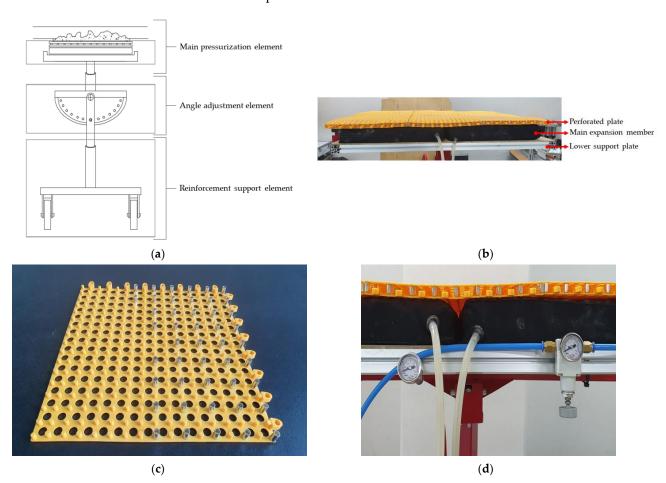
**Figure 2.** Composition of MPE. (a) Detailed diagram of MPE; (b) main pressurization part; (c) perforated plate of the main pressurization part; (d) pressure adjustment part of the main expansion member.

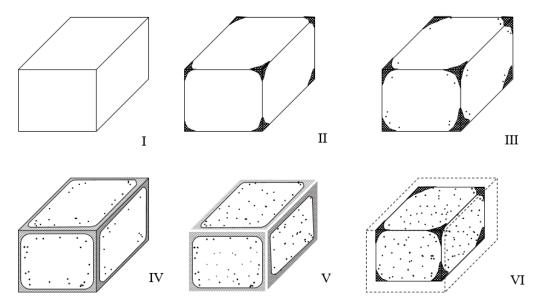
**Figure 3.** Appearance grades of mortar eroded by acid. (I) Negligible; (II) very small deterioration; (III) detectable deterioration; (IV) delamination and small mass loss; (V) considerable mass loss; (VI) almost failure.

To evaluate the acid resistance of the mortar specimens, ninety-six 50 mm cube specimens were immersed in fresh water, a 5% sulfuric acid solution, and a 10% sulfuric acid solution for 14 and 28 days, after which the appearance of the specimens was investigated. As shown in Figure 3, the appearance standard and damage conditions through chemical erosion were classified into six grades, according to a previous study [17].

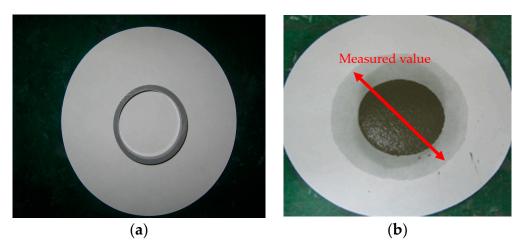
Figure 4. Water retention test. (a) Before the test; (b) after the test.

To measure the water retention of the thickener, the mortars prepared according to the mixtures listed in Table 2 were placed in a ring with a diameter of 50 mm on absorbent paper and left for 20 min, after which the diameter of the water absorbed by the absorbent paper was measured. Equation (3) was used to calculate the water retention, and Figure 4 shows the water retention test [16].

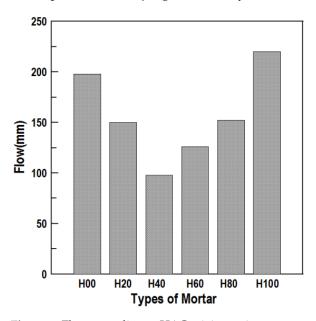
Figure 5. Flow according to HAC mixing ratios.

According to the flow test results, as shown in Figure 5, the flow values of H20, H40, H60, and H80 were smaller than that of H00, and the flow value of H100 was larger than that of H00. Though it seems necessary to consider the amount of HAC-mixed mortar used in terms of fluidity based on the test results, a superplasticizer was applied in the actual repair material mixture, and the W/C was adjusted according to workability and strength standards. Therefore, the effect of the fluidity according to the HAC mixing ratio on the new repair material is judged to be very limited.

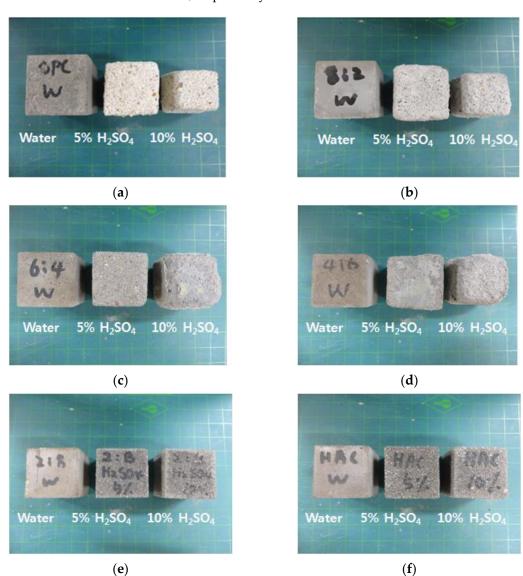
Figure 8. Appearance of the mortars (28 days). (a) H00; (b) H20; (c) H40; (d) H60; (e) H80; (f) H100.

Figure 8 shows the appearances of the eroded HAC-mixed mortars. The appearance grades of the six types of mortar are categorized by acid solution concentration and presented in Table 3 and Figure 9. Figure 8 shows that, compared to the H00 mortar cured in water, the H00 mortar immersed in the acid solution was significantly eroded, resulting in prominent section loss and generation of reaction products. Moreover, according to a comparison with H00 mortar immersed in 5% H<sub>2</sub>SO<sub>4</sub> solution, as presented in Table 3 and Figure 3, the mortar immersed in the 10% HSO solution had already reached appearance grade VI at 14 days and erosion to the point of failure occurrence. The H00 mortar immersed in 10% H<sub>2</sub>SO<sub>4</sub> solution exhibited more than 40% section loss, demonstrating that the degree of erosion varied with the acid solution concentration.

The appearances of the acid-eroded H80 and H100 mortars showed excellent acid erosion resistance compared to the mortars mixed with a small amount of HAC. Particularly, even when immersed in 10%  $\rm H_2SO_4$ , there was barely any performance degradation due to acid erosion. The HAC-mixed mortars have excellent acid resistance because alumina gel, whose main component is  $\rm Al_2(OH)_3$ , is formed, creating a protective layer against the acid solution. In contrast, calcium hydroxide (Ca(OH)<sub>2</sub>) generates when general OPC is hydrated and gypsum (CaSO<sub>4</sub>·2H<sub>2</sub>O) is dehydrated, and has a weak structure due to its porosity.

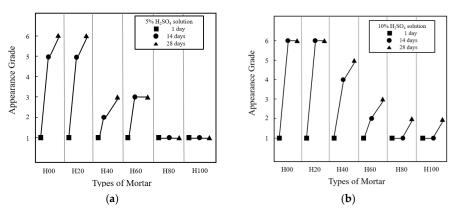
Figure 9. Appearance grades of the mortars. (a) 5% H<sub>2</sub>SO<sub>4</sub>; (b) 10% H<sub>2</sub>SO<sub>4</sub>.

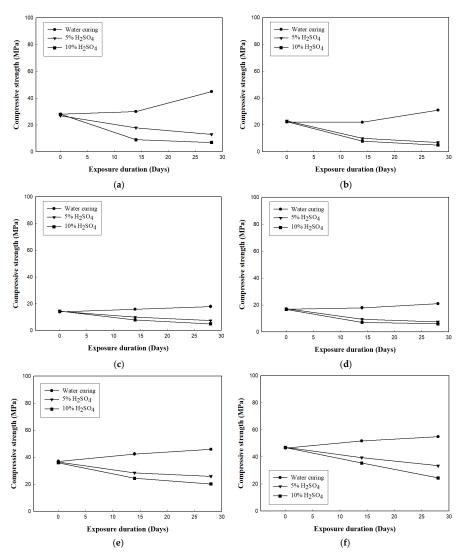
**Figure 10.** Change in the compressive strength of the mortars after acid or water immersion. (a) H00; (b) H20; (c) H40; (d) H60; (e) H80; (f) H100.

Figure 10 shows the change in compressive strength of the cement mortars.

Figure 10a shows the change in the compressive strength of H00. For the mortar cured in water, the compressive strength increased as the exposure period increased. However, the compressive strength of the mortar immersed in the acid solution decreased as the exposure period increased, and the mortar immersed in  $10\% \ H_2SO_4$  solution exhibited a greater decrease in compressive strength than the mortar immersed in  $5\% \ H_2SO_4$  solution. At 28 days, the H00 mortar cured in water showed a compressive strength of approximately

46.0 MPa, whereas the compressive strength of the mortars immersed in 5% and 10%  $H_2SO_4$  solutions was 12.9 and 6.2 MPa, respectively.

Figure 10b shows the change in compressive strength of H20, which had a similar trend to that of H00. Figure 10c,d shows the change in compressive strength due to the acid erosion of the H40 and H60 mortars, respectively. The compressive strengths of the

mortars exposed to 5% and  $10\%~H_2SO_4$  cured in water were similar. However, the change in compressive strength of H80 (Figure 10e) showed a relatively small decrease in strength due to acid erosion compared to the mortars mixed with a small amount of HAC. Figure 10f shows the change in compressive strength of H100, which exhibited the best acid erosion resistance among the six mortar types.

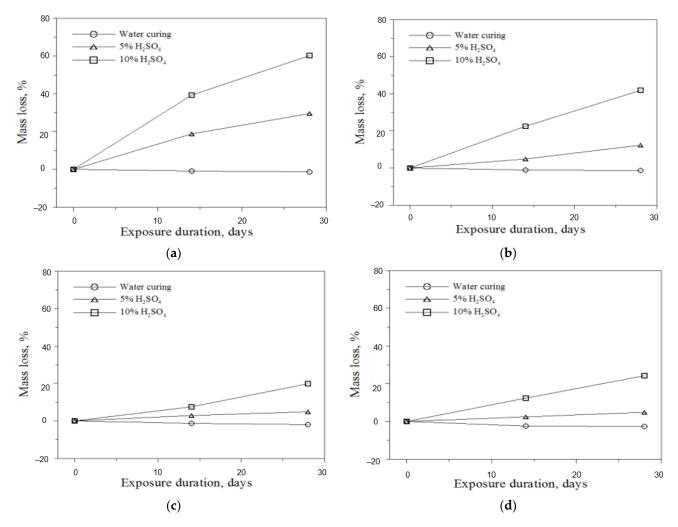
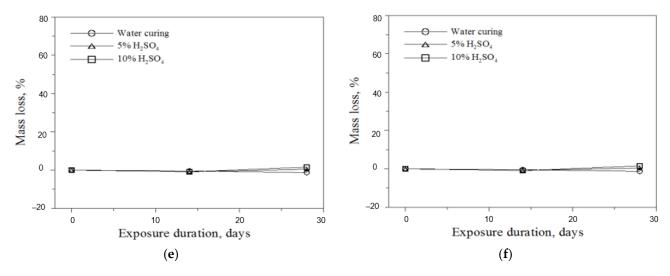
Figure 11. Mass loss of mortar. (a) H00; (b) H20; (c) H40; (d) H60; (e) H80; (f) H100.

Figure 11 shows the change in masses by the age of the acid-eroded mortars. The mass loss at 14 and 28 days after immersing H00 in 5% and 10% H<sub>2</sub>SO<sub>4</sub> solutions was compared with the mass change of the mortar cured in water; the results are shown in Figure 11a. According to the results, the mass loss increased as the concentration of the immersion solution increased. At 28 days, the mass loss of the mortar immersed in the 5%H<sub>2</sub>SO<sub>4</sub> solution was 29.5% and that of the mortar immersed in the 10% H<sub>2</sub>SO<sub>4</sub> solution was 60.2%. Figure 11b shows the mass loss due to the acid erosion of H20. The mass loss was smaller than that of the H00 mortar. Figure 11c,d show the mass loss of H40 and H60, respectively; as indicated, the mass loss due to acid erosion tended to decrease as the replacement rate increased. The mass loss of H80, as shown in Figure 11e, was similar to that of the mortar cured in water regardless of the H<sub>2</sub>SO<sub>4</sub> solution concentration. The H100 mortar in Figure 11f shows a similar trend. These results confirmed that the performance of the HAC-mixed mortar exposed to an acid erosion environment was excellent when the replacement rate of the HAC-mixed mortar was at least 80%. In this test, it was confirmed that the chemical resistance increased in proportion to the amount of HAC used. For the repair material developed in this study, securing resistance to biochemical corrosion is an important factor in the case of sewage boxes, which are mainly applied. The reason why 100% HAC binder cannot be used is that it should be mixed with OPC for controlling the setting time of the repair material.
