# Studying the Water Supply System of the Roman Villa of Pisões (Beja, Portugal) Using Ground-Penetrating Radar and Geospatial Methods

**Abstract:** The Roman villa of Pisões (Beja, Portugal) was part of the Lusitanian colony of Pax Iulia. This place stands out for the predominance of the water element in several structures of the villa, highlighting the *balneum* and the large *natatio*, one of the largest known in Roman Hispania. The records of the initial excavations that took place beginning in 1967 do not allow the establishment of clear functionalities of the villa. The University of Évora, the owner of the site, conceived an action plan for the requalification and enhancement of the archaeological site. One of the tasks aims to investigate the site using applied geophysics. This work analyses the landscape directly related to the villa, given that it is in the flooded area of a river with a Roman containment dam. It is uncertain whether the water supply comes from this structure or other nearby springs. The use of ground-penetrating radar, combined with unmanned aerial vehicles, all integrated in a geographic information system, allows us to determine the location of underg

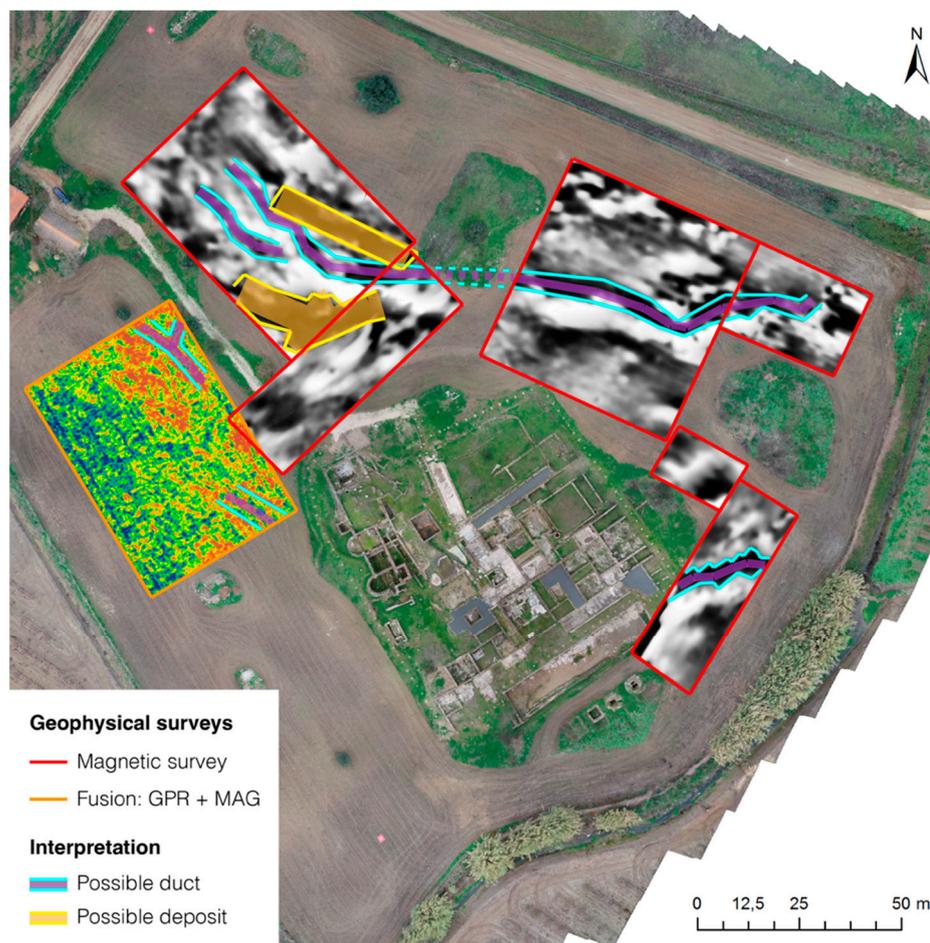
**Figure 2.** Location and results of the geophysical surveys carried out at Pisões.

In 2017, several geophysical surveys have been carried out with different methods to prospect the subsurface and assess the state of conservation of some structures. Between 2018 and 2020, magnetic (vertical gradient mode) and ground-penetrating radar (GPR) surveys were carried out in several sectors around and inside the *pars urbana* (Figure 2) [14–16].

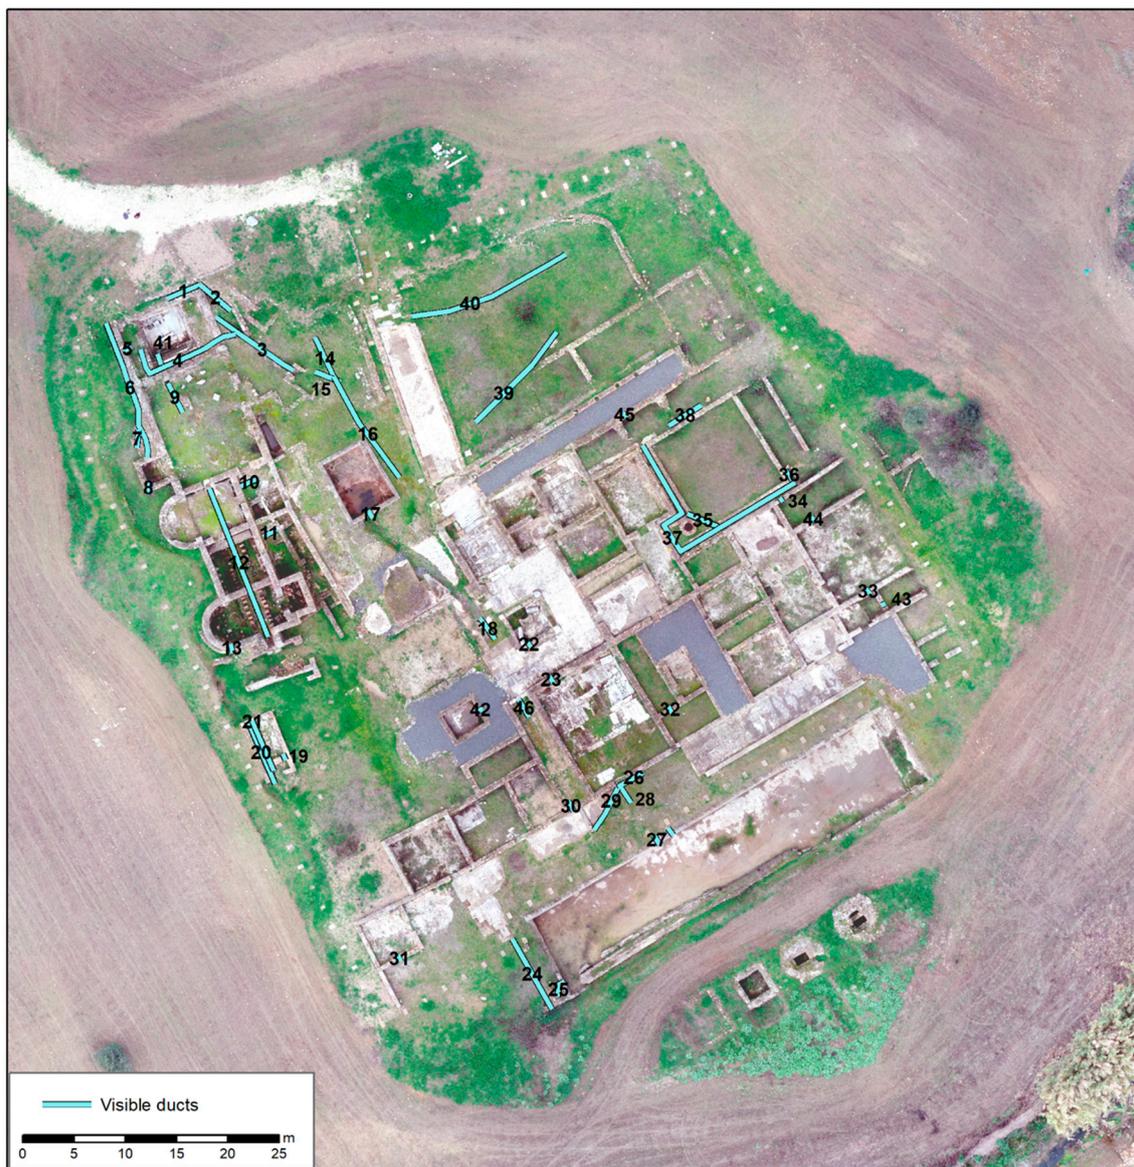
**Figure 3.** Location of visible water conduits in Pisões on the orthophotography of the site.

In the first stage of surface work, we were able to discover a total of 46 water conduits in the villa, within which they served different functionalities and may not have been related to each other. Figure 3 shows the visible conduits, which are described below in groups according to their function. The altitude values of the visible ducts were measured with differential GNSS (Table 3).

Ducts 1 to 9 correspond to the original supply of the thermal building, where pipe 1 is at an elevation of 181.60 m, the highest topographical point in the whole villa. This part of the complex can be understood quite well, given that water flows from pipes 1 and 2 to 6 and from there through 3, 4, and 5 to the *natatio* located there, exiting at pipe 9.

Figure 4 shows examples of the different elements that we detected in the villa with a water conduction function, whose numbering corresponds to the structures identified in Figure 3. Conduit 4 would be under the pavement and would serve to conduct water within the enclosure itself, while conduit 6 is on the side of the *balneum*. Duct 9 is the water exit of one of the *natatio*, and duct 12 is where the water would have gone, which can be seen on the floor of the well-preserved *hypocaustum* with its brick basins. Element 13 is the only water exit that we located on the side of the *balneum* for hot water. Structure 18 is the water conduit that would have supplied water to the center of the villa, while structure

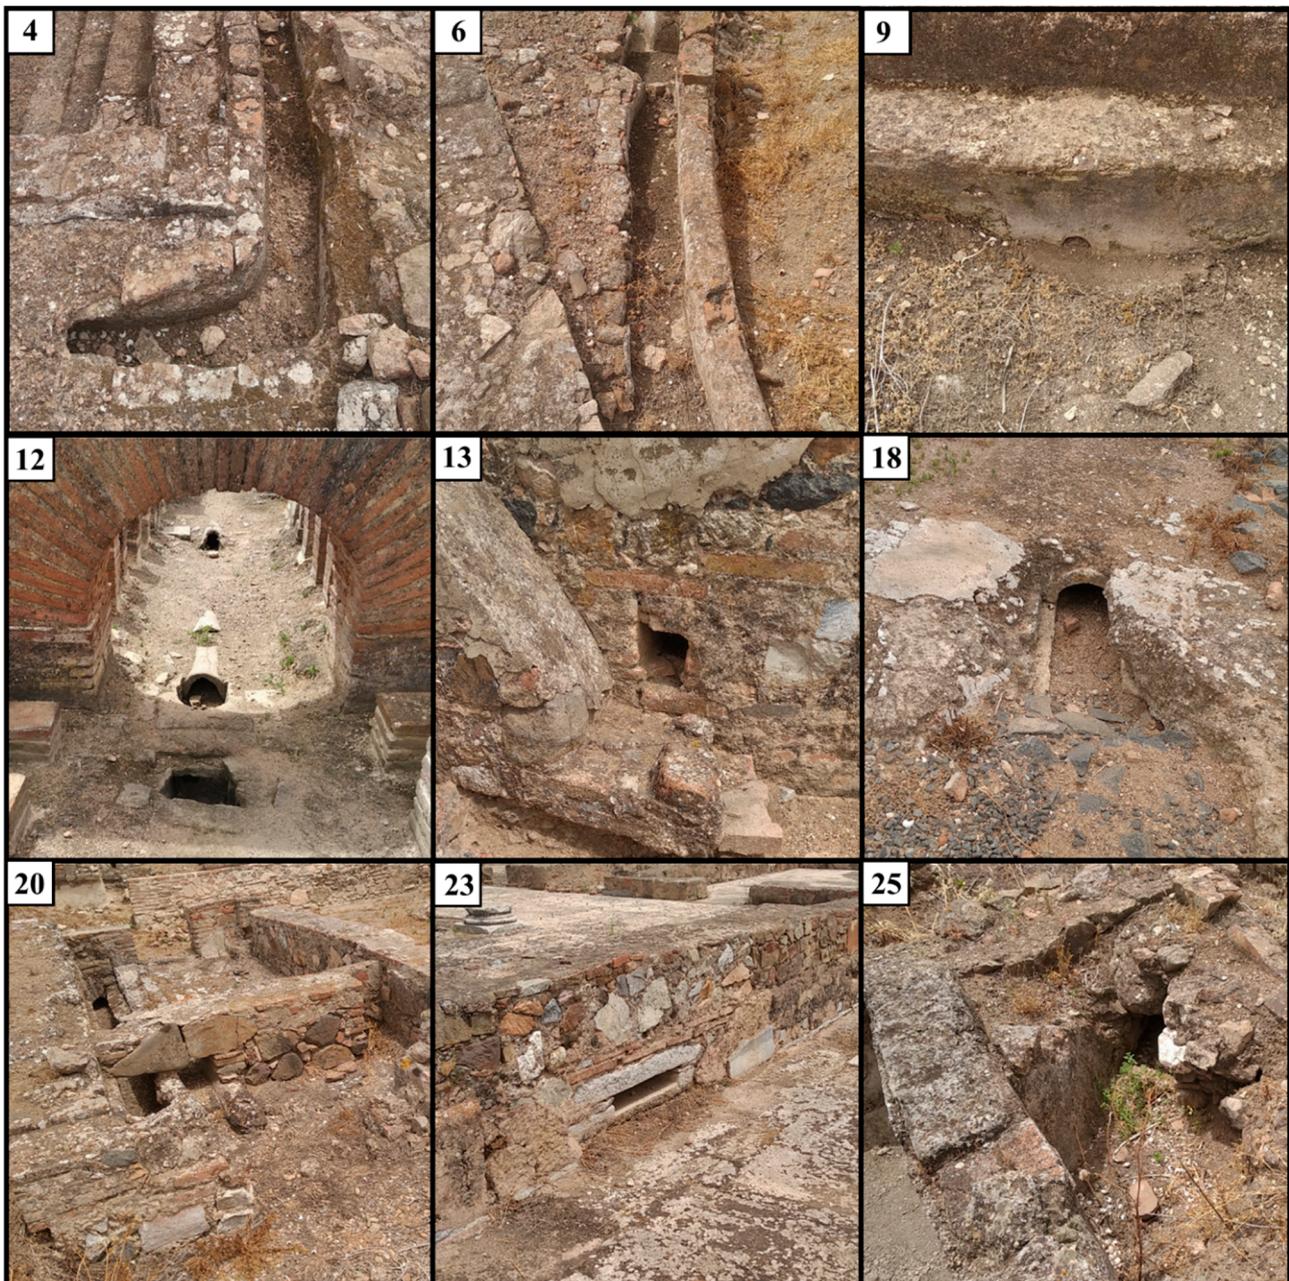
20 is a duct coming from the latrines. Structure 23 is a strange element that seems to be to supply water to the room that could be a low *natation*. Finally, structure 25 would be the main sewage collector of the villa in a poor state of preservation.

**Figure 4.** Examples of water conduits of Pisões. The numbering corresponds to the structures identified in Figure 3.

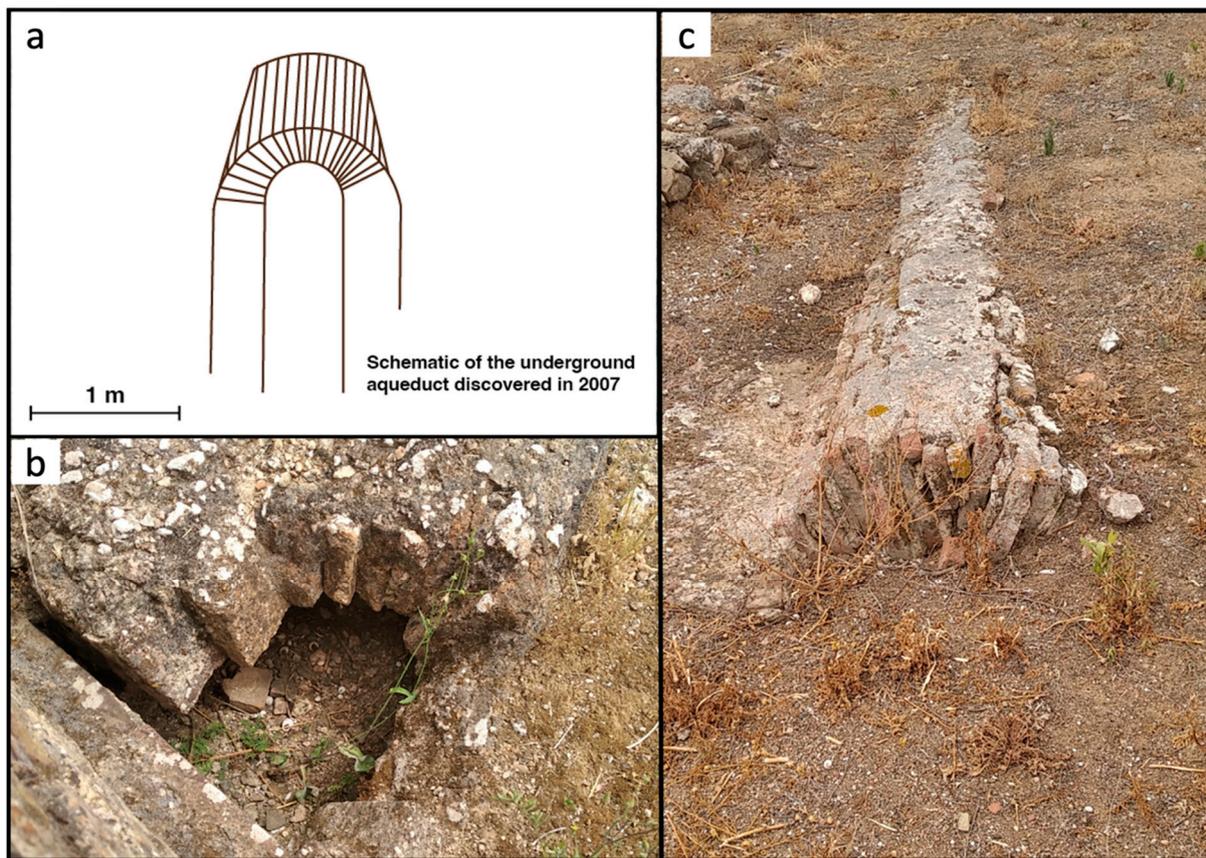
**Figure 5.** (a) Underground aqueduct schematics discovered in 2007 in an archaeological survey carried out on the outside of Pisões. (b) Upper part of duct 11. (c) Traces of the upper part of duct 39.

Considering all the elements analyzed, the only water supply point, i.e., where it may have come from, is conduit 39. This is a small, partially collapsed brick vault in which small access and cleaning well is preserved, as well as part of its roof being visible. This construction is very similar in shape to an aqueduct located northeast of the villa [18,19] and could be the access point for water from nearby springs. In addition, structure 39 is very similar in shape to structure 11, so all three could be part of the same aqueduct, as can be seen in Figure 5.

Here, we discuss the water inlet in the villa. Undoubtedly, due to the appearance of the aqueduct referred to in Figure 5, it could be the main source of water coming from nearby springs. However, the continuation of this aqueduct up to the second *balneum* must be questioned, given that the roof of the aqueduct is at an altitude of 180.10 m and 179.80 m, i.e., with a difference in height of 30 cm at the two points where we were able to document it. Given the height of this vault-shaped aqueduct, the water could have circulated at an altitude of 179.50 m, with the hydraulic elements of the *balneum* at 179.70 m at the lowest point and 180.40 m at the highest point. It is unlikely that the water was distributed from these elements, especially as the access to the water for the northernmost *natatio*, which is well preserved, is at 180.30 m. Moreover, *natatio* 3 is right in the middle of the conduit, the bottom of which is at 179.30 m, i.e., it is impossible for the aqueduct to pass under this pool. It could go around it, but we found no traces of this hydraulic element in the prospectings planned precisely for this purpose.

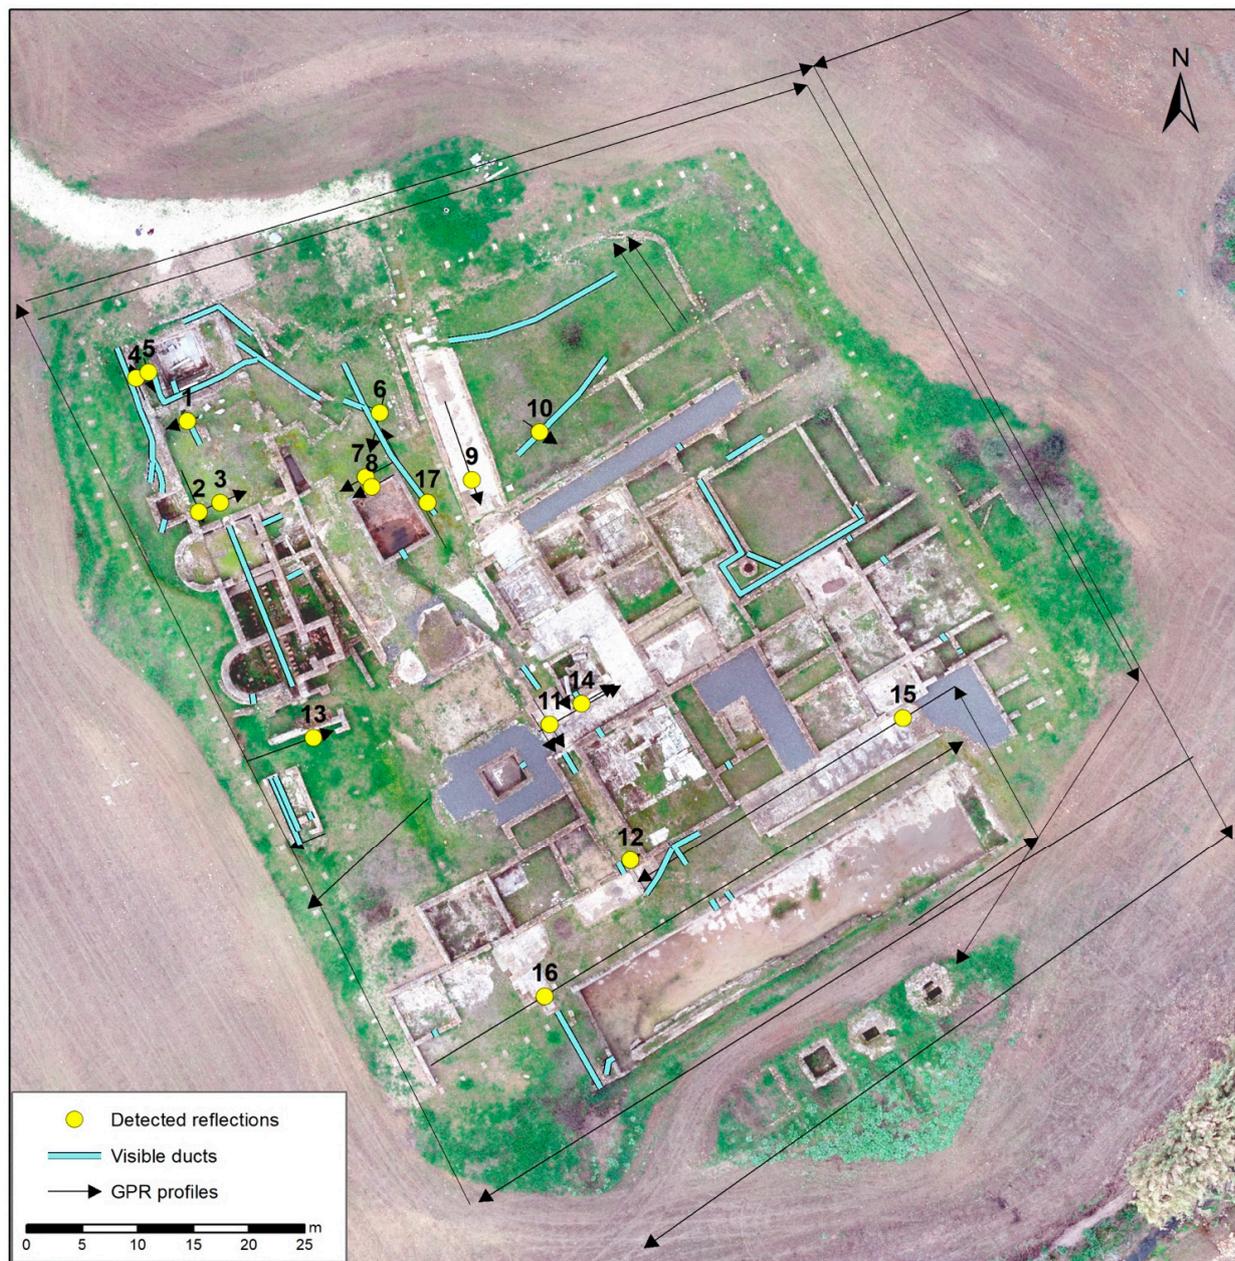
**Figure 6.** Location of the GPR reflection patterns compatible with water conduits.

Thus, in the inner part of the *pars urbana*, 17 reflection patterns were identified in the B-scans, all compatible with water conduits, and, at expected locations, near-visible conduits or structure holes were detected. The location of these patterns is shown in Figure 6.

The results of the GPR survey can be observed in the following figures. All B-scans are overlaid into a picture of the prospected sector in Pisões, with a schematic of the profile location and direction.

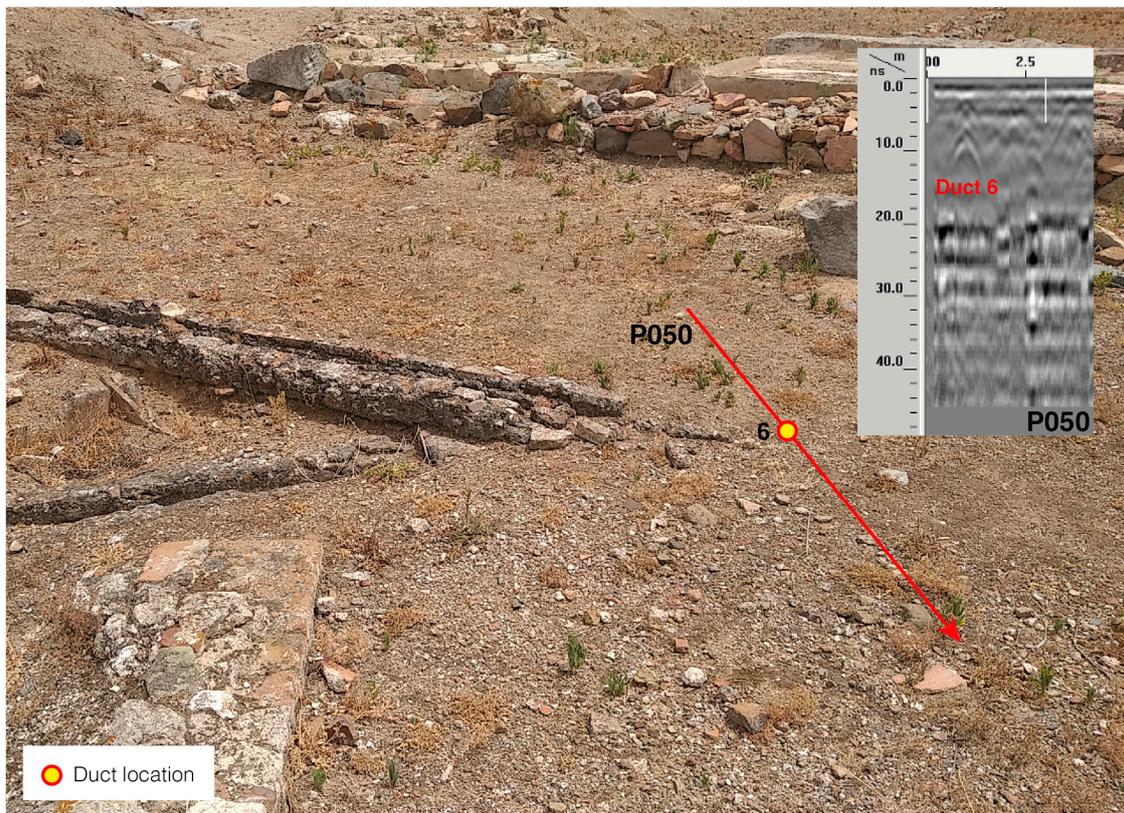
Figure 7. Representation of the B-scan P050 and location in the field.

In Figure 7, a B-scan acquired near the remains of two conduits is shown. However, just one can be observed and correspond to the observation in the field. As these tubes are quite degraded, it is possible that parts of them no longer exist.

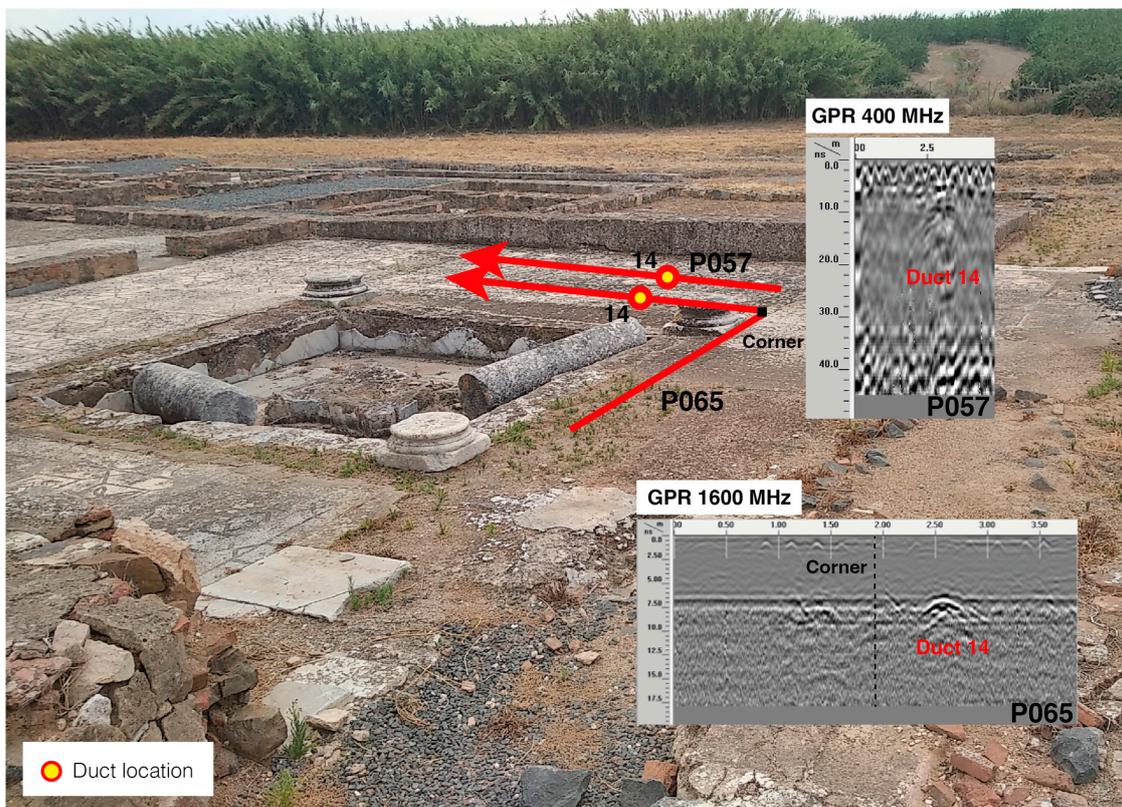
Figure 8. Representation of B-scans P057 and P065 and their location in the field.

In Figure 8, two B-scans carried out with 400 and 1600 MHz antennas are shown. Both profiles were acquired partially in the same location and show a reflection pattern compatible with a duct in the expected location of the *peristilum* drainpipe. For small structures, the 1600 MHz antenna allowed more details to be observed. This is related to the concept of radial and lateral resolution that establish the limits from which the structures can be detected.

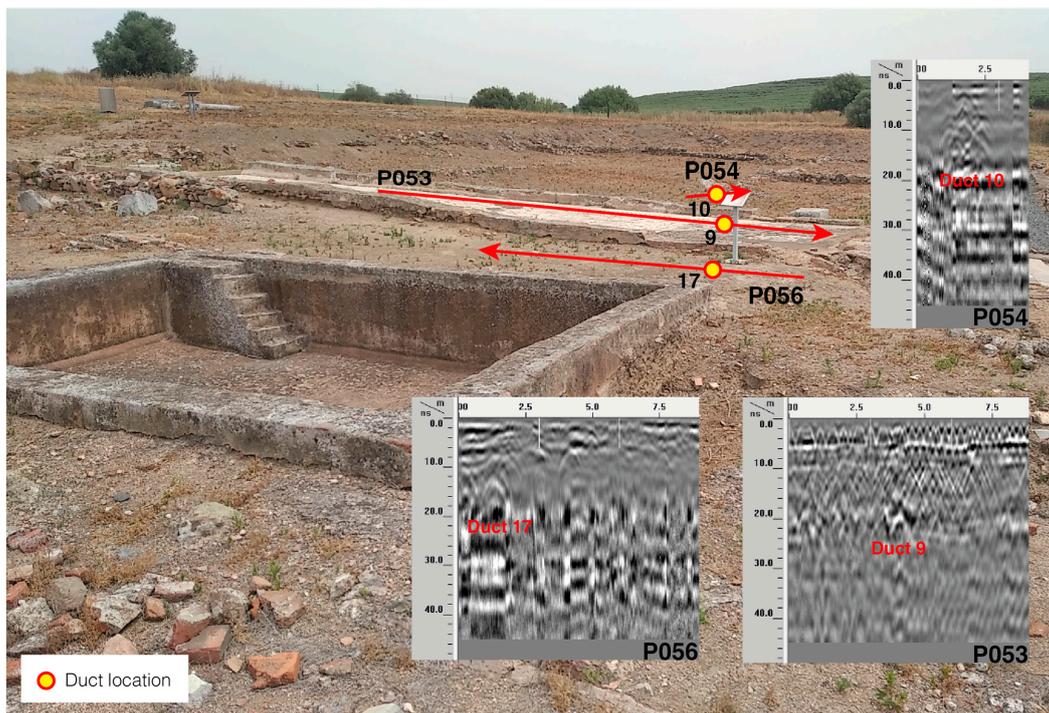
Figure 9. Representation of B-scans P053, P054, and P056 and their location in the field.

Figure 9 shows the spatial distribution of an underground aqueduct. Near the P054 B-scan, we can observe the top part of the structure. The results show reflections compatible with a great conduit that passes under the mosaic floor and continues toward the small pool and the thermal baths.

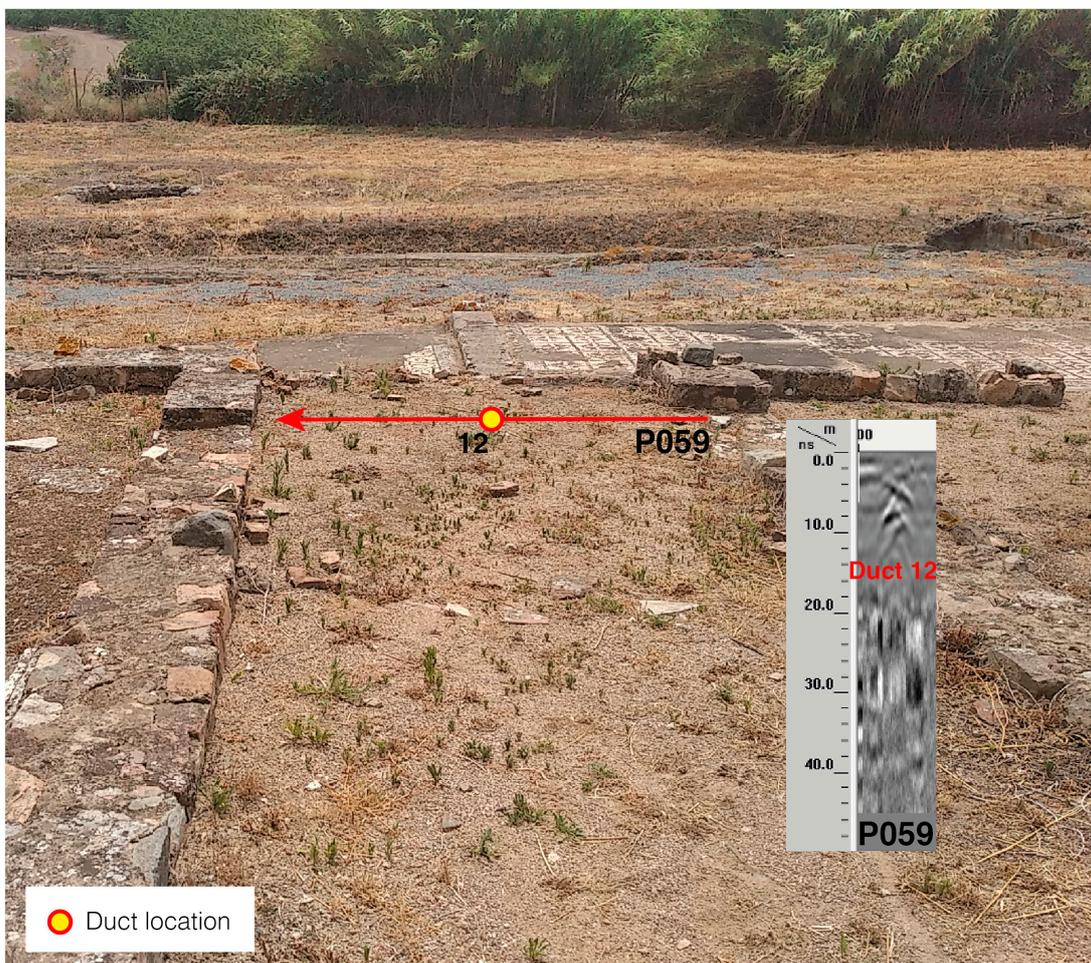
Figure 10. Representation of B-scan P059 and its location in the field.

Figures 10 and 11 show the B-scan reflections in the continuation of drainage conduits.

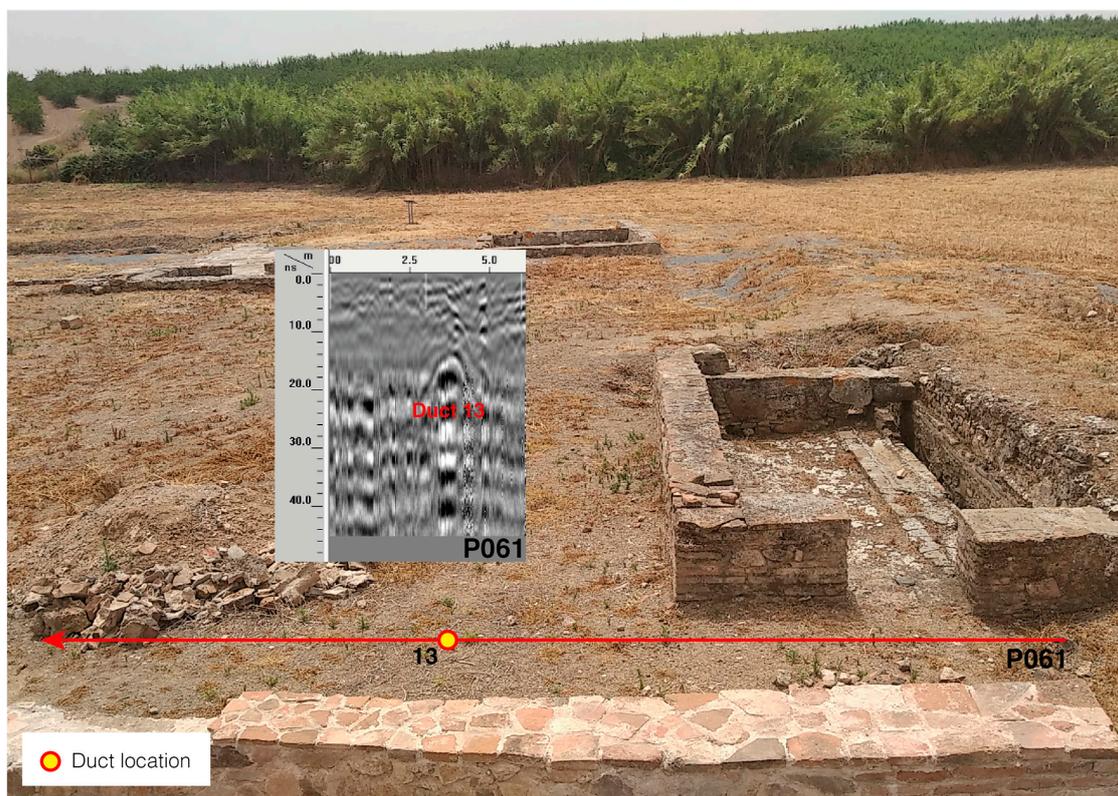
Figure 11. Representation of B-scan P061 and its location in the field.

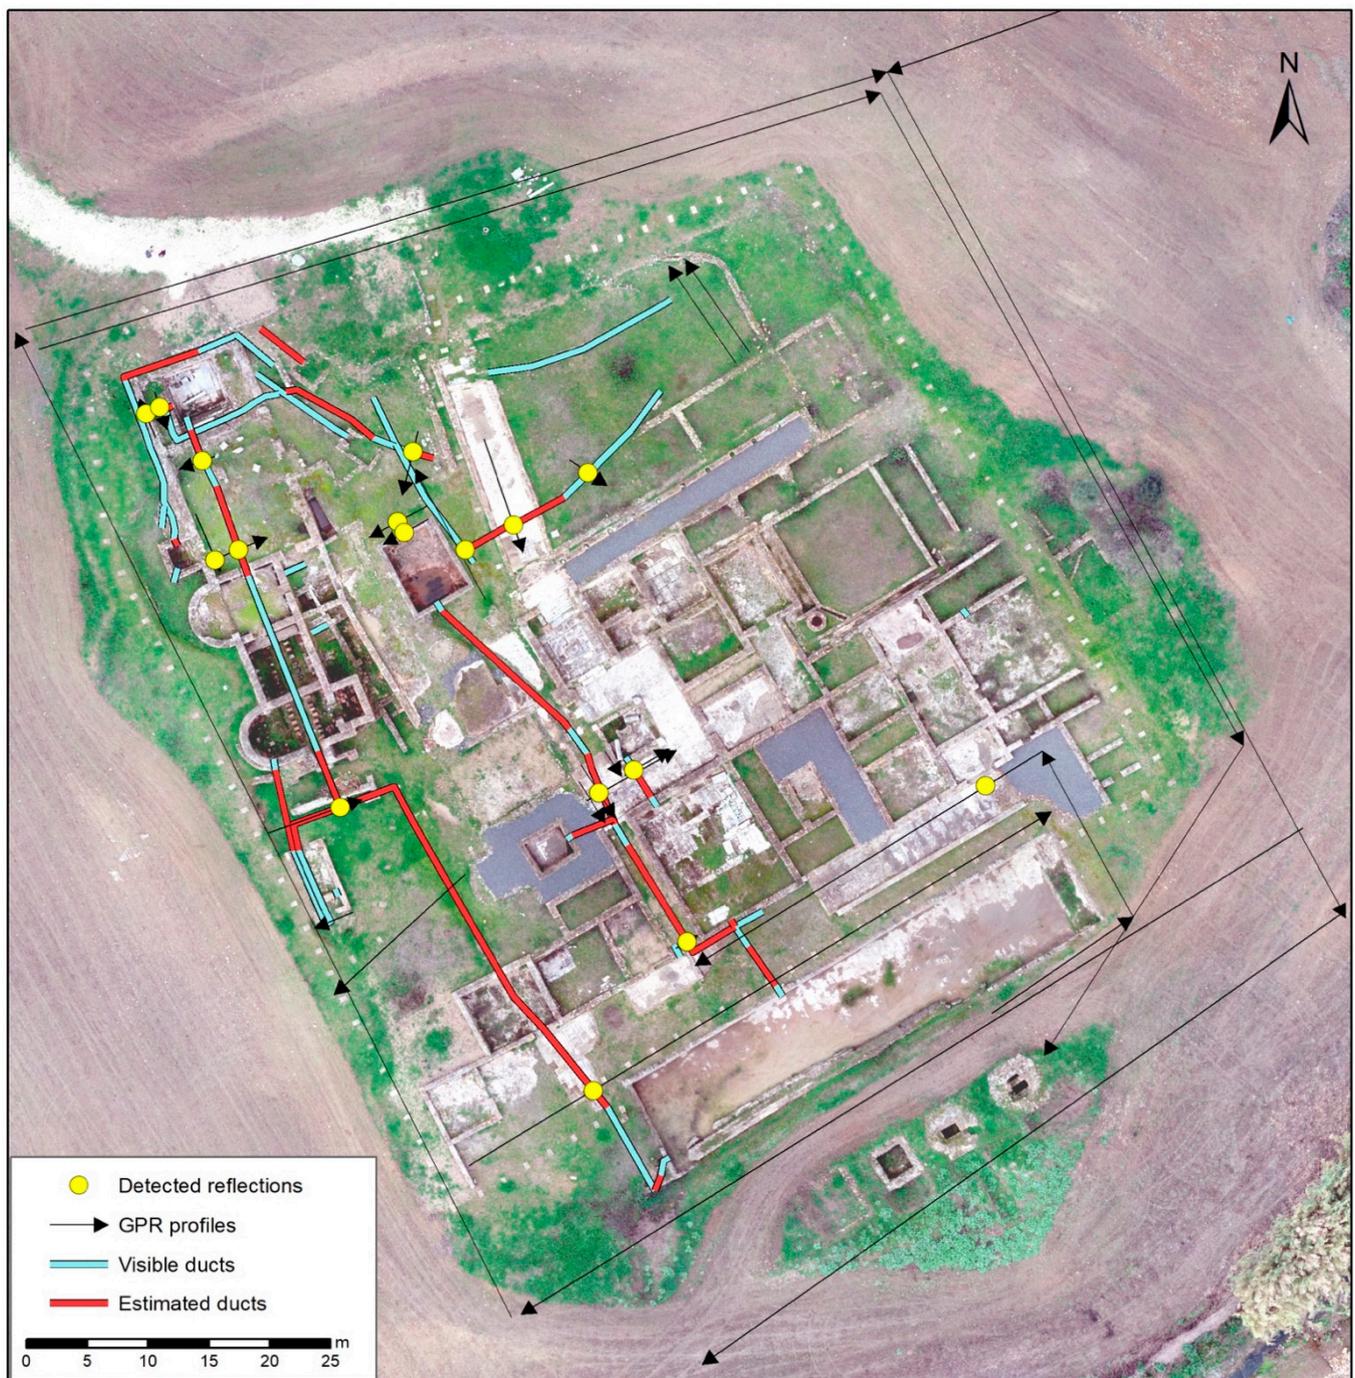
**Figure 12.** Location of estimated ducts, combining archaeological and GPR information sources.

Excluding from the initial analysis several conduits that are not related to the main entrance, such as some small ones in the rooms and others related around the well, we propose a series of conduits that should have existed, based on the combination of all the data (Figure 12). The tracing was produced by considering the connections between the visible and preserved elements that explain the water circulation of the main system. There is a high possibility that many of these features are not preserved on the surface, which may have been because of the history of the site, such as the agricultural works that destroyed structures. These problems may also have been detected in previous excavations, but the lack of technical information at that time does not allow us to know if this occurred. Therefore, we can describe the water networks that seem to have worked at the time of greater expansion of the villa when the main hydraulic elements were in operation. Added to this is a series of elements located in the northwest that have no direct connection and may date from another phase, as will be discussed later.

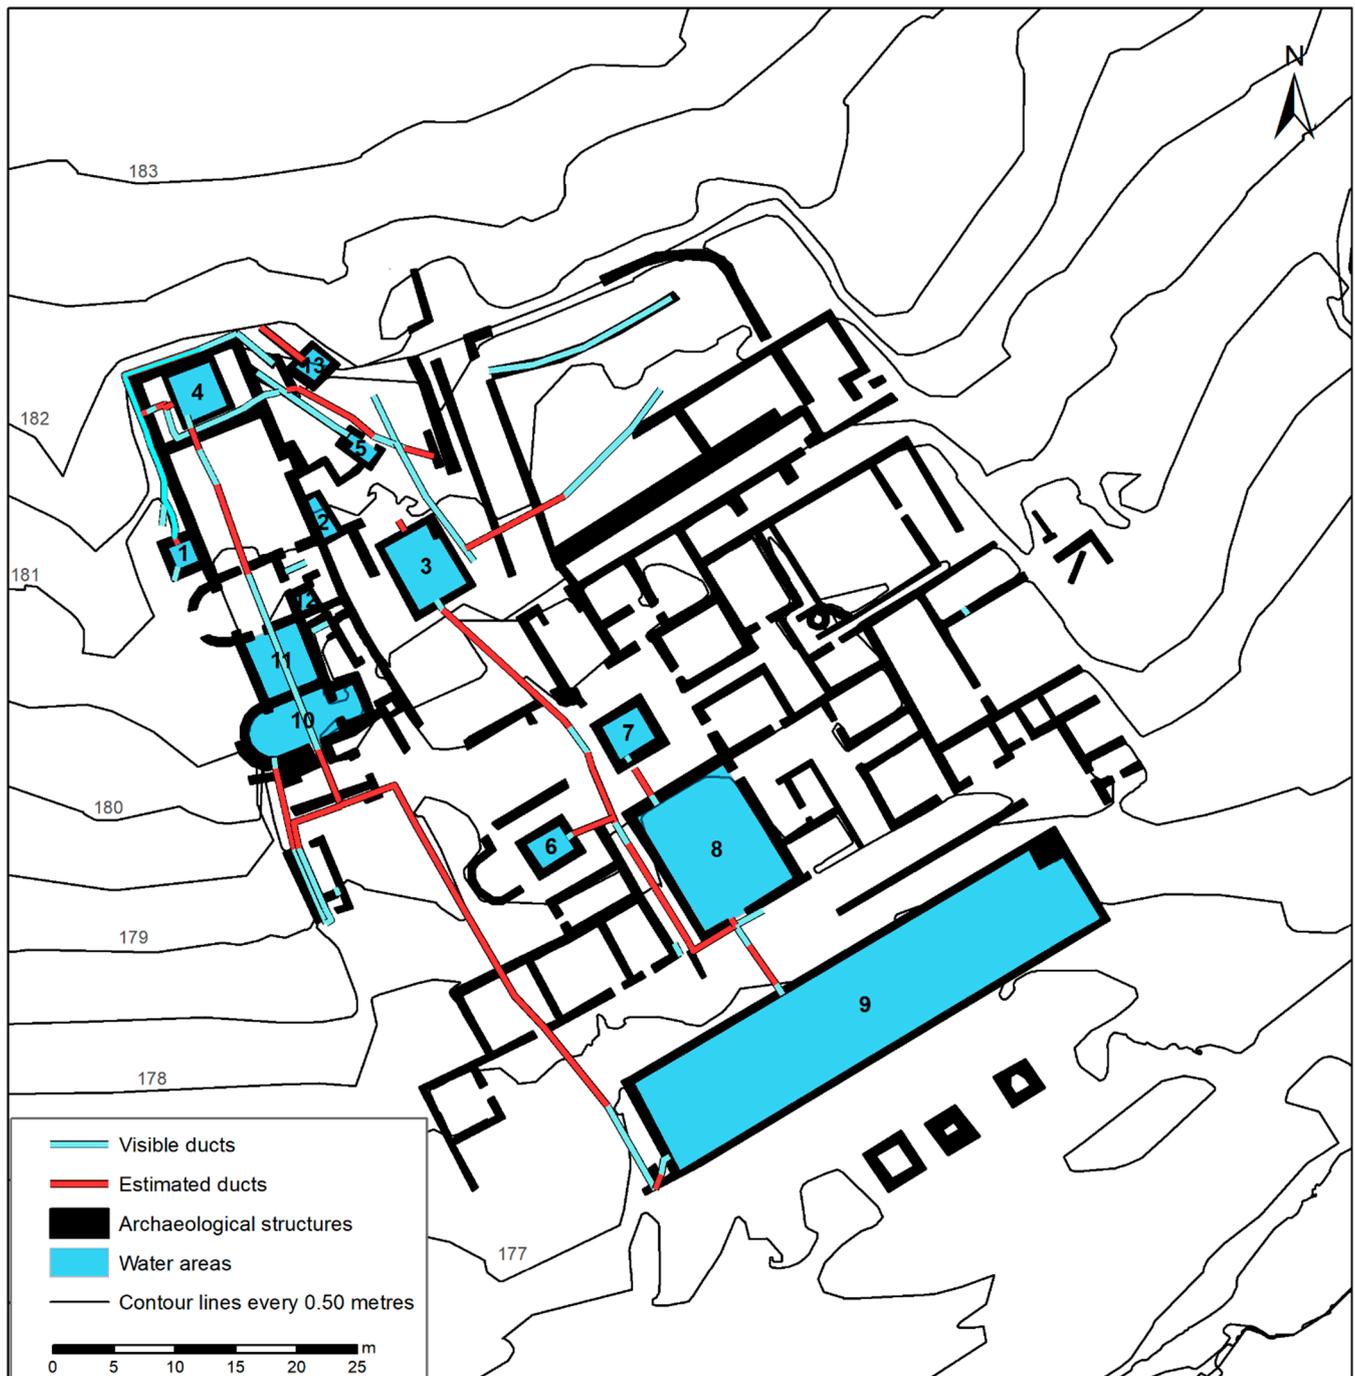
**Figure 13.** Location of the estimated water connections between the existing conduits (visible and those detected by geophysics).

The detailed study between the visible water pipelines and those estimated by geophysics allowed us to reconstruct almost all the missing sections. The estimated sections are about twice the length of the parts that are currently preserved. The reconstruction of the main water connections can be observed in Figure 13.

Considering the altitude values of the bottom part of the conduits and water receptacles, we can suggest that the water access is located at the northwest corner of the *pars urbana*, with an altitude of 181.60 m, the highest value measured in Pisões. The lowest value is in the large *natatio* to the south of the villa, with an altitude value of 175.90 m. The villa is, therefore, distributed on a hill that slopes down in a south-easterly direction with a change in elevation of more than 6 m in total. The water supply must come from the northwest. This source of water to the inner part of the villa is compatible with the magnetic results shown in Figure 2 [15,16]. In this sector, anomaly alignments are visible that could correspond to conduits. Therefore, the main water access can be well reconstructed to supply the main hydraulic elements of the *balneum*, corresponding to elements 1 and 4 (Figure 13).

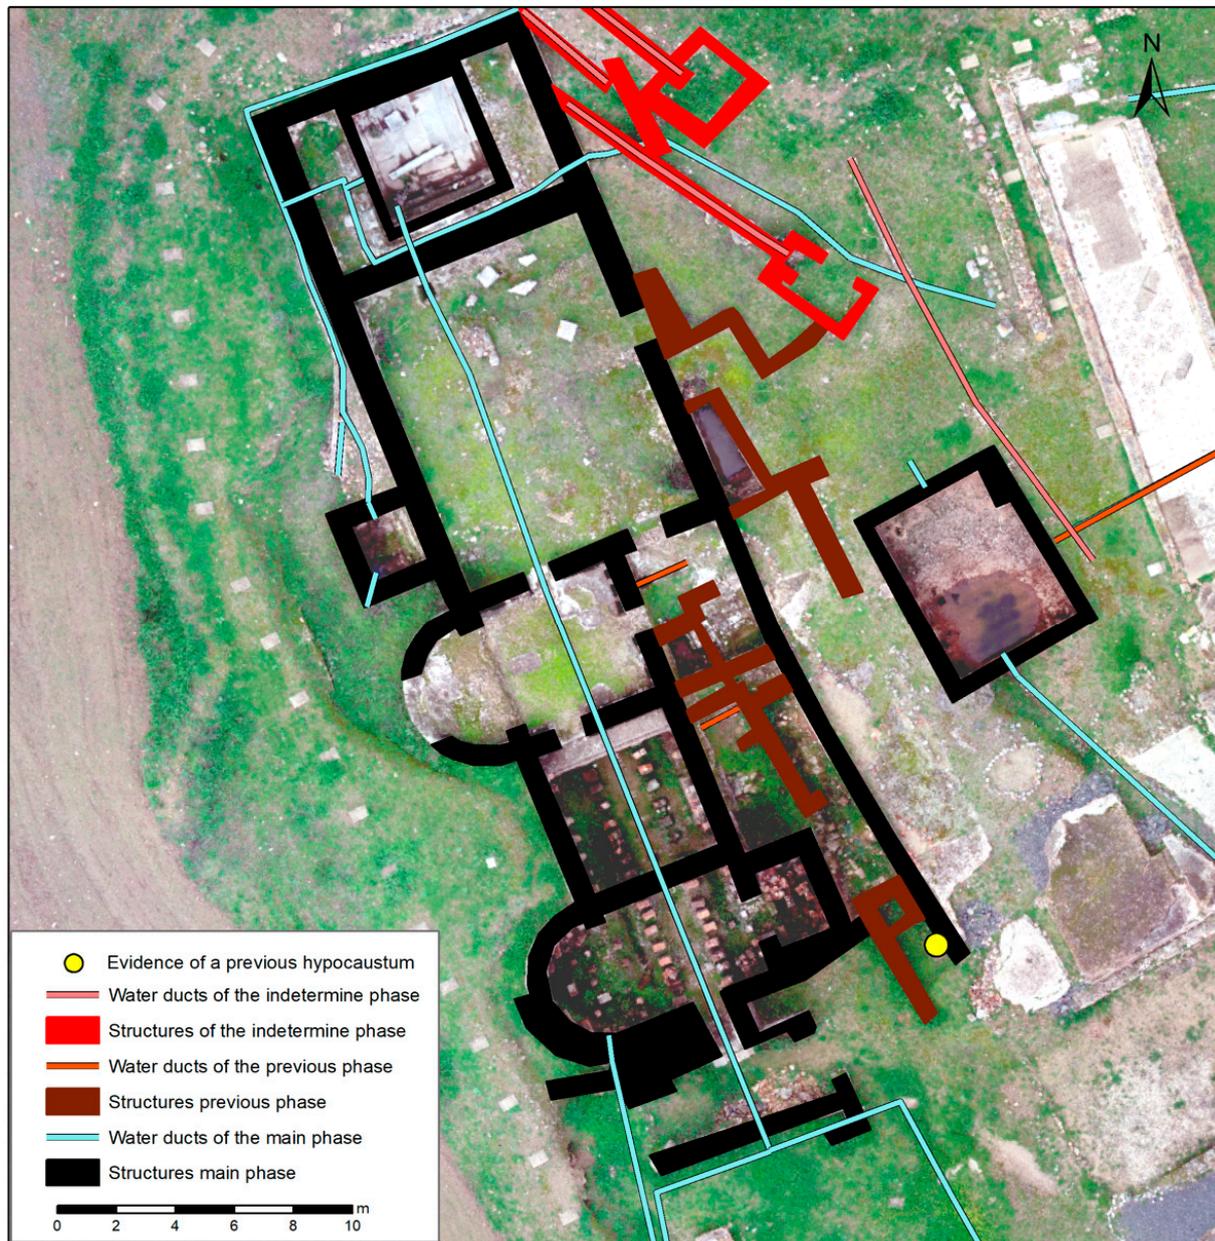
**Figure 14.** Possible different archaeological phases detected with this study.

Above this element, we have a series of pools that have been interpreted as part of the previous villa, specifically structures 2, 5, 12, and 13; therefore, there are two superimposed thermal complexes. This was already detected in previous studies [11] and was observed in the field and in the UAV results (Figure 14) in this study. This hypothesis includes *natatio* 3 within these elements, where there would also be a *hypocaustum* below some archaeological elements at a much lower level than the second one, something we were able to verify given that several pools were found in a profile approximately one meter below those of the second thermal complex. We also verified that the directions of the two generations of bath complex were slightly rotated from each other.

With these considerations, we suggest that the aqueduct found at the outside part of the villa [19] corresponds to the first phase of the villa, or is at least related to the ancient *balneum*, and to *natationes* 2 and 12, which were partially divided by the second and

more recent bath complex and *hypocaustum*, which has not been excavated. *Natatio* 3 must necessarily be later and possibly contemporary with the second, as it seems to cut off the access to water from the oldest *balneum*.
