# Investigation of CFRP-Countersunk Bolted Assembly Fatigue Damage under Three-Point Bending via Experimental and Numerical Analysis

**Abstract:** In this research, the fatigue damage behavior under three-point bending of a composite joint incorporating a single countersunk fastener is investigated. Firstly, a self-developed fatigue test system was set up to test the fatigue characteristics of CFRP-countersunk bolted assembly under the displacement amplitude cycles of  $10^3$  to  $10^6$  to study the formation and expansion rule of damage and cracks. It found two typical damage processes, both of which involve some formal interface damage between fiber and matrix. Based on the experiment, a finite element fatigue damage analysis on this assembly was carried out according to the Hashin failure criterion. The simulation result shows an identical fatigue damage location and fatigue life with the experimental phenomenon. Moreover, it predicted the final fatigue life of the specimen under 10 Hz cyclic loading with 1 mm displacement and 10 Nm bolt preloading. This research provides guidance for the engineering fatigue issues of single-bolted joint composite connection structures and pr

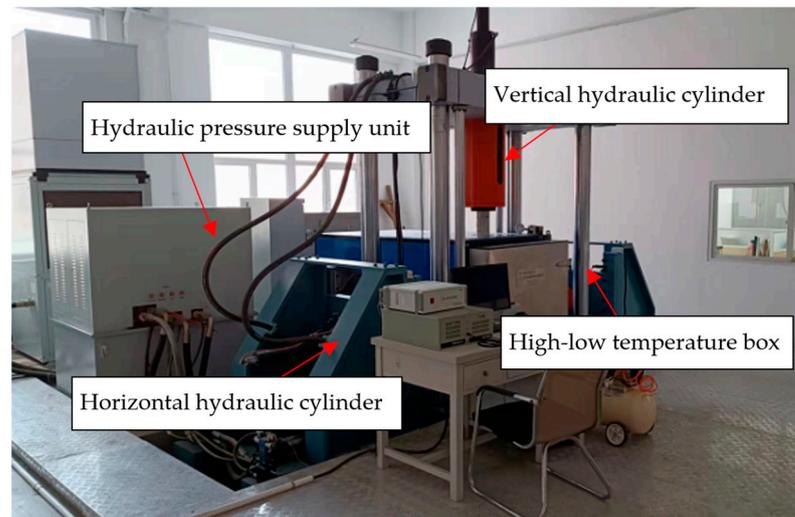
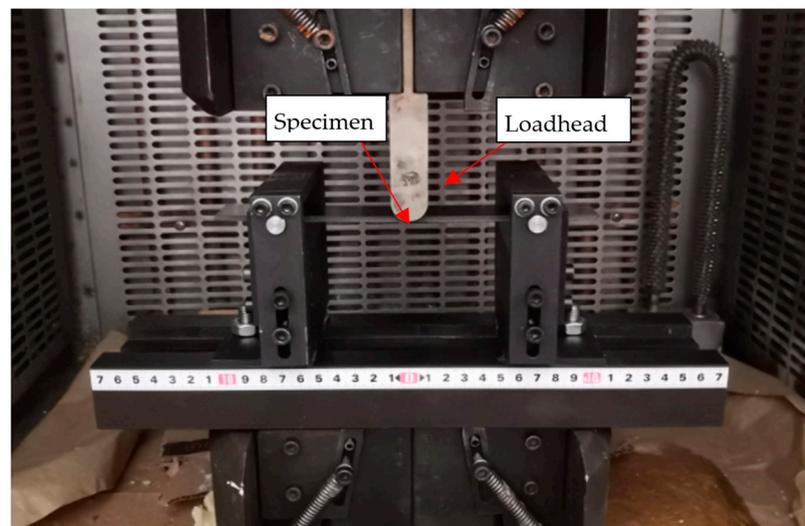
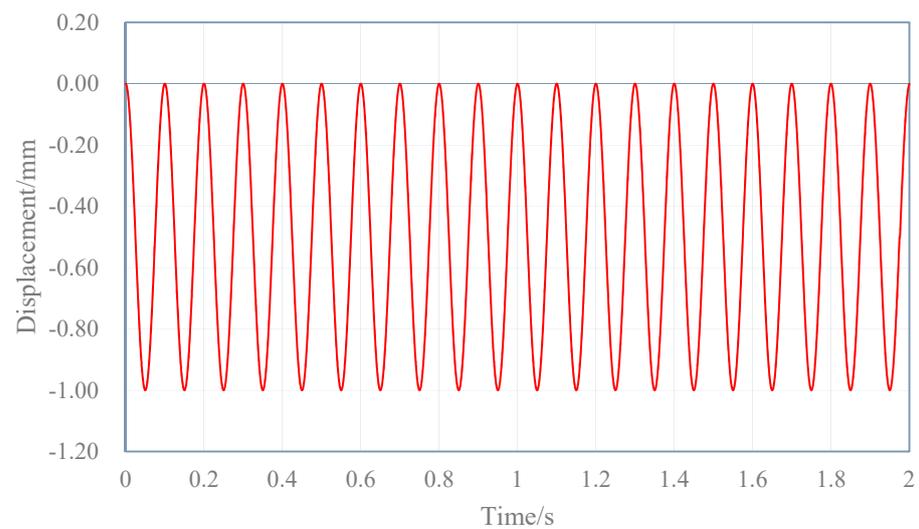
**Figure 1.** Test loading system and specimen installation. (a) Fatigue Test System. (b) Fixture and three-point bending specimen installation. (c) Displacement loading curve.

The study employed a self-developed 50t multi-axis fatigue electro-hydraulic servo test system, capable of conducting various tests such as uniaxial dynamic stretching, biaxial dynamic stretching, uniaxial tensile fatigue, and three-point bending fatigue tests, as presented in Figure 1a. The equipment is jointly developed by Shenyang Aerospace University and Shenyang Hongderun HVAC Equipment Co., Ltd., including a low-temperature chamber, a universal testing machine from Changchun Xintai Testing Machine Co., Ltd.,

and self-made three-point bending fixtures. The experimental fixture is completely self-developed and can better simulate the common ambient and low-temperature conditions of the specimen on the aircraft, ensuring the reliability of the test, illustrate as Figure 1b. A three-point bending fatigue test was conducted with a displacement loading of 10 Hz, where the minimum displacement was set to 0 mm, the maximum displacement was 1 mm, and the displacement amplitude was 1 mm, as illustrated in Figure 1b of the specimen fixture and Figure 1c of the loading curve. This test system enabled the researchers to accurately simulate the fatigue conditions that the material would experience in real-life applications, providing reliable data for the analysis of the material's fatigue behavior.

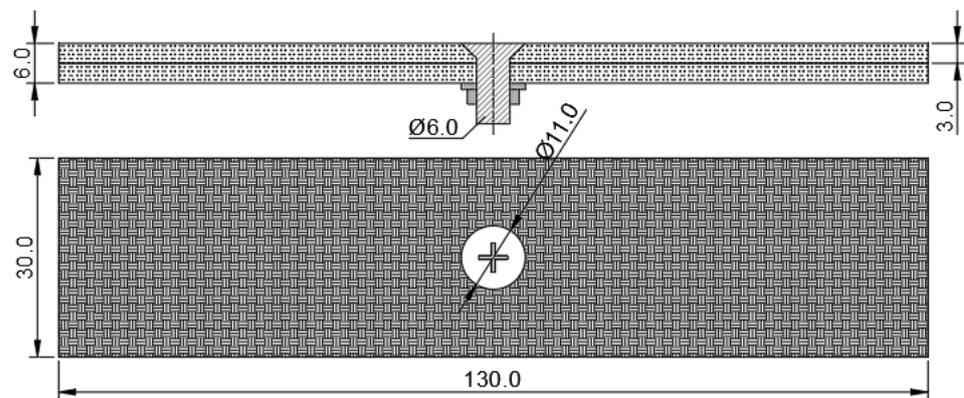
Figure 2. Countersunk bolt laminate specimen (Units: mm).

The plates of three-point bending fatigue specimens of CFRP-countersunk bolt assembly are made of T300BZ-3234 material, of 0/90° × 30 layers of plain weave composite carbon fiber prepreg, and are formed under high pressure in an autoclave at 0.5 MPa and 120 °C. The average thickness of the single-layer fiber woven fabric (including the matrix) is 0.1 mm, and the total thickness of the laminate sample is 3.0 mm. The size of the sample is 130 mm × 30 mm × 6 mm, and the countersunk head bolts are M6 bolts (according to the Chinese navigation mark “HB/1-129-2002 90° countersunk head bolts”) with a material of Ti<sub>6</sub>Al<sub>4</sub>V. A hole was drilled in the middle of the laminate, M6 countersunk head bolts were inserted, a steel washer with a thickness of 1 mm was placed between the nut and the laminate, and a preload torque of 10 Nm was applied to the bolt. The structure and size of the specimen are shown in Figure 2 (mm).

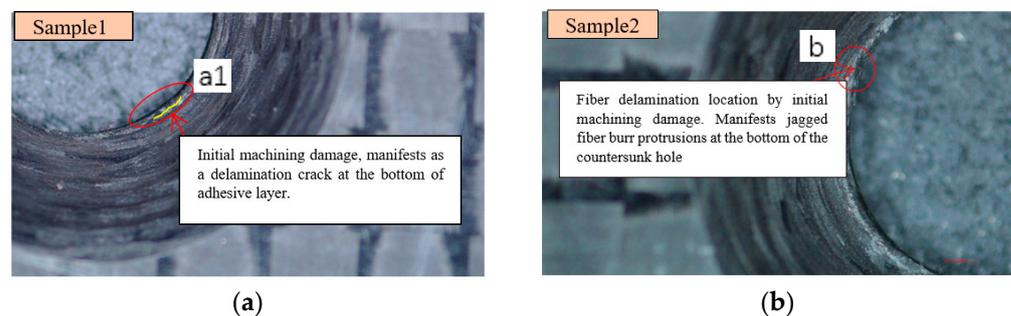
Figure 3. Micromachining damage before specimen loading. (a) Sample 1. (b) Sample 2.

Figure 3 shows two typical micro-damages in the oblique lower part of the countersunk hole due to the drilling opening. Although this picture is not clear enough due to the depth of field of the bevel, the microzone damage of sample 1 at region a1 can also be observed in Figure 3a. It manifests as a delamination crack at the bottom of the adhesive layer (hereinafter referred to as the initial delamination crack). The initial delamination crack is 1 mm in length, and the edge of the countersunk hole is smooth. Figure 3b shows the microdamage of Sample 2 b location. It manifests as jagged fiber burr protrusions at the bottom of the countersunk hole. Both the two kinds of microdamage above will cause microzone stress concentration, which may cause the initial fatigue damage of the composite laminate.

The drilling micro damage showed that the fatigue crack formed and expanded at the location of the initial damage region of the CFRP-countersunk bolt hole. This could be due to the distribution of micro load concentration in this region. These findings suggest that the countersunk hole edge is a fatigue potential area, and further investigation is necessary to prevent or mitigate the damage in this area.

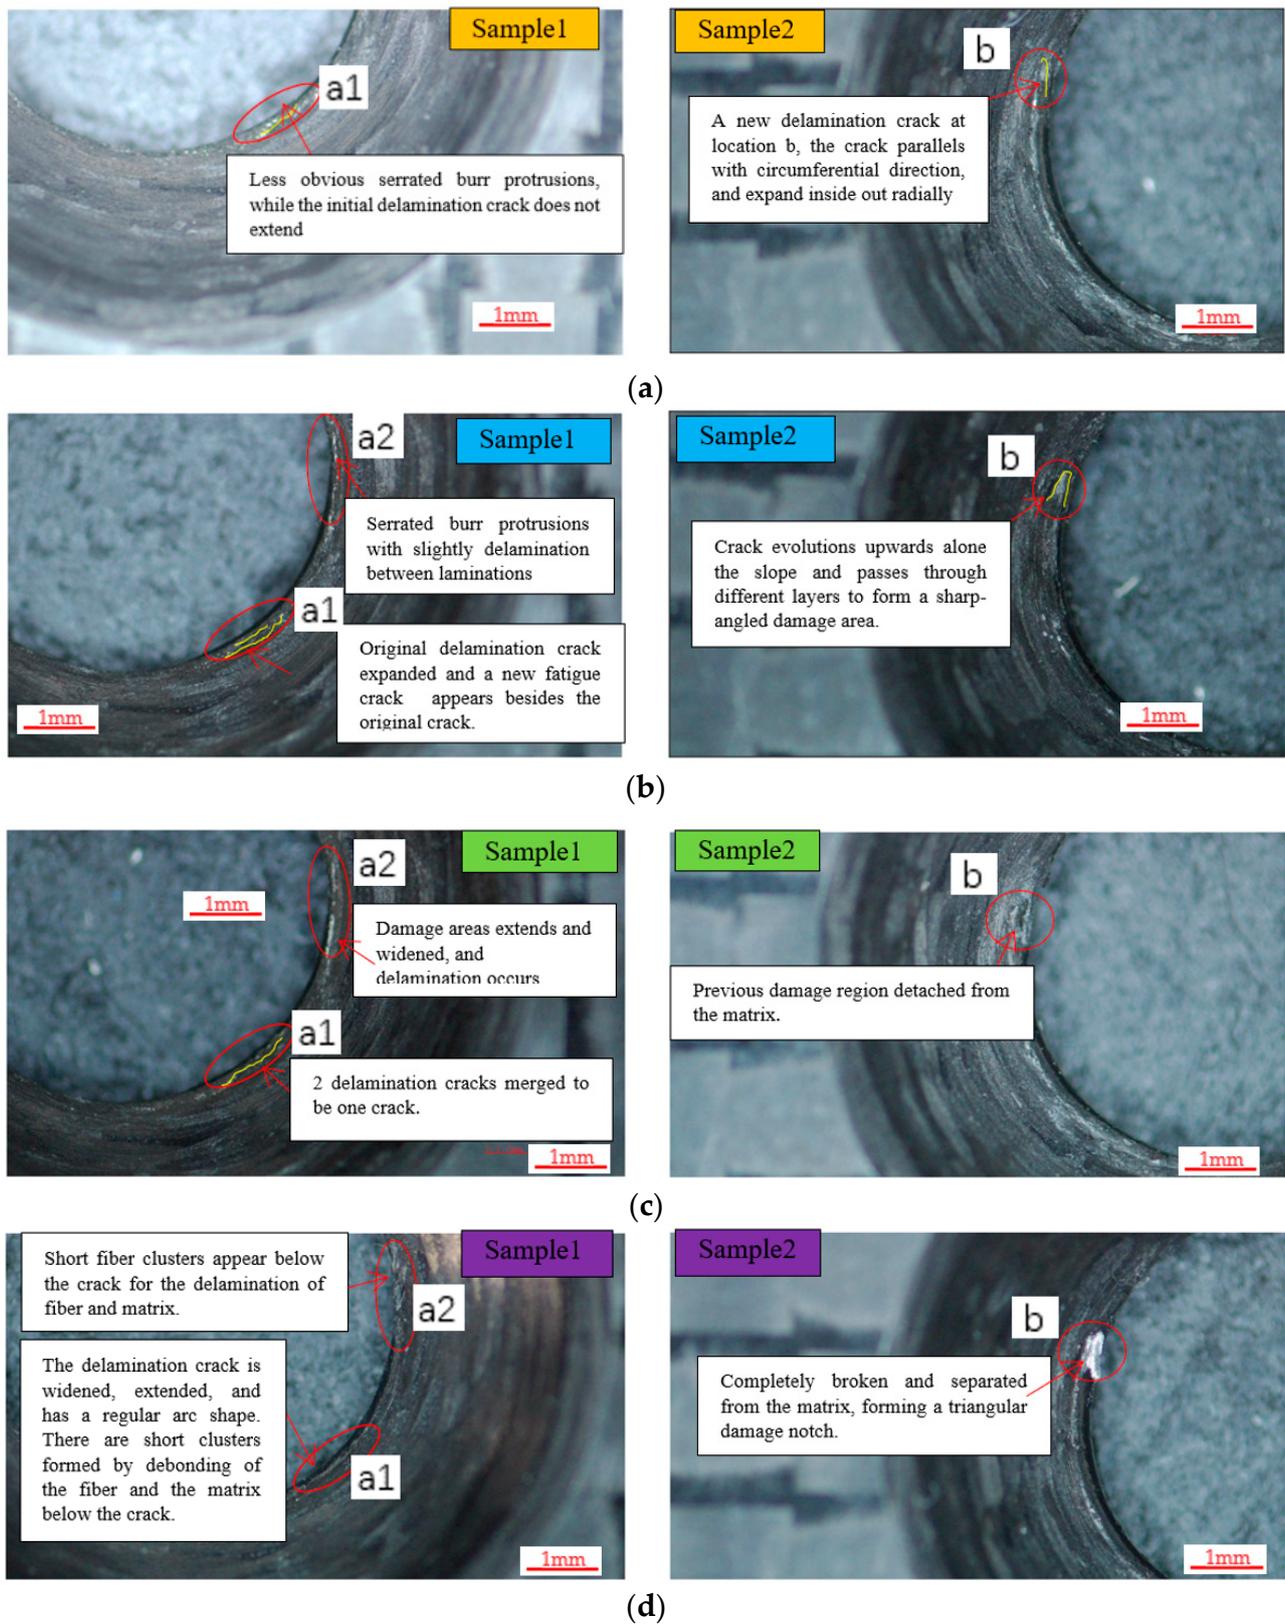
**Figure 4.** Fatigue damage. (a) Fatigue damage after  $10^3$  cycles of loading. (b) Fatigue damage after  $10^4$  cycles of loading. (c) Fatigue damage after  $10^5$  cycles of loading. (d) Fatigue damage after  $10^6$  cycles of loading.

In this study, the fatigue damage of Sample 1 and Sample 2 was observed after 10<sup>3</sup> displacement cycles, and the results are presented in Figure 4a. Sample 1 shows wear on the countersunk hole edge, which is characterized by less obvious serrated burr protrusions. The initial delamination crack did not extend, and no changes such as crack widening were observed. On the other hand, Sample 2 generated a new delamination crack at location b, which parallels the circumferential direction and expands inside-out radially. The length of the crack was 1 mm.

In Figure 4b, the fatigue damage of Sample 1 and Sample 2 is depicted after  $10^4$  displacement cycles. For Sample 1, two types of damage were observed. Firstly, the original delamination crack at location a1 increased by 0.3 mm, and a new fatigue crack with a length of 0.5 mm appeared beside the original crack. The new crack is parallel in direction to the first original crack, as shown by Figure 4b region a1. Secondly, a new micro damage region a2 appeared on top of a1. The a2 region exhibits serrated burr protrusions with slight delamination between laminations and tearing through fibers on the hole edge.

For Sample 2, the delamination crack at b evolved upwards along the slope of the countersunk hole, passing through different layers and forming a sharp-angled damaged area. The two long sides of the damaged area were lifted, and a short side was connected with the material around the specimen hole, as shown in Figure 4b region b.

The observations indicate that the damage on Sample 1 has progressed significantly compared to Sample 2, with the appearance of a new fatigue crack and a micro damage region. On the other hand, Sample 2 exhibited delamination damage, which evolved upwards along the slope of the countersunk hole and formed a sharp-angled damaged area. The lift of the two long sides of the damaged area is likely due to the bending moment caused by the slope of the hole.

In Figure 4c, the fatigue damage of Sample 1 and Sample 2 after  $10^5$  displacement cycles is illustrated. The observations indicate that the two delamination cracks in region a1 of Sample 1 have merged to form a single crack that evolves around the circumference. Moreover, the damaged area in region a2 has widened and extended, resulting in delamination. For Sample 2, region b is detached from the matrix, forming a discontinuous domain of material in the sharply angled damage region that appeared in the previous cycles.

The findings suggest that the fatigue damage in Sample 1 has progressed further, with the merging of the delamination cracks and the extension of the damaged area. The evolution of the crack around the circumference is also indicative of more severe damage. Similarly, in Sample 2, the formation of a discontinuous domain of material suggests a more severe level of fatigue damage.

In Figure 4d, the fatigue damage of Sample 1 and Sample 2 is depicted after  $10^6$  displacement cycles. In Sample 1, the delamination crack in the a1 region widened and extended, forming a semi-arc regular shape along the circumference of the hole. Short fiber clusters appeared below the crack due to the delamination of fiber and matrix. In the a2 damage region, fibers in the layers and fibers between layers detached from the matrix, forming short fiber clusters. As a result, the bottom edge of the countersunk hole slope was damaged in a zigzag shape.

In Sample 2, the fibers in damage region b were completely broken and separated from the matrix, forming a triangular damage notch. The observed damage suggests that both samples experienced severe fatigue damage, with Sample 1 showing delamination and fiber/matrix detachment, whereas Sample 2 exhibited complete fiber breakage and matrix separation.

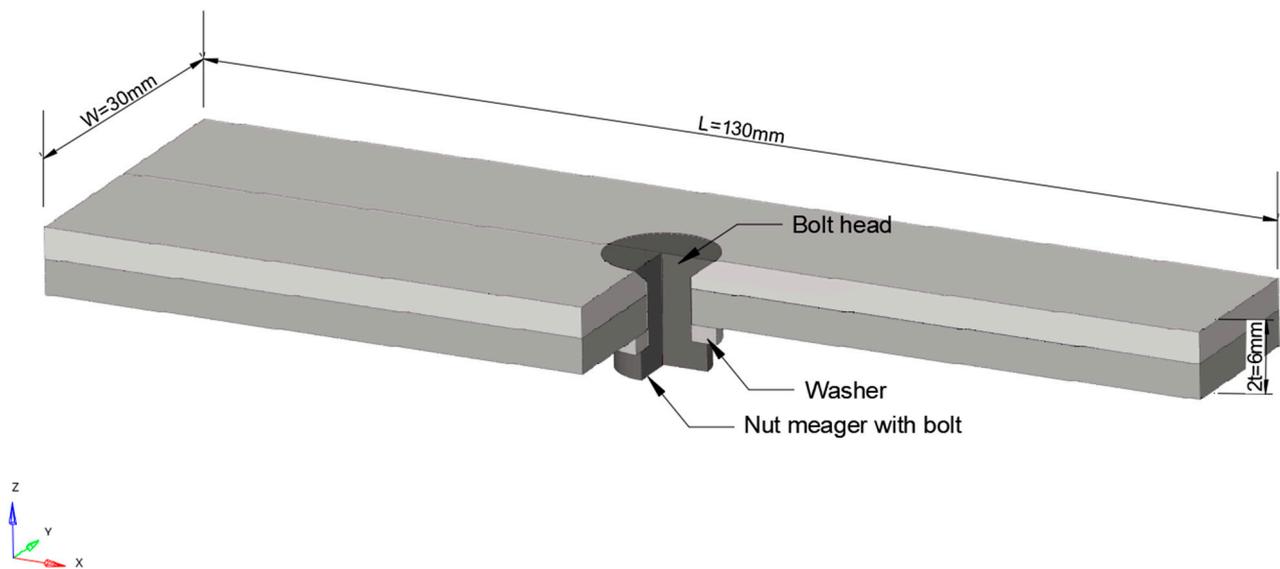
**Figure 5.** Schematic diagram of the geometry.

A 3D model was created for the same specimen as shown in Section 2.1.1, using a discrete rigid body of a fulcrum and loading indenter. The gasket had an inner diameter of 5.3 mm, an outer diameter of 10.06 mm, and a thickness of 1.5 mm. The fulcrum and loading indenter were modeled as discrete rigid bodies without consideration of their mechanical properties. The model is depicted in Figure 5. This approach was taken to simulate the mechanical behavior of the specimen under load, which allowed for the analysis of stress and strain distribution in the vicinity of the countersunk hole. The use of a discrete rigid body for the fulcrum and loading indenter simplified the model and reduced computational complexity.

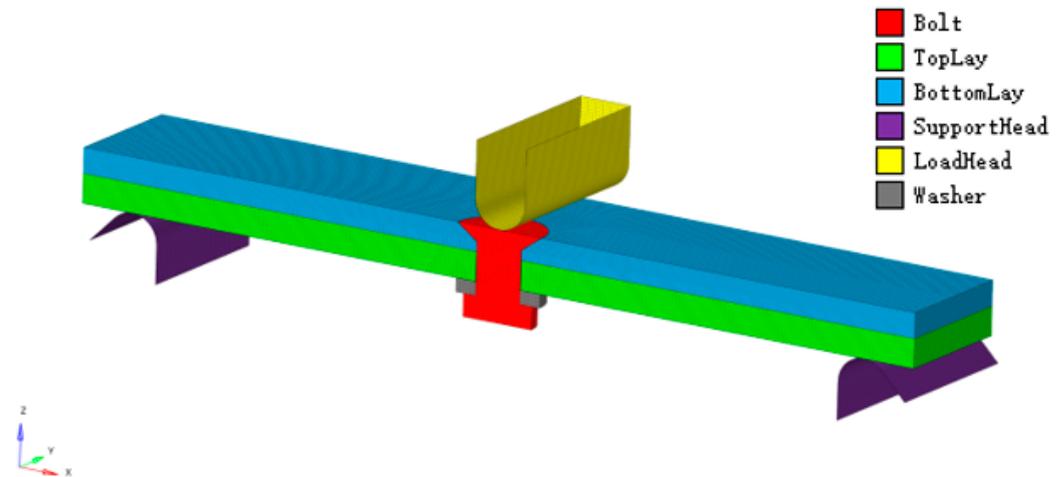
Figure 6. Simulate analysis FEA model mesh distribution.

The composite laminate elements' type is SC8R with  $0^\circ$  along the x-axis and  $90^\circ$  along the y-axis and the global mesh size is  $0.3 \text{ mm} \times 0.3 \text{ mm} \times 0.1 \text{ mm}$ , where  $0.1 \text{ mm}$  is the element thickness along z-direction. The countersunk bolt and gasket are meshed by the C3D8R with the size of  $0.33 \text{ mm} \times 0.33 \text{ mm} \times 0.2 \text{ mm}$ . The fulcrum and loading indenter is modeled as a discrete rigid body. There are a total of 562,264 elements and 602,256 nodes in this model. Figure 6 is the model grid division.

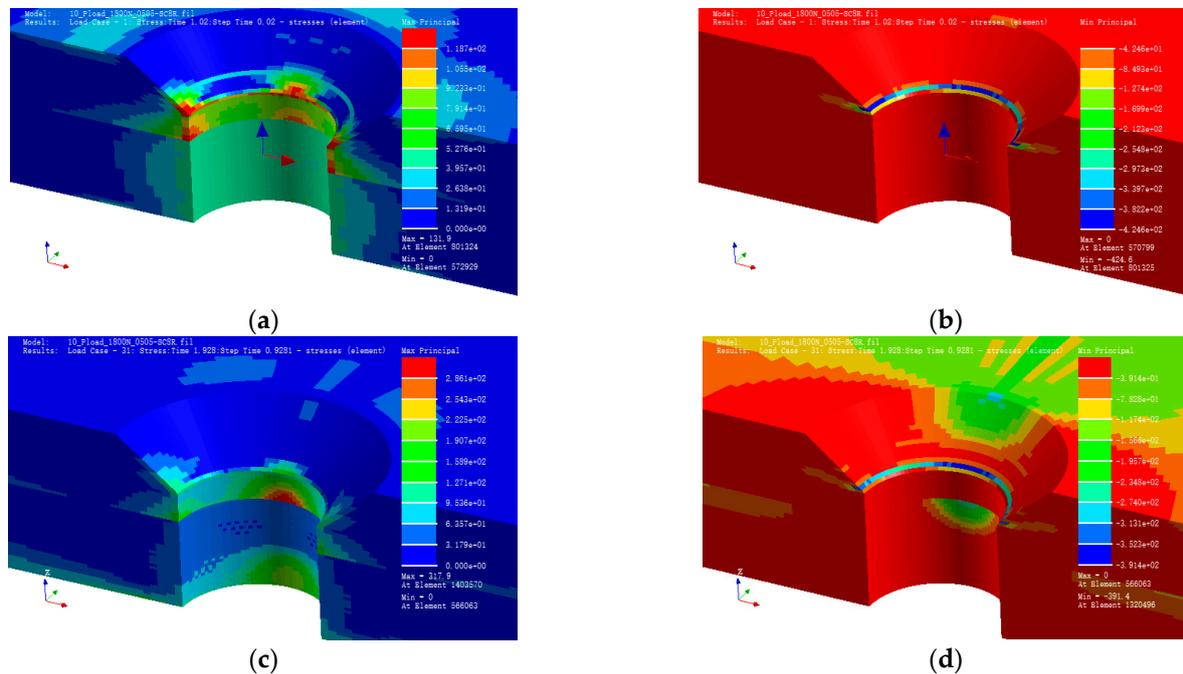
**Figure 7.** Max./Min. principal stress. (a) Max. principal stress. (b) Min. principal stress. (c) Max. principal stress. (d) Min. principal stress.

Figure 7a and b depict the preloading conditions. The maximum principal stress is located on the bottom edge of the countersunk hole with a value of 237.4 MPa, whereas the

minimum principal stress is located at the maximum principal stress location with a value of  $-223.8$  MPa.

Figure 7c and d illustrate the maximum and minimum principal stress under a three-point bending load with a displacement of 1 mm for the loading indenter. The maximum principal stress is 332.8 MPa, whereas the minimum principal stress is  $-265.7$  MPa.

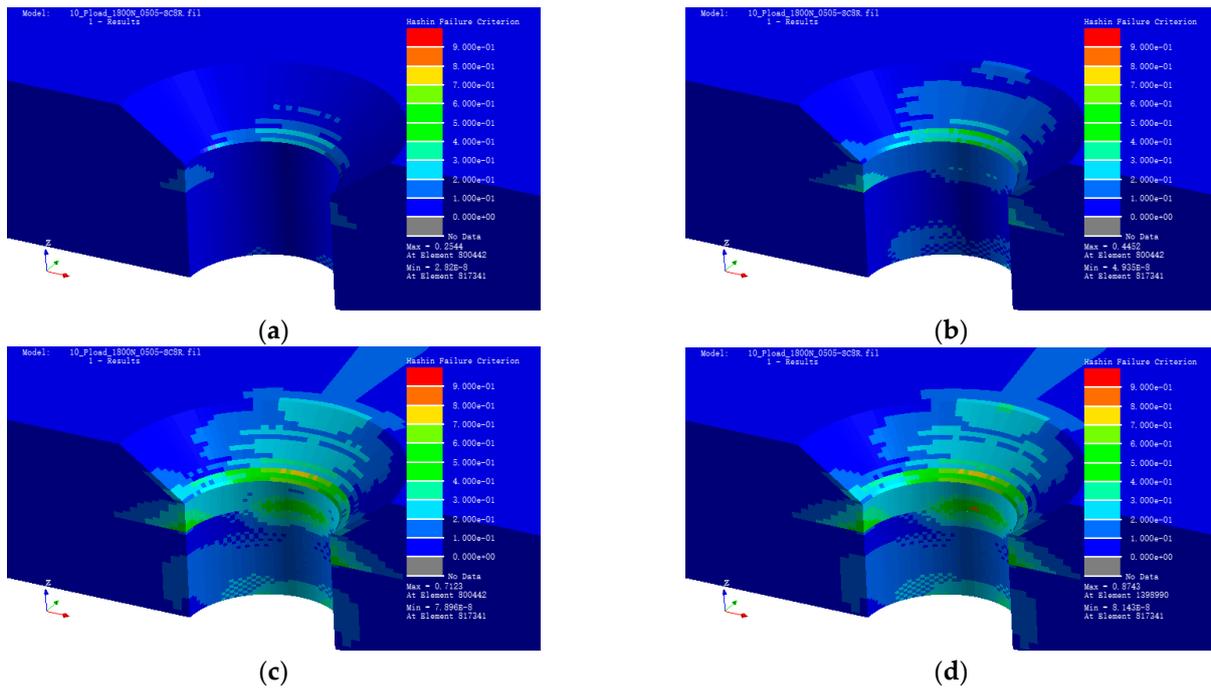
**Figure 8.** Laminate damage. (a) Laminate damage after  $10^3$  cycles. Hashin damage value 0.254. (b) Laminate damage after  $10^4$  cycles. Hashin damage value 0.445. (c) Laminate damage after  $10^5$  cycles. Hashin damage value 0.712. (d) Laminate damage after  $10^6$  cycles. Hashin damage value 0.874.

Using the FEA result above, simulate the assembly with a displacement fatigue load based on the Hashin damage criterion. The load is a sine wave with a frequency of 10 Hz, the loading time is  $10^3$  s,  $10^4$  s,  $10^5$  s, and  $10^6$  s respectively. The Hashin damage value is shown in Figure 8a–d.

According to the results presented in Figure 8a–d, the damage value on the bottom of the countersunk hole slope gradually increases with the increase of loading cycles. The location of the damage in the FEA results correlates with the location of the experimental sample. Based on the final fatigue results, a curve of cycle number  $\lg N$  and Hashin damage value was plotted as shown in Figure 9.

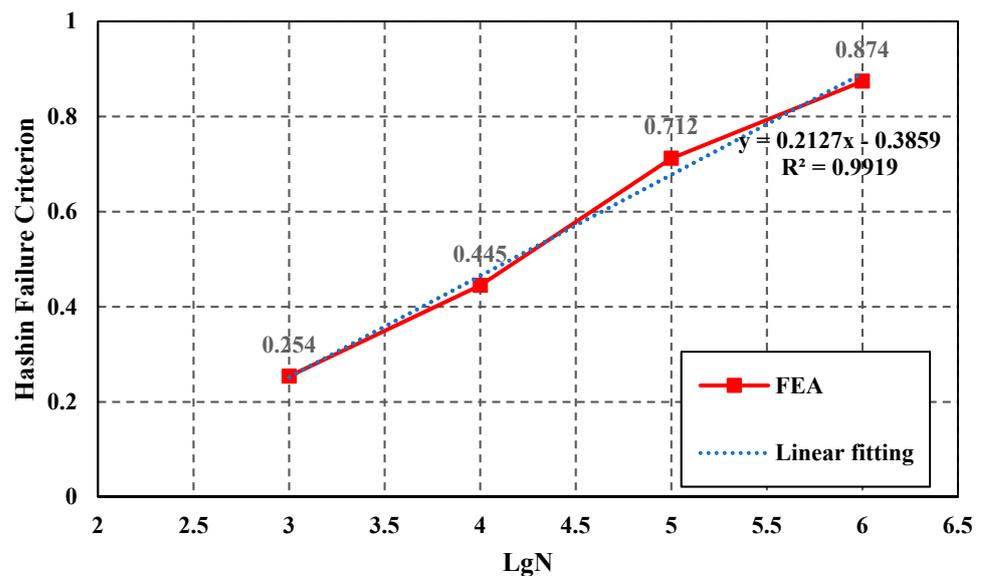
**Figure 9.**  $\lg N$ -HFC correlation relationship.

The simulation results show that HFC has a linear relationship with  $\lg N$ , which is the logarithmic load cycle number  $N$  (the dark solid line). The two parameters fit a linear curve (the light dash line) as shown in Equation (7); here, if HFC equals 1, the  $N \approx 3.0 \times 10^6$ ,
