Effect of Emergency Water Discharges from the Dam in Włocławek on the Sedimentary Structures of Channel Bars in the Lower Flow Regime of the River Vistula

Keywords: discharge; sedimentary structures; channel bar; dam; Włocławek reservoir

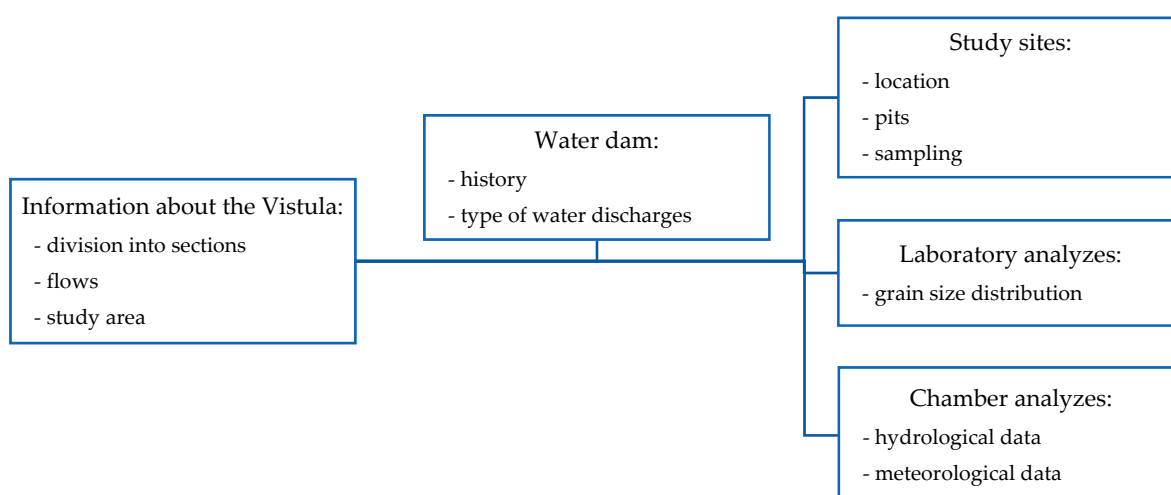
Figure 1. The flowchart describes the methodological approach applied in this study.

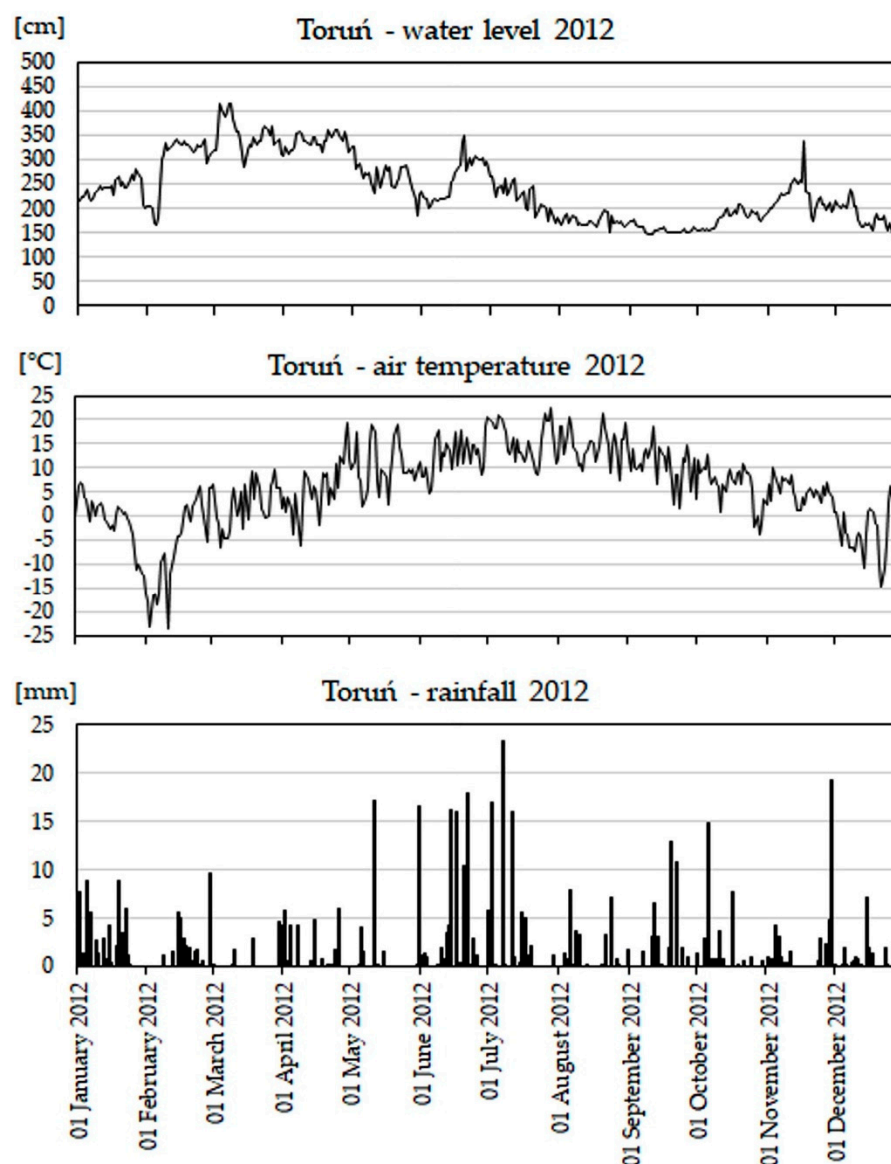
Figure 3. Water levels at the Toruń water gauge, year 2012, and air temperature and precipitation at Toruń Meteorological Station 12250 WMO (World Meteorological Organisation), year 2012. Own elaboration. Data source: www.pogodynka.pl.

In January 2012, the level of water at the Włocławek water gauge showed low values with an upward trend to medium level (Figure 3). At the end of January and in February, the air temperature dropped below zero, which resulted in a rapid development of ice cover on the Vistula [49]. Warmer weather at the end of February and in March contributed to increasing the water level as a result of ice melting in the river, melting of the ice cover in the catchment basin, and rainfall. In March and April, the water level was close to medium level. In May and at the beginning of June 2012, low water levels were recorded with an increase to medium level from mid-June. This increase was due to heavy rainfall during storms. From July to September, the level of water gradually decreased and was classified as low. In October and November, the level of water increased but was still low. In December, ice phenomena, such as frazil ice, appeared on the Lower Vistula.

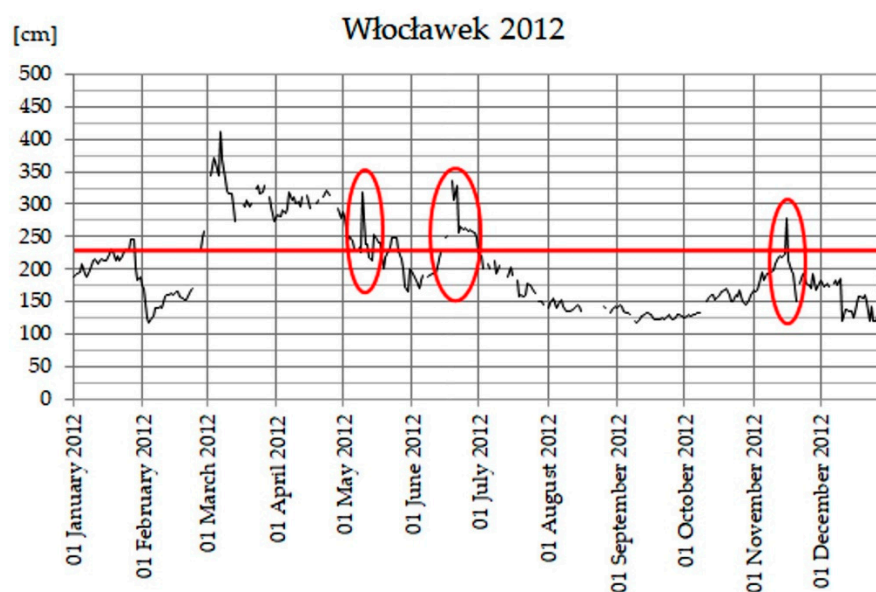
Figure 4. Water levels at the Włocławek water gauge. Red ellipses—emergency discharge, red line—flooding of the channel bars.

On the date on which the pit was made on the Byzie site (19 October 2012), the level of water in the Vistula in Włocławek was 172 cm. The highest part of the bar head was 110 cm above the water table, so it was assumed that the bar emerged above the water table when the water level was 280 cm (Figure 4). Analysis of sedimentary structures in the pit and analysis of the water level showed that the reactivation surface was formed during a sudden decrease in water level (Figure 5). Over 7 h after the emergency discharge in May 2012, the level of water decreased by 185 cm (the maximum decrease over an hour

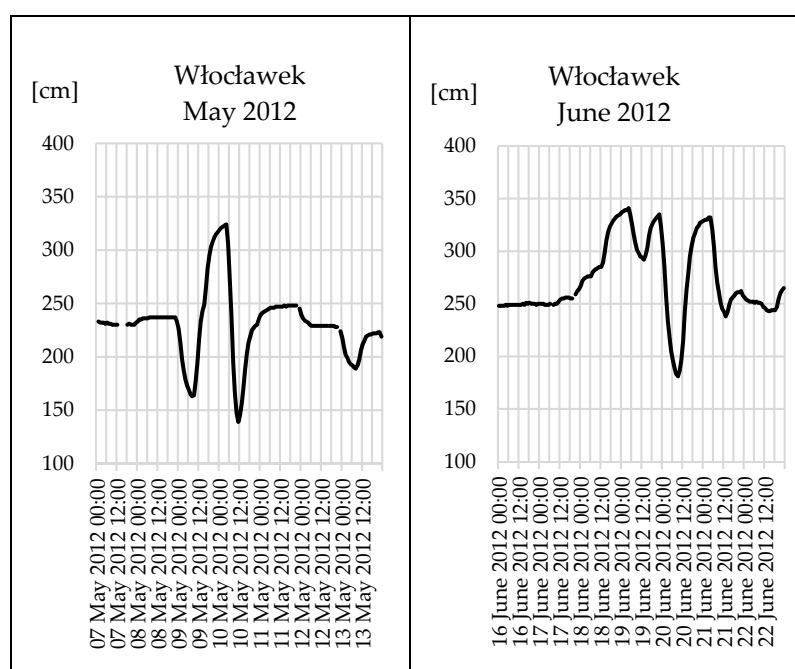
Figure 5. Water levels at the Włocławek water gauge during emergency discharge from the dam in Włocławek. Own elaboration. Source: www.pogodynka.pl.

The movement of 2D dunes across the surface increased the height of the sand bar by about 0.3 m. This process was fostered by increases in the level of water and flow rate: the first on 18 June 2012 and the second on 20 June 2012 (Figure 5).

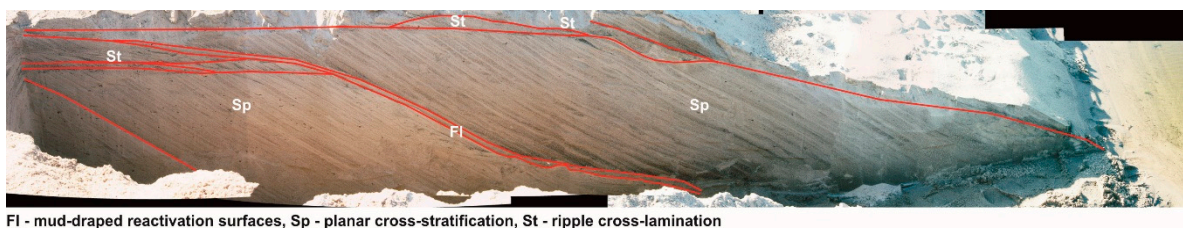
Fl - mud-draped reactivation surfaces, Sp - planar cross-stratification, St - ripple cross-lamination

Figure 6. Sedimentary structures-Byzie bar head 19 October 2012.

Sedimentary structures exposed in the pit on the Byzie site reflect the emergency discharges from May and June 2012. In the vertical section, 75 cm-thick foreset *Sp* structures inclined at an angle of 28° – 30° are predominant. Sediments of those structures were formed in May 2012 and consist of medium-grained sand with grain size $D_{50} = 0.33$ – 0.39 mm (Figure 5). They are well sorted. The foreset bed *Sp* structures are covered with sediments of low-energy *Sp* megaripples and *St* shallow troughs connected with a decrease in the flow rate at the end of the emergency discharge. These sediments are also built of medium-grained sand with grain size $D_{50} = 0.44 \text{ mm}$. They are moderately sorted. These structures are overlain by a 0.02 m-thick reactivation surface composed of a thin layer of *Fl* silt covered by medium-grained sand. A layer of silt reflected in the reactivation surface was formed during a fast decrease in water level (157 cm over 5 h, max. 44 cm in one hour). The grain size D_{50} in the reactivation layer is smaller than in *Sp* structures. The reactivation layer is moderately and moderately well sorted. Silt making the reactivation surface is covered by a layer of sand (2 cm) deposited over several hours during which the surface of the bar was under a thin layer of water (Figure 6). The reactivation surface is overlain by foreset *Sp* structures formed as a result of the emergency discharge from June 2012. The structures are built of medium-grained sand with grain size $D_{50} = 0.36$ – 0.48 mm . They are well and very well sorted. The ceiling of foreset *Sp* structures contains layers of coarse-grained and very coarse-grained sand with grain size $D_{50} = 0.86$ – 1.09 mm . They are moderately sorted and poorly sorted. Their presence in the lower portion of the foreset structures is due to gravity falling of coarser grains on the downstream slope of the bar. During the emergency discharge in June, *Sp* and *St* megaripples (2D dunes) migrated across the surface of the bar. They featured planar cross-stratification with a thickness of up to 10 cm. Sediments of these ripple marks are coarse-grained and have a similar grain size $D_{50} = 0.53$ – 0.55 mm . Their sorting is moderate and moderately good.

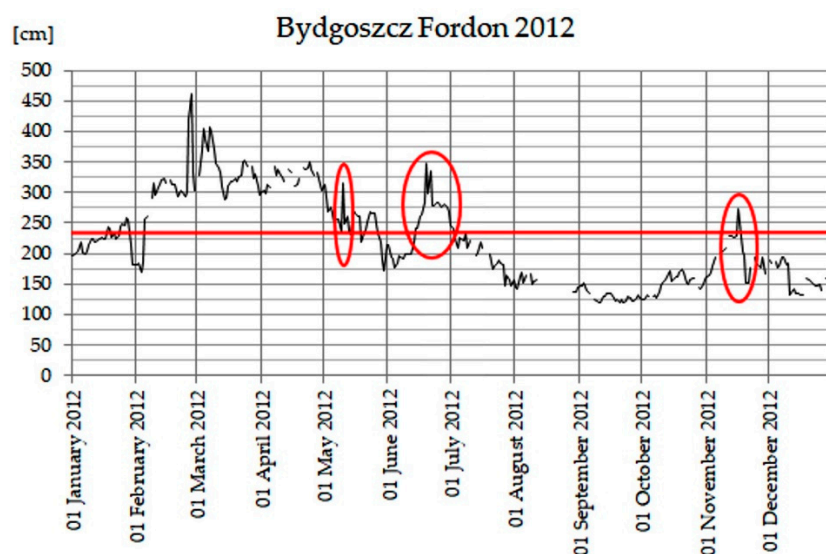
Figure 7. Water levels at the Bydgoszcz Fordon water gauge. Red ellipses—emergency discharge, red line—flooding of the channel bars.

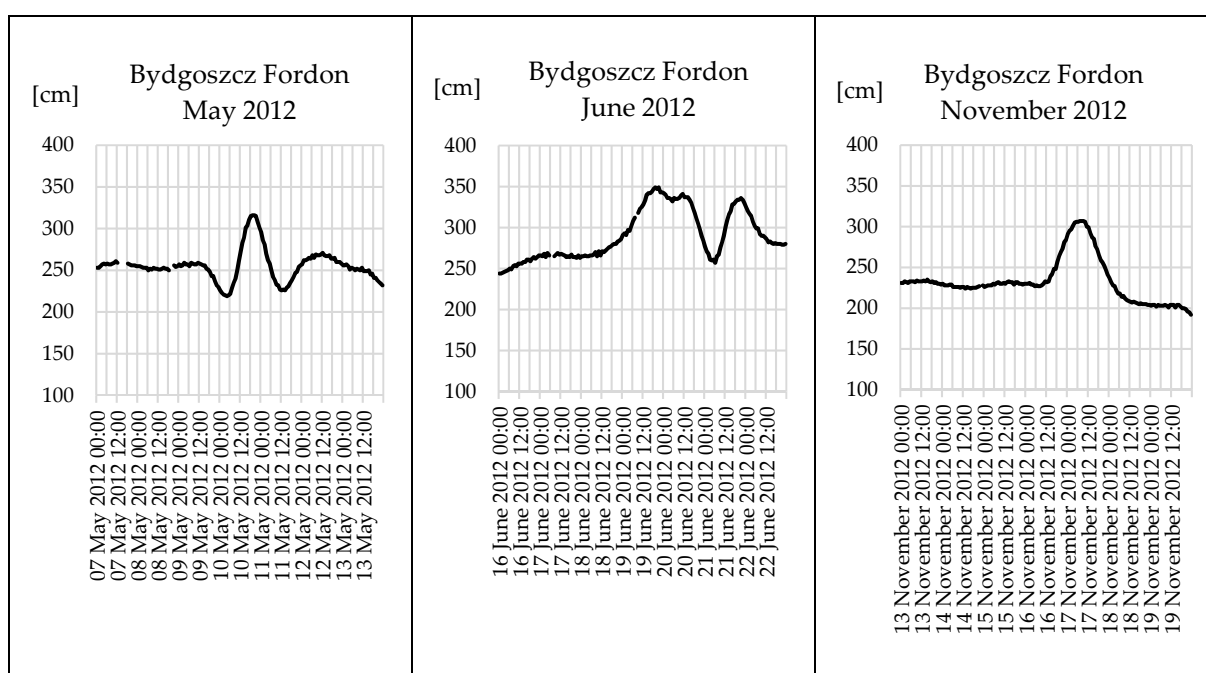
Figure 8. Water levels at the Bydgoszcz Fordon water gauge during emergency discharge from the dam in Włocławek. Own elaboration Source: www.pogodynka.pl.

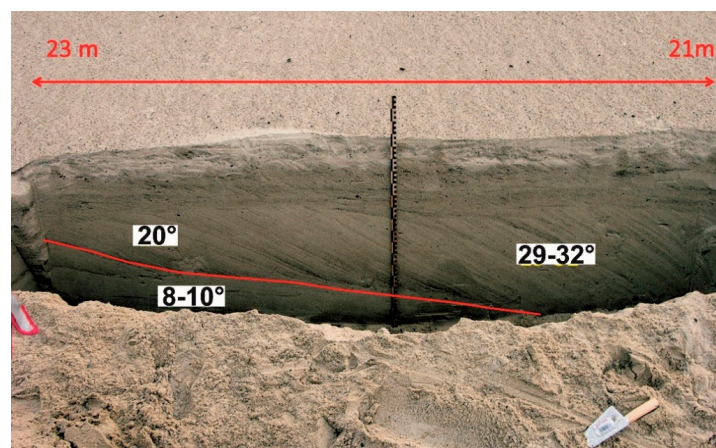
Figure 9. Sedimentary structures in the first pit.

The first pit was 21–23 m away from the bar head. It contained sedimentary structures reflecting the bar head formed in May 2012. Sediments of that bar head were composed of medium-grained sand with grain size $D_{50} = 0.29\text{--}0.38$ mm. Medium-grained sand was well sorted. The bar head featured structures deposited at an angle of $8^{\circ}\text{--}10^{\circ}$ (Figure 9). The bar head structures from May 2012 are overlain with S_p large-scale cross-stratified structures associated with the emergency discharge from June 2012. Initially, they are inclined at an angle of 20° , and further the angle of inclination of the strata increases to $28\text{--}30^{\circ}$. The lower portion of these structures is built of coarse-grained sand with grain size $D_{50} = 0.51$ mm that is moderately and moderately well sorted. The presence of coarse-grained sand is

connected with gravity movement of coarser grains on the downstream slope of the bar. The upper portion of *Sp* stratified structures is built of medium-grained sand with grain size $D_{50} = 0.34\text{--}0.39$ mm. The sand is well sorted. *Sp* structures are overlain by three sets of structures associated with the movement of planar megaripples (2D dunes) across the surface of the bar. Each set is about 8–10 cm thick. The ceiling of *Sp* structures is cut by erosion. The sediments of planar megaripples (2D dunes) consist of medium-grained sand with an addition of coarse-grained sand with grain size $D_{50} = 0.44\text{--}0.57$ mm. The sand is moderately and moderately well sorted. Samples were also taken from a thin (1 cm) layer of sand covering the surface of the bar. This was coarse-grained sand with grain size $D_{50} = 0.56\text{--}0.62$ mm, moderately and moderately well sorted. The presence of coarse-grained sand on the surface of the bar is associated with finer fractions being blown out by the wind and the formation of aeolian deposits. From the beginning of July until November, the bar was underwater.

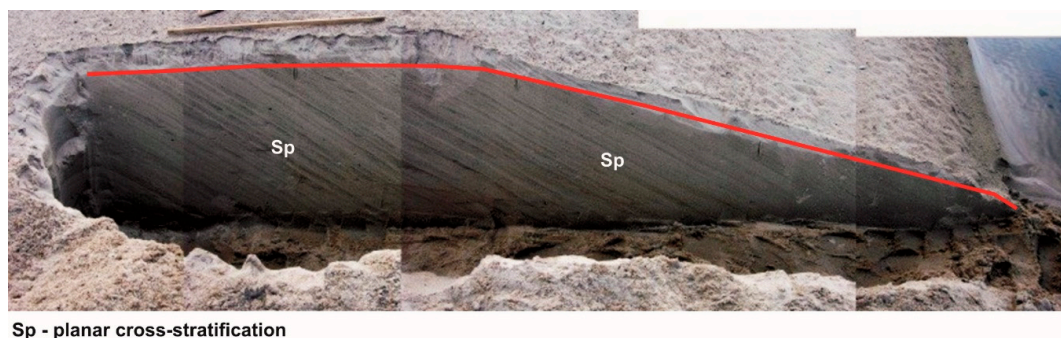
Sp - planar cross-stratification

Figure 10. Sedimentary structures in the channel bar head—2 November 2012.

The second pit was made in the bar head on 2 November 2012. The pit contained *Sp* large-scale cross-stratified structures reflecting the emergency discharge from June 2012 (Figure 10). The dip angle was $28^{\circ}\text{--}30^{\circ}$. The *Sp* structures were built from medium-grained sand with grain size $D_{50} = 0.31\text{--}0.43$ mm (on average 0.36 mm). Samples collected from the surface were composed of medium- and coarse-grained sand with grain size $D_{50} = 0.41\text{--}0.53$ mm. The sand was moderately well sorted. Small ripple marks associated with a thin layer of water covering the sand bar and a low rate of flow moving across the surface of the bar were observed. The bar head was displaced by 22 m in June. The surface of the sand bar was underwater for 436 h. This results in the bar being displaced by $1.21\text{ m}/24\text{ h}^{-1}$.

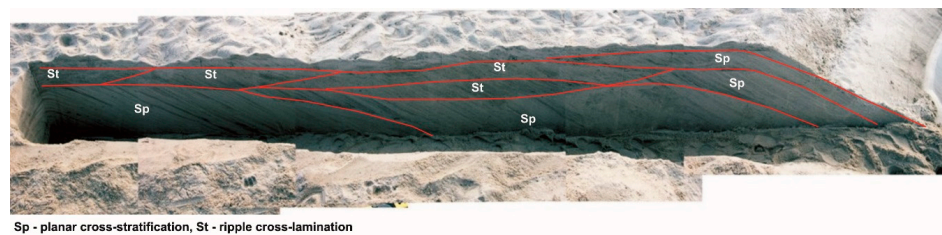
Figure 11. Sedimentary structures in the channel bar head—20 November 2012.

Sediments of the bar head deposited in June 2012, exposed in the third pit, are sediments included in fluvial transport at the initial stage of increase in the water level and flow rate due to the emergency discharge from November 2012. They can be clearly seen in the pit on the reactivation surface as medium-grained laminated deposits with an addition of coarse-grained sand. Their grain size is similar to that of 3D dunes. The grain size D_{50} of these sediments is 0.46 mm and they are moderately well sorted. At a further stage of increase in the water level, *Sp* large-scale cross-stratified structures were formed (Figure 11). Their grain size is finer than that of structures covering the reactivation surface. This is medium-grained sand with grain size D_{50} amounting to 0.35–0.42 mm. The gradient of *Sp* structures is 28° – 30° . In the cross-section of the bar, *Sp* structures are overlain by two sequences of megaripples (3D dunes). They were formed during the emergency discharge of water in November 2012 when the water level and flow rate rapidly increased. Due to high water energy, the sediments were transported across the bar surface forming megaripples (3D dunes). The ceiling portion of the *Sp* bar was scoured to a depth of 25 cm and then covered with the sediments of migrating megaripples (3D dunes) with parasitic ripples on their surface. The megaripples are 15–20 cm thick and have a span of 2–2.5 m. The megaripples (3D dunes) are built of medium-grained sand with grain size D_{50} amounting to 0.41–0.49 mm. They are usually moderately well sorted and less often well and moderately sorted.

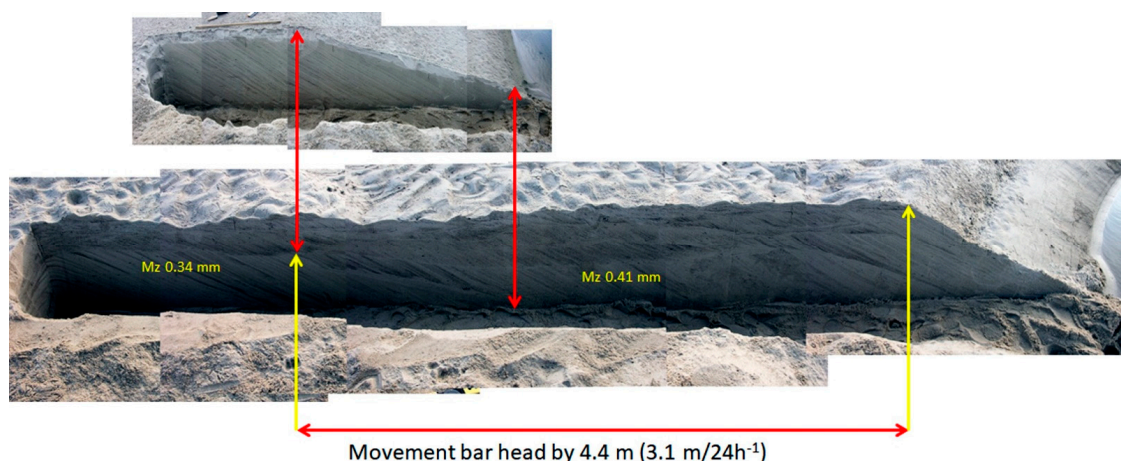
Figure 12. The record of bar head movement in sedimentary structures of the channel bar—20 November 2012.

The bar head also reflects two sequences associated with the megaripples (3D dunes) crossing the bar head. Changes in the flow rate in the foreground of megaripples (3D dunes) led to scouring of the upper ridge of the bar head and forming of the reactivation surface. The average grain size D_{50} of these sequences of sediments was 0.43 mm. This was medium-grained, well and moderately well sorted sand. During the emergency discharge of water in November 2012, the bar head was displaced by 4.4 m over 32 h, which corresponds to 3.3 m in 24 h (Figure 12). It was the largest distance among the analysed sedimentary structures.

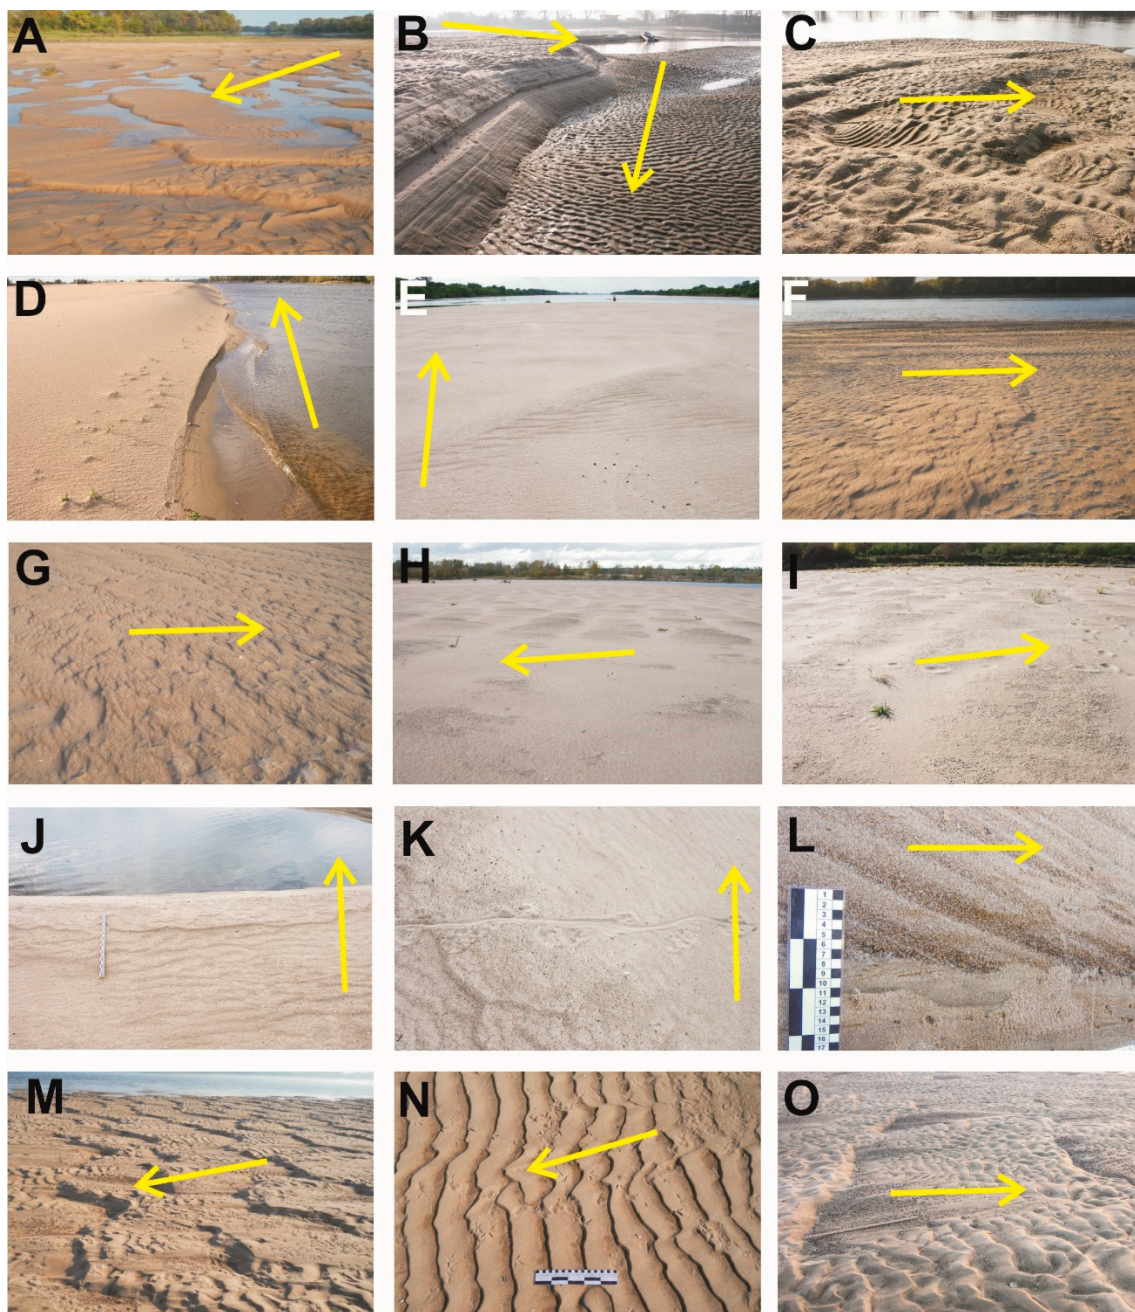
Figure 13. Types of bedforms on channel bars. The yellow arrow marks the water flow. (A)—the surface of the bar after lowering the water level with clear freshly formed 2D dunes, (B)—bar surface during lower flow regime, (C)—clear freshly formed 3D dunes with parasitic ripples on their surface, (D,E)—aeolian processes on bars, (F,G)—aeolian erosion of parasitic ripples, (H,I)—aeolian erosion and accumulation of 2D dunes and 3D dunes, (J)—coarsest-grained aeolian deposits (granule ripples), (K)—traces of a beaver on the bar, (L)—large-scale cross-stratification, (M–O)—typical fresh bedforms on the analyzed bars.

The starting point is the high waters at the end of winter and in early spring when snow melts in the mountains and the meltwater runs off into the Vistula. All the channel bars are then under the water and move downstream. After the spring swell, the water level in the Vistula gradually drops. The first, the highest bars emerge when the water level is about 250–280 cm (Figure 13A). There are several such bars in the analysed section (3–5). The largest number of bars can be seen in the channel of the lower flow regime of the Vistula when the water level falls below 180 cm (Figure 13B). There can be 50–80 bars along the analysed section of the river (100 km). The end of the swell is recorded in the sedimentary structures as large-scale cross-stratification with a thickness ranging from 60 to 120 cm depending on the height of the bar. When the water level drops and the bar emerges, its surface shows clear freshly formed 2D dunes and 3D dunes with parasitic ripples on their surface (Figure 13A,C).

The emerged surface of channel bars in the Vistula dries out. Aeolian processes smoothing the surface of the bars can often be observed (Figure 13D,E). Aeolian transport of sand building the surface portion of the bar initially leads to erosion of the ridges of parasitic ripples (Figure 13F,G) and then also of 2D dunes and 3D dunes (Figure 13H,I) and recesses between ripple marks are filled with sand. The finest-grained sand is blown out into the water and included in fluvial transport again. If the bars are emerged for a long time, their surface becomes flat and is covered with aeolian deposits with grain size $D_{50} = 0.5\text{--}2\text{ mm}$. At the topmost parts of the bars, the coarsest-grained aeolian deposits form so-called granule ripples [50] (Figure 13J). The surface of the bars is also transformed by birds often sitting on sand bars in whole flocks. In addition, traces of beavers, foxes and other migrating animals were observed. Traces of animals and birds are not reflected in the sedimentary structures of channel bars (Figure 13K).

End of emergency discharge. At this stage, depending on the method of ending the discharge (decreasing the flow or suspending the flow on the dam in Włocławek for a few hours), the level of water drops by several to several dozen centimetres in an hour. Fresh bedforms can be seen on channel bars emerging from the water. These are most often megaripples (2D dunes and 3D dunes) with parasitic ripples. The type of bedform reflects the flow conditions that dominated on the bar during the discharge of water. The fresh bedforms (Figure 13M–O) are clearly recorded in the sedimentary structures exposed in
