Floating Debris in the Low Segura River Basin (Spain): Avoiding Litter through the Irrigation Network

Abstract: The Vega Baja region lays on the lower course of the Segura River (southeastern Spain). It is one of the six traditional “huerta” European landscapes and has an ancient, extensive, and complex network of irrigation and drainage channels. The accumulation of floating waste causes numerous economic, environmental, and landscape problems in its irrigation infrastructures, hindering farmers’ water management practices. This work classifies and estimates the total volume of floating waste at various points along the Segura River and its irrigation channels as a first systematic approach to define and quantify the problem of floating waste accumulation. Aerial images taken by a drone were analyzed over time and a manual count of residues was performed on selected points. The results obtained show that reeds and residues of riparian vegetation represent more than 95% of the floating debris volume measured on the riverbed. Anthropogenic waste, which represents less than 5% of debris volume, was characterized, finding that plastics of domestic sources are the most abundant by cou

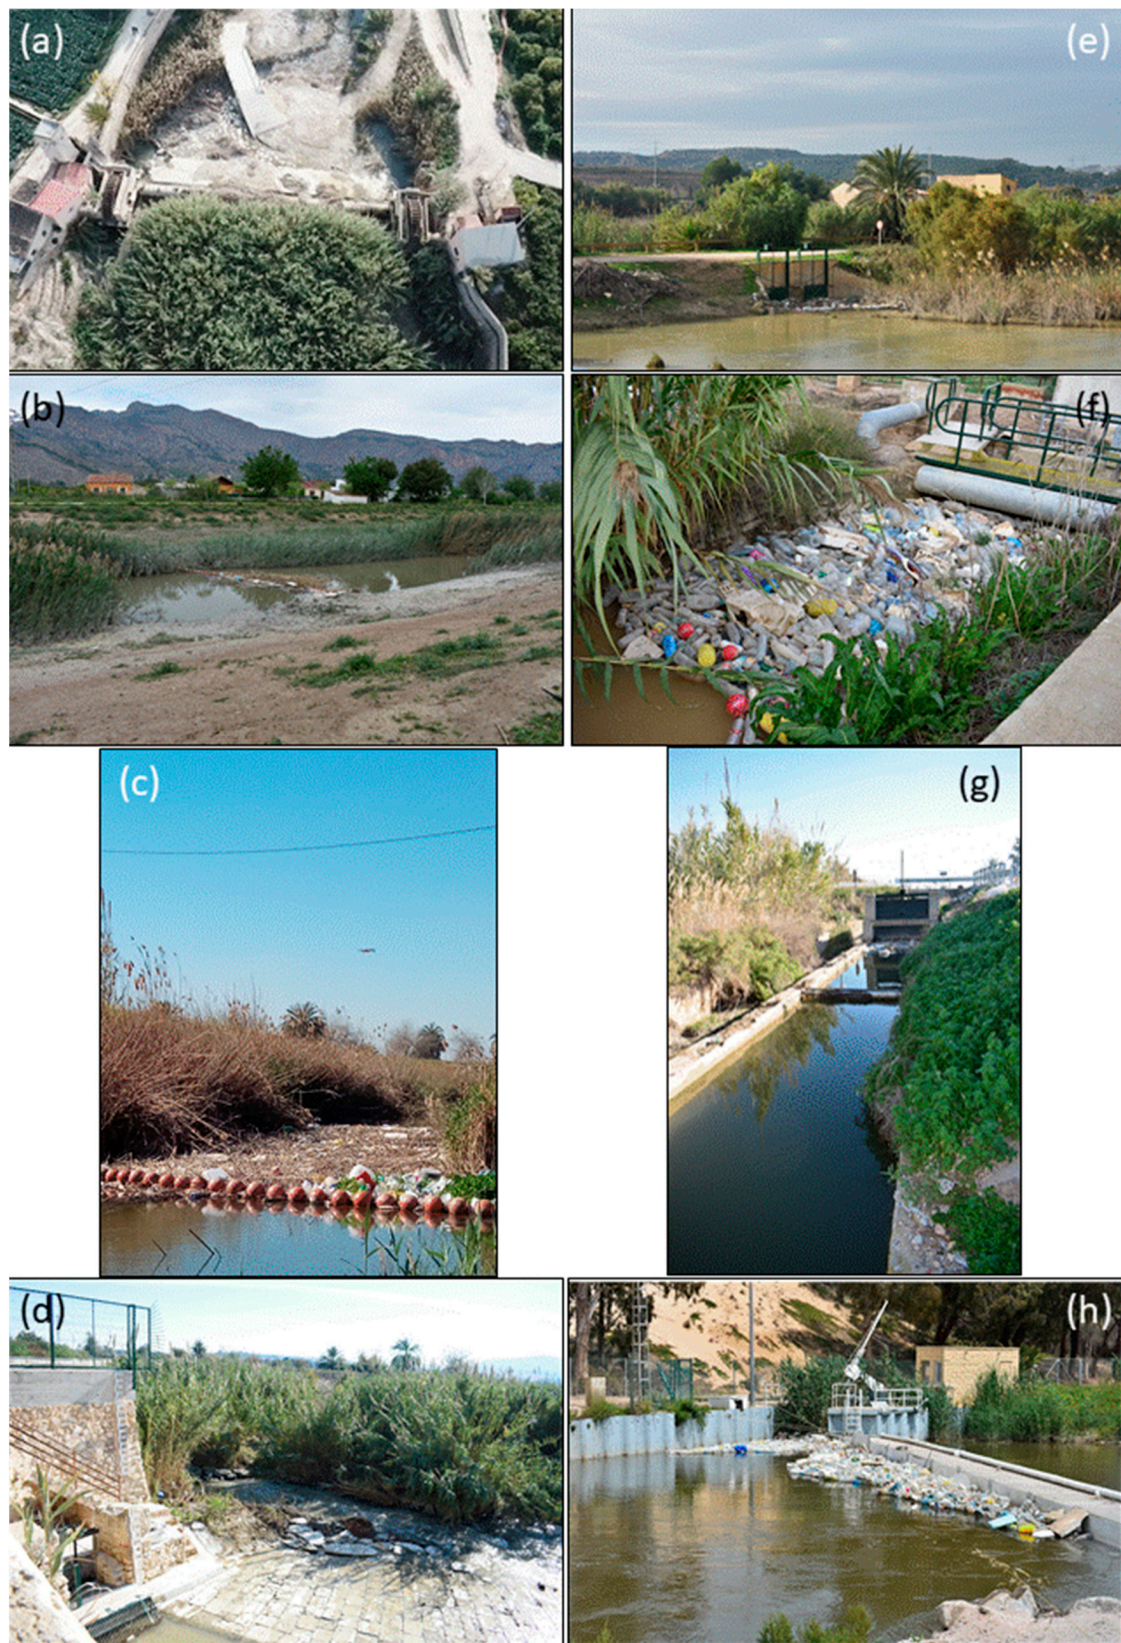
Figure 3. Sampling points. ID1, *Azud de las Norias* (a); ID2, boom at the *Molino de la Ciudad* (b); ID3, boom at *Almoradí* (c); ID4, *Azud de Alfeitamí* (d); ID5, inlet of *Riegos de Levante* (e); ID6, *Acequia de Callosa* (f); ID7, *Azarbe de Cebadas* (g); and ID8, *Guardamar floating screen* (h).

The sampling points are shown in Figure 3 and described in Table 1.

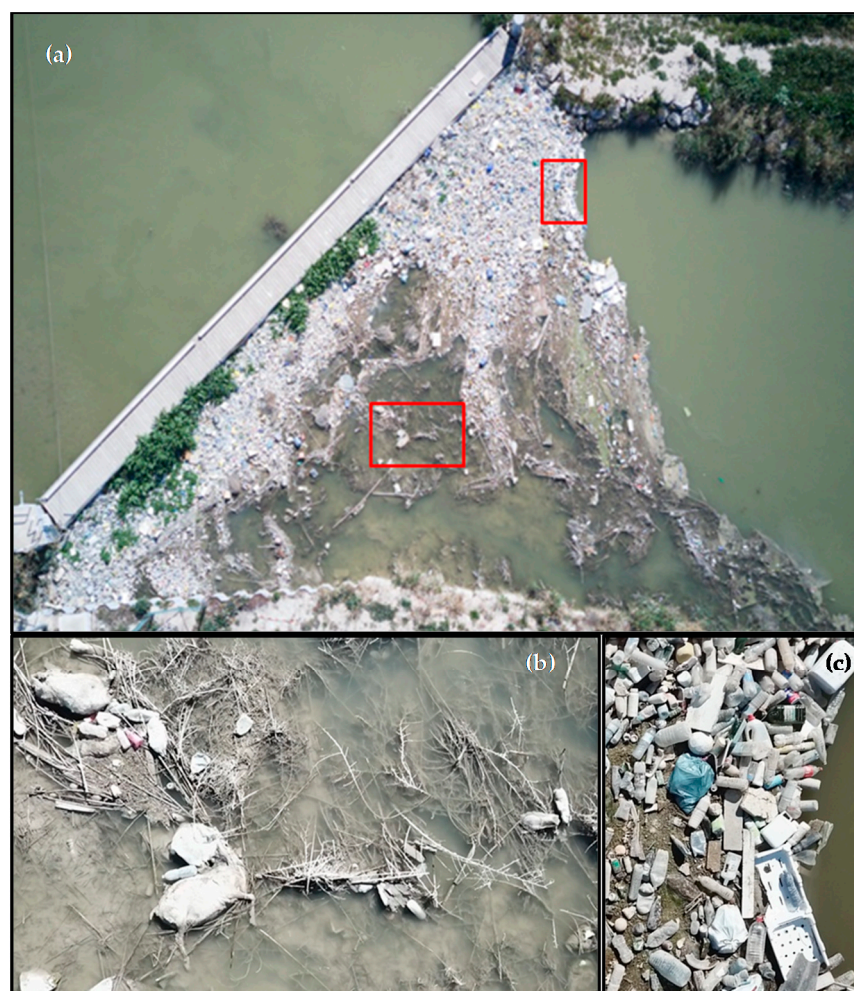
**Figure 4.** Zenith images captured from the drone: general (a) and details (b,c).

The photographs were taken from a sufficient height for the spot of floating debris to be captured in a single image. In each image, a ranging rod was photographed along the debris for scale determination. Other images were captured from lower heights to obtain better images for the waste characterization (Figure 4).
