Effect of Turning on the Surface Integrity and Fatigue Life of a TC11 Alloy in Very High Cycle Fatigue Regime

Abstract: In this work, the effect of a turning process on fatigue performance of a Ti-6.5Al-3.5Mo-1.5Zr-0.3Si (TC11) titanium alloy is studied in the high cycle fatigue (HCF) and very high cycle fatigue (VHCF) regimes. For this purpose, the surface characteristics including surface morphology, surface roughness and residual stress were investigated. Moreover, axial fatigue tests were conducted with an ultrasonic fatigue testing system working at a frequency of 20 kHz. The results show that the turning process deteriorated the fatigue properties in both HCF and VHCF regimes. The fatigue strength at 1×10^8 cycles of turned samples is approximately 6% lower than that of electropolished ones. Fracture surface observations indicate that turning marks play a crucial role in the fatigue damage process, especially in the crack initiation stage. It was observed that the crack of all the turned samples originated from turning marks. In addition, the compressive residual stress induced by the turning process played a more effective role in resisting crack propagation in the VHCF reg

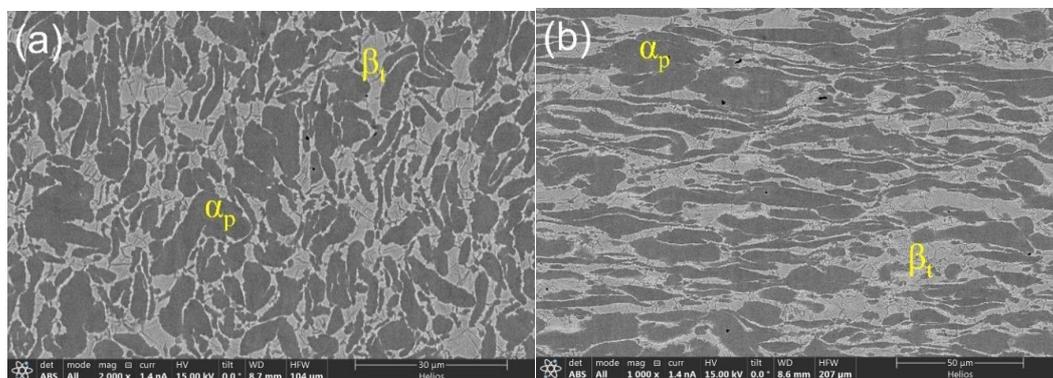
Figure 1. Microstructure images of the studied TC11 titanium alloy: (a) transverse section, and (b) longitudinal section.

A commercial Ti-6.5Al-3.5Mo-1.5Zr-0.3Si (TC11) titanium alloy was investigated in this work. It is an $\alpha + \beta$ titanium alloy usually used in aeronautical structures, such as aero-engine compressors, blades and turbine discs. This alloy has higher strength, superior creep resistance and better thermal stability in comparison with Ti-6Al-4V alloy thanks to the addition of silicon. The small amount of silicon can reduce dislocation mobility, which allows improving creep resistance and stabilizing the microstructure under moderate temperature to meet the service requirements of aero-engine components. After grinding and polishing, the microstructure of the studied TC11 alloy was observed by scanning electron microscope (SEM). Metallographic characteristics of transverse and longitudinal sections are shown in Figure 1a,b, respectively. The microstructure is composed of primary alpha phase (α_p) and transformed β matrix (β_t), corresponding, respectively, to the dark and bright regions indicated in Figure 1. The volume fraction of α_p is about 60%.

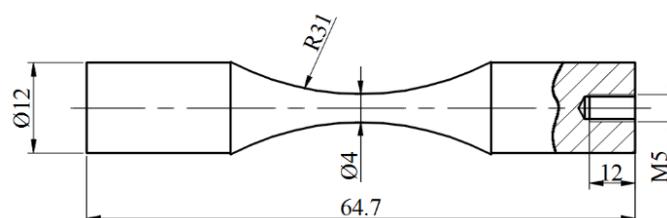
Figure 2. Geometry and dimensions of the fatigue sample (unit: mm).

In this work, hourglass-shaped fatigue sample was designed through analytical and finite element methods to meet the requirements of 20 kHz ultrasonic resonant vibration. The dimensions and the geometry of the sample are shown in Figure 2. The minimum diameter at the central reduced section is 4 mm. Fatigue samples were machined by turning and the processing parameters are cutting speed $v_c = 10$ m/min, feed rate $f_z = 0.04$ mm/rev and depth of cut $\alpha_p = 0.1$ mm. In order to quantitatively analyze the influence of turning on fatigue performance of the TC11 alloy, some samples were polished using SiC paper and then electropolished in a solution composed of HClO_4 and ethanol to obtain a mirror-like surface and eliminate surface defects and residual stress induced by turning. The electropolished samples are considered as a reference to analyze the effect of surface integrity resulting from turning on the HCF and VHCF performance. The fatigue performance of electropolished samples of the TC11 alloy has been investigated in our previous work [13].

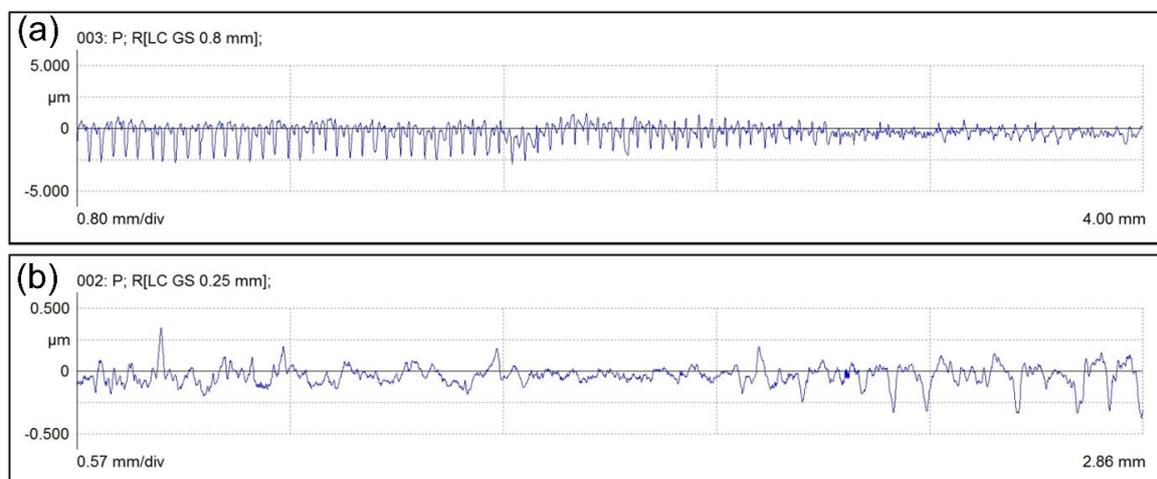
Figure 3. Surface profiles of (a) turned and (b) electropolished specimens.

The surface profiles of the turned and the electropolished samples are illustrated in Figure 3. For the turned sample, there is the presence of a regular fluctuating profile, and the maximum profile height induced by turning is about 2.5 μm (Figure 3a), which is much larger than that of the electropolished sample. The electropolished sample has a much smoother surface and the maximum profile height is below 0.5 μm (Figure 3b), which means that the electropolishing process effectively reduced the surface roughness and improved the surface quality. Several typical values of surface roughness, such as arithmetic mean roughness R_a , mean roughness depth R_z , difference in height between the highest peak and the deepest valley R_t , and mean peak width R_{sm} , were calculated according to the standards of EN ISO 4287 and EN ISO 16610-21, and the results are presented in Table 1.

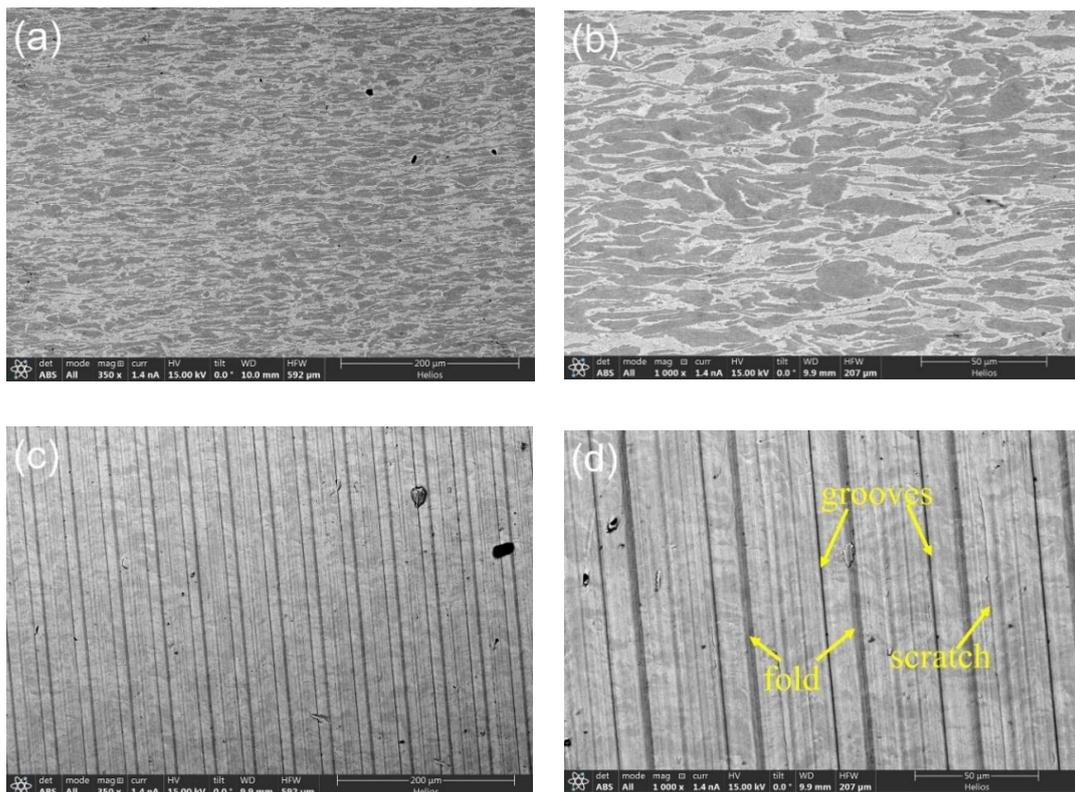
**Figure 4.** SEM surface morphology observations of (a,b) electropolished and (c,d) turned samples.

Considering that surface profile and roughness parameters are not sufficient to describe surface topographical features, the surface morphologies of the electropolished and the turned samples were observed using SEM and they are shown in Figure 4. It can be seen that the surface of the electropolished sample presents free-defects characteristics (Figure 4a,b), and is similar to the microstructure features highlighted at the longitudinal section shown in Figure 1b. These electropolished samples with high surface quality would reveal the intrinsic damage mechanisms of the alloy itself and avoid the effect of turning on the damaging process. Different from the smooth surface of the electropolished sample, the surface obtained by turning is obviously rough, as shown in Figure 4c,d. A series of defects such as grooves, fold and scratch markings can be observed at the turning surface. These surface turning defects could give rise to stress concentration and promote fatigue crack initiation. Similar turning defects were also observed by several researchers for titanium alloys [20–22]. It has been suggested that the grooves result from the mapping of microchipping of tool cutting edges to the machined surface [22,23], which is related to the plowing effect of the built-up edges [24,25].

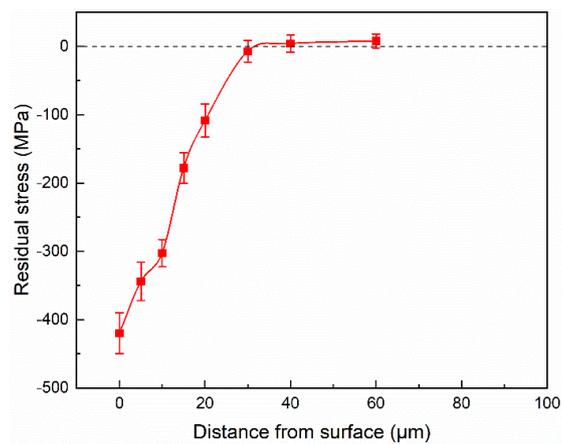
Figure 5. In-depth residual stress of a turned sample.

The in-depth axial residual stress profile of the turned sample is shown in Figure 5. Considering the residual stress relaxation induced by iterative removal of material, the measured values of residual stress were corrected using a mathematical method proposed by Moore and Evans [26]. The depth of the compressive residual stress field generated by the turning is about 30 μm . The maximum compressive residual stress is located at the turned surface and the corresponding value is about -420 MPa.

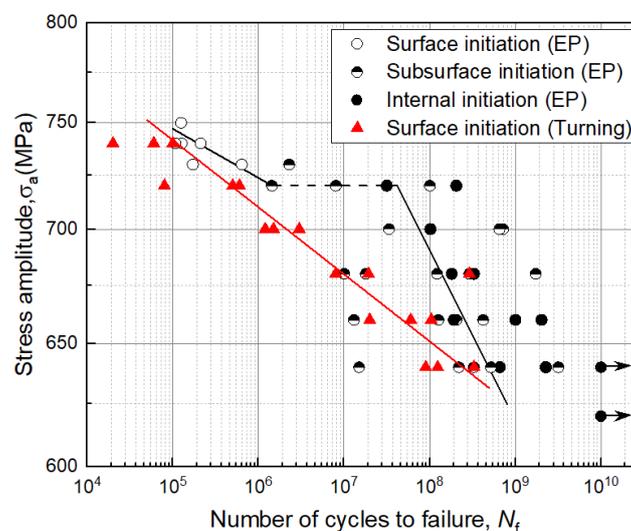
Figure 6. $S-N$ plot for the fatigue test data of electropolished (EP) and turned samples for the studied TC11 alloy.

The fatigue test results of both electropolished and turned samples of the TC11 alloy are presented in the form of an $S-N$ plot, as shown in Figure 6. It should be noted that the fatigue life data and the fracture surface observation of electropolished samples were obtained in our previous work, and they are presented in this paper as a reference to analyze the effect of turning on fatigue life and damage mechanism. The fatigue lives of the electropolished and the turned samples exhibit different tendencies depending on the applied stress amplitudes. The fatigue life of the turned samples continuously increases with the decrease in applied stress and presents a lower scatter in comparison with the electropolished samples. It seems that there is no transition between the HCF regime and the VHCF regime for the fatigue data obtained with the turned samples. The fatigue datapoints obtained for the turned samples can be fitted using an $S-N$ curve which was determined by a linear regression model according to the ASTM standard [27]. However, the $S-N$ curve of the electropolished samples exhibits multi parts with different slopes between the two regimes. The SEM observations of the fracture surfaces indicate that fatigue failure of all the turned samples occurred at sample surface, whereas subsurface-induced or interior-induced failure occurred in the VHCF regime for the electropolished samples. The difference in fatigue life distribution between electropolished and turned samples could be ascribed to the different damage processes, which will be discussed in the following sections.

As shown in Figure 6, the obtained fatigue lives of turned samples vary from about 2×10^4 cycles to 3.29×10^8 cycles under the applied stress amplitudes ranging from 740 to 640 MPa. The limited fatigue life data of turned and electropolished samples seem to show that the turned samples exhibit lower fatigue resistance than the electropolished ones in both HCF and VHCF regimes, especially in the fatigue life range of 1×10^6 – 2×10^8 cycles. The fatigue strengths of turned and electropolished samples at 10^8 cycles ($\sigma_{(10^8)}$) were calculated based on a failure probability of 50%. The values of fatigue strength at 10^8 cycles for the electropolished and the turned samples are 690 and 651 MPa, respectively. The fatigue strength $\sigma_{(10^8)}$ of the turned samples is approximately 6% lower than that of the electropolished ones. For the turned samples, the synergetic effect between applied stress amplitude and surface characteristics is responsible for the reduced fatigue strength.

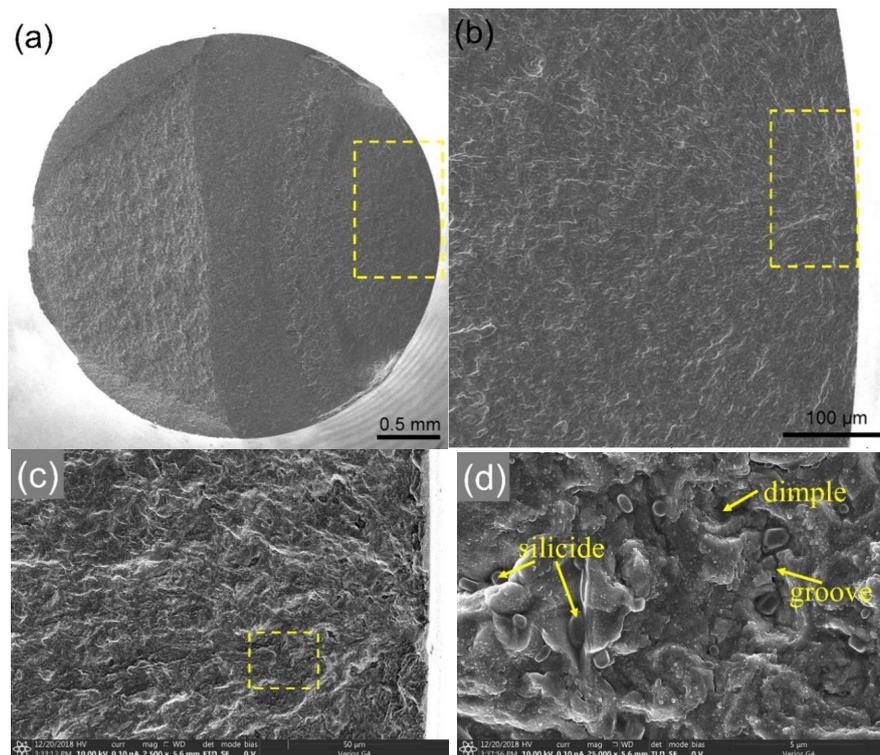
Figure 7. Fracture surface of an electropolished sample tested at $\sigma_a = 730$ MPa, failed after $N_f = 6.39 \times 10^5$ cycles in the HCF regime: (a) overall view showing the surface crack initiation, (b) magnified image of the rectangular area in (a), (c) magnified image of the rectangular area in (b) showing the surface crack initiation morphology, (d) magnified image of the rectangular area in (c) revealing the morphology of the area near the crack initiation site.

Fracture surface observations indicate that for the electropolished samples, fatigue crack initiated from surface in the HCF regime, whereas it initiated from the subsurface or interior in the VHCF regime. Two representative fracture surfaces of electropolished samples failed at $\sigma_a = 730$ MPa with $N_f = 6.39 \times 10^5$ in the HCF regime and at $\sigma_a = 680$ MPa with $N_f = 1.81 \times 10^8$ in the VHCF regime are presented in Figures 7 and 8, respectively. Under high applied stress amplitudes, the electropolished samples failed from surface. The crack initiation source started from a small surface area, as shown in Figure 7a–c. The area near the surface crack initiation site exhibits a rough appearance with the presence of dimples, grooves and particles, but without facets, as shown in Figure 7c,d. It was revealed in our previous work [13] that these particles in the crack initiation region are silicides. The crack initiation in the HCF regime is attributed to local stress concentration induced by large silicides. Under low applied stress amplitudes, the fatigue crack of electropolished samples initiated from subsurface or interior. The internal crack initiation area exhibits a fish-eye pattern, as shown in Figure 8. It is generally reported that in the VHCF regime, the internal crack initiation of $\alpha + \beta$ titanium alloys is ascribed to facet clusters of α_p grains [8,9], and thus the fracture surface commonly presents brittle characteristics. However, in the present study, the internal crack initiation area with fish-eye pattern is covered by dimples, grooves and peak-like features instead of facets, as shown in Figure 8c,d. This means that the fracture surface of this TC11 alloy exhibits typical ductile damage appearance. At ultra-high resolution SEM, several nano-silicides were observed in the dimples at the fish-eye region, as shown in Figure 8d. In this case, the internal crack initiation is attributed to microvoids nucleation around nano-silicides.

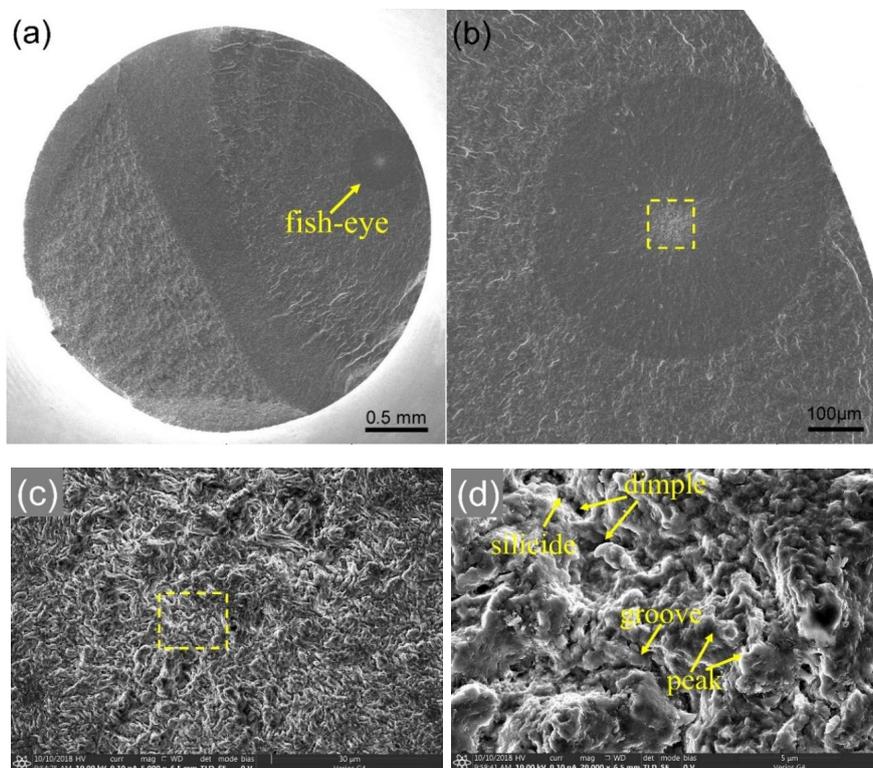
Figure 8. Fracture surface of an electropolished sample tested at $\sigma_a = 680$ MPa, failed after $N_f = 1.81 \times 10^8$ cycles.

cycles in the VHCF regime: (a) overall view showing the internal crack initiation, (b) magnified image of the fish-eye pattern in (a), (c) central area of the fish-eye pattern in (b) showing ductile damage appearance, (d) detailed morphology of the rectangular area in (c) showing dimples, silicides, grooves and peaks.

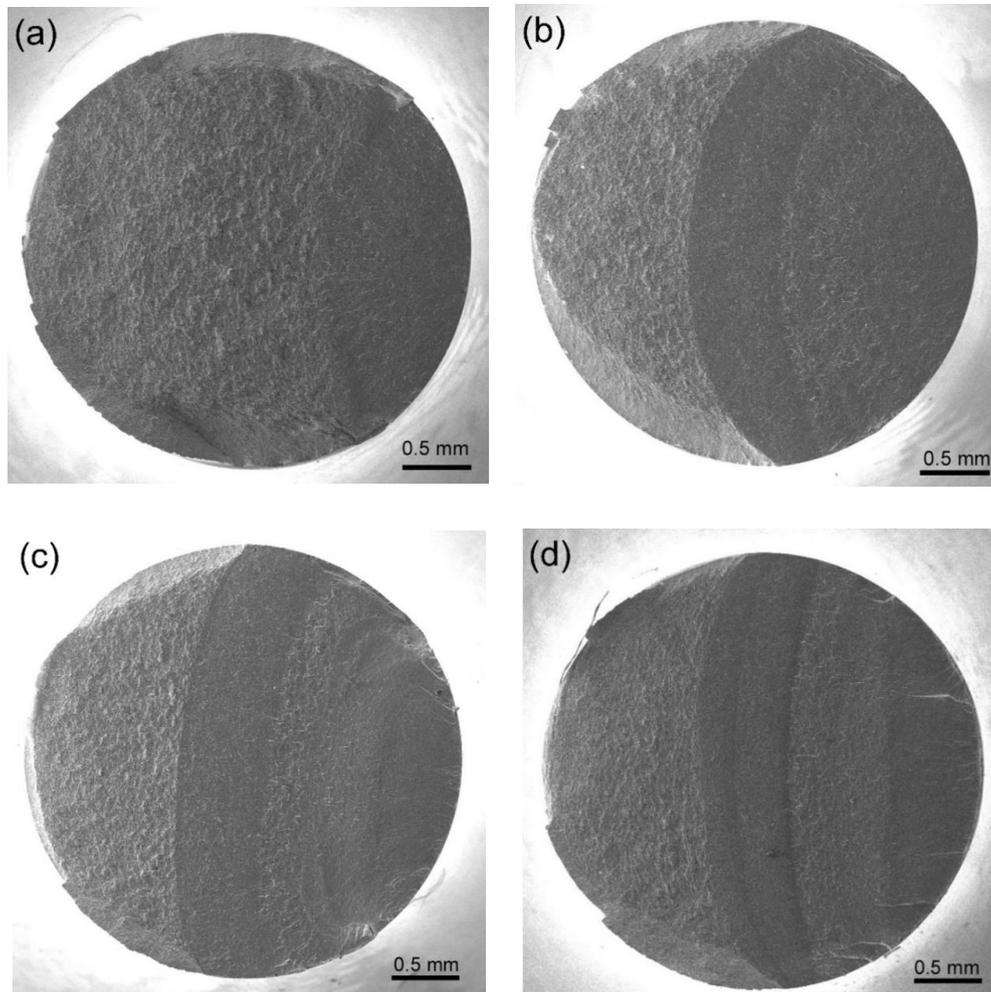
Figure 9. Typical macroscopic fracture surfaces of turned specimens failed at different fatigue lives: (a) $\sigma_a = 740$ MPa, $N_f = 1 \times 10^5$, (b) $\sigma_a = 700$ MPa, $N_f = 1.5 \times 10^6$ cycles, (c) $\sigma_a = 660$ MPa, $N_f = 6 \times 10^7$ cycles and (d) $\sigma_a = 640$ MPa, $N_f = 3.29 \times 10^8$ cycles.

Typical fracture surfaces of turned samples failed in the HCF and the VHCF regimes are presented in Figure 9. The fracture surface morphology and the crack initiation site for turned samples are different from those of electropolished ones. The crack initiation sites of turned samples are all located at the surface, and no internal crack initiation was observed even in the VHCF regime. With the decrease in applied stress, the crack initiation region extends to a larger area along the sample surface and the corresponding arc length of crack sources becomes larger. To highlight the difference in the microscopic topography of the fracture surface induced by the turning process, more detailed SEM observations of the surface initiation area were conducted and the representative morphologies of turned samples that failed in both HCF and VHCF regimes are shown in Figures 10 and 11.

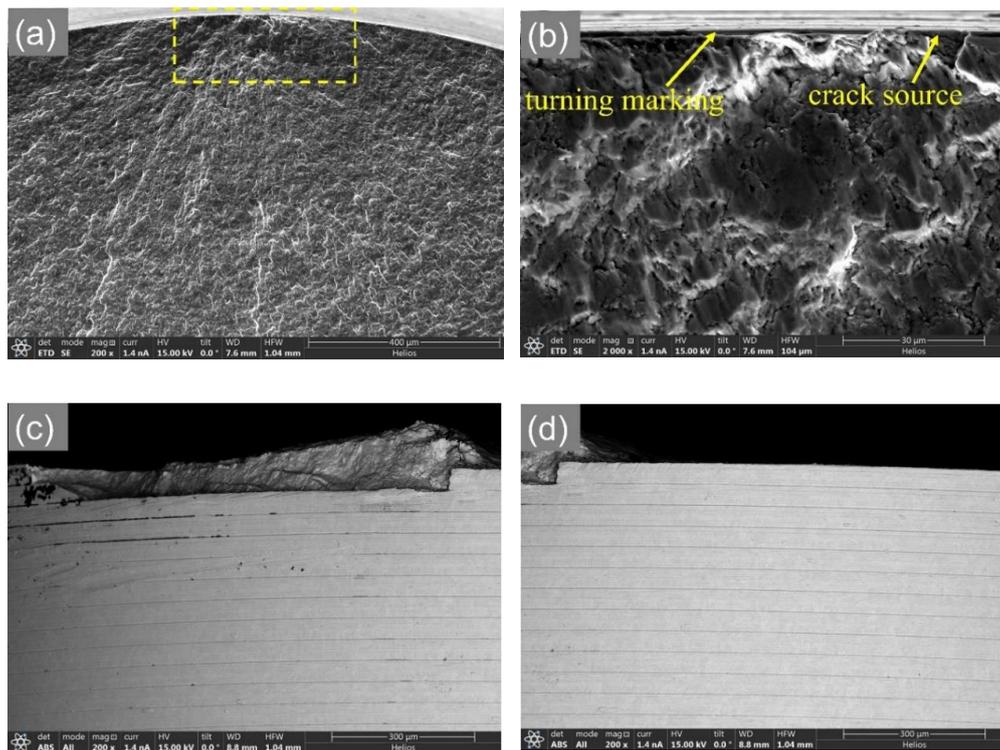
Figure 10. Fracture surface and surface morphology of a turned sample tested at $\sigma_a = 700$ MPa and failed with $N_f = 1.5 \times 10^6$ in the HCF regime: (a) fracture surface showing surface crack initiation, (b) magnified image of the rectangular area in (a) revealing that the crack initiated from a turning mark, (c,d) morphological features near the crack initiation site on the turned surface revealing that the crack seemingly initiated from a specific turning mark and propagated rapidly along another turning mark.

Figure 10 shows the fracture surface and the morphology of cracks on the surface of a sample tested at $\sigma_a = 700$ MPa and failed with a number of cycles to failure of $N_f = 1.5 \times 10^6$ cycles in the HCF regime. The fatigue crack initiation occurred at surface turning marks, as shown in Figure 10a,b. The arc length occupied by the crack initiation area at the sample surface is about 0.6 mm. No apparent dimples, grooves and silicide particles were observed in the crack initiation region. Friction-induced markings are the main microscopic appearance of the crack initiation area of turned samples failed in the HCF regime, as shown in Figure 10b. The formation of friction-induced markings may be attributed to contact between the two separated surfaces due to repeated tension-compression loading. From the surface morphology shown in Figure 10c, no secondary cracks along turning marks below the crack initiation site can be observed. It could be inferred that the HCF crack initiation occurred at a specific turning mark. Once a surface fatigue crack initiated, it propagated preferably along a specific turning mark and formed a quite flat surface crack path, as shown in Figure 10d.

surface without exception, even in the VHCF regime, as shown in Figures 10 and 11. The difference in fracture morphology and fatigue cracking process between turned samples and electropolished ones are attributed to the surface integrity.

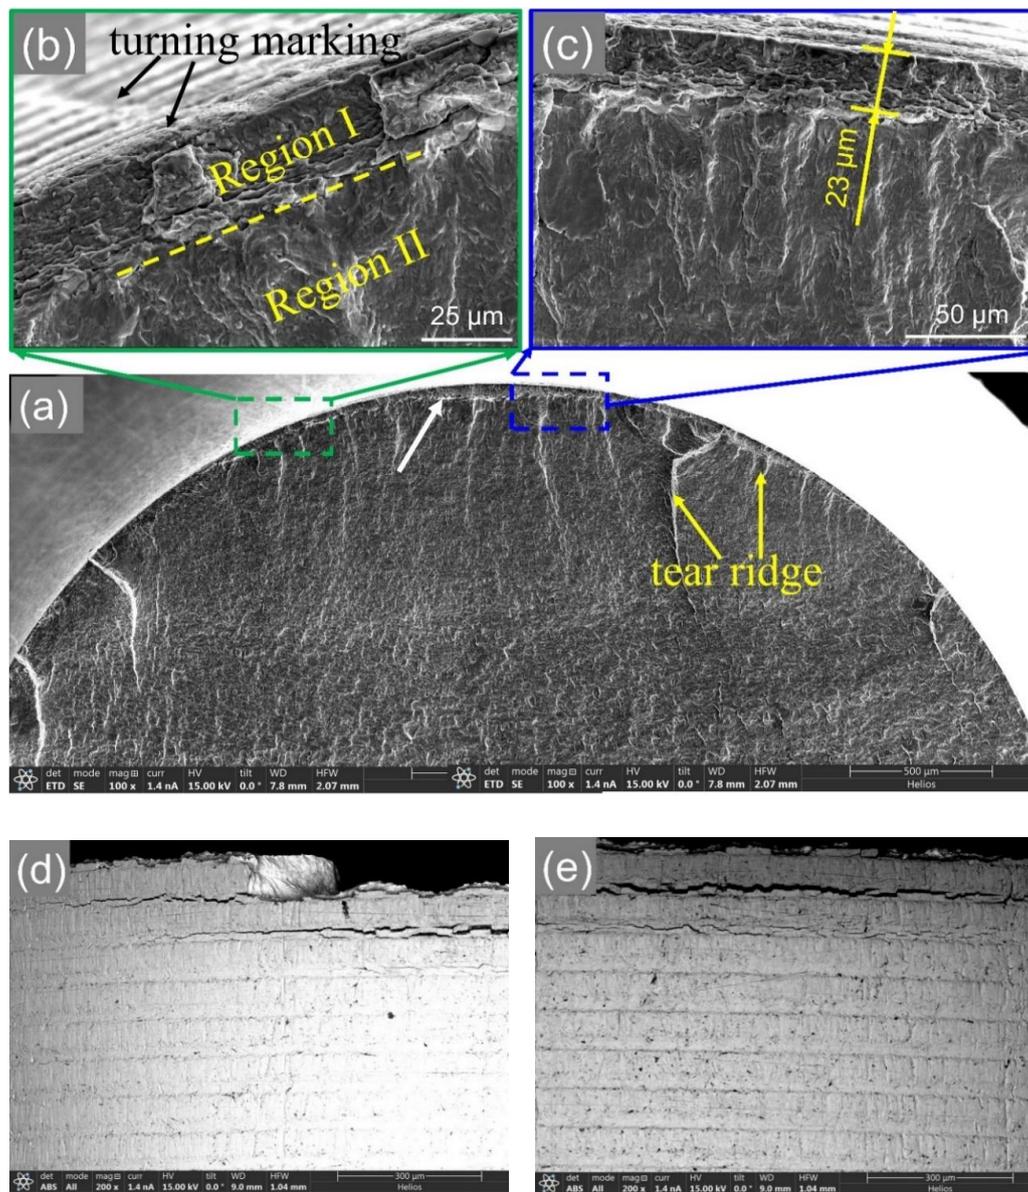
Figure 11. Fracture surface and surface morphology of a turned sample tested at $\sigma_a = 640$ MPa and failed after $N_f = 3.29 \times 10^8$ cycles in the VHCF regime: (a) fracture morphology of the surface crack initiation area, (b,c) magnified image of the local crack feature on the surface, (d,e) several cracks along turning marks below the crack initiation site on the turned sample surface.

Figure 11 shows the fracture surface of a sample tested at $\sigma_a = 640$ MPa and failed after $N_f = 3.29 \times 10^8$ cycles in the VHCF regime. The VHCF crack also initiated from turning marks, but the fracture surface morphology exhibits a significant difference with respect to that of the sample failed in the HCF regime. It seems that the VHCF crack initiation resulted from several turning marks, instead of one single specific turning mark in the HCF regime, as shown in Figure 11a,d,e. The corresponding arc length of surface crack initiation area increases obviously and the value is more than 4 mm. A bright band boundary (indicated by a white arrow in Figure 11a) near the sample surface and several tear ridges can be observed at the macroscopic fracture surface. At high magnification, the bright band boundary shows more likely tearing steps, as shown in Figure 11b,c. The regions on both sides of the boundary show completely different fracture morphologies. For the convenience of presentation, the area outside and inside the bright band boundary is defined as Region I and Region II, respectively, as shown in Figure 11b. The thickness of Region I is in a range of 20–25 μm , which is consistent with the depth of the compressive residual stress layer (Figure 5). Several step cracks and numerous microcracks can be observed in Region I. These step cracks are attributed to the junction of adjacent surface cracks which initiated from different surface turning marks. The direction of intensive microcracks is approximately parallel to the turning marks and perpendicular to the crack propagation direction. The presence of microcracks in Region I can be attributed to the slow growth of surface cracks in the layer where the compressive residual stress is present. The bright band boundary indicates that the surface crack tips did not continuously propagate inward, and it can be inferred that the surface crack tips stopped propagating temporarily at the bright band boundary. When adjacent surface cracks both propagated at the bright band boundary, they coalesced to form a larger surface crack and then continued to propagate until failure.

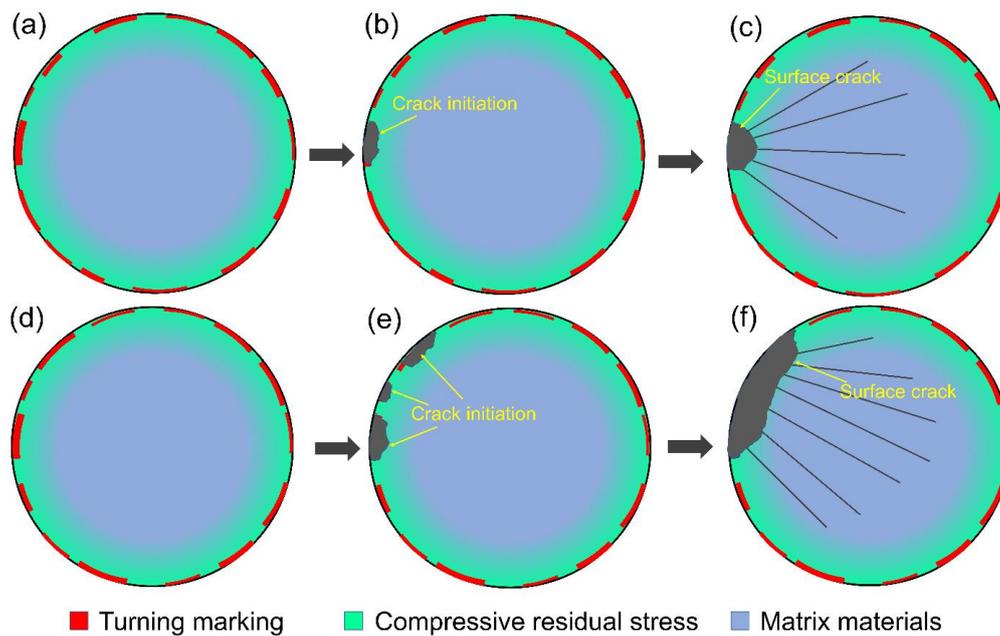
Figure 12. Schematic description of crack initiation and early propagation of turned samples at high applied stress in the HCF regime (a–c), and at low applied stress in the VHCF regime (d–f): (a) and (d) surface turning marks and compressive residual stress induced by the turning process, (b) crack initiating from a deep surface turning mark at high applied stress, (c) surface crack breaking through the compressive residual stress belt and rapid propagation until final fracture, (e) several cracks initiating from turning marks and tending to coalesce along the surface direction at low applied stress, (f) these cracks slowly propagating and coalescing to an annular notch in the compressive residual stress belt, and then rapidly propagating until final fracture.

As regards the influence of residual stress, it is clear that compressive residual stresses can delay crack initiation and propagation, which can reduce or compensate the negative effects of rough surface on fatigue properties. It has been reported that a deep compressive residual stress belt with large values can prevent crack initiation from occurring at sample surface and can consequently improve fatigue strength [30]. In the present study, all the cracks initiated from turned surface due to a high stress concentration factor generated by deeper turning marks. In the HCF regime, a high applied stress can promote the crack to initiate from a turning mark, as illustrated in Figure 12a,b. The compressive residual stress is not high enough to prevent the crack initiation from occurring at deep turning marks where the stress is strongly concentrated, but can only delay the crack initiation and early propagation. Therefore, the fatigue crack propagated continuously from the surface initiation sites until the final fracture, as shown in Figure 12c. However, the role played by compressive residual stress to delay crack initiation and early propagation seems to be more obvious in the VHCF regime. This is because more extended surface crack initiation and an early propagation area can be observed in the annular belt with compressive residual stress. The thickness of the annular crack initiation and early propagation zone (Region I, as shown in Figure 11b,c) is in a range of 20–25 μm , which is consistent with the depth of the compressive residual stress layer. Due to the effect of compressive residual stress on delaying crack initiation and early propagation, it is difficult for initial surface cracks to coalesce to form/join the main crack. As fatigue damage accumulated, several cracks initiated from turning marks, as shown in Figure 12d,e. When the cracks' tips were in the turning affected region, these surface cracks propagated slowly along the depth direction and simultaneously tended to propagate along the surface direction. These cracks coalesced, which gave rise to the formation of an annular crack initiation and propagation area. Once these cracks broke through the compressive residual stress layer, they would further coalesce and propagate more rapidly along the depth direction until the final failure, as described in Figure 12f.
