Stress Corrosion Cracking in an Extruded Cu-Free Al-Zn-Mg Alloy

Abstract: Stress corrosion cracking (SCC) in Cu-free Al-Zn-Mg (7xxx) aluminium alloys limits its use in many applications. In this work, we study in detail the microstructure of a peak and slightly overaged condition in an AA7003 alloy using transmission- and scanning electron microscopy in order to provide a comprehensive understanding of the microstructural features related to SCC. The SCC properties have been assessed using the double cantilever beam method and slow strain rate tensile tests. Grain boundary particles, precipitate free zones, and matrix precipitates have been studied. A difference in the SCC properties is established between the two ageing conditions. The dominating difference is the size and orientation of the hardening phases. Possible explanations correlating the microstructure and SCC properties are discussed.

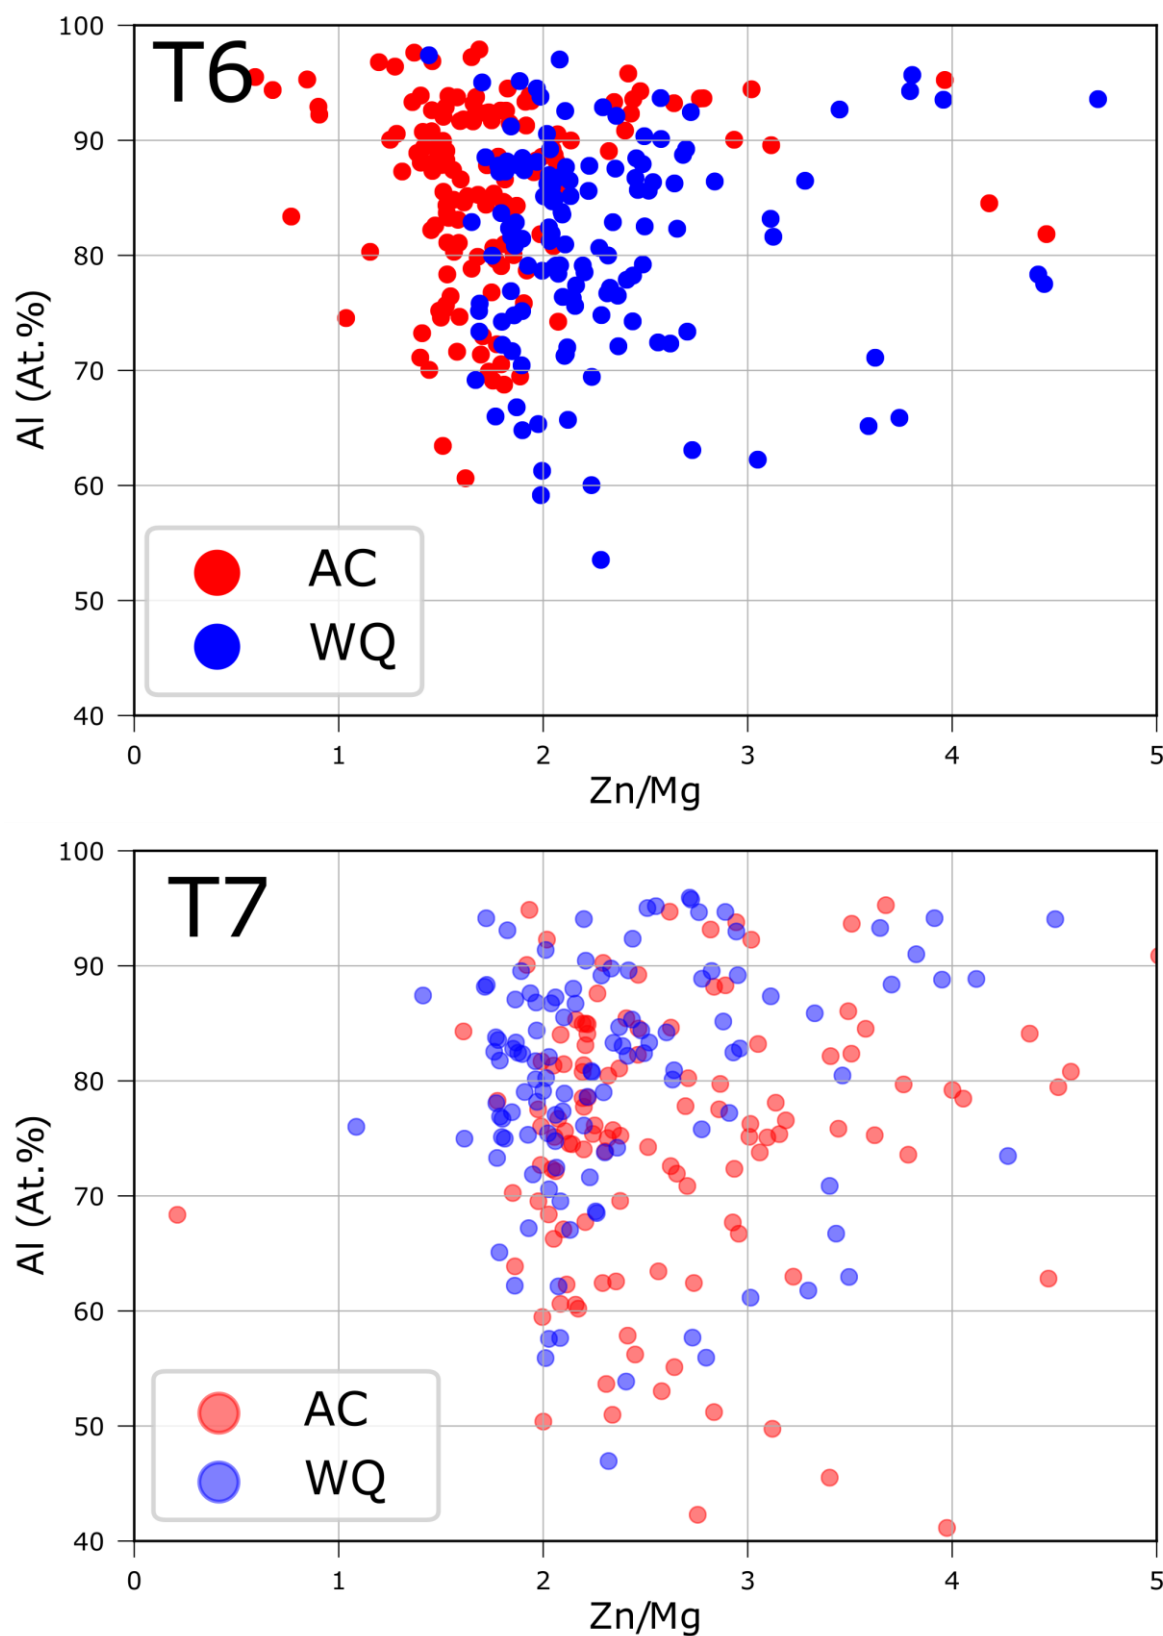
Figure S1. Results from 150 EDS point analysis of grain boundary particles in different tempers acquired using microscope (i) (see main text for details). The Al at.% is shown as function of the Zn/Mg ratio.
