Article

Influence of Anodization on the Fatigue and Corrosion-Fatigue Behaviors of the AZ31B Magnesium Alloy

Abstract: The aim of the present work was to investigate the effect of anodization on the fatigue and corrosion-fatigue behavior of the AZ31B magnesium alloy. Samples were anodized in constant current density mode at 20 mA cm⁻² for 5 min at room temperature, in an environmentally friendly electrolyte consisting of a mixture of sodium hydroxide and sodium silicate. Fatigue tests were conducted in air and in phosphate buffer solution (PBS) at room temperature in the tension-tension mode, at a frequency of 5 Hz and stress ratio of 0.1. S-N curves were obtained for polished and anodized samples. Fracture surface morphology was examined by optical stereo-microscopy and scanning electron microscopy. Results indicated that the fatigue limit was reduced approximately 60% at 10⁶ cycles for the anodized specimens, either for the fatigue tests conducted in air or PBS solution. Anodization had a remarkable effect on the fatigue behavior of the AZ31B alloy. The effect of the corrosive environment, in turn, was not significant.

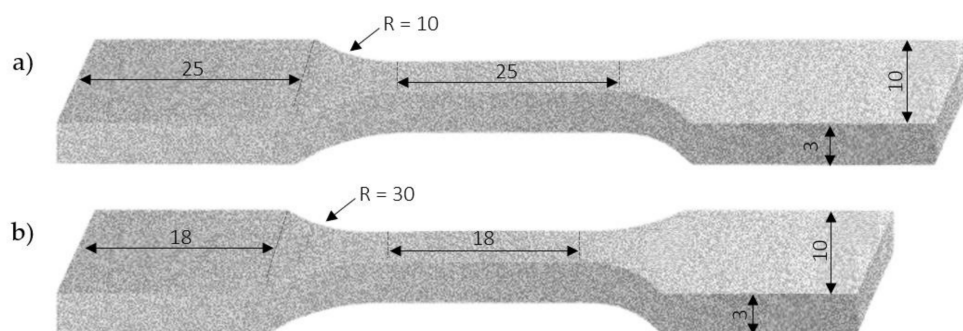
Figure 1. Shape and dimensions (in mm) of (a) tensile and (b) fatigue specimens.

The material was a hot rolled AZ31B magnesium alloy sheet (composition in wt.% Al 2.54%, Zn 1.08%, Mn 0.38% and Mg balance), supplied by Xi'an Yuechen Metal Products Co. Ltd. (Xi'an, China). The tensile and fatigue samples were machined by laser-cutting along the rolling direction following ASTM E8M-16a [26] and ASTM E466-15 [27], respectively. Figure 1 shows the shape and size of the specimens employed for tensile and fatigue tests. The dog-bone shaped specimens were sequentially ground using waterproof silicon carbide paper (from #220 to #4000), and polished using diamond paste slurry (diameter 3 μm and 1 μm). Right after, they were cleaned using deionized water and ethanol, being dried in a warm air stream provided by a conventional heat gun.

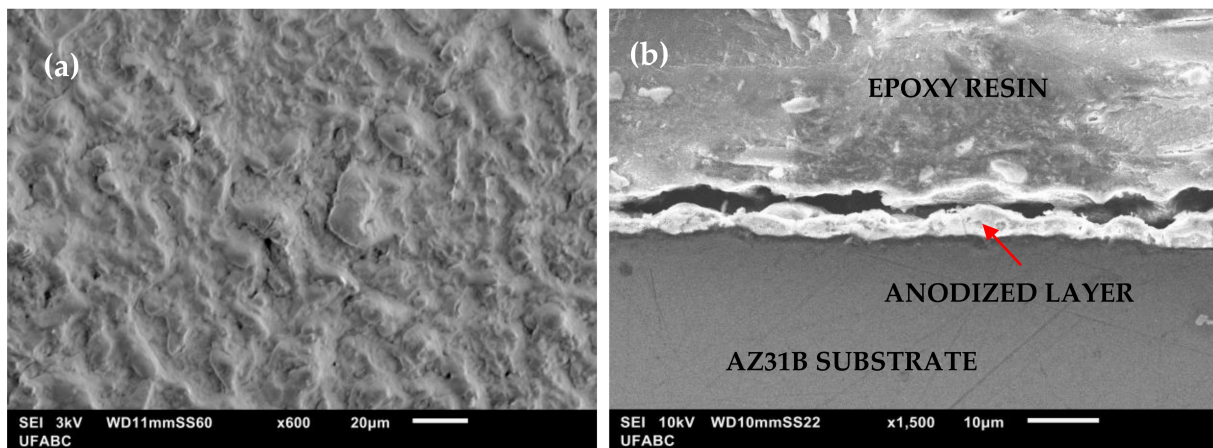
Figure 2. SEM images of the anodized layer (a) top surface and (b) cross-section.

SEM micrographs of the top surface and cross-section of the AZ31B magnesium alloy in the anodized condition are shown in Figure 2. As seen in Figure 2a, the artificial oxide layer produced by the anodization treatment covered the whole substrate. Several cracks and carved regions are unevenly distributed over the surface. The cross section of the anodized specimen is showed in Figure 2b. The interface anodized layer/substrate displays an irregular thickness. A roughened interface greatly affects the design of the implantable devices, once it plays an important role behaving as a stress concentrator [32], thus limiting the fatigue resistance of the component.

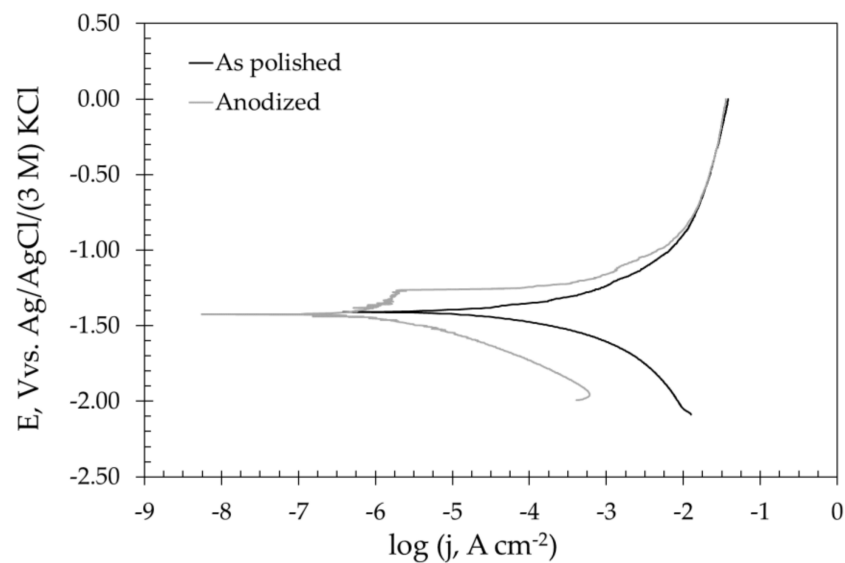
Figure 3. Potentiodynamic polarization curves obtained for the as polished and anodized samples immersed in PBS solution at room temperature.

Potentiodynamic polarization curves of the polished and anodized samples tested in PBS solution at room temperature are presented in Figure 3. The values of corrosion potential (E_{corr}) and corrosion current densities (j_{corr}) were determined from the curves using the Tafel extrapolation method. The results are shown in Table 1. The j_{corr} values were significantly affected by the presence of the anodic film. The dissolution rate of the anodized sample was reduced by one order of magnitude. The anodized layer acted as a barrier layer against electrolyte penetration. However, as seen in Table 1, the produced oxide layer presents an inherent porosity, which could be related to the cracks and cavities observed from the SEM micrographs (Figure 2).

In the cathodic branches, the value of the cathodic Tafel slope (b_c) was increased after anodization, as shown in Table 1. According to Rahman et al. [33], this effect could be due to the formation of $\text{Mg}(\text{OH})_2$ inside the pores and cracks of the anodized layer, as shown in Equations (2) and (3).

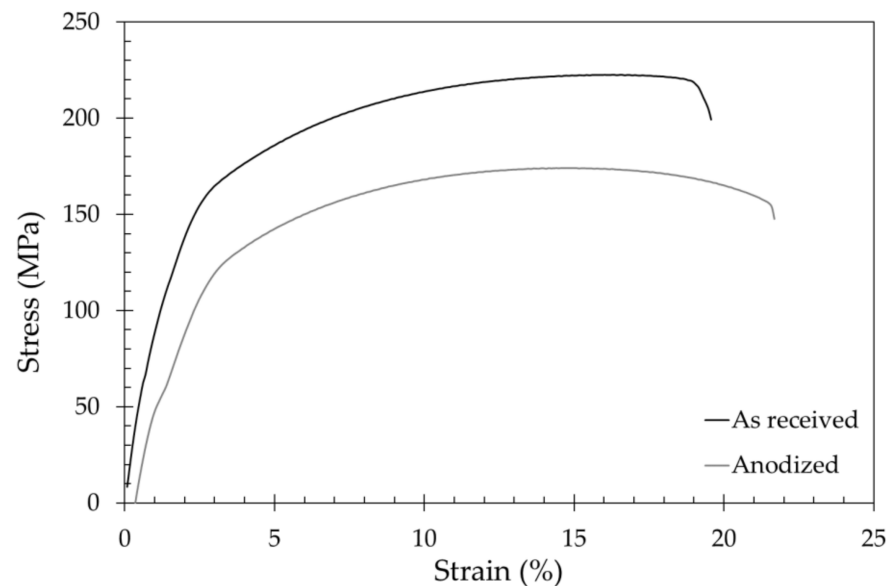
Figure 4. Stress-strain curves in uniaxial tensile tests at room temperature.

Figure 4 shows the stress–strain curves of the AZ31B magnesium alloy in the as received and anodized conditions. The average values of yield strength, ultimate strength, and elongation at break of the alloy in the as received and anodized conditions are displayed in Table 2. It is clear that the ultimate tensile strength and yield strength decreased after anodization. According to the literature [34], this effect is due to the presence of pores and defects in the oxide layer that act as crack nucleation sites, reducing the mechanical strength of the anodized substrate.

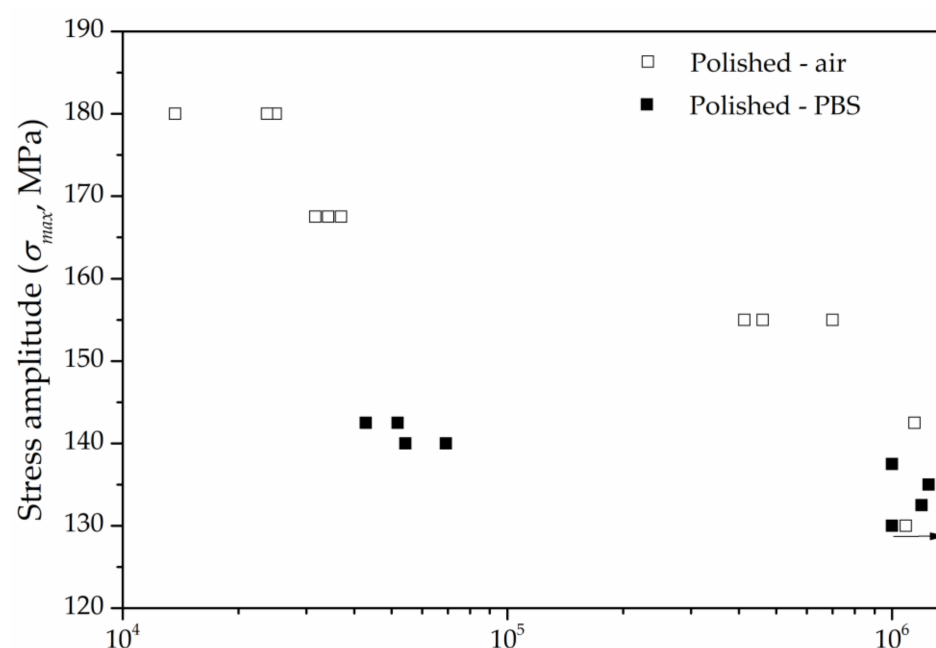
Figure 5. S-N curves for the polished AZ31B alloy specimens in air and in PBS solution at room temperature.

Figure 5 presents the S-N curves for the polished AZ31B alloy exposed to the air and to the PBS solution. Comparatively, a decrease on the maximum applied stress is noticed when the tests were performed in the PBS solution. Considering 10^6 cycles to failure, according to ASTM F1801, the fatigue limit was reduced from 142.5 MPa when the tests were conducted in the air, to 137.5 MPa when the tests were conducted in PBS. However, at an intermediate number of cycles to failure, the influence of the testing environment is even more evident. It can be seen that an applied stress of 140 MPa led to the fatigue life of approximately 69,000 cycles, while the fatigue life was extended to 10^6 cycles at a compatible applied stress when the tests were conducted in the air. These results indicate that there is an abrupt change in the fatigue life for a relatively low variation of the applied stress in the corrosion-fatigue condition. A similar trend was observed by Nan et al. during fatigue tests of the AZ31 alloy [35]. A slight loading variation was sufficient to drastically reduce the fatigue life of this material. In another work, Nan et al. have also investigated the influence of the 3.5 wt.% NaCl on the corrosion fatigue behavior of the AZ31 alloy [36]. A remarkable decrease in fatigue resistance was noticed when the tests were performed in the chloride solution. Authors have pointed out the combination of cyclic stress and pit growth as responsible for this behavior [37,38].

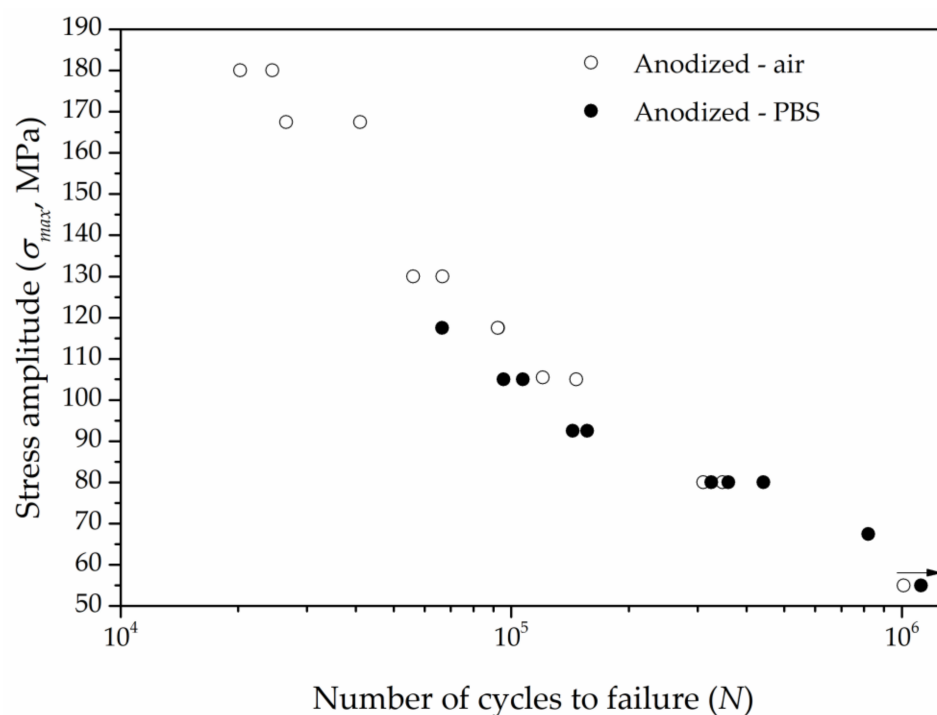
Figure 6. S-N curves for the anodized AZ31B alloy specimens in air and in PBS solution at room temperature.

The S-N curves for the anodized specimens exposed to air and PBS solution are shown in Figure 6. Corrosion was less detrimental for the surface treated samples than the polished ones. As displayed in Figure 5, the fatigue life was little affected by the corrosive environment for stress levels lower than 130 MPa.

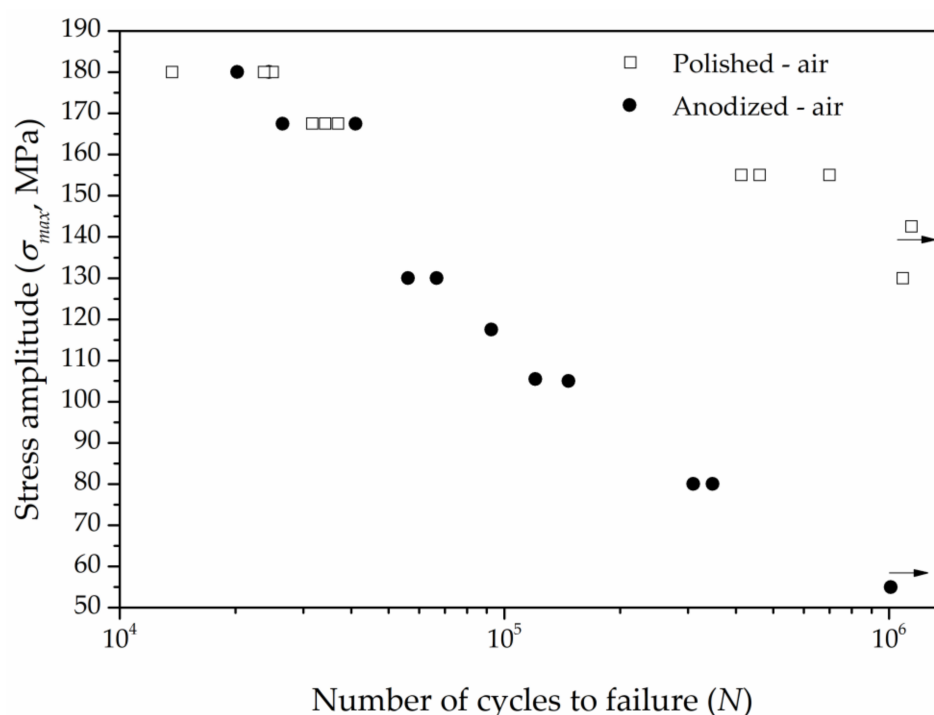
Figure 7. S-N curves for the polished and anodized AZ31B alloy specimens in air.

Figures 7 and 8 show the S-N curves for the polished and anodized samples exposed to air and PBS solution, respectively. As seen in these figures, there was a remarkable reduction of the fatigue resistance for the anodized specimens compared to the polished condition regardless of the environment. In both scenarios, the reduction of the fatigue limit at 10^6 cycles was approximately 60% for the anodized samples.

The reduction of the fatigue strength for the anodized specimens was much more intense at low stress levels, independently of the testing environment. This behavior has been associated to a significant influence of the crack nucleation than the crack propagation, which causes the premature failure of the material [40]. In other words, the anodic layer facilitates fatigue crack nucleation. Khan et al. [41] observed a distinguished effect of the crack nucleation of anodized magnesium alloy when subjected to fatigue tests. The authors concluded that the crack nucleation step, which is defined by the material surface conditions in a crucial manner, exerts more influence than the crack growth and propagation stages. As the anodized layer greatly affects the surface characteristics, this means that fatigue failure would easily happen when a certain number of cycles are able to nucleate the crack. Besides that, other adverse effects concerned with the fatigue behavior of anodized magnesium alloys have been reported in the current literature. Yerochin et al. [42] mentioned that the plasma micro-discharges which occur during the oxidation process led to strain distortions of the metal subsurface layers. Some other works have pointed out the presence of a microcrack network [39] and disordered porous structure [24,32] of the coating layer. Furthermore, the compactness and uniformity of the oxide layer, its adhesion to the substrate, and relevant aspects of roughness on the interface of coating and the material may also affect the fatigue properties of anodized alloys [43,44].

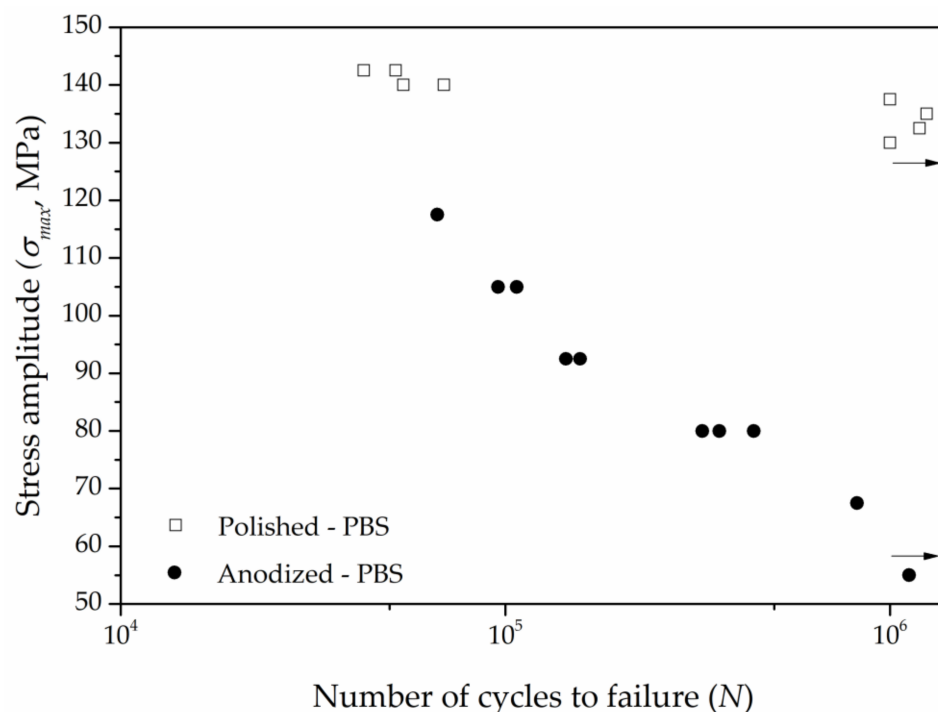
Figure 8. S-N curves for the polished and anodized AZ31B alloy specimens in the PBS solution at room temperature.

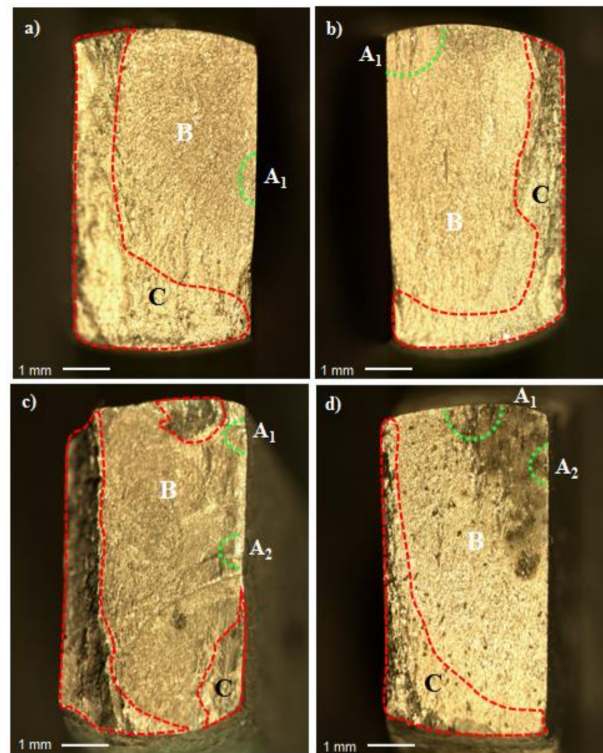
Figure 9. Optical stereo-micrographs of the AZ31B alloy: (a) polished (air; 167.5 MPa); (b) anodized (air—105 MPa); (c) polished (PBS solution—140 MPa); and (d) anodized (PBS solution—92.5 MPa). Marks on the micrographs represent the following fracture regions: (A₁ and A₂) crack initiation; (B) crack propagation; (C) catastrophic failure.

Optical stereo-micrographs of the fracture surfaces of polished and anodized AZ31B specimens after fatigue tests in air and PBS solution are shown in Figure 9. The specimens for optical stereoscopic analysis were chosen based on the number of cycles to failure. The aim was to identify the microfractographic features in the initial hours of the test, as it would lead to the most relevant information regarding the nucleation of fatigue cracks. Hence, specimens that failed in the first hours of test, at different applied stresses but with similar fatigue lives were chosen in order to investigate the effect of the PBS solution on the fractographic aspects of the AZ31B alloy. Table 5 displays the applied stress and corresponding number of cycles to failure of the polished and anodized specimens selected for fractographic analysis.

The fatigue fracture surface may display distinguishable regions, denoting three different steps of fatigue failure: (i) crack nucleation; (ii) crack growth and propagation; (iii) catastrophic failure (final fracture) [45,46]. These regions are indicated in Figure 9 for the AZ31B specimens in the polished and anodized conditions. Fatigue fracture is often initiated in the surface or subsurface region [47]. However, identifying the exact point of crack nucleation is not an easy task [48]. These sites are indicated as A1 and A2 in Figure 9. Growth region generally expands radially for the surface of the specimen (region B in

Figure 9). The transition from region B to final fracture (region C) is accompanied by a change of the fractographic features to a darker, uneven region. Details regarding each one of these regions were obtained by SEM analysis.

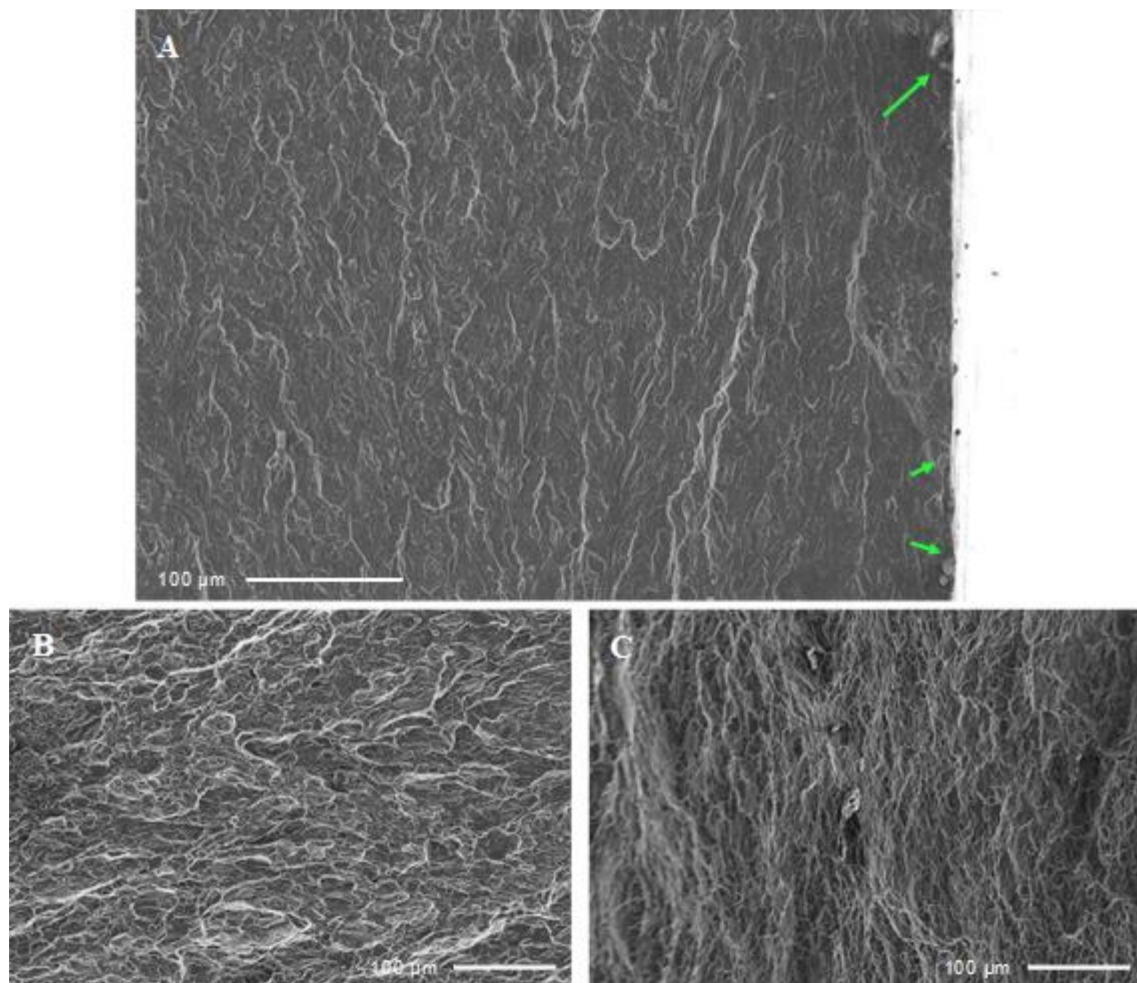
Figure 10. Fatigue fracture morphologies of the polished specimen tested in air at 167.5 MPa. The micrographs (A–C) correspond to the three different regions pointed out in Figure 9a.

Figure 10 shows the SEM micrographs corresponding to regions A (Figure 10A), B (Figure 10B) and C (Figure 10C) of Figure 9a. Green arrows point to possible crack nucleation sites in Figure 10A, denoted by discontinuities and small particles at the bottom right of the micrographs. However, the nucleation site was not clearly distinguished. A different aspect is seen in the crack growth region (Figure 10B). Faceted regions and shallow dimples are encountered over this region, suggesting an unstable crack growth mechanism was predominant. Conversely, a typical ductile dimpled fracture surface is seen in Figure 10C, suggesting that plastic deformation occurred in this region, before final fracture. Similar features of fractographic aspects of fatigue fracture surfaces of magnesium alloys were reported by other authors [48–51].

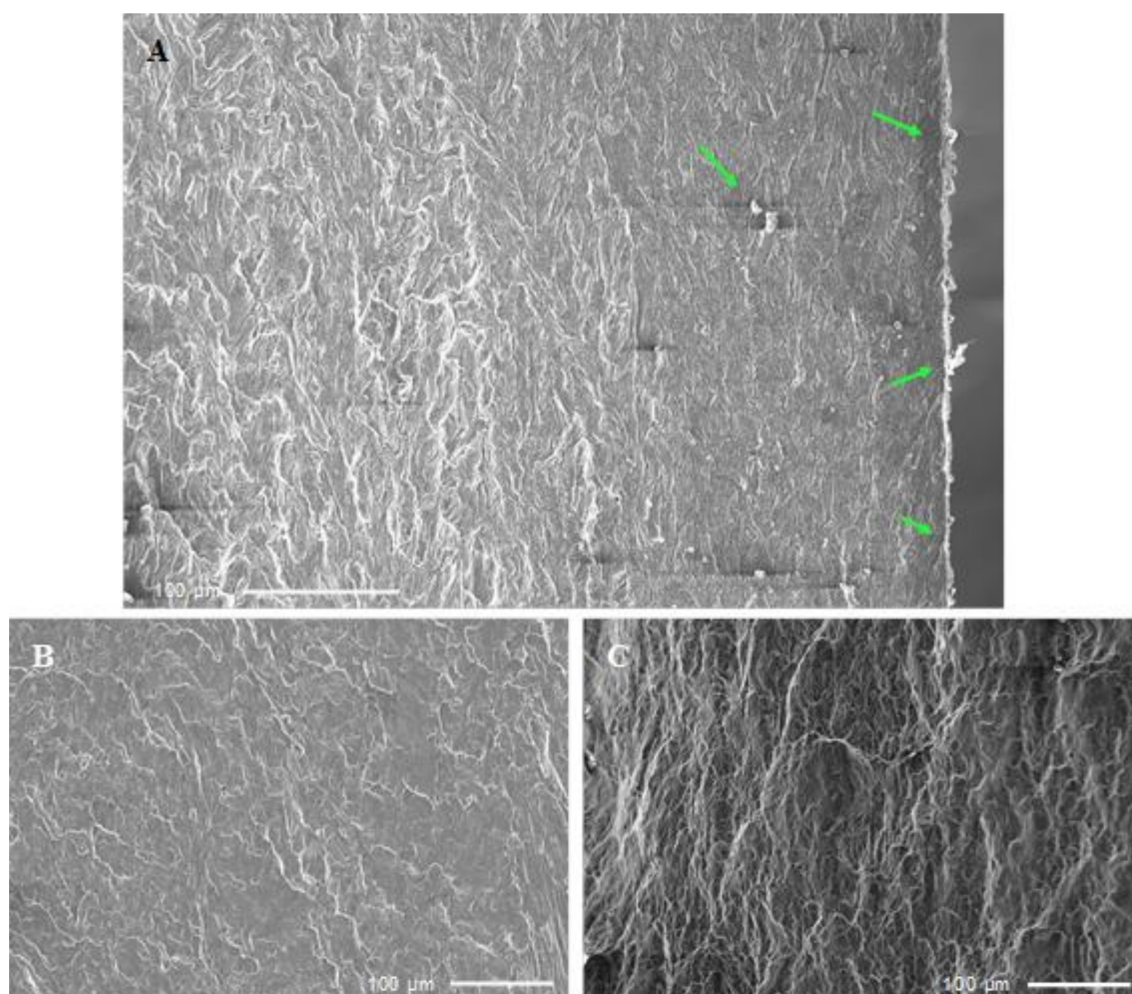
Figure 11. Fatigue fracture morphologies of the anodized specimen tested in air at 105 MPa. The micrographs (A–C) correspond to the three different regions pointed out in Figure 9b.

Regions A–C of the fracture surface of the air-tested anodized specimen shown in Figure 9b were further explored by SEM analysis. The corresponding micrographs are displayed in Figure 11. The nucleation region (A₁ in Figure 9b) is shown in Figure 11A. Green arrows point to the interface between the anodized layer and the bulk AZ31B alloy, revealing different roughness at these sites. Moreover, subsurface particles are also observed and may have contributed to crack nucleation, as observed by other authors [24,45]. Yet, a gradual transition in the surface appearance from a smooth to a rough aspect is seen at the middle of the micrograph, indicating that crack propagation may have started at this site [52]. In Figure 11B, the crack growth region is further detailed. Its aspect resembles that shown in Figure 9b for the polished sample tested in air, being characterized by faceted regions and shallow dimples, typical of unstable crack growth. In the final fracture region (Figure 11C), the fracture surface is dominated by an intense dimpled structure, indicating plastic deformation at these sites, as also observed in Figure 10C for the polished sample.

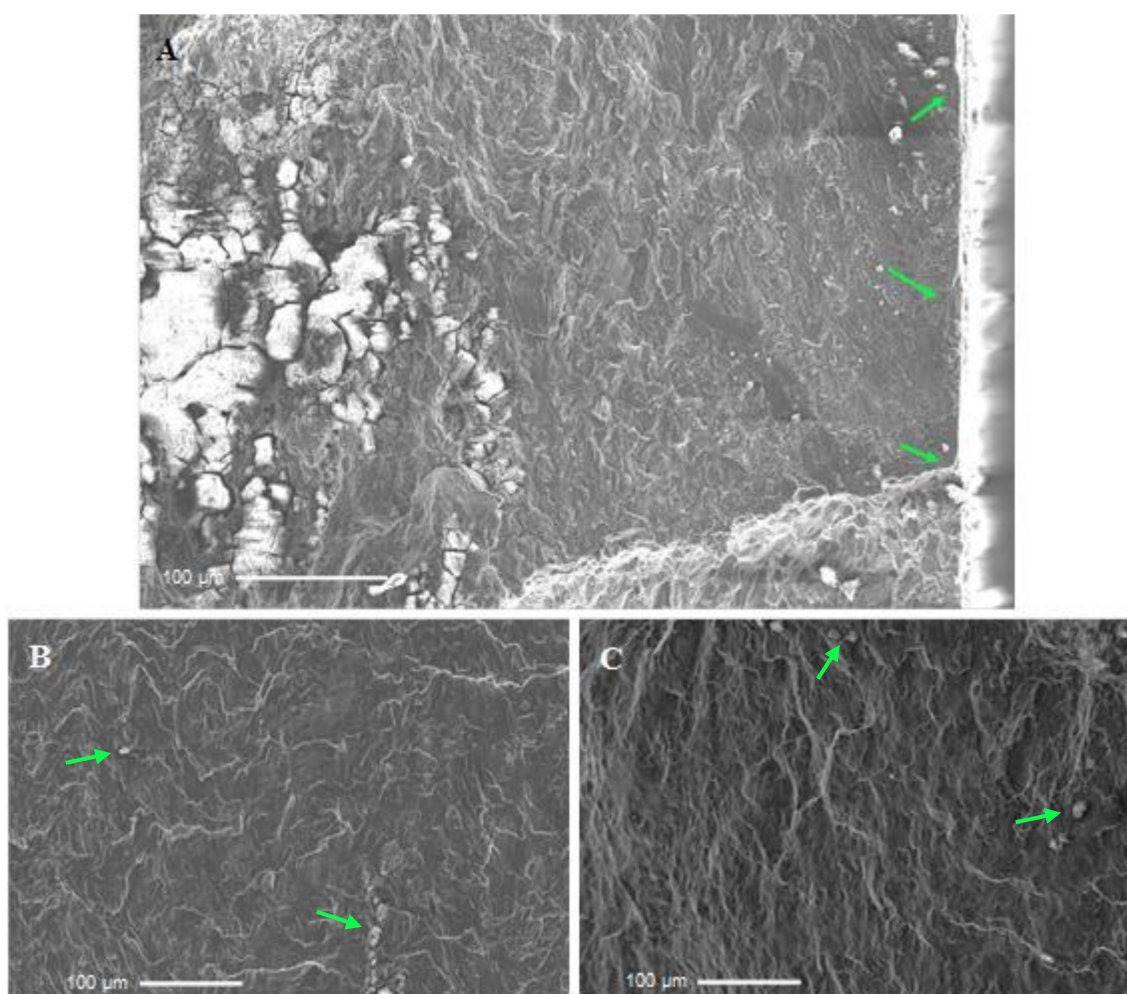
Figure 12. Fatigue fracture morphologies of the polished specimen tested in PBS solution at 140 MPa. The micrographs (A–C) correspond to the three different regions pointed out in the Figure 9c.

SEM micrographs of regions A1, B, and C (Figure 9c) for the polished sample tested in PBS solution are displayed in Figure 12. The most probable crack nucleation sites (region A1, Figure 9c) are shown in Figure 11A where potential stress risers are pointed by the green arrows, such as discontinuities in the $\text{MgO}/\text{Mg}(\text{OH})_2$ layer spontaneously formed in the electrolyte and subsurface inclusions that may have facilitated fatigue crack nucleation. The transition between the smooth and rough aspects of the fracture surface is remarkable, as seen in the left part of the micrograph, in contrast with that of the polished samples tested in air (Figure 10A). According to the literature [23,53], this suggests a faster transition from the nucleation step to crack growth. Cracks would appear simultaneously at different sites, triggered by surface porosity or subsurface cracks. Hence, material plasticity is reduced, increasing the crack propagation rate, and leading to rough aspect of the fracture surface. It is likely that the concomitant action of corrosive environment and cyclic loading is responsible for such an enhanced propagation rate. In spite of the surface cleaning step before fractographic analysis, some oxide inclusions still remained in the fracture surface, as indicated by the arrows in Figure 12B,C. The final fracture region (Figure 12C) is similar to those of the specimens tested in air (Figures 10C and 11C), showing a dimpled structure.

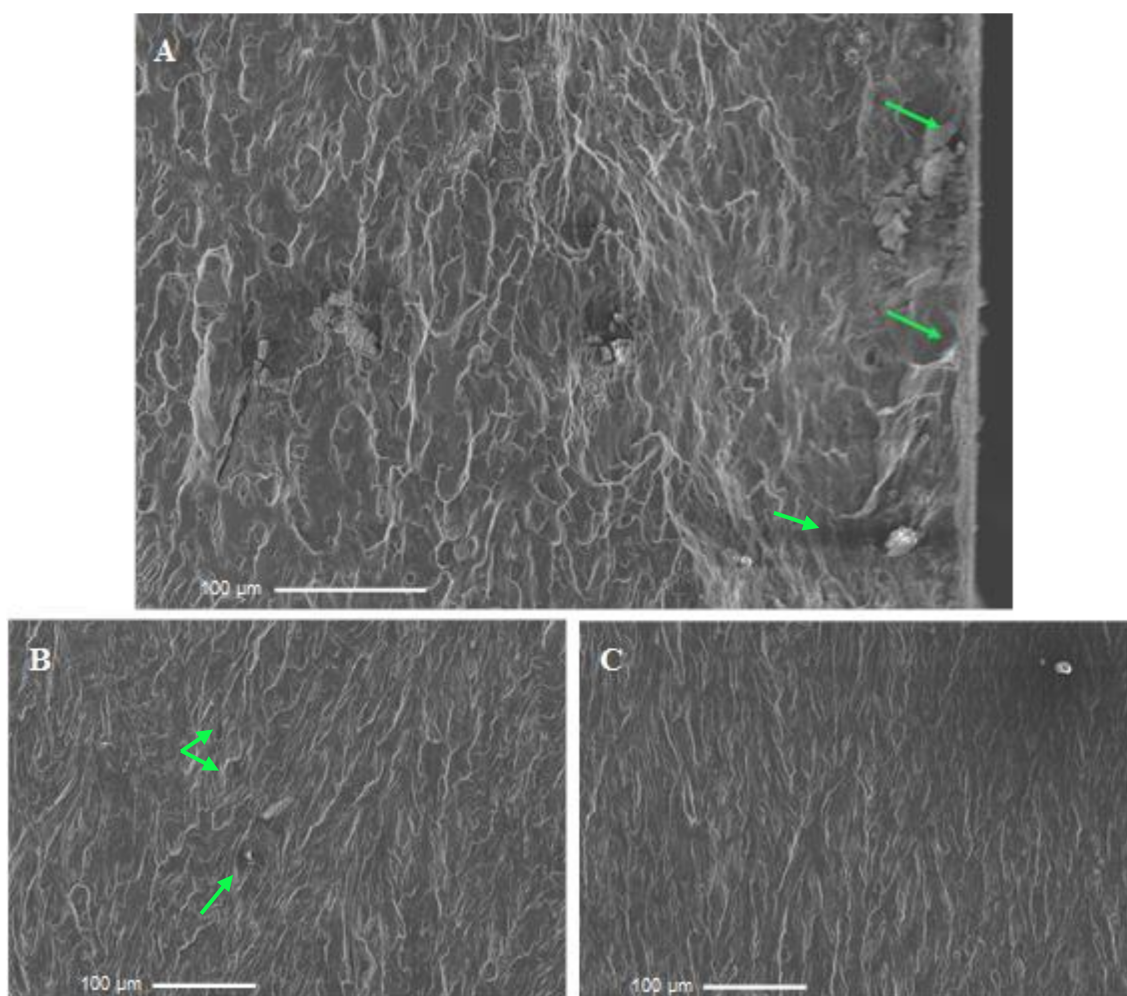
Figure 13. Fatigue fracture morphologies of the anodized specimen tested in the PBS solution at 92.5 MPa at room temperature. The images (A–C) correspond to the three different regions pointed out in the Figure 9d.

SEM micrographs of the fracture surface of the anodized specimen tested in PBS solution are shown in Figure 13. In Figure 13A (region A1 in Figure 9d), green arrows indicate pores, subsurface defects between the substrate and the anodized layer, and inclusions that may be related to crack nucleation by acting as stress risers during fatigue loading. In the crack propagation region (Figure 13B), the fracture surface is quite flat and some micropores are indicated by green arrows. The aspect of the final fracture region (Figure 13C) is quite different from that of the polished sample fractured in PBS (Figure 12C). Instead of a dimpled structure, the surface is flat, indicating that plastic deformation was not as marked as observed for the polished sample. In this respect, it is evident that the presence of the anodized layer reduced plasticity at the final fracture step.
