# Pitting Corrosion of Steel Induced by Al<sub>2</sub>O<sub>3</sub> Inclusions

**Abstract:** To study the effect of Al<sub>2</sub>O<sub>3</sub> inclusions on pitting corrosion in steel, our researchers utilized industrial pure iron as the raw material with the addition of a proper amount of pure aluminum powder to form Al<sub>2</sub>O<sub>3</sub> inclusions. Corrosion experiments were performed by exposing the samples to a 6% FeCl<sub>3</sub> solution at room temperature (25 °C) for different lengths of time. Microscopic corrosion morphology was observed by scanning electron microscope (SEM), and the size change of the inclusions was quantitatively analyzed with Image Pro Plus. The experimental results showed that pitting corrosion arose preferentially around the Al<sub>2</sub>O<sub>3</sub> inclusions, and that pitting corrosion initiated at the junction of the Al<sub>2</sub>O<sub>3</sub> inclusions. The steel matrix dissolved and micro-cracks occurred as the Al<sub>2</sub>O<sub>3</sub> inclusions that were buried shallowly below the surface of the steel matrix promoted corrosion of the steel matrix. As corrosion progressed, the shallowly buried Al<sub>2</sub>O<sub>3</sub> inclusi

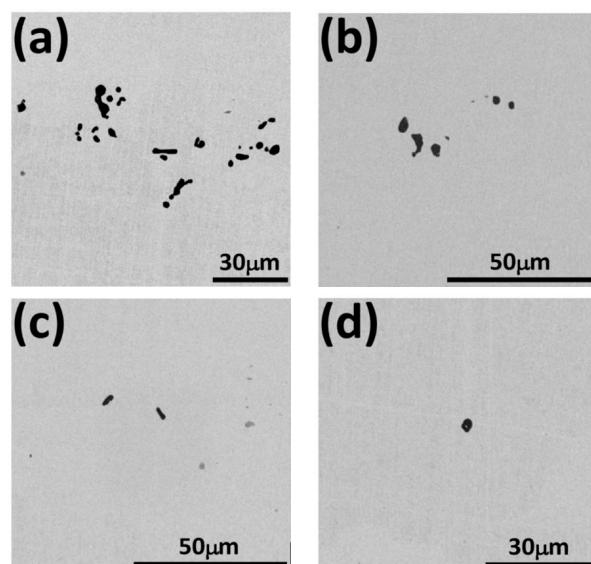
**Figure 1.** SEM (Scanning Electron Microscope) images of  $\text{Al}_2\text{O}_3$  inclusions from sample: (a) a large number of  $\text{Al}_2\text{O}_3$  inclusions gathered together to form a cluster distribution; (b) a small amount of  $\text{Al}_2\text{O}_3$  gathered together; (c)  $\text{Al}_2\text{O}_3$  inclusions were long strip-shaped and with a lone distribution; (d)  $\text{Al}_2\text{O}_3$  inclusions were mainly irregular in shape.

Figure 1 represents the typical  $\text{Al}_2\text{O}_3$  inclusions found in the samples. According to the experimental results,  $\text{Al}_2\text{O}_3$  inclusions were classified into four types: (1) a large number of  $\text{Al}_2\text{O}_3$  inclusions gathered together to form a cluster distribution, as shown in Figure 1a; (2) a small amount of  $\text{Al}_2\text{O}_3$  gathered together (generally between 3–6), as shown in Figure 1b; (3) Figure 1c indicates that  $\text{Al}_2\text{O}_3$  inclusions were long strip-shaped and with a lone distribution; and (4) Figure 1d shows that  $\text{Al}_2\text{O}_3$  inclusions were mainly irregular in shape.

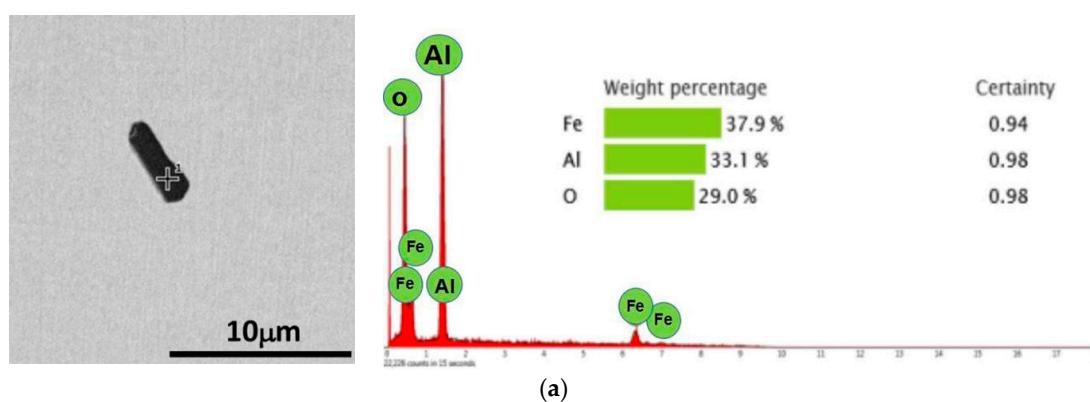
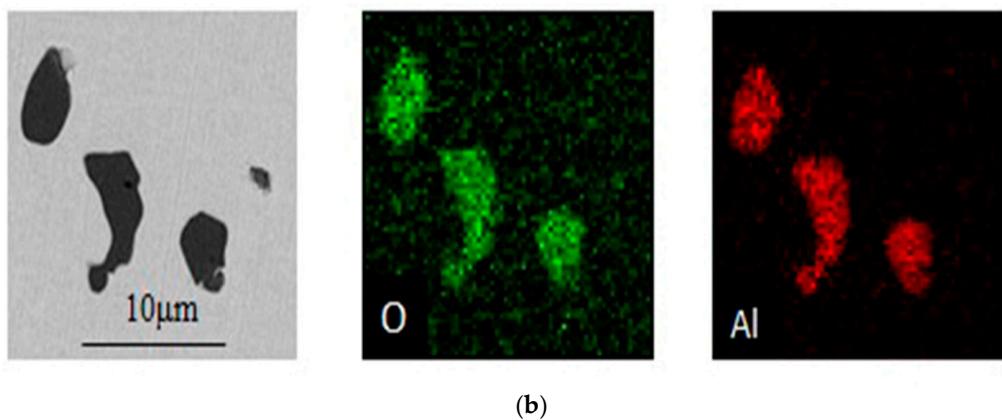
**Figure 2. Cont.**

**Figure 2.** EDS (Energy Dispersive Spectroscopy) results of the typical Al<sub>2</sub>O<sub>3</sub> inclusion from sample. (a) Point scan analysis; and (b) elemental distribution in Al<sub>2</sub>O<sub>3</sub> inclusion.

Figure 2 shows the composition analysis of typical  $\text{Al}_2\text{O}_3$  inclusions. Through the EDS results, it was concluded that the inclusions in the samples were  $\text{Al}_2\text{O}_3$  inclusions.

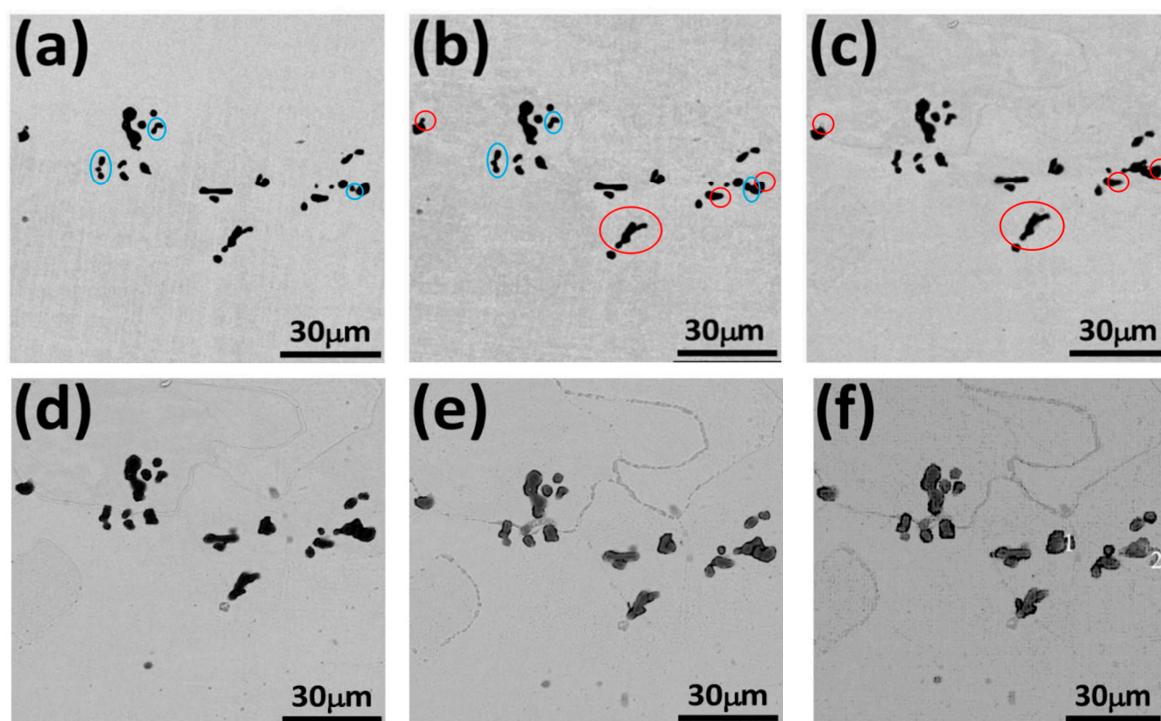
**Figure 3.** Morphology observation of clustered Al<sub>2</sub>O<sub>3</sub> inclusions: (a) 0 s; (b) 15 s; (c) 35 s; (d) 65 s; (e) 105 s; and (f) 155 s.

A comparison of Figure 3a,b shows that the  $\text{Al}_2\text{O}_3$  inclusions and steel matrix had almost no significant changes. Furthermore, it was found that the dissolution of single  $\text{Al}_2\text{O}_3$  with a relatively small spacing was transferred to other adjacent inclusions (blue circles) to form a little larger area of pitting corrosion. Figure 4 is the local enlarged image of Figure 3. It was found that there was a small spacing between the inclusions at 0 s, which disappeared after 15 s, and indicated that the  $\text{Al}_2\text{O}_3$  inclusions induced pitting corrosion where the matrix was dissolved. Instead, the samples only presented slight corrosion under corrosion immersion at 15 s.

Figure 3c shows the morphology for further corrosion. Since there were more light-colored corrosive products (blurred gray) around the inclusions (compared red circles in Figure 3b,c), it was obvious that pitting corrosion occurred at the junction of  $\text{Al}_2\text{O}_3$  inclusions and its adjacent steel matrix. Additionally, part of the  $\text{Al}_2\text{O}_3$  inclusions had fallen off, as shown in the far-left figure. The local enlarged drawing is shown in Figure 5.

Figure 3e clearly shows the formation of micro gaps between the  $\text{Al}_2\text{O}_3$  inclusions and steel matrix. By using Image Pro Plus software to compare the size of  $\text{Al}_2\text{O}_3$  inclusions before and after corrosion, it was found that the average size of  $\text{Al}_2\text{O}_3$  inclusions increased, which indicated that the steel matrix adjacent to the inclusions dissolved and the  $\text{Al}_2\text{O}_3$  inclusions originally buried in the steel matrix were partially exposed. Thus, it was concluded that the formation of the micro gap was mainly caused by the dissolution of the steel matrix adjacent to the inclusions.

Figure 3f shows the  $\text{Al}_2\text{O}_3$  inclusions at Position 1 were significantly larger than that in previous pictures (the same location in Figure 3a–e) due to the dissolution of the steel matrix near the inclusions. Furthermore, the  $\text{Al}_2\text{O}_3$  inclusions at Position 2 partially disappeared and fell off to form micro pits. Additionally, some of the inclusions disappeared, indicating that pitting corrosion occurred along the junction between the  $\text{Al}_2\text{O}_3$  inclusions and steel matrix; and  $\text{Al}_2\text{O}_3$  inclusions buried shallowly in the steel matrix fell off and formed micro pits.

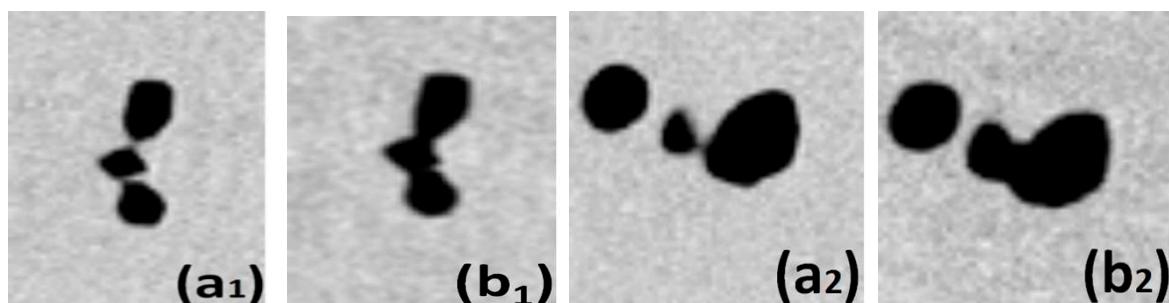
**Figure 4.** Graphs are local enlarged diagrams (a<sub>1</sub>) 0 s; (b<sub>1</sub>) 15 s; (a<sub>2</sub>) 0 s; (b<sub>2</sub>) 15 s.

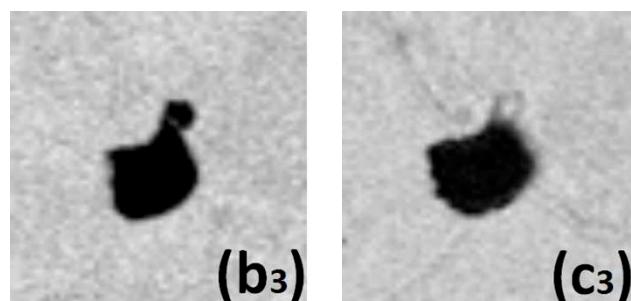
**Figure 5.** Graphs are local enlarged diagrams (b<sub>3</sub>) 15 s; and (c<sub>3</sub>) 35 s.

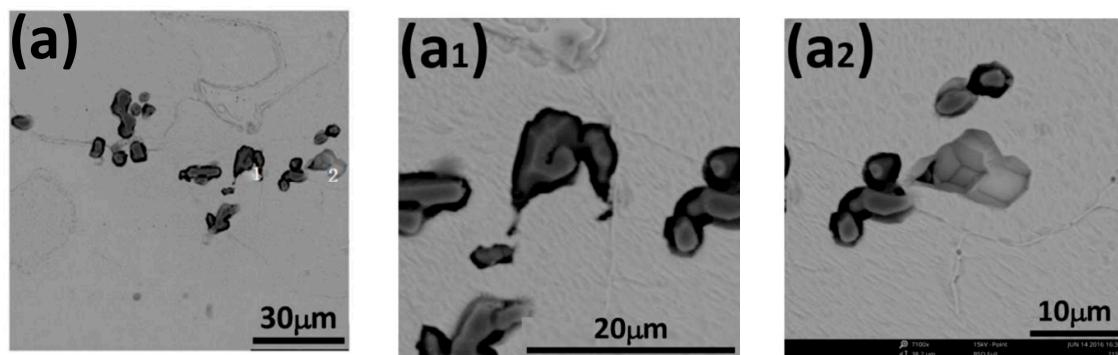
**Figure 6.** The corroded morphology of clustered  $\text{Al}_2\text{O}_3$  at (a) 215 s; (a<sub>1</sub>) a local enlarged diagram of Position 1; and (a<sub>2</sub>) a local enlarged diagram of Position 2.

Figure 6 shows the corrosion morphology of the samples at 215 s. The area of  $\text{Al}_2\text{O}_3$  inclusions at Position 1 was further increased with respect to 155 s, and the local enlarged image is shown in Figure 6a<sub>1</sub>. By using Image Pro Plus software to measure the area of  $\text{Al}_2\text{O}_3$  inclusions, it was found

that the area of  $\text{Al}_2\text{O}_3$  inclusions increased from  $44.83 \mu\text{m}^2$  to  $65.81 \mu\text{m}^2$  and the size of the micro gap between the inclusions and the steel matrix was larger. These phenomena resulted from the further dissolution of the surrounding steel matrix, which was due to the formation of an occlusion zone; other locations of the  $\text{Al}_2\text{O}_3$  inclusions also showed similar phenomena. The area of the micro pits at Position 2 increased from  $72.19 \mu\text{m}^2$  at 155 s to  $81.88 \mu\text{m}^2$  at 215 s. Furthermore, it was noteworthy that new  $\text{Al}_2\text{O}_3$  inclusions appeared on the left side of the micro etch pits, and the local enlarged drawing is shown in Figure 6a<sub>2</sub>. In contrast, it was found that the increased areas of micro pits were mainly concentrated on the side of newly emerging  $\text{Al}_2\text{O}_3$  inclusions. This indicated that the presence of  $\text{Al}_2\text{O}_3$  inclusions had a positive effect on the increment of micro pits, and the inclusions fell off to form micro pits, which reduced the damage to the steel matrix.

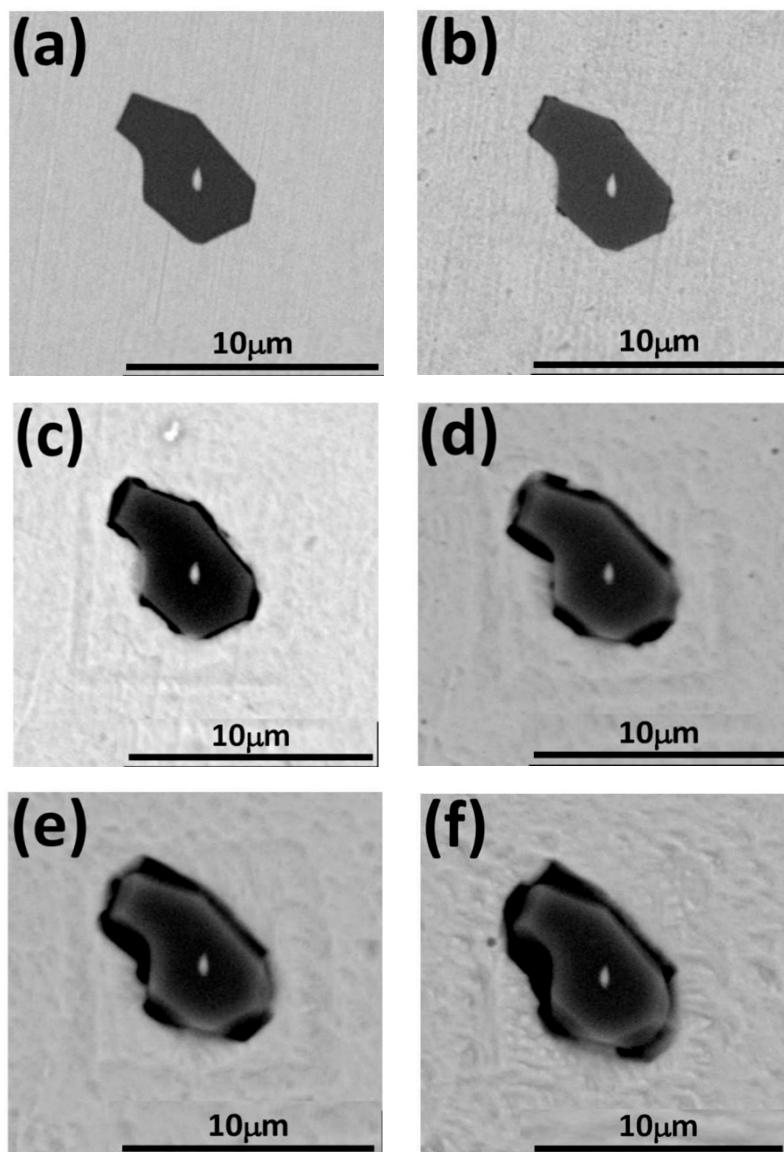
**Figure 7.** Morphology observation of singly distributed  $\text{Al}_2\text{O}_3$  inclusions. (a) 0 s; (b) 15 s; (c) 35 s; (d) 65 s; (e) 105 s; and (f) 155 s.

In SEM morphology of lone distributed  $\text{Al}_2\text{O}_3$  inclusions is presented in Figure 7. Figure 7a–c reveal the corrosion morphology of the specimen under short immersion time. It was observed that the pitting-induced location was at the junction of the  $\text{Al}_2\text{O}_3$  inclusion and its adjacent steel matrix. By comparing the changes of  $\text{Al}_2\text{O}_3$  inclusion at different time, it was found that the  $\text{Al}_2\text{O}_3$  inclusions did not dissolve. Thus, the formation of the micro-gaps was due to the dissolution of the adjacent steel matrix, which was the same as the pitting-induced regularity of clustered  $\text{Al}_2\text{O}_3$  inclusions.

Figure 7 shows further corrosion morphology. It was observed that the edge of  $\text{Al}_2\text{O}_3$  inclusions appeared to be corrosion products from the steel matrix. The corrosion products were lighter in color compared to the  $\text{Al}_2\text{O}_3$  inclusions. As the  $\text{Al}_2\text{O}_3$  inclusions were covered by the corrosion products of the steel matrix, the dissolution of the adjacent steel matrix was obviously subsided. This indicated that with the dissolution of the steel matrix, corrosion products increased, which has a certain degree of inhibition on the development of corrosion.

Figure 7e,f shows the corrosion morphology at longer immersion time, where the edge of  $\text{Al}_2\text{O}_3$  inclusions obviously dissolved, thus it was concluded that the corrosion products of the steel matrix were unstable. From Figure 7b, we could find that a micro-gap appeared between the steel matrix and inclusion (the picture showed the color of micro-gap is darker than that of inclusions). From Figure 7c–f, the micro-gap is growing larger, based on the position of Figure 7b. It was also noted that the dissolved edge of  $\text{Al}_2\text{O}_3$  inclusions were concentrated on the larger gaps between the steel matrix and inclusions (compared with Figure 7b), the reason being that the concentration of dissolved iron ions (which were produced in the larger cracks of the steel matrix) was higher. The hydrolysis degree of the iron ions was large, thereby resulting in low pH, where the edges of the  $\text{Al}_2\text{O}_3$  inclusions dissolved.

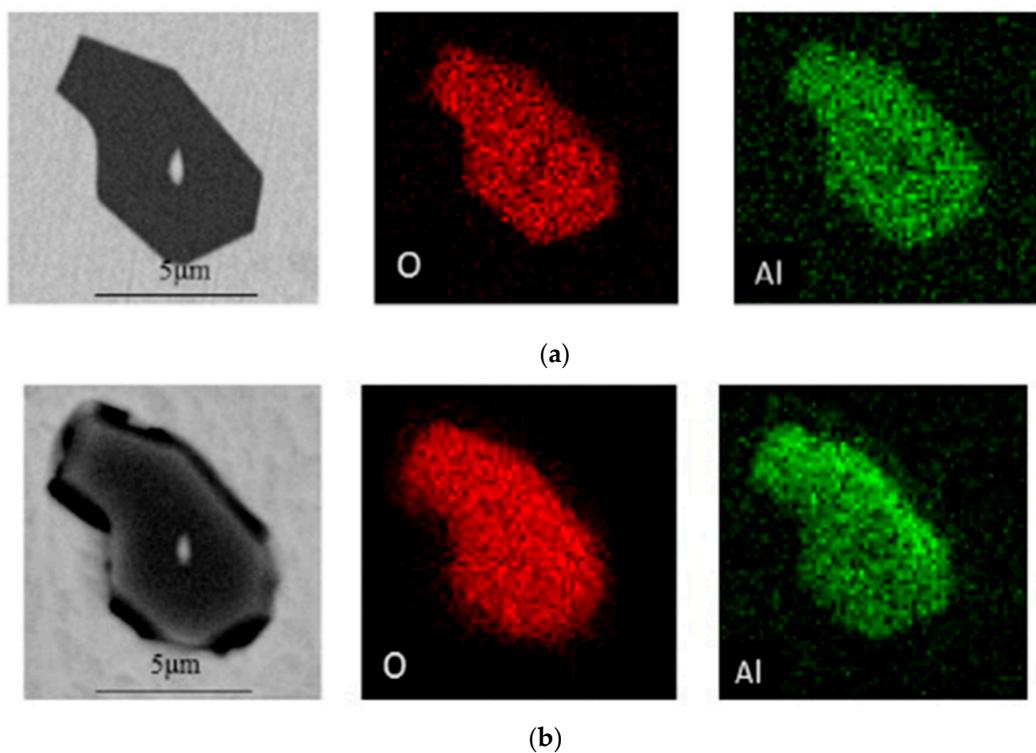
**Figure 8.** Analysis of  $\text{Al}_2\text{O}_3$  inclusions at different immersion time. (a) 0 s; and (b) 65 s.

Figure 8 compares the map analysis results of the two immersion time of 0 and 65 s. It was found that the distribution of elemental Al in the  $\text{Al}_2\text{O}_3$  inclusions was consistent with the shape of the inclusions at 0 s and the edge of inclusions also had an obvious contour. While the distribution of elemental Al at 65 s had no obvious contour at the edge, elemental Al was also detected in the micro gap, which indicated that the  $\text{Al}_2\text{O}_3$  inclusions dissolved. Compared to 0 s, the content of the O element at the edge became higher at 65 s due to the reaction of oxygen absorption occurring during the corrosion process and produced iron oxides and hydroxides that covered the edges of the inclusions. The results of the elemental composition analysis of the inclusions were in good agreement with the corrosion morphology of Figure 7.

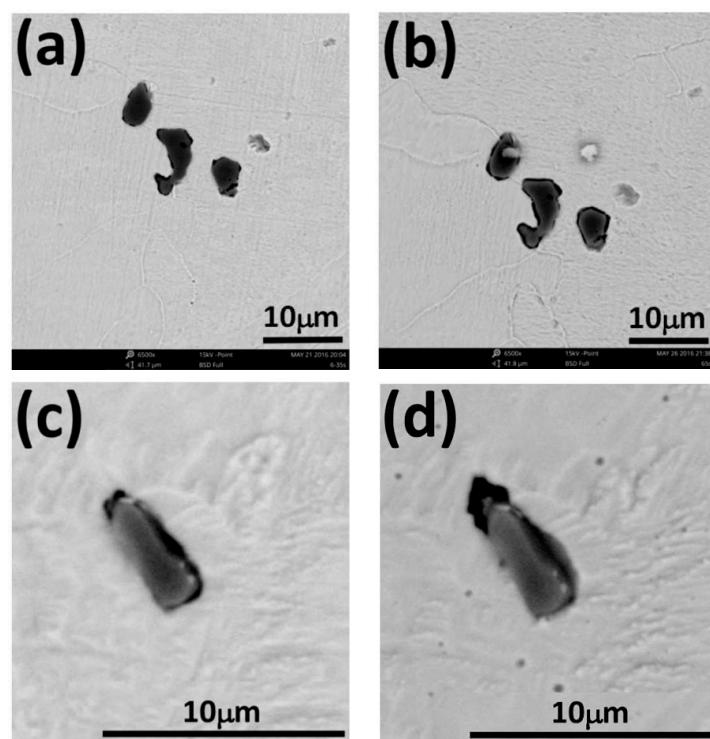
**Figure 9.** Other types of  $\text{Al}_2\text{O}_3$  inclusion corrosion morphology. (a) 35 s; (b) 65 s; (c) 105 s; (d) 155 s.

The above phenomena were also observed in the shorter strip-like  $\text{Al}_2\text{O}_3$  inclusions and a small amount of clustered  $\text{Al}_2\text{O}_3$  inclusions, as shown in Figure 9. Figure 10 shows the following phenomena observed in the corrosion morphology. The  $\text{Al}_2\text{O}_3$  inclusions were still in the steel matrix at 35 s. Furthermore, the inclusions were not visible on the SEM image at 65 s, leaving only the pits. Since the  $\text{Al}_2\text{O}_3$  inclusions were not easily dissolved, the formation of the etch pits was caused by the shedding

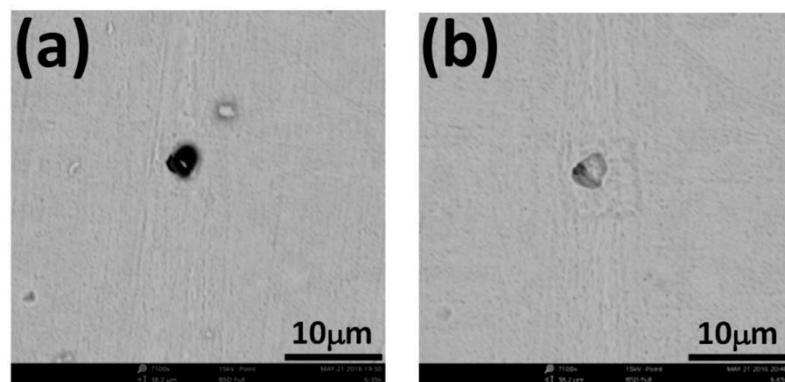
**Figure 10.**  $\text{Al}_2\text{O}_3$  inclusions fall off. (a) 35 s; and (b) 65 s.

of the inclusions. This also showed that corrosion occurred along the junction of the inclusions and steel matrix. The number of small, shallow  $\text{Al}_2\text{O}_3$  inclusions in the adjacent steel matrix was less, as the inclusions separated from the steel matrix and fell off when the adjacent steel matrix dissolved.

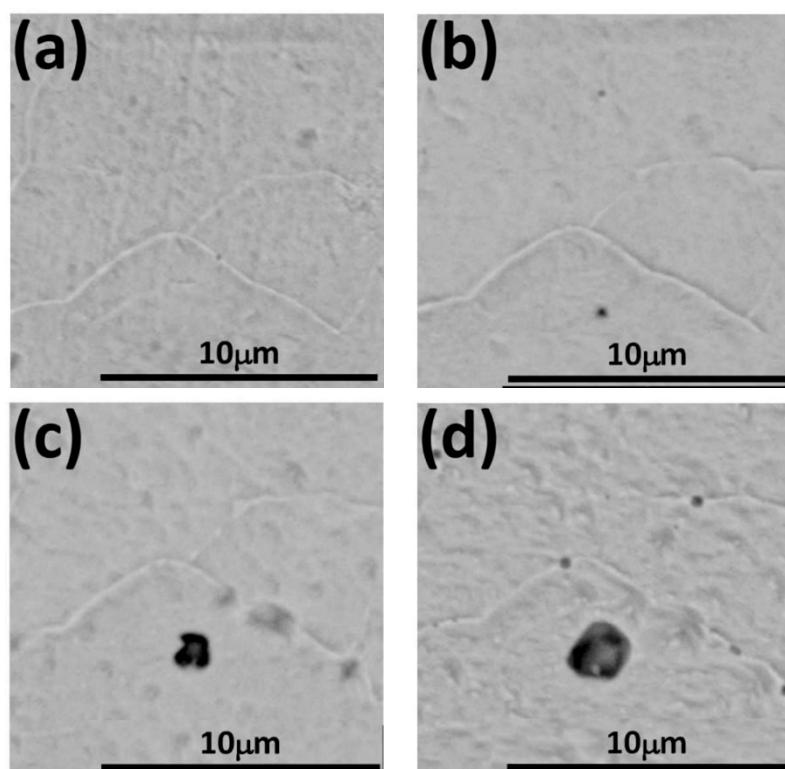
**Figure 11.** The surface morphology of the specimen changes: (a) 35 s; (b) 65 s; (c) 105 s; and (d) 155 s.

During the process of corrosion immersion, a certain field of view of the specimen was observed, as shown in Figure 11. Figure 11a shows the morphology of corrosion at 35 s.  $\text{Al}_2\text{O}_3$  inclusions were not observed. When the samples were corroded for 65 s, inclusions occurred, as shown in Figure 11b (black dots).  $\text{Al}_2\text{O}_3$  inclusions appearing as inclusions buried on the surface of the steel matrix can promote corrosion in the steel matrix. With the dissolution of the steel matrix, the  $\text{Al}_2\text{O}_3$  inclusions buried in the steel matrix began to appear, and as the corrosion progressed, the size of the  $\text{Al}_2\text{O}_3$  inclusions became larger at 105 s, as shown in Figure 11c, because the inclusions near the steel matrix dissolved. Figure 11d shows that the size of the inclusions was further enlarged. This indicated that the inclusions buried shallowly in the surface of the steel matrix began to appear. As the corrosion progressed, the size of the inclusions became larger and once the inclusions appeared on the surface of the matrix, they caused a great deal of damage to the adjacent steel matrix. It was also proven that inclusions have an important effect on the corrosion of the steel matrix.

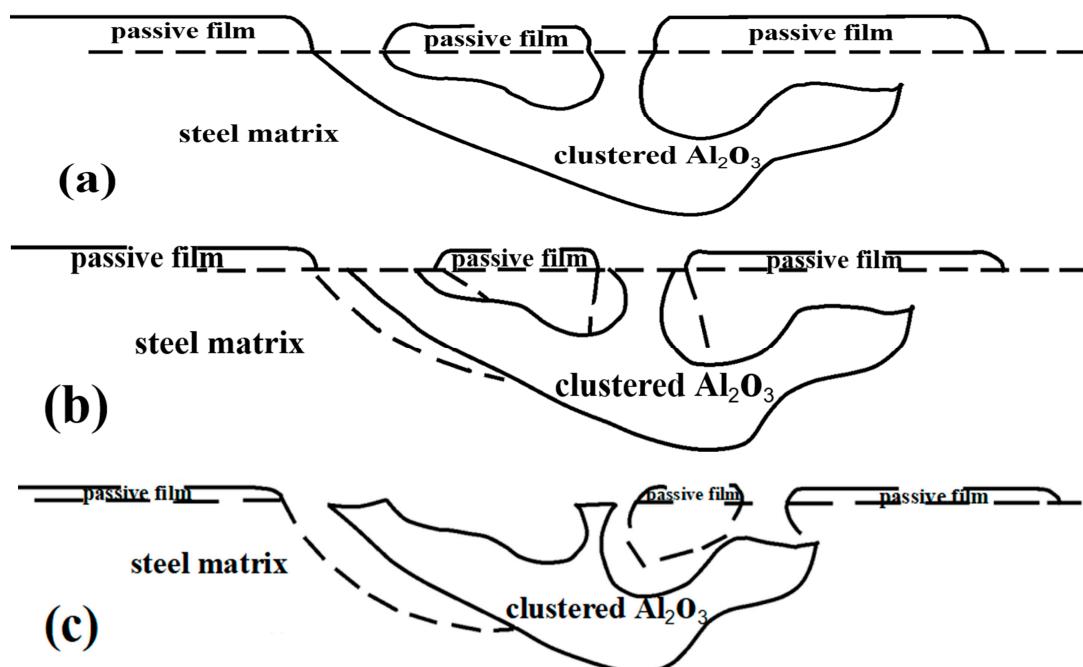
**Figure 12.** Corrosion mechanism diagram: (a) before corrosion; (b) during corrosion; (c) after corrosion.

The corrosion mechanisms are shown in Figure 12.  $\text{Al}_2\text{O}_3$  inclusions have a higher potential than the steel matrix and can form micro-corrosion batteries with the steel matrix. Due to a different structure or non-uniformity of components of the boundary between  $\text{Al}_2\text{O}_3$  inclusions and steel matrix [22,23], the steel matrix was unstable, the grain boundary energy was high, and the ionization tendency was great [24,25]. At the same time, the presence of inclusions broke the continuity of the passive film and the boundary was weakly protected by the passive film, as shown in Figure 12a–c. Thus, pitting corrosion was preferentially induced at the boundaries. The steel matrix adjacent to the inclusions dissolved, resulting in the production of micro gaps that formed a self-catalyzed activation-passivation corrosion battery based on the occlusion battery [26]. This caused the cracks to expand and corrosion pits to become deeper. The clustered  $\text{Al}_2\text{O}_3$  inclusions were more destructive to the steel matrix than the lone  $\text{Al}_2\text{O}_3$  inclusions. As the corrosion took place along the direction of the presence of inclusions, the clusters of  $\text{Al}_2\text{O}_3$  inclusions accelerated the corrosion process. Small and shallow  $\text{Al}_2\text{O}_3$  inclusions in the corrosion process easily fell from the steel matrix and formed the pits, thus weakening the harmful impacts on the steel matrix.
