# Taxonomy of Defects in Auxiliary Elements of Facades and Its Relation with Lawsuits Filed by Property Owners

**Abstract:** While at first it can be thought that the auxiliary elements of facades are merely ornamental with little practical function, this study shows that these components of the building envelope have a high impact on the envelope's functioning and performance. This is carried out through the analysis of all relevant lawsuits filed in Spain over a 10 year period, a data set in which a surprisingly high number of 1033 cases of defects was found to affect external windowsills, exterior wainscots or cornices (the three auxiliary elements considered) was found. Considering the total number of lawsuits, this is an objectively unprecedented study. An analysis is carried out regarding the interrelations between elements, defects, causes, and types of buildings, with the aim of obtaining a sorted classification of the data. This constitutes a useful tool to prevent future problems arising from either the design, execution, or maintenance of facades. These include various issues resulting from humidities, one of the most frequent envelope defects, which are found to signif

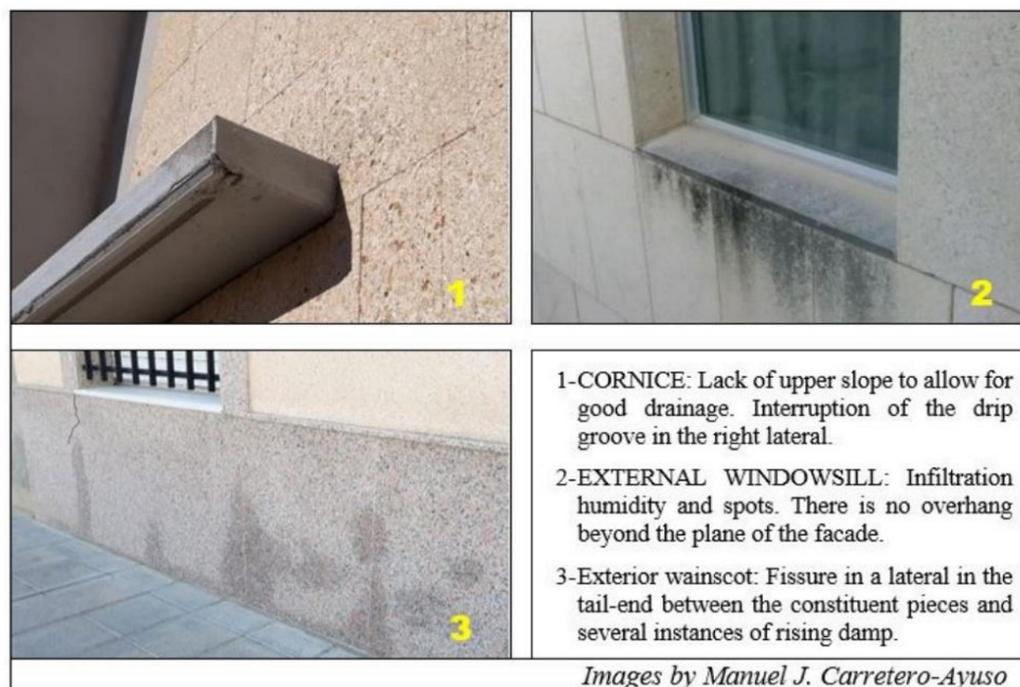
Below are shown photographs of some cases of defects found by the authors during the execution of works (see Figure 1), included as a visual addition to this research.

**Figure 1.** Photographic examples of defects in the three types of elements.

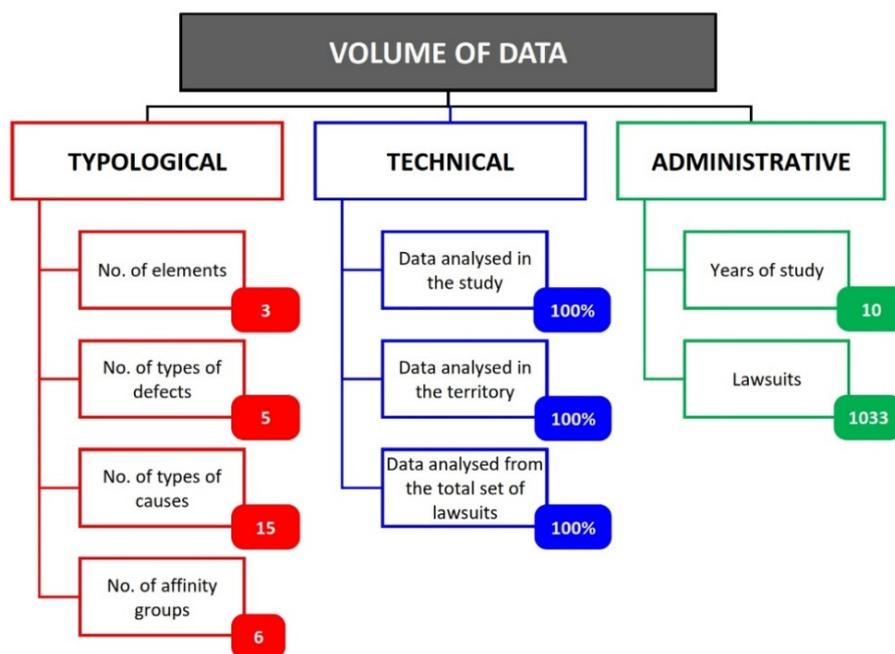
The collection of data used in this research corresponds to 100% of the existing cases, both with regard to the number of cases and to the number of years under analysis (there not being any uncertainty, given that it is not a partial sample). These are represented in Figure 2.

**Figure 2.** Amount of data used in the research.

The idea behind the above categorisation is to obtain a quadrant of construction interrelations between the defects that normally occur in these elements and the possible causes behind them. Some examples of these types of interrelations have been used in research on brick walls [37] and roofs [38]. The creation of these types of quadrants of construction interrelations is not in any way intended to replace the professional experience of technicians nor their judgment/assessment of each case. The idea is to provide basic information that can then be accessed by less experienced individuals once it has been validated through this work (volume and types of data shown Figure 2).

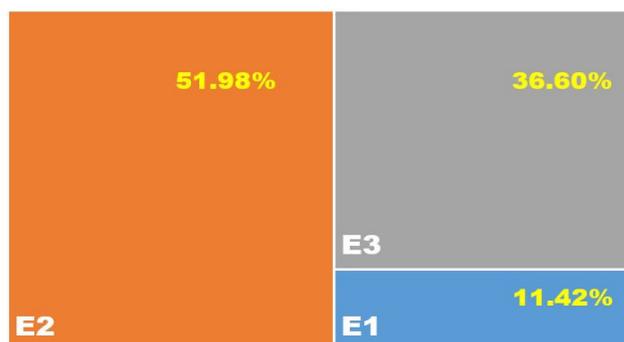
Figure 3 shows the percentages of defects occurring in each type of element. It can be seen that over half the cases occur in external windowsills (E2 = 51.98%), followed by exterior wainscots, which aggregate over a third of all cases.

Figure 3. Percentage of presence by type of element.

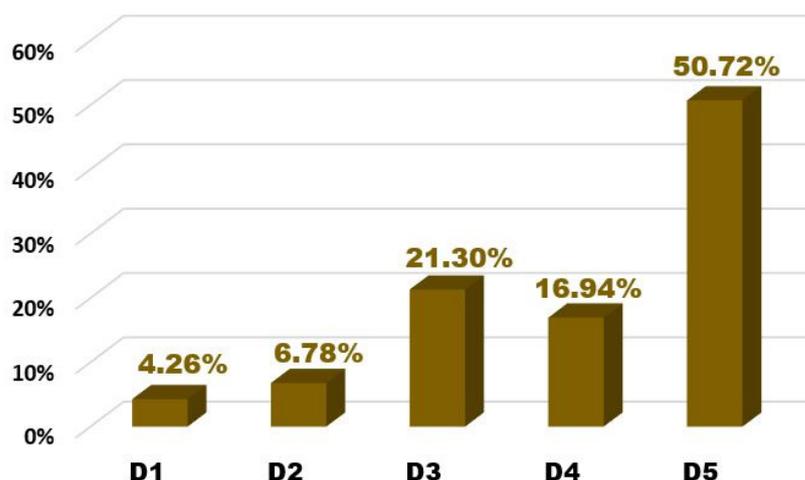
Figure 4 shows the recurrence of each defect. The most frequent defect is ‘infiltration humidity’ (D5 = 50.72%), followed by ‘detachment and fracture of pieces’ (D3 = 21.30%), with ‘rising damp’ in third place (D4 = 16.94%). These three defects account for around 90% of the total cases.

Figure 4. Percentage of presence by type of defect.

It is apparent that, as indicated by previous research [8–10], problems related to the undue presence of water in the envelope are the most common issues in auxiliary elements of facades (>70% defects), which is particularly significant in light of the high impact that this type of issue usually entails.

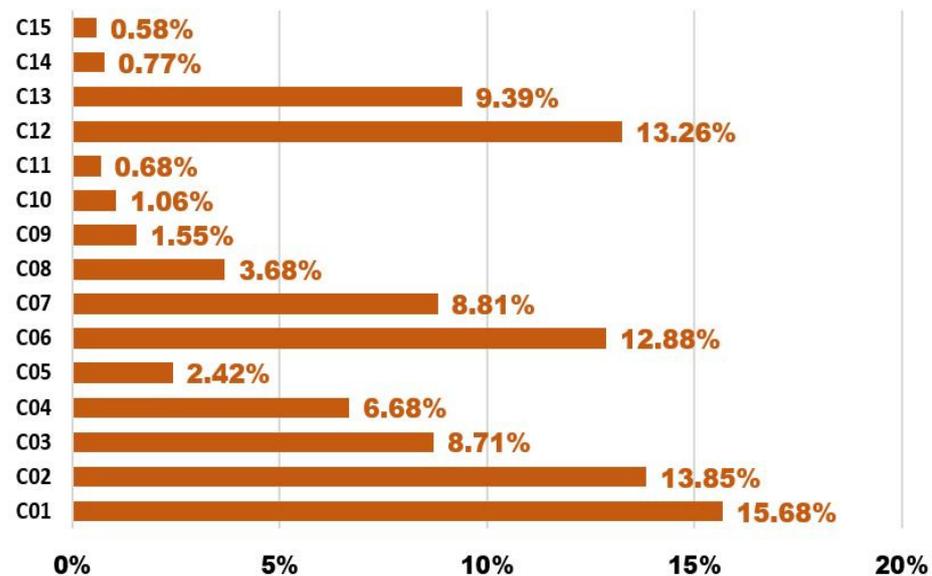
Among the 15 types of causes in this study, four stand out as a result of their frequency which, as shown in Figure 5, is greater than 10%. They are, in decreasing order of frequency: ‘lack/anomaly of drip groove, gutter, and/or roof downpipes’ (C01 = 15.68%), ‘lack/insufficiency of sealant’ (C02 = 13.85%), ‘incorrect anchoring material’ (C12 = 13.26%) and ‘lack of barrier against capillary humidity’ (C06 = 12.88%).

Figure 5. Percentage of presence by type of cause.

Three interesting causes reside in a lower frequency range (between 8% and 10%): ‘characteristics of the material used’ (C13 = 9.39%), ‘direct contact with the terrain’ (C07 = 8.81%), and ‘lack/insufficiency of slope’ (C03 = 8.71%).

Like the most common types of defects, the most common types of causes are closely related to water: causes C01, C02, C03, C04, and C06 are all related to water, humidity, and infiltrations, and they add up to more than 50% of causes.

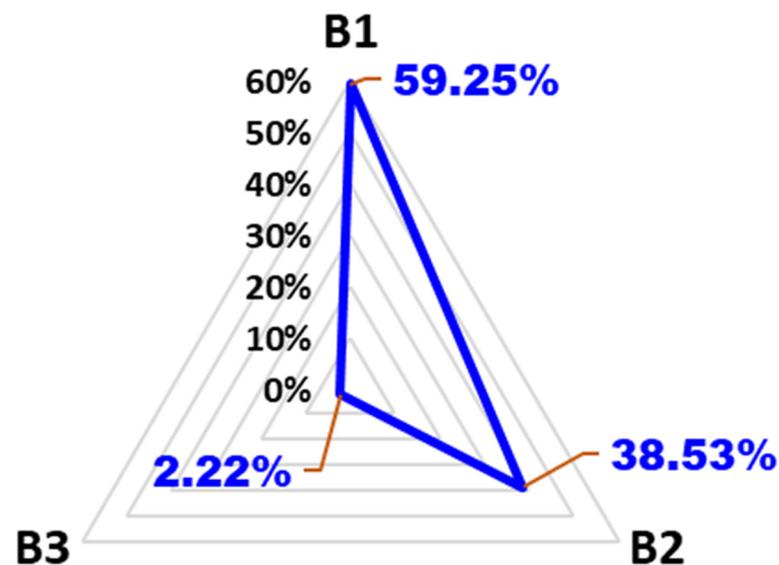
The results by type of building (Figure 6) indicate that the overwhelming majority of cases (97.78%) occur in residential buildings (B1 + B2). Flats (B1) hold nearly 60% of cases, while houses (B2) account for nearly 40% of cases.

Figure 6. Percentage of presence by type of building.

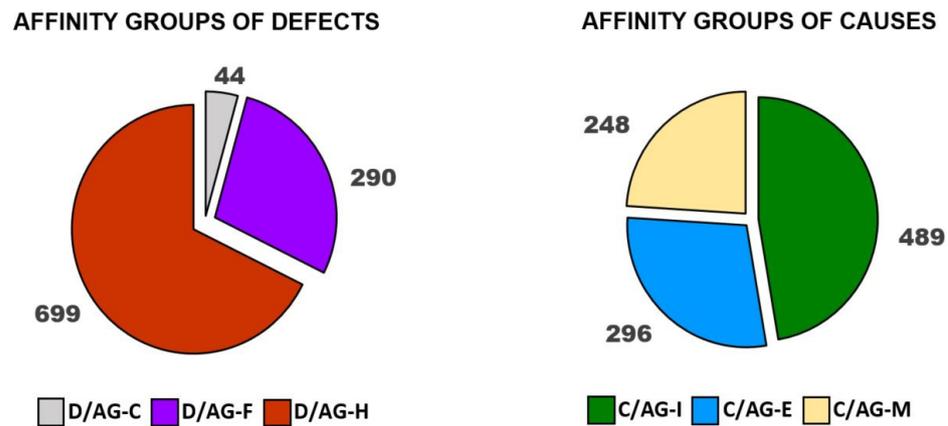
The results by types of affinity groups established in the methodology (D/AG and C/AG) are shown in Figure 7.

Figure 7 (left) shows the results related to the grouping of defects. It can be seen that the most common group is 'Humidities' (D/AG-H = 699 cases), whether as a consequence of 'rising damp' or 'infiltration humidity'. In second place is the 'Breaks' affinity group (D/AG-F = 290 cases).

Figure 7 (right) shows the results related to the grouping of causes. The most common group is 'Incorrect conditions of execution' (C/AG-I = 489 cases). The other two groups have very similar numbers of cases: C/AG-E = 296 cases and C/AG m = 248 cases.

Figure 7. Number of cases by affinity groups.

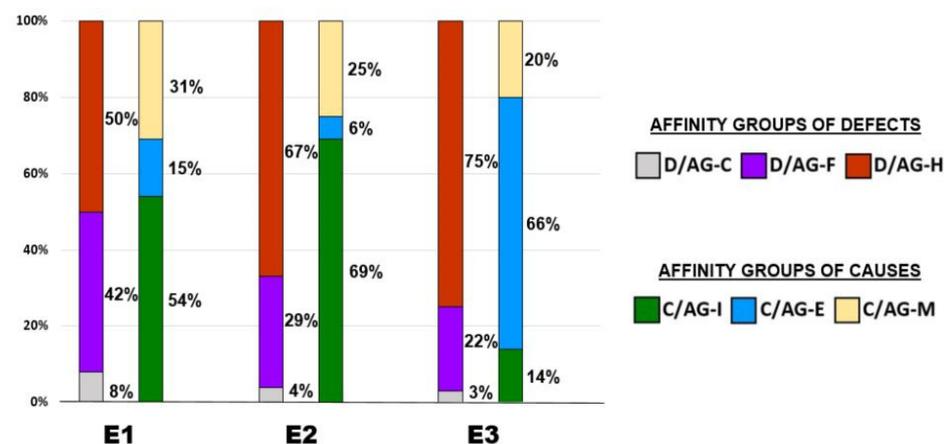
The percentage distribution within each type of element according to the affinity groups is shown in Figure 8. The most prevalent affinity group is D/AG-H (Humidities), which represents, with regard to defects, half the cases in E1 (cornices), two-thirds of cases E2 (external windowsills) and three-quarters of cases in E3 (exterior wainscots); nevertheless, D/AG-C (Cleaning) has very low values (between 3% and 8%). As for the affinity groups of causes, there is significant diversity in the percentages, though C/AG-I (Incorrect conditions of execution) represents the majority in E1 (cornices) and E2 (external windowsills), while C/AG-E (conditions of contact between elements) has the majority in E3 (exterior wainscots).

Figure 8. Percentage distribution of affinity groups by type of element.

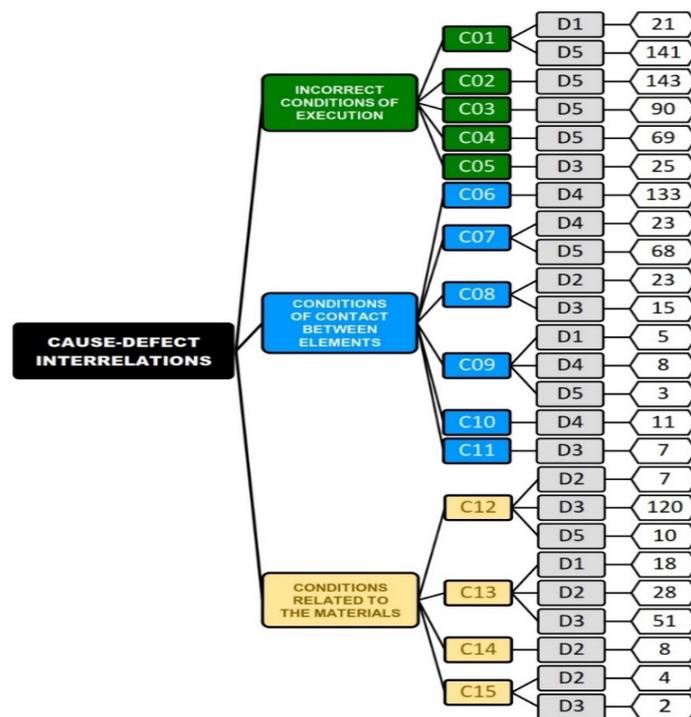
Once Table 7 was prepared and analysed, it was intended to verify the interrelation between elements, defects, and causes in different order. Figure 9 was thus prepared, showing that relation in a sequential hierarchy by: cause affinity group, type of cause, type of defect, and type of element.

Figure 9. Descending tree chart of interrelations between types of causes and types of defects.

It can be seen that there are eight causes that lead to just one type of defect, four causes that lead to two types of defects, and three causes that lead to three types of defects. The lowest value for cause-defect-element is held by C15-D3 (two cases), followed by C09-D5 (three cases). The more numerous interrelations are C02-D5 (143 cases) and C01-D5 (141 cases). It can also be noted that the type of defect that occurs most often is D5 (seven times). This chart can be of great interest to professors of architecture and engineering, as it provides a causal summary of defects in external windowsills, exterior wainscots, and cornices.

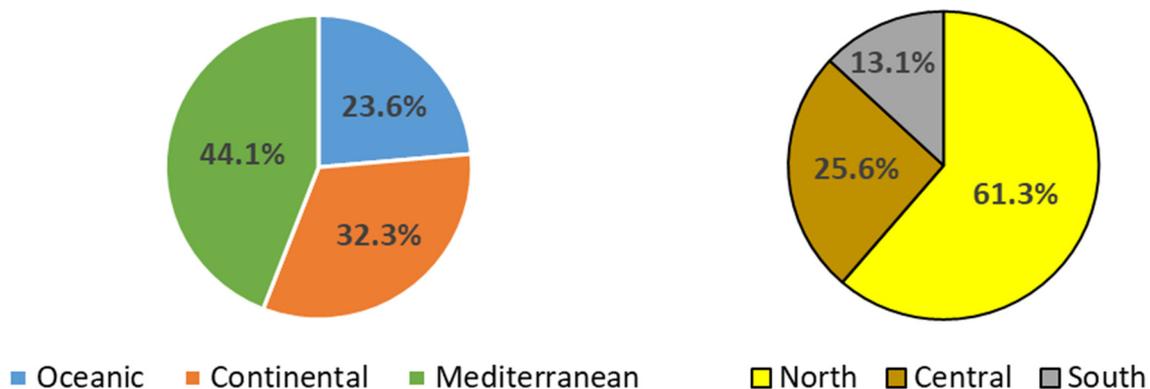
The percentage distribution of cases, from the total set of defects, by type of climate and latitude, is as follows (see Figure 10). It can be seen that there is a higher concentration of defects in the Mediterranean climate and in the North latitude [51].

Figure 10. Distribution of cases by type of climate (left) and by latitude within Spain (right).
