Damage Prediction Observation for Existing Buildings in Sabah under Moderate Risk Earthquakes

Abstract: Seismic design in building construction is still new in Malaysia. Sabah, a Malaysian state, is situated southeast of the Eurasian Plate, between the highly active Philippine Sea Plate and Indo-Australian Plate, and has a history of earthquakes, with the largest measuring a magnitude of 6.3 (2015). Although small earthquakes occur annually, most old buildings in Sabah were built pre-code and designed without considering earthquake loadings. This study aimed to analyze the potential damage to buildings in Sabah based on their vulnerability to moderate earthquakes. More than 500 buildings in seven districts were evaluated using a quantitative method based on score assignment, within 100 kilometers of the epicenters. According to the findings, more than 160 buildings in the Kota Kinabalu and Kudat districts were assessed as vulnerable to Grade 4 damage. In Ranau, Kota Marudu, Tawau, Semporna, and Lahad Datu, most buildings had a Grade 3 damage potential, with some at Grade 2 or 4. This study's findings provide a summary of the damage risk for structures in Sabah and offer a starting

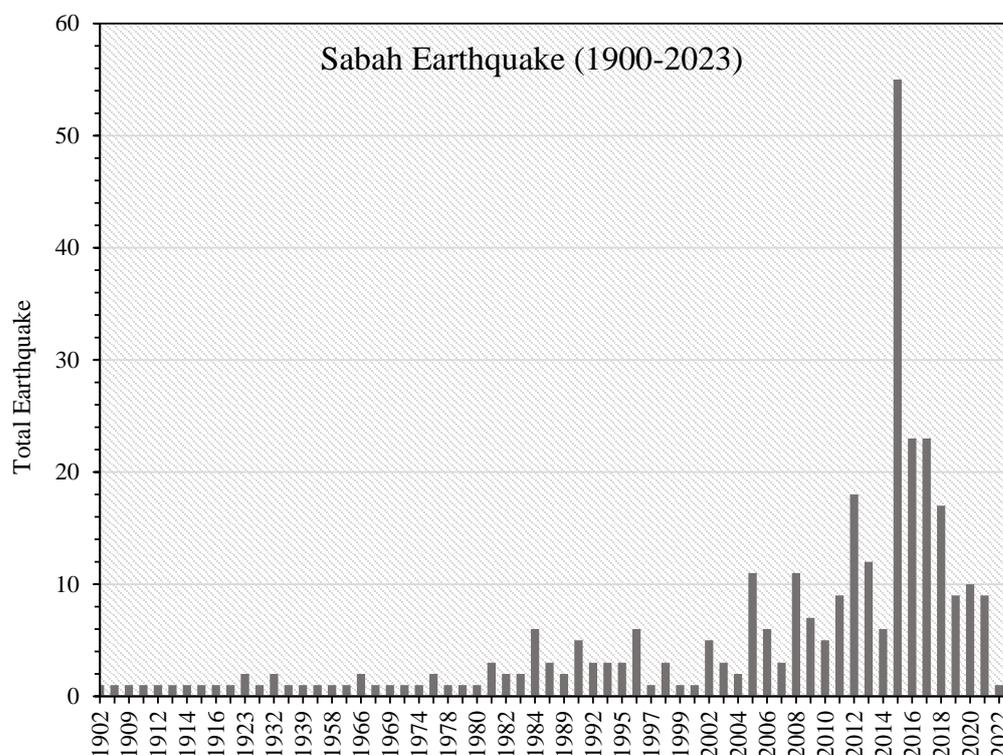
Figure 1. Several Sabah earthquakes with a magnitude greater than 2.0 have been reported in each year from 1902 to recently in 2023.

Between 1902–2023, Sabah experienced about 300 earthquakes with moment magnitudes ranging from 2.0 to 6.3. The recorded earthquakes were internal, in that no external influences from medium or far-field earthquake sources were accounted for. Ranau had 112 earthquake epicenters, whereas Lahad Datu had 60. Sabah in Borneo is situated in the center of Southeast Asia, surrounded by the long-lasting westward subduction of the Pacific Plate, the northward subduction of the Indian Plate underneath the Eurasian Plate, and the passive continental border of the South China Sea [15]. Several analyses of sedimentary and magmatic data indicate that the Borneo region represents an accretionary orogeny during the Mesozoic and Cenozoic eras [16]. Sabah is the second largest state in Malaysia and is located on the island of North–East Borneo. Many large numbers of large-scale developments, including pipelines, power plants, and dams, are currently ongoing to bring the state to the same level as other industrialized nations [5,17]. The statistics for an updated earthquake recorded for 120 years of observation indicate an increment of earthquake events as shown in Figure 1. Thus, numerous geological investigations, such as the one by Tongkul [18], have been conducted in Sabah to study fault activity.

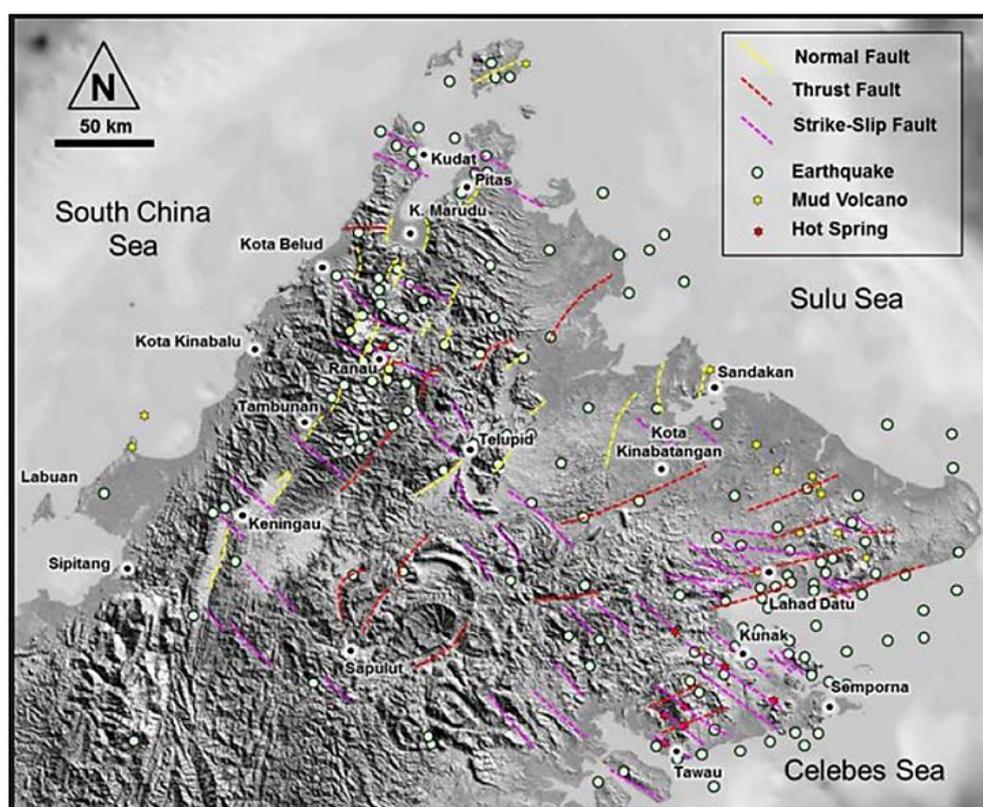
Figure 2. Active and potentially active faults in Sabah based on the presence of negative lineaments, triangular facets, earthquake epicenters, mud volcanoes, and hot springs [4].

Sabah has been found to have moderate earthquakes, with the highest earthquake magnitude being equal to six, and this region also has its fault lines as mentioned in Tongkul's study [4]. Several prominent active and potentially active faults in Sabah have been identified based on the presence of earthquakes, mud volcanoes, and hot springs, as well as remote sensing analysis and field surveys conducted over the past few years (Figure 2). The active faults can be grouped into compressional structures (thrust faults are mostly orientated East Northwest–West Southwest (ENW–WSW), and strike-slip faults are mostly oriented Northwest–Southwest (NW–SW)) and extensional structures (normal faults are mostly oriented Northeast–South West (NE–SW)). The evidence for thrust and strike-slip faults is most prevalent in the Lahad Datu–Tawau region of southeast Sabah. The region is surrounded by several linear features with a value of 20 to 40 km in length that are predominantly connected with earthquakes. Active normal fault evidence is particularly prevalent in the Northwest–Southeast (NW–SE) trending inland valleys of the Crocker-Trusmadi Range in western Sabah. The Northeast–Southwest (NE–SW) scarps intersect with the Lobou-Lobou Fault, which is believed to have caused the 2015 Ranau earthquake of magnitude six. In addition to the normal fault scarps, evidence of strike-slip faults can be observed here, as a sequence of NW–SE trending negative lineaments cutting through the south-flowing Mesilou River.

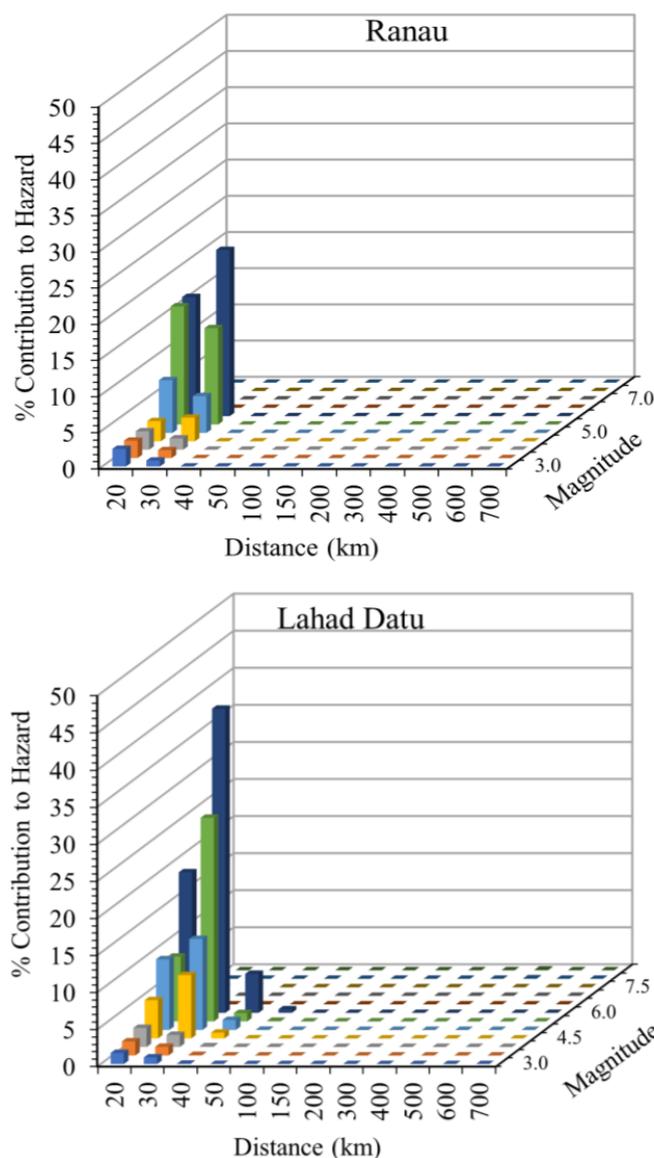
Figure 3. De-aggregation of the total seismic hazard of Ranau and Lahad Datu, in a 50-year design period for a 475-year return period with total seismic hazard, is discrete in magnitude, distance bins, and percentage contribution to hazard.

seismic hazards in Ranau and Lahad Datu result from various earthquake sources in Sabah namely, line, area, and point source faults as studied by Harith et al. [21]. The end result of seismic hazard assessment is seismic de-aggregation. The study conducted a probabilistic analysis that led to the finalization of the current de-aggregation assessment. According to their findings, the fault zone near Lahad Datu and Ranau has a recurrence rate, expressed as a beta value, of 0.921, with a maximum magnitude of 6.5. Moreover, the predicted peak ground acceleration (PGA) values for the 10%, 5%, and 2% probability of exceedance are 0.16 g, 0.22 g, and 0.28 g, respectively. The seismic de-aggregation results are a function of the site location, return period of interest, and intensity measure considered. The fact that site location affects the seismic hazard should be evident because it changes the site's proximity to nearby faults, contributing the most to the total hazard. The de-aggregation is a function of the return period because of the different occurrence rates of the sources and their potential to produce large and small ground motions. The de-aggregation analysis on Ranau and Lahad Datu, shown in Figure 3, are moderate magnitude (>M 5.0) and close proximity (20–30 km) sources, which tend to dominate the PGA hazard.

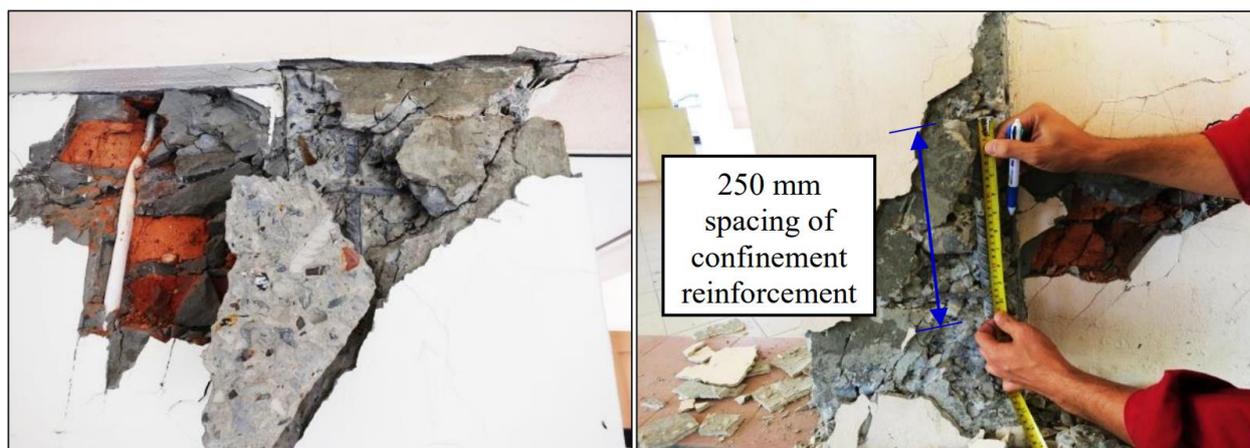
Figure 4. Significant damage due to the 2015 Ranau earthquake [22].

The approaches of existing damage prediction on buildings are post-disaster observation-based and numerical simulation-based. For instance, the post-disaster observation-based approach consisting of an in situ field investigation on affected buildings by Majid et al. [22] found that damage was observed due to a recent earthquake in Ranau (2015). Figure 4 illustrates the significant damage where wider cracks occurred, and the concrete cover spalled. As a result, the reinforcement of the longitudinal and transverse columns is visible. The damage also occurred in the critical regions, located at the top and bottom parts of the columns. Based on quick observation, it appears that the confinement or transverse reinforcement spacing within the crucial zone of the column is insufficient to withstand earthquake load. The confinement reinforcement in one of the inspected columns is spaced at 250 mm intervals. In addition, a numerical simulation-based approach to predict existing damage is not applicable since the present study is limited to fieldwork observation only to save the time consumed for numerous buildings in the study areas.

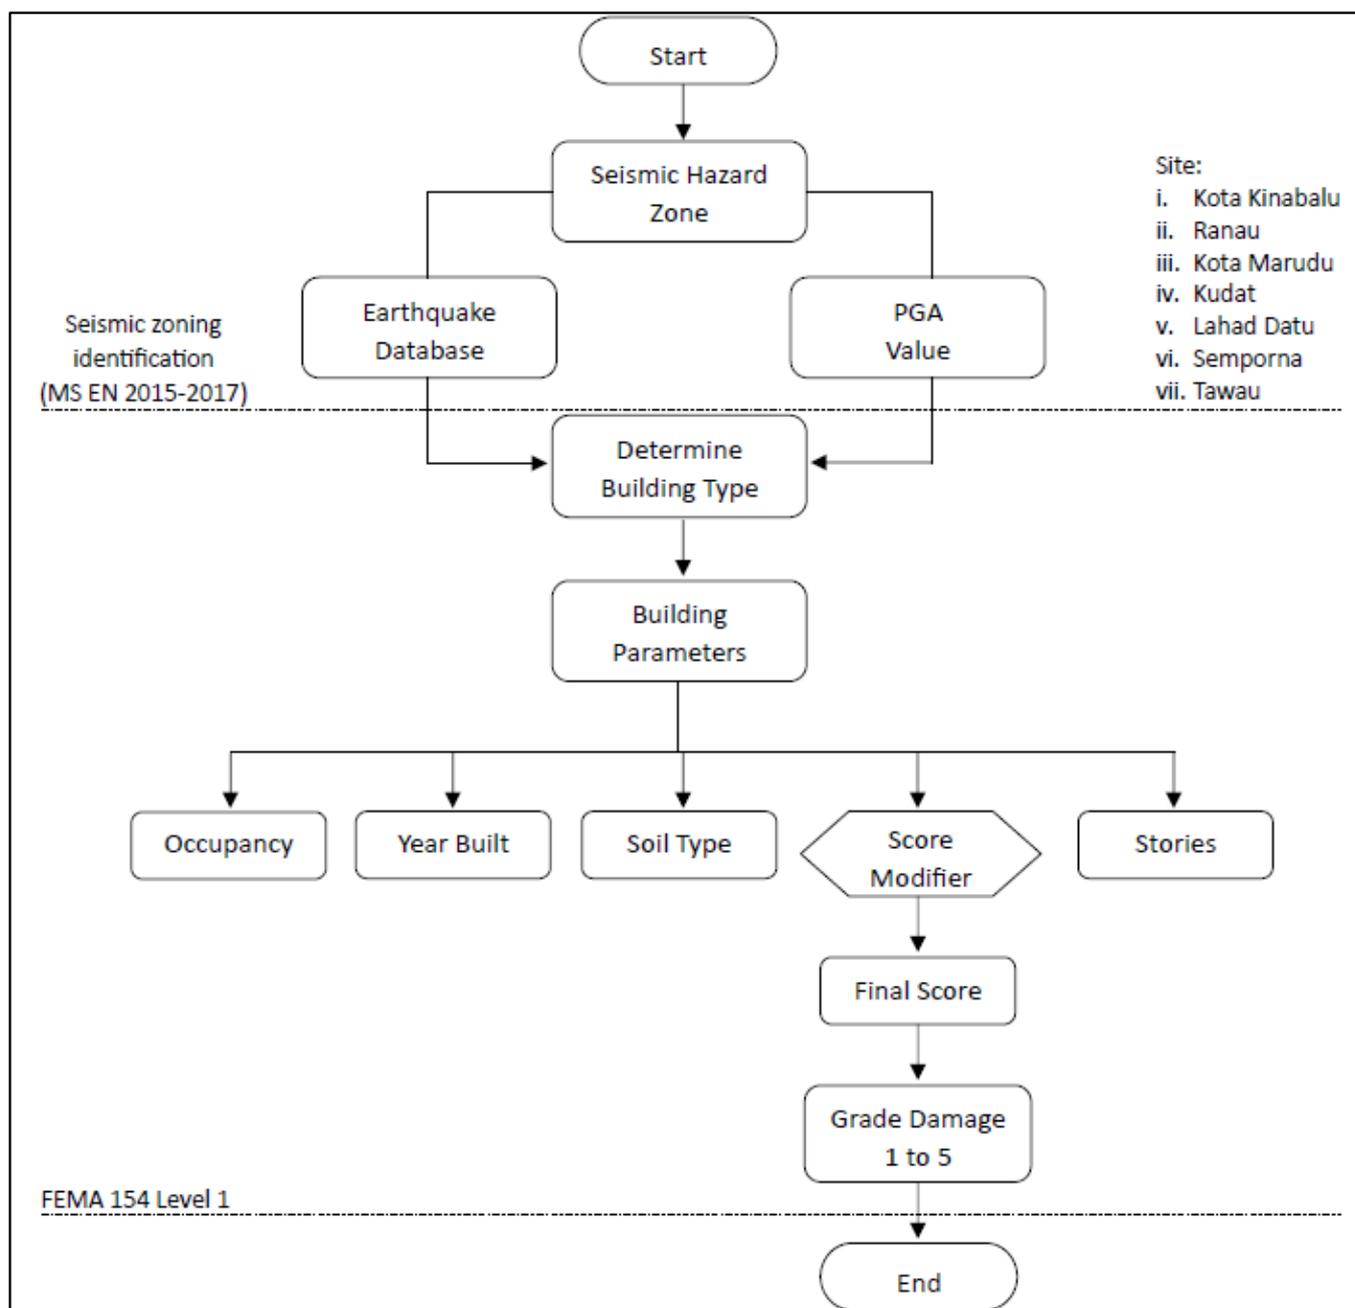
Figure 5. Flowchart of Sabah buildings' vulnerability assessment procedure.

Figure 5 presents the methodologies utilized in this investigation. In the first phase of the earthquake and seismic hazard condition assessment, a review of earthquake activity was conducted in the study region, in accordance with MS EN1998-1:2015 [23], to assess the hazard risk in both study areas (Ranau and Lahad Datu). Multiple databases on earthquakes or seismicity were compiled from a large dataset provided by numerous national and international organizations. These international agencies included the United States Geological Survey/National Earthquake Information Center (USGS/NEIC), the Advanced National Seismic System (ANSS), the International Seismological Center (ISC), the National Geophysical Data Center (NGDC), the Harvard Centroid Moment Tensor (CMT), and the Malaysian Meteorological Department (MetMalayisa). The site condition was determined based on the soil characteristics listed in Mohd Zainudin et al. [20]’s geological map of Sabah.

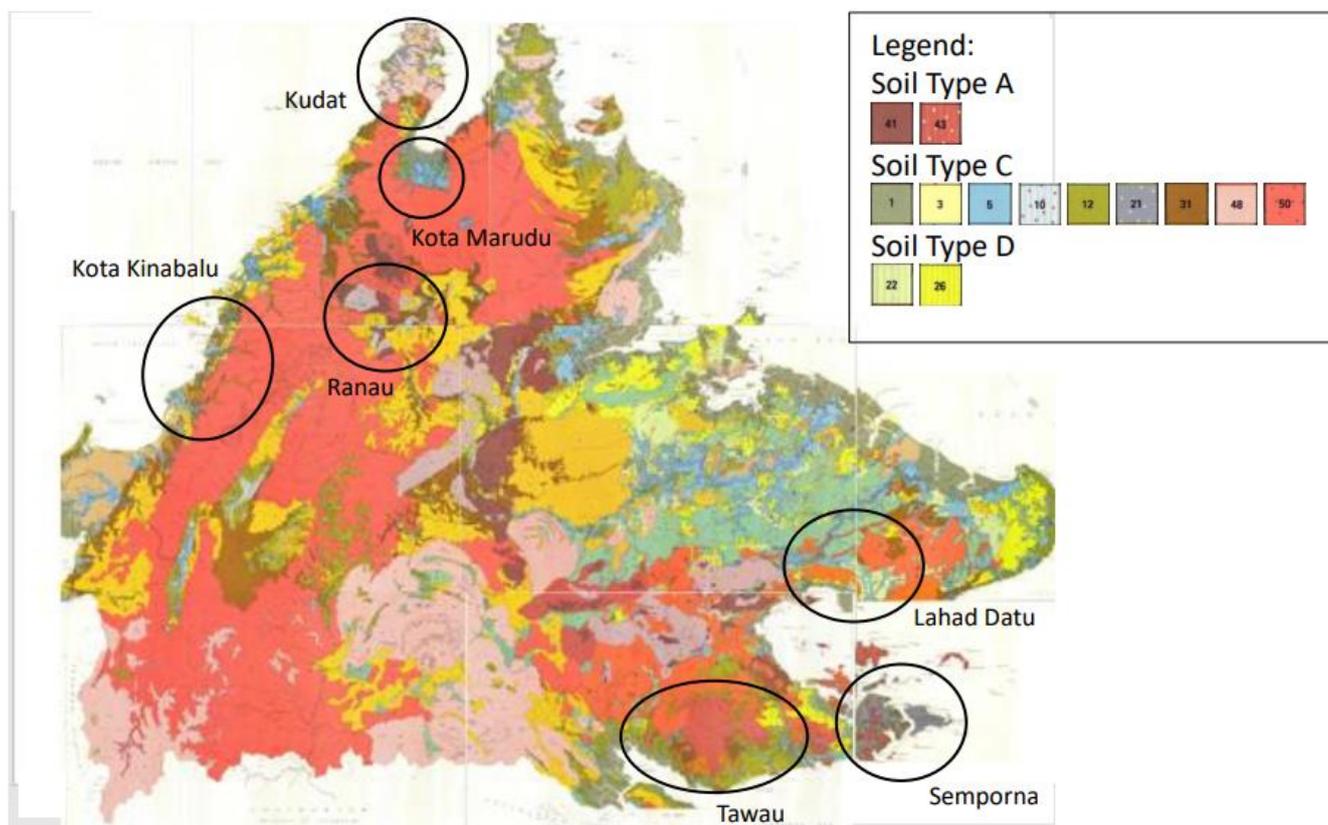
Figure 7. Soil type based on European Soil Data Center (ESDAC) map.

planning stage, as visual techniques in the field cannot instantly discover it. The soil type is determined based on the map by the European Soil Data Center (ESDAC), as shown in Figure 7. During the sidewalk survey, the Rapid Visual Screening approach started with determining building inventory statistics including the number of stories, the occupancy, and the building irregularities. The year of construction was obtained from the local building authority, which focuses on structures that have been in service for 20 to 50 years. A study conducted by Karapetrou et al. [30] can be linked to the aging effects noticed in buildings that have been in use for many years. The study investigates the impacts of aging on reinforced concrete (RC) buildings, with a particular emphasis on performance decline over time. It implies that buildings designed purely for gravity loads are expected to be more vulnerable to increased fragility over time than structures developed in compliance with seismic code regulations.

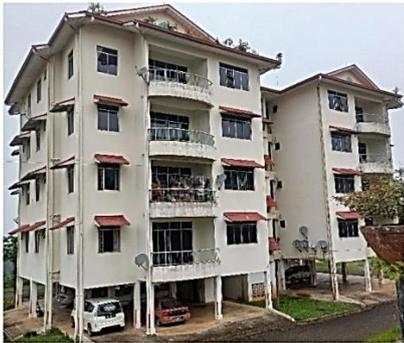
Figure 8. An example of the FEMA P-154 Data Collection Form assessment.

into their respective potential damage groups and it is determined using Equation (1). This involves adding the Score Modifiers for the building to the Basic Score, which takes into account various parameters such as irregularities, building code compliance, benchmarks, and soil type. Engineers and researchers can better evaluate a building’s susceptibility to damage in the event of a natural disaster by carefully considering these factors. An example of the FEMA P-154 Data Collection Form evaluation is shown in Figure 8.

FINAL LEVEL 1 SCORE, $S_{L1} \geq S_{MIN}$: 2.0 - 1.0 - 0.8 - 0.3 = -0.1 < 0.3 Thus, $S_{L1} = 0.3$

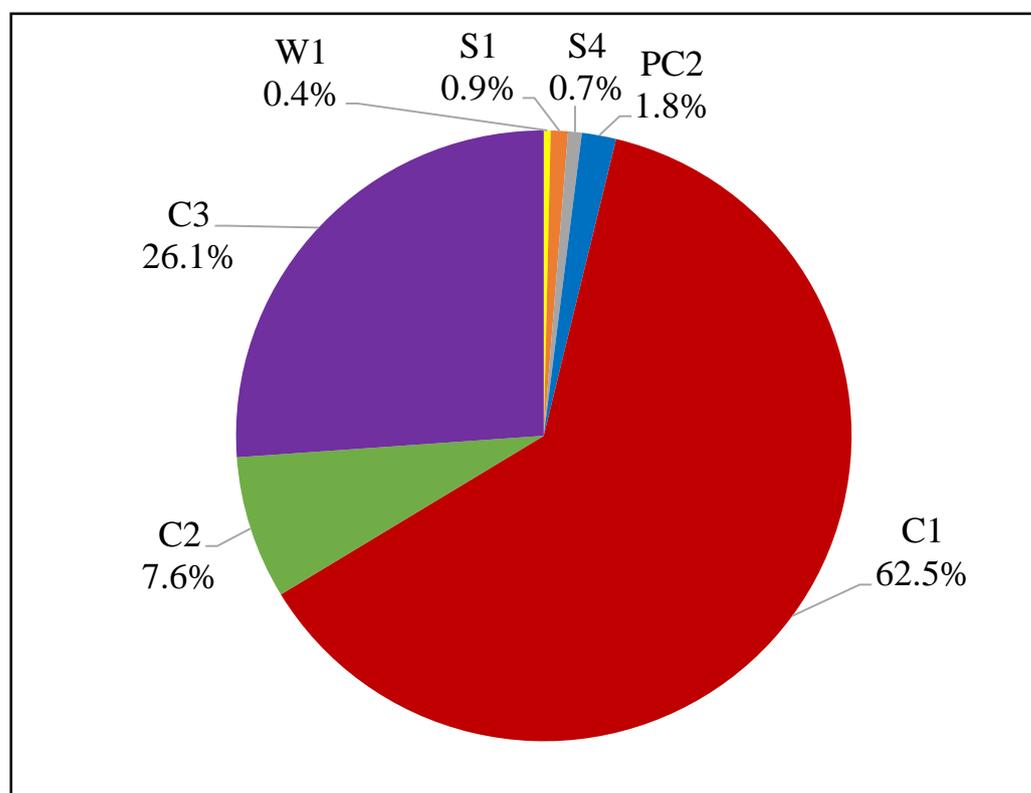
Figure 9. Typical building types in Sabah.

There are seven types of buildings commonly found in Sabah, based on references provided in FEMA P-154 [25]. The buildings that are classified into the seven types include C1, C2, C3, PC2, S1, S4, and W1, as described in Table 3. As shown in Figure 9, the assessed buildings in the seven districts are divided into three major types: C1 (Moment-resisting concrete frame structures), C2 (Buildings with concrete shear walls), and C3 (Unreinforced masonry infill walls in concrete frame buildings). With a percentage of 62%, the C1 category has the most buildings (347). The C3 category has the second-highest number of buildings, with a value of 26%. There are 145 buildings in the C3 class in total. The C2 building type accounts for 8% of the total number of structures. PC2 (Precast concrete structures), S1 (Buildings with steel moment-resisting frames), S4 (Shear walls composed of cast-in-place concrete in steel frame buildings), and W1 (Residential and industrial structures with a light wood frame of 500 square feet or less) were the four minor building types found in the seven districts. The percentages for PC2, S1, S4, and W1 types are 2% (10 buildings), 1% (5 buildings), 1% (4 buildings), and 0.36% (2 buildings), respectively.

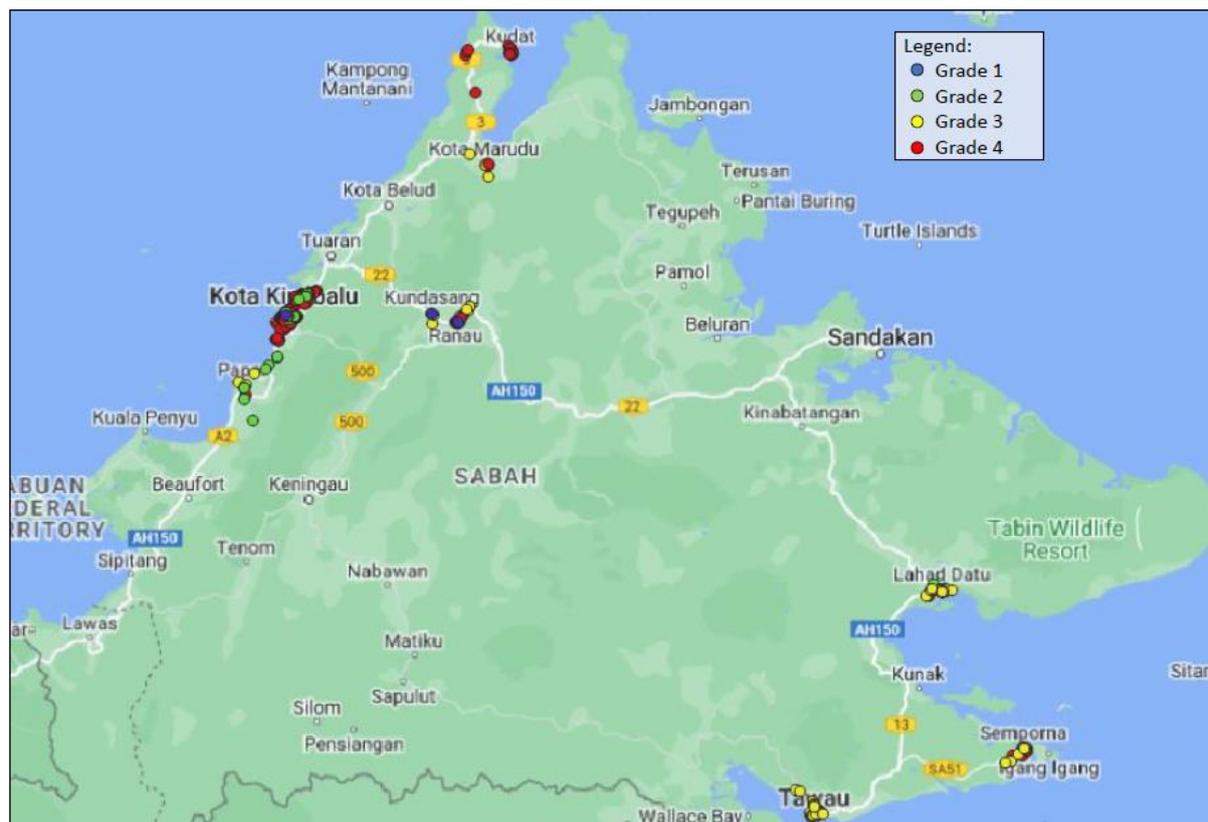
Figure 10. Damage prediction categorized under Grade 1 to 4 for buildings in the Kota Kinabalu, Kudat, Kota Marudu, Ranau, Lahad Datu, Tawau, and Semporna districts.

There are 555 buildings in the study areas (compiled from seven different districts) to be analyzed for their damage predictions. Grade 1 to Grade 4 damage can be seen amongst the buildings but, fortunately, no Grade 5 category damage was found in the Sabah buildings. Figure 10 shows the map with the plotted damage level for the compiled observations of buildings in the seven study areas. Many medium- to high-rise buildings located in the main city of Kota Kinabalu accumulated about 50% of the overall total of surveyed buildings.

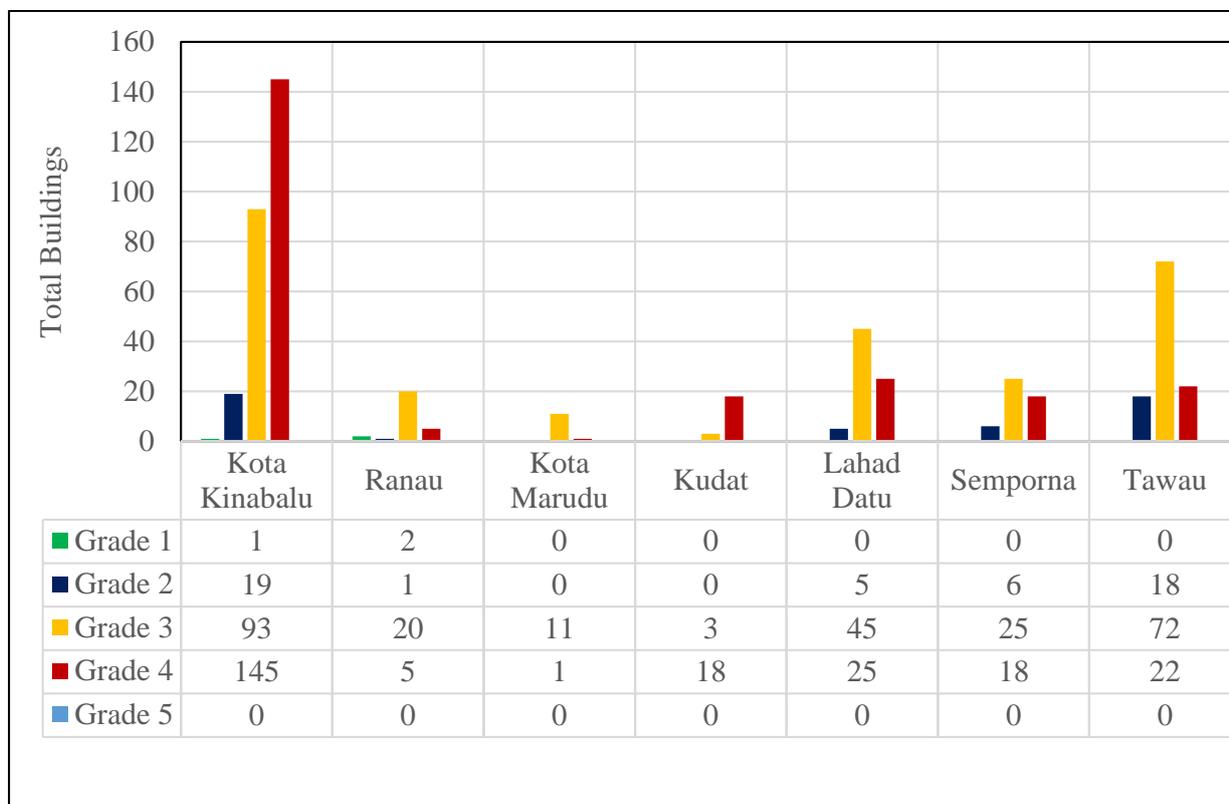
Figure 11. The total number of buildings plotted with the level of damage (Grades 1 to 5) predicted in the study areas: Kota Kinabalu, Kudat, Kota Marudu, Ranau, Lahad Datu, Tawau, and Semporna.

The detailed number of buildings surveyed in the study areas breaks down into the seven districts summarized in Figure 11. Based on the findings, three buildings have been observed with predicted Grade 1 damageability. One building is located in Kota Kinabalu and two buildings are located in Ranau. The predicted damage of Grade 2 can be found in all study areas, except for Kota Marudu and Kudat, with 49 buildings. The district with the highest number of Grade 2 buildings is Kota Kinabalu. The total number of buildings accumulated under Grade 3 damageability is more than 260 buildings. Similarly, Kota Kinabalu has the most buildings under this grade, with a total of 93 buildings. Most buildings are categorized under Grade 4 (a total of 234 buildings). Since most of the buildings surveyed were in Kota Kinabalu, the total is 145 buildings. Surprisingly, Grade 4 damageability is found to be the highest number among the other grades. Based on preliminary observations, Kota Kinabalu is among the fastest developing districts because its main city has been actively growing. A city's quick development can mostly benefit society, but it can also put lives in danger since the implementation of seismic design (Malaysia building standard, MS EN1998: 2015, first published in 2017) is still new. Subsequently, as there were a rapidly growing number of medium- to high-rise buildings in this city, the seismic design can be applied to new buildings. In the current study, the

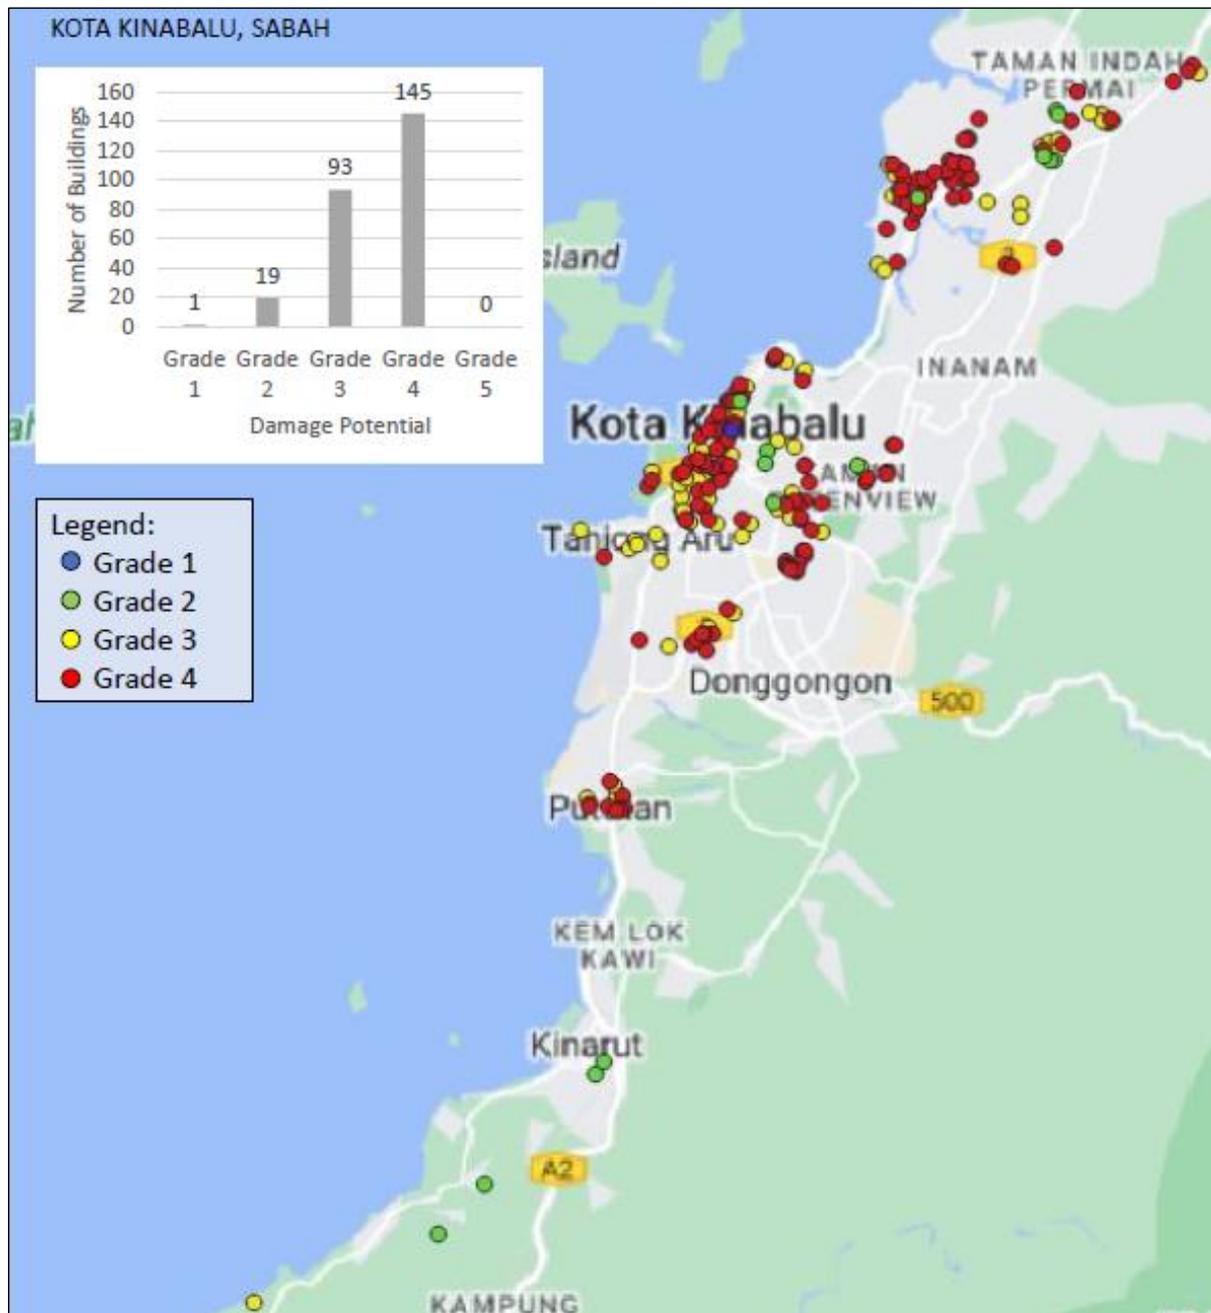
Figure 12. Building damage prediction in Kota Kinabalu based on surveyed data under moderate earthquakes.

As depicted in Figure 12, most of the buildings are concentrated in North Kota Kinabalu and a few are located along the South shoreline. Most of the buildings in the North area of Kota Kinabalu are medium- to high-rise buildings. According to the final surveyed results, Grade 4 recorded the most buildings (with a total of 145) and the final score ranges from 0.3 to 0.7. Next, Grade 3 damageability applied to a total of 93 buildings. In comparison with Grade 1, only one building in the study area has a final score of more than 2.5; Grade 2 has 19 buildings. In summary, buildings in Kota Kinabalu can be seen to be affected by Grade 4, followed by Grade 3 and then Grade 2. The de-aggregation analysis on

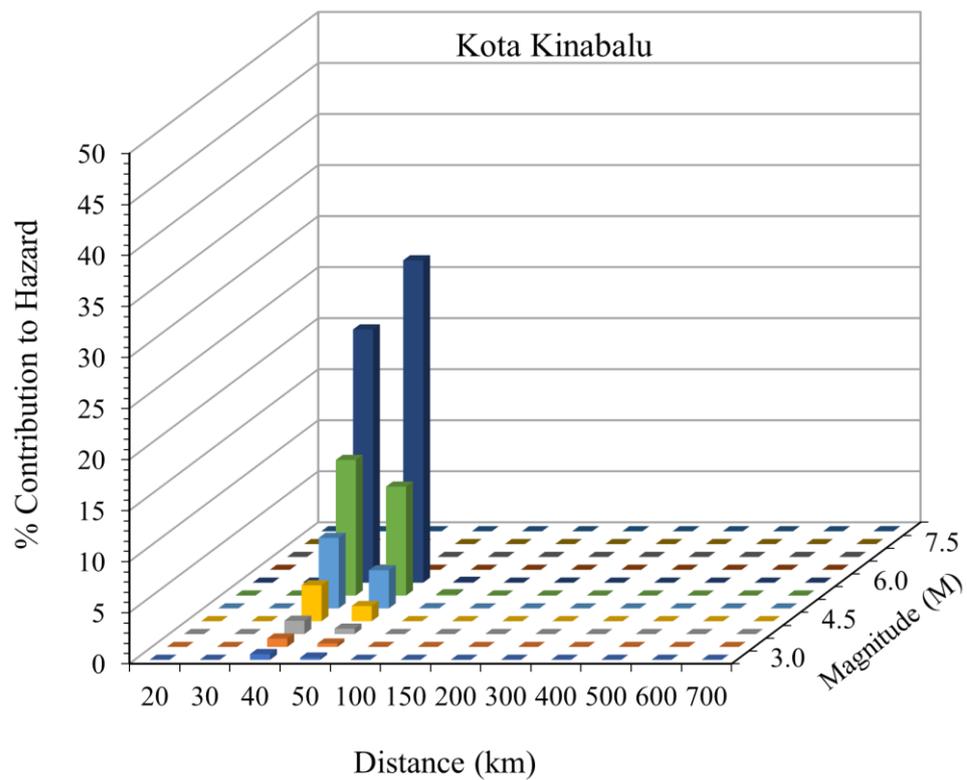
Figure 13. De-aggregation of the total seismic hazard of Kota Kinabalu in a 50-year design period of a 475-year return period, with a total discrete seismic hazard in terms of magnitude, distance bins, and percentage contribution to hazard.

Kota Kinabalu shows that moderate magnitudes ($>M 5.0$) at close proximity, in the range of 40–50 km earthquake sources, predictably affect the buildings. The contribution of this type of earthquake affecting the buildings is 25%. The de-aggregation analysis was carried out based on the previous earthquakes recorded within the area and performed using seismic hazard assessment with a 50-year design period and a 475-year return period, as illustrated in Figure 13.

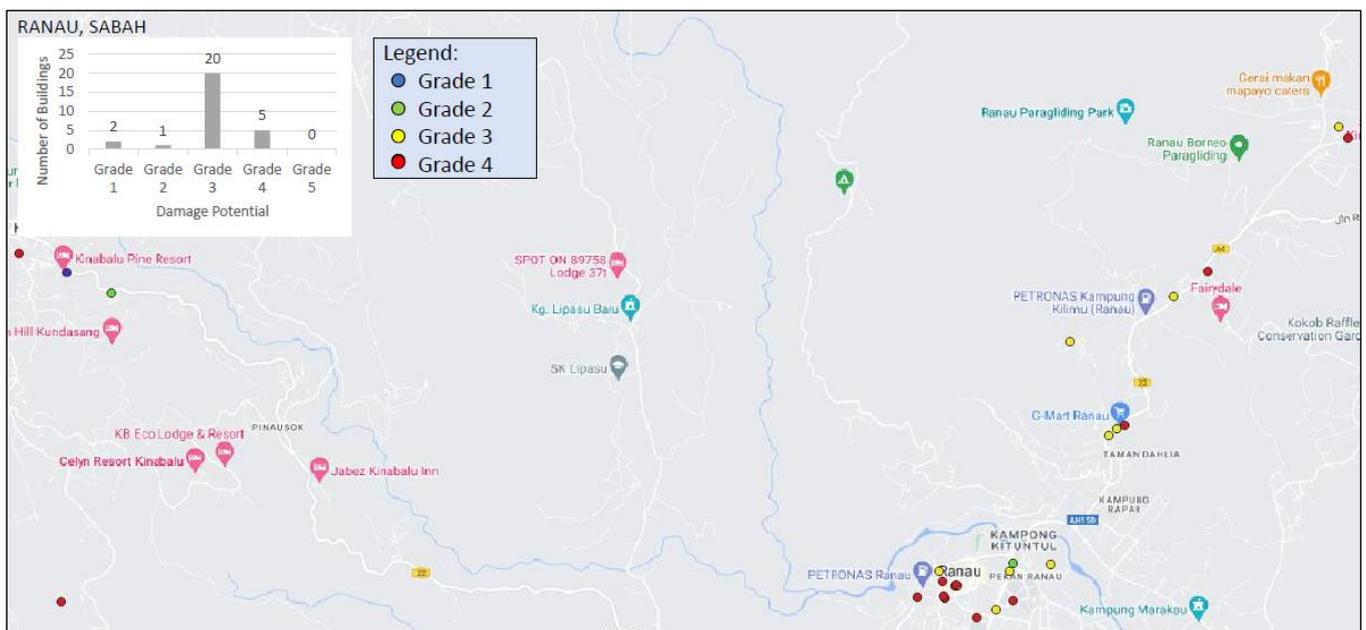
Figure 14. Building damage prediction in Ranau based on surveyed data under moderate earthquakes.

Based on the statistics for Ranau, given in Figure 14, Grade 3 damage was recorded as the highest value, with 20 out of 28 buildings. In addition, Grade 4 damage was recorded as the second highest number with five buildings, followed by Grade 1 with two buildings. Meanwhile, Grade 2 damage recorded the lowest value, with one building.

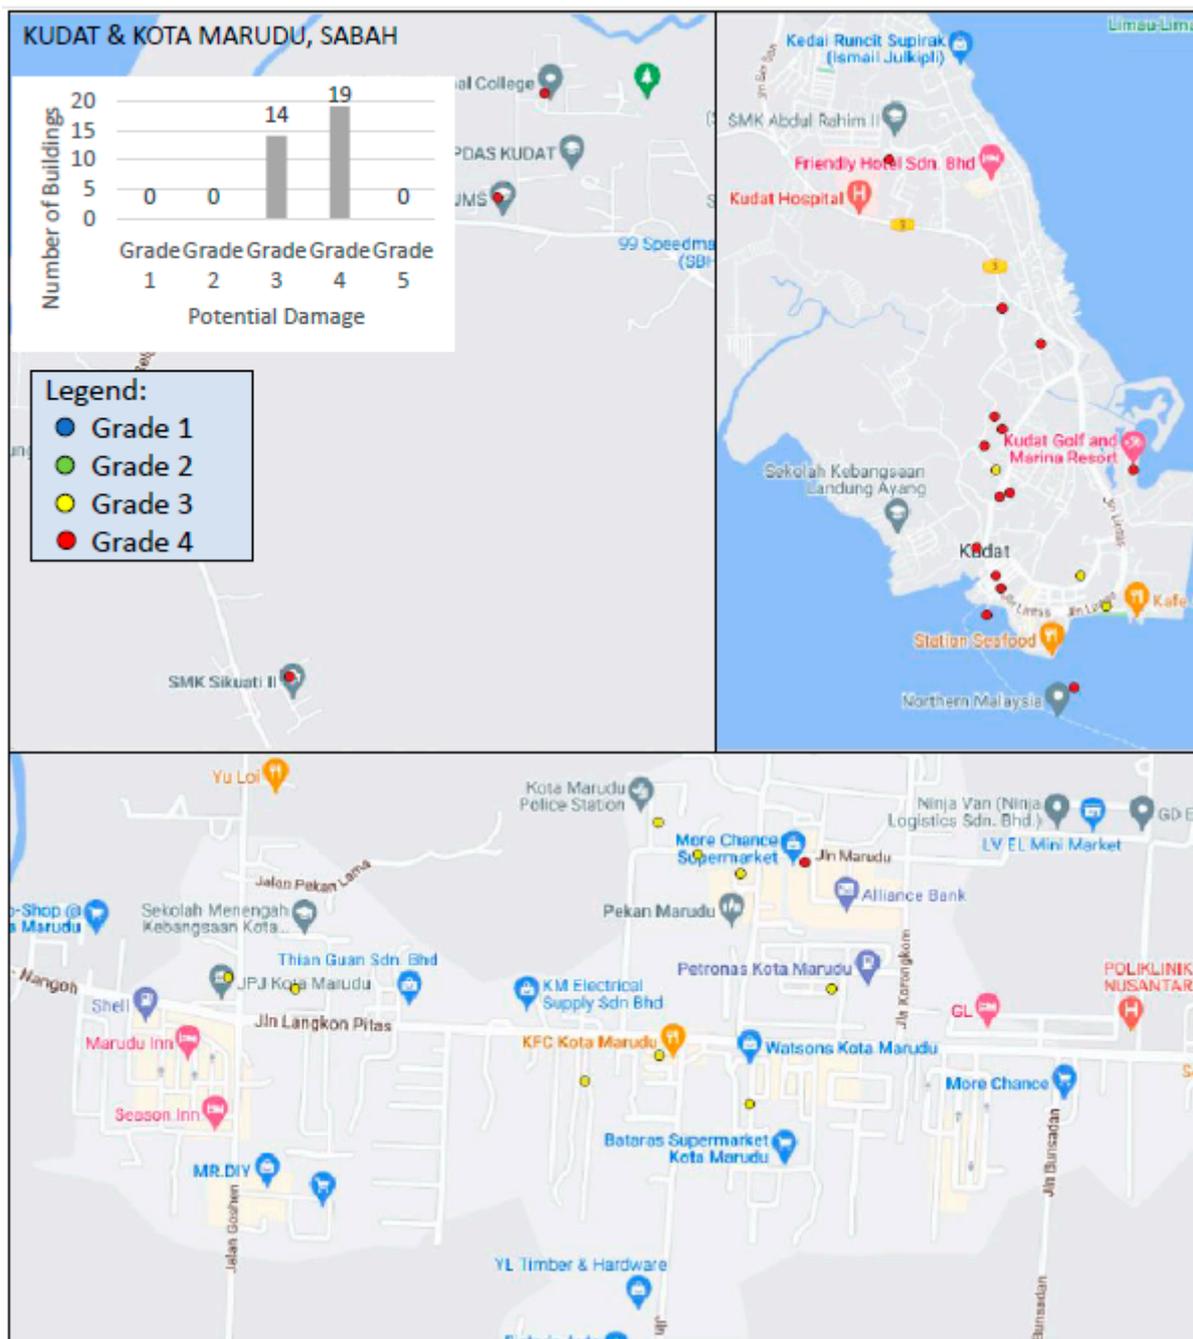
Figure 15. Building damage prediction in Kudat and Kota Marudu based on surveyed data under moderate earthquakes.

In the study areas of Kota Marudu and Kudat, there are a total of 33 buildings. The generated map of damage potential for structures in Kudat and Kota Marudu is shown in Figure 15. According to the data, most structures have a damage potential of Grade 4 (0.3 to 0.7), accounting for 57.6% of the total. Grade 3 damage potential has the second largest number of buildings (14). According to the research, no structures in the area have a Grade 1, 2, or 5 damage potential. The de-aggregation analysis on Kudat shows that small magnitude (<M 5.0), close proximity (20 km) sources tend to dominate the PGA hazard. Kota Marudu shows a moderate magnitude (>M 5.0) at close proximity (50 km) and sources tend to overlook the PGA hazard (Figure 16).

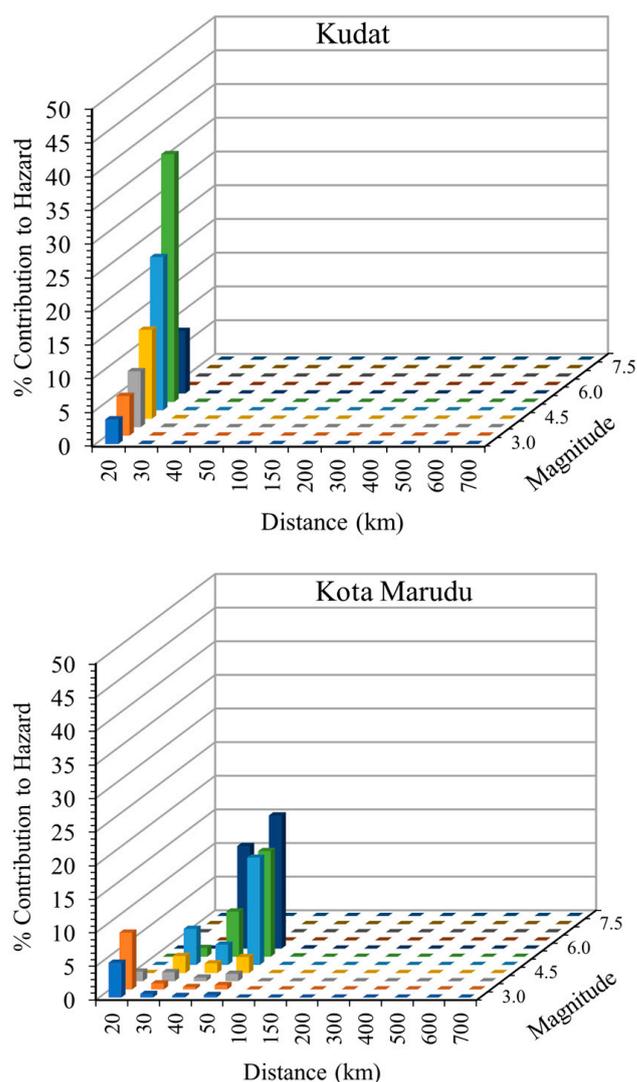
Figure 16. De-aggregation of the total seismic hazard of Kudat and Kota Marudu in a 50-year design period of a 475-year return period with total seismic hazard being discrete in magnitude, distance bins, and percentage contribution to hazard.

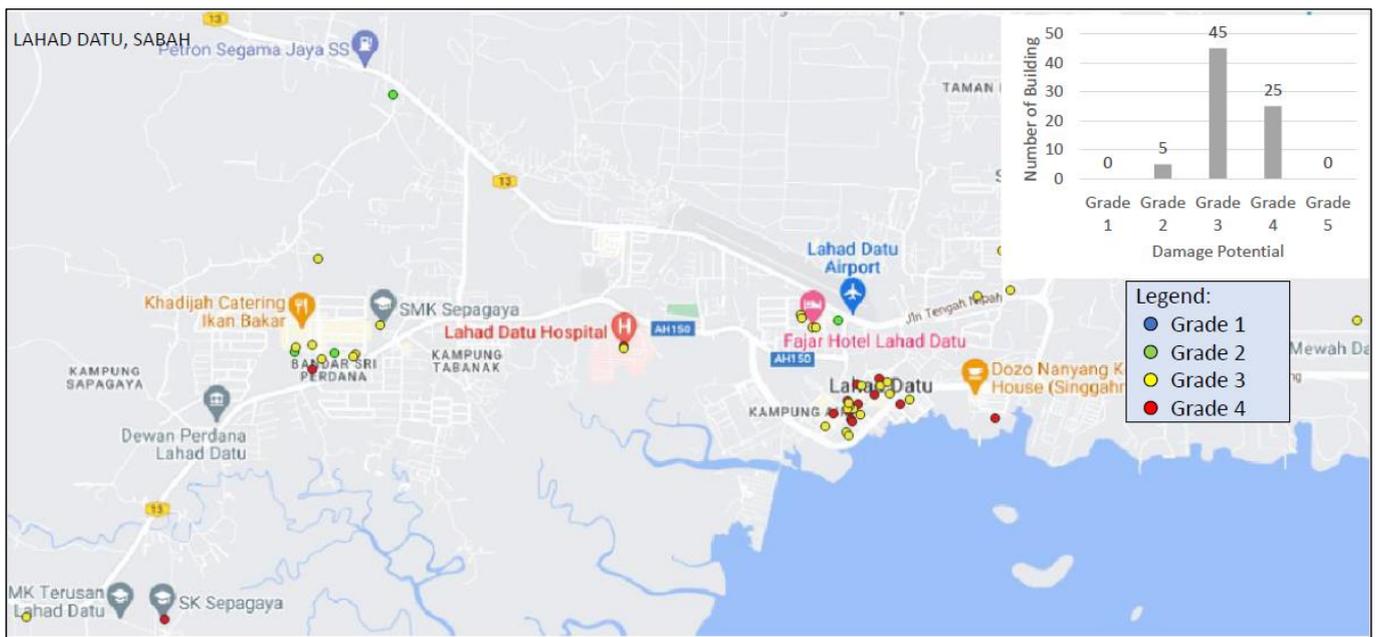
Figure 17. Building damage prediction in Lahad Datu based on surveyed data under moderate earthquakes.

Figures 17–19 represent maps of damage potential for buildings in Lahad Datu, Semporna, and Tawau, respectively. The total number of buildings in all three study areas is 236. Most structures acquired a final score of 0.7 to 2.0, indicating Grade 3 damage potential. The distribution for the buildings with Grade 3 is 60%, 51%, and 64.3% for Lahad Datu, Semporna, and Tawau, respectively. Meanwhile, Grade 4 damage potential was recorded as the second highest value, with 33.3% in analyses in Lahad Datu, 36.7% for buildings in Semporna, and 19.6% for Tawau. The overall number of buildings with Grade 2 damage is five for Lahad Datu, six buildings for Semporna, and 18 structures for Tawau. This grade was recorded as the lowest in all three districts. Grade 1 damage potential contributes 0%, as none of the examined buildings in those three locations received a score higher than 3.0. The de-aggregation analysis on Semporna (Figure 20) shows moderate magnitude ($>M 5.0$) at close proximity (30–40 km) and high magnitude ($M 6.0$ – 7.0) at long distance (400 km) sources tending to dominate the PGA hazard. The de-aggregation analysis on Tawau shows small magnitude ($<M 5.0$) at close proximity (10–30 km) sources tending to dominate the PGA hazard (Figure 21).

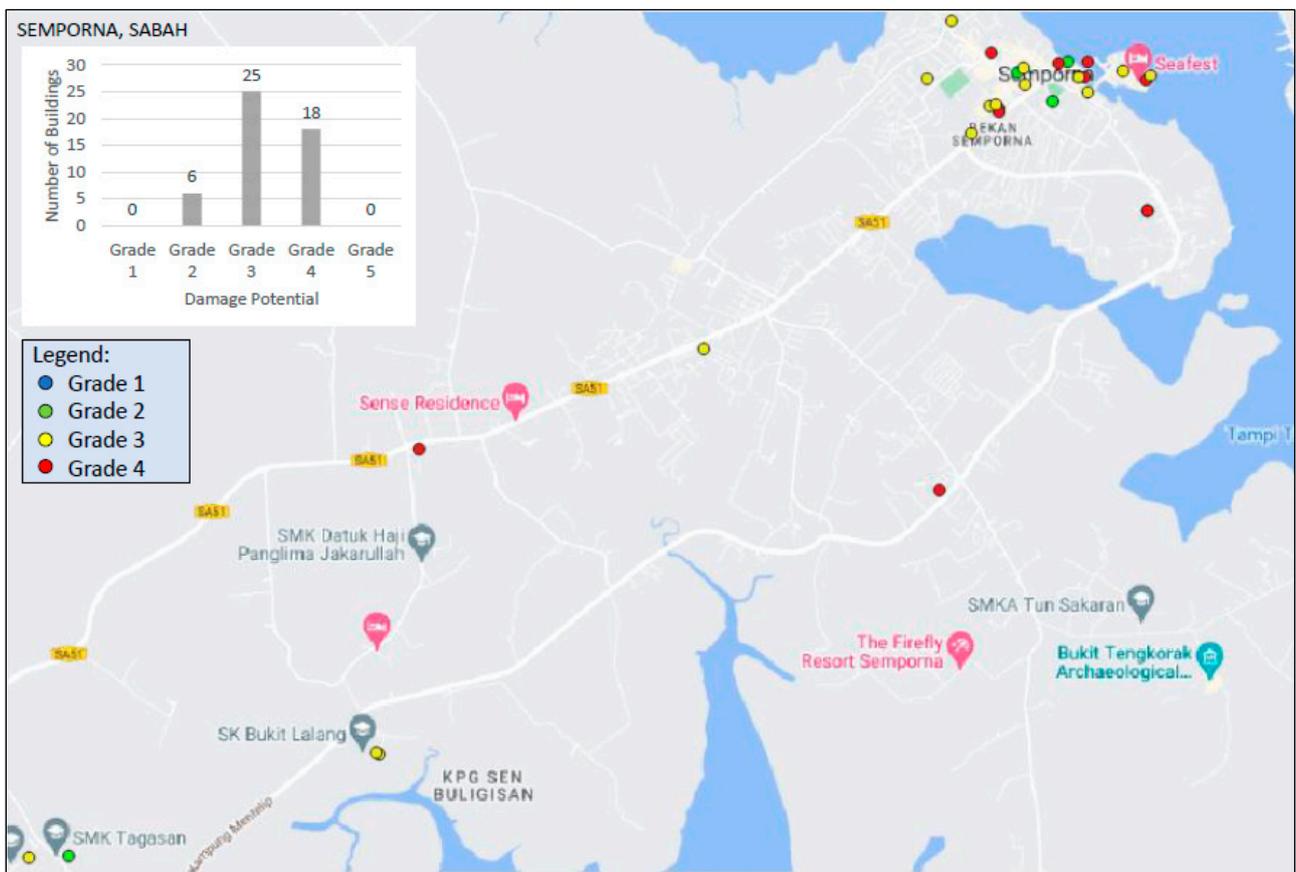
Figure 18. Building damage prediction in Semporna based on surveyed data under moderate earthquakes.
