Damage Prediction Observation for Existing Buildings in Sabah under Moderate Risk Earthquakes

Abstract: Seismic design in building construction is still new in Malaysia. Sabah, a Malaysian state, is situated southeast of the Eurasian Plate, between the highly active Philippine Sea Plate and Indo-Australian Plate, and has a history of earthquakes, with the largest measuring a magnitude of 6.3 (2015). Although small earthquakes occur annually, most old buildings in Sabah were built pre-code and designed without considering earthquake loadings. This study aimed to analyze the potential damage to buildings in Sabah based on their vulnerability to moderate earthquakes. More than 500 buildings in seven districts were evaluated using a quantitative method based on score assignment, within 100 kilometers of the epicenters. According to the findings, more than 160 buildings in the Kota Kinabalu and Kudat districts were assessed as vulnerable to Grade 4 damage. In Ranau, Kota Marudu, Tawau, Semporna, and Lahad Datu, most buildings had a Grade 3 damage potential, with some at Grade 2 or 4. This study's findings provide a summary of the damage risk for structures in Sabah and offer a starting

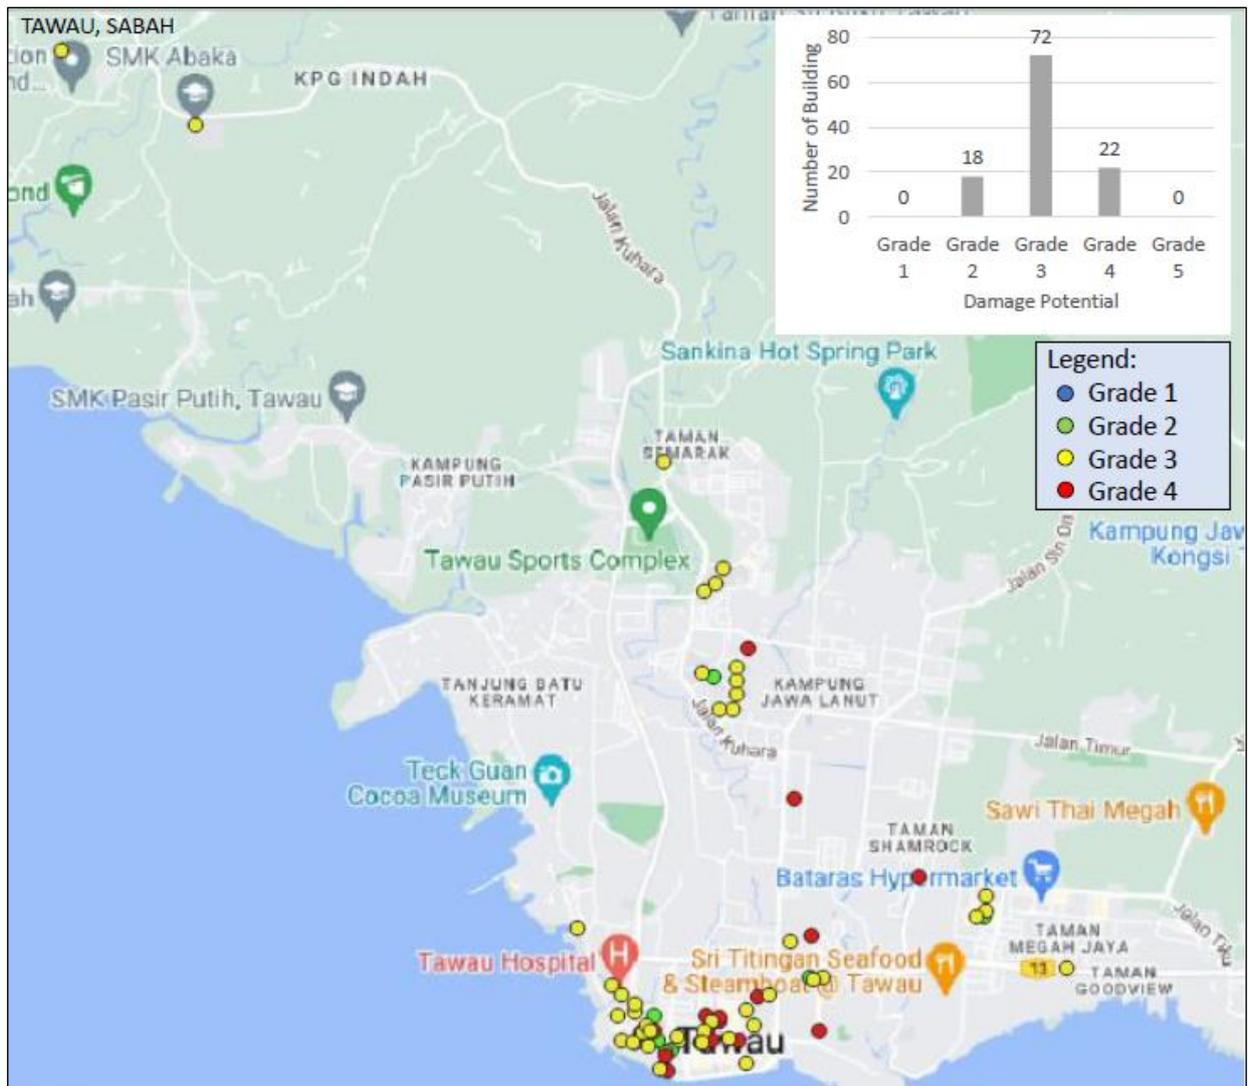
Figure 19. Building damage prediction in Tawau based on surveyed data under moderate earthquakes.

Figures 17–19 represent maps of damage potential for buildings in Lahad Datu, Semporna, and Tawau, respectively. The total number of buildings in all three study areas is 236. Most structures acquired a final score of 0.7 to 2.0, indicating Grade 3 damage potential. The distribution for the buildings with Grade 3 is 60%, 51%, and 64.3% for Lahad Datu, Semporna, and Tawau, respectively. Meanwhile, Grade 4 damage potential was recorded as the second highest value, with 33.3% in analyses in Lahad Datu, 36.7% for buildings in Semporna, and 19.6% for Tawau. The overall number of buildings with Grade 2 damage is five for Lahad Datu, six buildings for Semporna, and 18 structures for Tawau. This grade was recorded as the lowest in all three districts. Grade 1 damage potential contributes 0%, as none of the examined buildings in those three locations received a score higher than 3.0. The de-aggregation analysis on Semporna (Figure 20) shows moderate magnitude ($>M 5.0$) at close proximity (30–40 km) and high magnitude ($M 6.0$ – 7.0) at long distance (400 km) sources tending to dominate the PGA hazard. The de-aggregation analysis on Tawau shows small magnitude ($<M 5.0$) at close proximity (10–30 km) sources tending to dominate the PGA hazard (Figure 21).

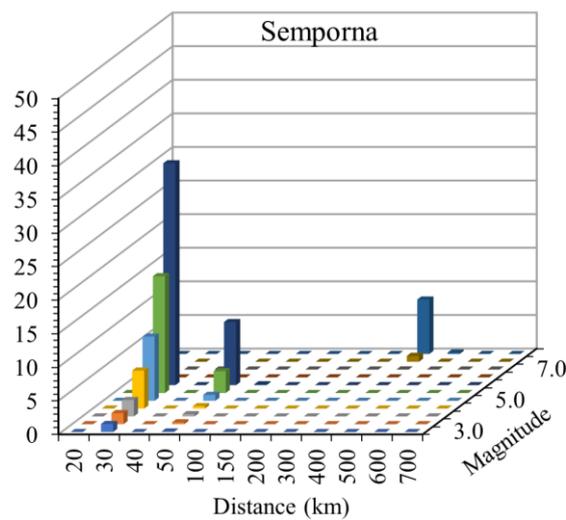
Figure 20. De-aggregation of the total seismic hazard of Semporna in a 50-year design period of 475-year return period with total seismic hazard being discrete in terms of magnitude, distance bins, and percentage contribution to hazard.

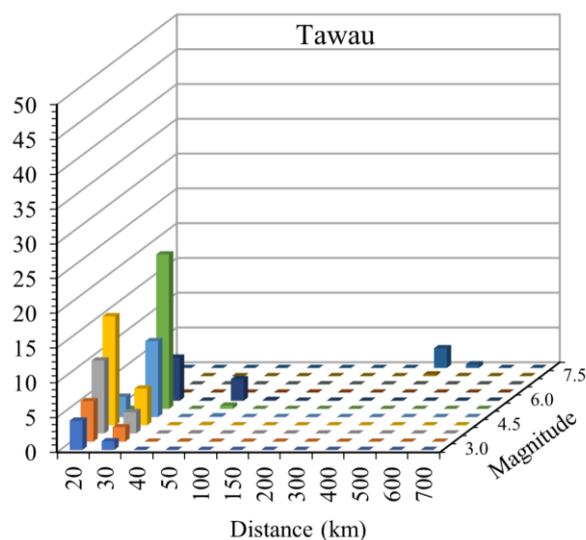
Figure 21. De-aggregation of the total seismic hazard of Tawau in a 50-year design period of a 475-year return period with total seismic hazard being discrete in terms of magnitude, distance bins, and percentage contribution to hazard.
