# An Improved Anchorage System for L-Shaped FRP Composites to Enhance the Seismic Response of Beam-Column Joints in a Low-Strength Substandard Reinforced Concrete (RC) Frame

**Abstract:** Reinforced concrete buildings are prone to collapse during seismic events due to the brittle shear failure of non-seismic beam-column joints (BCJ). In this study, two one-third scale reinforced concrete (RC) frames incorporating various non-seismic details were tested under lateral cyclic loading. One of the RC frames was used as control, while the other was strengthened using externally bonded carbon-fiber-reinforced polymer (CFRP) sheets in a L-Shaped configuration with particular attention to anchorage to evade debonding. For the strengthening process, L-shaped CFRP sheets were bonded to the inner face of columns, extended on beams both above and below the joint up to a hinge length. To avert debonding, the L-shaped CFRP sheets were fully wrapped with CFRP sheets around the column, both near the joint and at the end of the sheet. The sheets were also wrapped around the beam, through two slots in the slab that were adjacent to the beam-column interface and at the far end of the sheet. Test resu

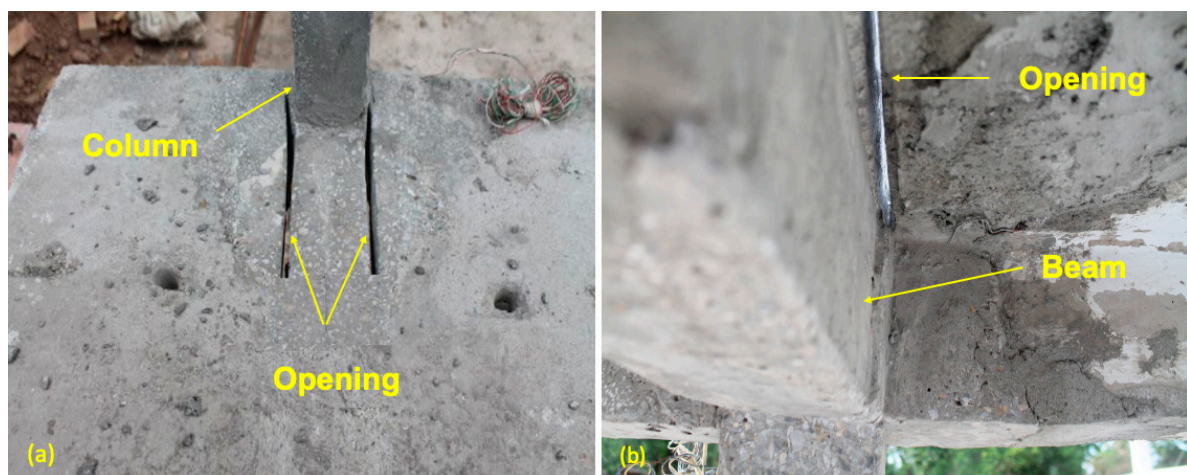
To assess the effectiveness of L-shaped CFRP sheets (LCS), only the BCJ of the ground floor slab was strengthened with LCS. To avoid debonding of the FRP composites, which is most likely to occur at the beam–column interface [24,47], a narrow opening in the slab adjacent to the beam along with complete wrapping around the L-shaped FRP sheets were proposed. The ACI 440.2R also suggests the superior performance of a complete wrapping around the perimeter of the strengthened section [51]. A narrow opening (300 mm long  $\times$  8 mm wide), in a ground floor slab adjacent to the beam-column interface and extending to the far end, where the L-shaped CFRP sheet terminates, was produced by a machine grinder with a steel disc, as shown in Figure 4. These slots were made flush to the beam on both sides.

**Figure 4.** Opening in slab for aiding complete wrapping, (a) above joint and (b) below joint.

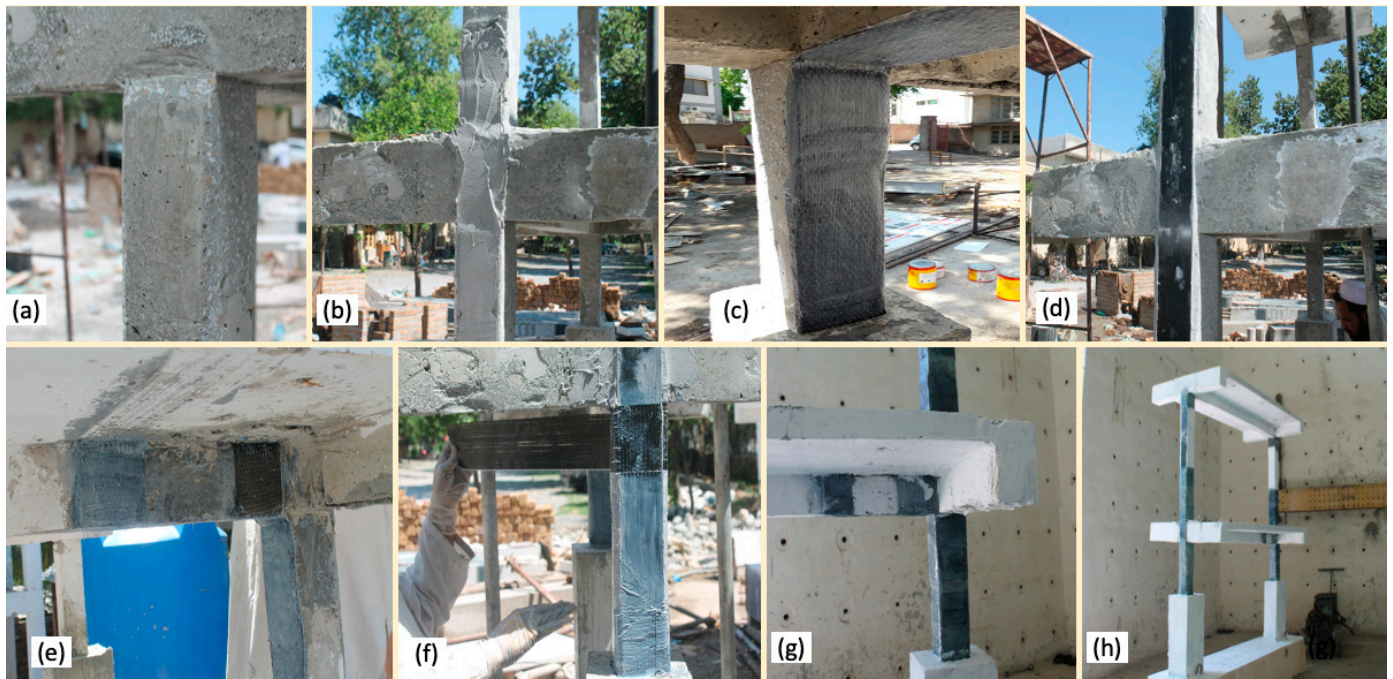
Once the proposed openings were incorporated, the concrete substrate (surface) was smoothed by a harsh sandpaper disc mounted on a grinder machine. Subsequently, all the sharp edges of beams and columns were rounded by a radius of 15 mm, as recommended, to elude stress concentration in wrapping sheets [51]. Afterwards, a Sikadur-30 LP adhesive was applied on the external face to bond the CFRP laminates, and Sikadur-330 primer resin was applied on the internal faces to bond the LCS to the concrete substrate. Upon applying the adhesives, the initial layer of the LCS was placed both above and below the joints. Subsequently, primer resin was applied to facilitate the curing process. Meanwhile, the CFRP laminates were bonded to the outer face of the columns. Afterwards, the second layer of the LCS was applied in the respective locations. Finally, for anchorage, the CFRP sheets (50 mm wide) were wrapped around the proposed locations. More specifically, the CFRP was initially cut to the required length (twice the perimeter plus the depth of the beam). The CFRP sheet was applied around the beam, through the openings starting from the lower corner of the beam's side and finishing at the top of the same side. In order to avoid premature failure of the FRP fabric at the concrete corners, the concrete surface of the beam at the slot was rounded using a grinder to a 15 mm radius. A detailed view of the systematic application of the proposed FRP scheme is shown in Figure 6.

**Figure 6.** FRP application procedure (a) smooth concrete surface, (b) adhesive applied on the surface, (c) LCS installed, (d) CFRP laminate on the outer face of the column, (e) complete wrapping below joint, (f) complete wrapping around column, (g) view of strengthened joint, and (h) complete FRP strengthening scheme.

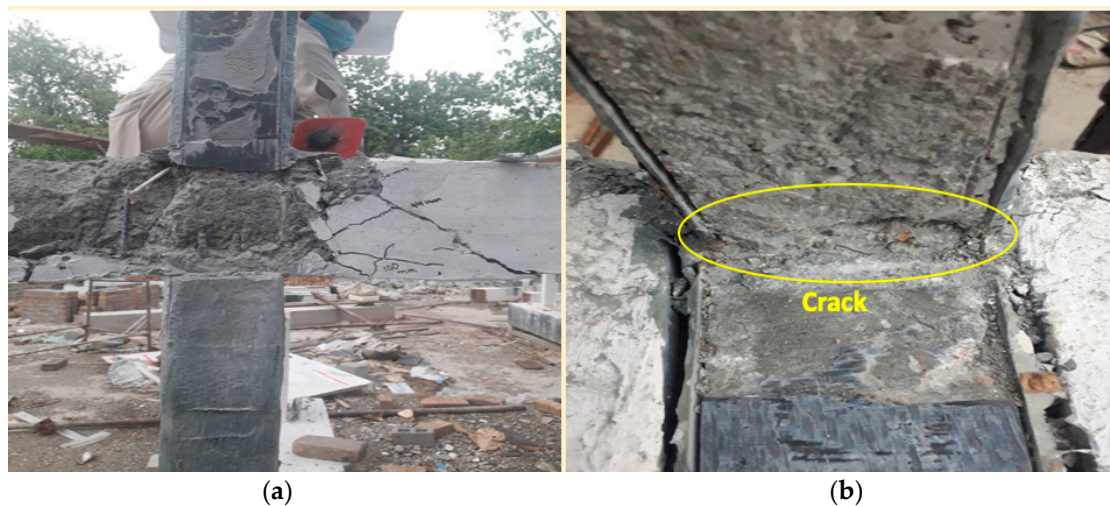
After the test, the LCS and laminates were removed to inspect damages in the concrete at joints, columns, and beams. No damage appeared in the concrete core of the joint, as seen in Figure 11a. However, a crack was observed at the top interface of beam–column joints, as seen in Figure 11b. Moreover, the column’s flexural cracking was eliminated in the strengthened frame. This further justified the superior performance of the L-shaped CFRP configuration.

**Figure 11.** Undamaged concrete, (a) in joint covered by CFRP laminate, and (b) above joint covered by L-shaped CFRP sheets.

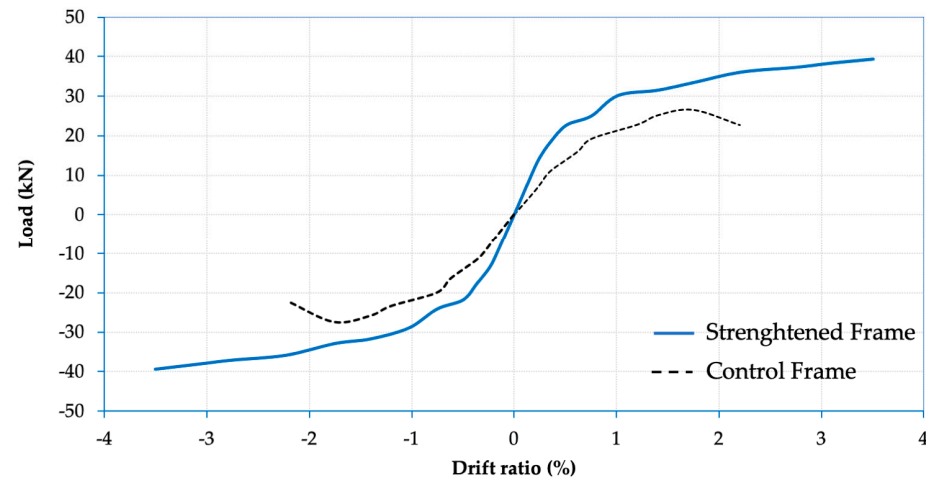
The force-displacement envelope curves of the control and strengthened test frames are shown in Figure 13. It can be inferred that the LCS successfully enhanced the lateral

load-carrying capacity of the strengthened test frame by 45% compared to the control test frame. Moreover, the application of the LCS significantly increased the initial stiffness of the strengthened test frame. Moreover, the peak loads, ultimate loads, and the corresponding drift ratio of the test frames are summarized in Table 4.

Figure 13. Comparison of force vs. displacement envelope curves.
