Article

Corrosion Performance of Buried Corrugated Galvanized Steel under Accelerated Wetting/Drying Cyclic Corrosion Test

Abstract: Rehabilitation of corroded buried galvanized steel structures, including corrugated metal culverts (CMCs) and pipes (CMPs), requires a deep understanding of the corrosion process and the corresponding deterioration. The current paper describes an accelerated laboratory corrosion test of corrugated galvanized steel coupons exposed to sequenced wetting/drying cycles ranging from 50 and up to 1600 cycles. The analysis demonstrates the influence of applying an increased number of wetting/drying cycles on the acceleration of the developed corrosion in the buried galvanized steel coupons. The study examines changes in the steel geometry represented by thickness loss and the accompanied deterioration of the mechanical properties such as tensile strength, hardness, and ductility over relatively short periods of time. It was observed that corrosion was insignificant as long as the zinc coating of the galvanized steel lasted. However, when the zinc was almost fully depleted, the bare steel was directly subjected to the surrounding corrosive environment, causi

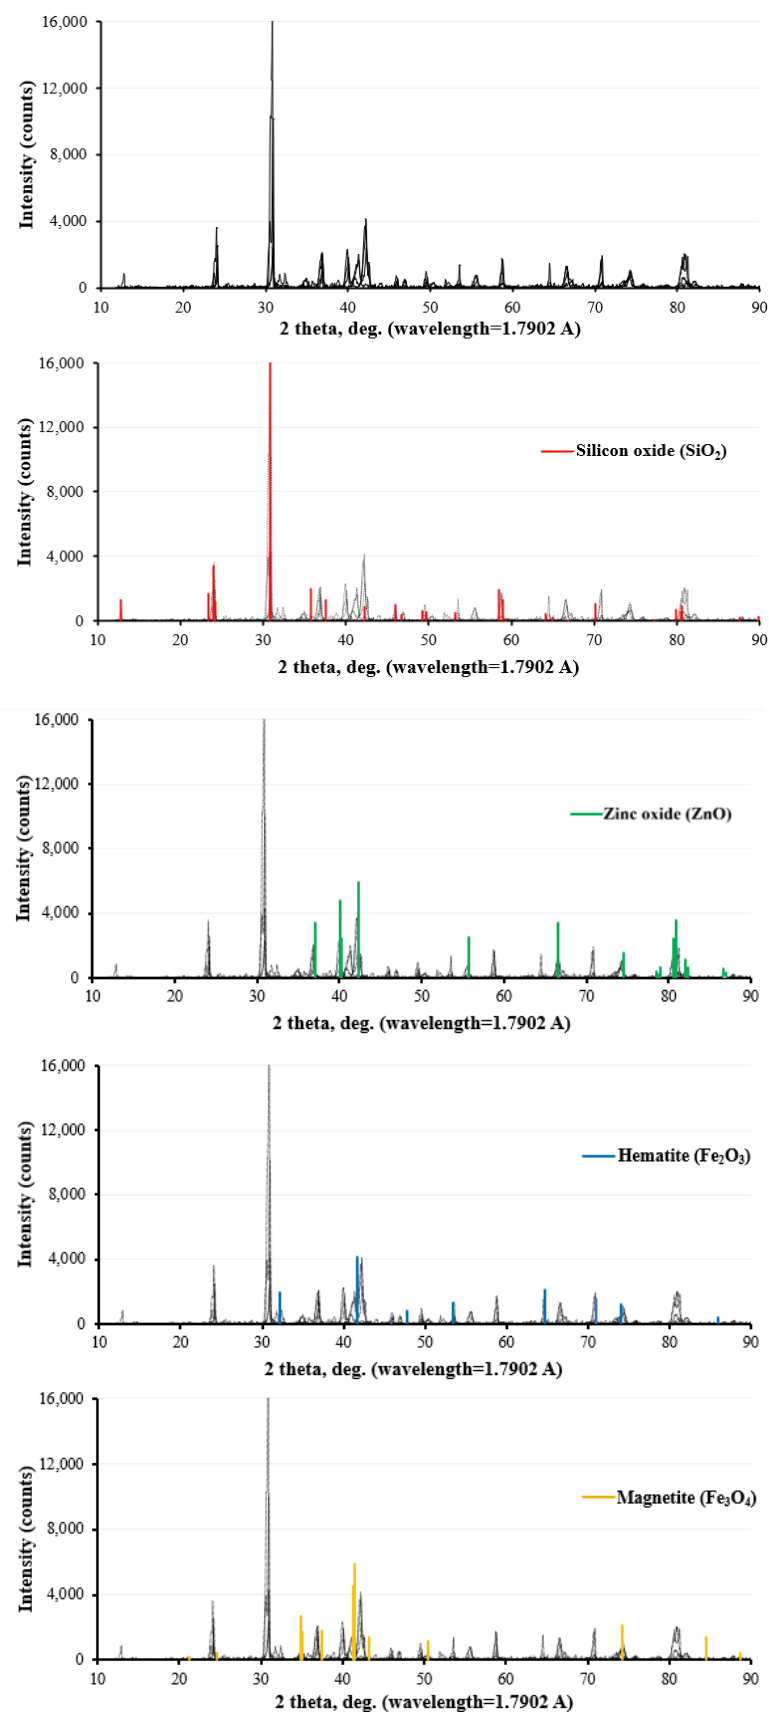
Figure 6. X-ray diffraction (XRD) patterns (intensity) indicating corrosion products propagated on the candidate corroded galvanized steel coupons.

As exhibited in Figure 6, based on the results of the XRD analysis, the corrosion products obtained from the galvanized steel coupons included silicon oxide (quartz) (SiO_2), zinc oxide (ZnO) (see Equations (1) to (10) below), magnetite (Fe_3O_4) (see Equation (11) below), and hematite (Fe_2O_3) (see Equations (12) to (16) below). In addition, forms of iron oxyhydroxides (FeOOH) such as akageneite ($\beta\text{-FeOOH}$) and lepidocrocite ($\gamma\text{-FeOOH}$) were hardly observed. The formation of quartz and zinc oxide was observed in the corrosion products of almost all the candidate galvanized steel coupons. The existence of quartz can be attributed to the cohesionless granular sandy soil used to bury these coupons, and to the stickiness of the sand particles at the coupon's surface during the corrosion test wetting/drying cycles. In contrast, zinc oxide developed due to depletion of the zinc coating layer during the corrosion test, until the zinc coating was almost fully depleted at around 200 wetting/drying cycles. The corrosion of the zinc coating layer began with the dissolution of zinc at the anodic zone in an aqueous solution based on three different intermediates (see Equations (1) to (8)) followed by an oxygen reduction reaction at the cathodic zone (see Equation (9)). Then, the initial rust layer develops by the reaction of OH^- and Zn^{2+} (see Equation (10) for the overall reaction) [44,45].

Following 400 wetting/drying cycles, the formation of magnetite and hematite was observed in the XRD analysis. The XRD analysis results are also supported by the appearance of the corroded coupons shown in Figure 3a. For the coupons exposed to 50, 100, and 200 wetting/drying cycles, the white color represents zinc oxide, and the yellow-white color represents quartz (silicon oxide). Moreover, for the coupons exposed to 400, 800, and 1600 wetting/drying cycles, the dark black rust corresponds to magnetite, and the reddish-brown rust corresponds to hematite, as discussed in the previous literature [6,46]. The formation of black magnetite corrosion products is usually associated with a lower oxygen environment, which may have occurred in the conducted accelerated wetting/drying corrosion test due to a decrease in dissolved oxygen over time, caused during the drying stages under high temperatures. Moreover, variations in the dissolved oxygen content could also occur at different spots due to compaction of the cohesionless sandy soil above each coupon. A lower concentration of dissolved oxygen could arise particularly in highly densified soil zones, because of the reduced volume of voids following soil compaction. In contrast, the presence of hematite could result from the periodic remixing and recompacting

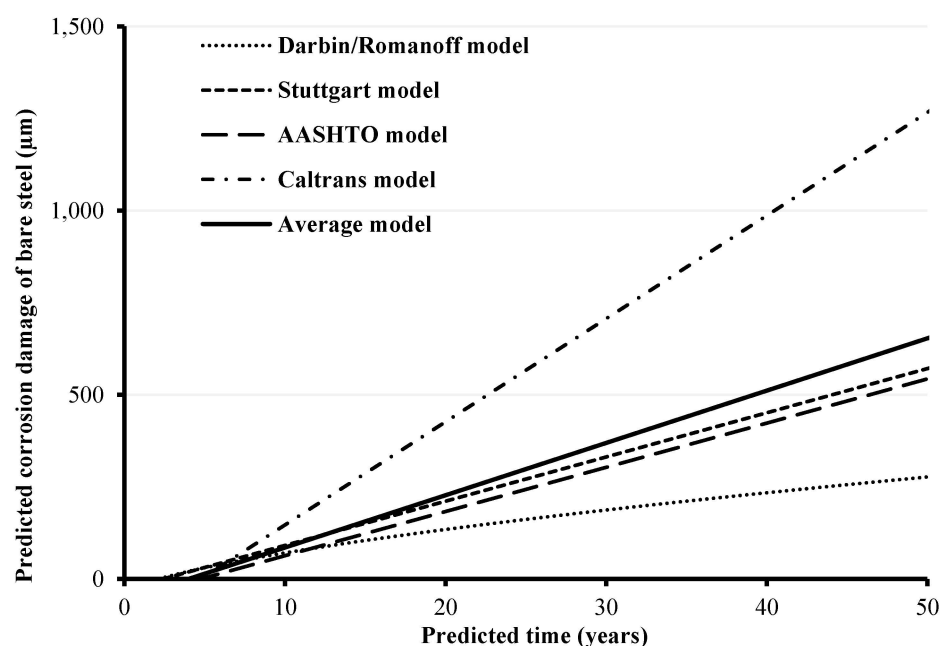
Figure 11. Corrosion damage predictions for the bare steel in the galvanized coupons.

When used to predict the corrosion time (in years) of the bare steel utilized in this study, these formulas yielded various results, as illustrated in Figure 11. Therefore, a simplified

prediction model was developed according to the average predictions of the four considered prediction models. The simplified developed model is presented in Equation (22).

* The total zinc depletion time can be taken as approximately 4 years, based on the average prediction model shown in Equation (22) and Figure 11.
