Investigation of the Causes of Soft-Storey and Weak-Storey Formations in Low- and Mid-Rise RC Buildings in Türkiye

Abstract: This study investigates the causes of soft-storey and weak-storey formations in low- and mid-rise RC (Reinforced Concrete) buildings in Türkiye. In the first phase of the study, 96 model buildings were designated for the examination of soft-storey irregularity when the ground floors are used for commercial purposes and the upper floors for residential use. The ground floor heights that would cause soft-storey irregularity in each of the selected buildings were determined according to the formulas given in the Türkiye Building Earthquake Code (TBEC) and the American Society of Civil Engineers Standard (ASCE). It was found that the ground floor heights obtained according to ASCE are usable in practice, whereas those obtained according to the TBEC, particularly for buildings over three storeys, are excessively high for practical use. This indicates that, even if the buildings in Türkiye are designed with very high ground floor heights, they do not have soft-storey irregularities, according to the TBEC, but soft-storey formation may occur in these buildings due

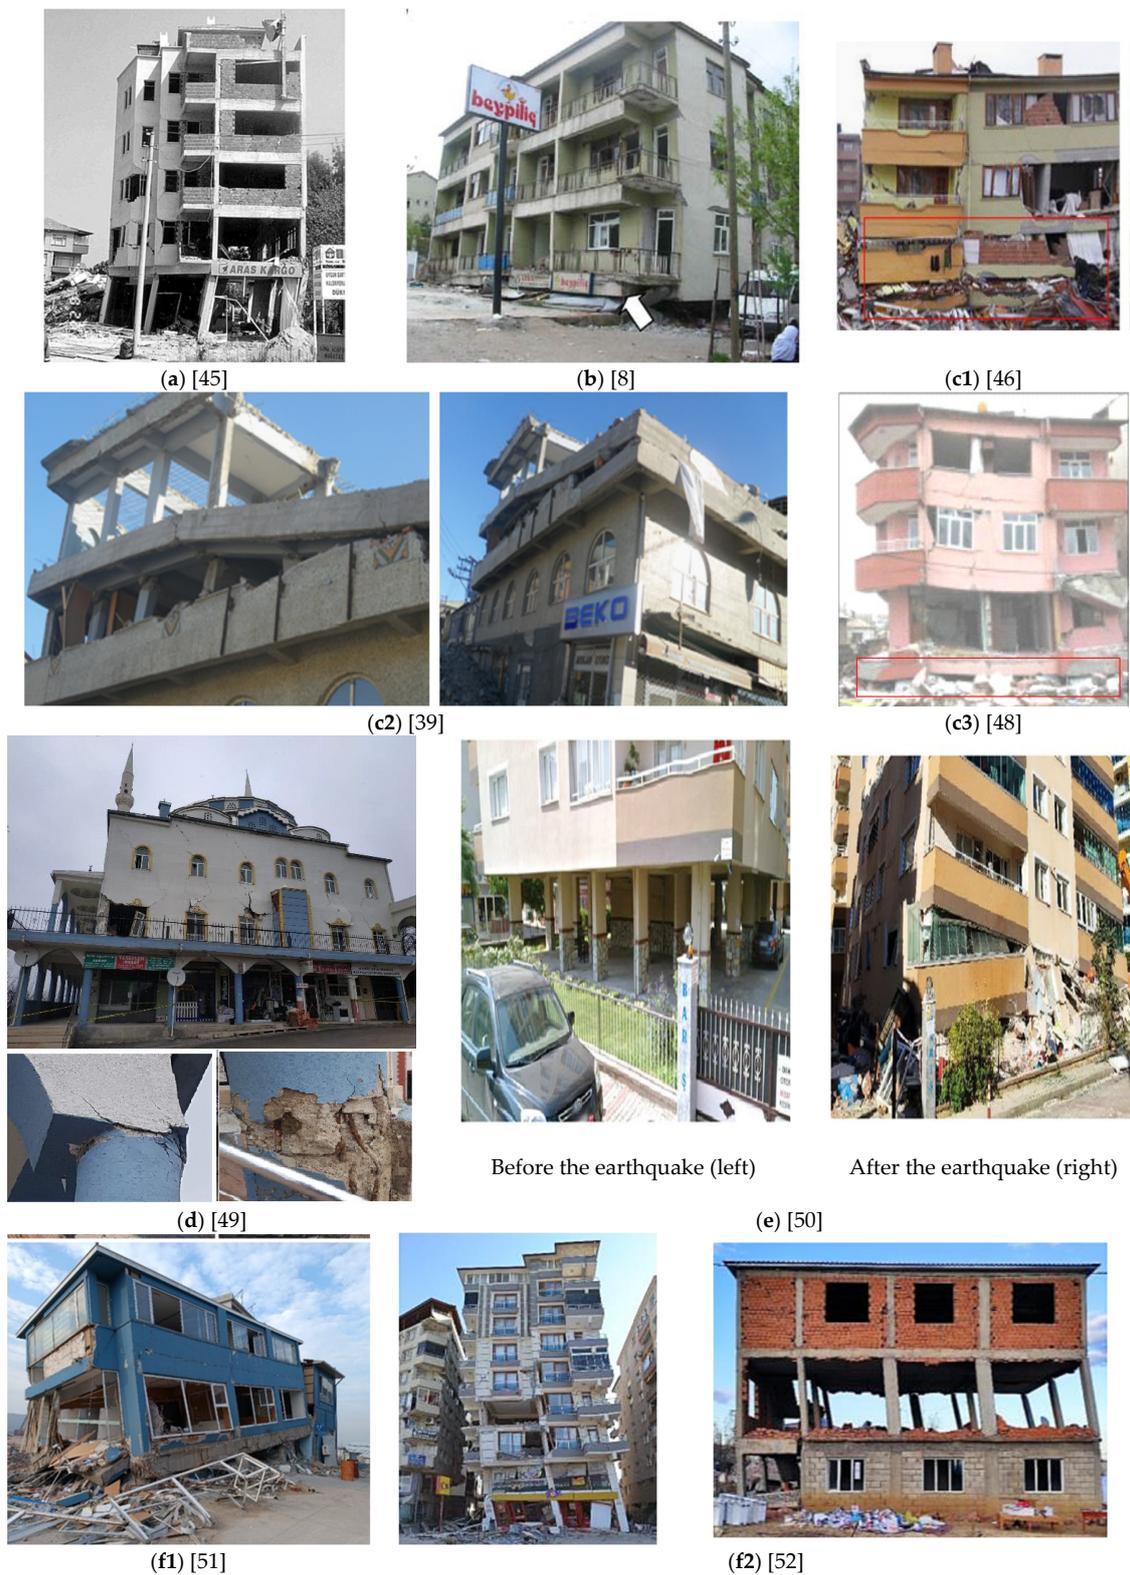
Figure 1. Damages and collapses observed in some buildings with weak- and/or soft-storey formation: (a) 17 August 1999 Kocaeli earthquake [45]; (b) 1 May 2003 Bingöl earthquake [8]; (c1–c3) 23 October 2011 Van earthquake [39,46,48]; (d) 24 January 2020 Sivrice earthquake [49]; (e) 30 October 2020 izmir Earthquake [50]; (f1,f2) 6 February 2023 Kahramanmaraş earthquake [51,52].

soft or weak-storey behaviour [8,43–45]. Soft-storey formation is caused by the difference in stiffness between neighbouring storeys. The difference in stiffness between neighbouring storeys causes different amounts of displacement in the storeys due to lateral loads. If the ratio of drift between the storeys is too high, the building cannot cope with lateral forces. Weak-storey formation is caused by the difference in strength between neighbouring storeys. The strength of a storey is obtained by summing the cross-sectional areas of the load-bearing elements. According to TBEC, 15% of the cross-sectional area of the infill walls is taken into account in the calculation of weak-storey irregularity. Since the cross-sectional areas of columns and shear walls generally do not change between storeys in low- and mid-rise RC buildings, the difference in the amount of infill walls between neighbouring storeys may cause weak-storey irregularity in such buildings. It is necessary to avoid sudden changes in lateral stiffness and strength, since a large difference in stiffness or strength between storeys will prevent the building from moving as a whole [8,46,47]. Kirac et al. [41] reported that 78% of a group of 300,000 buildings in Türkiye had soft- or weak-storey configurations and that 725 out of 1215 RC buildings were damaged due to weak-storey configurations during the 1999 İzmit earthquake. Some of the damages or collapses caused by soft or weak-storey formations due to major earthquakes in Türkiye in the last 25 years are shown in Figure 1.

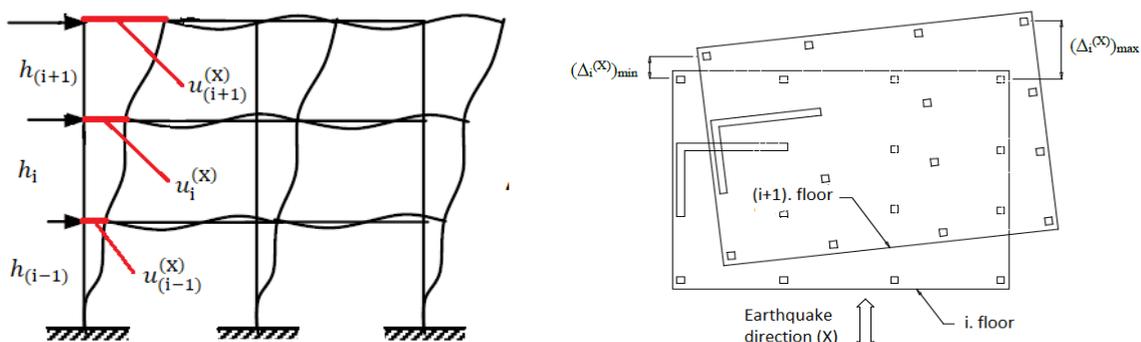
Figure 2. Obtaining the relative storey drift.

In Equation (3), $u_i^{(X)}$ denotes the total displacement of the i -th floor. The terms given in Equations (2) and (3) are illustrated in Figure 2.

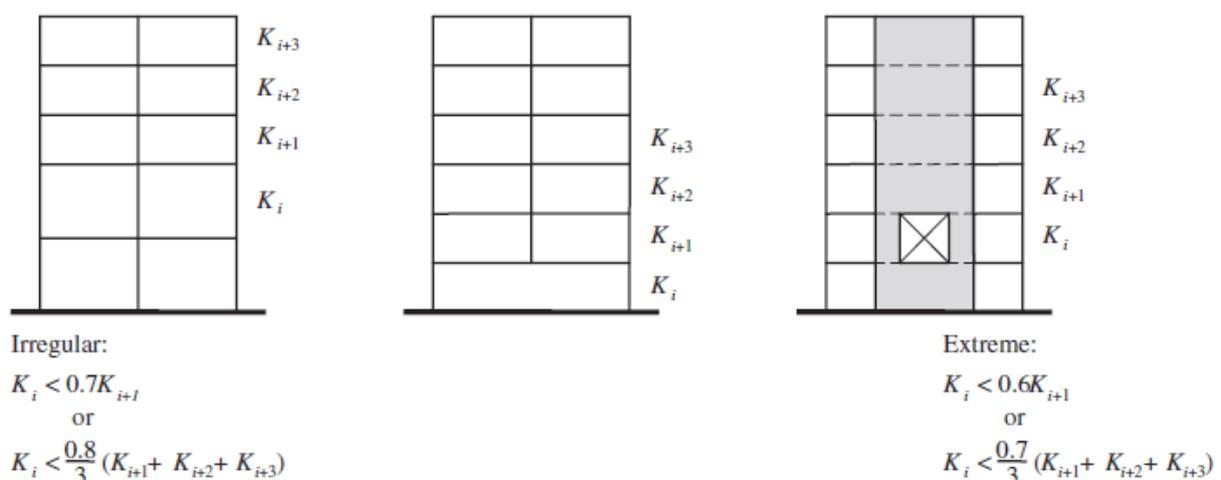
Figure 3. Soft-storey definition in ASCE [57].

The terms in Equations (4) and (5) are schematized in Figure 3.

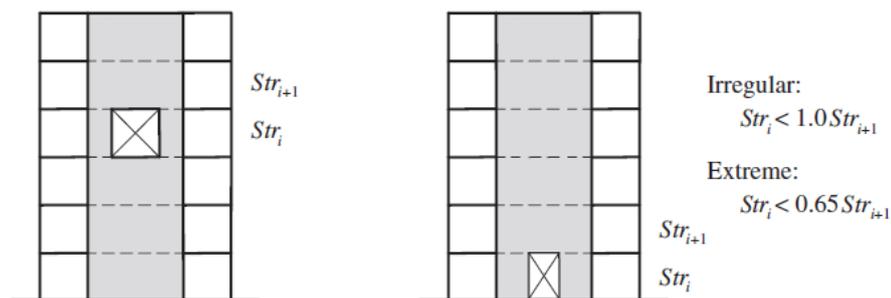
Figure 4. Weak-storey definition in ASCE [57].

The details and terminologies outlined in Equations (9) and (10) are illustrated in Figure 4.

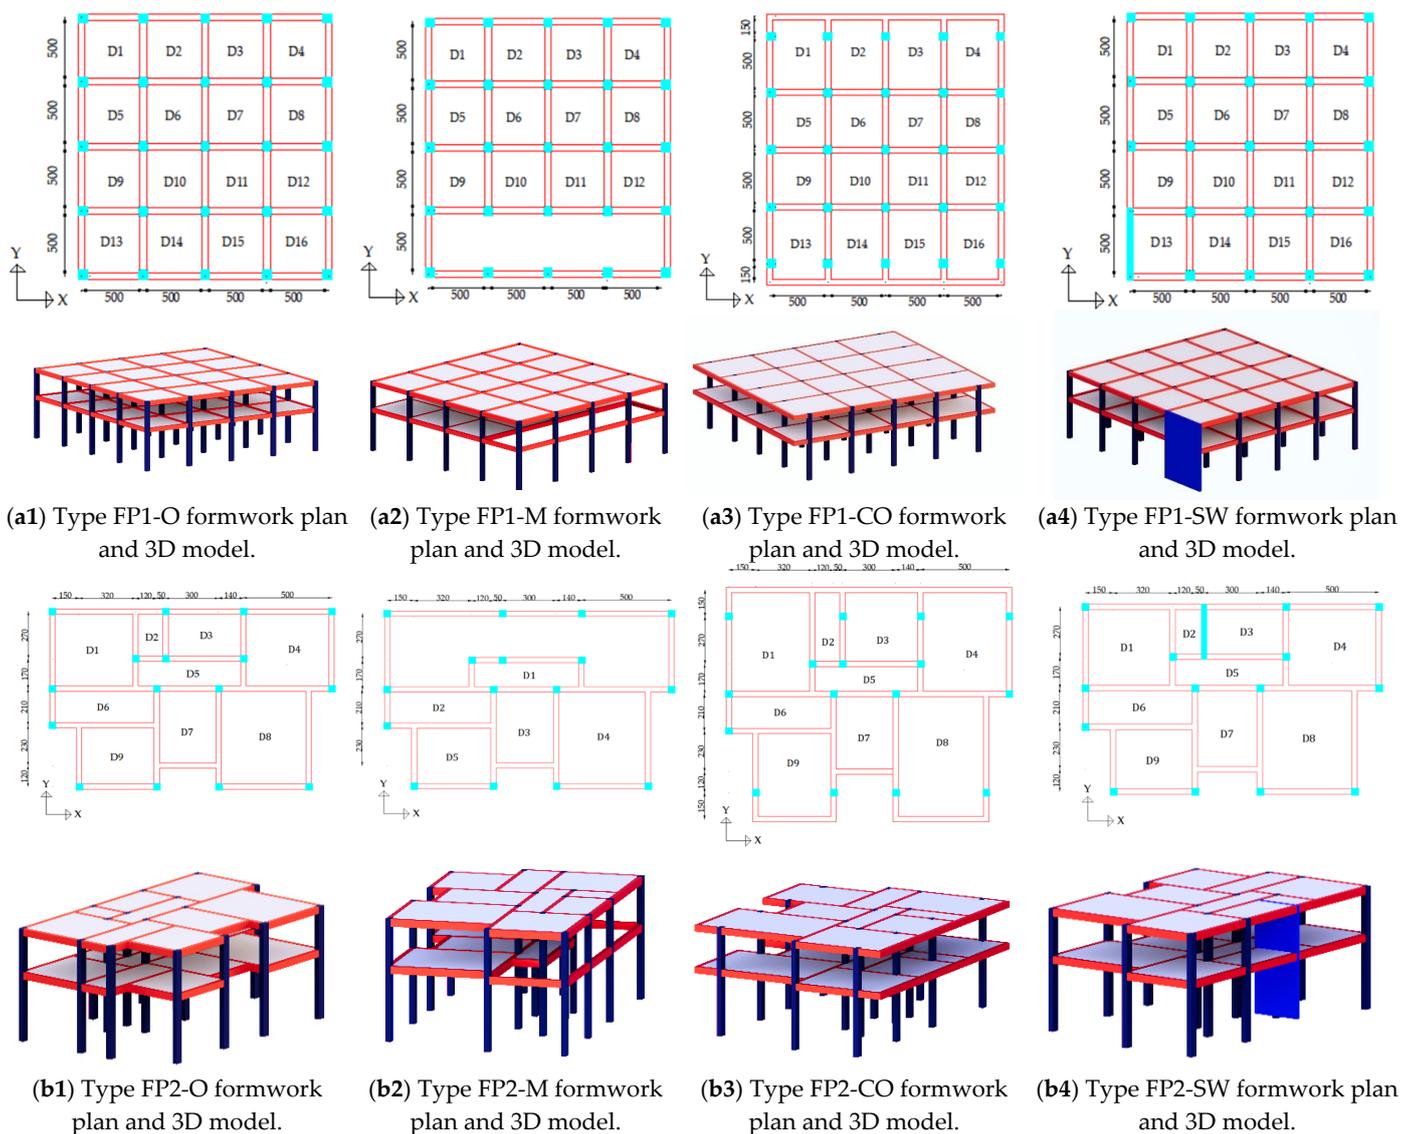
Figure 5. Selected formwork plans and 3D model illustrations (units in cm).

The study encompasses eight types of formwork plans with commercial ground floors and residential upper floors. The characteristics of these buildings are presented in Table 2, and their formwork plans and 3D model illustrations are shown in Figure 5.

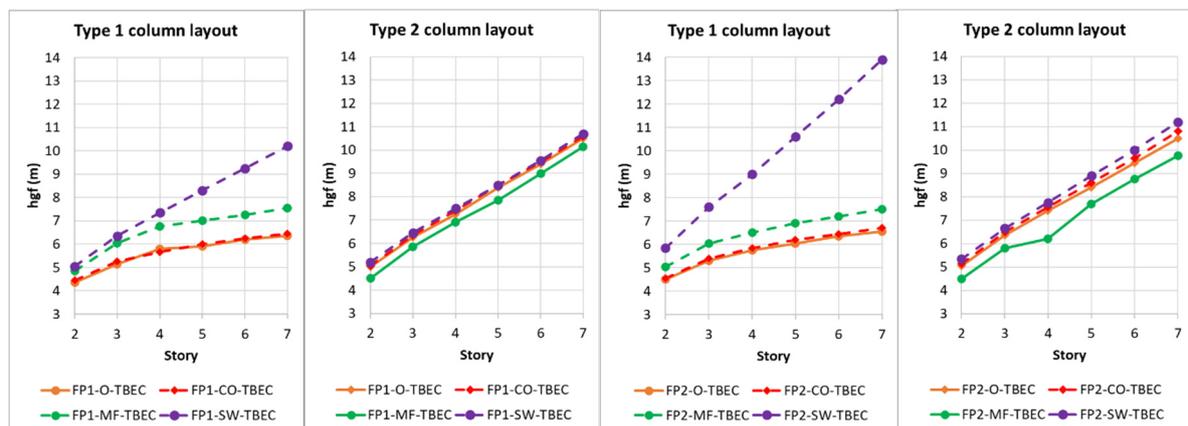
Figure 6. Ground floor heights (h_{gf}) causing soft-storey irregularity according to TBEC, depending on the number of storeys.

The ground floor height (h_{gf}) obtained for each of the two types of column layouts depending on the number of storeys is presented in Figure 6.

Considering the results obtained according to the TBEC, for the Type 1 column layout, the presence of a shear wall in one direction or a mezzanine floor in the building causes soft-storey irregularities at higher ground floor heights than the original models (FP1-O or FP2-O). In other words, the presence of a shear wall in one direction or a mezzanine floor has reduced the risk of soft-storey irregularities. The closed overhang in the building did not change the results compared to the original models. However, for the Type 2 column layout, the presence of a mezzanine floor in the building caused soft-storey irregularities at lower ground floor heights than the original models (FP1-O or FP2-O). The presence of a shear wall in only one direction or a closed overhang in the building changed the h_{gf} values (ground floor heights causing soft-storey irregularities) only slightly compared to the original models (FP1-O or FP2-O). Therefore, it can be said that the presence of a mezzanine floor increases the risk of soft-storey irregularity, while the presence of a shear wall in only one direction or a closed overhang in the building has a limited impact on soft-storey irregularity. The results obtained according to the formulas in TBCE are far from the ground floor heights used in practice. Also, the presence of a mezzanine is not expected to reduce the risk of soft-storey irregularities.

Figures 6 and 7 show that changes in the number of storeys do not significantly alter the results according to the ASCE, while according to the TBEC, the h_{gf} values increase more noticeably as the number of storeys increases. So that, according to TBEC, the ratio of the ground floor height causing a soft-storey irregularity in a seven-storey building to that in a two-storey building is on average 1.66 for the Type 1 column layout (average value obtained from eight typical formwork plans) and 2.1 for the Type 2 column layout.

As seen in Figure 6, considering the results obtained according to the TBEC, the ground floor height (h_{gf}) causing soft-storey irregularity in four-storey model buildings was obtained as at least 5.75 m for the Type 1 column layout (the smallest value obtained from eight types of formwork plans) and at least 6.2 m for the Type 2 column layout. As the number of storeys increases, these values also increase. These values are not the ground floor heights seen in practice. As seen in Figure 7, the ground floor heights (h_{gf}) obtained according to the ASCE are between 3.25 and 5.2 m, and these values are the ground floor heights frequently encountered in practice. Therefore, the ground floor height of each model building was chosen as the minimum ground floor height (h_{gf}) that causes soft-storey irregularity in that building according to the ASCE, and the soft-storey irregularity coefficients of the buildings were recalculated according to the formula given in the TBEC (see Figure 10). The aim was to determine the range within which the obtained n_{ki} values fall.

- (a) According to the formulas given in the TBEC, the ground floor heights (h_{gf}) that cause soft-storey irregularities are too high to be used in practice, especially in buildings above three storeys (this can be seen in Figure 6). The results reveal that, even if the buildings are designed with very high ground floor heights, they do not have soft-storey irregularities according to the formulas given in the TBEC, but they can be damaged by earthquake effects due to soft-storey formation. This can be attributed to the excessively high limit value of the soft-storey irregularity coefficient ($n_{ki} > 2$) in the TBEC.

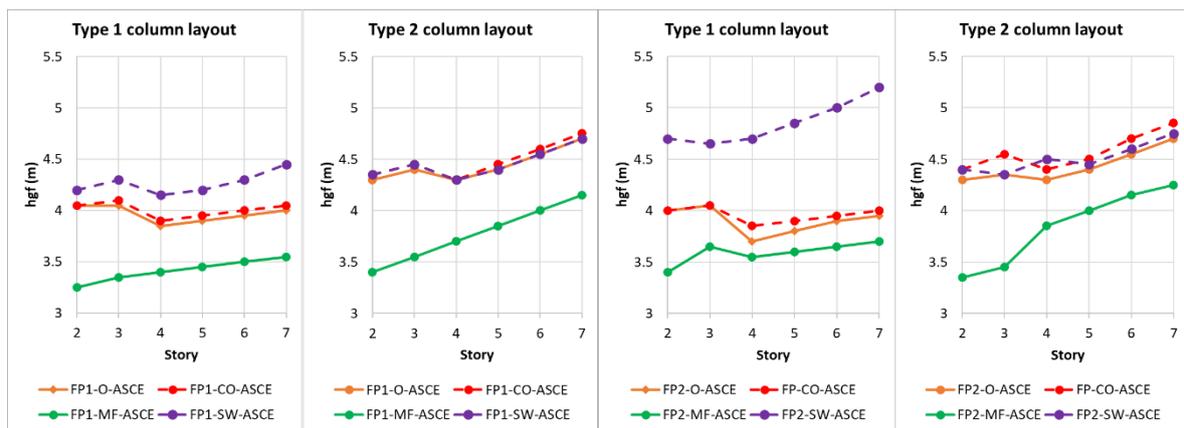
Figure 7. Ground floor heights causing soft-storey irregularity according to ASCE, depending on the number of storeys.

The same model buildings were analysed according to ASCE, and the minimum ground floor height (h_{gf}) that would cause soft-storey irregularity was obtained in all models (Figure 7). Unlike the TBEC, minimum ground floor heights (h_{gf}) were determined by considering Equation (3) instead of Equation (1).

The results obtained according to the ASCE indicate that the presence of a mezzanine floor in buildings with both types of column layouts increases the risk of a soft storey, while the presence of a closed overhang almost does not alter the results at all. Additionally, it was found that the presence of a shear wall in one direction reduces the risk of a soft storey in Type 1 column layouts but does not change this risk in Type 2 column layouts. Here, it can be concluded that the effect of shear wall placement in one direction on soft-storey irregularity is limited in regular column layouts. The results obtained according to the ASCE are ground floor heights that can be used in practice. The results given by the soft-storey irregularity formulas in ASCE for different formwork plans are reasonable and expected.

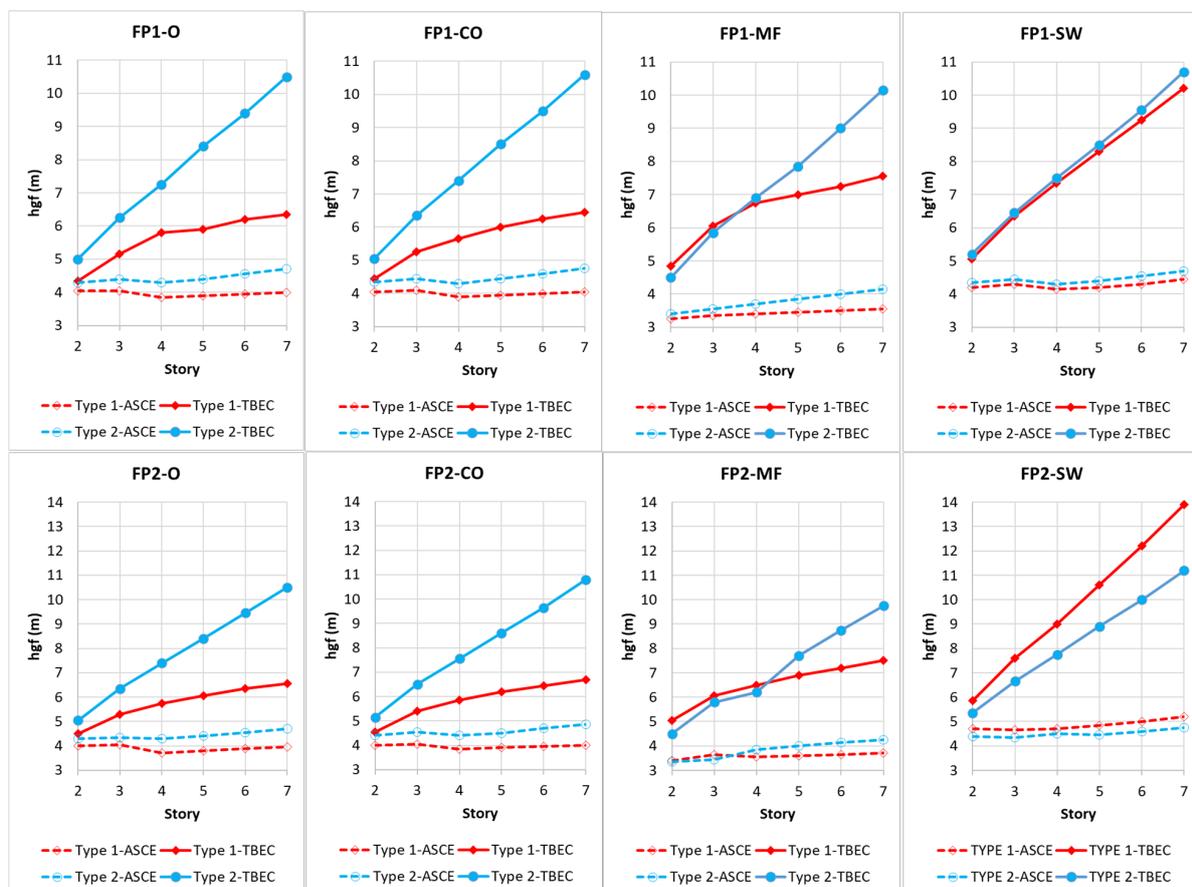
Figure 8. Comparison of h_{gf} results obtained according to TBEC and ASCE.

For a comparison of the results obtained according to the TBEC and ASCE regulations, the h_{gf} values obtained according to both regulations are shown on the same graph (Figure 8).

Figure 8 shows that there are significant differences between the results obtained according to the TBEC and ASCE regulations. The soft-storey irregularity formulas in the ASCE give more reasonable and consistent results than those in the TBEC. For a numerical comparison of the differences between the regulations, the h_{gf} values obtained with the TBEC were rationed to the values obtained according to the ASCE (Figure 9).

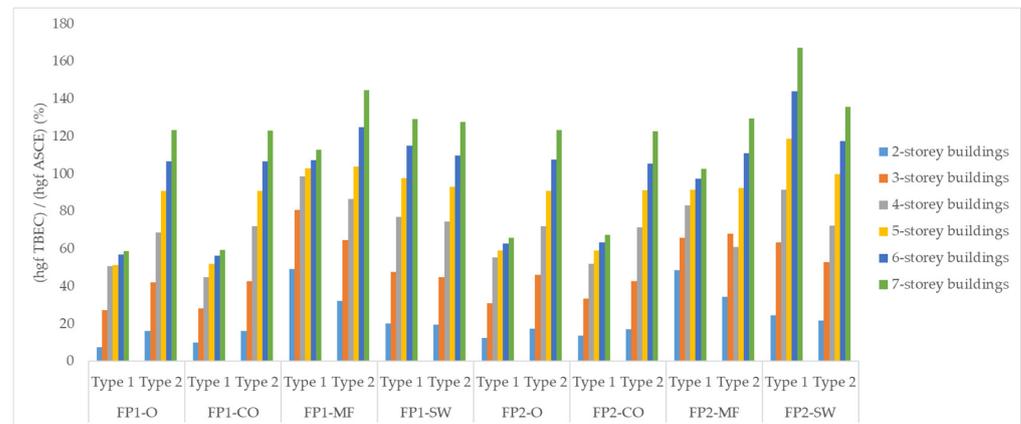
Figure 9. h_{gf} ratios obtained according to regulations, depending on the formwork plan and column layout.

Figure 9 shows that the difference in results obtained with the TBEC and ASCE regulations (ground floor heights causing soft-storey irregularity) increases as the number of storeys increases. The greatest difference among the regulations occurred in the FP2-SW formwork plan's Type 1 column layout, reaching 167%.

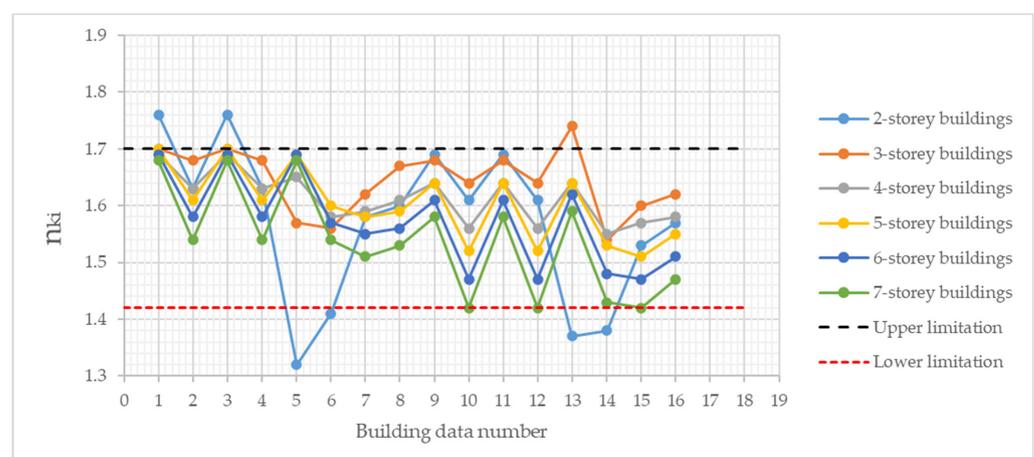
Figure 10. The n_{ki} values determined using the (h_{gf}) values obtained according to ASCE.

Figure 10 shows that the n_{ki} values are concentrated in the range of 1.4–1.7.

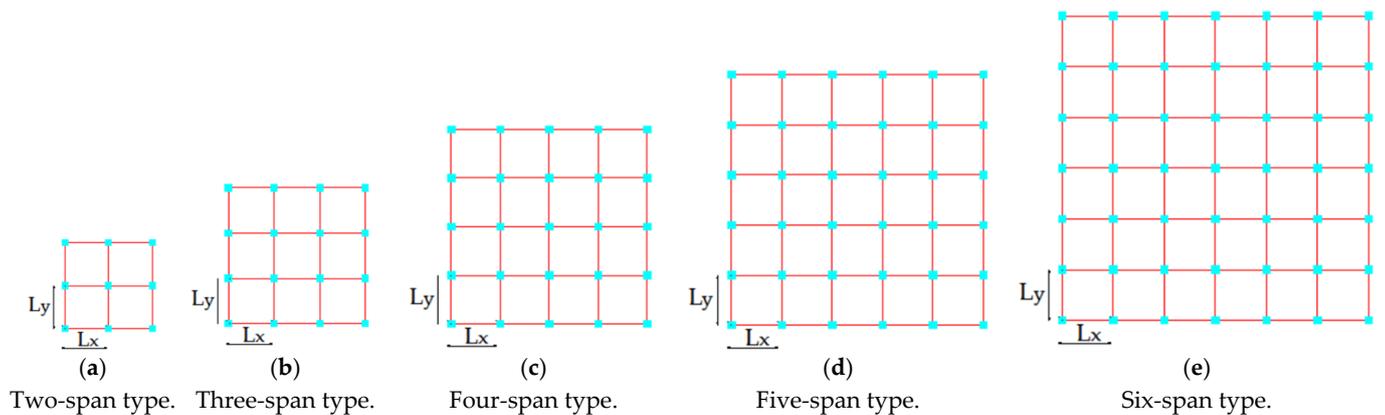
Figure 11. Two, three, four, five, and six-span formwork plans.

A total of 35 model buildings were identified for cases where there are two, three, four, five, and six spans and each span length (L_x , L_y) is 3, 3.5, 4, 4.5, 5, 5.5, and 6 m. The selected formwork plans are provided in Figure 11.

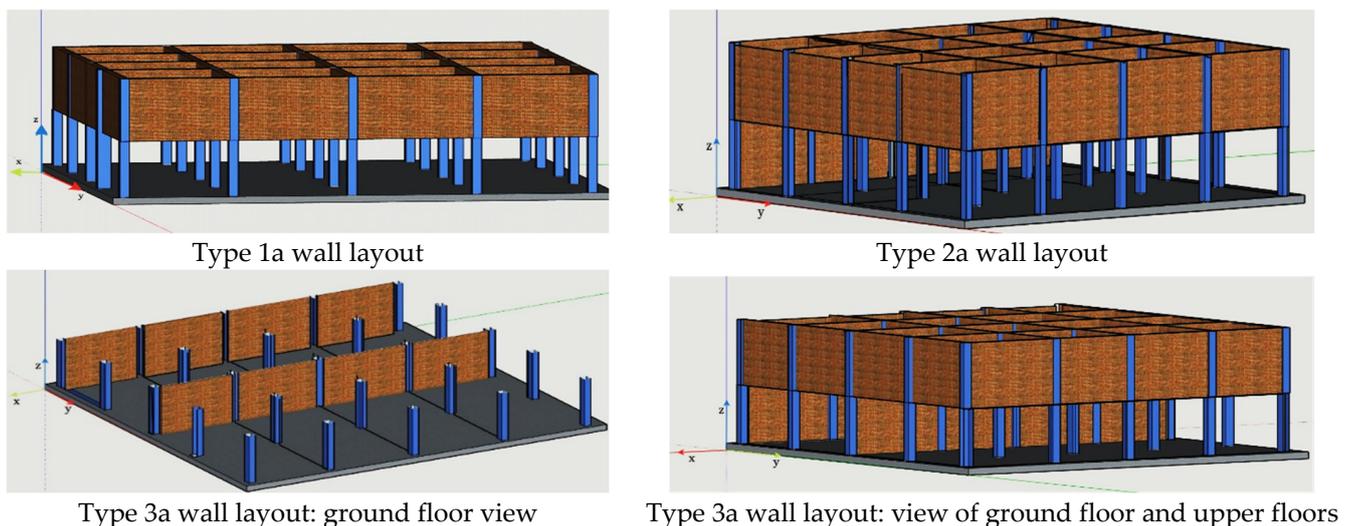
Figure 12. Infill wall layout in the x-direction for the ground floor and upper floors of a 4-span model building.

Since the ground floors of the model buildings are intended for commercial use or parking, the layout of the infill wall was made such that each building's ground floor has no infill walls in the x-direction (Type 1a wall layout), one of the exterior axes in the x-direction has an infill wall (Type 2a wall layout), and one of the exterior and interior axes in the x-direction has an infill wall (Type 3a wall layout). All the axes of the upper floors have infill walls. As an example, the infill wall layout of the ground and upper floors of a four-span model building is provided in Figure 12.

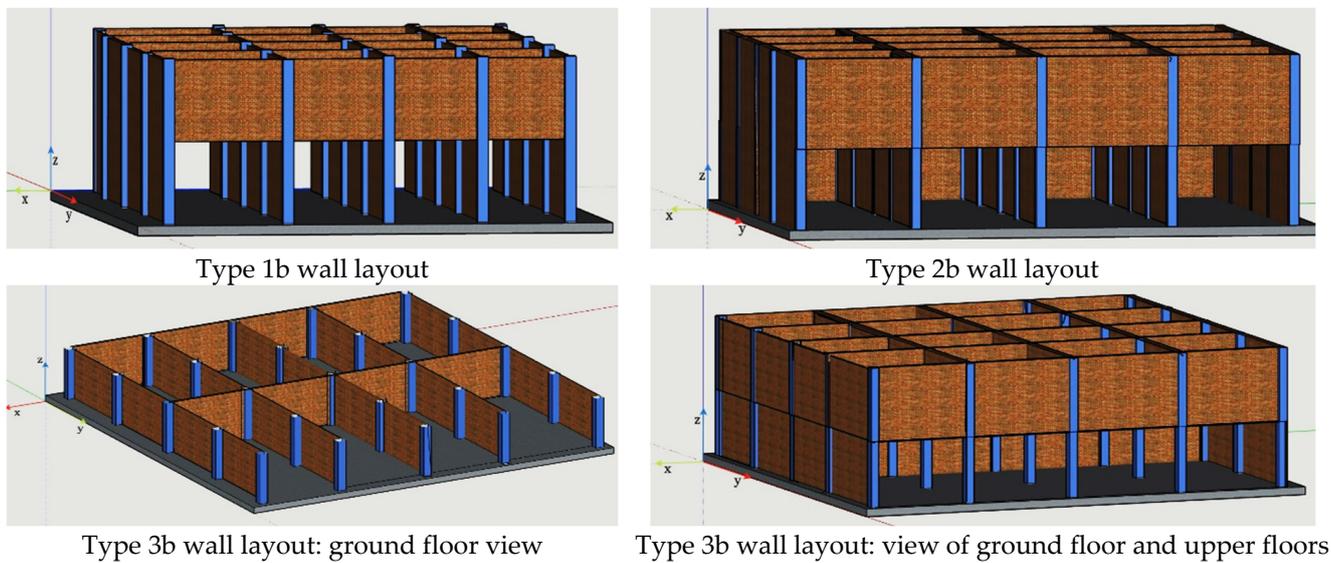
Figure 13. Infill wall layout in both the x- and y-directions for the ground floor and upper floors of a 4-span model building.

Type 2b, and Type 3b wall layouts obtained by adding infill walls in the y-direction to the infill wall layouts in Figure 12 are given in Figure 13.

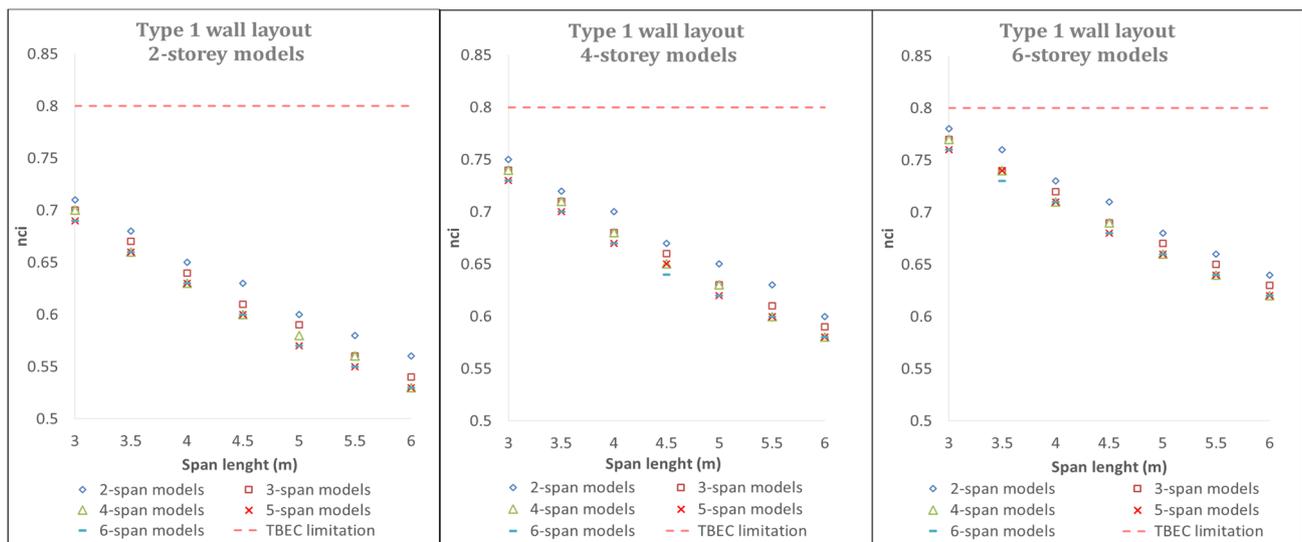
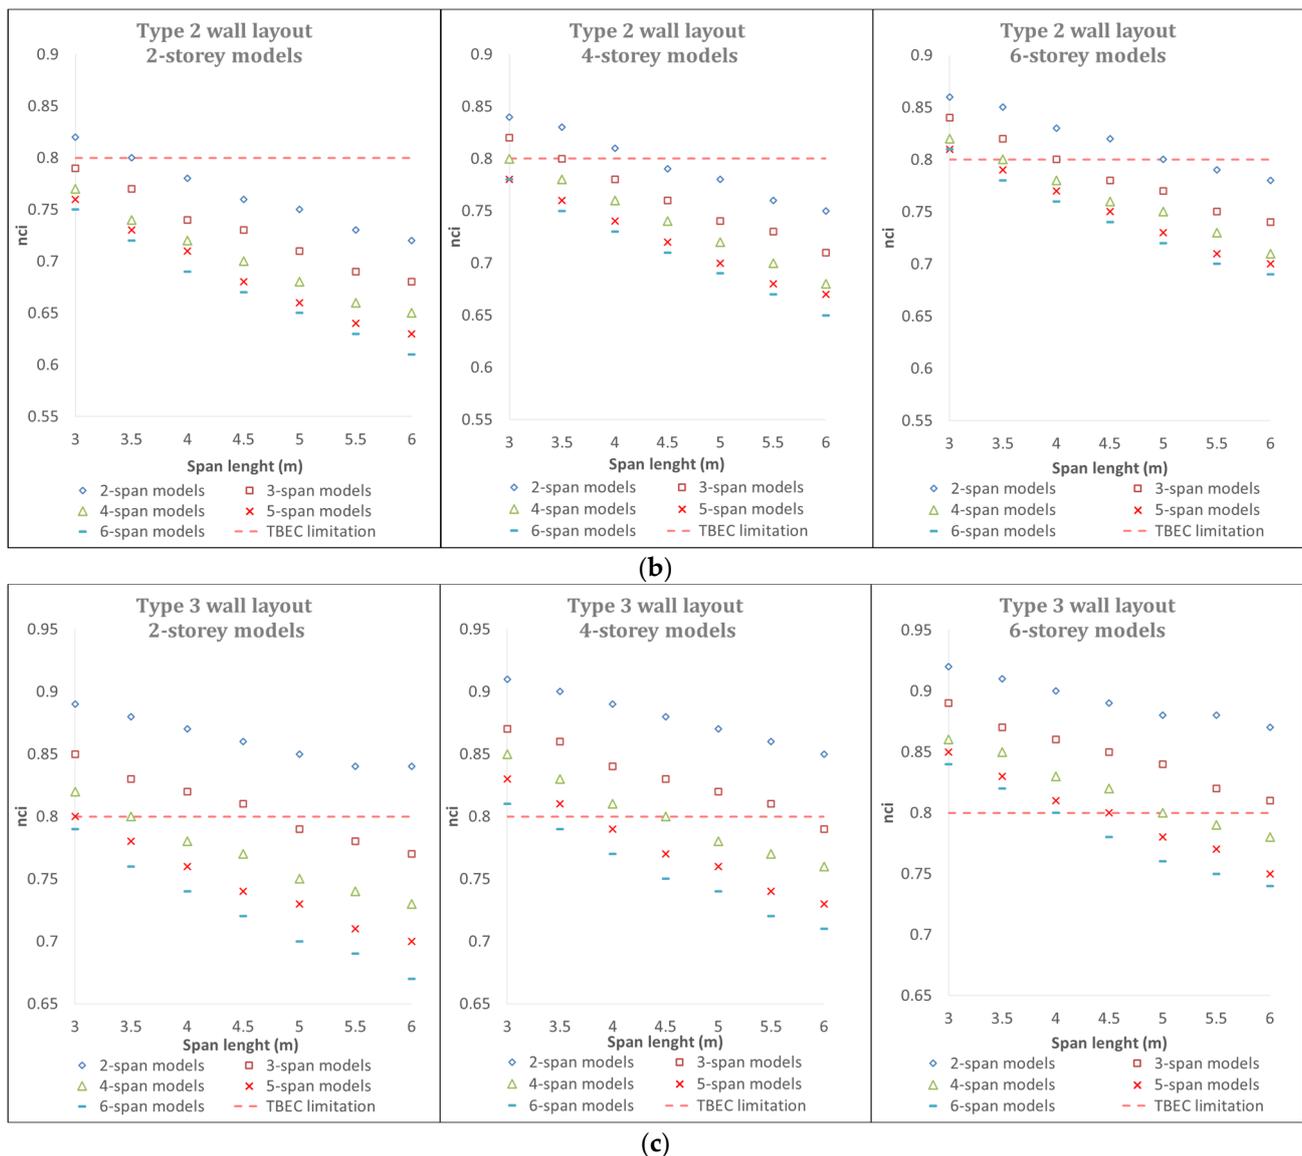
Figure 14. (a) Weak-storey irregularity coefficients obtained for Type 1 infill wall layout. (b) Weak-storey irregularity coefficients obtained for Type 2 infill wall layout. (c) Weak-storey irregularity coefficients obtained for Type 3 infill wall layout.

The weak-storey irregularity coefficients (n_{ci}) for each of the different cases of infill wall layout, number of spans, span length, and number of storeys were obtained according to the TBEC (Figure 14).

Figure 14 shows that the Type 1 infill wall layout causes weak-storey irregularity in all of the models. The Type 2 infill wall layout has caused weak-storey irregularity in 66% of the six-storey models, 83% of the four-storey models, and 94% of the two-storey models. The Type 3 infill wall layout has led to weak-storey irregularity in 26% of the six-storey models, 43% of the four-storey models, and 60% of the two-storey models. It is observed that as the number of spans or the span length increases in all models, and the weak-storey irregularity coefficient decreases. As the number of storeys increases, the column cross-sectional dimensions also increase; thus, the ratio of the column effective cross-sectional area $(\sum A_w)_i$ in the total effective shear area $(\sum A_e)_i$ increases, and consequently, the effect of the amount of infill walls on the weak storey irregularity decreases. Therefore, it can be said that the effect of the amount of infill walls on weak-storey irregularity is higher in low-rise buildings compared to mid-rise buildings. The results in Figure 14 show that structures without infill walls in one direction or with infill walls in only one of the outer axes in one direction are very sensitive to weak story formation.
