# Carbon Footprints of a Conventional Norwegian Detached House Exposed to Flooding

Line Berg Oppedal \* and Tore Kvande

Department of Civil and Environmental Engineering, Norwegian University of Science and Technology (NTNU), 7034 Trondheim, Norway; tore.kvande@ntnu.no

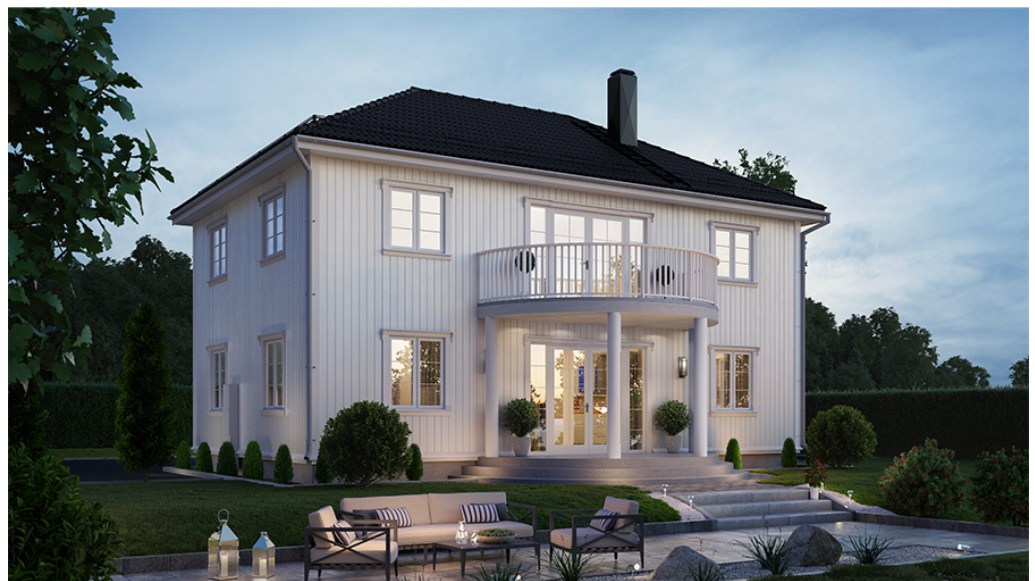
The house model «Arv» used in this study represents a typical modern Norwegian detached house, as shown in Figure 1. The original house model was designed as a timber-frame house, and the entire set of building plans and list of construction materials were made available for the authors by Norgeshus. «Arv» comprises a concrete slab on the ground, a hip roof structured by a wooden roof truss, and a floor of wood-based I-profile beams. Ceramic tiles exist at entrances, bathrooms, and laminate flooring elsewhere. The house had a footprint of 93.6 m<sup>2</sup> and a heated floor area of 171 m<sup>2</sup>. Figure 2 shows the ground floor of the house.

**Figure 1.** Case building, «Arv». Concept illustration: Norgeshus.
