Article

Impact Damage Resistance and Post-Impact Tolerance of Optimum Banana-Pseudo-Stem-Fiber-Reinforced Epoxy Sandwich Structures

Abstract: Banana fiber has a high potential for use in fiber composite structures due to its promise as a polymer reinforcement. However, it has poor bonding characteristics with the matrixes due to hydrophobic–hydrophilic incompatibility, inconsistency in blending weight ratio, and fiber length instability. In this study, the optimal conditions for a banana/epoxy composite as determined previously were used to fabricate a sandwich structure where carbon/Kevlar twill plies acted as the skins. The structure was evaluated based on two experimental tests: low-velocity impact and compression after impact (CAI) tests. Here, the synthetic fiber including Kevlar, carbon, and glass sandwich structures were also tested for comparison purposes. In general, the results showed a low peak load and larger damage area in the optimal banana/epoxy structures. The impact damage area, as characterized by the dye penetration, increased with increasing impact energy. The optimal banana composite and synthetic fiber systems were proven to offer a similar residual strength

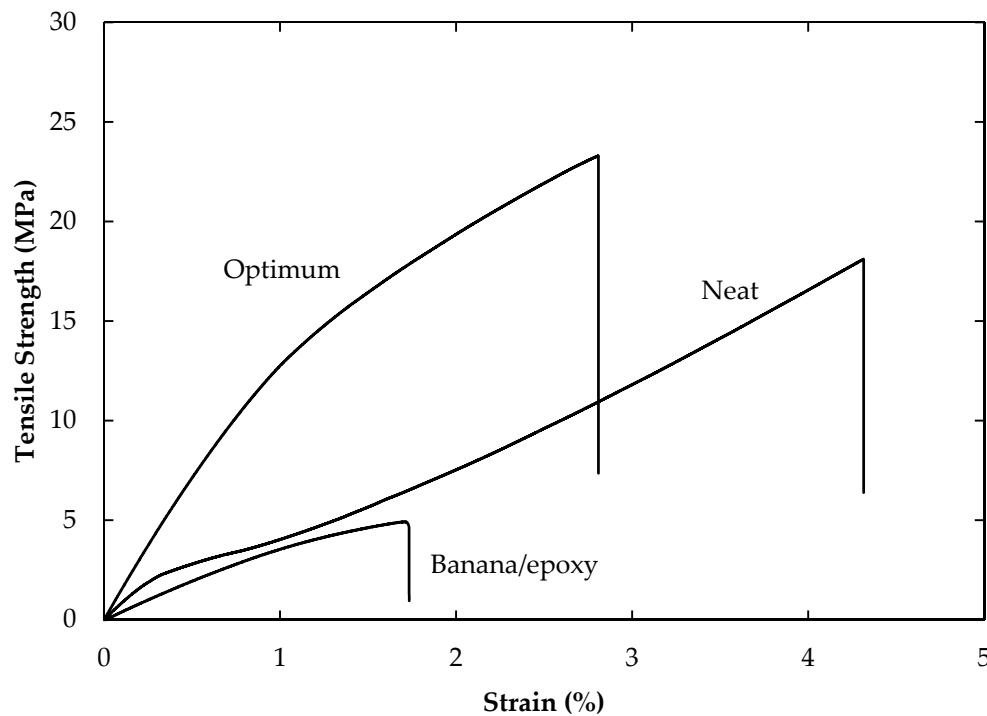
Figure 4. Typical stress–strain curve for neat, optimal banana/epoxy composite, and banana/epoxy composite.

Figure 4 illustrates the stress–strain curves of the neat epoxy system, banana fiber composite, and optimal banana reinforced epoxy composites. It can be seen that the maximum stress and tensile modulus of the optimal banana fiber reinforced epoxy composite were increased by 66% and 22%,

respectively, compared to the neat epoxy resin. It is suggested that the properly optimized the fiber blending condition improved the load-bearing capabilities between the fibers and matrixes. A similar finding was also reported by Yaghoobi and Fereidoon [23]. In this figure, the untreated, 0.25-mm length, and mixed at 50 wt.% fiber loading of a banana-fiber-reinforced epoxy composite was also included for comparison. Interestingly, these composites unfolded at lower tensile strength and modulus values than the virgin epoxy-resin. In addition, the tensile modulus of this unoptimized composite was found to be 792 MPa, which was lower than that of the optimal banana epoxy composite with 1628 MPa. It was demonstrated that adding inappropriate natural fiber “debris” in the polymeric matrixes decreased the material properties of the structure.

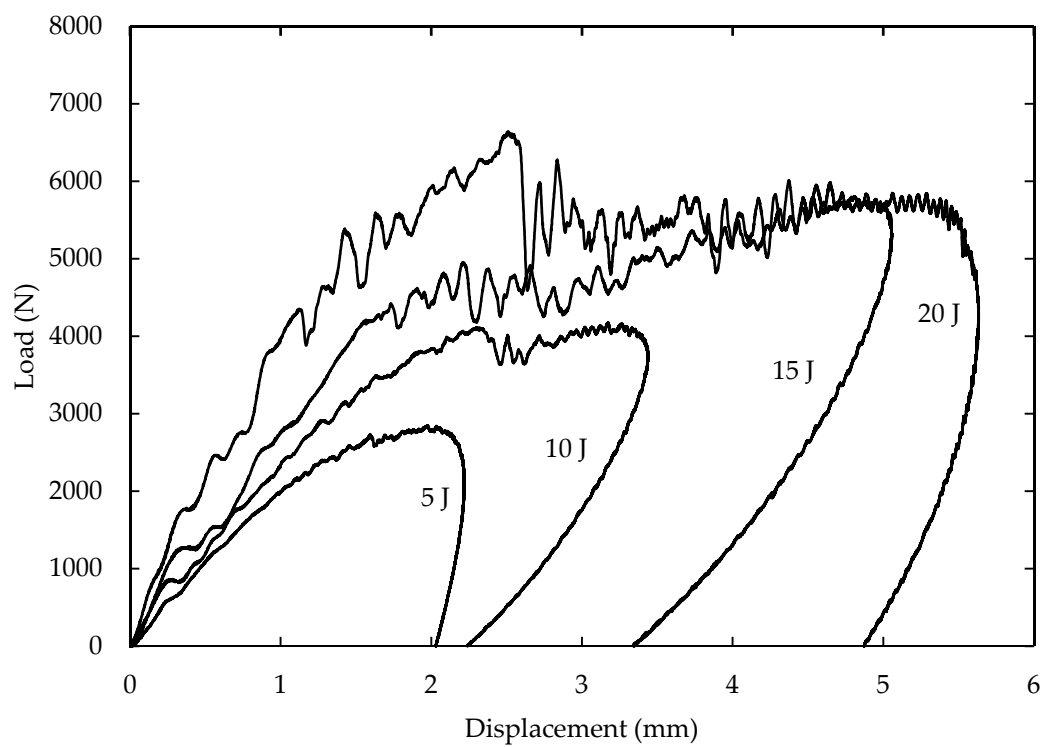
Figure 5. Typical load–displacement traces of (a) banana, (b) Kevlar, (c) glass, and (d) carbon/epoxy sandwich structures.

Figure 5 illustrates typical load–displacement traces for the low-velocity impact response at four different impact energy levels correspond to the optimal banana, Kevlar, glass, and carbon epoxy sandwich structures. All traces initially exhibited a similar pattern with the force increasing in an

almost linear manner before reaching a peak load. This was associated with the plastic deformation of the sandwich structures directly beneath the hemispherical impactor. Figure 5a presents typical load versus displacement traces for the impact loading of the optimal banana epoxy sandwich structures. It can be seen from the figure that increasing the incident impact energy increased the effective slope of the curve up to 3 mm of displacement, suggesting a rise in the contact stiffness of the system. Beyond this point, a non-linear trace pattern was observed, resulting in the initiation of unstable crack propagation and fiber fracturing. A very drastic fall in the contact load was apparent in the trace for the 20 J impact energy level due to sub-critical propagation and brittle failure of the core. Continued loading often resulted in microcracking and instabilities, with this being most evident in the 15 J impact energy trace where very small load jumps were apparent in the trace at displacements above 3 mm. In addition, the enclosed area within the loading and unloading curves was a measure of the energy absorbed due to the damage in the laminates. Then, the impactor was rebounding since the force and deflection values decreased in the unloading phase. At all the energy levels used in this study, the impactor did not fully perforate the sandwich structures and a portion of the impact energy was conserved as elastic energy. This energy was then transferred back to the steel impactor, causing it to rebound. He et al. [33] suggested that if the core structure was a highly brittle material, the rapid rebound of the skin under impact can result in debonding at the interface between the adjacent layers of the face sheet and the core. Figure 5b–d reveals the typical load displacement traces for Kevlar, glass, and carbon epoxy sandwich structures after being subjected to 5, 10, 15, and 20 J impact energies. From the figure, it is evident that the Kevlar/epoxy composite has a characteristically higher contact stiffness than that of the other composite structures; however, the carbon/epoxy structure offered less “resting” displacement during the unloading phase. It can be suggested that this has resulted in less of a dent depth for the carbon epoxy structures.

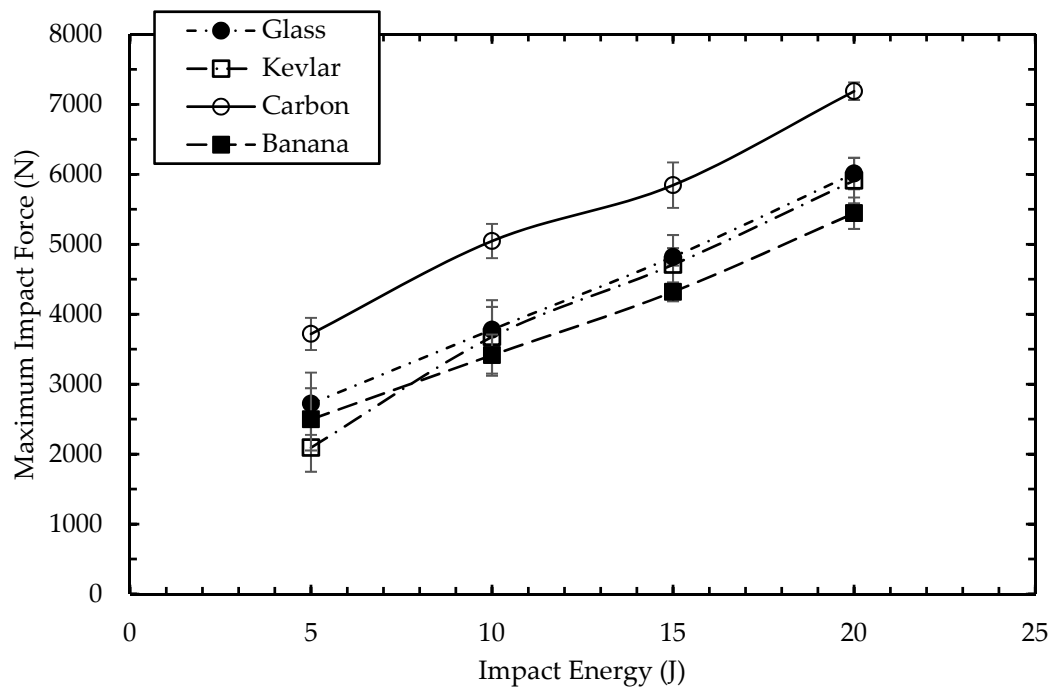
Figure 6. The variation of the maximum impact force at different impact energy levels for composite structures.

The variations in the peak force at different impact energy levels for composite structures are shown in Figure 6. It can be observed that the peak impact force was increased with increases in the energy level. A similar observation was also reported by Olsson et al. [34]. In addition, the optimal banana/epoxy composite offered a lower peak force than those of the synthetic/epoxy structures. Joseph et al. [35] claimed that fiber pullout and fiber compatibility were the major contributors to the toughness of the composite. Thus, synthetic fibers offered a significantly higher peak load, suggesting higher bonding capabilities with the matrix due to the surface smoothness and consistency of the cross-section. In the case of natural fibers, such a mechanism was not favored due to the mechanical interlocking between fibers and the matrices. In this study, to increase the compatibility between the banana fiber and the matrix, the chemical treatment was promoted; however, the peak force still remained unimpressive.

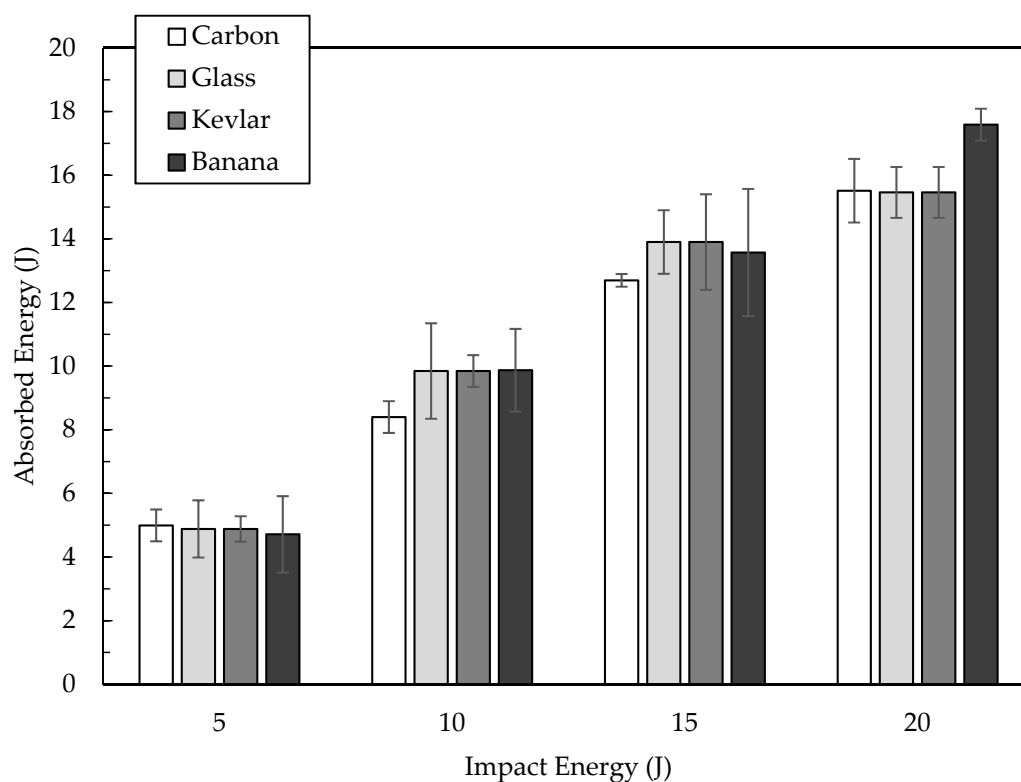
Figure 8. Typical absorbed energies at various incident energy levels.

The total impact energy is a combination of the energy absorbed and the elastic energy loss of the impacted structures [37]. If the percentage of the energy absorbed is high, the energy converted to elastic energy lost by the impactor is low. As a result, the impact energy is fully transferred to the structures at the point of maximum displacement [38]. In order to evaluate the impact response and resistance of the composite structures, the energy absorbed against impact energy traces are shown in Figure 8. The absorbed energy was measured by calculating the area under the force–displacement

traces. An observation of the figure suggests that the absorbed energy tended to increase with the incident impact energy, although there did appear to be scattering in the findings, particularly between the optimal banana/epoxy and carbon/epoxy composites. The lower energy absorption means that there was not much energy lost due to failure. Thus, each failure mechanism, including matrix cracks, interlayer failures, delamination, and fiber breakage, absorbed a fraction of the impact energy. The variation of energy absorbed depends on the skin thickness [39], the mechanical properties of fibers and matrices [40], the density of the core [41], and the impactor head [42].

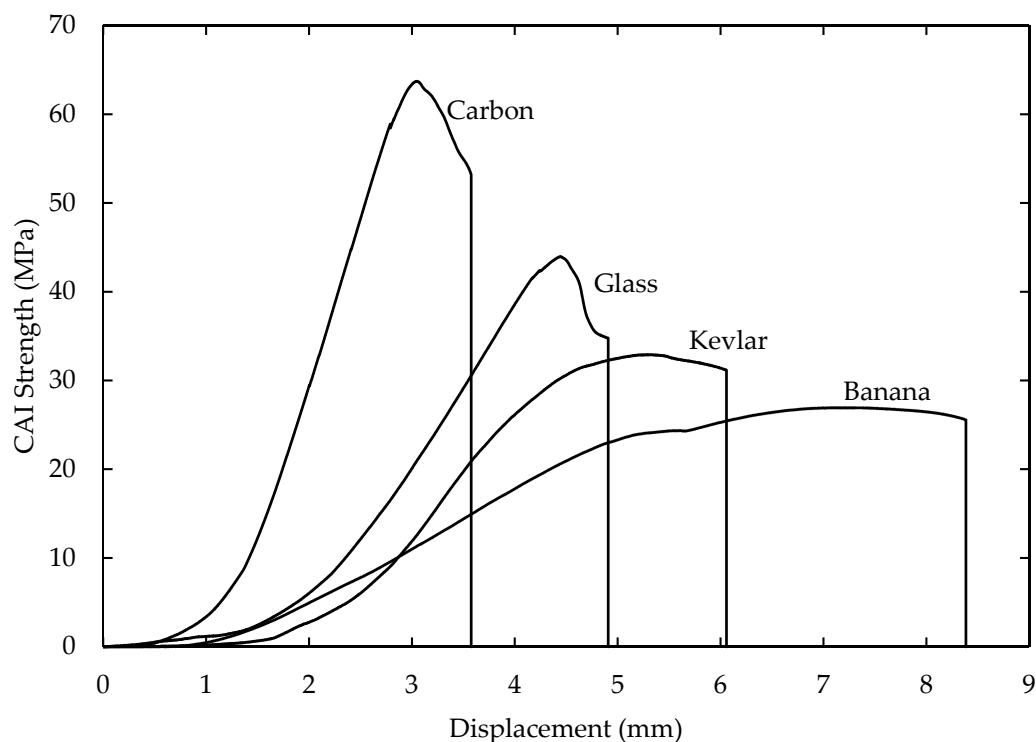
Figure 11. The variation of compression after impact (CAI) strength with the displacement for four different sandwich structures subjected to an energy impact of 10 J.

Figure 11 shows the variations of CAI strength performance with the displacement for the optimal banana, carbon, Kevlar, and glass sandwich structures following an impact energy of 10 J. For all sandwich panels, the structures exhibited an initial linear CAI strength before reaching a maximum value, following which the strength gradually fell, an effect that was also reported previously [47]. The figure shows that an increase in peak stress resulted in a decrease in the displacement, highlighting the presence of the stronger and stiffer core structures. The carbon/epoxy based sandwich structure was seen to offer a greater residual strength than those of other systems. Furthermore, the findings also show that the CAI strength of the natural-fiber-reinforced epoxy was still lower than its synthetic fiber counterparts. The differences in residual stress were recorded at 22%, 63%, and 136% between banana and Kevlar, glass, and carbon respectively.
