Experimental Study of Stepped-Lap Scarf Joint Repair for Spar Cap Damage of Wind Turbine Blade in Service

Abstract: The objective of this paper was to design configuration parameters for a stepped-lap scarf joint repair, which can be used for spar cap damage of a wind turbine blade in service and to realize the post-repair monitoring. Two experimental studies were included. First, tensile test for the unidirectional tape specimens with a large aspect ratio repaired using a multiple stepped-lap scarf joint method was carried out. The results showed that the reinforcement layer could effectively improve the load-carrying capacity of the repaired zone. The stepped-lap joint surface was identified as the weak part of the spar cap repair, which should be monitored. Second, by embedding carbon nanotube buckypaper sensors on the stepped-lap joint surface of the repaired specimens, quasi-static tensile tests and fatigue tests were carried out. According to the resistance response of the sensors, the quasi-static tensile test confirmed the failure processes, namely the stiffness turning point, damage evolution, crack propagation, and fracture. The fatigue test could accurately identify the

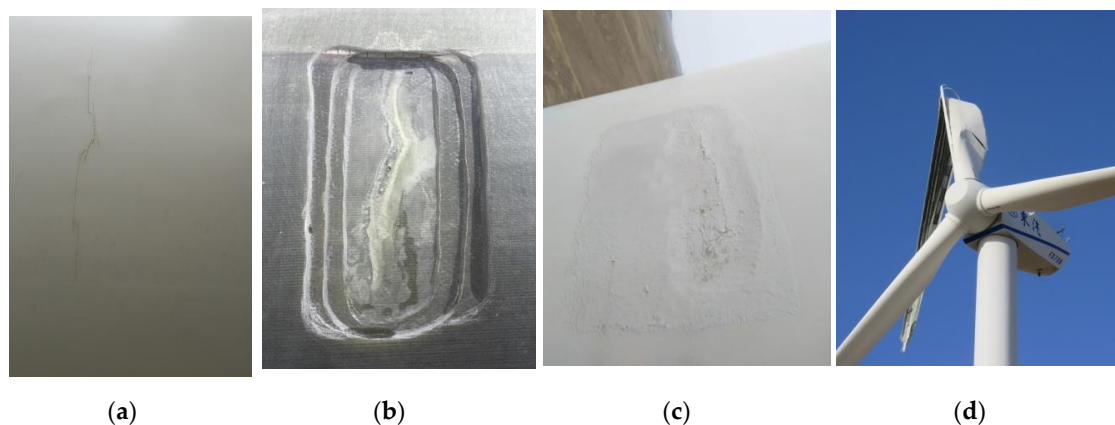
Figure 1. Spar cap damage of a blade in service: (a) crack in the spar cap zone, (b) serious damage, (c) new crack after repair, and (d) blade fracture.

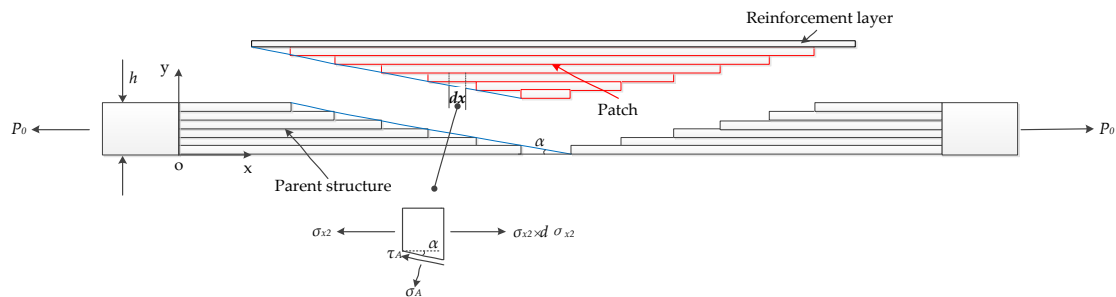
The theoretical model shown in Figure 4 is a stepped-lap scarf joint repair with a large aspect ratio, where the thickness of the laminates along the y-direction is taken to be small compared with the length and width of the model in the x- and z-directions. The tangent angle between the tangential joint surface and the x-direction of the scarf joint model is defined as α . Figure 4 also shows a free body with stepped-lap width dx between the patch and parent structure; τ_A and σ_A are the shear stress and normal stress of the adhesive layer at the stepped-lap joint surface, respectively; and σ_{x2} is the tensile

Figure 4. Stepped-lap scarf joint repair theoretical model.

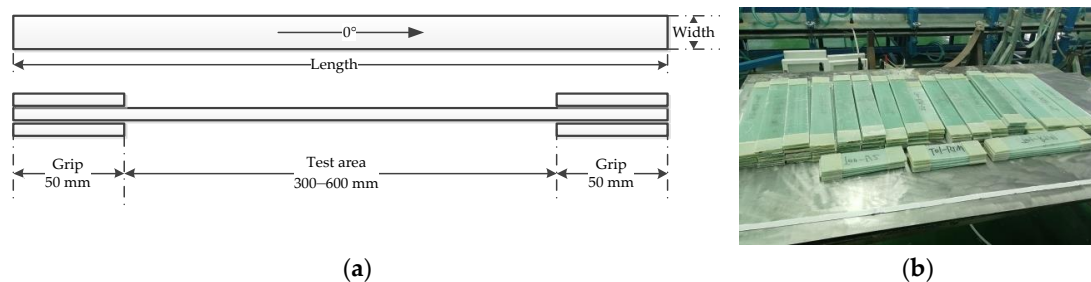
The material of the specimen's parent structure and patch was EUL1200 (0) ep-600e7 (CTG, Taishan, China). The matrix was HEXION epoxy resin LR235 (HEXION, Shanghai, China). The specimen followed a unidirectional 0° fiberglass direction including the test area and grip areas (Figure 5a). Multiple configuration parameters of the stepped-lap scarf joint repaired specimens were designed in the test area. The parent structure was formed using a vacuum infusion process. The patch was laid layer by layer using a stepped-lap joint method. The whole specimen was cured at 180 °C and 0.1 MPa conditions for 2 h (Figure 5b). Tensile tests of the stepped-lap scarf joint repaired specimens were carried out using a universal testing machine (GOTECH, Taiwan, China) with 200 kN load cell. All specimens were tested at room temperature with the crosshead speed held constant at 1 mm/min. The strength was taken as the maximum load recorded by the machine and computer.

Figure 5. Test specimens design and cured: (a) the configuration of the stepped-lap scarf joint repaired specimens, and (b) test samples.

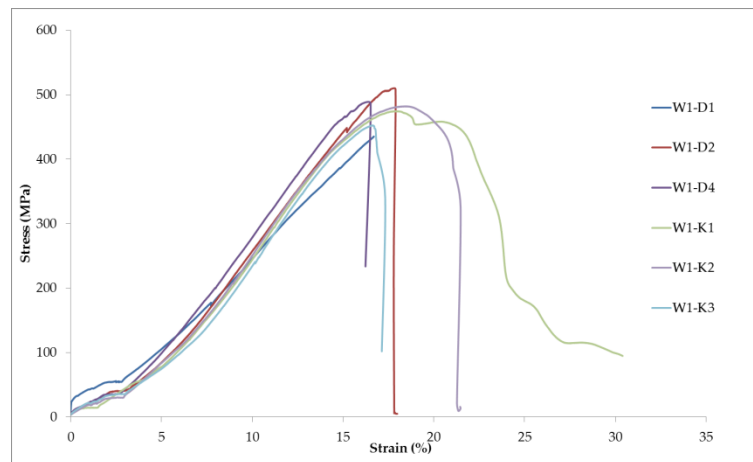
2. In Figure 6, the stress–strain curves of the W1-K and W1-D specimens were basically identical before failure. It indicated that the load carried by the three-layer spar cap specimen repaired using a double stepped-lap scarf joint was basically consistent with the blade strength status of running for several years. The stress–strain curve of the W1-K specimen had an obvious nonlinear unloading section after failure, which was related to different degrees of stiffness attenuation after the specimen had been running for a certain number of years. It was indicated that there would be a serious performance degradation of the structural material after several years of operation.

Figure 6. Tensile stress–strain curves of the W1-K and W1-D specimens.

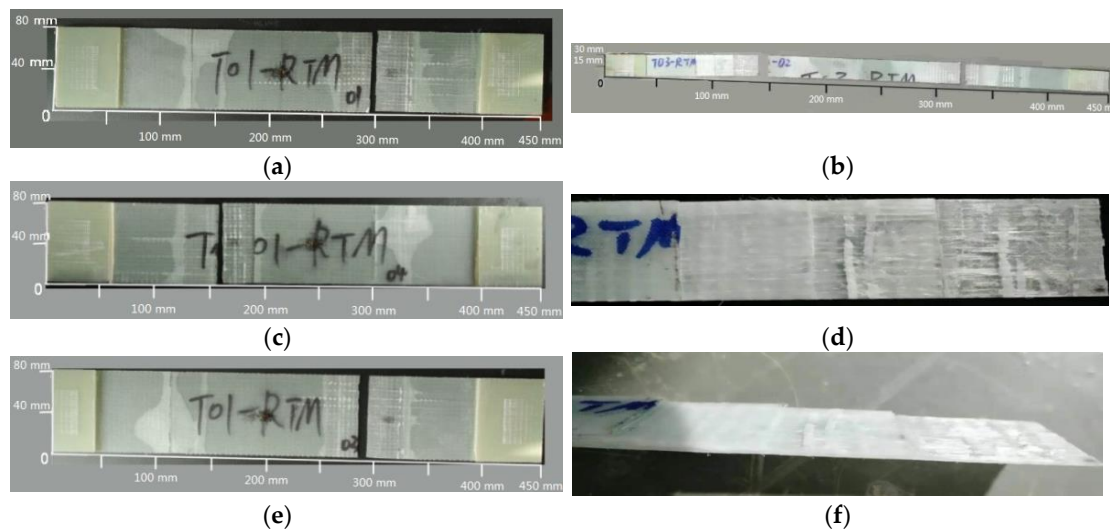
1. The failure specimens for the tensile test of the one stepped-lap joint surface and three stepped-lap joint surfaces are shown in Figure 7, where all specimens failed on the stepped-lap joint surface. The initial failure mode of the stepped-lap joint surface appeared as delamination. The final failure of the specimens was characterized by the coupling mode of the shear failure of the adhesive layer and the fiber fracture on the stepped-lap joint surface.
2. In Figure 8, the strain of the stepped-lap joint surface increased rapidly in the rising section, then fell rapidly, which indicated that a certain damage had occurred there, while no strain agitation occurred in the patch and parent structure. Therefore, the initial damage failure position of the specimen was located at the stepped-lap joint surface.

Figure 7. The failure position and failure mode: (a) tensile failure damage of one stepped-lap joint surface of effective sample 1, (b) tensile failure damage of three stepped-lap joint surface sample, (c) tensile failure damage of one stepped-lap joint surface of effective sample 2, (d) the top view of the stepped-lap joint surface, (e) tensile failure damage of one stepped-lap joint surface of effective sample 3, and (f) the side view of the stepped-lap joint surface.

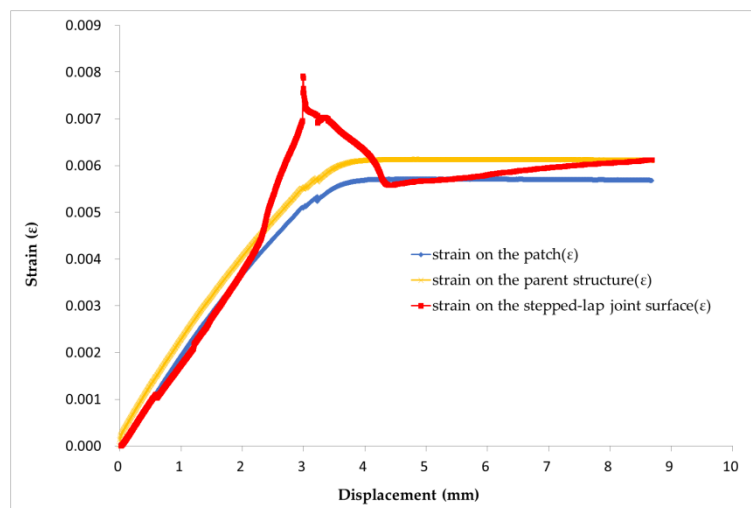
Figure 8. Displacement–strain curve of the parent structure, stepped-lap joint surface, and patch.

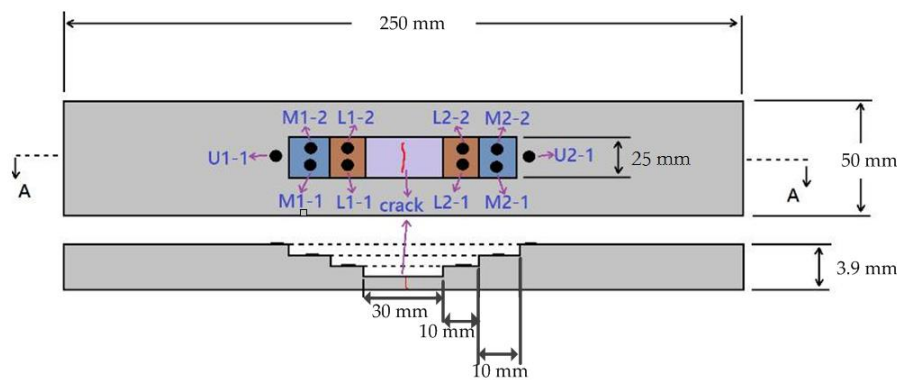
The length and width of the specimen were 250 mm and 50 mm. The dimensions of the three layers of the unidirectional patch were 25 × 70 mm, 25 × 50 mm, and 25 × 30 mm. The size of the reinforcement layer was 25 × 90 mm. The specimen size and the carbon nanotube buckypaper sensor positions are shown in Figure 9, where the circular carbon nanotube buckypaper sensors with a diameter of 8 mm were symmetrically arranged on the stepped-lap joint surface.

Figure 9. Specimen size and sensor arrangement.

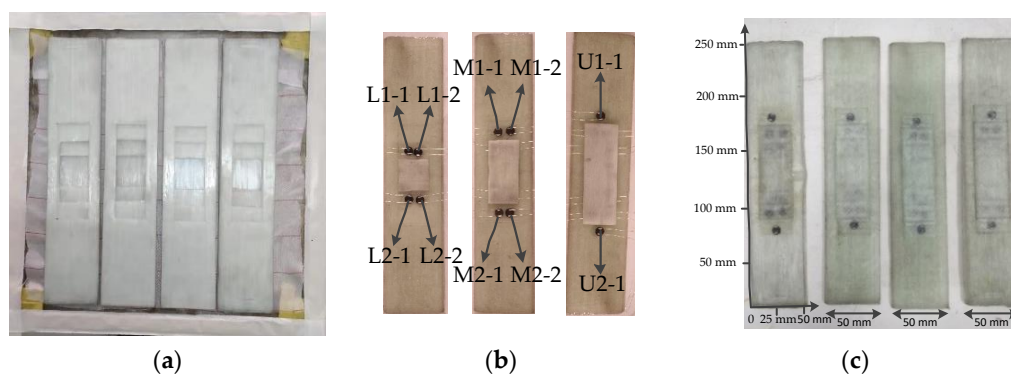
The parent structure was a 24-layer G20000 prepreg laminate structure (Figure 10a). When the parent structure was cured, the carbon nanotube buckypaper sensors (Figure 10b) and the patch were laid on the stepped-lap joint surfaces. Four sensors were arranged on the bottom stepped-lap joint surface, which were defined as L1-1, L1-2, L2-1, and L2-2. Four sensors were arranged on the middle stepped-lap joint surface, which were defined as M1-1, M1-2, M2-1, and M2-2. Two sensors were arranged on the joint surface between the reinforcement layer and the parent structure, which were defined as U1-1 and U2-1. After sealing and vacuuming, the specimens were put into an oven at 120 °C for curing (Figure 10c).

Figure 10. Specimen preparation process: (a) parent structure, (b) carbon nanotube buckypaper sensor locations, and (c) curing.

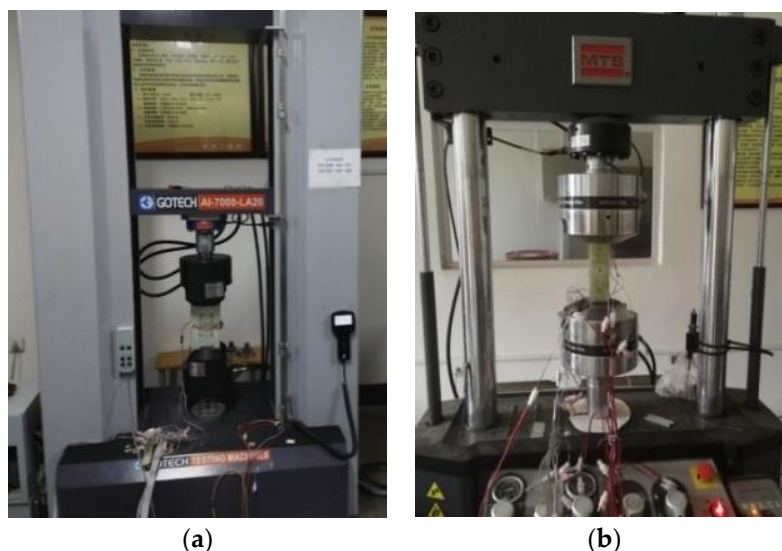
The quasi-static tensile test used a GOTECH AL-7000-LA20 (GOTECH, Taiwan, China) universal testing machine as shown in Figure 11a. The specimen was loaded to 5 kN at a rate of 0.5 mm/min and then unloaded to 0 kN, with each test repeated three times, at the same rate. Then, the specimens were loaded to 10 kN–55 kN with a load increment for 5 kN for each successive load step, where they were unloaded to 0 kN between each test. Each load step was repeated three times until failure. The curves of the loading and unloading under different maximum loads were fitted. The performance changes of the stepped-lap joint surface under different loads were evaluated via sensor response. A Fluke 2638A (FLUKE, Everfried, WA, USA) was used to collect the changes of the sensor resistance during the whole loading course.

Figure 11. Mechanical test equipment:(a) universal testing machine GOTECH AL-7000-LA20 and (b) electro-hydraulic servo fatigue testing machine MTS Landmark.

The fatigue test used the MTS Landmark electro-hydraulic servo fatigue testing machine (MTS, Minneapolis, MN, USA), as shown in Figure 11b. During the experiment, the fatigue load was adjusted according to the response stability of the sensors. The segmentation load of the tensile–tensile fatigue test was as follows: 20,000 fatigue cycles were performed at 9–15 kN, 60,000 fatigue cycles at 10–20 kN, 30,000 fatigue cycles at 16–24 kN, 1000 fatigue cycles at 15–25 kN, 1000 fatigue cycles at 14–26 kN, and 13–27 kN fatigue cycles until failure. The load of the tension–compression fatigue test was –5 to 15 kN until failure.

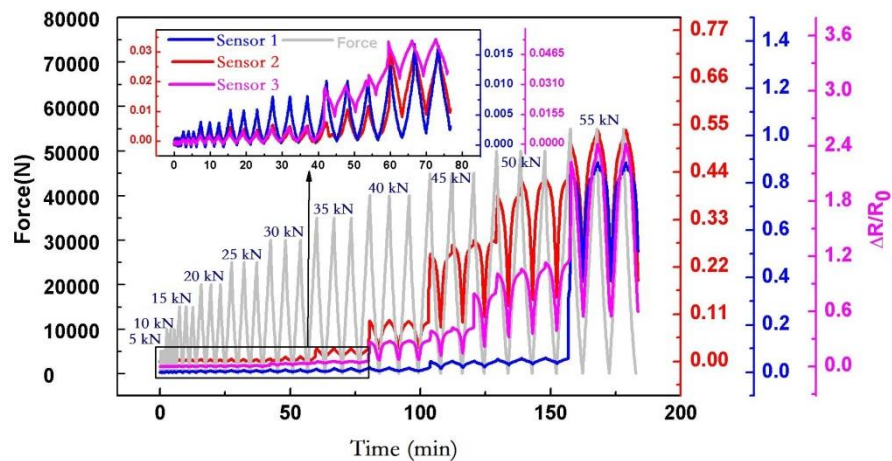
The load–time curve and resistance rate–time curve of the graded load-and-unload test were designed according to the test program, as shown in Figure 13. When the maximum load did not exceed 35 kN, the sensor resistance remained relatively stable and the specimen was in the linear elastic phase, such that the resistance could be restored to the initial resistance after unloading. When the load exceeded 40 kN, the sensor resistance had a large step and could not return to the original resistance. According to the analysis results of Section 4.4.1, when the load exceeded 55 kN, the damage and fracture of the specimen began to evolve, such that the maximum load of the fatigue test was 55 kN.

Figure 13. Data distribution of the load-and-unload test.

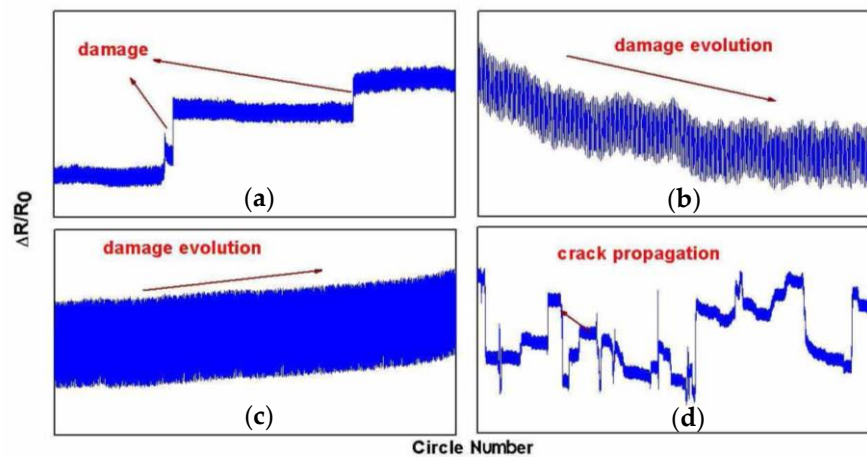
- During the whole fatigue cycle test, the response of the sensor could mainly represent four kinds of structural status of the specimen: the response of the sensor when the damage was derived, as shown in Figure 16a; the response of stiffness degradation when the damage was accumulated, as shown in Figure 16b,c; and the response of the initial crack and crack propagation, as shown in Figure 16d.

Figure 16. Damage process of the fatigue test: (a) initial damage, (b,c) damage accumulation, and (d) crack propagation.

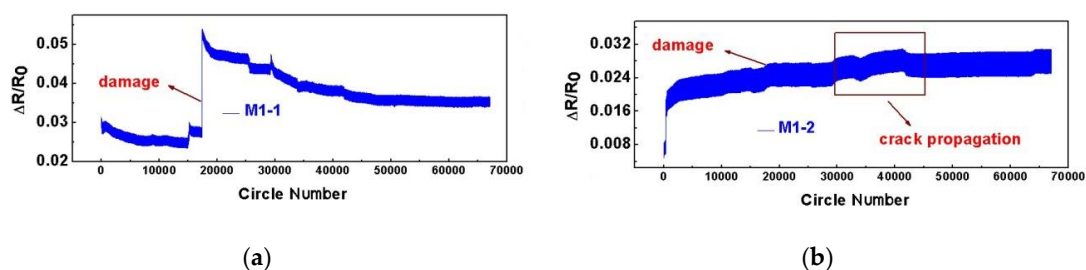
Figure 17. Response of the 60,000 fatigue cycles of all effective sensors with loads at 10–20 kN: (a) resistance response of sensor M1-1, (b) resistance response of sensor M1-2, (c) resistance response of sensor L1-1, (d) resistance response of sensor L1-2, (e) resistance response of sensor L2-1, (f) resistance response of sensor L2-2, (g) resistance response of sensor M2-1, (h) resistance response of sensor M2-2, and (i) resistance response of sensor U2-1.

- Figure 17 showed the response results of 60,000 fatigue tests with a 10–20 kN load. When the fatigue cycle of all the sensors reached about 18,000, the resistance response of all the sensors presented different degrees of steps. It indicated that the specimen suffered serious structural damage at this moment, which could affect the response of all the sensors on the specimen.

- When the number of fatigue cycles of all sensors was at around 30,000–45,000 cycles, irregular fluctuations occurred, as shown in Figure 17. The crack was in the accelerated propagation during this time, and the L2-1 and L2-2 sensors fluctuated violently. This indicated that the crack was near the monitoring area of L2-1 and L2-2.

- At each loading stage of the fatigue test, the change rate of the sensor residual resistance on the left side of the specimen was generally lower than that on the right side. Until fatigue failure, the change rate of the residual resistance of the sensor on the left reached 0.25 at most, while the sensor on the right failed completely. It could be inferred that the right sensor's stepped-lap joint surface was completely delaminated. This was consistent with the development results after the failure of the fatigue specimen (Figure 18), which indicated that the carbon nanotube buckypaper sensor could accurately detect the progressive damage of the stepped-lap scarf joint repaired unidirectional tape specimen.

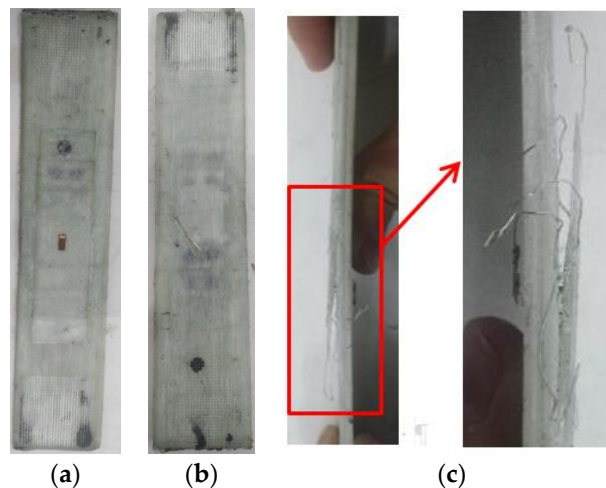
Figure 18. Specimen development of tensile–tensile fatigue failure: (a) face, (b) back, and (c) side.

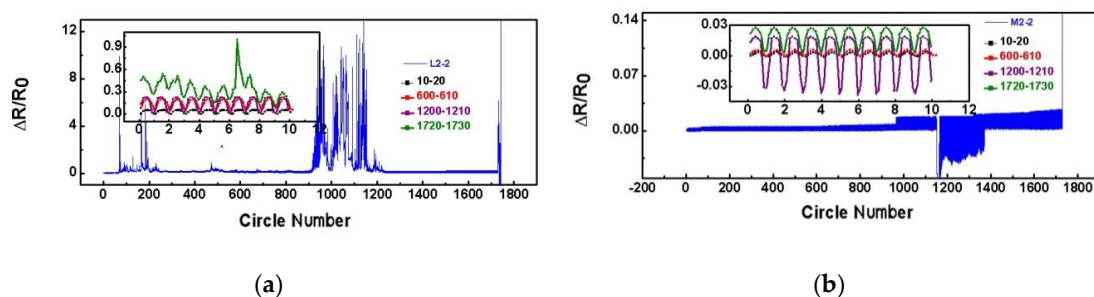
Figure 19. Responses of tension–compression fatigue: (a) resistance response of sensor L2-2 and (b) resistance response of sensor M2-2.

The blade's spar cap was subjected to alternating loads of tension and compression in the field. Therefore, the tensile and compressive fatigue load of -5 to 15 kN was conducted in this test. Under the tension–compression fatigue load, the test was carried out for less than 1800 cycles, and then the patch completely fell off, all the sensors failed, and resistance change rate tended to infinity. The response of the tension–compression fatigue is shown in Figure 19, where the local magnification of resistance change rates with the cycles 10–20, 600–610, 1200–1210, and 1720–1730 are shown as well. The resistance change rate of L2-2 and M2-2 both started to surge when at 900 cycles, but the resistance responses of L2-2 and M2-2 were different. As the number of cycles increased, the resistance change rate at different stages showed deviation. The response of the sensors on the stepped-lap joint surface fluctuated violently after 1200 cycles, which indicated that the buckling delamination damage rapidly accumulated and propagated. The sensors could successfully capture the damage.
