Article Inductive Thermography as Non-Destructive Testing for Railway Rails

Christoph Tuschl¹, Beate Oswald-Tranta^{2,*} and Sven Eck¹

Abstract: Inductive thermography is a non-destructive testing method, whereby the specimen is slightly heated with a short heating pulse (0.1-1 s) and the temperature change on the surface is recorded with an infrared (IR) camera. Eddy current is induced by means of high frequency (HF) magnetic field in the surface 'skin' of the specimen. Since surface cracks disturb the eddy current distribution and the heat diffusion, they become visible in the IR images. Head checks and squats are specific types of damage in railway rails related to rolling contact fatigue (RCF). Inductive thermography can be excellently used to detect head checks and squats on rails, and the method is also applicable for characterizing individual cracks as well as crack networks. Several rail pieces with head checks, with artificial electrical discharge-machining (EDM)-cuts and with a squat defect were inspected using inductive thermography. Aiming towards rail inspection of the track, 1 m long rail pieces were inspected in two different ways: first via a 'stop-and-go' techniq

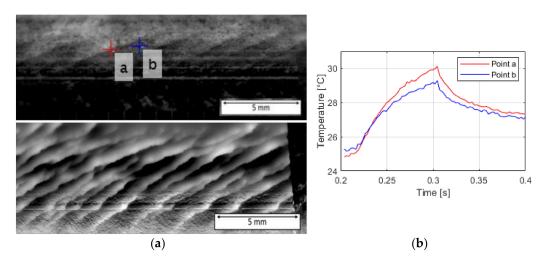
Figure 2. a: Top image: thermogram after an inductive heating pulse of 0.1 s; two points were marked: (a) point on a crack position, (b) point on sound surface; bottom image: phase image for the same measurement; b: temperature vs. time diagram of the heating and cool-down for the two marked points in (a).

The IR camera records the surface temperature during the heating pulse as well as the cooling period after switching off the heating. For the desired crack detection a small temperature increase of 1–2 °C is enough, as can be seen in Figure 2b. Figure 2a shows that cracks on the surface are slightly more heated than the surrounding material. However, it is difficult to detect head checks in a single temperature image as e.g., in the top image of Figure 2a.

where $\tau = t_{pulse} + t_{cooldown}$ and $t_{cooldown}$ is usually taken in the range of $t_{pulse}/2$ and t_{pulse} . In this study $t_{cooldown} = t_{pulse}$ was chosen, but the selection of $t_{cooldown} = t_{pulse/2}$ leads to very similar results to the presented ones. In the bottom image of Figure 2a, the resulting phase image is shown. A phase image emphasizes the differences in the temperature increase during the heating as well as during the cool-down for each pixel. The effect of inhomogeneous heating and inhomogeneous surface property as emissivity is strongly decreased by the transformation [15,21] and the noise in the image is reduced, resulting in a higher signal-to-noise ratio [22].

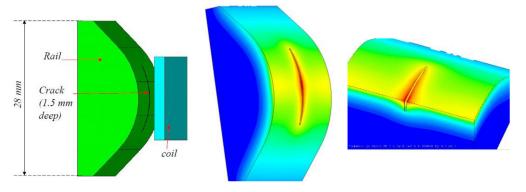
Figure 3. Left side: geometrical model of the rail in the head check region; mid: temperature distribution after 0.1 s inductive heating pulse; right side: half of the same model in order to show the temperature distribution below the surface.

The ANSYS multiphysics simulation package [23] was used to model the inductive thermography measurements of the head checks in the rail. This package has the advantage that different physical phenomena can be simulated in a coupled way, as in this case electromagnetic induction is coupled with thermal calculation. In the first step inductive heating and the distribution of the induced eddy currents are modelled. Based on these results the Joule heating is calculated. In a further step the heat flow due to the generated Joule heating is modelled. The left image in Figure 3 shows the geometrical model of the gauge corner, where typically the head checks occur. The images in the middle and on the right side of Figure 3 show the temperature distribution after 0.1 s inductive heating pulse around a crack, which has at the deepest position 1.5 mm depth. The excitation frequency in the simulation model was 200 kHz and typical pearlitic steel material parameters were used for the rail piece. With these parameters the penetration depth of the eddy current is about 0.03 mm. As this depth is much less than the defect depth, the induced eddy currents flow around the defect, causing a higher current density and higher Joule heating in the vicinity of the crack. Additionally, the heat flow is also hampered by the crack and due to the heat accumulation the region around the crack has a higher temperature than the surrounding surface.

The simulation was set up using 3D hexahedral grids with 20-node elements. The size of the grid was about 0.01 mm in the region close to the surface and around the crack, and the grid size continuously increased towards the regions far away from the crack with a maximum element size of 0.6 mm. The electromagnetic part of the model consists of 296,000 elements, of which 134,000 are modeling the rail piece, 12,000 the induction coil and 150,000 the surrounding air. The thermal modelling was only performed for the work-piece part; the elements of the coil and the air were not included in the thermal calculation.

Several different numerical models were set up by varying the defect depth, its inclination angle below the surface and it's angle at the surface regarding the gauge corner. Further simulation results are presented in Section 5. The temporal change of the simulated temperature was also evaluated by Fourier transformation and this phase image was then compared to the experimental results. The goal of the finite element simulations was to investigate the influence of the crack parameters on the phase distribution. For artificial cracks with known characteristics the simulated and the experimental results can be easily compared, which was used to validate the simulation models. In a further step, this supports the usage of the simulation results also for real cracks where the depth and inclination angle below the surface are not known so that they can be estimated from the simulations. Additional models were also set up, varying the heating pulse duration and the excitation frequency [15]. These models were used to optimize the experimental setup, resulting in the usage of 200 kHz as the excitation frequency and a heating pulse duration between 0.1 and 0.2 s.

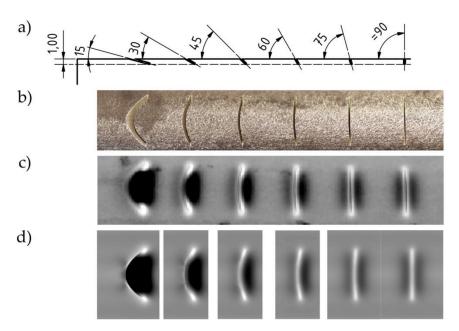
Figure 5. (**a**) CAD drawing of the EDM-cuts; (**b**) photo of EDM-cuts with different penetration angles; (**c**) phase image of EDM-cuts after 0.1 s inductive heating pulse; (**d**) simulation results of the slanted artificial cracks.

Figure 5 shows the results for the other gauge corner on the second side of the reference rail piece RP01. On this side the defect depths of all EDM cuts are identically 1 mm and the inclination angle varies between 90° (perpendicular cut) and 15°, see Figure 5a.

The difference between varying inclination angles in a phase image can be easily recognized in Figure 5c. The EDM cut on the rightest side is perpendicular to the surface and therefore has the same symmetrical feature as described before in Section 4.1. With increasing inclination angle (from right to left) the widths of the darker regions on both sides of the cut become increasingly asymmetrical, as the heat accumulates stronger at the flank with the acute angle. Therefore, the phase image can be used to determine the direction of a crack beneath the surface. Furthermore, estimations of the penetration angle of a crack can be made by using phase images [15]. Figure 5d shows the corresponding simulation results, obtained by a model similar to the one shown in Figure 3. It is noteworthy that the simulation and measurement results agree very well.

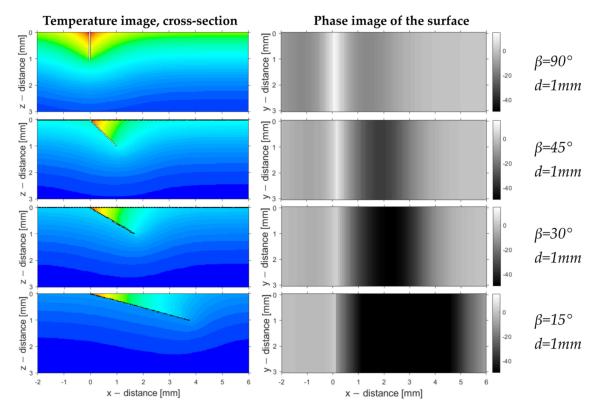
Figure 8. The simulation results for cracks with d = 1 mm depth. The inclination angles are varied from $\beta = 90^{\circ}$ to 15° . The left column of images shows the temperature after 0.1 s inductive heating, and the right one the corresponding phase images.

Further simulations were carried out to investigate how the inclination angle below the surface affects the phase images. In Figure 8 the temperature and phase images are compared for cracks with 1 mm depth but with different angles. The images on the top row show the results for a vertical crack ($\beta = 90^\circ$). In this case the temperature and phase distribution are symmetrical around the crack position at x = 0 mm. As the inclination angle decreases, the length of the crack increases to $d/sin(\beta)$ and the overlapped length $o = d/tan(\beta)$. In the phase image this overlapping can be easily recognized: due to the small inclination angle the heat is captured for longer in this region, causing a low phase value. It is easy to see that the width of the low phase value region corresponds well to the width of the overlapped region. This gives the possibility of recognizing at the surface of the phase image in which direction the crack is inclined and how wide the overlapped region is.

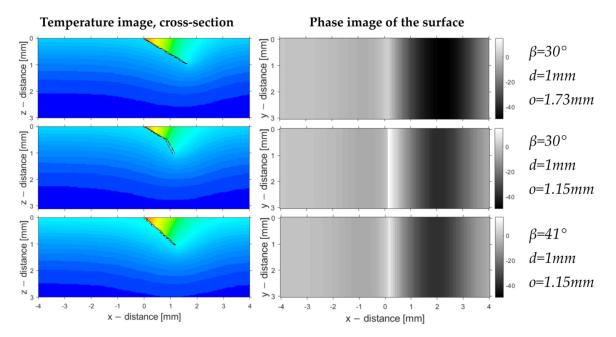
Figure 9. The simulation results for cracks with d = 1 mm depth, investigating the effect of the region width, which is overlapped by the crack below the surface.

Figure 9 demonstrates how the angle below the surface (β), the depth and the width of the overlapped region influence the phase image. In the image at the top, the crack is modelled as a straight line, starting with an angle of 30°. In many cases head checks change

their direction and, after a small starting angle, penetrate under a larger angle into the rail. The image in the middle of Figure 9 shows such a situation. The starting angle and the depth are the same, as in the case at the top image, but the overlapped region is shorter. This can be also noticed in the phase image, as the region with low phase value is narrower. In the case at the bottom of Figure 9, the crack is again modelled as a straight line, having the same depth and overlapped region as in the middle case, but its starting angle is larger with $\beta = 41^{\circ}$. As the overlapped region is the same is in the middle case, the width of the low phase region is also the same. Due to the slightly larger inclination angle to the surface, the phase value is slightly less at the crack position than in the case in the middle.

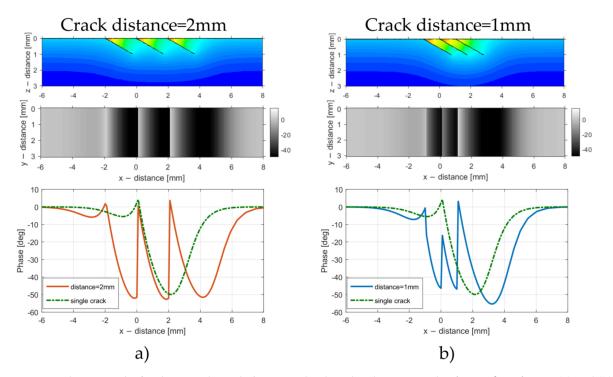
Figure 10. Simulation results for three cracks with d = 1 mm depth and inclination angle of $\beta = 30^{\circ}$. In figures (**a**) and (**b**) at the top: temperature distribution in the cross-section; mid: phase distribution at the surface; bottom: phase profile through the cracks at the surface along the x axis. (**a**): distance between the cracks is 2 mm, therefore they do not overlap each other below the surface; (**b**): distance of the cracks is 1 mm and overlapping each other in the depth.

In typical head check pattern the cracks are close to each other, therefore the question is how the phase distribution around a crack is influenced by the neighboring cracks. In Figure 10 two situations are compared: in one situation the cracks do not overlap each other in the depth and once in the other situation do. All the cracks have a depth of 1 mm and $\beta = 30^{\circ}$. If the distance between cracks is larger than the overlapped region by a crack, then all the phase values at the crack positions are the same and they are also equal to the phase profile around one single crack (see Figure 10a). If the cracks are closer to each other, then the heat is trapped longer between the cracks than would be the case for one single crack, and the phase value around the crack is less (see Figure 10b). In this way it is possible to tell from the phase image of more parallel cracks, whether they are overlapping each other below the surface or not.

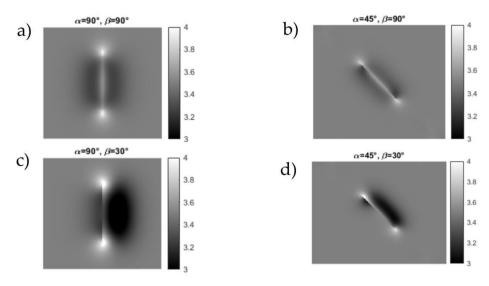
Figure 11. Simulated phase images for cracks with d = 1 mm depth and l = 6 mm length at the surface with different inclination angles at and below the surface. (**a**): the crack is perpendicular to the gauge corner ($\alpha = 90^{\circ}$) and it is perpendicular to the surface ($\beta = 90^{\circ}$); (**b**): the crack has an angle of 45° (α) to the gauge corner and it is perpendicular to the surface ($\beta = 90^{\circ}$); (**c**): the crack is perpendicular to the gauge corner ($\alpha = 90^{\circ}$) and it has an angle of 30° to the surface (β); (**d**): the crack has an angle of 45° (α) to the gauge corner and it has an angle of 30° to the surface (β).

The simulations shown in Figures 8–10 were calculated in a 2D model, so the results are valid for long cracks. The head checks have usually a length about 6–10 mm at the surface. In the mid of the crack the phase values are the same as for a long crack, but at the crack tips additional hot spots occur [24]. In Figure 11 the results are presented simulated with a 3D model, where the crack is placed in the middle of a plane surface. For the 6 mm long and 1 mm deep crack the two inclinations angles are varied. If α is 90°, then the line of the crack is perpendicular to the line of the modelled coil (Figure 11a,c), which is lying in the x direction. The angle β is the inclination angle below the surface; if β = 90° the crack is vertical, which means perpendicular to the surface (Figure 11a,b). In Figure 11a the phase pattern is symmetrical, but in Figure 11b the induced eddy currents flow not perpendicular to the crack, but under 45°, therefore the disturbance in the vicinity of the crack is less and also the phase pattern changes along the crack line. Similarly to previous results, the

inclination angle below the surface causes an asymmetric phase pattern (Figure 11c,d). The phase pattern of Figure 11d demonstrates the case, which is the most similar one to head checks, as it is presented in the next section.

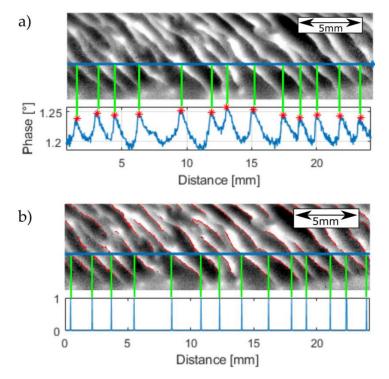
Figure 16. Two options for counting head checks for RP02; (**a**) distances of head checks with profile of the phase image; (**b**) distances of head checks with edge detection.

In Figure 16 two ways of evaluation of the number of head checks as well as their distances on a phase image are shown:

- In Figure 16a the phase profile along a line over the head checks is evaluated, and the maximum values of the profiles are counted. With the image resolution, given as pixels per mm, the average distance between two head checks is calculated. For the case in Figure 16a it gives 13 head checks for 25 mm, resulting an average distance of 1.9 mm.

- Alternatively, the same edge detection algorithm, as in Figure 15, is used to compute the number and the distances of the head checks. Evaluating the results of the edge detection along a straight line produces a plot with peaks where the head checks are located, see Figure 16b. In this case 14 head checks were recognized in the 25 mm distance. As the number of the head checks found along a single line slightly depends on the position of the line, the method was improved in such a way that several lines were taken and an average number of head checks was counted from all of them.
