Article

Microstructure Study on Very High Cycle Fatigue of an Additively Manufactured Aluminium Alloy via Advanced Characterization Methods

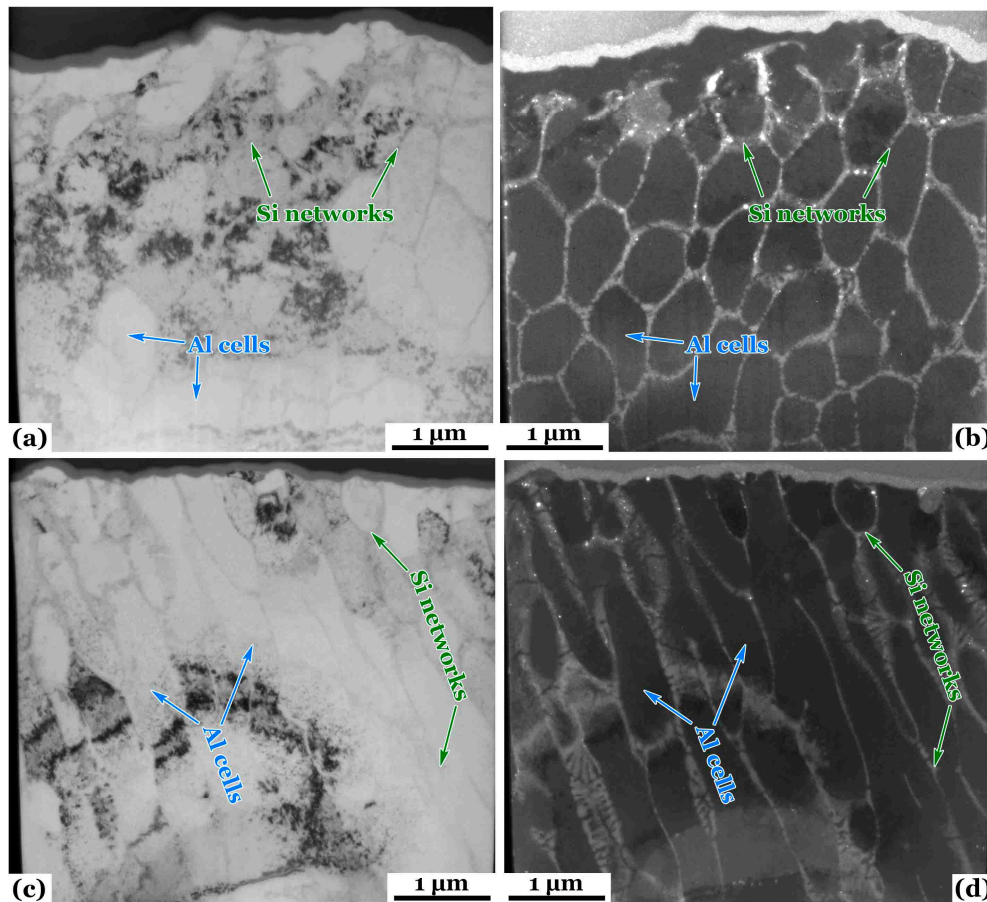
Figure 3. TEM characterizations for sample A1 cut from specimen A: (a) bright-field image, (b) dark-field image. TEM characterizations for sample A2 cut from specimen A: (c) bright-field image, (d) dark-field image. Specimen A printed horizontally and failed by fatigue loading of $R = -1$, $\sigma_m = 1 \text{ MPa}$, $\sigma_a = 93 \text{ MPa}$, and $N_f = 3.67 \times 10^8$ cycles.

TEM samples A1, A2 and B1, B2 were carefully examined through transmitted electrons under 300 kV of accelerating voltage to characterize the profile microstructure along the specimen axes, i.e., perpendicular and parallel to the building direction of the AM aluminum alloy, in a microscope (Tecnai G2 F30 S-Twin, FEI, Hillsboro, OR, USA). Figures 3 and 4 demonstrate bright- and dark-field images of TEM samples A1, A2 and B1, B2, respectively.

In each subfigure of Figures 3 and 4, VHCF loading direction is along the height of the image, and the uppermost curve of the microstructure corresponds to the fracture surface profile. Above the profile curve, there are two protective layers of platinum, the inner one was guided by electron beam, and the outer one was guided by Ga^+ cations, as described in Ref. [4]. In bright-field images of microstructures, the light areas are Al-rich regions, and the gray areas are Si-rich regions. Contributing to different crystallographic orientations of Al and Si [44], the Si-rich regions are quite easy to identify in dark-field images. Contrary to the situation in bright-field images, for dark-field ones, the black areas are Al-rich regions, the white areas are Si-rich regions, and the sparkling particles might be rearranged Si precipitates according to Ref. [17]’s opinion.

In Figures 3 and 4, Si networks and Al cells are typical microstructure features with characteristic size of sub micrometers. Basically, Si-rich regions are interconnected with each other to constitute a continuous web of Si networks, and the rest can be regarded as many isolated islands, namely Al cells. In TEM samples A1 and B1, Al cells and Si networks are near-equiaxed; and in samples A2 and B2, Al cells and Si networks are all elongated. It is noted that the elongation in samples A2 and B2 are with different directions. In comparison with Figures 3a–d and 4c,d, there is only one grain of Al solid solution in sample A1, A2, and B2. This means that all Al cells are with the same orientation, and most

For the distribution of chemical elements, Si networks are broken and disappeared in the profile surface layer of TEM sample A1. As shown in Figure 3b, it seems that Si precipitates with various orientations sparkle along the subsurface of dark-field image. Outside of the surface layer, the Si networks and Al cells in sample A1 are not distinctly different from other TEM samples, except for shapes and orientations. The shapes and orientations of Si networks and Al cells are closely tied with the original AM microstructure, depending on the location of TEM sampling. In addition, the rearranged Si is preferred to precipitate in the region near the fracture surface on the profile microstructure of VHCF loaded specimens.

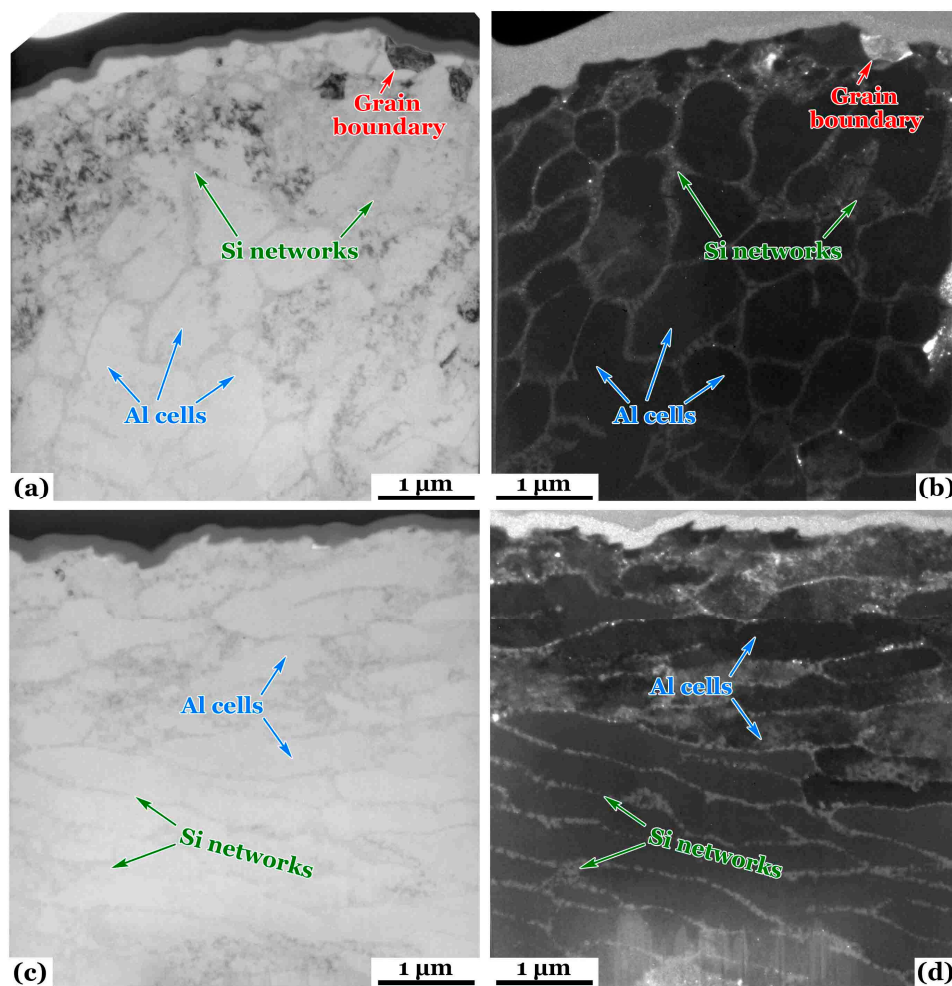
Figure 4. TEM characterizations for sample B1 cut from specimen B: (a) bright-field image, (b) dark-field image. TEM characterizations for sample B2 cut from specimen B: (c) bright-field image, (d) dark-field image. Specimen B printed vertically and failed by fatigue loading of $R = 0$, $\sigma_m = 40$ MPa, $\sigma_a = 40$ MPa, and $N_f = 3.82 \times 10^8$ cycles.

of the Si networks keep another same orientation in these samples. In comparison with Figure 4a,b, only a few (two or three) nanograins with size about hundreds of nanometers appear in the upper right corner of sample B1, and the grain boundaries are clearly visible. In the neighbor of nanograins, there is still only one big grain whose equivalent size is larger than 6 μm .
