Thermal Behavior of Tunnel Segment Joints Exposed to Fire and Strengthening of Fire-damaged Joints with Concrete-filled Steel Tubes

Abstract: Owing to its discontinuous configuration, segment joint is of particular concern when the shield tunnel lining is exposed to fire. The thermal behavior of such joints when exposed to fire was investigated experimentally in full scale. In addition, the effectiveness of using concrete-filled steel tubes (CFSTs) to restore joint strength after a fire was also investigated. Five full-scale reinforced concrete segment joints were fabricated. Four were exposed to the ISO 834 standard fire for 60 or 120 min, with the fifth serving as a control. Two fire-damaged specimens were then strengthened with CFSTs. All five specimens were then loaded to failure at room temperature. It was found that: (1) The effect of the joint gap on the temperature distribution was observed to change markedly during heating; (2) the temperature of the bolt end was much higher than that of the bolt mid-point, insulating the bolt ends is probably called for; (3) the bearing capacity and flexural stiffness of the fire-damaged segment joints can be significantly improved by st

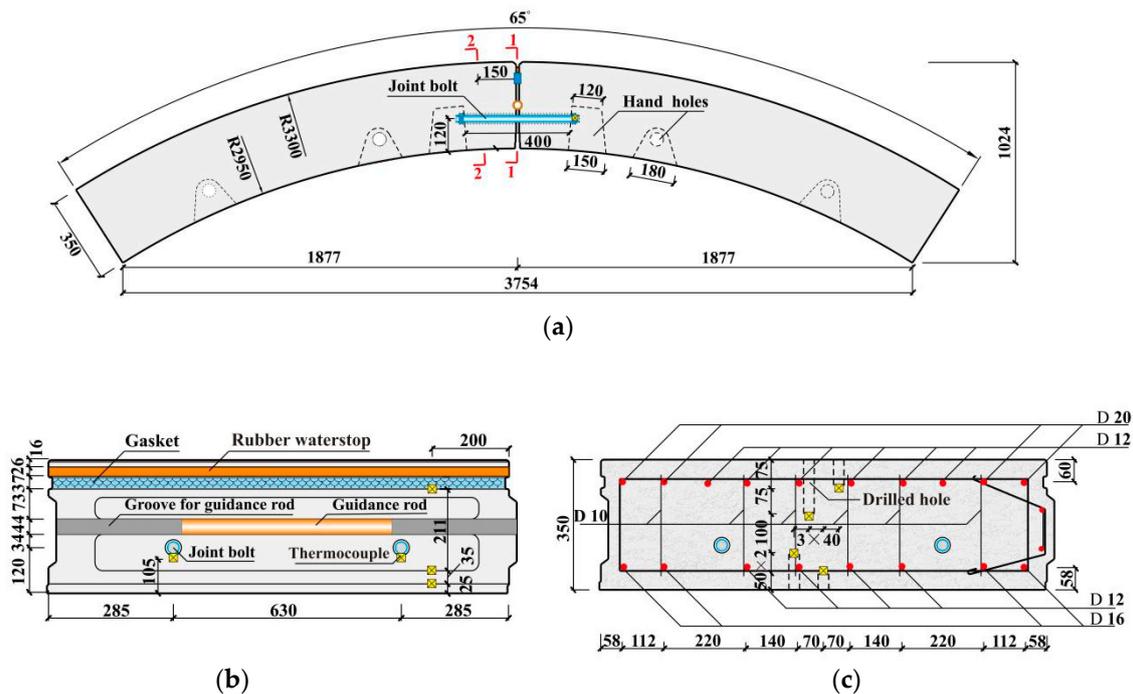
In general, the tunnel ceiling is more susceptible to fire damage than other parts of the tunnel lining [17]. In view of this, the specimens represented a typical tunnel ceiling. Figure 1 presents a schematic diagram and the reinforcement details of the specimens. Each specimen was composed of two neighboring segments, which were identical to the segments used in the Shanghai Metro tunnels. The two segments were tightly jointed by two straight steel joint bolts (grade 6.8; 30 mm in diameter and 485 mm in length). The pre-tensioning of the joint bolts was estimated to be 115 kN based on the bolt strain.

Figure 1. Schematic diagrams and reinforcement details of segmental joint specimen (unit: mm). (a) Elevation view; (b) section 1-1; (c) section 2-2.

For the fire tests, thermocouples were installed on the specimens. Their layout is presented in Figure 1. Three thermocouples were installed in Section 1-1 to monitor the temperature of the joint gap. In addition, four further thermocouples were used in Section 2-2 to measure the concrete temperature. To install the thermocouples in Section 2-2, four holes with a diameter of 10 mm were drilled 40 mm apart along the segment's width. Afterward, the holes were filled with cement paste. Owing to the joint configuration, most of the length of the joint bolts was entirely within the bolt holes and hardly experienced any direct fire exposure. Only the protruding bolt ends were exposed to the fire. To investigate the temperature histories of the joint bolts, one thermocouple was fixed to the end of one of the bolts and another was carefully placed at the same bolt's mid-point (see Figure 1a,b).

Figure 1b,c show that the positions of the thermocouples along the segment thickness at Section 1-1 and Section 2-2 were different. ABAQUS software was therefore used to develop numerically a temperature distribution at Section 2-2, so the temperature distributions at the two sections could be compared. The meshes of section 2-2 are presented in Figure 9. The segment’s concrete was meshed with eight-node solid heat transfer elements (DC3D8). The thermal properties of the concrete, including the density, specific heat capacity and heat conductivity were assumed based on the Eurocode 2 standard [24]. The density of the concrete at room temperature was set to 2350 kg/m³. The specific heat c_c (J/kg·°C) for a moisture content of $u = 0$ in the concrete was calculated using Equation (2). The effect of water evaporation on the temperature in the concrete was considered by adjusting the specific heat of the concrete: The maximum ($c_{p, peak}$) of the specific heat was at 100–115 °C followed by a linear decrease in the specific heat between 115 and 200 °C (see Figure 10). $c_{p, peak}$ was taken as 1470 and 2020 J/kg·°C for concretes with moisture contents of $u = 1.5\%$ and 3% , respectively. The moisture content u was set to 2.6%, the $c_{p, peak}$ was set to 1873 J/kg·°C in that calculation. The upper and lower limits of the thermal conductivity λ_c of the concrete were determined using Equation (3). The value of α was set to 0.5. The convective heat transfer coefficients were 25 W/m²·K for the heated surfaces and 9 W/m²·K for the others. The resultant heat emissivity on the surface of the concrete was set to 0.5.

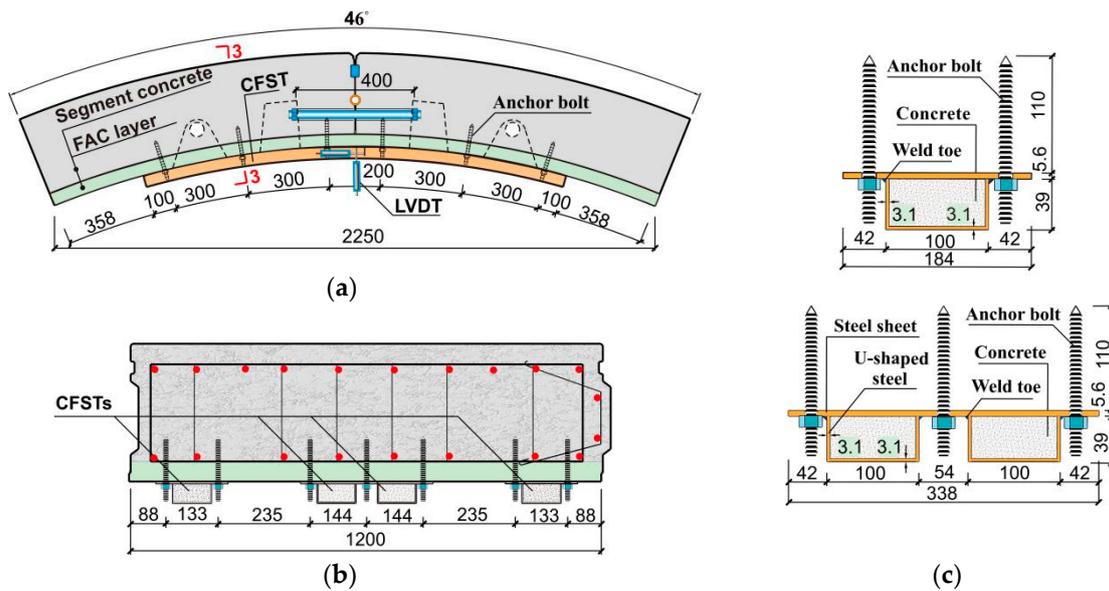
In order to meet the dimensional requirements of the load testing equipment, all specimens were cut after the fire treatment. The joint bolts were then retightened to recover the pre-loading, which decreased during the fire treatment. Afterward, S60C and S120C were repaired using fine-aggregate concrete (FAC) and strengthened with curved CFSTs. The details are presented in Figure 2. The repair and strengthening process comprised three steps:

Figure 2. Details of strengthened specimen (unit: mm). (a) Elevation view; (b) section 3-3; (c) details of concrete-filled steel tubes (CFSTs).

In the loading tests, four linear variable differential transformers (LVDT) were installed on the internal segment edge to measure any joint opening and mid-span deflection during the flexure tests (see Figure 2a). The calibrated range and accuracy of the LVDTs were 100 mm and 0.01 mm, respectively. To obtain the strain profile in the CFST at different load levels, a series of strain gauges was installed on the tubes' surface. The positions and numbers of the strain gauges are presented in Figure 3.

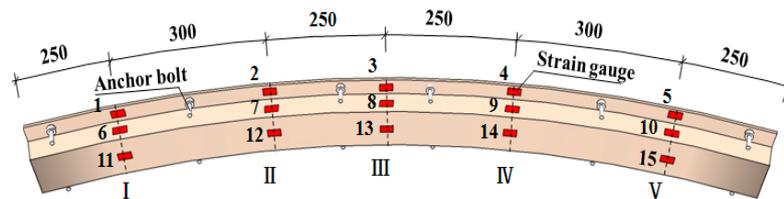
Figure 3. Arrangement of strain gauges (unit: mm).

Figure 17 presents the strain profiles in the strengthening parts of Specimens S60C and S120C under different load levels. The details of the strain gauges are presented in Figure 3. It can be observed that:

The variation in the local shear force between the strengthener and the segment can reflect the performance of the local connection between the strengthener part and the segment. The five sections (I–V) defined in the longitudinal direction are shown in Figure 3. Assuming that the plane-section assumption still applies, the longitudinal strains at different positions in each section can be determined quantitatively based on the measured strains obtained from strain gauges 1–15. Thus, the axial force on each section can be obtained via an integration of the observed stress distribution. The elastic modulus of the steel was assumed to be 200 GPa. Any hardening of the steel after yielding and any contribution of the core concrete in tension were neglected. The local shear force between the strengthener and the segment was determined via the difference in axial force between neighboring sections, as presented in Figure 18. The following observations were made:

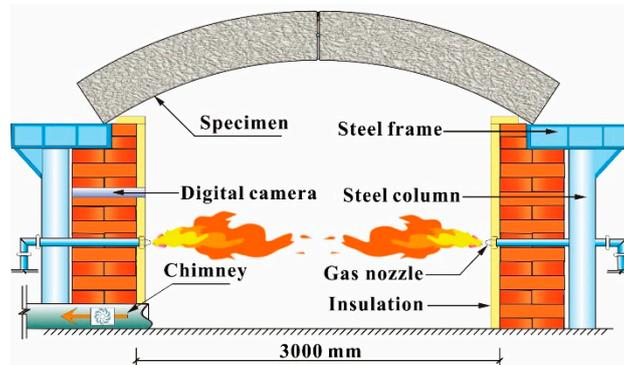
As presented in Figure 4, the furnace consisted of a steel frame supported by four steel columns and a fire chamber. The fire chamber had firebrick walls and insulation plates. Natural gas was injected through four nozzles to provide the thermal energy. The flow was automatically adjusted to maintain the desired chamber temperature. To observe spalling of the specimens during the fire tests, two digital cameras with a water-cooling system were installed on two adjacent walls of the chamber. At the chamber bottom, two chimneys removed the smoke. The specimens were supported by the steel frame (see Figure 4), and the undersurfaces of the specimens were exposed to the fire. The fronts and backs of the specimens were insulated with ceramic-fiber plates.

Figure 4. Setup of fire test.

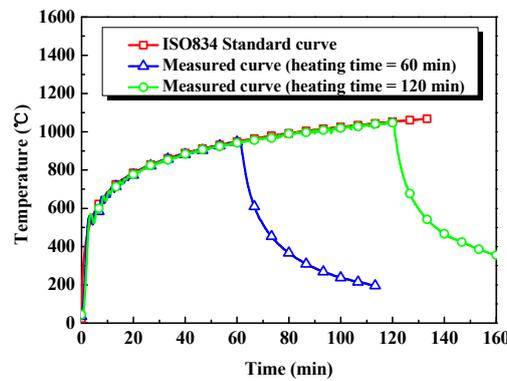
Figure 5. Measured temperature-time curves in the furnace chamber.

fire experiments. No load was imposed on the specimens during the heating. After the required heating time, the furnace was turned off, and the specimens were allowed to cool to ambient temperature. A comparison of measured time-temperature curves in the furnace chamber and the ISO 834 standard curve is presented in Figure 5. Evidently, the curves are in a good agreement.

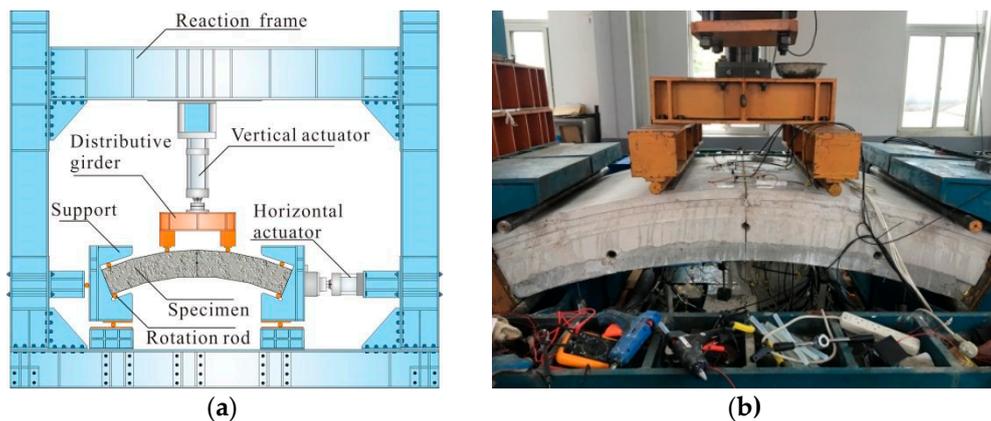
Figure 6. Setup of loading test. (a) Schematic diagram; (b) photo.

Based on the load equivalence principle and the mechanical characteristics of the tunnel lining, all of the specimens were tested using the TJGPJ2000 facility at Tongji University after the fire tests. The TJGPJ2000 equipment consists of a reaction frame, supports for the specimen, and horizontal and vertical loading systems (see Figure 6). The horizontal loading system consists of two 1000 kN hydraulic actuators. The vertical loading system has a 1500 kN hydraulic actuator. The maximum travel ranges for the horizontal and vertical hydraulic actuators are 150 and 200 mm, respectively. The vertical load (F_v) was applied at two points 800 mm apart via a distributive girder (see Figure 6).

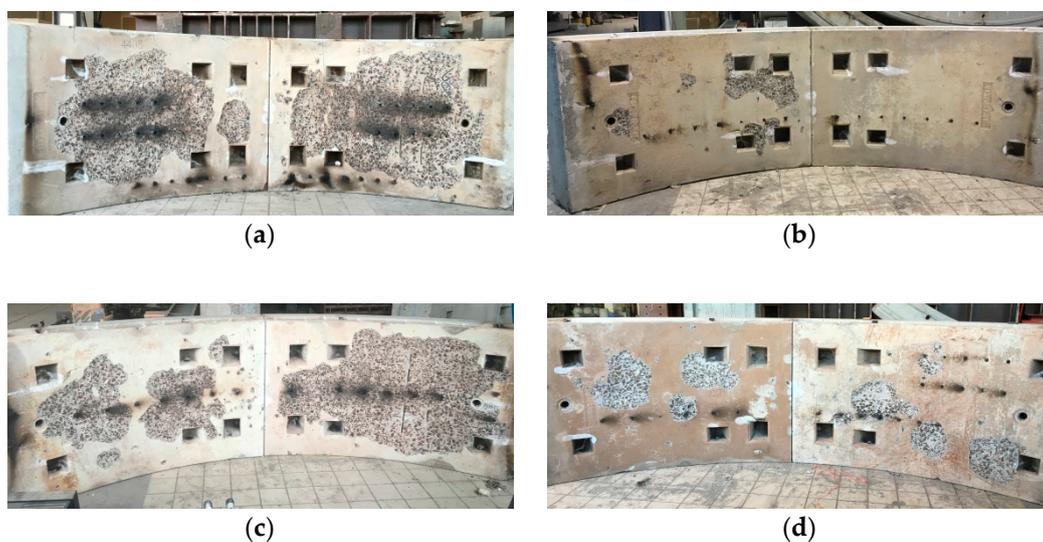
Figure 7 presents images of the specimens after the fire tests. Spalling occurred on the heated surfaces of the different specimens. The first significant spalling was observed through the digital camera during the first 8–15 min of the fire tests. The spalling lasted approximately 12–22 min, and mainly occurred at furnace temperatures of 645–856 °C. The spalling of Specimens S60, S120, and S120C was more severe than that of S60C because the moisture content of those three samples (see Table 1) was higher. A higher moisture content is known to promote spalling [22].

Figure 7. Concrete spalling after fire exposure (MESD: maximum explosive spalling depth in mm; SAR: ratio of the spalled area to the area of the specimen's soffit). (a) Specimen S60 (MESD = 48.5, SAR = 45.7%); (b) specimen S60C (MESD = 29.1, SAR = 5.5%); (c) specimen S120 (MESD = 56.2, SAR = 38.8%); (d) specimen S120C (MESD = 25.6, SAR = 17.2%).

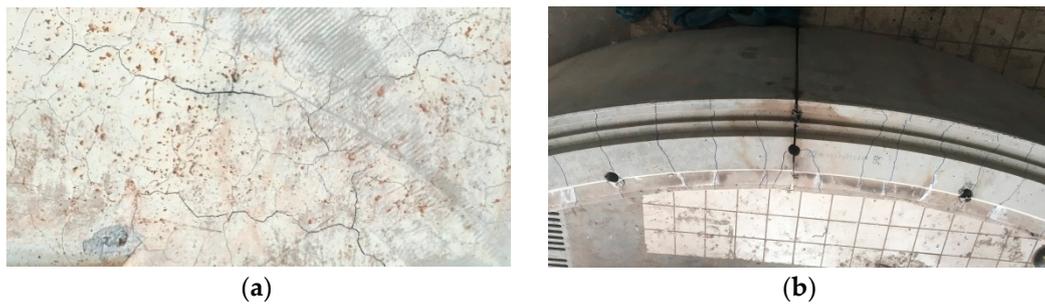
After the specimens had cooled to room temperature, extensive map cracks were found in the un-spalled regions of the heated surfaces, and the color of the concrete surface had turned light yellow (see Figure 8a). In addition, a few vertical cracks spaced about 200 mm apart were observed on both the front and back of the different specimens (see Figure 8b). They can be attributed to the following reasons: (1) The excessive expansion of the concrete at elevated temperatures; and (2) the incompatible expansions and contractions of the concrete and steel reinforcements during heating and cooling [23]. Owing to the structural characteristics of a tunnel lining, the vertical cracks within the circumferential joints between the segments would be difficult to discover and repair. Evidently, sufficient attention must be devoted to these vertical cracks, which would eventually aggravate the deterioration of the tunnel lining after a fire.

Figure 8. Cracks of specimen. (a) Cracks on the soffit; (b) cracks on the front and back surfaces.

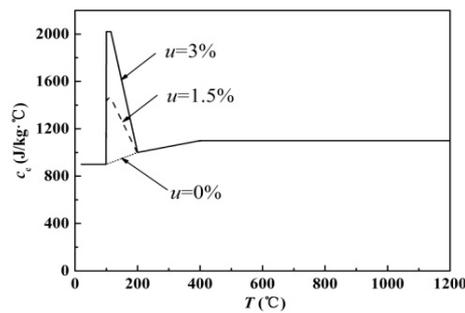
Figure 10. Specific heat of concrete as a function of temperature with different moisture contents.

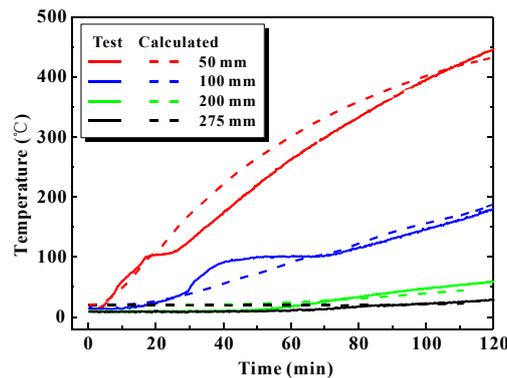
Figure 11 compares the calculated and measured temperature–time curves at Section 2-2 of Specimen S120C. In general, the calculated results agree well with the measured results, so the numerical method provides a good prediction of the temperatures at any point on Section 2-2.

Figure 11. Comparison of calculated and recorded temperature-time curves related to Section 2-2 of Specimen S120C.

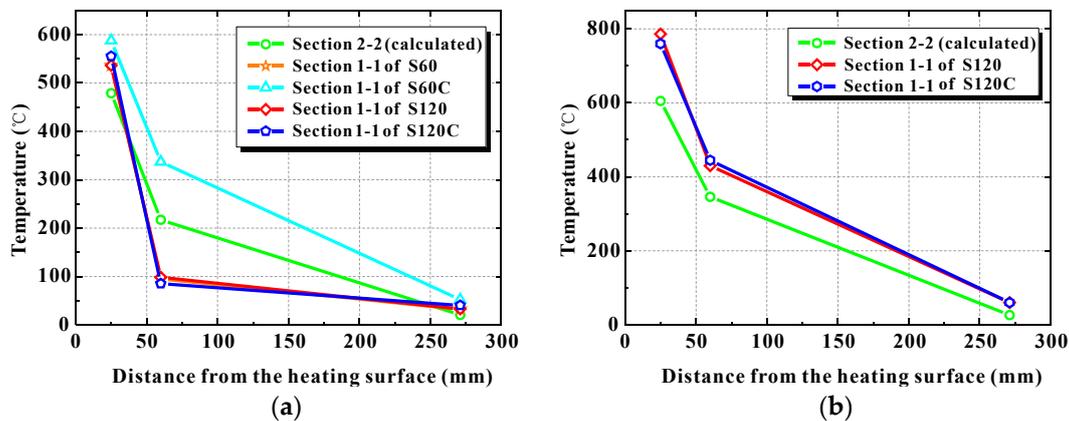
Figure 12 compares the measured temperatures at Section 1-1 with the calculated temperatures at Section 2-2 for the different specimens. The following can be observed:

Figure 12. Comparison between measured temperatures at Section 1-1 and calculated temperatures at Section 2-2. (a) Heating time = 60 min; (b) heating time = 120 min.

(1) The temperatures at both Section 1-1 and Section 2-2 rapidly declined with distance from the heated surface in all of the specimens.

(2) For a heating time of 60 min, in Specimens S60, S120, and S120C, the temperature at Section 1-1 declined more sharply than that at Section 2-2 for the first 25–60 mm from the heated surface. Between 60 and 270 mm, however, the temperature at Section 1-1 declined more gradually than that at Section 2-2. In addition, the temperature at most of Section 1-1 was below 100 °C and lower than that at Section 2-2. This is probably because water vapor released from the concrete accumulated in the narrow joint gap and barely dissipated. That would have hindered heat transfer into the joint gap to

(3) For a heating time of 120 min, the temperature at Section 1-1 was higher than that at Section 2-2. This is because all of the moisture within the joint gap eventually dissipated with the longer heating time. Heat then penetrated the gap, increasing its temperature. Yan [4] observed a similar phenomenon in fire tests with reduced-scale segment joints. In his study, the surface temperature of the concrete near the joint was higher than that farther away. This is mainly due to heat being transferred into the joint gap, the nearby concrete was heated on two sides. Note, though, that this is different to what was observed by Wu and his co-workers [5]. They observed that the temperature in the crack was lower than that of the neighboring concrete. This is presumably because the joint opening tested here (9.5–11.8 mm) was much larger than the crack width in Wu's tests (0.5–3 mm).

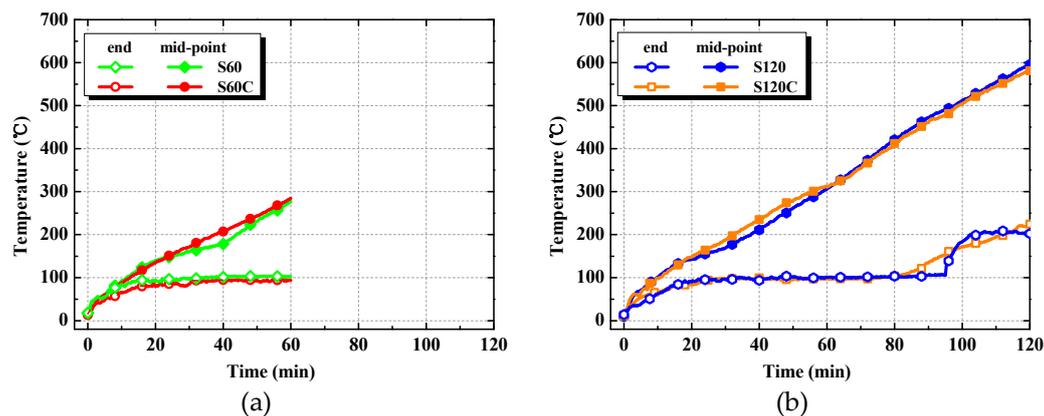
Figure 13 presents temperature–time curves for the joint bolts. The temperatures of the bolt ends were much higher than those in the mid-point during the entire heating process. The temperatures of the bolt ends increased approximately linearly with heating time, and reached a critical temperature of 300 °C [25] after approximately 60 min, and 596 °C after approximately 120 min. To guarantee that the temperature of the joint bolts does not exceed the allowable value in a real tunnel fire, the bolt ends may need to be insulated.

Figure 13. Measured temperature–time curves of joint bolts. (a) Heating duration = 60 min; (b) heating duration = 120 min.

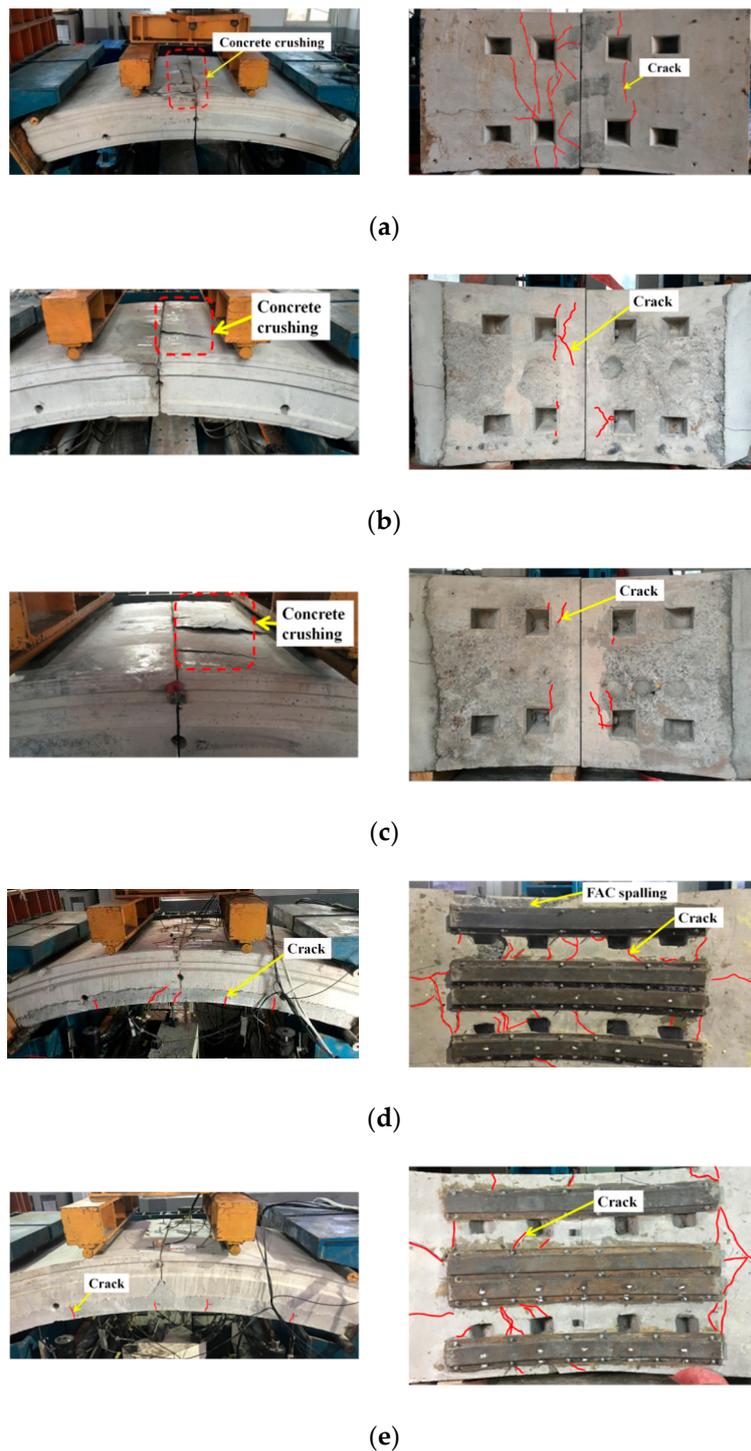
Figure 14 presents the final failure patterns of all of the specimens after the mechanical tests. The following can be observed:

(1) The failure modes of the unstrengthened specimens S60 and S120 were similar to that of untreated specimen S0. All three specimens primarily experienced concrete crushing in the compression region of the joint. However, flexural cracks in the tensile zones of the former two specimens were fewer than in the latter.

(2) The failure patterns of strengthened specimens S60C and S120C were similar. Flexural cracks were observed on the back and front of the FAC, however they did not obliquely propagate deep into the segment concrete. In addition, some cracks in the direction of the anchor bolt's root were found on the tension side of the specimens, and these cracks were resulted from the shear force transmitted from the bolts to the FAC. After the occurrence of the shear cracks, the restraint effect of surrounding FAC on the anchor bolts reduced, resulting in a certain bending deformation of the bolts. However, fracture of the anchor bolts was not observed during the loading tests. The epoxy adhesive between the strengthening members and the FAC experienced some local failure, and local debonding between the FAC and the segment concrete was observed.

Figure 14. Concrete crushing and cracks. (a) Specimen S0; (b) specimen S60; (c) specimen S120; (d) specimen S60C; (e) specimen S120C.

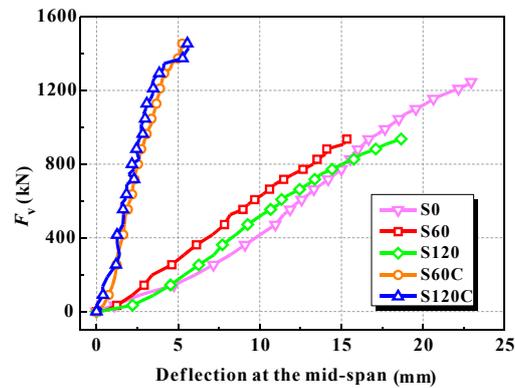
Figure 15. Load versus mid-span deflection.

The relationship between the applied load and mid-span deflection for all of the specimens is presented in Figure 15. The following can be observed:

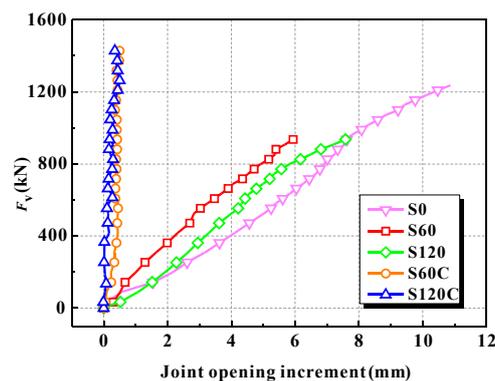
Figure 16. Load versus joint opening increment.

Joint opening is an important indicator of deformation in a shield tunnel and it is often investigated to assess a tunnel's safety [28]. Figure 16 presents the joint opening increment versus vertical loading data for all of the specimens. It shows that:

(1) The joint opening increments of the unstrengthened specimens S60 and S120 were smaller than that of the untreated specimen S0 under equal loads. The previously-mentioned explanation is that the rotational stiffness of the fire-damaged joints became higher than that of the untreated specimen when the joint bolts were re-tightened after the fire test.

(2) The joint opening increments of strengthened specimens S60C and S120C were generally similar. At the end of the loading process, an increment of only 0.5 mm was observed, which was significantly smaller than those of the unstrengthened and untreated specimens.

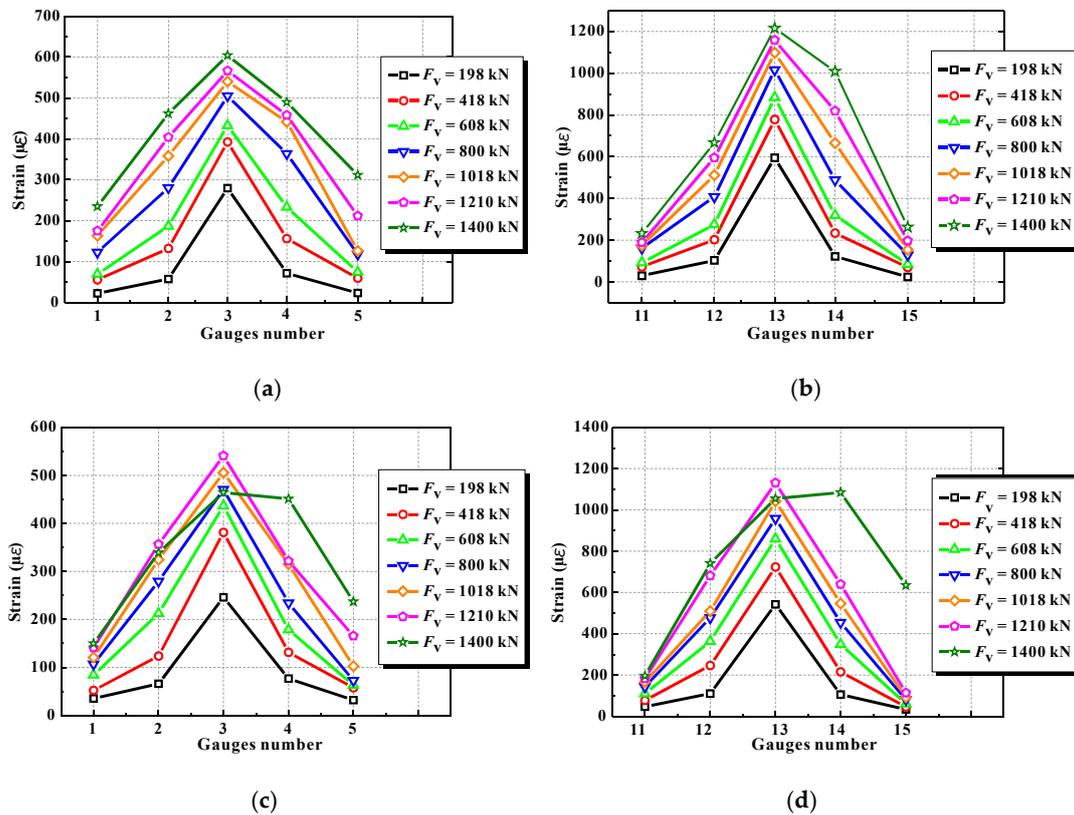
Figure 17. Measured steel strains of Specimens S60C and S120C. (a) Gauges 1–5 for Specimen S60C; (b) gauges 11–15 for Specimen S60C; (c) gauges 1–5 for Specimen S120C; (d) gauges 11–15 for Specimen S120C.

(1) All of the positions where strain gauges were attached were in tension. The deformations were approximately symmetrical about the mid-span. Further, the maximum and minimum strains were at the mid-span and the ends of the strengthening parts, respectively.

(2) The strains recorded by gauges 11–15 were much higher than those of gauges 1–5 throughout the entire loading process. Thus, the strengthening played a significant role in determining the tension and bending resistance.

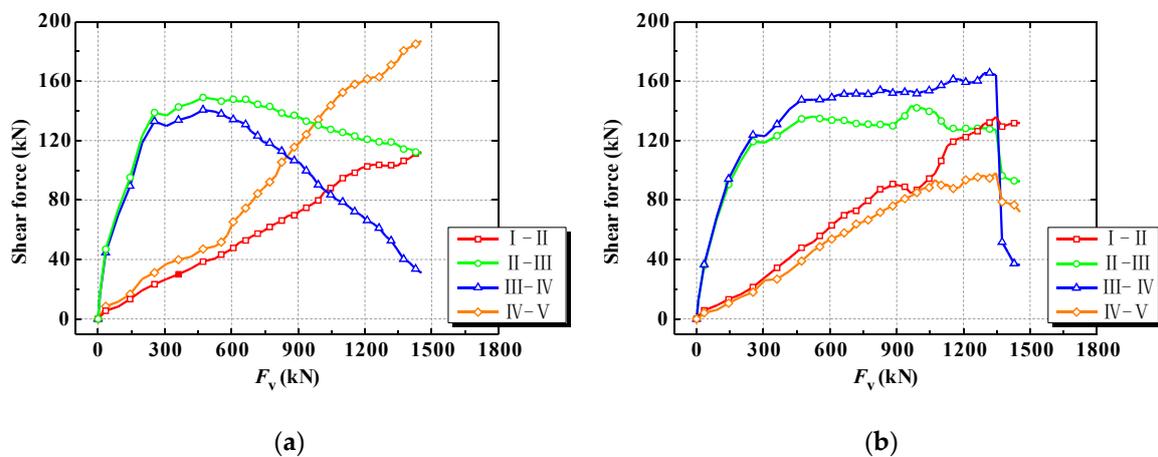
Figure 18. Local shear force between the CFST and the segment. (a) Specimen S60C; (b) specimen S120C.

(1) Regarding Specimen S60C, when the applied load was less than 17.5% of $F_{v, \max}$ the local shear force in regions II–III and III–IV increased much faster than in regions I–II and IV–V. There was thus significant strengthening near the joint during the initial phase of loading. Beyond 32.5% of $F_{v, \max}$, the local shear forces in regions II–III and III–IV reached their maxima and then decreased gradually with increasing applied load. The local shear force in regions I–II and IV–V increased continuously. Thus, when the applied load exceeded 1/3 of $F_{v, \max}$, the strengthening effect near the joint began to weaken, whereas far from the joint it was greater.

(2) Regarding Specimen S120C, when the applied load was less than 17.5% of $F_{v, max}$ the trends in the local shear forces of the various regions were similar to those of S60C. Between 17.5 % and 90.6% of $F_{v, max}$ the shear force in regions I–II and IV–V increased faster than in regions II–III and III–IV. When the applied load exceeded 90.6% of $F_{v, max}$ the local shear forces in regions II–III and III–IV suddenly dropped. The connection between the strengthener and the segment was severely damaged in regions II–IV, and the strengthening effect mostly depended on the part far from the segment joint.
