Very High Cycle Fatigue Properties of 18CrNiMo7-6 Carburized Steel with Gradient Hardness Distribution

Keywords: carburized gear steel; very high cycle fatigue; stress intensity factor; fatigue prediction model

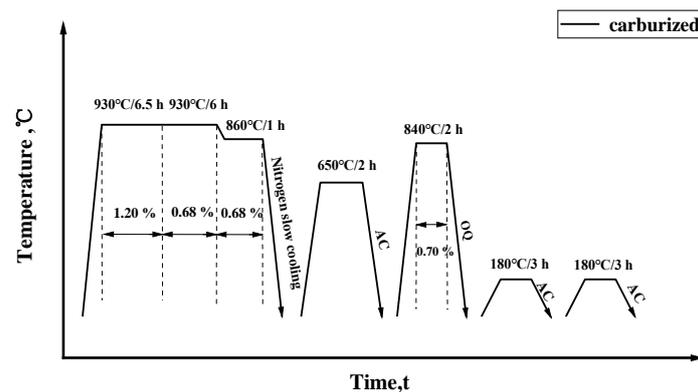
Figure 1. Carburizing heat treatment process, and the underlined data indicates the carbon potential.

The experiment materials used in this investigation were low-carbon gear steel, and the composition is listed in Table 1. All the specimens from 80-mm-diameter hot-rolled bars were machined hour-glass shapes with finishing margins. Then, the carburizing heat treatment process was conducted, as shown Figure 1. The specimens were carburized at 930 °C firstly at a carbon potential of 1.20% for 6.5 h and, then, at a carbon potential of 0.68% for 6 h, followed by carbon diffusion at 860 °C for 1 h. The gas-quenching specimens were then tempered at 650 °C for 2 h and air-cooled. After being tempered, the specimens were heated at 840 °C for 2 h and oil-quenched in a furnace (Beijing Research Institute of Mechanical & Electrical Technology, Beijing, China) with a carbon potential of 0.70% to avoid decarburization. At last, the twice-low-temperature tempering was conducted at 180 °C for 6 h. After the carburizing heat treatment, all the specimens were finely ground to the final dimensions of the USF-2000 ultrasonic fatigue testing machine (Shimadzu, Kyoto, Japan) to ensure surface accuracy and axiality, as shown in Figure 2.

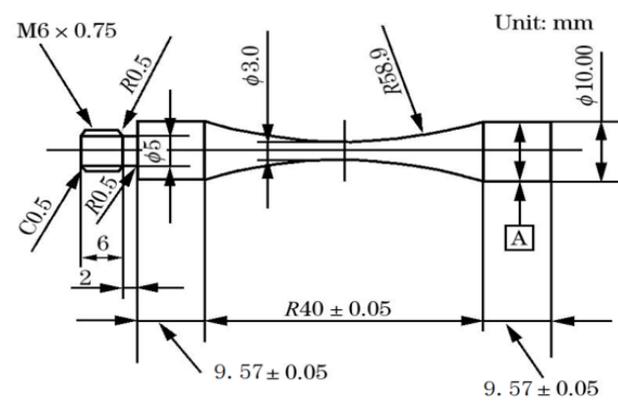
Figure 2. Final machined dimensions and shape of the specimen.

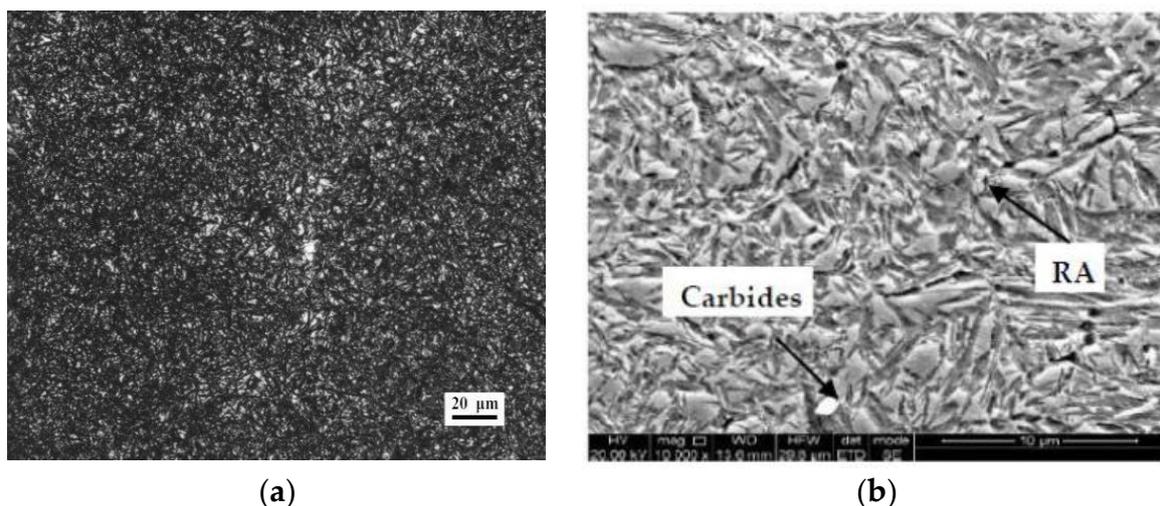
Figure 3. OM and SEM of the carburizing layer: (a) optical microscope microstructure of the carburizing layer and (b) electron microscope microstructure of the carburizing layer.

Figure 3 presented the microstructural features of the carburized layer on the surface of the carburized specimen, and Figure 4 presented the microstructural features 1.0 mm away from the surface of the carburized specimen by OM and SEM, respectively. Figure 3 illustrates that the microstructure of the carburized layer consisted of acicular martensite and retained austenite, and carbides could be observed in the carburized layer. Figure 4 shows that the microstructure at 1.0 mm away from the surface of the carburized specimen mainly consisted of lath martensite and carbide, and there was a little residual austenite and acicular martensite. The microstructure characteristics of these different locations are different mainly because the carbon content of the section is not uniform after the carburizing heat treatment. The carbon content of the surface is the highest, and the carbon content decreases with the distance from the surface and eventually tends to the matrix carbon content [27]. Due to the difference in carbon contents, the martensite phase transformation structure and phase transformation temperature are different [28]. The high carbon will form acicular martensite, and low carbon will form lath martensite. The transformation of high-carbon martensite in the formation process is not complete, with a certain amount of residual austenite and low-carbon martensite with a little amount of residual austenite.

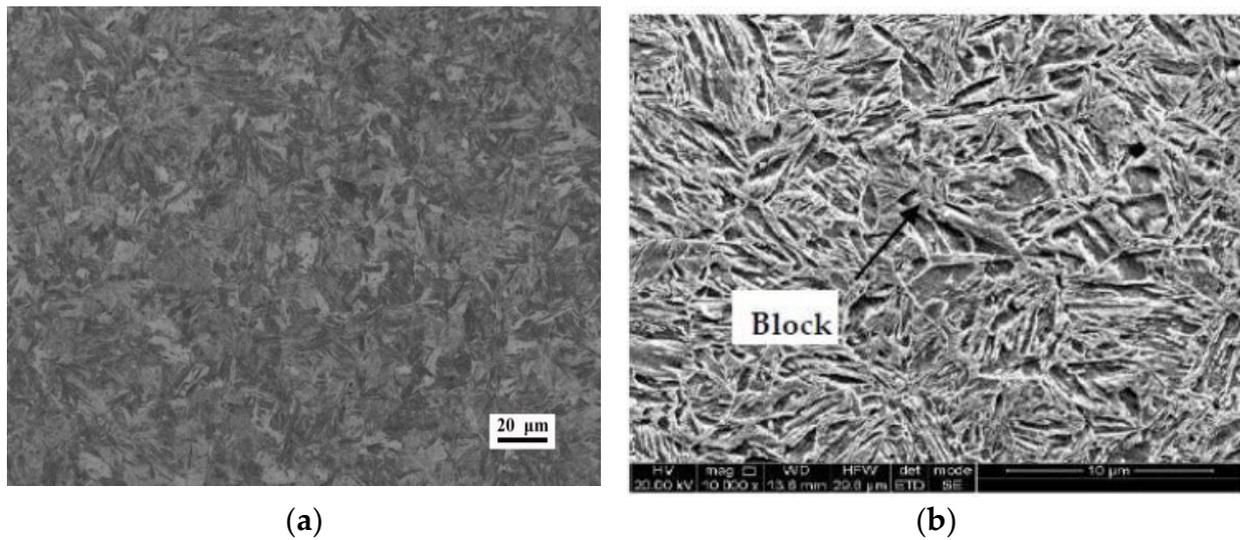
Figure 4. OM and SEM images of the area 1.0 mm from the surface: (a) optical microscope microstructure image and (b) scanning electron microscope microstructure image.

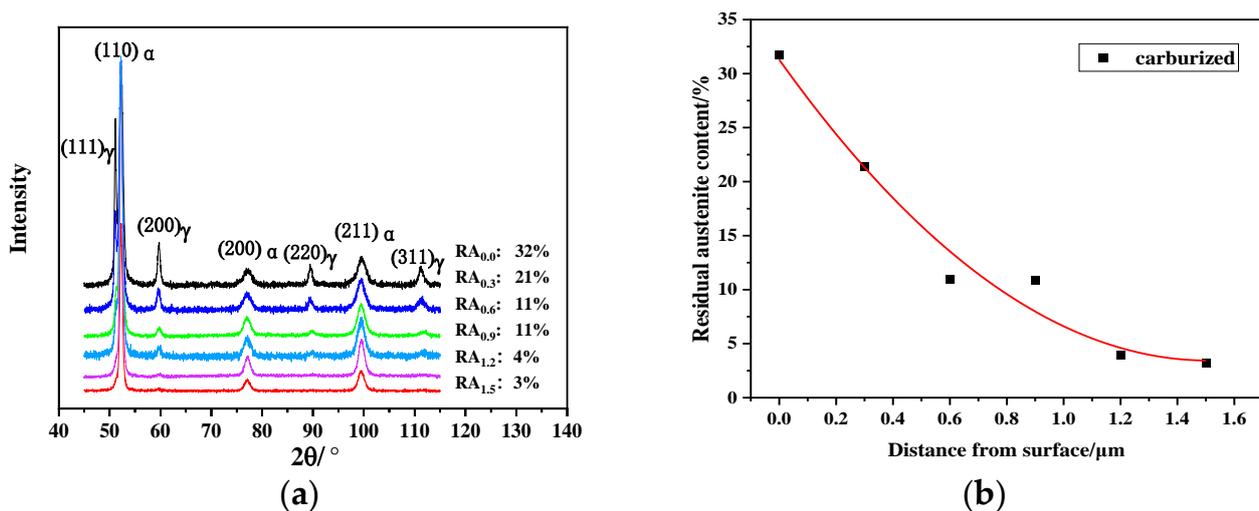
Figure 5. The XRD patterns of the experimental steel at different depths of 0~1.5 mm from the carburized surface show different fractions of retained austenite (RA): (a) XRD RA results and (b) RA changes with the surface distance.

Since the surface of the carburized layer contains a large amount of residual austenite, it has a significant effect on the hardness and fatigue. The content of the retained austenite at different depths of the carburized specimen was measured by XRD, with the spectra shown in Figure 5. According to the peak strength measured by XRD, the peak strength of martensite and austenite was calculated by using Jade software, and the content of residual austenite was calculated according to different peak strengths. The maximum residual austenite content of the carburized specimen is 32% on the largest surface of the specimen, and the residual austenite content decreases gradually with the increase of the depth from the surface. The residual austenite contents at 0.3, 0.6, 0.9, 1.2, and 1.5 mm of distance from the sample surface are 21%, 11%, 11%, 4%, and 3%, respectively. From the distribution of the residual austenite content in the carburized layer, the relationship between the residual austenite content and the depth of the carburized layer is nonlinear. The carburization process can increase the surface hardness and improve the fatigue and wear resistance of the material; at the same time, due to the high surface carbon content of carburizing, the residual austenite content of the surface due to high-carbon martensite cannot be completely transformed and increased [15,29].

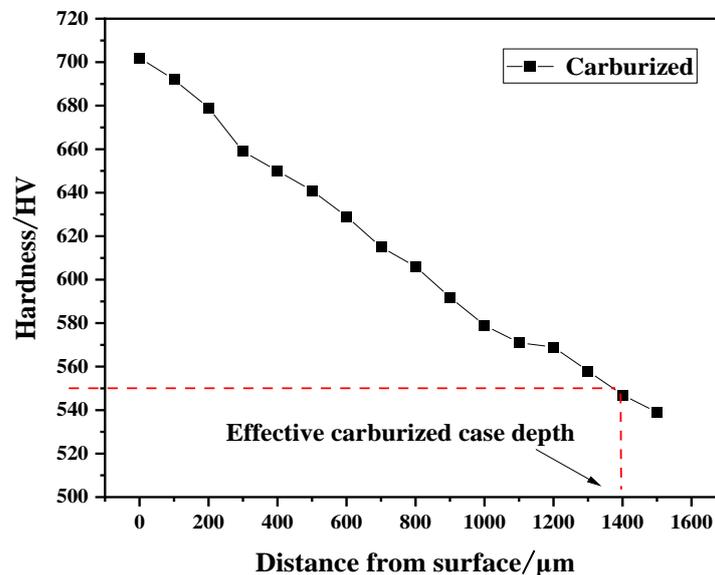
Figure 6. Cross-sectional distributions of microhardness of the experimental steel.

The cross-sectional distribution of the microhardness in the carburized specimen is shown in Figure 6. It can be seen that the hardness decreased linearly with the distance from about 705 HV in the near-surface case to about 530 HV in the core. If a hardness of 550 HV is defined as the critical value of hardening, the effective case depth was about 1.4 mm, indicating that the specimens were carburized deeply under the present carburizing process. Compared with the matrix hardness of 442 HV for the experimental steel after pseudo-carburizing [22,30], the hardness of the carburized specimens was remarkably increased by the carburizing treatment. Figure 6 presents the cross-section microhardness of the fatigue specimens after the carburizing process. It can be seen that the hardness decreased linearly with the distance, from about 705 HV in the near-surface case to about 530 HV in the core. If a hardness of 550 HV is defined as the critical value of hardening, the effective case depth was about 1.4 mm, indicating that the specimens were carburized deeply under the present carburizing process. Compared with a matrix hardness of 442 HV for the pseudo-carburizing steel [22], the hardness of the carburized specimens was tremendously increased. Zhao et al. [30] indicated that, although the carburization changed the distribution of the microstructure and hardness, the distribution of the elastic

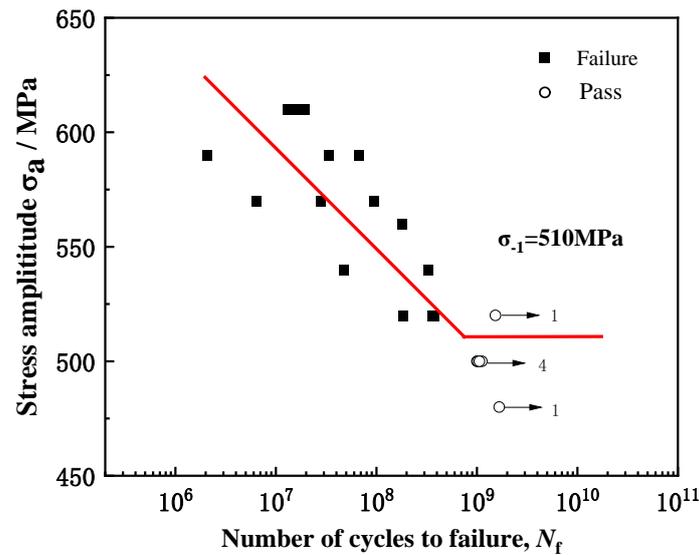
Figure 7. S-N curve of a carburized specimen during an ultra-high cycle.

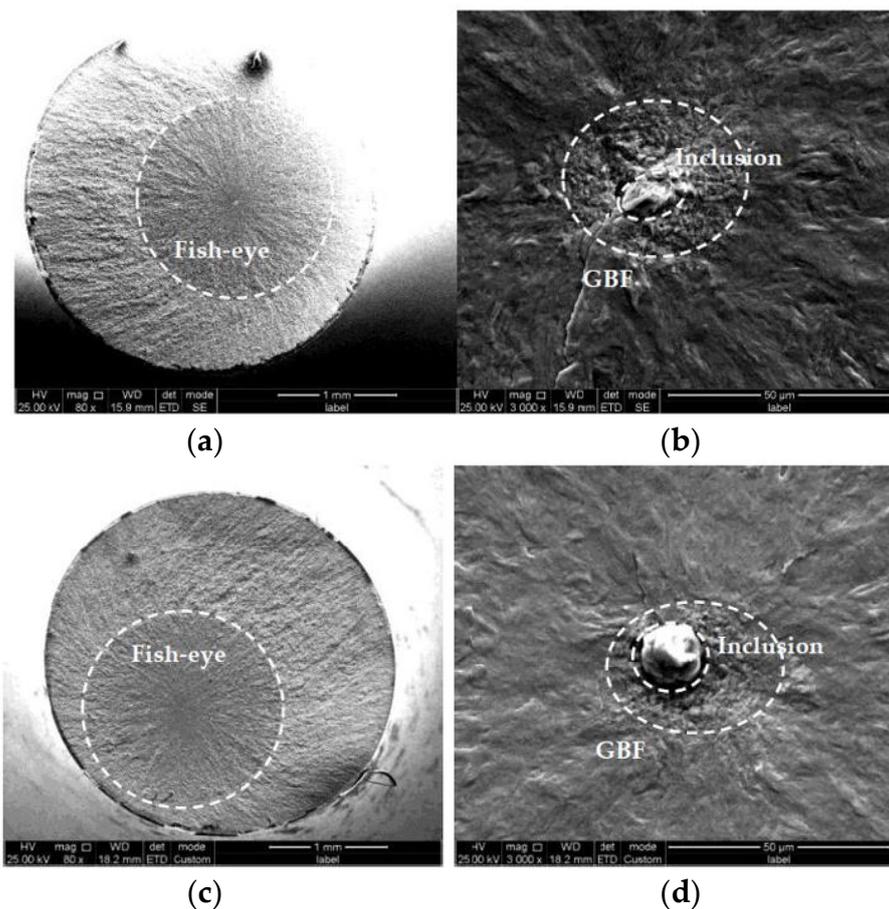
Figure 8. Typical fracture diagrams of carburized samples during ultra-high cycle fatigue: (a,b) $\sigma_a = 590$ MPa for $N_f = 6.66 \times 10^7$ and (c,d) $\sigma_a = 570$ MPa for $N_f = 9.53 \times 10^7$.

The typical fracture surfaces of the carburized specimens after the VHCF tests are shown in Figure 8. It can be seen that the fatigue crack initiated from the interior of the specimen with an obvious fish-eye feature, as shown in Figure 8a,c. The granular bright facet (GBF) area can be clearly seen around a nonmetallic inclusion, which acted as the crack initiation site (Figure 8b,d). According to the typical fracture morphology in Figure 8, the crack initiated in the internal inclusion, and the size of GBF area was different with the distance between the inclusions and the surface, all of which were related to the stress amplitude and cycle times of loading.

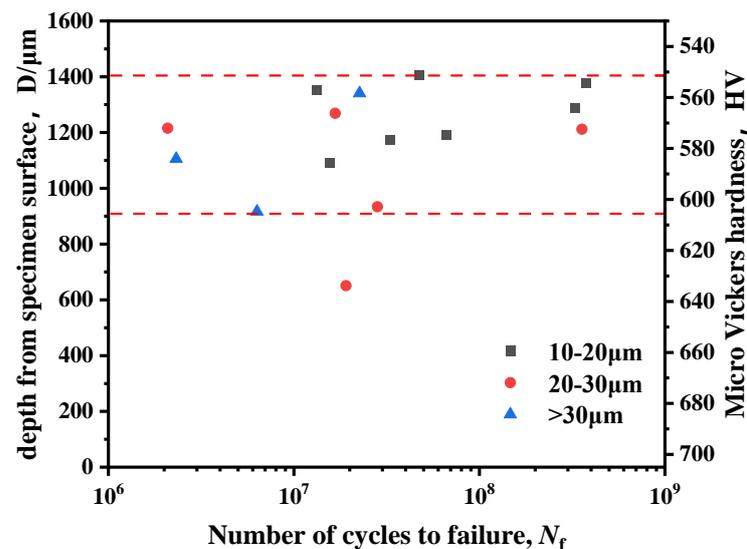
Figure 9. The relationship between the inclusion depth from the specimen surface, Vickers hardness, and number of cycles to failure.

Figure 9 shows the depth of the VHCF crack initiation sites from the carburized surface against the number of cycles to failure. It can be seen that most of the crack initiation sites of the fracture specimens were located at a depth of 0.9–1.4 mm. It can be seen from the hardness distribution curve that this region is a transition zone with an average hardness of 580 HV. We tried to find out the relationship between the area size of the GBF and the location of initiation but failed to find a direct relationship. In other words, there was no obvious correlation between the size of the GBF area and the crack initiation position, which was random and may be related to different stress amplitudes and the loading stress of damaged samples. Ultra-high cycle fatigue stress belongs to axial loading stress, namely the tension and compression fatigue test. Theoretically, the stress level is even throughout the whole section of the specimen. Numerical analyses of the static tests showed that the highest level of stress one can find was in the center of the cylindrical specimen, but in the case of fatigue after some cycles, the maximum stress could be found close to the free surface. The carburized specimens had a hardness gradient, the closer it was to the surface, the higher the carbon content, the higher the martensite hardness and microhardness, and the higher the strength, which had a protective effect on the fatigue. The hardness and strength decreased with the increasing distance from the surface, and weakened the protection effect on fatigue failure.

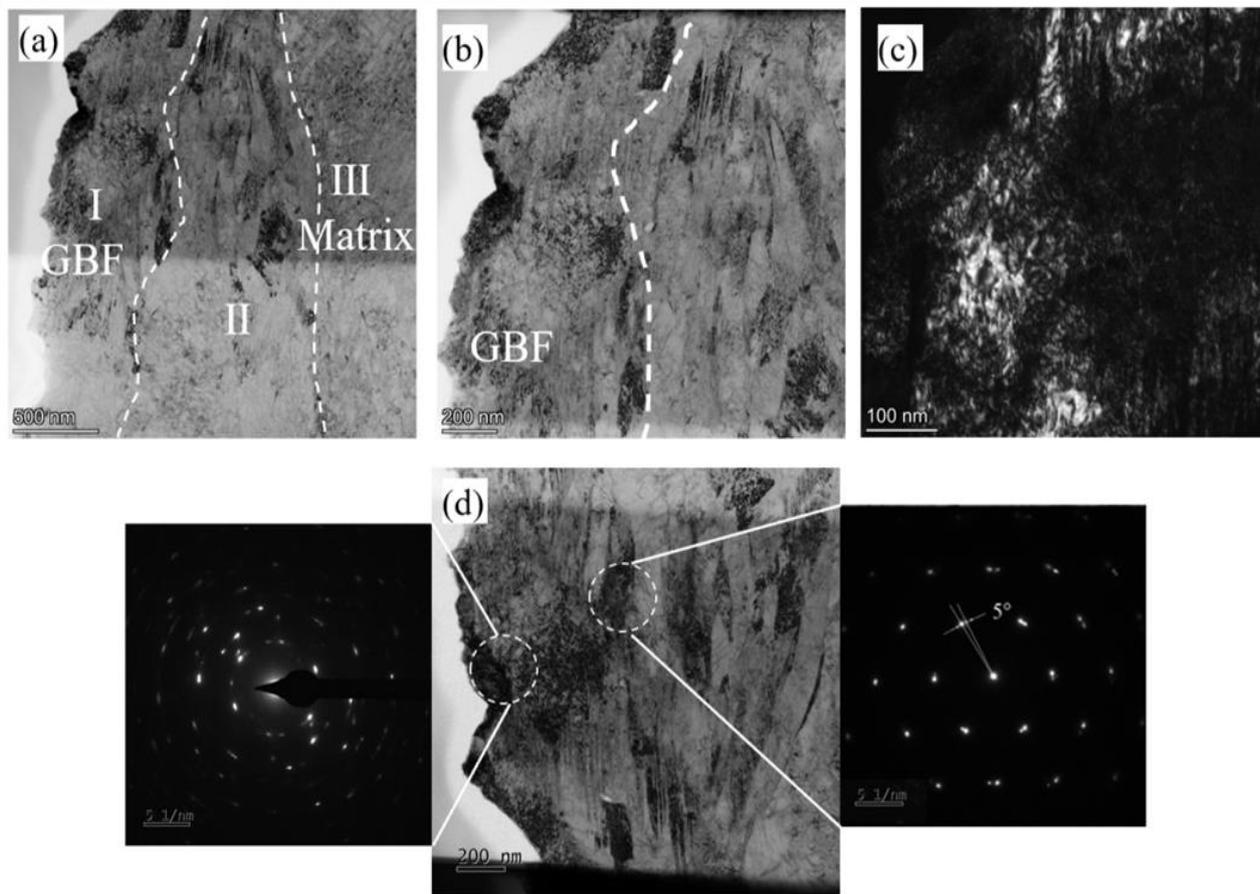
Figure 10. TEM bright field image together with the SAD patterns in the GBF area of the carburized specimen after the VHCF tests at $\sigma_a = 590$ MPa for $N_f = 6.66 \times 10^7$. (a) is transmission morphology of GBF region, transition region and matrix, (b) is transmission morphology of GBF region, (c) is GBF region transmission amplification morphology, (d) is the location of the selected area diffraction.

Figure 10 shows a TEM image together with selected area diffraction (SAD) patterns of the cross-section and GBF for a carburizing specimen around the inclusion, which was fractured beyond 10^7 cycles under a 590 MPa stress amplitude. During a TEM analysis of the longitudinal profile, the fracture surface could be roughly divided into the GBF region, transition region, and matrix. GBF region I was the refined nanograin, the transition region was the partially refined microstructure, and the final region, III, was the martensite of the matrix, as shown in Figure 10a. It could also be found that the width of the GBF region varied due to the “unevenness” of the fracture, and its average value was about 500 nm. According to the comparison of light and dark fields in Figure 10b,c, it could be seen that the GBF region and matrix had two different tissue forms. In Figure 10d, it specified the location of the selected area diffraction, showing that the location near the fracture zone was a continuous polycrystalline diffraction ring. It indicated that the nanocrystals formed during the fatigue process under high stress and plastic strain. Below the fracture was greater than 400 nm (transition area), which was a 5° misalignment angle diffraction spot, which showed that the plastic deformation of the grains at that position was small. It could be seen that the fracture surface in the GBF area was rough, and the near-surface area was much finer than the areas deeper beneath the surface, where martensitic laths could be clearly observed in the center and right sides of the image.

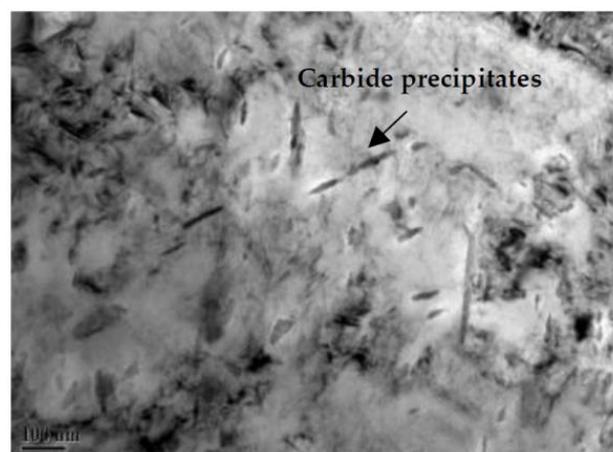
Figure 11. TEM characterization of the carbide precipitates.

Figure 11 shows a TEM image with the morphology of carbide precipitation near the crack origin. The precipitates are Cr-rich carbides in long strip forms in the matrix. Cr-rich carbides have lower dissolution temperatures, and most of them dissolve after carburizing for a long time. However, the carbides precipitated after high-temperature tempering were not completely dissolved in the subsequent short austenitizing, and the undissolved carbides were distributed in long strips in the matrix.

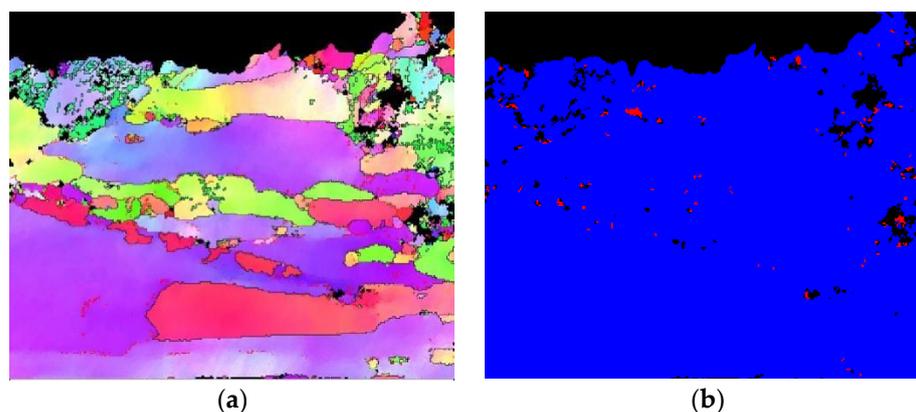
Figure 12. EBSD map showing the fracture surfaces of the carburized specimens after VHCF tests at $\sigma_a = 590$ MPa for $N_f = 6.66 \times 10^7$. (a) The near-surface area microstructure and (b) the near-surface area RA.

Figure 12 shows EBSD maps of the same carburized specimen cross-section around the inclusion and GBF. It also indicated that the near-surface area was much finer than the areas deeper beneath the surface (Figure 12a). As shown in Figure 12b, retained austenite, as shown by the peak areas, was distributed between the martensitic boundaries. Figure 12 shows that a large number of nanocrystallines exist in the GBF region, which is consistent with the transmission results, further verification that nanocrystalline layers are formed around inclusions under millions of cycles of ultra-high cycle fatigue.

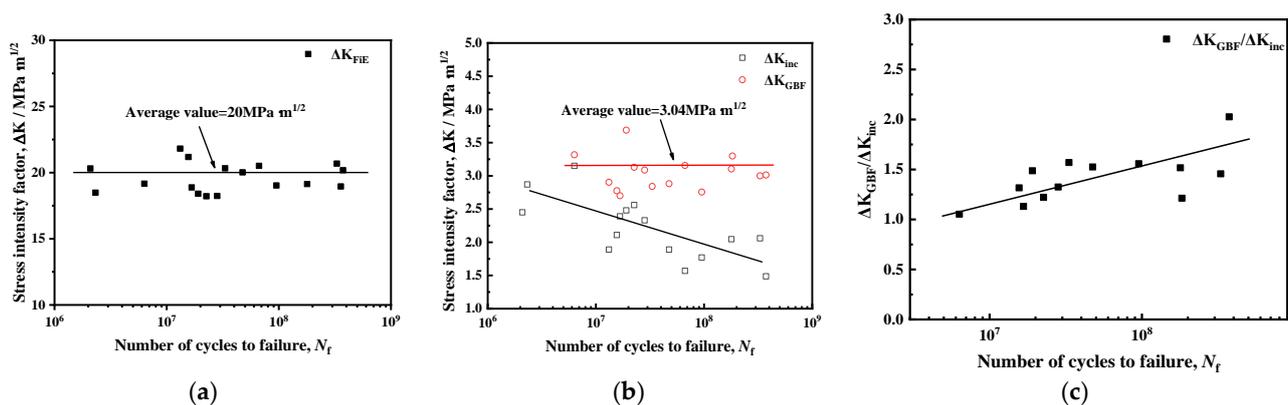
Figure 13. The relationship between ΔK_{inc} , ΔK_{GBF} , $\Delta K_{Fish-eye}$, and the fatigue life of experimental steel: (a) $\Delta K_{Fish-eye}$ changes with the fatigue cycle life, (b) ΔK_{inc} and ΔK_{GBF} changes with the fatigue cycle life, and (c) $\Delta K_{GBF}/\Delta K_{inc}$ changes with the fatigue cycle life.

where $\sqrt{\text{area}}$ is a crack size defined as the square root of the measurement area, and σ_a is the stress amplitude. Figure 13 shows the relationship between the stress intensity factor ΔK and fatigue life N_f . The crack propagation process of the fatigue specimens was GBF-FIE-FCGZ-MFZ [21], where 99% of the life of the crack initiation was mainly consumed in the GBF region [10], and ΔK_{GBF} can be regarded as the threshold value ΔK_{th} [21] of the crack initiation. When the stress intensity factor at the crack edge was $\Delta K < \Delta K_{\text{th}}$, the fatigue short crack did not expand and directly formed a fisheye; when $\Delta K > \Delta K_{\text{th}}$, the short crack formed a GBF nanograin layer. Similarly, ΔK_{FIE} can also be regarded as the critical value of crack growth. When $\Delta K < \Delta K_{\text{FIE}}$, the fatigue long crack did not grow, and a fatigue fracture occur suddenly. As indicated in Figure 13a,b, the values of ΔK_{GBF} and ΔK_{FIE} did not change with the increase of N_f but fluctuated within a small range, which was consistent with the research results of many researchers [31,32].

It assumed that ΔK_{GBF} and ΔK_{FIE} were regarded as constants; the average values of ΔK_{GBF} and ΔK_{FIE} after the carburization of low-carbon gear steel 18CrNiMo7-6 were 3.04 and 20 $\text{MPa}\cdot\text{m}^{-1/2}$, respectively. According to the above analysis, the threshold value formed by the GBF region was far less than that formed by FIE, and it was inevitable that the crack front end of the GBF grew slowly, thus consuming most of the fatigue life. At low cyclic stresses of millions of times, the dislocations moved and piled up, further slowing down the propagation of short cracks. The value of ΔK_{Inc} decreased with the increase of N_f , while N_f increased only when the stress amplitude decreased; that is, in the case of low stress, the cracks were first initiated at an inclusion with a small size. As can be seen from Figure 13c, the ratio of $\Delta K_{\text{GBF}}/\Delta K_{\text{Inc}}$ increased with the increase of the number of cycles, further indicating that the formation of GBF consumed the vast majority of the life of the VHCF at a lower stress amplitude.

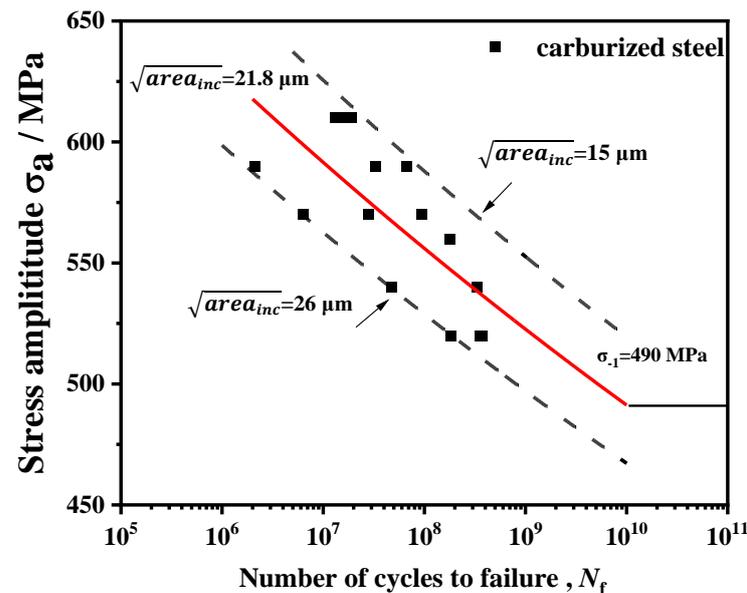
Figure 14. Fatigue S-N curve of the carburized specimens of the experimental steel.

where m , D , and α are constants that determine the crack propagation properties. D is a constant that simplifies the right side of Formula (3). Through nonlinear fitting, we can obtain the parameters for the carburized specimens of the experimental steel as follows: $D = 2.04 \times 1087$, $m = 37.17$, and $\alpha = -0.28$.
