Effect of Thickness of Ti Coating Deposited by Vacuum Arc Melting on Fatigue Behavior of Aluminum Alloy Al–5%Si

Abstract: Fatigue strength tests of Ti-coated aluminum alloys with a thickness of 1 μm , 3 μm , and 5 μm were conducted to investigate the effect of the coating thickness on fatigue strength. Under the same applied stress amplitude, the optimum thickness with the most-extended fatigue life was around the coating thickness of 5 μm . This may be attributed to the good resistance to surface cracks under repeated loads. The results suggested that a lower fatigue life of a coating thickness of 1 μm results from the fracture of the coating layer under the strong influence of the deformation of the substrate. This could be due to the higher tensile residual stress induced in the substrate near the coating layer and substrate interface. The titanium coating restricted the initiation of offsets and cracks beneath the surface of the specimen, which may be attributed to the high strength of the Al–5%Si substrate, good flexibility, and strong adhesion, which provided sufficient compressive stress to suppress slip band protrusions. The fatigue life and fatigue limit increased proport

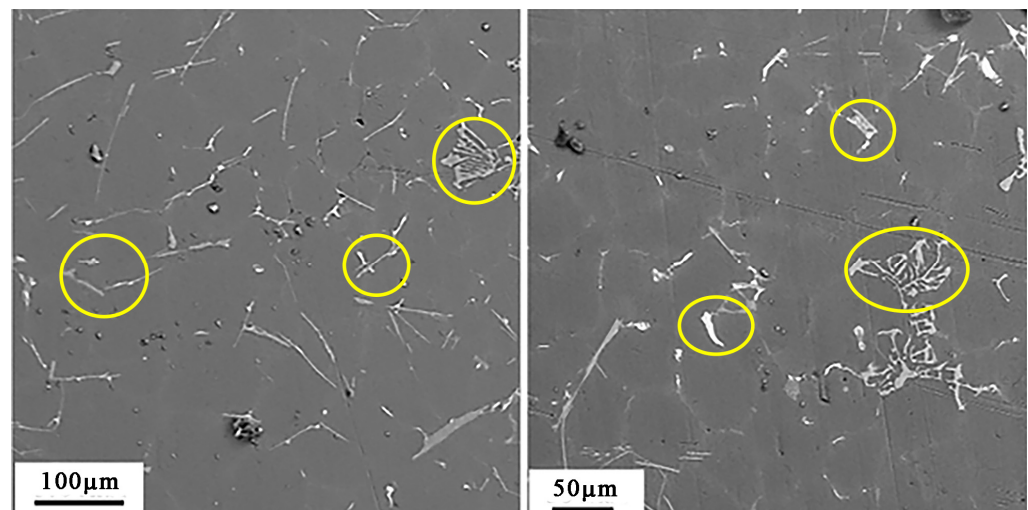
Figure 1. SEM image of etched Al-5%Si sample.

According to the metallographic studies presented in [39–41], selective etching methods can be used for the Al-Si alloy system. Al_5SiFe phases are like lamellar inclusions; the inclusions of $\alpha(\text{Al}_{15}(\text{FeMn})_5\text{Si})$ are in a regular polyhedron shape; iron particles are formed in the shape of Chinese characters; silicon particles are in the shape of oval inclusions. It was found that, in the Al-5%Si sample, a large number of inclusions (dashed circles) were predominantly present, which were in a lamellar shape (Figure 1). Figure 1 shows various sizes of the pores, droplet formation, and spikes. Droplets formed as microparticles, and a few spikes were clearly visible on the coating surface. Pores may have formed when solidified droplets broke off after deposition was complete. The formed pores were estimated to be in the 0.05–10 μm -diameter range.

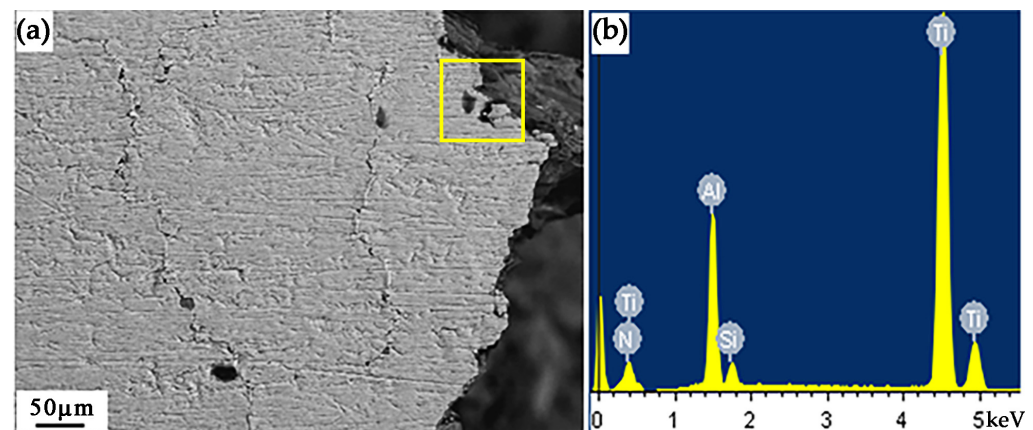
Figure 2. (a) SEM image of Ti-coated Al-5%Si sample of 1 μm thick. (b) EDS spectra of the area marked in (a).

The titanium-coated sample is shown in Figure 2a. A contact nanoprofilometer was used to measure the surface roughness of the substrate and coated samples. The surface roughness of the Al-Si substrate alloy before the deposition of a titanium layer was estimated to be $R_z = 1.21 \mu\text{m}$; $R_a = 0.147 \mu\text{m}$. The surface roughness of a Ti coating of 1 μm was $R_z = 0.660 \mu\text{m}$; $R_a = 0.099 \mu\text{m}$. The roughness decreased as the titanium film's thickness increased from 1 μm to 3 μm ($R_z = 0.452 \mu\text{m}$; $R_a = 0.071 \mu\text{m}$). The surface roughness was further reduced as the coating thickness increased to 5 μm ($R_z = 0.360 \mu\text{m}$; $R_a = 0.056 \mu\text{m}$). The lower surface roughness made it difficult to form stress concentrators, which contributed to the initiation of microcracks during the fatigue tests.

To know the elemental composition of the coating sample, an EDS analysis was carried out. As shown in Figure 2b, titanium and aluminum were predominantly present in the selected area. As observed from Figure 3a, numerous microcracks were observed on the surface after the fatigue testing. However, with the increase in the thickness of the titanium coating, the surface roughness was found to decrease, and microcracks were barely visible. To assess the microcracks of all fatigue samples tested, the SEM images were analyzed with the crack width calculation. It was found that the open crack width of the Al-5%Si sample was 12.5 μm (Figure 4a). The width of the open crack of the sample with a 1 μm -thick coating was 2.5 μm . The width of the open crack of the sample with a 3 μm -thick coating was 2 μm . Similarly, the width of open crack of the sample with a 5 μm -thick coating was 1.25 μm . The above results indicated that the deposited coating showed better bonding with the substrate. Even after the fatigue tests, the coatings remained bonded to the substrate. However, with the increase in coating thickness, the resistance to crack initiation and crack growth increased substantially. Thereby, the fatigue life of the sample increased. In this study, the failure of the Al-5%Si sample occurred at 1.14×10^5 . However, the sample with a 5 μm -thick coating of titanium sustained a higher number of cycles (2.45×10^5).

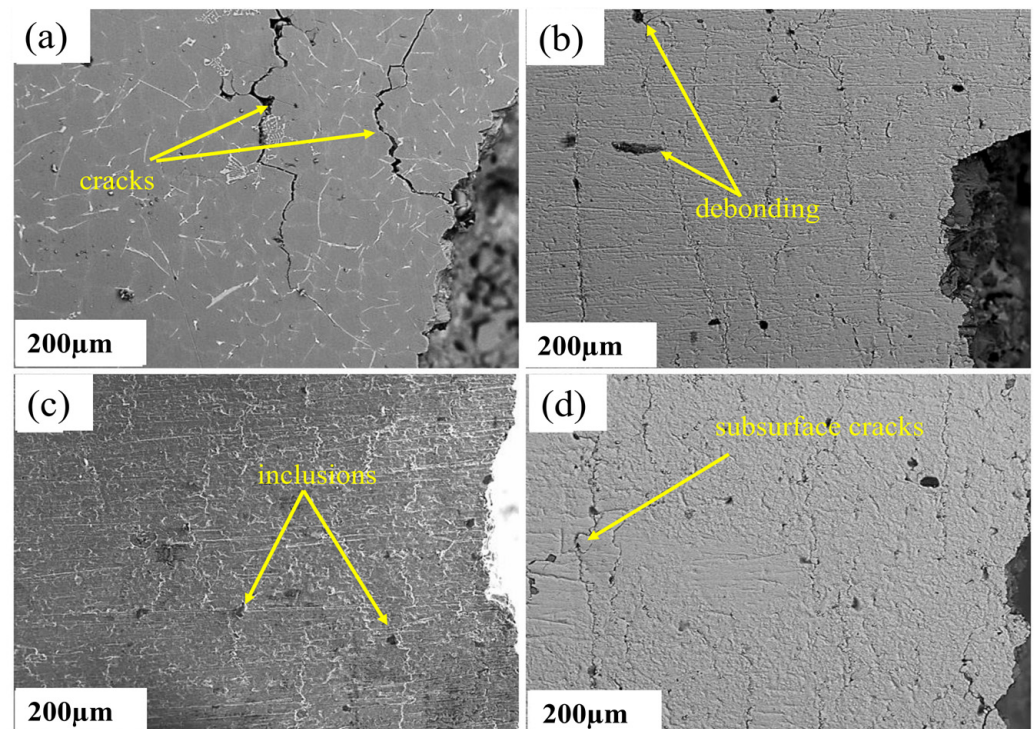
Figure 3. SEM images of surfaces showing crack propagations after fatigue failure. (a) Al-5%Si sample; (b) 1 μm Ti coating; (c) 3 μm Ti coating; (d) 5 μm Ti coating.

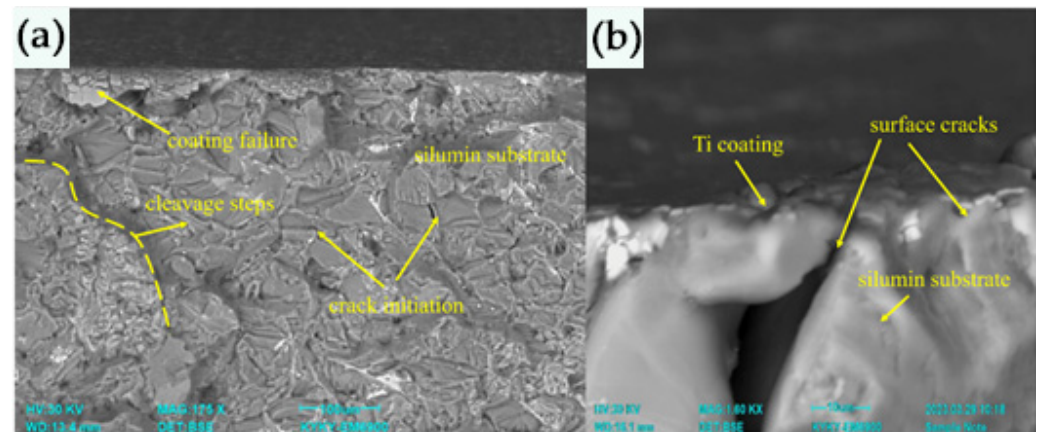
Figure 5. (a) SEM image of 5 μm Ti-coated fractured sample. (b) Crack propagation.

Figure 5a,b depict the fatigue striation morphologies in the crack-growth zone. The crack propagated forward as a fatigue striation in the crack-growth zone. The greater the grain boundary, the more energy the fatigue crack propagation consumed, reducing the

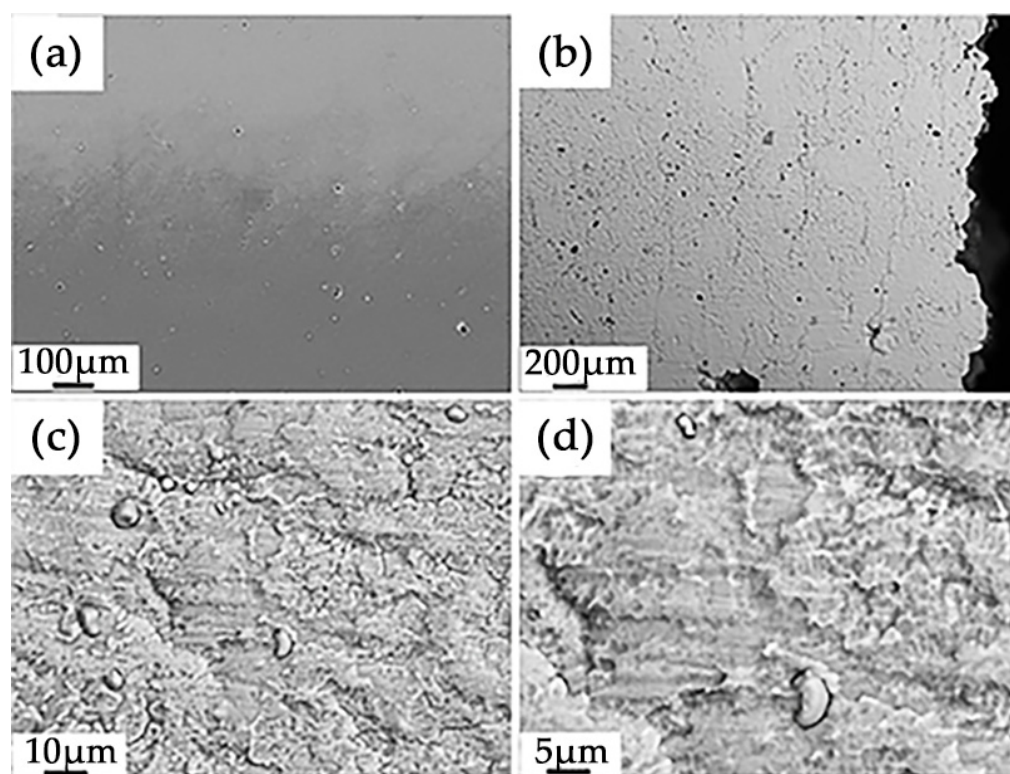
Figure 6. SEM images of the surfaces of 5 μm Ti-coated sample. (a) Initial state; (b–d) after fatigue test.

Figure 6a indicates the Ti-coated sample before the fatigue analysis. The crack initiation was transferred from the surface to the subsurface in the fatigue crack initiation, as shown in Figure 6b,c. The microstructures might primarily influence this in the surface layer. With the difference in the elastic moduli and residual stresses between the particles, the inclusions and surrounding second-phase particles caused a local stress concentration during each vibration cycle [43]. As a result, many small voids aggregated into microcracks and formed fatigue cracks in the vicinity of the inclusion and second-phase particles. Transmission electron microscopy was used to examine the coated samples that were subjected to fatigue tests. It was clearly seen that the fatigue tests of the samples were accompanied by a significant transformation of the Al–5%Si layer adjacent to the titanium film (Figure 7). The maximum thickness of the contact layer varied from 0.5 μm to 2.0 μm. It increased monotonically with the increase in the number of fatigue test cycles. The contact layer had many micropores and microcracks, which increased as the number of fatigue test cycles increased.

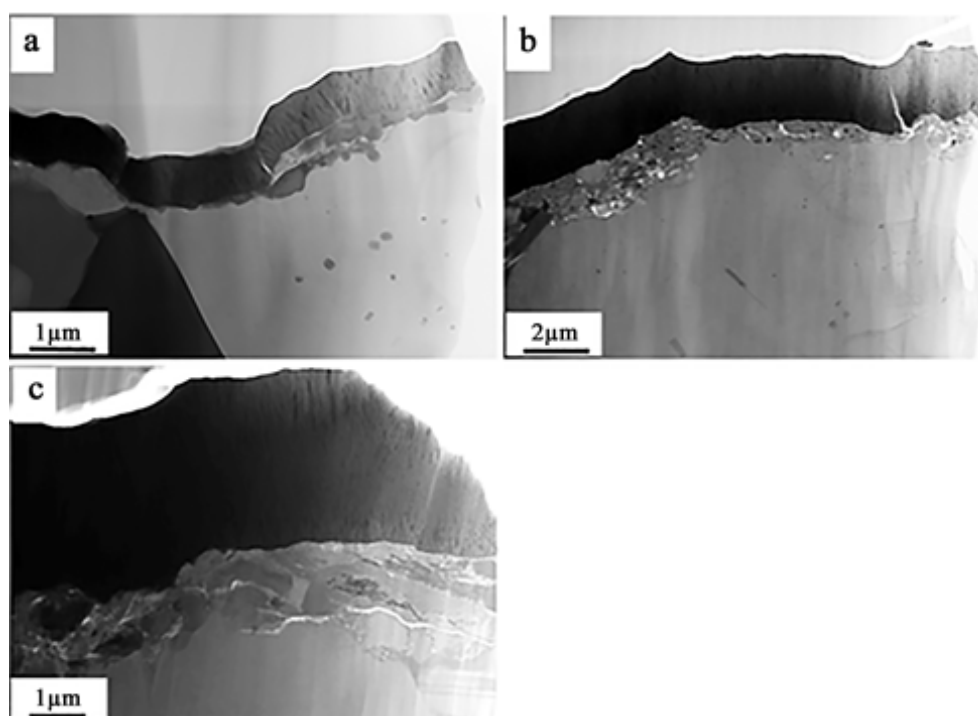
Figure 7. Transmission electron microscope images of Ti coatings after fatigue tests: (a) 1 μm (1.1×10^5); (b) 3 μm (2.0×10^5); (c) 5 μm (2.5×10^5).

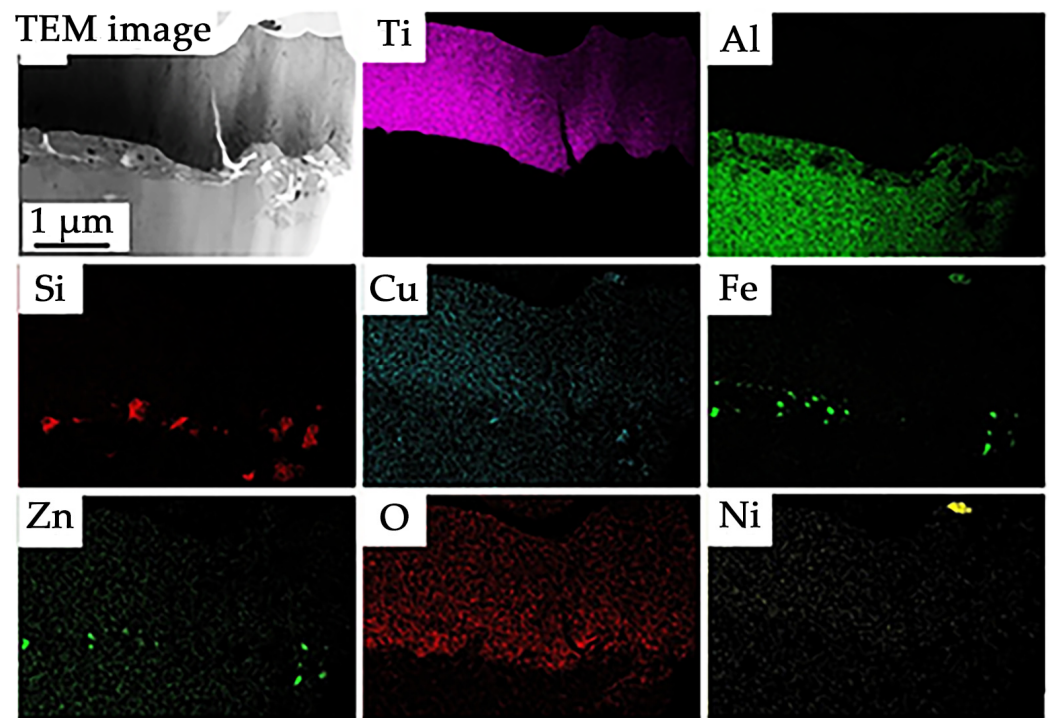
Figure 8. Elemental mapping of the 5 μm Ti coating.

X-ray microanalysis was performed to investigate the elemental composition of the film and the contact layer (mapping method). Figure 8 shows that aluminum atoms formed the contact layer and contained inclusions enriched with silicon, iron, copper, and zinc atoms. The film's main component was titanium, but it also contained copper and oxygen atoms. As a result, it is reasonable to assume that the Al–5%Si fatigue tests were accompanied by the oxidation of the titanium film deposited on the surface of the samples. The phase composition of the deposited film was examined using diffraction electron microscopy techniques, such as the dark-field technique and the indexing microelectron diffraction patterns (Figure 8).

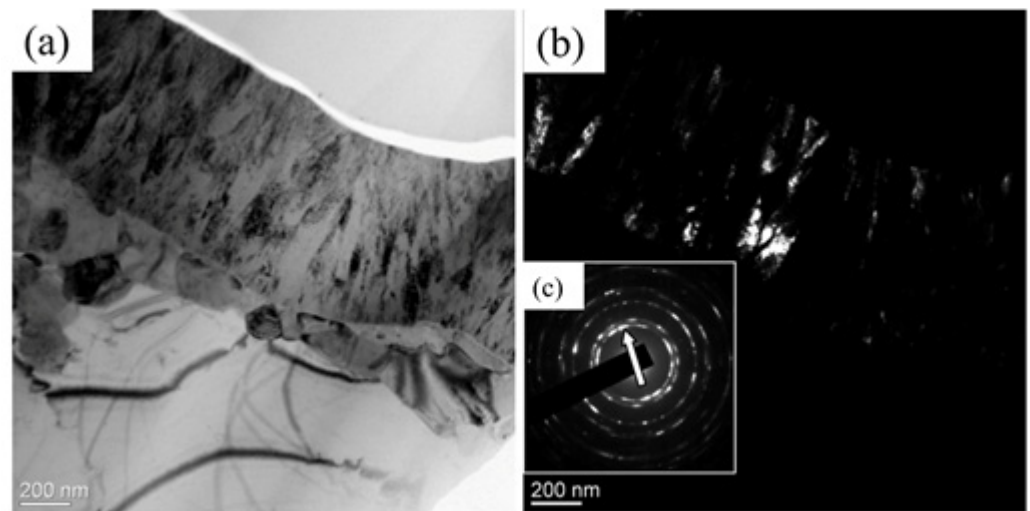
Figure 9. (a) TEM image of the Ti coating after fatigue tests at 1.1×10^5 . (b) Dark field in the [111] TiO reflection. (c) Microelectron diffraction pattern (the arrow indicates the reflection in which the dark field was obtained).

The nanoprecipitation was uniformly distributed within the grains. The many dislocations gathered around the nanoprecipitations. The nanoscale precipitations can bind the dislocation movements. As a result of the formed deformation, new deformations were formed to locate the plastic deformation, leading to an increase in dislocation density. It was established that the vacuum arc plasma-assisted deposition film formed on the surface of Al-5%Si had a columnar structure with a column thickness of 20–35 nm (Figure 9a,b). The microelectron diffraction pattern obtained from the film (Figure 9c) showed that the main phase of the film was titanium oxide with the formula TiO . As a result, the Al-5%Si fatigue tests were accompanied by the oxidation of the titanium film deposited on the samples. The fatigue life of the samples was found to increase from 110,784 cycles to 245,274 cycles as the thickness increased from 1 μm to 5 μm . The Al-5%Si samples with no titanium film on the surface lasted fewer cycles ($N = 113,742$) (Figure 9). As shown in Figure 10, a defective substructure in a titanium-coated Al-5%Si sample subjected to fatigue loading resulted in a significant transformation of the layer adjacent to the fracture surface. The presence or absence of a titanium layer had the most-significant influence on the substructure. In the absence of the titanium coating, the scalar density of the dislocations was $1.5 \times 10^{10} \text{ cm}^{-2}$, as shown in Figure 10 as a network-type dislocation substructure. The formed dislocations formed tangled structures as they accumulated near the grain boundaries. Furthermore, subgrain boundaries were formed around the dislocation gathering areas. The nanoprecipitations were observed on the surface layer, and some crack deflection and breaching morphologies were attributed to the interactions between the crack tip and the heterogeneous microstructure. The produced structures could improve the fracture toughness by restricting crack propagation and lowering the crack growth rate.

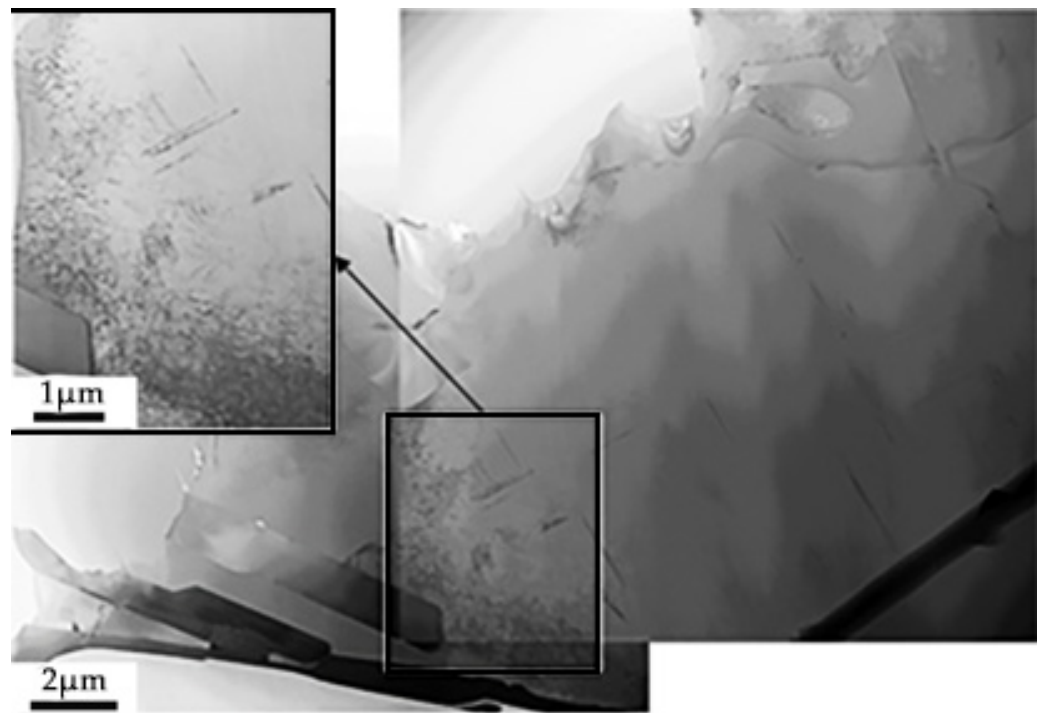
Figure 10. TEM image of the fracture surface of the Al-5%Si substrate without the titanium coating under fatigue loading.

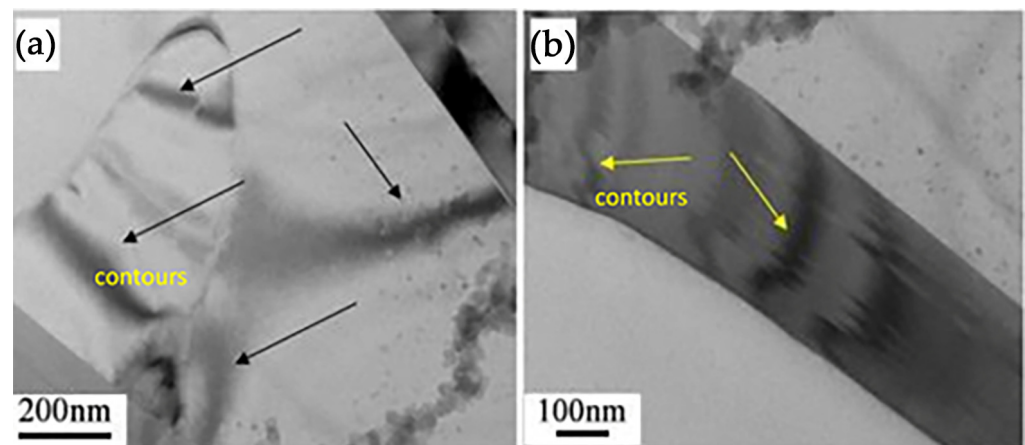
Figure 11. TEM image of fractured sample of (a) Al-5%Si and (b) Al-5%Si with a 5 μm titanium coating.

The formation of internal stress fields was influenced by the fatigue loading. The bending extinction contours in the TEM image indicated the presence of identified stress fields, as shown in Figure 11a. The aluminum grain interface and second-phase inclusions dominated the thin foil structure. In the volume of the bending extinction contours, both primary aluminum grains and second-phase inclusions were found to be elastically stressed (Figure 11b).

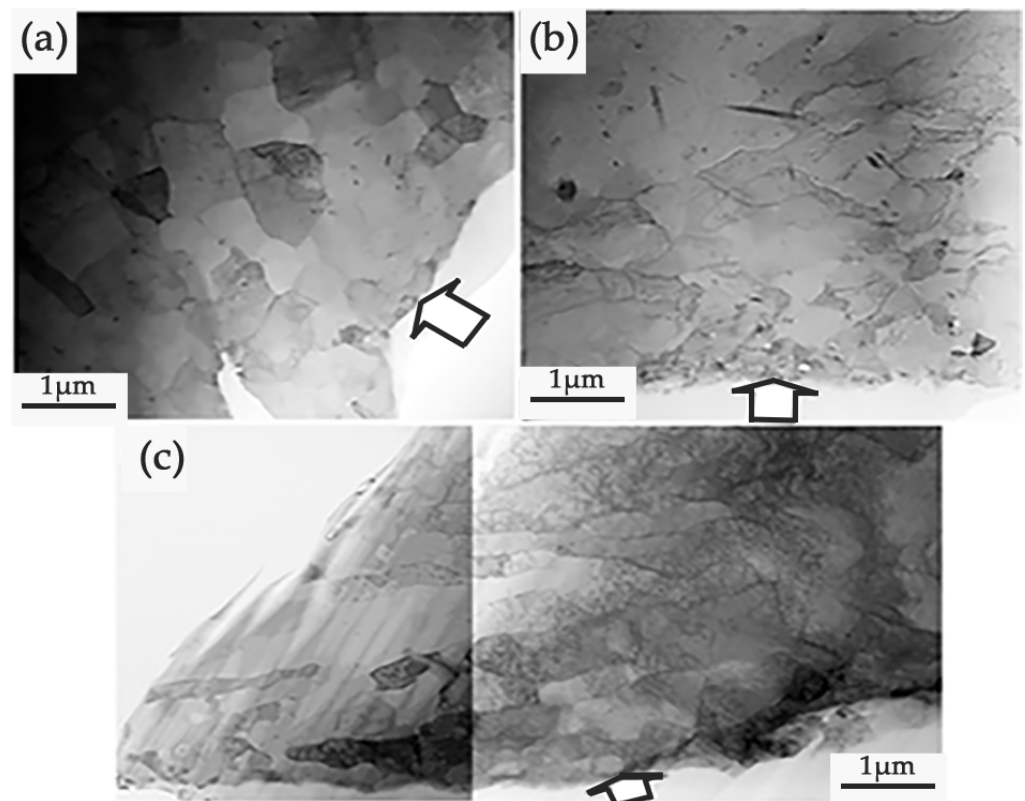
Figure 12. Formation of layer on the fracture surface of a Al–5%Si sample with a preliminarily deposited titanium film of thickness (a) 1 μm, (b) 3 μm, and (c) 5 μm.

The formation of a subgrain structure upon Al-5%Si destruction occurred with and without the deposition of a titanium film on the working part of the Al-5%Si samples (Figure 12). It was noted that the Al-5%Si sample with a 1 μm -thick titanium film was destroyed after fewer cycles ($N_1 = 110,784$) than the Al-5%Si sample without a titanium film ($N_0 = 113,742$). This implies that the formation of a subgrain structure in the Al-5%Si destruction zone was caused by the joint deformation of two materials: Al-5%Si and titanium. The thickness of the layer with a subgrain structure varied within (6–13) μm and increased with the number of cycles to destruction (thickness of the deposited titanium film). A layer with a subgrain structure had a gradient structure, which means that subgrains with minimal (0.1–0.2 μm) sizes were located on the fracture surface (Figure 12). The size of the subgrains increased as the distance from the fracture surface increased to (1–1.5) μm . The heterogenous grain structure is an essential factor in improving the fatigue performance. Near the subsurface, fine and coarse grains were observed as heterogenous grain structures. Due to the higher tortuosity, it can be stopped in the fine-grained zone during the initiation of the crack. Furthermore, crack propagation can be reduced with the formation of heterogenous grain structures, which further lowers the potential risk of microcrack initiation.

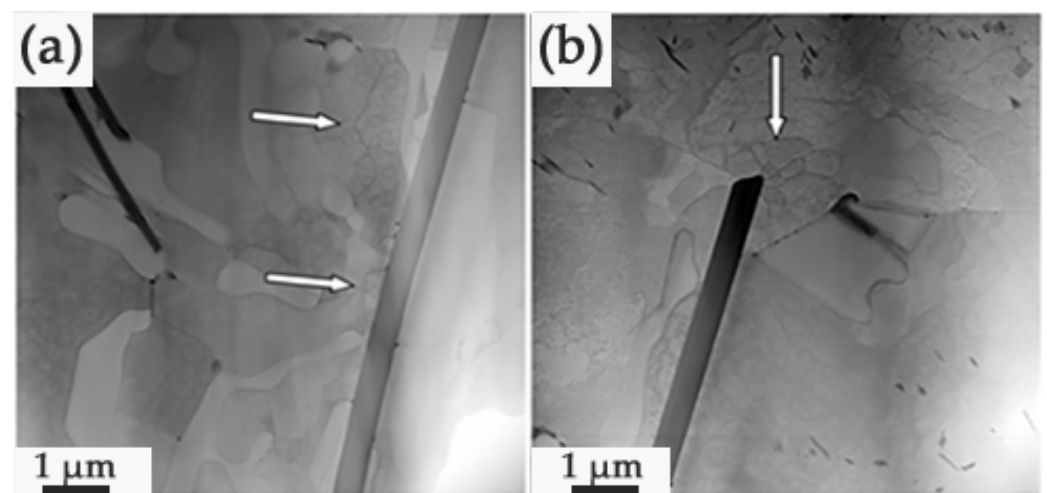
Figure 13. The structure of a Al–5%Si sample with a 3 m titanium film at a distance of (a) 30 μm and (b) 40 μm from the fracture surface.

A layer with a subgrain structure was visible at long (30–40 μm) distances from the Al-5%Si destruction surface. Figure 13a,b depict the formation of subgrains at the interface of two phases: aluminum and silicon. As a result, the formation of subgrains, in this case, resulted from the joint deformation of the two phases with different mechanical properties. Diffraction electron microscopy revealed that the subgrains were separated by boundaries with small-angle misorientation (Figure 14). The azimuthal component of the total misorientation angle of fragments varied within 3–5°, according to the analysis of the microelectron diffraction patterns obtained from such a structure. The defects that accumulated within the substrates during the fatigue test caused the crystalline substrate to form slip bands. When the slip bands spread to the film/substrate interface, they formed a step-like protrusion on the film's surface, which eventually formed a crack.

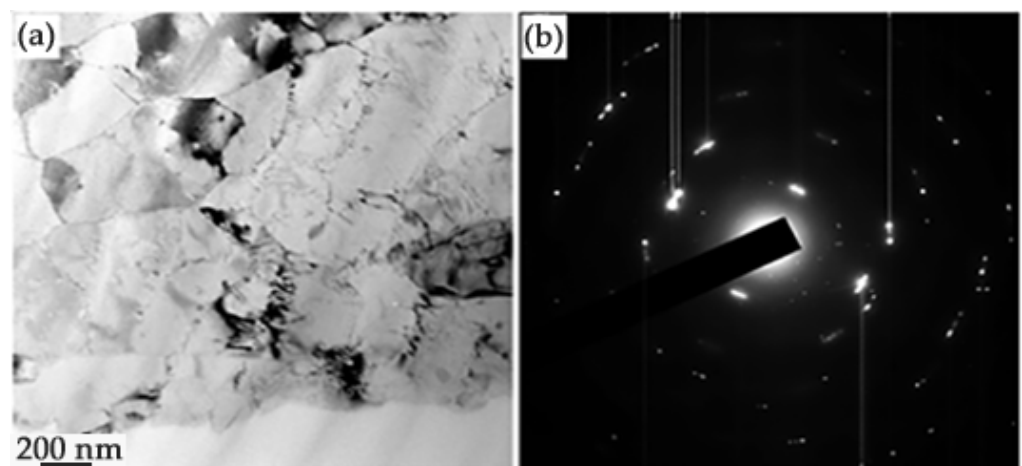
Figure 14. TEM images of the subgrain structure formed in the region of the destruction surface of the Al-5%Si sample with a 5 μm thickness: (a) bright field image; (b) microelectron diffraction pattern on foil section shown in (a).

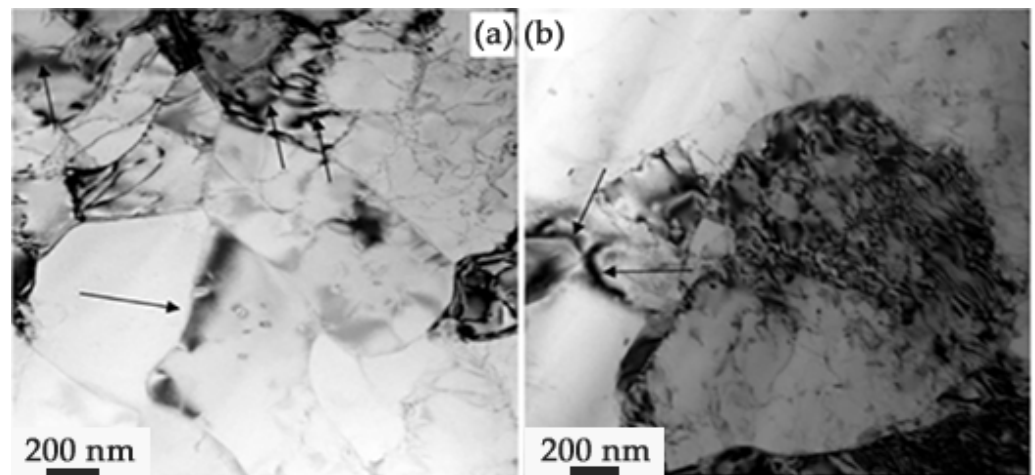
Figure 15. Bending extinction contours in the fractured Al-5%Si sample of (a) 3 and (b) 5 μm titanium film thickness.

As previously stated, the fatigue tests caused the formation of elastic stress fields in the material, which were revealed by bending extinction contours in the electron microscopic images of the structure of the thin foils. Figure 15a,b depict the typical images of a subgrain structure with bending extinction contours as the titanium film thickness increased. The variation of the subgrain structure with the film thickness is indicated as arrows.

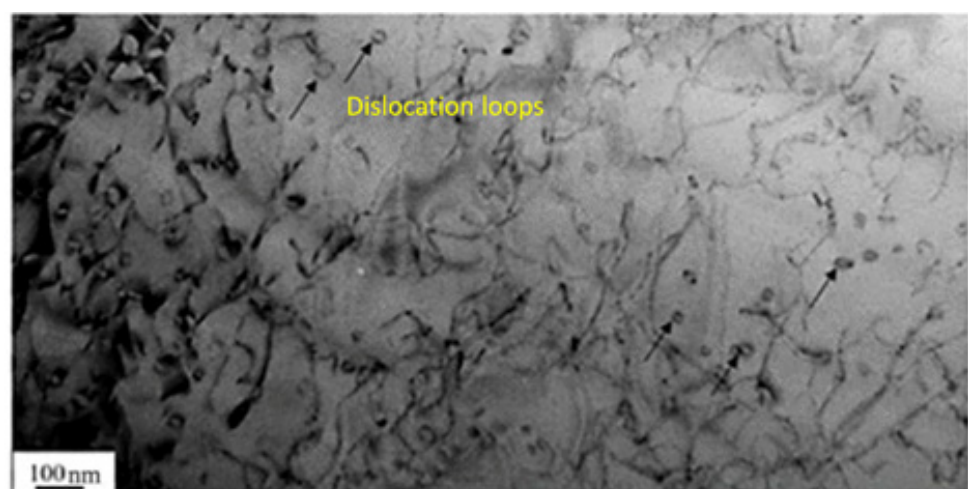
Figure 16. Electron microscopic image of the dislocation substructure of 5 μm titanium-coated Al-5%Si sample (black arrows indicate dislocation loops).

The presence of prismatic dislocation loops was discovered during the studies of the dislocation substructure in the layer adjacent to the fracture surface of the Al-5%Si samples with a pre-deposited titanium film (Figure 16). The lack of contrast within the loops, which is typical of stacking faults, indicated that the loops were formed by complete dislocations [44,45]. A large number of vacancies or interstitial atoms can combine to form
