Corrosion Behavior of Hydrotalcite Film on AZ31 Alloy in Simulated Body Fluid

Abstract: The hydrotalcite (HT) film is a promising bioactive coating for magnesium alloys. In the present study, we investigate the corrosion behavior of HT film in the simulated body fluid (SBF), and compare with which in NaCl solution. The HT film can provide a very plummy initial protection to the AZ31 alloy in SBF. The corrosion behavior of the HT film in the two solutions is quite different. When in $0.1 \text{ mol}\cdot\text{L}^{-1}$ NaCl solution, the film is dissolved gradually, and filiform corrosion is predominant after 3 days immersion. While in Hank's solution, the thickness and composition of the film are changed. A corrosion products layer mainly consisted of $\text{Mg}/\text{Ca-PO}_4^{3-}/\text{HPO}_4^{2-}$, and minor of CaCO_3 is deposited on the top of HT film, which enhances the barrier effect of the HT film. As a result, except for local pit corrosion at several active places, most of the area of the coated sample still remains integral even after immersion for 15 days. It is demonstrated that the HT film has better corrosion protection effect in SBF than in NaCl solution.

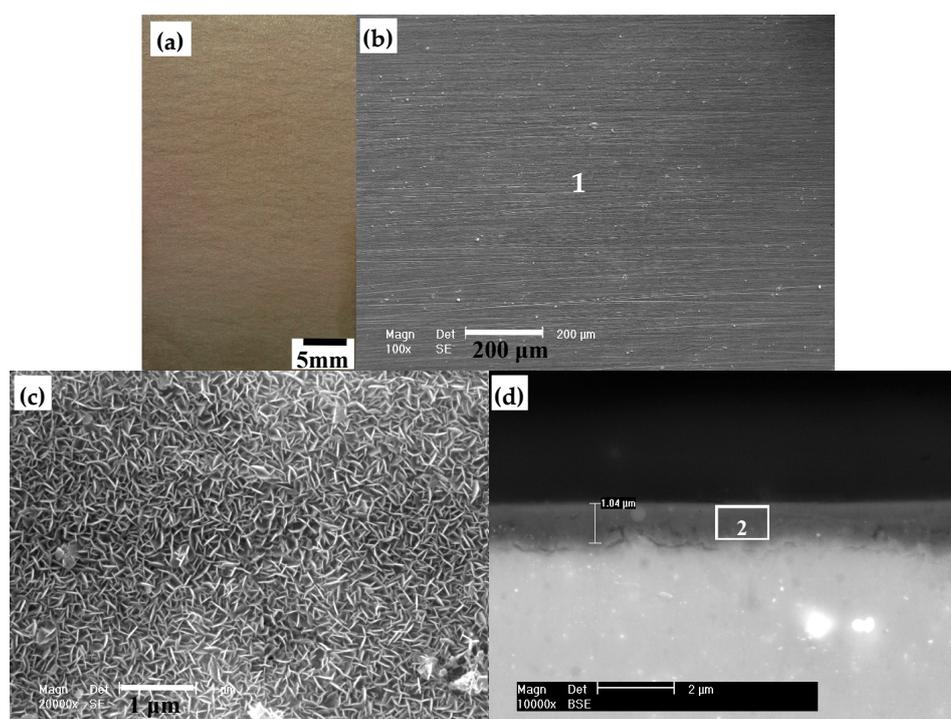
Figure 1 shows the morphology of the coated sample. According to our previous work [26], the chemical composition of the film was mainly $\text{Mg}_6\text{Al}_2(\text{OH})_{16}\text{CO}_3 \cdot 4\text{H}_2\text{O}$. The optical photo in Figure 1a shows that the HT film is very homogeneous. Figure 1b presents a compact and smooth film, and micro-cracks hardly can be seen. Higher magnification morphology in Figure 1c clearly demonstrates a typical HT structure. The surface of the Mg substrate is completely covered with the dense and uniform blade-like flakes. From the cross-sectional image of the coated sample in Figure 1d, it is observed that the HT film is strongly adhered to the substrate, and there is no crack on the film, which indicates that the film is very compact. The thickness of the film is about $1.04 \text{ }\mu\text{m}$.

Figure 1. Morphology of the hydrotalcite film coated sample: (a) Optical photo; (b) surface morphology in low magnification; (c) surface morphology in high magnification; (d) cross-sectional morphology. (1 and 2 represent the EDS full scan region in Figure 1b and EDS testing region in Figure 1d, respectively. They correspond to the numbers in Table 1).

The chemical composition of the film before and after immersion was analyzed by EDS and XPS. The content of various elements in different regions of the films in Figures 1, 4a and 5b marked by 1–7 is listed in Table 1. The original HT film only contains C, Mg, Al and O, and the content of Mg is very high (Region 1), indicating that the signal from the matrix is strong. While the composition of the film after immersion test is more complex, including C, O, Mg, Al, P and Ca, and the signal from the matrix Mg is weak (Region 4), implying that the detected information is mainly attributed to the film. It is because the thickness of the film after immersion is increased, and the result is in accordance with the cross-sectional morphology (compared Figures 1d and 5b). Furthermore, the atomic ratio of Mg and Al elements in Region 6 is decreased to 3.13:1, compared with Region 2 which is about 3.68:1. The main information from the composition comparison of the HT film before and after immersion is that Ca and P have been inserted into the HT structure. The corrosion products deposited on pit are composed of O, C, Mg, P and Ca, and the content of Ca is especially high (Region 3). According to the EDS analysis, the contents of Ca and P in the corrosion products film layer are high, but the Al content is very small (Region 5). The composition of the bottom corrosion products layer is C, O, Al, Mg, Ca and P (Region 7), and Mg is the main metal element. In addition, the content of Ca and P in the corrosion products film layer below the HT film is smaller than that in the top layer. It may be because that only small amount of electrolyte passed through into the HT film with poor liquidity.

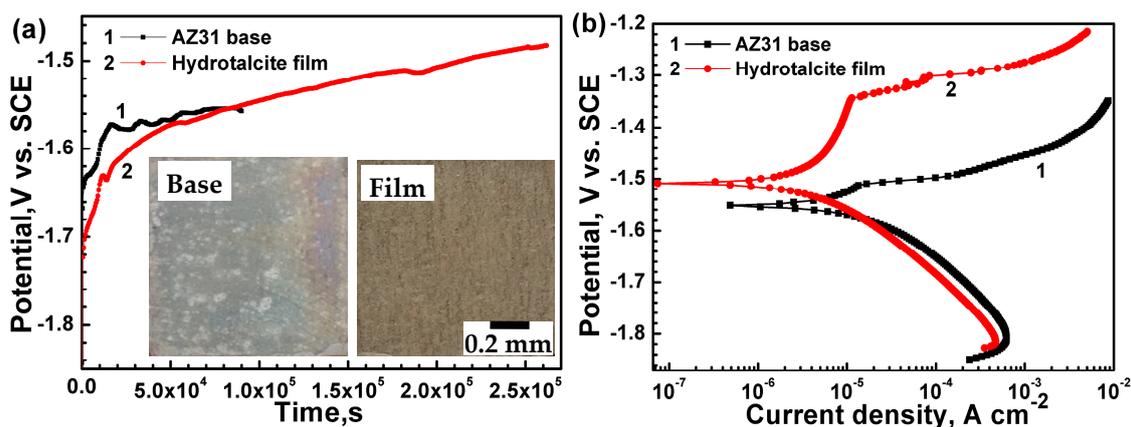
The potential vs. time curves of AZ31 alloy with and without film in Hank's solution is shown in Figure 2a. In the case of AZ31 substrate, the OCP keeps increasing from -1.84 to -1.57 V (vs. SCE) in the initial $1.66 \times 10^4 \text{ s}$, and then drops down slightly. It implies that a corrosion products film is formed continuously on the alloy surface, and then the film breaks down. Afterwards, OCP fluctuated in a small range, indicating that the rupture and formation of the corrosion products film reach a dynamic equilibrium. The optical morphology of the AZ31 substrate after being soaked for $9.0 \times 10^4 \text{ s}$

is also provided in the low section of Figure 2a. It is observed that there is a thin but non-homogeneous film on the surface, where many white-bright spots distribute randomly, indicating the rupture of the corrosion products film. In contrast, the performance of the sample coated with HT film is different. OCP of the coated sample increases from -1.90 to -1.63 V (vs. SCE) within 1.20×10^4 s. Subsequently, it keeps elevating with a relatively lower slope. It can be implied that the reaction between HT film and Hank's solution sustains during the whole immersion to form a corrosion products layer on the top, which is hardly stabilized. To the end of the testing, the OCP of the coated sample achieves to -1.49 V (vs. SCE). It is noteworthy that OCP fluctuates several times at the range around 1.20×10^4 , 5.70×10^4 and 1.84×10^5 s, respectively. It may be because that local superficial pit corrosion occurs at some active spots, but these active areas are covered by corrosion products immediately. No corrosion pits are observed by naked eye on the surface of the coated sample after being soaked for 2.62×10^5 s (more than 3 days). It can be implied that the film can effectively delay the initial appearance of megascopic corrosion pit. Figure 2b shows the polarization curves of the AZ31 alloy with and without film in Hank's solution. The HT film slows down the corrosion rate of bare alloy by inhibiting both the cathodic hydrogen evolution and anodic dissolution reactions. The hydrogen evolution rate in the cathodic side is decreased. The anodic sides of the two curves are quite different. In curve 2, there is a passive tendency region. The breakdown potential (E_b) of the film coated sample is about -1.34 V, which is more positive than that of the substrate (-1.51 V). The corrosion current density (i_{corr}) of the substrate and the coated sample is approximately 23.64 and $5.54 \mu\text{A cm}^{-2}$, respectively. The positive shift of the corrosion potential and the decrease of current density indicate that the HT film can improve the corrosion resistance of the AZ31 alloy in SBF.

Figure 2. (a) Potential vs. time curves; (b) polarization curves of the AZ31 alloy with and without the hydrotalcite film in Hank's solution.

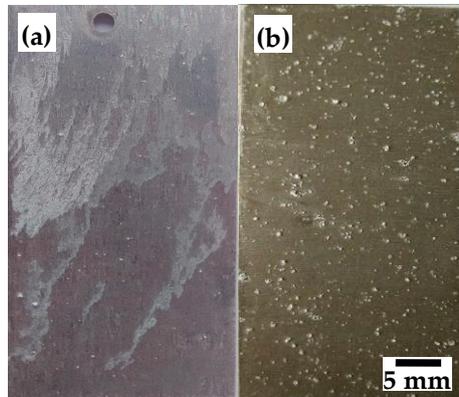
Optical images of the AZ31 alloy with and without HT film immersed in Hank's solution for different time are shown in Figure 3. After 3 days immersion, filiform corrosion has happened to more than half area of the bare alloy, which is corroded severely. The majority of the coated sample is not attacked after 15 days immersion. The immersion test also indicates that the HT film can offer good protection to the AZ31 alloy in SBF. However, compared to the morphology of the original HT film before immersion which is very homogeneous and smooth without any tubercle (Figure 1a), there are some white particles on the surface of the HT film after immersion test.

Figure 3. Optical corrosion morphology of: (a) The bare AZ31 alloy after immersion test for 3 days; (b) the hydrotalcite film coated sample after immersion tests for 15 days in Hank's solution.

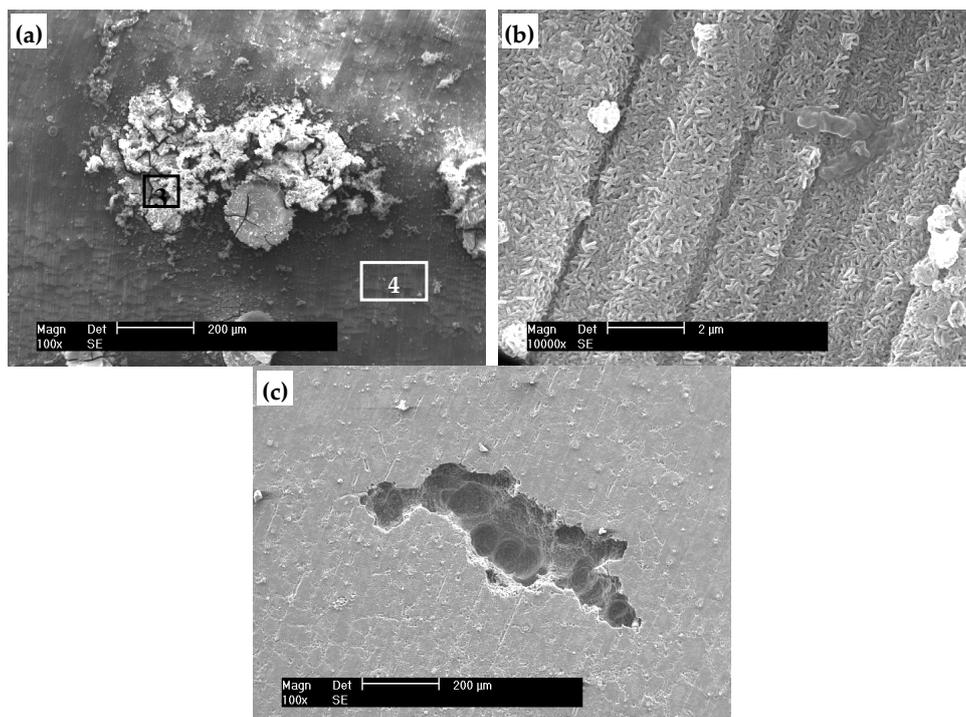
Figure 4 presents the surface morphology of the AZ31 alloy with HT film after immersion test for 15 days in Hank's solution. It is revealed from the low magnification morphology observation of the SEM image that lots of white corrosion products are deposited on the pit. However, these particles do not stack densely. It can be seen from the high magnification morphology that the microstructure of the top film changes greatly after immersion test. The baculiform particles stack tightly, which is quite different from the original HT microstructure before immersion (Figure 1c) than the curved

hexagonal platelets lying perpendicular to the substrate surface. After removing corrosion products, it is observed that the depth of pit is inhomogeneous, where it is deeper at the intermediate site (Figure 4c). It indicates that both vertical development and horizontal development of the pit corrosion occurred. Many shallow corrosion traces are also observed on the surface of the substrate.

Figure 4. Surface morphology of the hydrotalcite film coated sample after immersion test for 15 days in Hank's solution: (a) The white particle area in low magnification; (b) the intact area in high magnification; (c) the pit area after removing corrosion products. (3 and 4 in Figure 4a represent the EDS testing regions and correspond to the numbers in Table 1.)

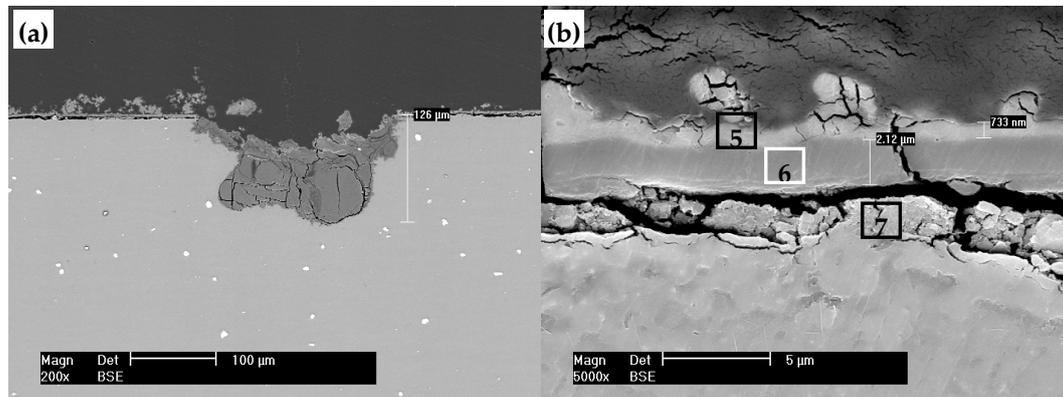
Figure 5 shows the cross-sectional morphology of the HT film coated sample after immersion test for 15 days in Hank's solution. Figure 5a displays a deep pit, the depth of which is about 126 μm , and it is filled up by corrosion products. In addition, there are many micro-cracks in the products block mass. In the high magnification image, there are three layers above the substrate, just like a "sandwich". The top layer is the corrosion products film covered above the HT film, the thickness of which is about 0.73 μm . The second layer is the HT film after immersion, but compared to the original HT film, the thickness of which is increased significantly (about 2.12 μm). There is an open crack, penetrating the

two layers directly to the substrate. Those micro-cracks can provide channels for the corrosion medium passing through to the substrate. As a result, the Mg substrate under the film is corroded, and another loose and discontinuous corrosion products film layer is formed underneath the HT film. In addition, there is a gap between the HT film and the bottom corrosion products layer. It may be caused by the mechanical ground because the corrosion products of the substrate underneath the HT film are loose and brittle.

Figure 5. Cross-sectional morphology of the hydrotalcite film coated sample after immersion test for 15 days in Hank's solution: (a) Low magnification; (b) high magnification. (5, 6 and 7 in Figure 5b represent the EDS testing regions and correspond to the numbers in Table 1.)

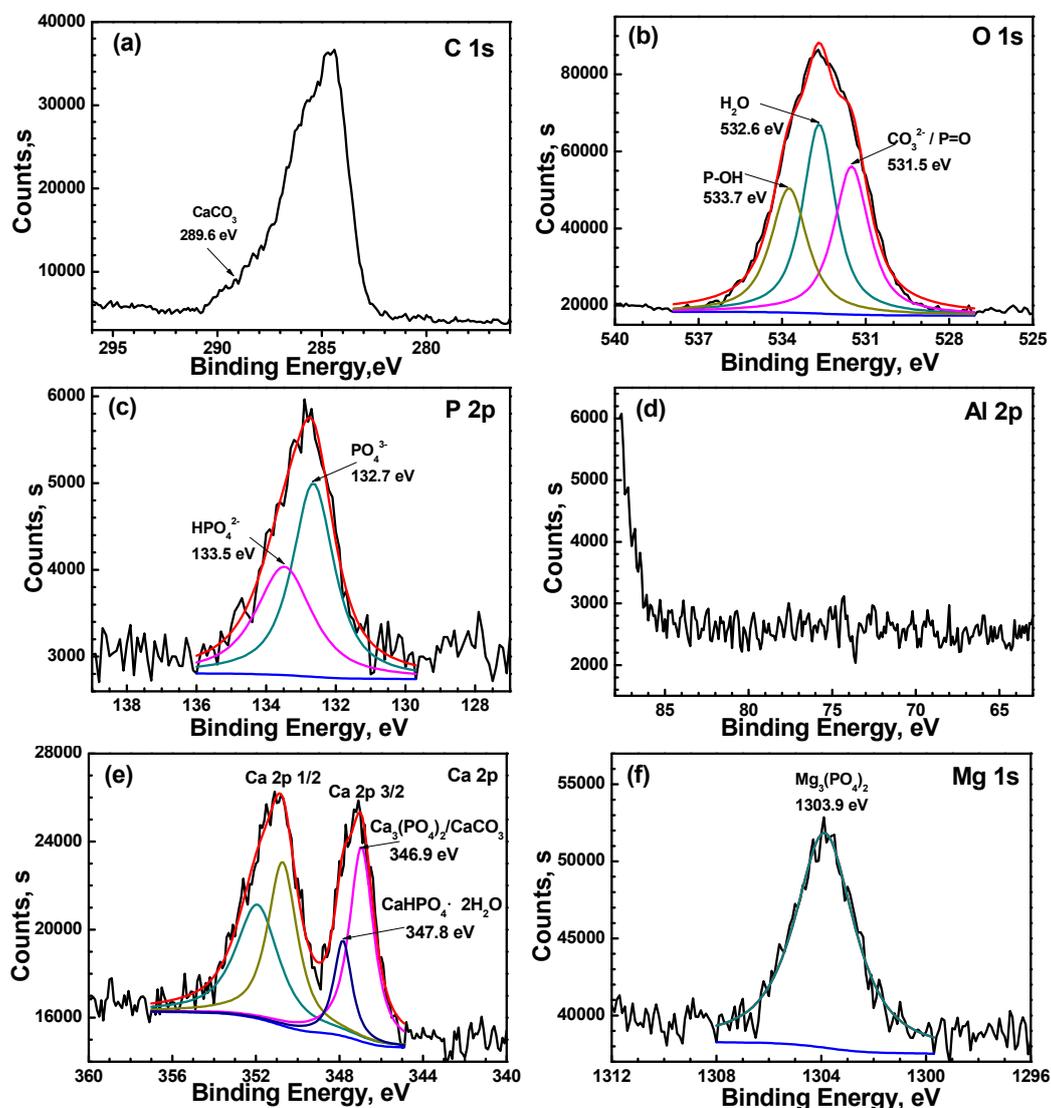
The XPS analysis of the HT film after immersion test for 15 days in Hank's solution is shown in Figure 6. The C1s spectrum has two peaks. The strong peak is due to the adventitious hydrocarbons from the environment. Small shoulder at approximate 289.6 eV indicates the presence of CaCO_3 . Figure 6b presents the high resolution XPS spectrum of O 1s, which is deconvoluted into three peaks. The peak at 533.7 eV can be attributed to P-OH [31,32]. The binding energy of 532.6 eV is H_2O . The peak at 531.5 eV is attributed to CO_3^{2-} or P=O [26,31–33]. The spectrum of P 2p is divided into two peaks, 132.7 and 133.5 eV, which are attributed to PO_4^{3-} and HPO_4^{2-} , respectively [34,35]. Al signal is inexistent in the spectrum (Figure 6d), indicating that the XPS signals are mainly attributed to the corrosion products film after immersion test, not from the HT film. The result is in accordance with the above results that there is another film layer on the top of HT film (Figure 5b) and almost no Al is identified in this layer. The high-resolution spectrum of Ca 2p displays two distinctive peaks due to the spin orbit splitting. The Ca 2p_{3/2} peak at 347.8 eV can be attributed to $\text{CaHPO}_4 \cdot 2\text{H}_2\text{O}$. The binding energy of Ca 2p_{3/2} peak at 346.9 eV can be attributed to $\text{Ca}_3(\text{PO}_4)_2$ or CaCO_3 [34]. The Mg 1s peak at 1303.9 eV is assigned to $\text{Mg}_3(\text{PO}_4)_2$ [35]. It is observed that the content of phosphates is larger than that of hydrogen phosphates. Based on the composition analysis, it can be seen that the top corrosion products layer is mainly consisted of $\text{Mg}_3(\text{PO}_4)_2$, $\text{Ca}_3(\text{PO}_4)_2$, $\text{CaHPO}_4 \cdot 2\text{H}_2\text{O}$ and CaCO_3 .

Figure 6. XPS analysis of the hydroxylapatite film after immersion test for 15 days in Hank's solution: (a) C 1s; (b) O 1s; (c) P 2p; (d) Al 2p; (e) Ca 2p; (f) Mg 1s.

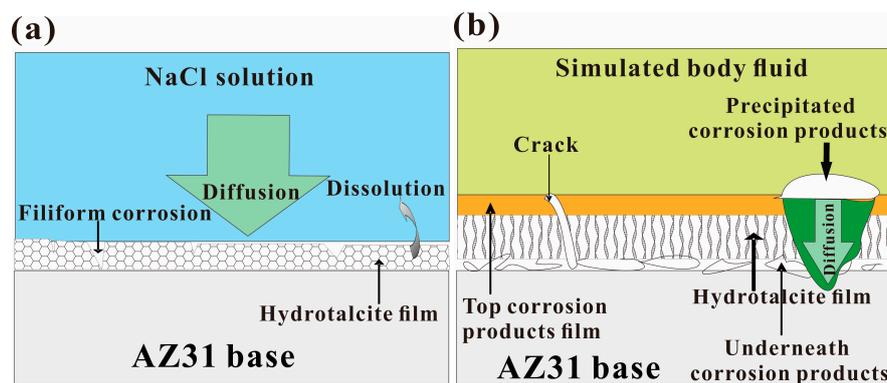
We preliminarily compared the corrosion protection effect of the HT film for AZ31 alloy in $0.1 \text{ mol}\cdot\text{L}^{-1}$ NaCl and Hank's solution. The corrosion behavior of the HT film in SBF is quite different from that in NaCl solution. In NaCl solution, localized corrosion has already occurred on the coated sample after 12 h immersion (Figure 5e in Reference [26]). When after 3 days immersion, the coated sample displayed a filiform corrosion characteristic and metal brightness (Figure 5a in Reference [28]). As illustrated in Figure 7a, dissolution of the HT film takes place, accordingly, the HT film cannot continuously provide protection to the Mg substrate for longer periods of time, and many long filaments are observed. Differently, in SBF, no corrosion is visible in the region of the coated sample after OCP test for more than 3 days. And, the whole surface of the substrate is still covered with film even after 15 days immersion. However, pit corrosion occurs at some active spots. Although the corrosion products deposited on the pit can provide some degree of protection, the corrosion suppression effect is limited in view of the fact that the products particles deposit is loosely above the pits (Figure 4a). In addition, the electrolyte can penetrate the film at the weak sites during the long-time immersion, and then micro-cracks appear on the surface of the film. Once the electrolyte passes through the micro-cracks to the substrate, underneath corrosion occurs. The corrosion behavior of the HT film in SBF can be illustrated as shown in Figure 7b. The corrosion protective effect of the HT film in SBF is superior to that in NaCl solution. It may be attributed to the corrosion products layer precipitation above the HT film. As a diffusion barrier against electrolyte uptake, the top corrosion products layer governs the dissolution of HT film and suppresses the corrosion activity. These facts indicate that the corrosion environment governs the corrosion behavior of the HT film.

Figure 7. Schematic illustration of the corrosion behavior of AZ31 with hydroxylapatite film in: (a) NaCl solution; (b) Hank's solution.

The difference in corrosion behavior of the AZ31 alloy with HT film in SBF and NaCl solution is preliminarily revealed. In NaCl solution, the HT crystals could be dissolved, and macroscopic filiform corrosion occurred only after 3 days immersion. In SBF, corrosion is localized, but most areas of the coated sample still remain integral even after 15 days of immersion. In SBF, the deposited top corrosion products layer can enhance the barrier effect of the HT film. Hence, the HT film can provide protection for longer periods of time in SBF than in NaCl solution.
