Article

The Impact of Temperature on the Surface Colour of Gas Turbine Blades Heated in the Presence of Kerosene

Air Force Institute of Technology, 6 Księcia Bolesława Street, 01-494 Warszawa, Poland

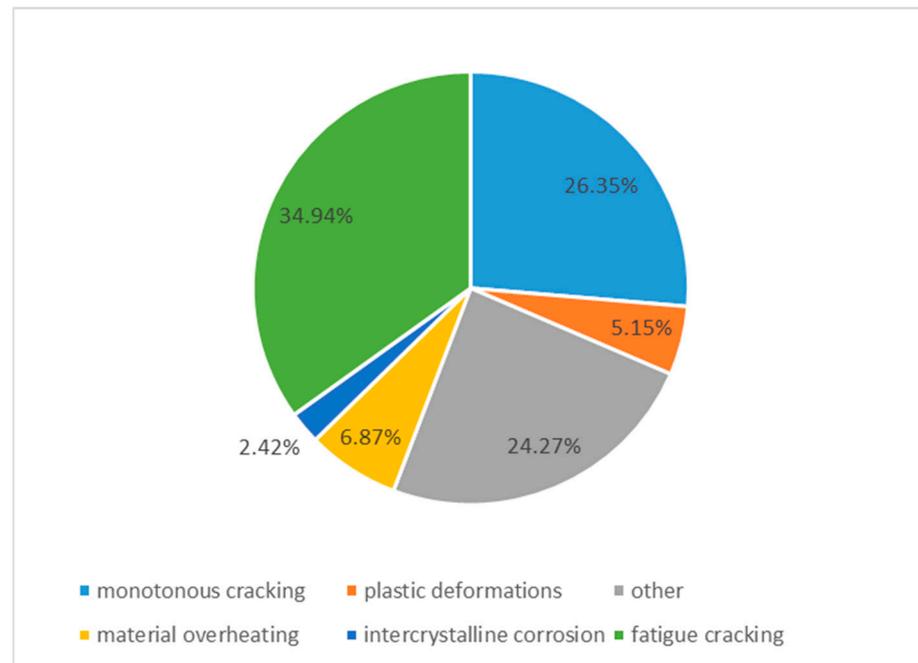
Figure 1. Causes behind aircraft turbine engine damages in the course of operation (Adapted with permission from Ref. [6]. 2007, AFIT.).

Most turbine damages are operational [1–5]. The causes behind aircraft turbine engine damages are shown in Figure 1.

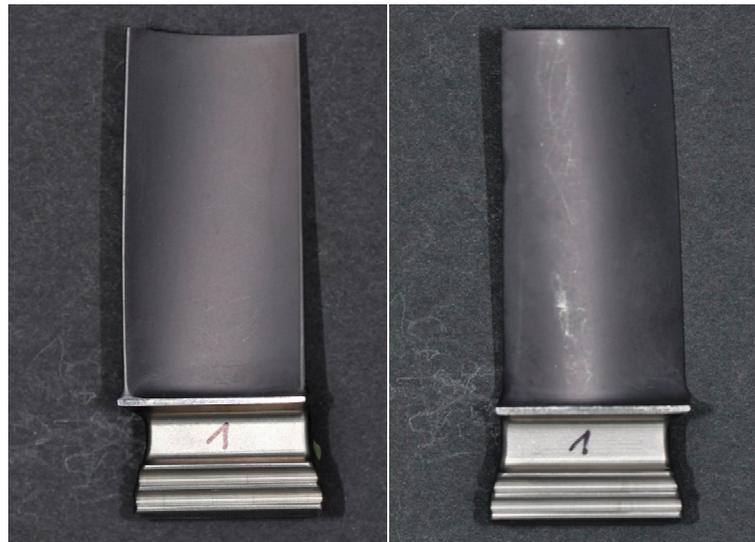
Figure 2. The blade No. 1 concave and convex surfaces (Reprinted with permission from Ref. [2]. 2011, AFIT.).

Laboratory tests were covered new gas turbine rotor blades (Figure 2 [2,8]). They were made of a conventional nickel and cobalt superalloy called EI-867WD (HN62MWKJu). Due to lower chromium content, it is less resistant to degrading environmental action, particularly in the presence of sulphur and sodium, and it often undergoes catastrophic corrosion (so-called hot corrosion) under operating conditions, which is why protective coatings are used—an aluminide coating [22–24].

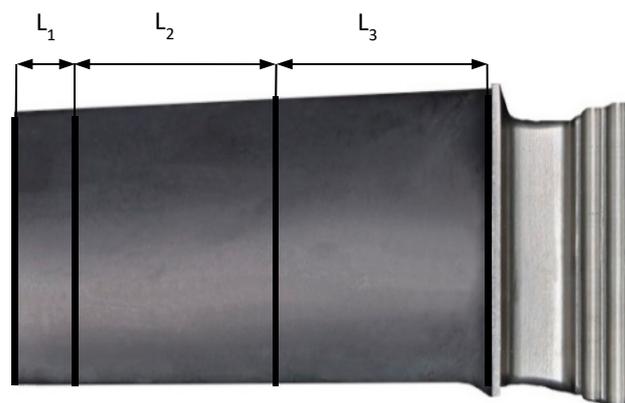
Figure 3. General pattern of gas turbine blade division into samples (Reprinted with permission from Ref. [8]. 2022, AFIT.).

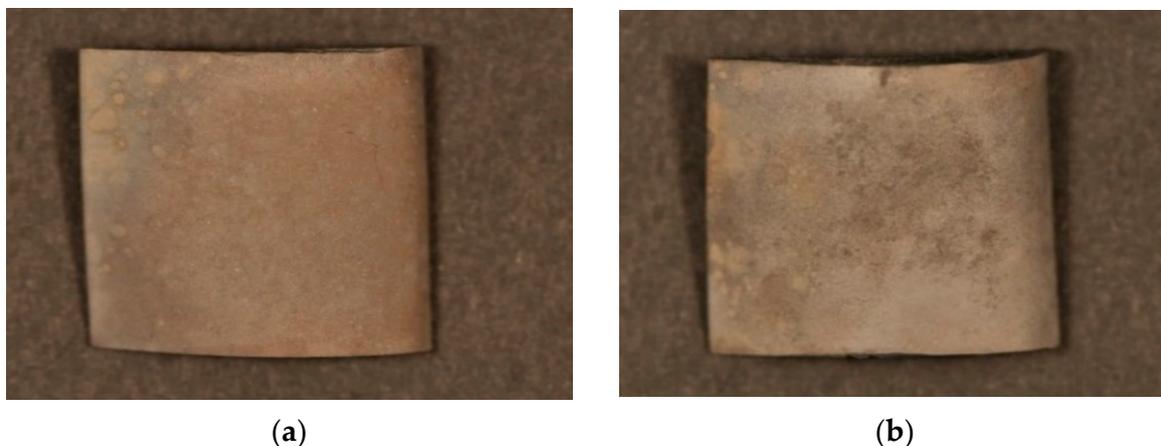
Figure 4. General surface images of blade samples after heating at a temperature of 1323 K in the presence of kerosene exhaust gases for: (a) 2 h and (b) 3 h (Reprinted with permission from Ref. [2]. 2011, AFIT.).

The first testing stage was determining the blade heating period. This parameter, together with temperature, impacts the γ' phase particle coagulation and growth kinetics, as well as a change in the thickness of the blade's protective coating thickness [24]. To this end, the authors conducted an experiment that involved heating blades at a temperature above $T_{4\max}$ (maximum temperature downstream of the turbine), i.e., 1323 K for 2 h and 3 h. Such a heating time was determined pursuant to the results of analysing records of an S2-3ai recorder onboard a Ts-11 Iskra aircraft with an installed SO-3W engine, taking into account the profile of executed flights associated with its training purpose and the engine service life between repairs of 400 h. The interval between the second and third heating hours was considered as the total time of elevated temperature impact associated with engine operating range changes and its user adjustments. The samples were prepared using one of the blades, out of which three vane fragments were cut (Figure 3). The blade fragment designated as $L_1 = 7$ mm was used to determine the primary blade structure, relative to which the structural changes of the L_2 blade fragment (heated for 2 h) and the L_3 blade fragment heated for 3 h at 1323 K were assessed. Samples were cut using a wire EDM machine. Heating was executed in an FCF 60 chamber furnace filled with continuously generated aviation kerosene exhaust gases. Blades were cooled in the furnace. General surface images of blade samples after heating at 1323 K for 2 h and 3 h are shown in Figure 4 [2,8].

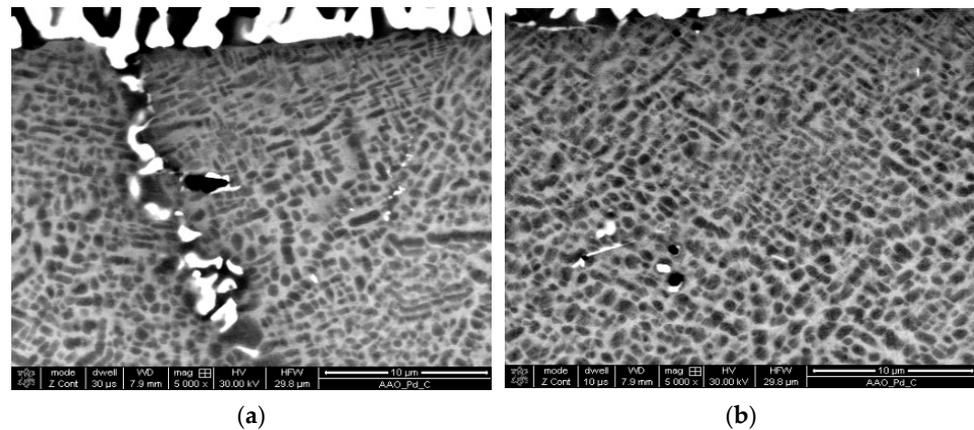
Figure 5. Phase γ' precipitation morphology—temperature of 1323 K for: (a) 2 h, (b) 3 h (Reprinted with permission from Ref. [2]. 2012, AFIT).

Phase γ' precipitation morphology test results—heating at 1323 K for: (a) 2 h and (b) 3 h—are shown in Figure 5 [2,8]. It was concluded that the test duration did not significantly impact a change in the γ' reinforcing phase morphology and essentially did not also lead to the increased thickness of the aluminide protective coating—see Figure 6 [2,8].

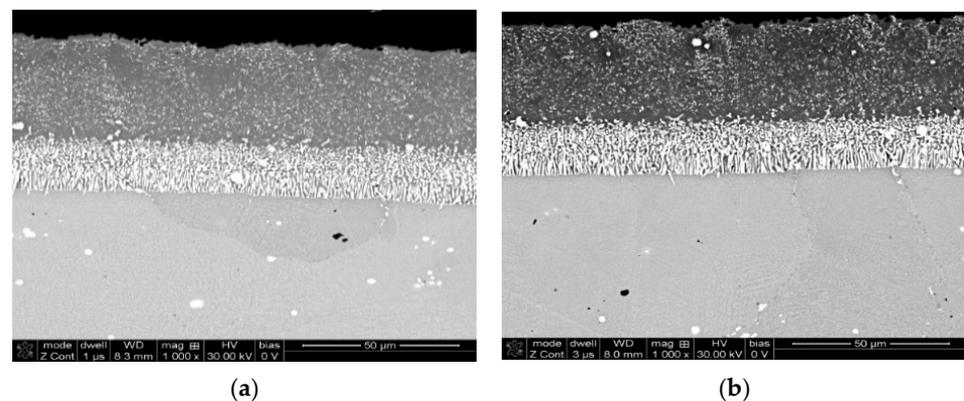
Figure 6. Aluminide layer structure—temperature of 1323 K for: (a) 2 h, (b) 3 h (Reprinted with permission from Ref. [2]. 2012, AFIT).

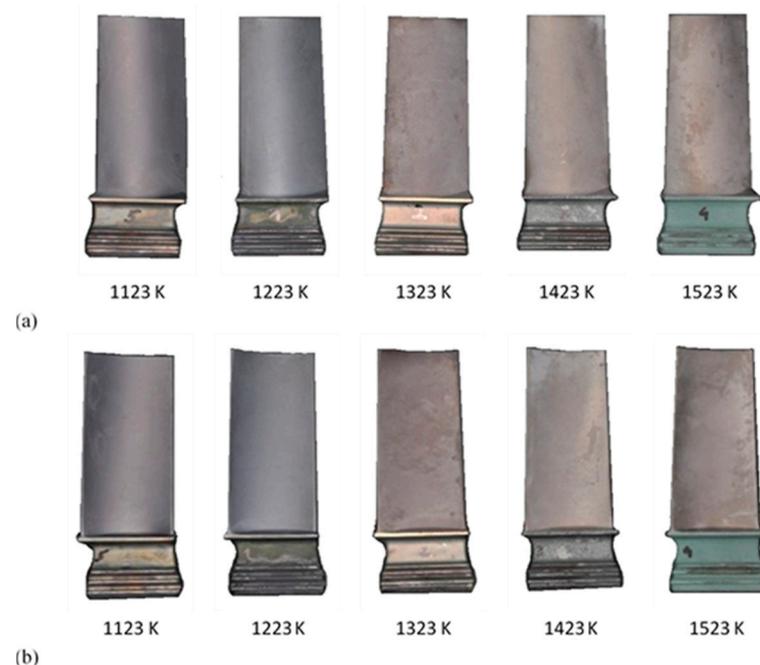
Figure 7. General view of blade surfaces after heating in the presence of aviation kerosene exhaust gases: (a) convex surfaces; (b) concave surfaces. (Reprinted with permission from Ref. [2]. 2012, AFIT.).

The first visible symptom of a change in the condition of the heated blades was their different colour—both the aluminide coating on the blade surface and the noncoated blade section (Figure 7 [2,8]).

A Nikon D900 digital camera was used to record surface images of heated turbine blades. Result repeatability was ensured through taking digital photos under identical laboratory conditions. A significant change in the surface colour was observed due to heating new blades in a furnace at different temperatures (Figure 7).

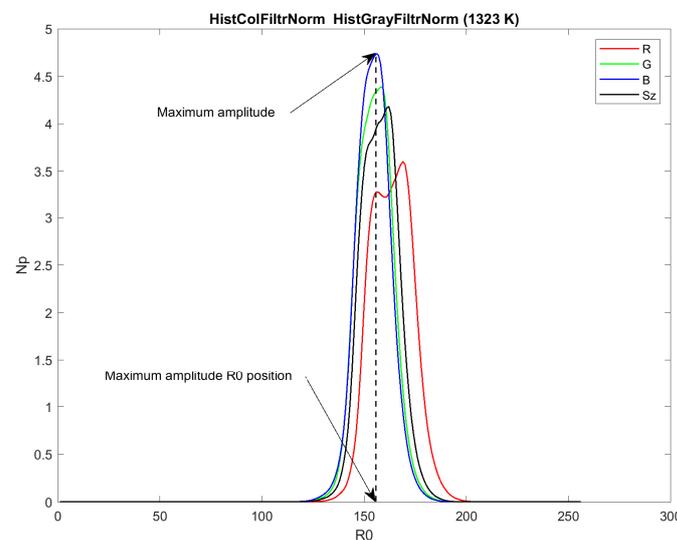
Figure 8. RGB and greyscale histograms.

Figure 8 presents the histograms of all image components—colour (R, G, B) and greyscale (Sz).

The parametric histogram description involves determining the position $R0_{max}$ of the maximum amplitude of each colour and greyscale component and each heating temperature.

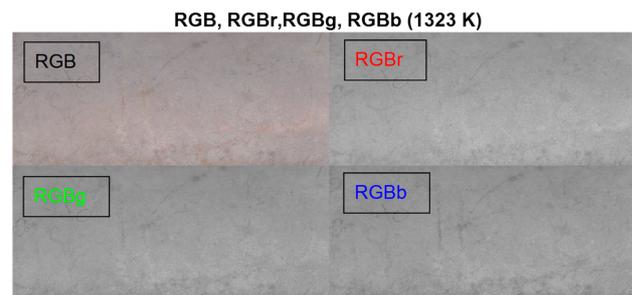
Figure 9. Surface image of blade No. 2 (1323 K). Adapted with permission from Ref. [8]. 2022, AFIT.)

The R0 saturation values (average and maximum amplitude position) are sufficient to describe colour changes in the acquired images. Such an approach is justified both by the recording method and obtained results. Figures 9–11 show examples of blade surface images and their histograms [8].

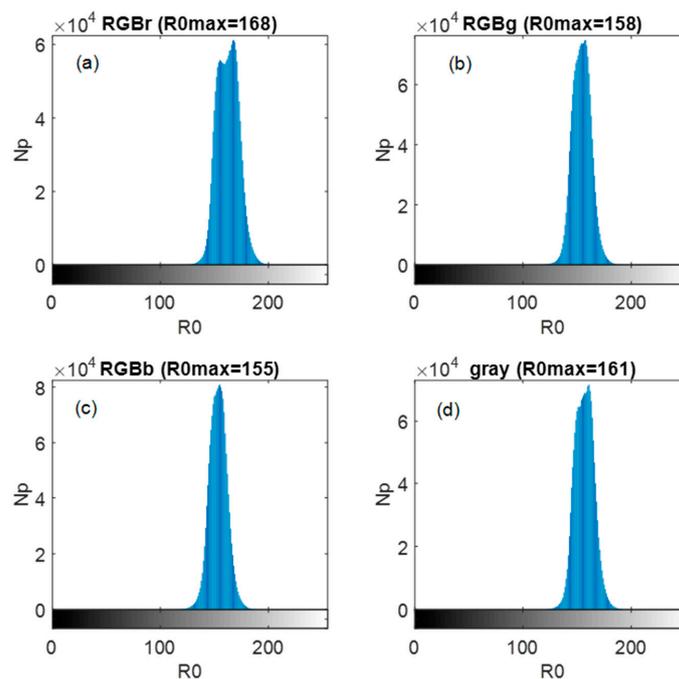
Figure 10. Histograms for blade No. 2 image (1323 K). (Reprinted with permission from Ref. [8]. 2022, AFIT.)

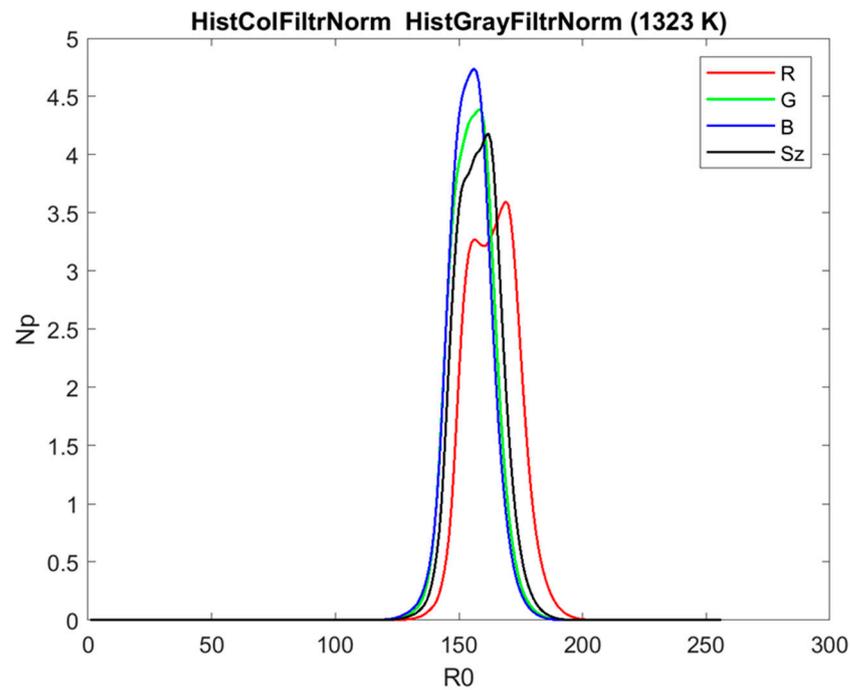
Figure 11. Normalized and smoothed R, G, B and Sz histograms for the blade No. 2 image (1323 K).

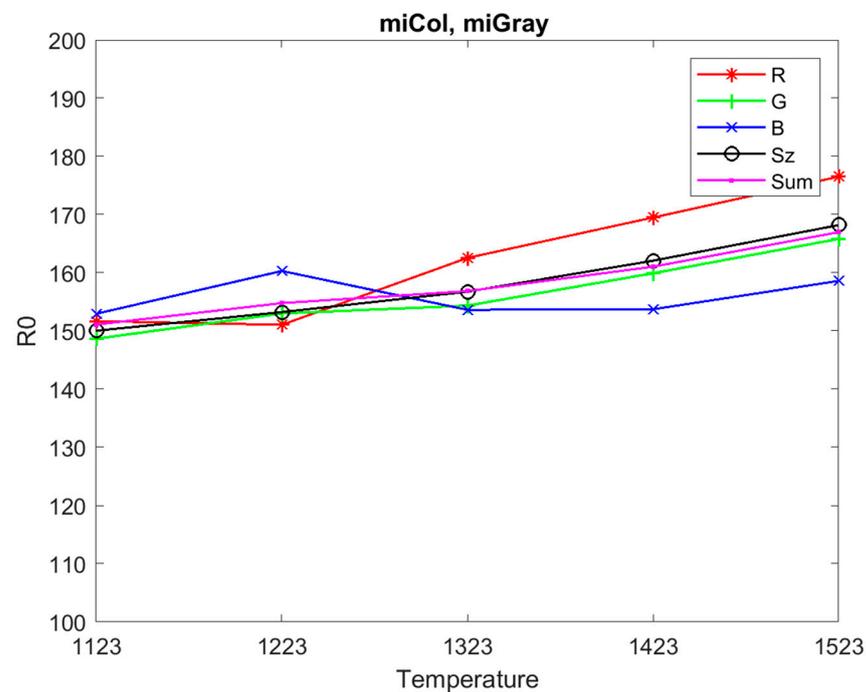
Figure 12. Change of average values of histograms as a function of blade heating temperature, where: Sum = $(R + G + B)/3$.

The average values of histograms of RGB components (R, G, B), grayscale Sz and Sum = $(R + G + B)/3$ as a function of blade heating temperature are presented in Figure 12.

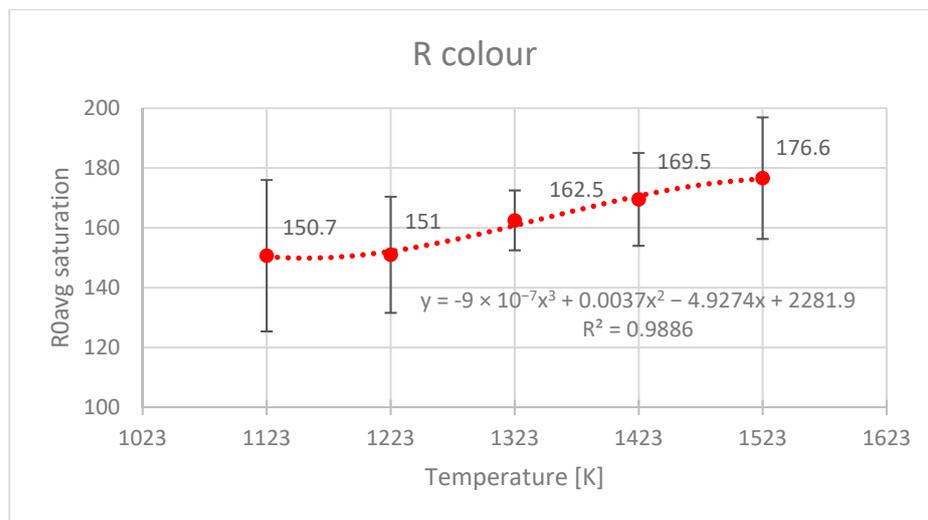
Figure 13. Mean R0 saturation of the R colour. (Reprinted with permission from Ref. [8]. 2022, AFIT).

Figures 13–16 show a comparison of R0 average saturation results for the entire blade surface histograms [8].

Third-degree polynomials approximate the change of R0 average saturation as a function of the heating temperature of the tested turbine blades.

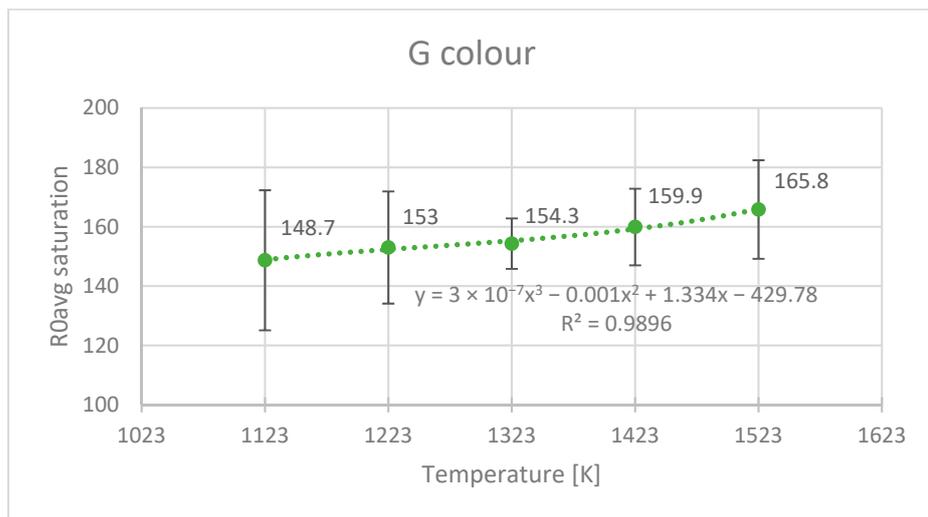
Figure 14. Mean R0 saturation of the G colour. (Reprinted with permission from Ref. [8]. 2022, AFIT).

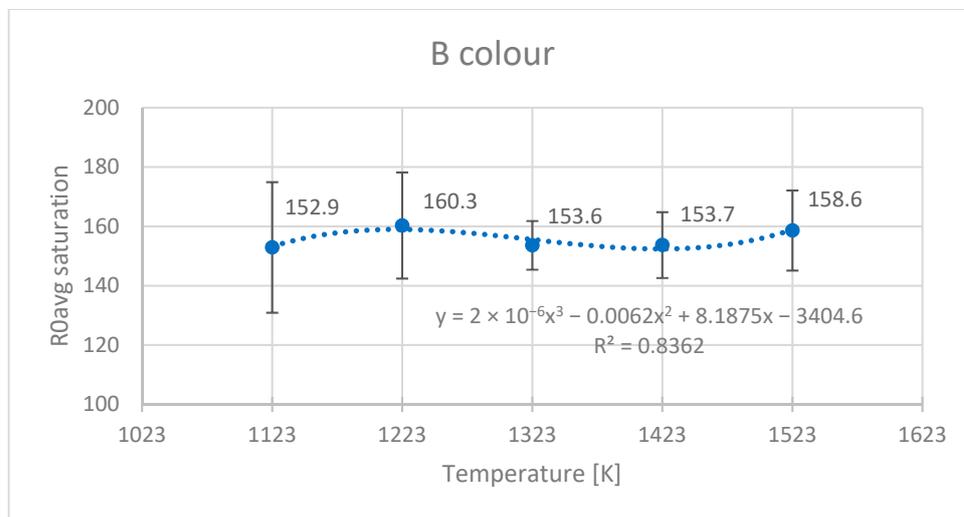
Figure 15. Mean R0 saturation of the B colour. (Reprinted with permission from Ref. [8]. 2022, AFIT).

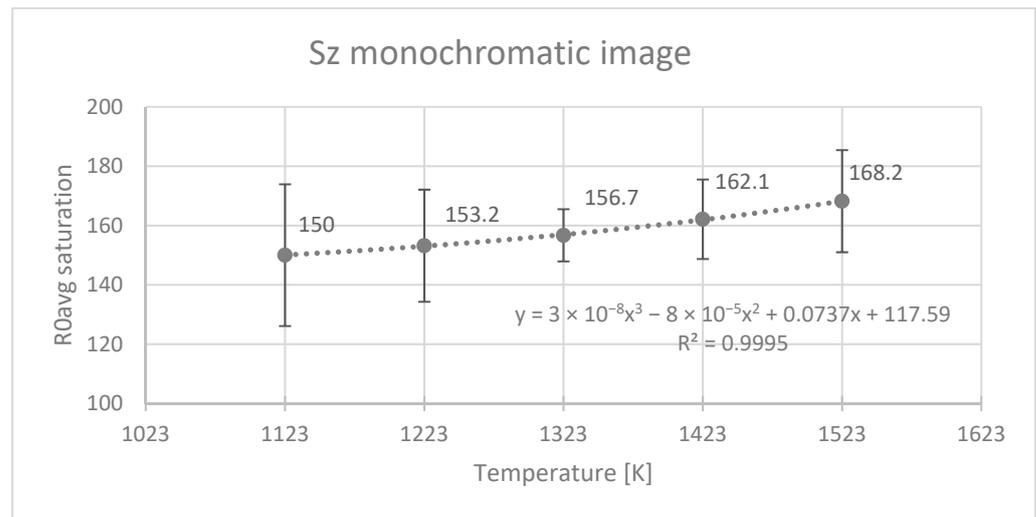
Figure 16. Mean R0 value of Sz greyscale levels. (Reprinted with permission from Ref. [8], 2022, AFIT).
