# Micrometric Growth Defects of DLC Thin Films

**Abstract:** Defects in diamond-like carbon coatings deposited on corrosion sensitive 100Cr6 steel have been studied. Diamond-like carbon (DLC) thin films are promising for corrosion protection due to chemical inertness and low electrical conductivity. Nevertheless, the performance of these coating is highly sensitive to the presence of uncoated areas. These defects represent the primary way of substrate degradation in aggressive environments. An in situ optical microscopy coupled to an electrochemical activation was developed to reveal micrometric growth defects and observe that they were at the origin of corrosion. A square wave voltammetry was applied to increase the sensitivity of electrochemical techniques based on the detection of the dissolution of the bare metal surface triggered by the presence of uncoated spots. This method can be utilized to quantify defect density arising from vapor deposition processes.

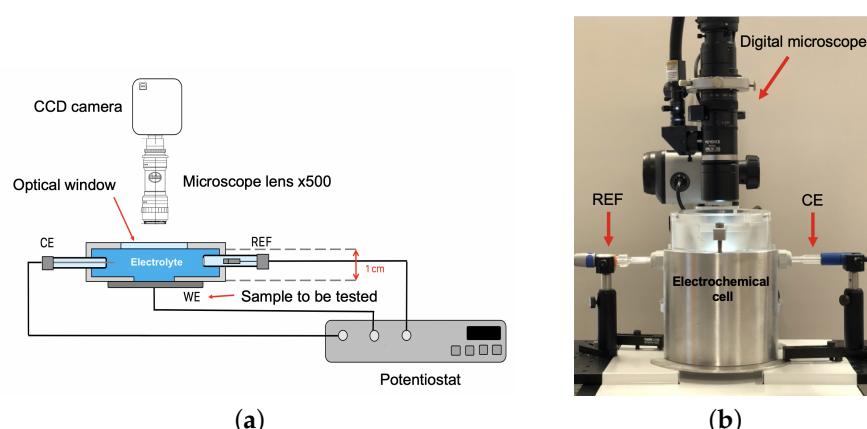
In situ observation using digital microscope KEYENCE VHX-5000 (Osaka, Japan) (equipped with long range zoom lens) was coupled to the conventional electrochemical set-up presented before. The set-up is schematically illustrated in Figure 1. The exposed sample area is scalable with a PTFE (Polytetrafluoroethylene also known as Teflon) adhesive mask to measure the electrochemical response of a very localized area.

**Figure 1.** Set-up for “in situ electrochemical test”; CE = platinum counter electrode, WE = working electrode and REF = saturated calomel reference electrode: (a) schematic diagram; (b) front view photograph showing the cell, the digital microscope.

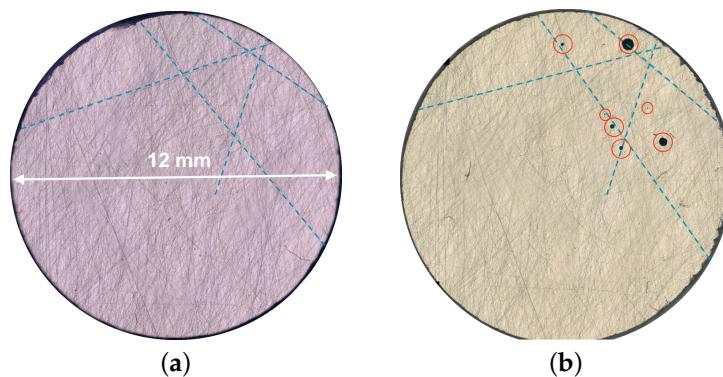
**Figure 2.** Reconstructed images of DLC (Diamond-like carbon) coated surface before (a) and after (b) the electrochemical experiment (polarization from  $-1$  V to  $+1$  V); images are oriented the same way to directly make the comparison.

Regarding the entire surface (12 mm diameter disk) before and after, corrosion spots have appeared after the polarization (Figure 2). Blue lines are drawn on surfaces following polishing lines and helping to match images. Red rings mark corrosion spots found at the surface. In this case, they are not randomly distributed at the surface but concentrated in one third of it. In addition, they exhibit a round shape but with various sizes.

A coated disk surface (100Cr6 coated with DLC coating) of a 12 mm diameter is chosen without any specific features. This surface is the maximum diameter that can be exposed into the electrochemical cell. However, because the surface is too large to be observed at the same time, a reconstructed image, done by VHX software (VHX-5000 series, Keyence, Osaka, Japan) and based on about 20 detailed images, is realized before and after the experiment (Figure 2a,b). The idea is to cover the largest surface and to obtain a maximum of information about corrosion. The polarization applied here was −1 V

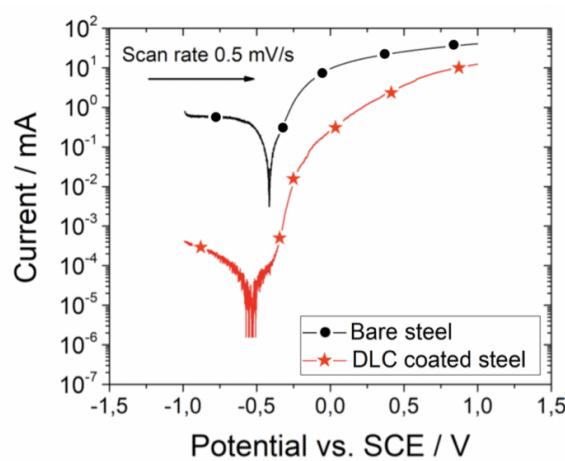
to +1 V logarithm scale representation allows for clearly defining the mixed corrosion potentials. Below this corrosion potential is the cathodic domain where dioxygen and then dihydrogen reduction happens and above it is the anodic domain where dissolution of steel occurs. For both samples, this corrosion potential is around  $-0.5$  V and  $-0.4$  V, indicating that substrate metal is in contact with electrolytes. Regarding curves of uncoated and coated samples in Figure 3, it can be deduced that DLC acts as barrier against electrolyte as the current is three orders of magnitude lower in the cathodic domain for the coated sample. Regarding the anodic domain, the recorded current, for the DLC coated specimen, is quite significant at 1 V even though it is lower than the uncoated one.

**Figure 3.** Polarization curves for a bare and coated with DLC (Diamond-like carbon) 100Cr6 steel plotted in a logarithm current scale.

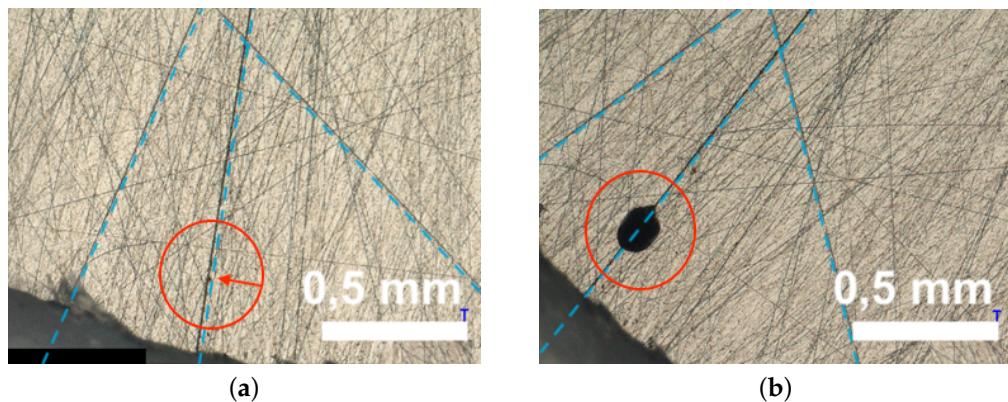
If a magnified zone from the previous image containing one of these corrosion spots is observed and compared with the same magnified “before” zone, it is nearly impossible to see the starting point of the corrosion spot at this exact location and for this level of magnification (Figure 4a,b).

**Figure 4.** Magnified zone of the previous reconstructed images DLC (Diamond-like carbon) coated surface before (a) and after (b) the electrochemical experiment (polarization from  $-1\text{ V}$  to  $+1\text{ V}$ ); images are not oriented the same way, but blue lines are placed to directly make the comparison.

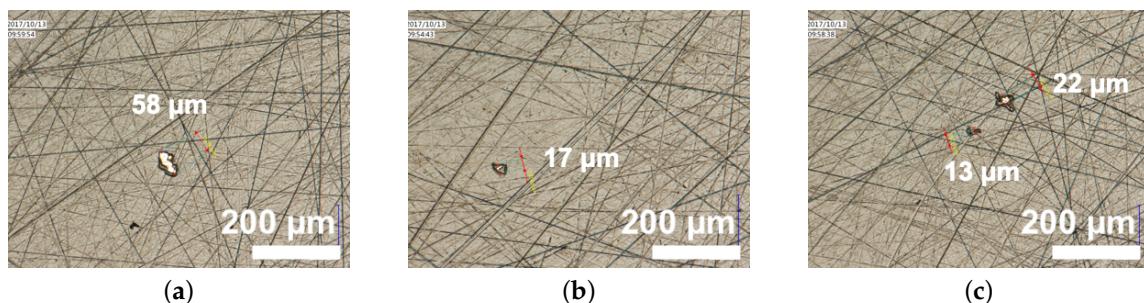
A fine observation of DLC coated substrate by digital microscope at higher magnifications has revealed that the surface contains several defects. These defects seem to be a micro-zone with the absence of coating. They measure around 60 to 10  $\mu\text{m}$ . Figure 5 presents three photographs of these uncoated areas of the surface.

**Figure 5.** 3 typical defected DLC (Diamond-like carbon) coated surface (a–c).

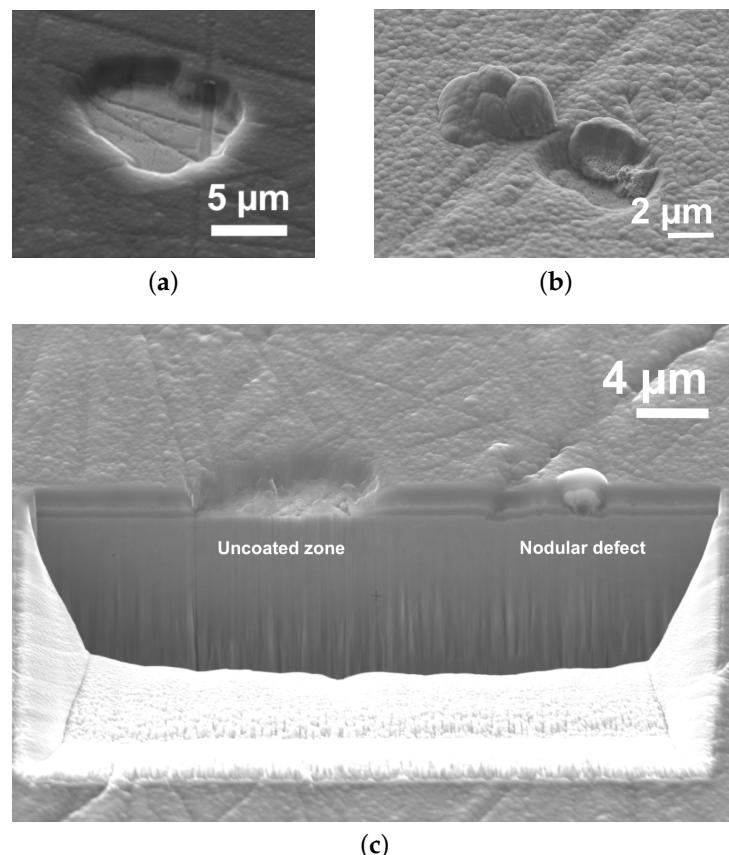
The surface has also been observed and studied with an SEM. Figure 6 presents some SEM surface and cross section images of these defects. An EDX analysis performed on the defect bottom (Figure 6a) showed that it was clearly steel surface. This means that the steel substrate, in this area, is clearly exposed to the corrosive environment. In addition, sometimes the formation of nodular or cone type defects is observed (Figure 6b). This nodule has poor adhesion compared to the overall coating and can be removed with mechanical solicitation. Figure 6b presents an example of nodule defects; one of them is partially removed leaving the substrate naked and unprotected.

**Figure 6.** Defects observed at DLC (Diamond-like carbon) coated surface: (a) micro uncoated zone; (b) nodule and broken nodule; (c) cross sectional observation (done by Focused Ion Beam (FIB)) of a micro uncoated zone and a nodule.

Even if the DLC are amorphous and deposited by PACVD, the observed defects (pinholes and nodules) (Figure 6) are very similar to those observed for crystalline transition metal nitride obtained by sputtering [16–18]. The main reason is that both processes are working in very similar conditions, and they share the same possible origins of particulates and flaking that leads to non-homogeneities of the surface coverage.

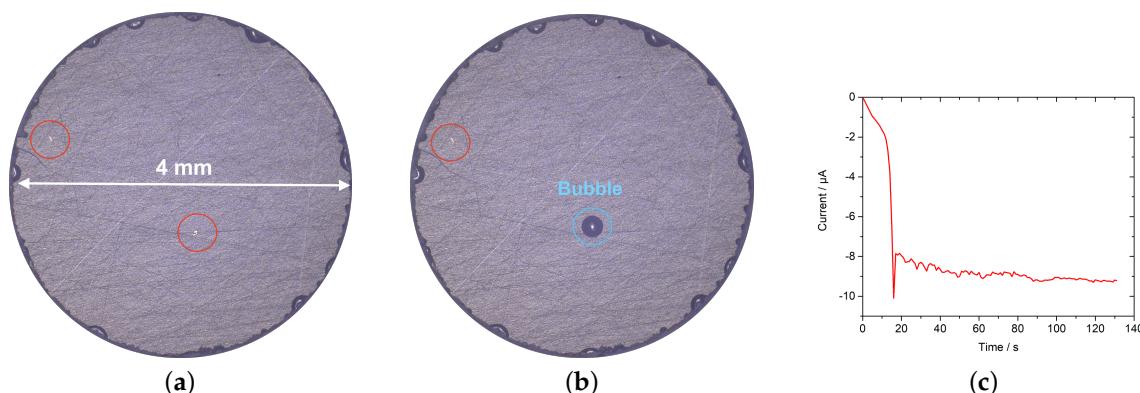
**Figure 7.** In situ observations (a) initial image ( $t = 0$  s) and (b) final image ( $t = 130$  s) and (c)  $i = f(t)$  curve of a coated surface under  $-1.2$  V static polarization.

Two “macro” defects are clearly identified from initial in situ observations (red rings in Figure 7a). They measure approximately 30 to 50  $\mu\text{m}$ . An open circuit potential (OCP) measurement is done and the value is stable at  $-460$  mV giving evidence of steel in contact with the solution. As it is difficult to observe any kind of other defect types than micro-uncoated areas, only these two are defined as clear corrosion pinholes candidates. When the  $-1.2$  V potential is applied, a current is detected and reach a steady state of  $-9 \mu\text{A}$  (Figure 7c). Above one of the defects, a gas bubble starts to form and grows, it remains stuck to the surface probably due to surface tension forces. Surprisingly, the other one has no visible bubble, but this doesn't mean that no reaction occurs for this defect.

In situ observation of the coated surface is started under a polarization test that consists of a  $-1.2$  V static polarization. At this potential, the reduction of the  $\text{H}^+$  proton produces only dihydrogen gas, which is non-destructive for a steel substrate. This reaction is clearly observable by gas bubbling at the surface. Then, a  $+0.4$  V static polarization is done. During  $+0.4$  V polarization, the anodic dissolution is stimulated. Figures 7 and 8 present the  $i = f(t)$  curves for, respectively, static cathodic and anodic polarizations with an image taken at  $t = 0$  s and at the end the experiments. Please note that experiments have various durations but always enough to see redox reaction phenomena.

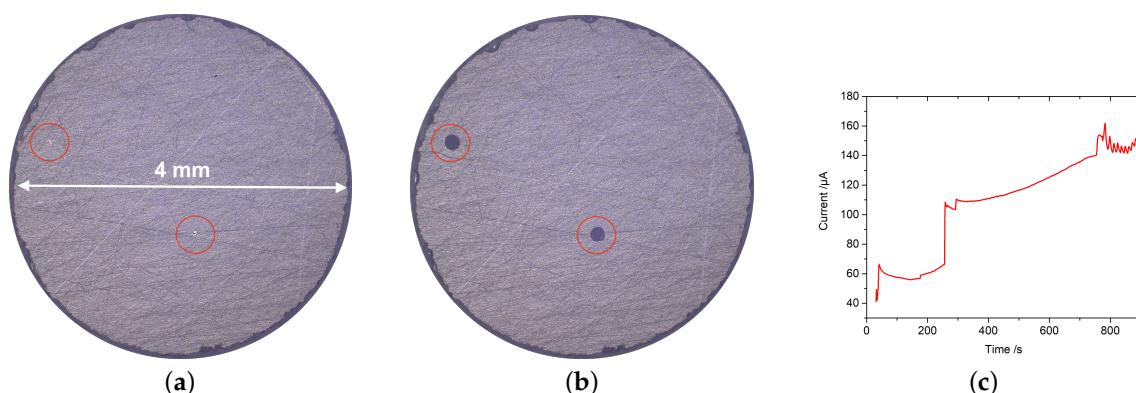
**Figure 8.** In situ observations (a) initial image ( $t = 0$  s) and (b) final image ( $t = 850$  s) and (c)  $i = f(t)$  curve of a coated surface under  $+0.4$  V static polarization.

Now,  $+0.4$  V polarization is applied on the same surface, OCP measurement, done before, remains in the same range of  $-500$  mV. As soon as the potential is applied, a current is detected but, contrary to the previous negative polarization, no steady state is reached and the current increases drastically by jump steps. At  $t = 840$  s, the current exceeds  $150 \mu\text{A}$ . According to the recorded images, these jump steps are correlated with growth of the corrosion pinhole. In this anodic polarization, the two initially identified defects have reacted and led to corrosion pinholes. No other defects have been detected, proving that the recorded current originates only from these two sites. It can be noticed that, contrary to reduction of  $\text{H}^+$  proton in dihydrogen, the anodic dissolution has occurred on both initially identified defects, which means that anodic polarization is more sensitive to detect preexisting defects.

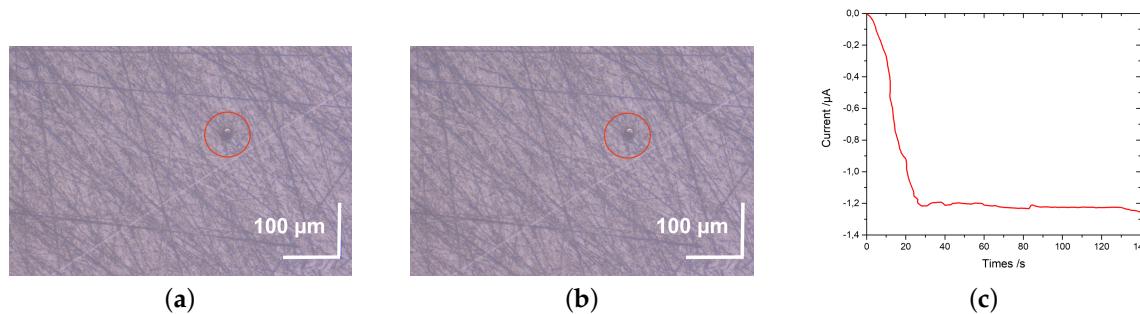
In the cathodic polarization, same observations were made with bubbles formation (not displayed on the final image but observed at intermediary stage) and correlated to a steady state current of  $-1.2 \mu\text{A}$ . This indicates that the potentiostat is able to detect a defect with surface of  $0.31 \text{ mm}^2$  on a surface of  $12.6 \text{ mm}^2$  (more than 40 times smaller) and visualize consequences of reduction reaction.

**Figure 9.** In situ observations (a) initial image ( $t = 0$  s) and (b) final image ( $t = 130$  s) and (c)  $i = f(t)$  curve of a coated surface under  $-1.2$  V static polarization.

Now, an area that exhibits a single defect is isolated and placed into the in situ electrochemical cell. The maximum magnification ( $\times 500$ ) is used here and thus the 4 mm disk surface is partially visible. Only the area containing the defect is observed and presented. The complete 4 mm diameter zone has been checked at the end of static polarizations to be sure that only one defect has reacted. The defect has a round shape and measures approximately  $20 \mu\text{m}$  in diameter. In the same way as before, a  $-1.2$  V followed by a  $+0.4$  V polarization is performed, and results are presented the same as before (Figures 9 and 10).

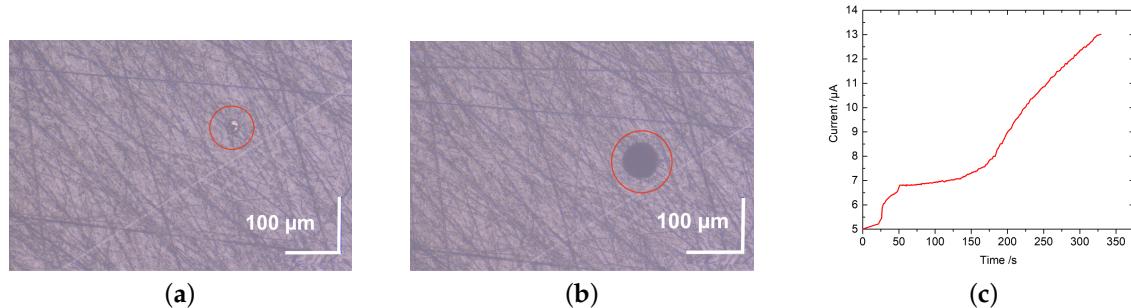
**Figure 10.** In situ observations (a) initial image ( $t = 0$  s) and (b) final image ( $t = 350$  s) and (c)  $i = f(t)$  curve of a coated surface under  $+0.4$  V static polarization.

In the anodic domain, the same trends are also noted. The defect becomes black as corrosion starts and expands in correlation with jump steps and rapid increase of current flow. After 350 s, an anodic current about  $13 \mu\text{A}$  is recorded.

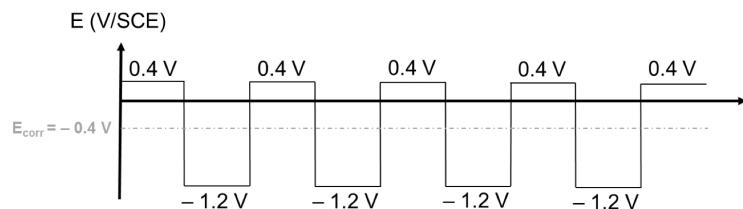
A specific potentiostatic polarization sequence has been designed (Figure 11) based on previously shown experiments. This sequence consists of a square wave polarization during which the potential of the working electrode is stepped through a series of forward and reverse pulses from  $-1.2$  V for 1 min to  $+0.4$  V for 1 min. This sequence was chosen to alternatively stimulate bare metal at the bottom of the small defects in an anodic domain to dissolve steel and in a cathodic domain, at sufficiently low potential, to reduce water (more precisely  $\text{H}^+$  proton) in dihydrogen allowing for mechanically removing corrosion products by  $\text{H}_2(g)$  bubbles motion. Before water reduction, at a potential close to the corrosion potential, the dissolved dioxygen reduction occurs first. This sequence can be considered as an enhanced defects detection procedure using corrosion reactions. Anodic dissolution increases the size of corroded zones quickly while dihydrogen bubbling aims at removing corrosion products and surrounding DLC films mechanically in order to clearly enhance to optical detection of corrosion spots.

**Figure 11.** Polarization sequence: square wave (period = 2 min).

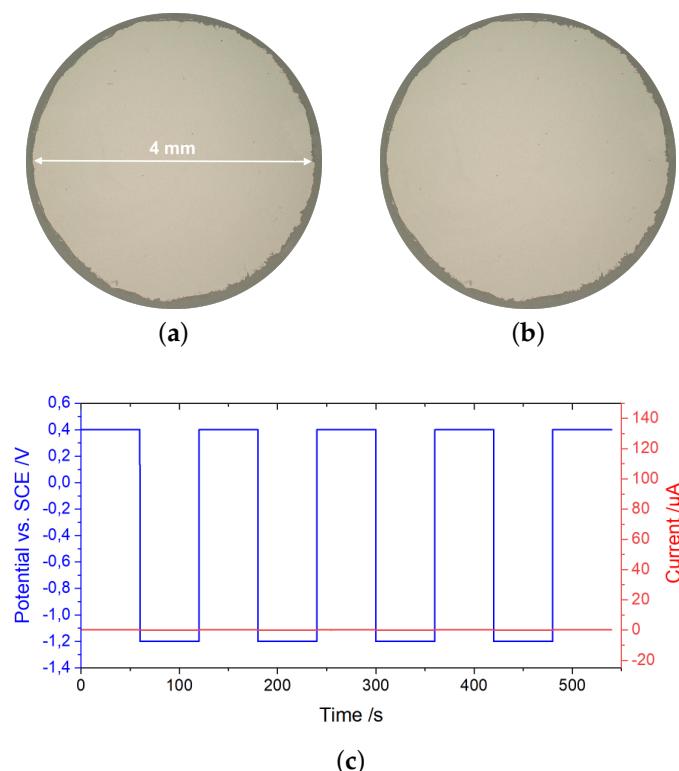
A first experiment using this electrochemical activation combined with digital microscope observations, a 4 mm diameter disk surface of a mirror-like polished steel B (90MnCrV8) coated with the DLC coating is tested (Figure 12). This surface appears to be free of uncoated areas or any visible coating defects. The use of a mirror-like polished specimen helps to easily detect intrinsic features of the coating. During the test, when the square wave polarization is applied, no current was recorded, and the current plot remains flat at  $0 \mu\text{A}$  (Figure 12c). The observation of the exposed surface along the polarization confirms that no feature is visible to suggest corrosion attacks or anything else. This validates that a-C:H is chemically inert with good insulating properties. Thus, as soon as the steel specimen is fully covered by DLC coating and free of defects from deposition stage, the sensitive steel substrate is completely protected against corrosion.

**Figure 12.** In situ observations (a) initial image ( $t = 0$  s) and (b) final image ( $t = 540$  s) and (c)  $i = f(t)$  curve of a coated surface under square wave polarization.

Contrary to the previous experiment (Figure 12c), a current is now recorded. At the beginning, it is not significant in the three first anodic steps, but, in the fourth, it drastically increases to reach at step end a value of 40  $\mu\text{A}$ . In the fifth step, the anodic has a steady state value of 20  $\mu\text{A}$ . The cathodic currents remain quite low at 0.4  $\mu\text{A}$  compared to anodic ones. A bubble has been observed in the cathodic step at  $t = 450$  s. The geometry of the squared artificial defect has also changed to become slightly rounded. The test is no longer continued after 540 s to perform a fine observation of the surface. The specimen zone, where the indentation artificial defect is located, is studied in the SEM-FIB device (Figure 14a). Half of the mark made by the Vickers tip is still visible on the left side of the SEM surface image. The other side has been totally removed, probably by the combined alternative effect of bubbling and steel dissolution.

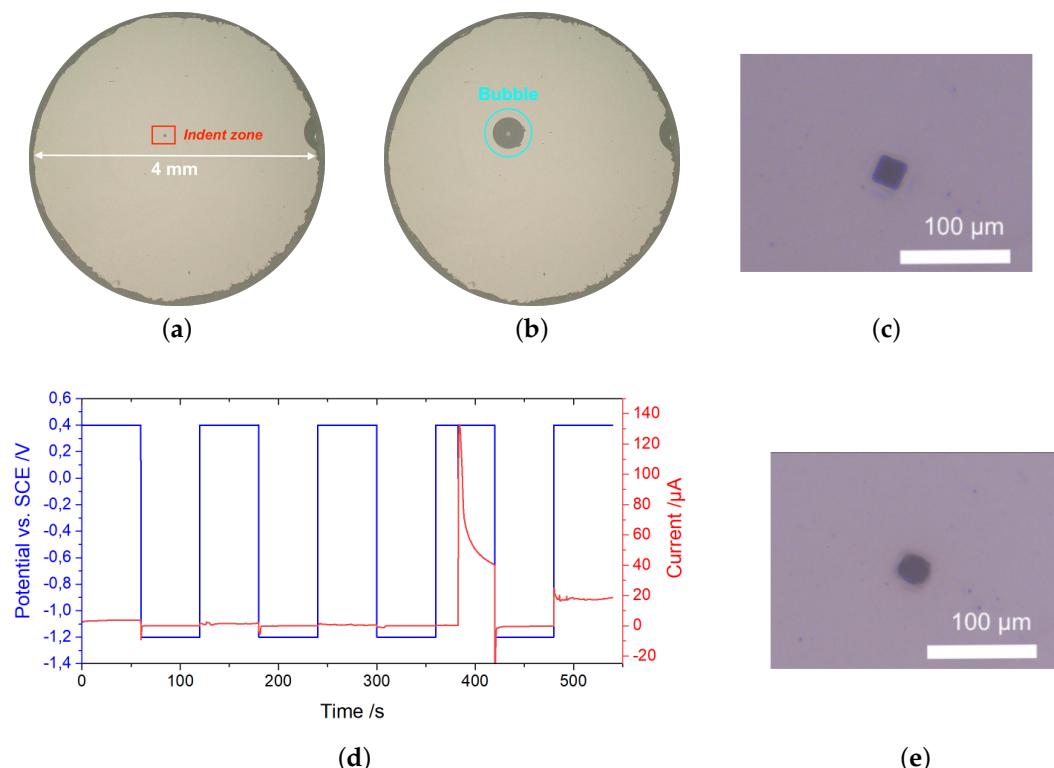
This same 4 mm diameter disk surface of a mirror-like polished QRS steel (90MnCrV8) is retested, but, this time, a single artificial defect is realized at the surface. This artificial defect is done by making an indentation mark with 25 N of load applied with a Vickers indenter tip. A square mark is visible in Figure 13a,c measuring approximately 20 by 20  $\mu\text{m}^2$ . The indenter has reached the substrate (estimated depth: 4  $\mu\text{m}$ ) and have created cracks field around letting the electrolyte penetrates until the substrate. The same square wave polarization is then applied (Figure 13d), and a focus is made on a smaller surface containing the artificial defect (Figure 13c,e).

**Figure 13.** In situ observations (a,c) initial images ( $t = 0$  s), (b) intermediary image ( $t = 450$  s) and (e) final image ( $t = 540$  s) and (c)  $i = f(t)$  curve of the same coated surface (as Figure 12) with one artificial defect (done by using a Vickers indenter tip) under square wave polarization.

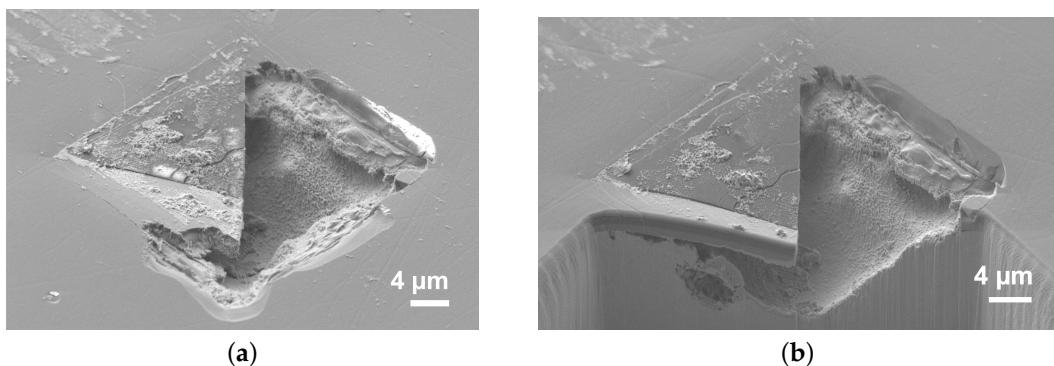
A cross section is performed by FIB milling on half of the defects to observe underneath consequences of the defect on substrate (Figure 14b). The corrosion has propagated along the bended coating and the corroded volume is empty underneath. The gas bubbling as well as the fact that a large part of the coating is removed could be the reason why it is empty.

**Figure 14.** SEM observations ((a) top surface and (b) cross section) of the coated surface with one artificial defect (Figure 13) after in situ electrochemical tests (square wave polarization).

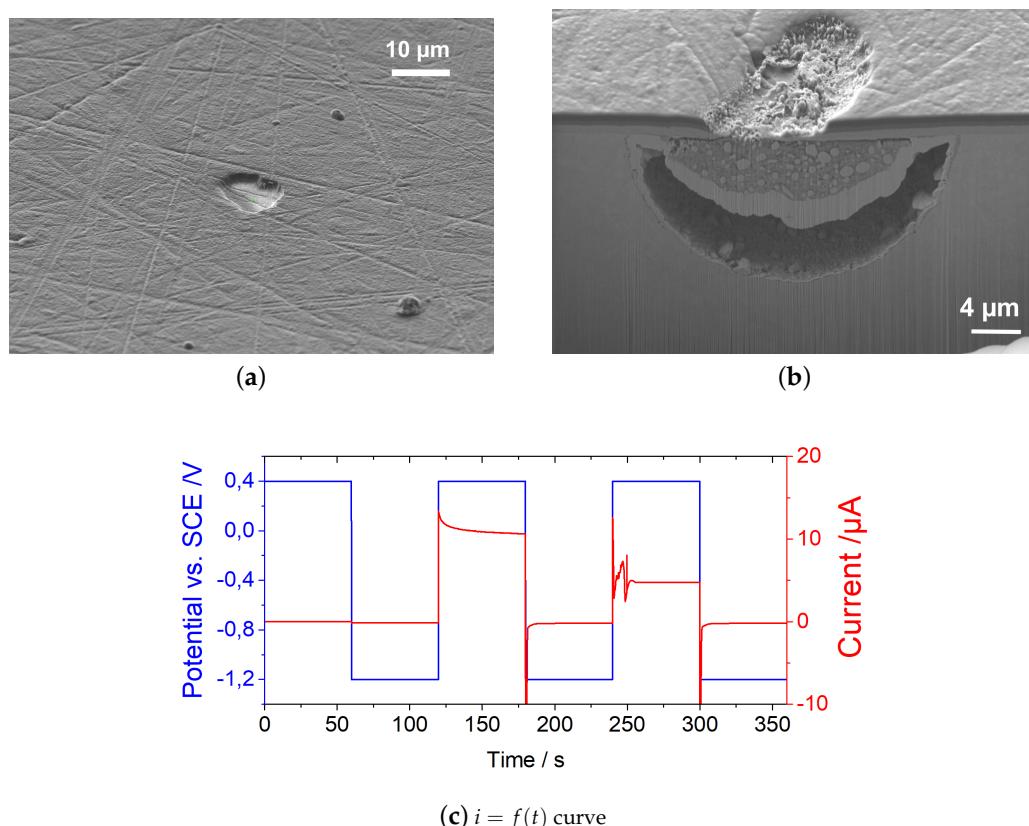
In addition, finally, on a third sample, an uncoated area found via an SEM observation was isolated. Figure 15a presents an SEM image of this defect untouched before any electrochemical activation. It measures around 10 μm. Then, this defect is submitted to the electrochemical activation and then re-observed in a cross section using SEM-FIB. The surface tested was still a 4 mm disk. The electrochemical stimulation was stopped after two active anodic steps in order to limit damage to the defects and preserve its initial shape.

**Figure 15.** SEM images of one isolated defect (a) before and (b) after electrochemical activation and (c)  $i = f(t)$  curve of the coated surface containing the defect under square wave polarization.

During the test, a significant current is recorded (Figure 15c). It was checked that only the selected defect has reacted. At the beginning, it is not significant in the first anodic step but in the second one, it drastically increases to reach at step end a value of  $10 \mu\text{A}$ . At the next active step the anodic has a steady state value of  $5 \mu\text{A}$ . The cathodic currents remain quite low at  $0.4 \mu\text{A}$  compared to anodic ones. Bubbles have been observed in the cathodic steps. A cross section is achieved by FIB milling on half of the defects to observe underneath consequences of the defect on substrate (Figure 15b). A hemispherical cavern is observed under the defects and it propagates under the remaining coating surrounding the defect. This cavern is partially filled with corrosion products and unconsumed carbides from steel matrix. These compounds filling the cavern are the main cause of the current limitation.

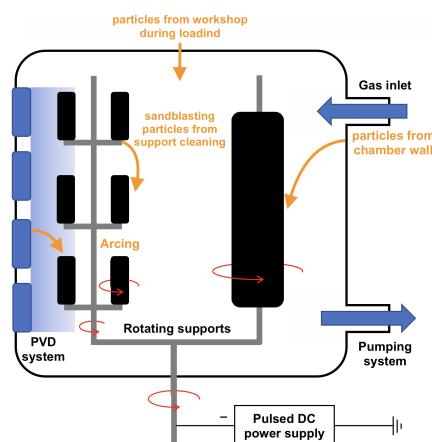
The contamination of the surface can thus arise from (Figure 16):

- an incomplete/inadequate surface preparation (cleaning, polishing, etching) of the substrate,
- workshop environment before deposition,
- flaking from previous coating on reactor walls or heaters during the outgassing step,
- flaking from rotation of support fixtures during deposition,
- microdroplets from evaporators or arcing from targets during deposition.

**Figure 16.** Diagram of an industrial PVD(Physical Vapor Deposition)/PACVD (Plasma Assisted Chemical Vapor Deposition) reactor with typical sources of defects.
