# Low-Power Vibrothermography for Detecting and Quantifying Defects on CFRP Composites <sup>†</sup>

<sup>†</sup> Presented at the 18th International Workshop on Advanced Infrared Technology and Applications (AITA 2025), Kobe, Japan, 15–19 September 2025.

Detecting and quantifying barely visible impact damage (BVID) in carbon fiber-reinforced polymer (CFRP) materials is a key challenge in maintaining the safety and reliability of composite structures. This study presents the application of low-power vibrothermography to identify and quantify such defects. Using a long-wave infrared (LWIR) camera, thermal data were captured from the CFRP specimens that inhibit BVID. How image processing, specifically principal component analysis (PCA) and sparse principal component analysis (SPCA), can enhance thermal contrast and improve the accuracy of defect size is also explored. By combining low-energy excitation with advanced data analysis, this research aims to develop a more accessible and reliable approach to non-destructive testing (NDT) for composite materials.

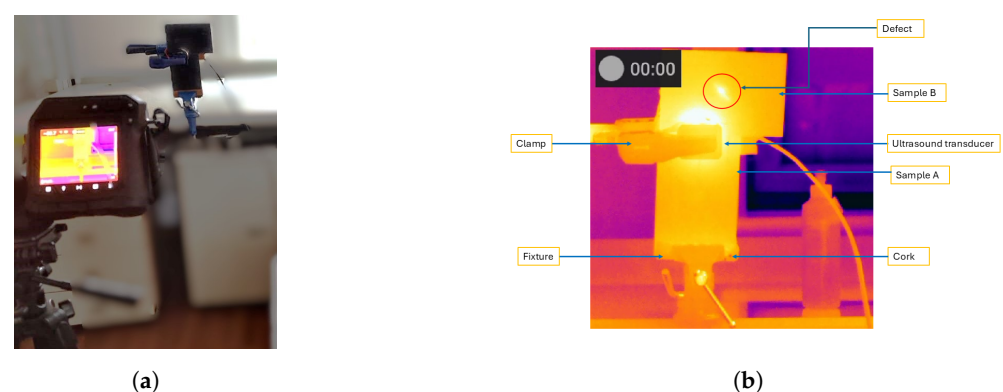
The experimental setup was designed to investigate BVID in CFRP specimens using a low-power vibrothermography technique. Mechanical excitation was delivered using a narrowband piezoelectric transducer with a center frequency of 28 kHz. A function generator produced a sinusoidal signal at 30.13 kHz and 20 V peak to peak (Vpp), which was then amplified using a voltage amplifier set to its maximum gain of 20 times. To ensure good transmission of ultrasonic energy into the specimen, a thin layer of couplant (Cytolax ultrasound gel) was applied between the transducer and the CFRP surface. The transducer was held firmly in place using a clamp. The amplifier is rated for a maximum peak output power of 40 watts. Thermal responses were captured using a FLIR T560 LWIR camera, featuring a resolution of 640 × 480 pixels and a frame rate of 30 frames per second. The camera records thermal image sequences before, during, and after excitation. All experiments were performed under stable ambient conditions to minimize environmental thermal noise. Figure 1a shows the setup of the vibrothermography experiment.

**Figure 1.** (a) Experimental setup of low-power vibrothermography; (b) Raw thermal image at 6 s.

Thermal responses from two CFRP specimens, each with a thickness of 3.8 mm and subjected to 8 J (sample A) and 12 J impact energy (sample B), respectively, were recorded using a low-power vibrothermography setup. Figure 1b is the raw image extracted from the video data at 6 s. In this experiment, both CFRP specimens were excited simultaneously using a single piezoelectric transducer. The transducer was positioned so that half of its surface was in contact with sample A (impacted at 8 joules) and the other half with sample B (impacted at 12 joules). This shared setup ensured that both samples received the same excitation conditions, enabling a fair comparison of their thermal responses. Under low-power excitation, sample B, which had experienced the higher impact energy, exhibited a clearly visible thermal signature at the damage site. The defect was detectable directly from the raw thermal frames, suggesting sufficient signal frequency to trigger localized heating through the low-power ultrasonic excitation. For sample A, the thermal response at the impact site was much less pronounced. While there was a slight temperature variation near the expected defect location, the thermal contrast was low, and the defect was not clearly visible in the raw thermal frames. To address this limitation, further image processing was applied to the thermal sequence from sample A using PCA and SPCA.

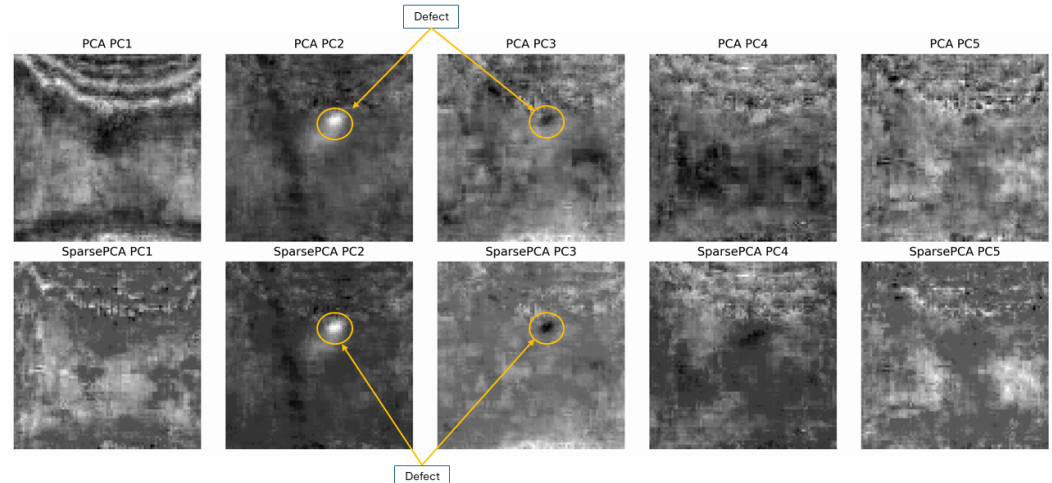
Figure 2 shows the first five principal components extracted from the thermal sequence by PCA and SPCA. In both methods, principal component 2 (PC2) and principal component 3 (PC3) clearly isolate the impact site. The defect signal is essentially absent or much weaker in principal component 1 (PC1), principal component 4 (PC4), and principal component 5 (PC5). The defect area on PC2 is larger than the defect area on PC3. Moreover, the SPCA PC2 image exhibits noticeably higher contrast at the damage location than the standard PCA PC2, easing visual detection of the BVID.

**Figure 2.** Defect identification on region of interest of sample A using PCA and SPCA (PC1 to PC5).

For sample A, we applied both standard PCA and SPCA to the sequenced image. In both cases, the second and third principal components (PC2 and PC3) clearly isolated the damage site, whereas the other components contained mostly background variation. PC2, in particular, captured the main defect related signal over a larger area than PC3, indicating it is the most informative component for identifying the BVID.

Comparing PCA and SPCA, we found that SPCA PC2 produces a slightly higher-contrast image of the defect. This improvement possibly comes from the sparsity constraint built into SPCA. The result is an eigen image in which the damage could be seen more distinctly against a background. The main trade-off is that SPCA is more computationally intensive than standard PCA. However, in situations where defect visibility is important, the extra processing time can be worthwhile.
