Delaying Effect of Fatigue Crack Propagation by Single-Pulse Laser Irradiation [†]

Keywords: fatigue crack propagation; delaying effect; single-pulse laser treatment; repair

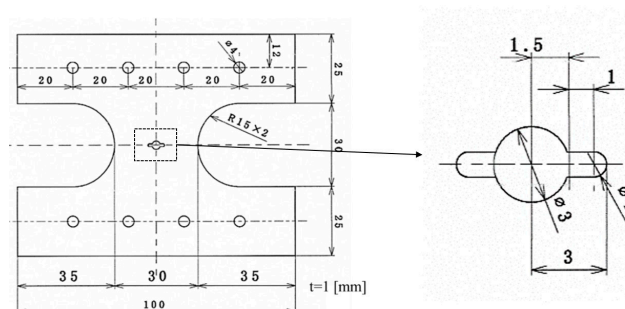
A type 304 stainless steel plate was cut as the required specimen geometry (Figure 4) with a hole at the center with the following dimensions: plate thickness: 1 mm, testing area: 30×30 mm and hole diameter: 3.0 mm. Fatigue tests were performed using the servo pulser (EHF-EB50kN-20L, Shimadzu, Kyoto, Japan) under a cyclic load-controlled condition (maximum load: 7500 N, minimum load: 0 N and frequency: 3 Hz). The crack propagation process was monitored using a digital microscope

Figure 4. Specimen geometry used for fatigue test.

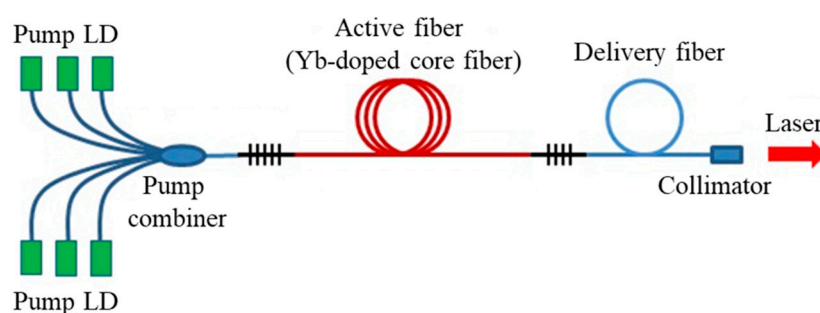
(ARTRAY, Tokyo, Japan). When the crack length reached approximately 1.0 mm, a single-pulse laser with a spot diameter of approximately 1.0 mm was aimed at the area ahead of the crack tip. Single-pulse laser was irradiated by on/off control of a continuous wave (CW) fiber laser. The CW fiber laser system is illustrated in Figure 5.

The laser system utilized in this study has a maximum power of 1500 W. In this study, the following laser parameters were used: power of 675 W and ON TIME of 0.02 s.

Figure 5. Configuration of fiber laser system utilized in this study.

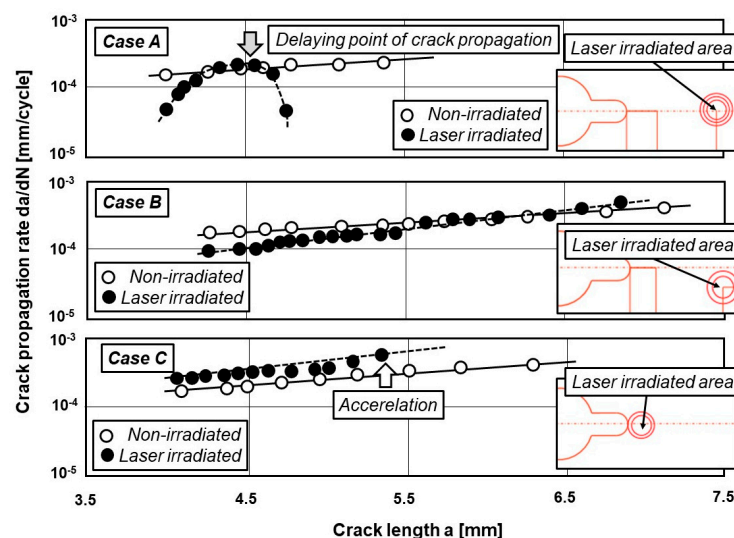
Figure 7 indicates the plot of the fatigue crack propagation rate (da/dN) vs. the crack length (a). The open circles represent the propagation rate of the non-irradiated specimen, and the solid circles represent the single-pulse laser irradiated specimen. The single-pulse laser irradiated positions were ahead of the crack tip (case A), slightly below and ahead of the crack tip (case B), and on the crack tip

itself (case C). In case B, the fatigue crack propagation rate is almost the same as that of the non-irradiated specimen, meaning that single-pulse laser irradiation has no effect when applied at this position. When the crack tip itself is irradiated by the single-pulse laser (case C), the crack propagation rate is slightly increased, from which we may conclude that the irradiation caused a brittle fracture. On the other hand, it is clear that case A is very effective in reducing the crack propagation rate. It is presumed that the formation of residual stresses around the laser-irradiated area strongly affected the crack propagation behavior. Consequently, the most suitable position for laser irradiation was area close to the tip of fatigue crack on the crack plane.

Figure 7. Effect of pulse laser irradiation location on fatigue crack propagation rate.
