Investigating the Effect of Stepped Scarf Repair Ratio in Repaired CFRP Laminates under Compressive Loading

Abstract: In this work the effectiveness of stepped repairs to damaged fiber reinforced composite materials is investigated by using previously validated numerical models which were compared with tested repaired composite plates. Parametric studies were carried out in order to assess the scarf ratio (i.e., step length to ply thickness ratio) influence on ultimate forces, displacements, stresses and stiffnesses. FE models with repair scarf ratios varying from the value of 20 to the value 60 with a step increase of 10 were developed. The numerical models allowed a direct comparison of the influence that the scarf ratio had to the strength and stiffness restoration of the repaired composite structure. The study verifies that the restoration of the strength of a damaged laminate depends largely on the size of the repair patch. Generally, the bigger the size of a patch, the stronger the repaired structure is, up to a critical threshold size. To maximize the strength restoration, it is advised that the number of steps in each patch are no less than the number of plies on the base

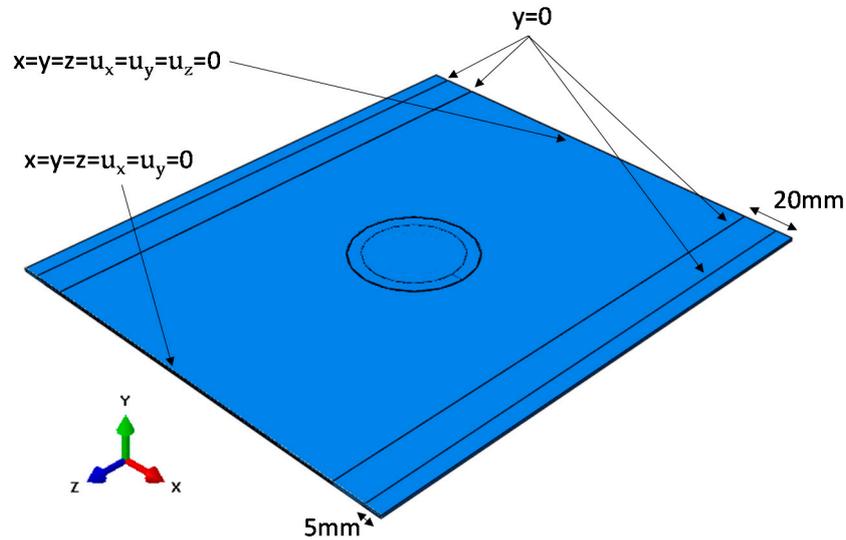
Figure 1. Illustration of rods that were placed onto the upper and bottom faces of the laminate.

More specifically, 5 models, whose repair patch has the same number of steps as the layers of the base laminate, were analyzed with scarf ratios varying between 20, 30, 40, 50 and 60. Then, another 3 models, whose repair patch has 4 steps in total were examined with scarf ratios 30, 60 and 120. And finally, 4 additional models whose repair patch has 3 steps, were analyzed. Scarf ratio is defined as the length of the step divided by the height of each step, $SR = l/t$. All models were subjected in maximum compressive displacement of 1.3 mm via this top clamp, which was set to be in tie constraint with the laminate. Boundary conditions were applied similar to what the AITM1-0010 standard indicates. In particular, one of the short sides of the plates was encastred, while the other was able to move only on the Z-axis. Also, eight rods in total were placed onto the upper and bottom face of the laminate (4 at the upper and 4 at the bottom face) in the direction of the applied compression load, and in order to prevent buckling (Figure 1).

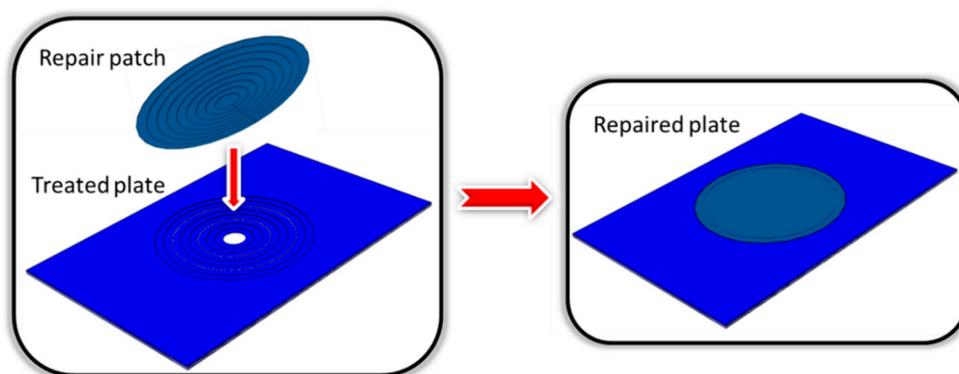
Figure 2. Schematic of patch installation.

Table 2 shows the geometrical characteristics of the repaired laminate. It was assumed that the lower layer of the plate had circular damage with a 10 mm diameter. Then, material was gradually removed in layers from the laminate. Each layer that was removed had the same thickness as the thickness of each ply of the base laminate. Afterwards, the circular repair patch was designed to perfectly fit onto the plate in the region where the material was previously removed. The material and the lay-up of the patch were the same with those of the base laminate in order to achieve the maximum strength and the restoration of the properties of the undamaged laminate (Figure 2).

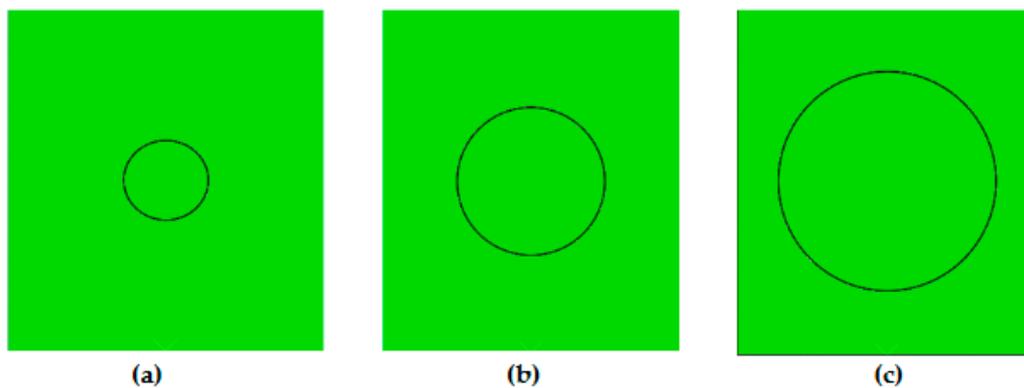
Figure 3. Sketch comparison of repaired plates with scarf ratios of (a) 20; (b) 40; and (c) 60.

The interfacial failure is driven by the progressive degradation of the cohesive layer stiffness. The damage modelling was defined using a damage initiation criterion and a damage evolution law. Initially the response was assumed to be linear until the maximum stress criterion was satisfied. Then, the rate of the stiffness degradation was described from the power law criterion that was defined using the fracture energy in mode I, II and III. The power law dictates failure in the normal or tangential mode and that failure is generated by an equation that takes into account both the normal and shear fracture energies. A schematic of the repair sizes is shown in Figure 3 where the size of the 20, 40 and 60 patches are being compared.

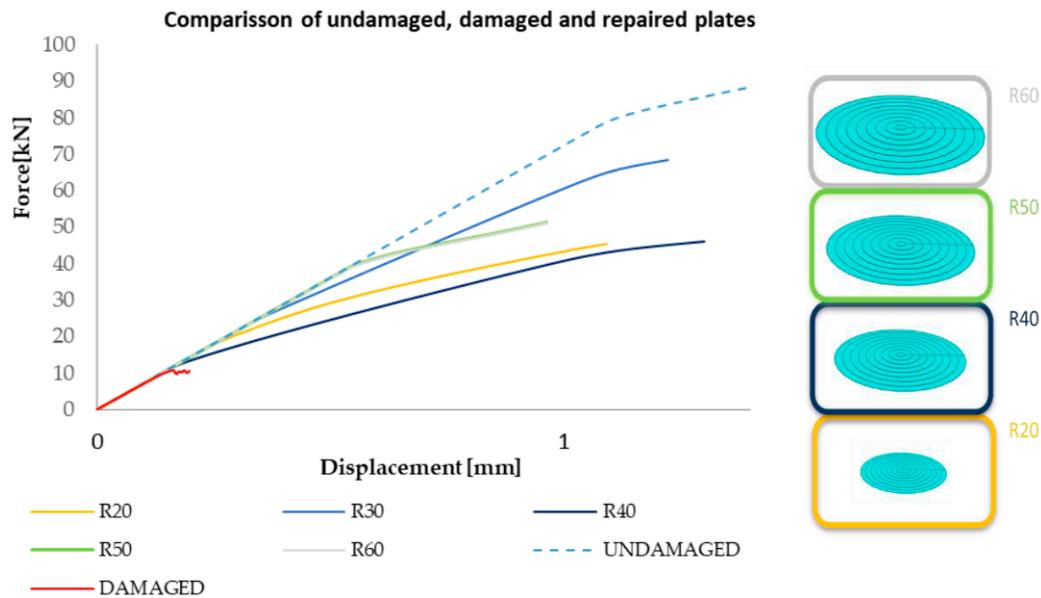
A graphical representation of the mechanical behavior of the repaired laminates as predicted by the FEA is given in Figure 4, together with those of the undamaged base laminate and the damaged laminate with the 10 mm through hole. The patches with scarf ratio 50 and 60 had a similar response, as their curves practically coincide.

The maximum compressive force that the undamaged plate can withstand, just prior to buckling, is 80 kN, while for the damaged plate this force is less than 10 kN. Regarding the repaired plates, the highest load before buckling corresponds to the repair cases with 50 and 60 scarf ratios and is about 40 kN. The plate with scarf ratio 20 had sufficiently lower buckling load at 17.5 kN. Finally, the repaired laminate with 40 scarf ratio showed a lower buckling load of 12.5 kN. However, by examining the patch with scarf ratio 40, it is remarkable that it was the less effective one, even compared to the patches with 20 ratio. This can be justified since the buckling load is affected by the different buckling modes. So, the response of the repaired laminate cannot be fully anticipated based on the scarf ratio since different buckling modes could introduce earlier deformations. Nevertheless, it is evident that the final failure load can be increased by increasing the scarf ratio up to a threshold value, which is 40 kN, where no significant difference can be observed. So, applying a repair is vital as a repaired laminate could have 5 times higher compressive strength compared to the strength of the damaged laminate. However, the repair could only restore up to 50% of the buckling load of the undamaged plate.

Figure 4. Numerically predicted force-displacement curves of undamaged, damaged and repaired laminates.

From the stress distributions in Figure 9, it can be easily observed that the maximum compressive stress in the X-axis for both laminates is about 550 MPa. On the other hand, the maximum tensile stress on the laminate with 20 ratio is 320 MPa, while on the laminate with 50 ratio is about 240 MPa. This difference would result in an earlier matrix failure of the plate with the smaller patch, that would potentially lead to delaminations and final failure. In the Y-axis, the maximum compressive stress for both the laminates is about 40 MPa, while the maximum tensile stress for the smaller and the larger patch is 28 MPa and 21 MPa, respectively. The shear stresses in the XY plane are similarly distributed on both laminas. However, the maximum stresses occurred on the 4 edges of the lamina for the laminate with 20 ratio and at the center of the plate for the laminate with 50 scarf ratio. It can be said that as the higher stresses were reached earlier by the plate with the 20 scarf ratio, it would have the worst performance, verifying the comparison of Figure 4.

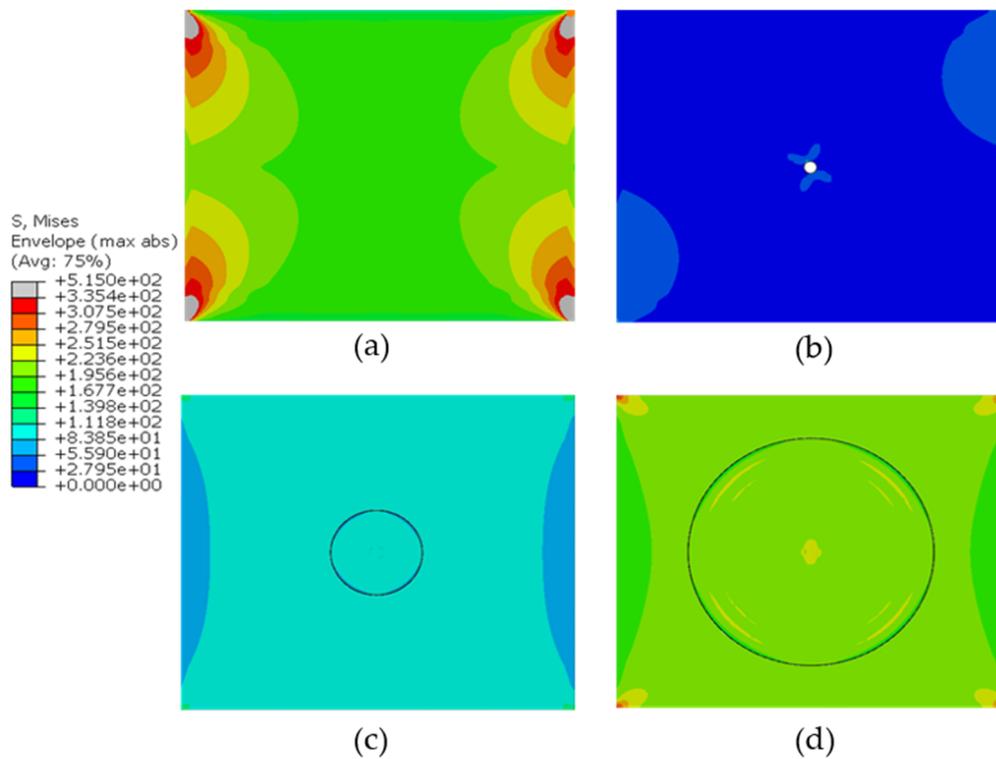
Figure 5 shows an illustrative comparison of the distributed Von Mises stresses just before the failure for four plate cases; pristine, damaged, repaired with ratio 20 patch and repaired with ratio 50 patch. It is observed that the biggest patch can withstand higher stresses before failure, whereas the smaller patch improved the performance of the damaged laminate, but to a smaller degree. Compared to the damaged laminate, the biggest patch can increase the maximum stress capacity of the structure even six times. Regarding the smaller patch, it could achieve approximately two times higher stress capacity. Nevertheless, none of the patches managed to recover the stress capacity of the pristine laminate before failure.

Figure 5. Breakdown using the criterion Von Mises (a): pristine plate, (b): damaged plate with a 5 mm radius hole, (c): repaired plate with ratio scarf 20, (d): repaired plate with ratio scarf 60.

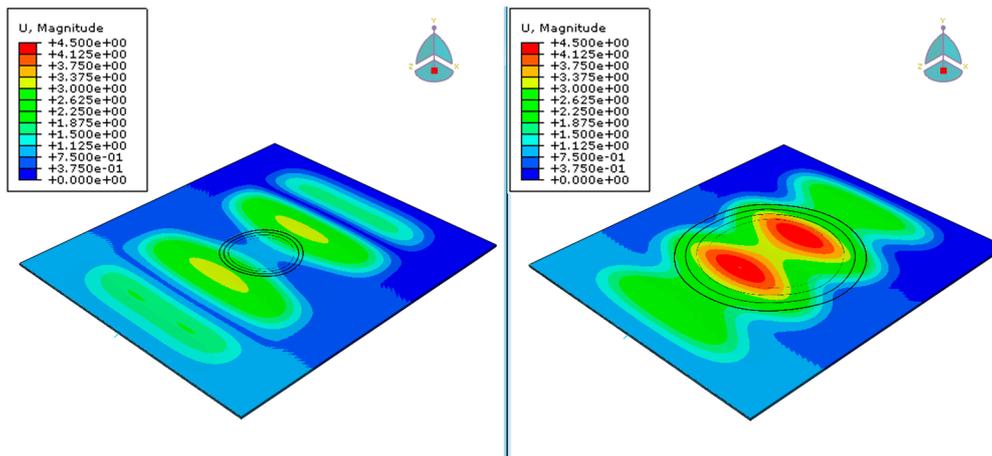
The worst and the best performed repair scenarios were picked, the 20 and the 50 scarf ratios, respectively, for a direct comparison between the weakest and the strongest patch. It has to be noticed that the patch with scarf ratio 60 was as strong as the 50 based on the comparison above, but more material has to be removed so it was excluded. Figure 6 presents the displacement magnitude on the two plates. This value represents an equivalent of the X, Y, Z displacements for each point, in this case for each element, of the laminate. It is notable that the maximum magnitude on the left laminate is

approximately 3.37 mm while on the right is 4.5 mm. This can be justified due to the fact that the latter can withstand bigger displacements before failure occurs.

Figure 6. Deformed body (U, Magnitude) for repair with 20 repair ratio (left) and 50 repair ratio (right).

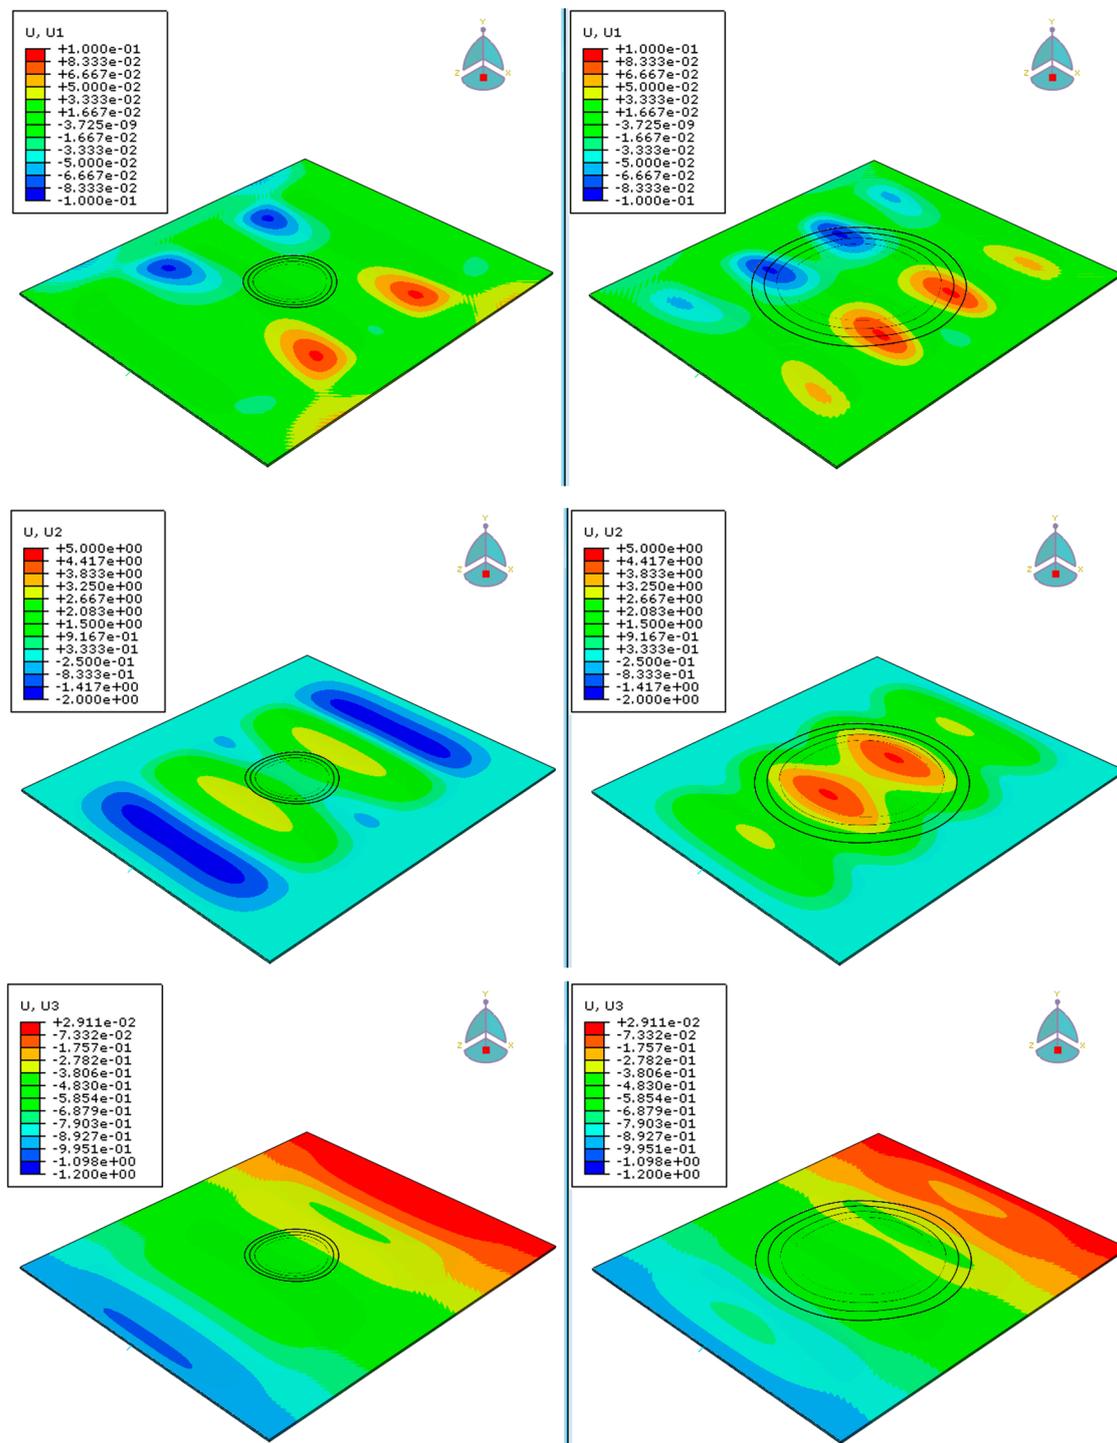
Going individually to each axis, Figure 7 illustrates the displacements in the X, Y and Z- axis and represents the case when the applied displacement was approximately 1.2 mm i.e., just before the failure for both plates. For the patch with ratio 20 the maximum displacement in the X-axis was 0.1 mm, while the maximum displacement in the Y-axis was 3.25 mm. In regard to the displacement in the Z-axis, corresponds to the loading-axis displacements. For the patch with ratio 50 the maximum displacement in the X-axis was 0.1 mm, while in the Y-axis was 5 mm. From the above, it is evident that the two laminates were similarly deformed in the X-axis. However, in the Y-axis the laminate with

the ratio 50 had 35% higher displacements, as it withstands a bigger load and had a different buckling mode before failure.

Figure 7. Displacements in X, Y and Z-axis for repair with 20 (left column) and 50 scarf ratio (right column).

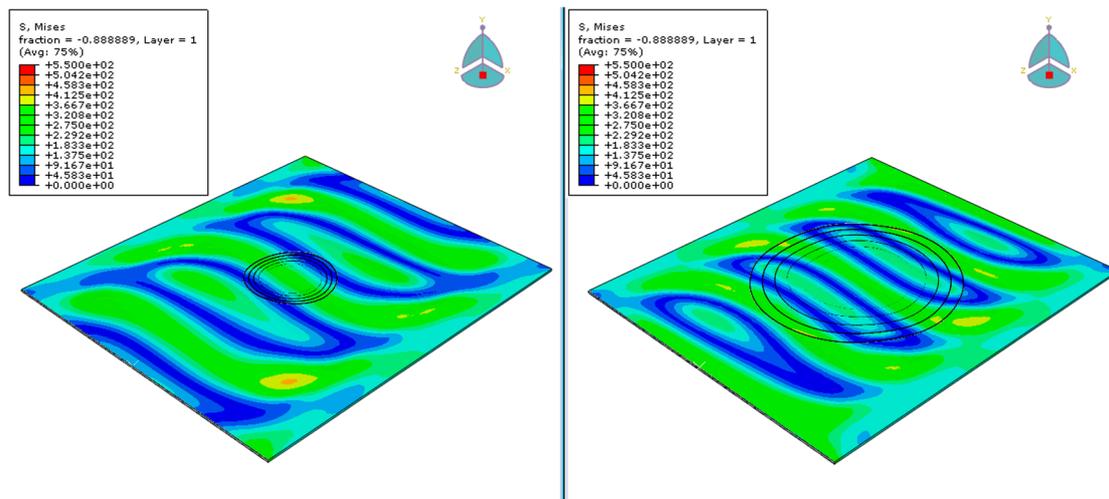
Moving to stresses, the stress distribution of the two laminates is shown below in Figure 8. The figures were captured at the same time frame as before, just before failure, to allow a direct comparison and better understanding of the response of the repaired laminates.

Figure 8. Distribution trends-based criterion Von Mises for repair with 20 (left) and 50 (right) ratio.

Based on the Von Mises criterion, the maximum stress that occurred on the laminate with the smaller patch is 450 MPa, while on the laminate with 50 scarf ratio the maximum stress is approximately 400 MPa. The smaller patch had higher stresses than the laminate with the bigger patch, at the same time frame. That means that it will more quickly reach its ultimate strength/fracture point.

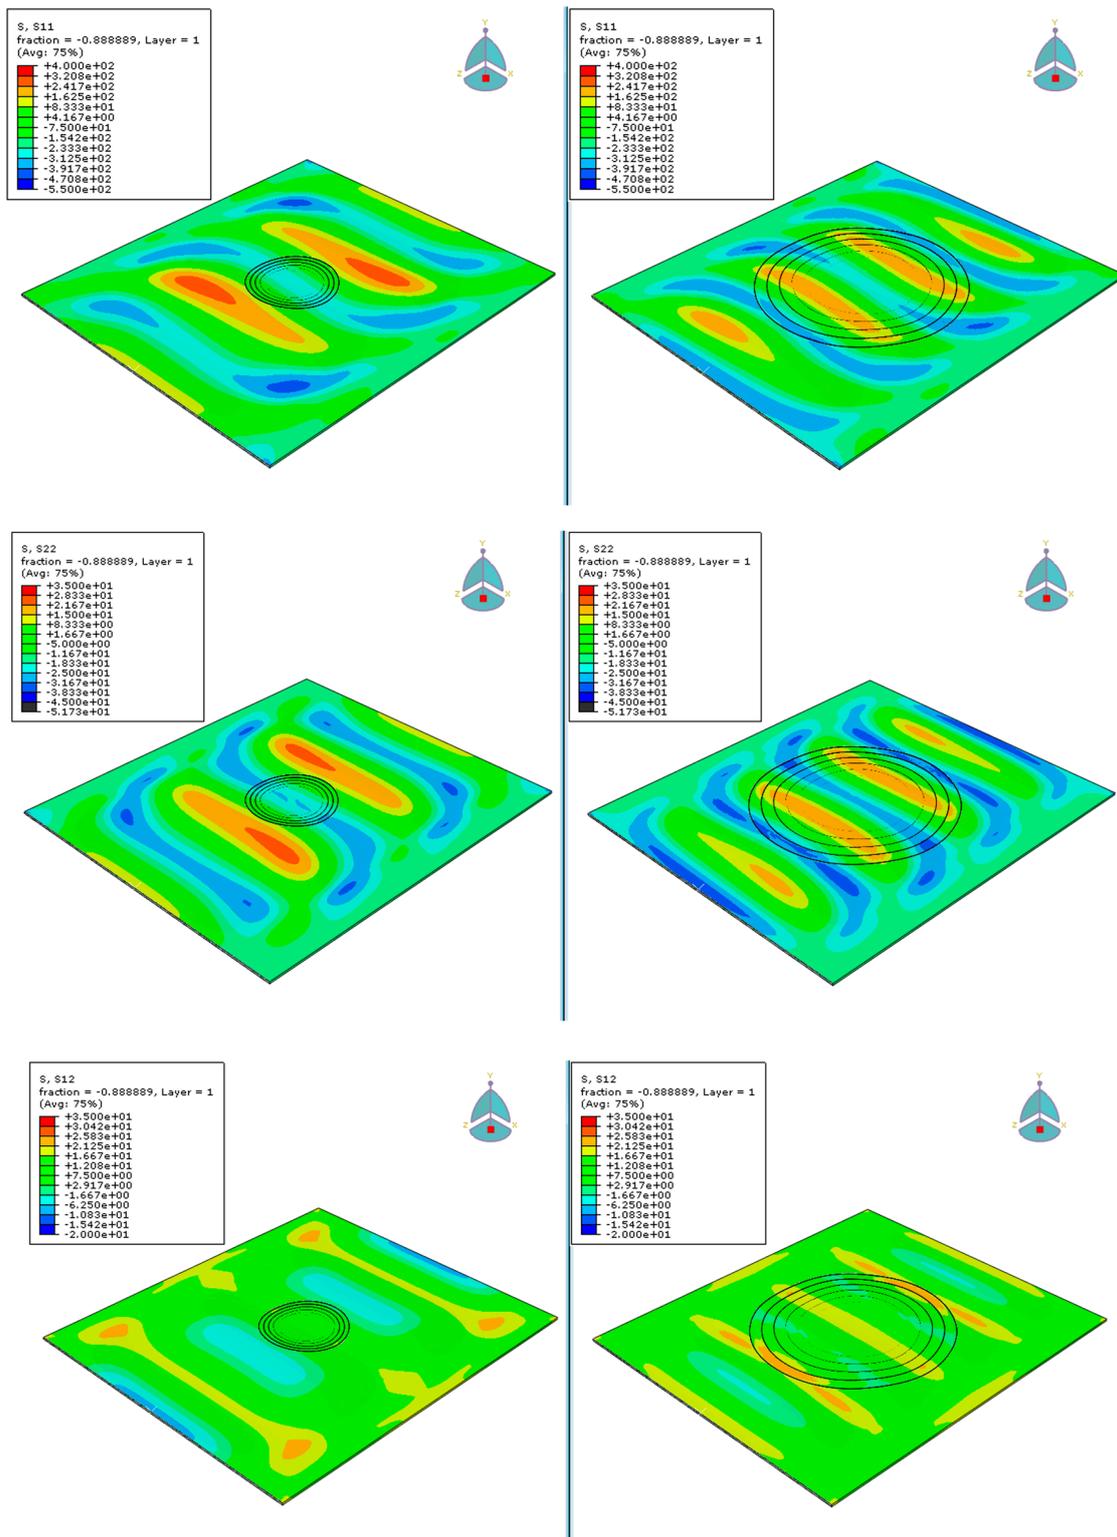
Figure 9. Breakdown strains S11, S22 and S12 for repair with 20 (left column) and 50 (right column) ratio.

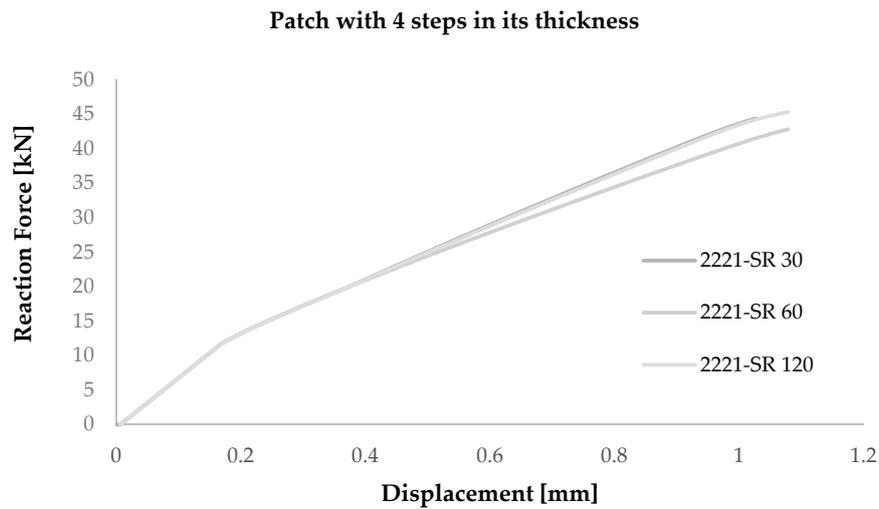
Based on Figure 10, it is evident that the scarf ratio does not significantly affect the response of the repair patch. Moreover, the buckling load is lower compared to the damage scenario and is equal to 14 kN, which is more than 4 times lower than the corresponding load of the 9-step patch with 50 scarf ratio.

Figure 10. Displacement-Reaction Force curve for repaired laminated with patch with 4 steps through its thickness and 30, 60 and 120 scarf ratio.

Moving to the effect of the patch steps compared to the number of the plies that constitute that base laminate, Figures 10 and 11 present the response of the repair patch with 4 and 3 steps through its thickness, respectively. This means that instead of having a ply by ply step repair, the patch steps will go every two and three plies, respectively. The two-ply step repair will result in a four-step patch (2221), while having a three step repair will result in a three-step patch (333).

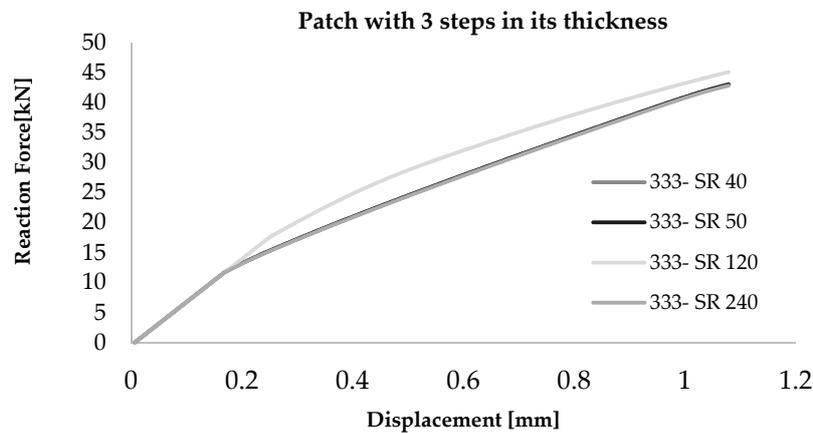
The same behavior was observed for the scenario with 3 steps in its thickness (Figure 11) where the buckling load was equal to 12.5 kN for all scarf ratios and was slightly lower than the patch that consisted of 4 steps. A minor increase of this load can be observed in the patch with ratio 120, where it is equal to 17 kN, but is again lower than the plate with 9 steps and 50 scarf ratio.

Figure 11. Displacement-Reaction Force curve for of repaired laminated with patch with 3 steps in its thickness.

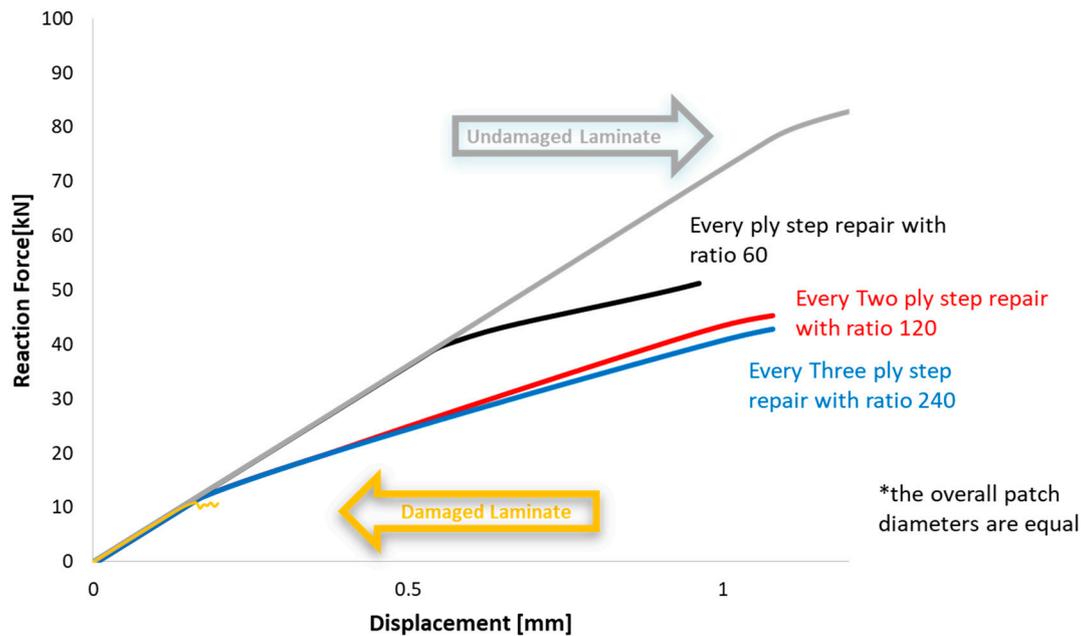
Figure 12 summarizes the maximum buckling and failure loads prior to failure for a damaged, an undamaged and three repaired plates. The overall patch diameter for the three repaired plates is equal. However, they have different number of plies in each step, varying from 1 to 3. The repair patches that have 2 and 3 plies in each step increase the maximum force that the structure can withstand but slightly increase the buckling load compared with the damaged plate. On the other hand, compared to the damaged plate, the patch that has one ply in each step increases buckling load 4 times and the failure load from 10 kN to 50 kN, and only 40% less compared to the undamaged plate. These means that the total strength of the repaired laminate is not only affected by the scarf ratio and the overall diameter of the patch, but also by the thickness of the step of the repair patch.

Figure 12. Displacement-Reaction force graph for damaged, undamaged and various repaired laminates with equal overall patch diameter.
