The Effect of Pre-Bond Contamination by Thermal Degradation and De-Icing Fluid on the Tensile Strength of Scarf Composite Bonded Joints

Konstantinos Tserpes *

and Elli Moutsompegka

Laboratory of Technology & Strength of Materials, Department of Mechanical Engineering & Aeronautics, University of Patras, 26500 Patras, Greece; e.moutsompegka@gmail.com

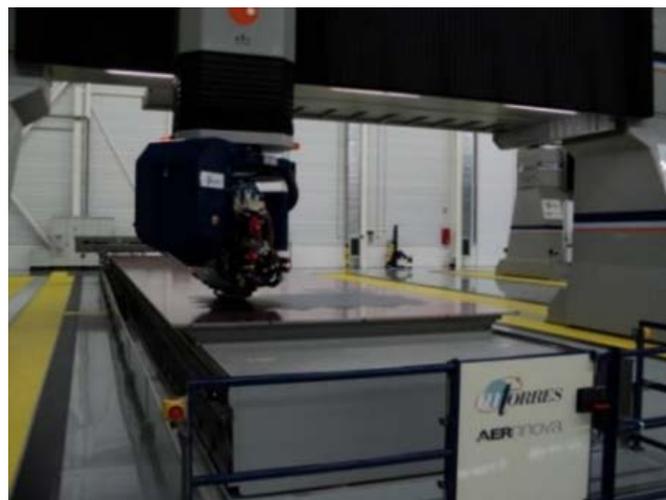
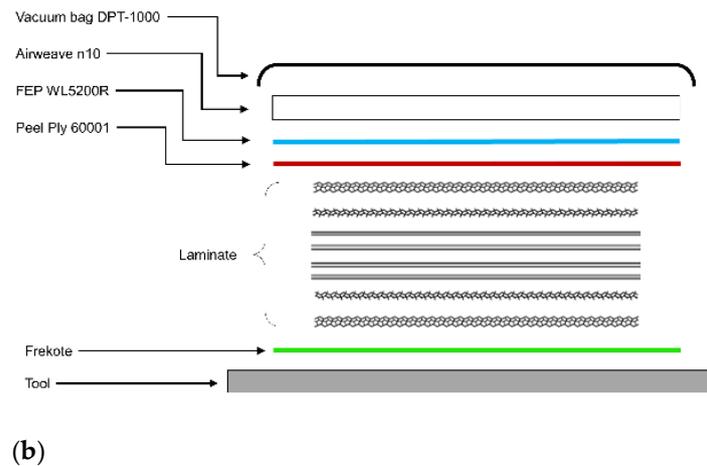
Figure 1. (a) Photograph showing the automated tape laying process of the laminated panels; (b) diagram of the vacuum bag.

The experimental investigation used HexPly M21E/IMA unidirectional epoxy/carbon prepreg for composite scarf joint adherents, which was developed for Airbus aircraft applications. The sample plates were produced by Aernnova Composites using the liquid water-based silicone-containing release agent Frekote[®] C-600 in order to obtain smooth surfaces. Regarding the structural layout, CFRP monolithic structures with a layout sequence of $[0_2, \pm 45]_s$ were manufactured according to the Airbus AIPS 03-02-019 standard for CFRP (“Manufacture of monolithic parts with thermoset prepreg materials”). The CFRP laminates for the coupons were manufactured using the automated tape laying (ATL) technique (Figure 1a). The diagram showing the applied vacuum bag is given in Figure 1b.

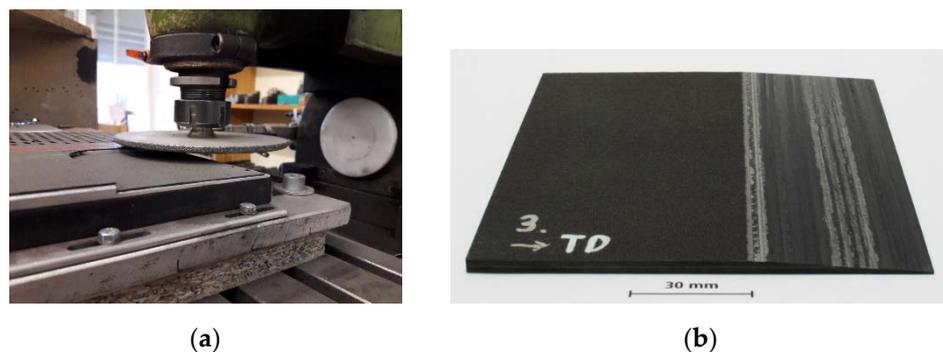
Figure 2. (a) Milling device; (b) overview of scarfed sample after milling.

When damage is detected, the aircraft part is locally scarfed to remove the damaged outer layers, which are then substituted with a patch that is bonded over the scarfed area in order to restore the load-carrying capacity. The scarfed samples used in this work were rectangular and consisted of two CFRP plates scarfed by milling with a ratio of 1:17 (Figure 2a) and were then manually grinded and cleaned with methyl ethyl ketone (MEK) to remove any handling contamination from thermoplastic residues resulting from the milling process. Lastly, the samples were cut to the final size using dry diamond cutting (Figure 2b).

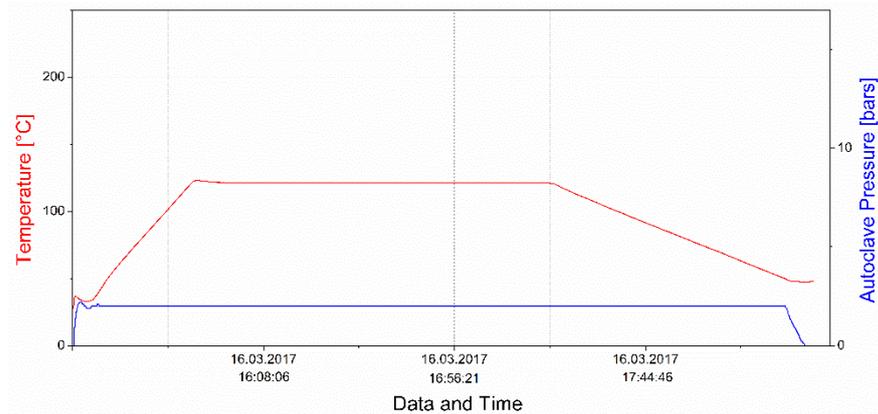
Figure 3. Autoclave thermal and pressure cycle for bonding repair samples with the adhesive FM[®] 300-2.

All the samples were bonded in the autoclave using the adhesive FM[®] 300-2 (0.25 mm), which is specially designed for bonded repair. The respective curing cycle is shown in Figure 3.

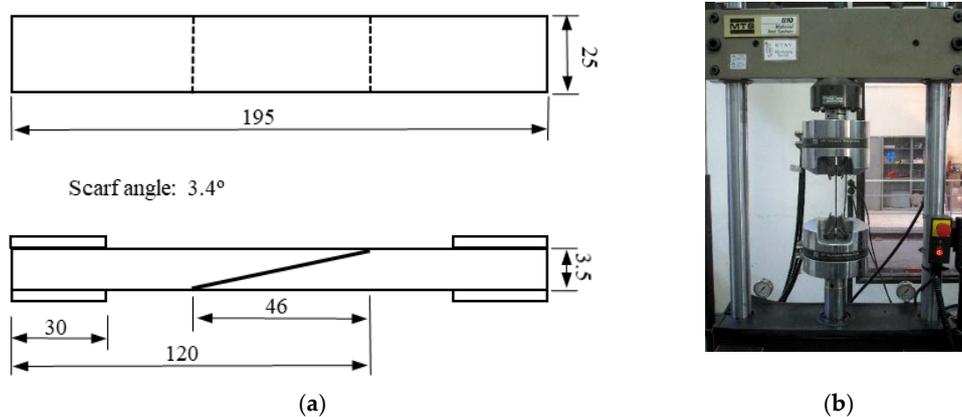
Figure 4. (a) Geometry and dimensions of the scarfed sample; (b) photograph showing a scarfed specimen under tensile loading.

The geometry and dimensions of the samples is presented in Figure 4a. The scarfed samples were loaded under ambient conditions (25 °C/48% RH) by tensile stress using an MTS universal testing machine with a load capacity of 100 kN under a constant crosshead speed of 0.5 mm/min (Figure 4b) until a final separation of the two scarfed adherends occurred. Aluminum end tabs (30 × 25 × 2 mm) were bonded to the ends of the specimens using a two-part adhesive (PM Mega Cryl) in order to achieve a successful and smooth introduction of the load into the specimen. Moreover, the end tabs prevented gripping damage to the adherends or premature failure as a result of a significant discontinuity. The load and crosshead displacement were recorded using a computerized data logging system. A total of four tests were performed for each contamination scenario and the failure load was the mechanical feature used for comparing the tested specimens.

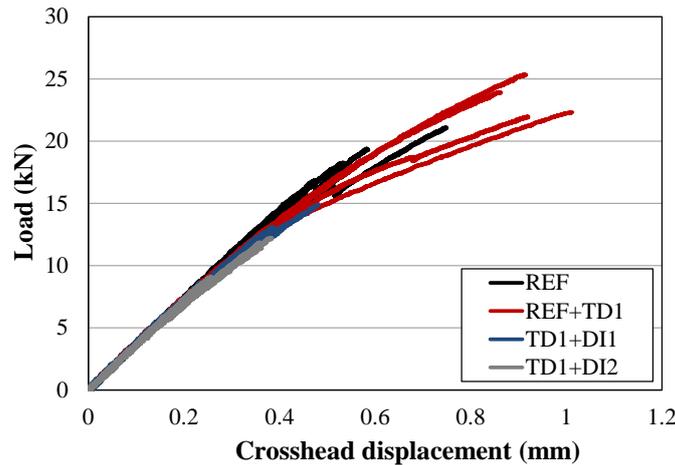
Figure 5. Load-displacement curves for reference and contaminated scarfed adhesive joints.

During tensile testing, it was observed that prior to the final failure (i.e., the separation of the two adherends), all specimens presented an initial failure revealed by a first load drop in the region of the load displacement curves (Figure 5), which corresponds to plastic deformation. This failure was localized at the edges of the scarfed area and is attributed to stress concentrations at this point as well as to edge effects. Having overcome this marginal fracture, the initial failure propagated along the scarfed area and led to the final separation of the two adherends.

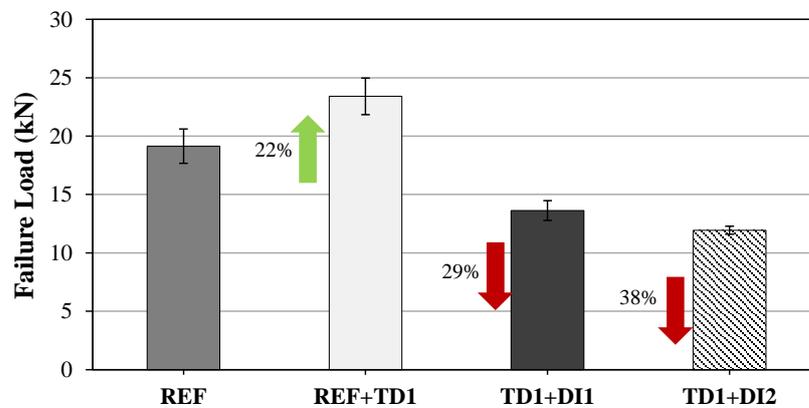
Figure 6. Tensile failure load presented for each contamination scenario.

Despite this research investigating the effect of the combination of TD and DI contaminations on scarfed adhesive joints, the effect of the distinct TD1 is also presented here as it showed interesting results. Specifically, for the specimens prepared following one of the contamination scenarios, all samples of the REF+TD1 scenario presented a higher failure load, by 22%, than the reference samples (Figure 6). Although the exposure of flat CFRP adherends to an elevated temperature following the R-TD-1 scenario decreased the fracture toughness tested in mode-I and mode-II loading [12] such a decrease was not prominently observed in the tensile testing of the joints prepared from scarfed CFRP adherends. Even though heat usually damages the CFRP structure or causes chemical changes in the matrix, there have been reports that high temperatures can cause oxidation of the resin which may improve adhesion due to the formation of carbonyl groups at the surface [13,14].

specimens prepared following the reference scenario. Specifically, for samples from the TD1+DI1 scenario, the reduction of the failure load was 29%, while for the TD1+DI2 scenario the reduction reached 38% (Figure 6).

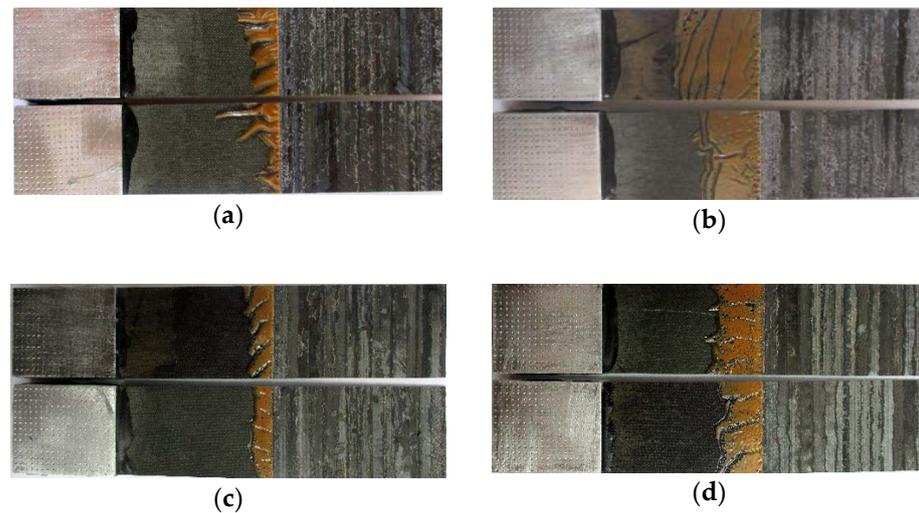
Figure 7. Representative fracture surfaces of the scarf joints after loading in tension (a) REF; (b) REF+TD1; (c) TD1+DI; (d) TD1+DI2.

After the tensile tests, a detailed inspection of the fracture surfaces was conducted, using visual inspection according to the ASTM D5573 standard specifications [15] to aid a deeper understanding of the tensile test results. Figure 7 depicts the representative fracture surfaces of each contamination scenario studied, showing the main failure modes observed in the tensile specimens.

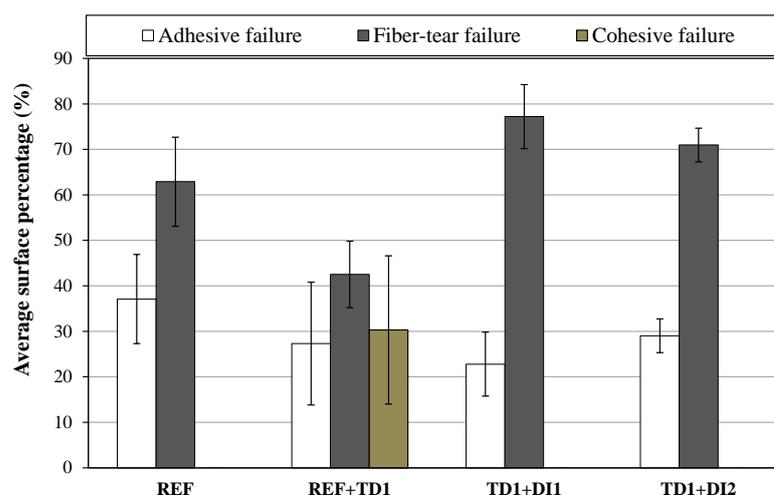
Figure 8. Average percentages of the failure modes presented in the tensile tested scarfed joints, sorted according to the contamination scenario.

The percentages of the different failure modes are compared for the different sample sets in Figure 8. For the reference samples, a mixed-mode failure was observed, with the dominant failure being the fiber-tear failure, at 63% of the surface area, while adhesive failure was observed for 37% of the surface area. In contrast, the tested samples prepared following the REF+TD1 case presented a higher amount of cohesive failure (30%), while FT failure and the adhesive failure modes showed a reduction (43% and 27%) as compared to the reference samples. This change of the fracture pattern coincides with the increase in the failure load observed for the specimens prepared from scarfed adherends that had been exposed to elevated temperatures following the REF+TD1 scenario. This can be explained by the fact that cohesive failure requires a greater amount of energy for a crack to develop and propagate compared to adhesive failure or fiber-tear failure, thus presenting an increase in the failure load.

Inspecting the fracture patterns obtained for the TD1+DI1 samples, the fiber-tear remained the dominant failure. The observed increase of the area percentage (77%), as compared to samples prepared following the REF scenario, indicates that the combined successive contamination with TD1 and DI1 had a deleterious impact mainly on the behavior of CFRP adherends under tensile loading. Finally, after testing the TD1+DI2 set, the fiber-tear failure showed a slight reduction compared to the findings for TD1+DI1. Specifically, 71% of the surface area with a fiber-tear failure was observed, while adhesive failure increased to 29%. These findings indicate that the TD1+DI2 combined contamination affects mainly the bondline performance (the interphase between the adherends and adhesive).
