# Investigation of Diffusion of Different Composite Materials on the Damage Caused by Axial Impact Adhesive Joints

**Abstract:** In this study, the effects of exposure to seawater on the material properties of glass fiber-reinforced polymer (GFRP) and carbon fiber-reinforced polymer (CFRP) samples were investigated. The samples were stored in seawater with a salinity of 3.3–3.7‰ and a temperature of 23.5 °C taken from the Aegean Sea in September for different periods (1, 2, 3, 6 and 15 months). The samples prepared in accordance with the ASTM D5868-01 standard were subjected to axial impact testing. In the first stage of this study, moisture retention percentages were determined, and, then, axial impact tests were performed. In the tests, a total of 36 samples bonded with single-lap adhesive were subjected to 30 Joule impact energy, and their mechanical strength was evaluated. In line with the experimental results, moisture absorption and axial impact energy values were compared in order to determine the most durable composite material connection, and the most durable connection was selected by evaluating the mechanical properties. Damage analysis on the samples was performed at t

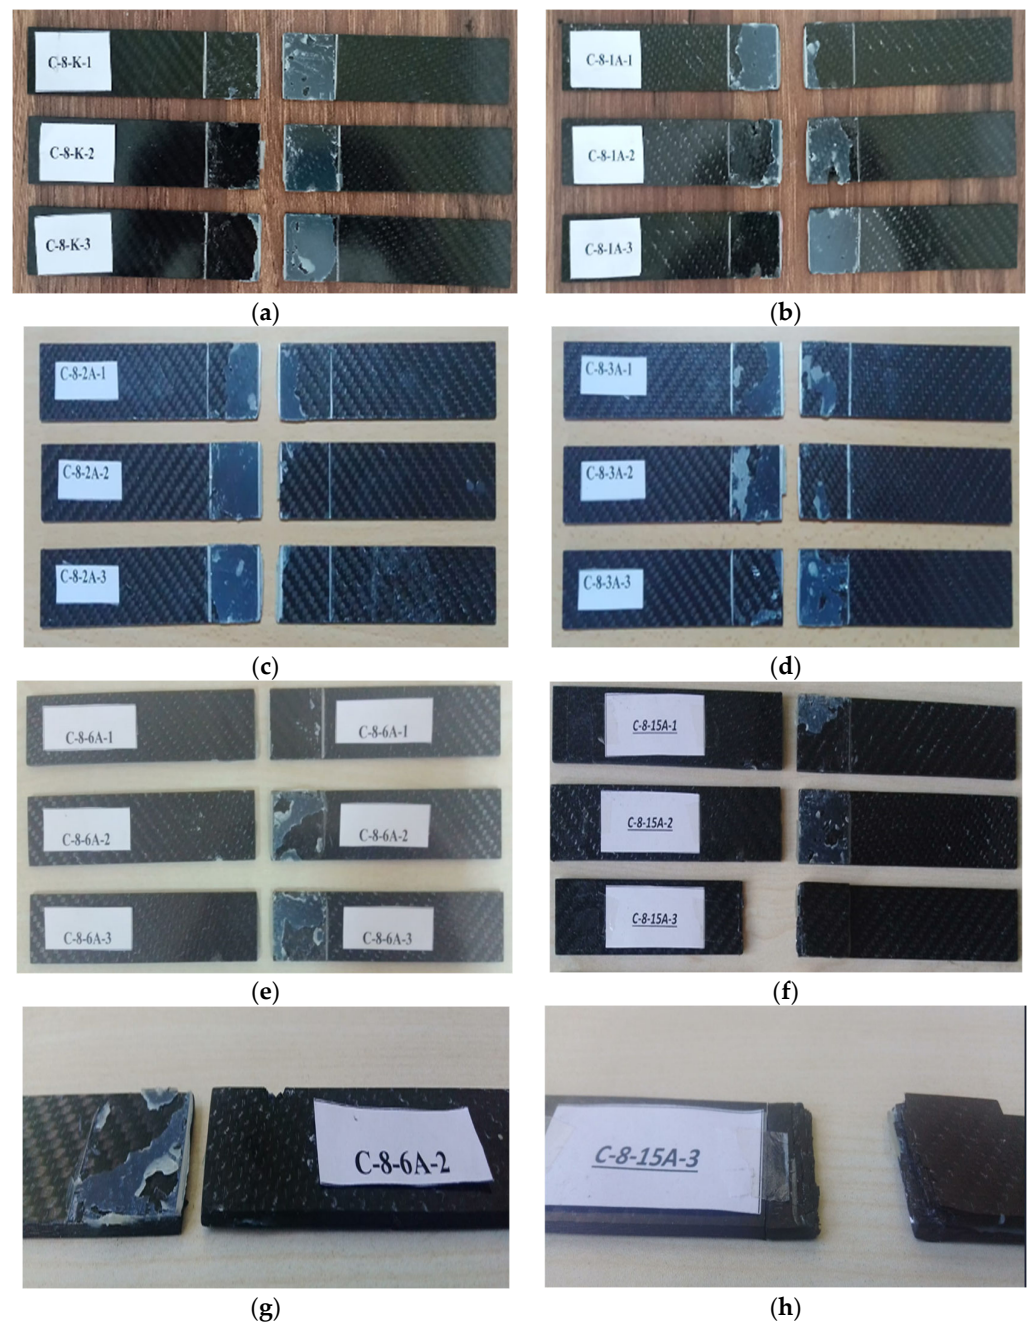
**Figure 9.** CFRP dry environment (a), 1st month (b), 2nd month (c), 3rd month (d), 6th month (e) and 15th month (f), adhesive bondline fracture (6th month) (g) and cohesive fracture (15th month) (h).

Figure 9 shows that the CFRP subjected to an axial impact test was exposed to sea water for dry environment (a), 1 month (b), 2 months (c), 3 months (d), 6 months (e) and 15 months (f)

Figure 9 shows the images of the samples exposed to 30 J of impact energy for the dry environment, 1st, 2nd, 3rd, 6th and 15th months. As a result of the absorbed energy, stress concentrations occurred at the joint after the impact in all CFRP samples. The damage observed in the CFRP dry samples is the complete separation of the adhesive from the substrate (Figure 9a). In the CFRP samples that were kept in seawater for the 1st month, 2nd month, 3rd month and 6th month, a break occurred at the bonding line. The composite layer and the bonding area were separated from each other. In Figure 9f, in addition to the breakage at the bonding line in the samples starting from the 15th month, some samples were broken. In Figure 9g, the failure of the adhesive bond line is generally related to the intensity and direction of the applied impact. In addition, seawater absorption and microcracks formed in the adhesive after the impact also caused the failure.

Figure 9h shows cohesive fracture damage. This is the fracture of the bonding material itself, while the adhesive bond line remains intact.

It was observed that the adhesive remained intact, but all of the samples broke, since the GFRP-bonded material, which was kept in sea water for 15 months, showed low strength under impact. In Figure 9f, it was observed that some samples broke, and some broke in CFRP. This is because the polymer matrix absorbs water, causing it to swell and become plastic [38]. This swelling weakens the matrix–fiber interface, creating internal stresses and microcracks that reduce the load-carrying capacity of the composite.
