Evaluating Deck Fire Performance—Limitations of the Test Methods Currently Used in California's Building Codes

Abstract: Combustible decks are identified as vulnerable components of buildings in wildfire-prone areas. In California, combustible deck boards can comply with the requirements of Chapter 7A of the California Building Code if they pass an under-deck flame-impingement exposure test. It is desirable if standard test methods can simplify procedures while not adversely affecting the reliability of the test. The test methods should also be able to discriminate the fire performance between products on the market. In this research, the specified conditions in the under-deck flame-impingement test, SFM 12-7A-4A and ASTM E2632, were evaluated. Different deck assemblies were exposed to above-deck ember and under-deck flame-impingement exposures. During the above-deck ember exposure tests, it was observed that embers accumulated in the gaps between deck boards, on top of the support joists, and, when ignition occurred, ignited in this area. Flames spread by burning into unburned areas of the deck boards and joists, thereby providing a pathway to the building. During the under-deck

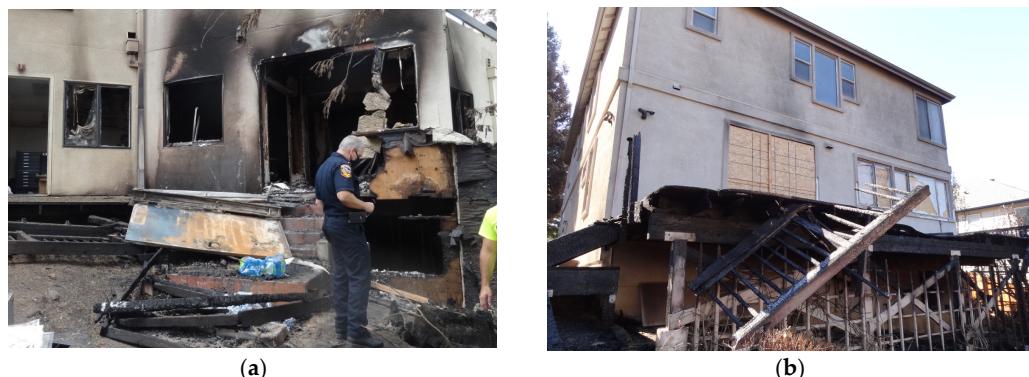
Figure 1. Examples of burning decks causing damage to the main structure of (a) a commercial wine-tasting room in Napa Valley and (b) a residential structure in Santa Rosa, California, during the 2020 Glass Fire. (Images taken during IBHS's post-event investigation).

Attached decks can be a vulnerable component of a building if they ignite and the resulting fire spreads to and into the occupied space. Figure 1 shows the cascade of damage from burning decks to the main buildings during the Glass Fire. Spread into the building could occur if the building cladding was combustible (such as a wood or plastic siding product), or if the radiant heat or flame-impingement exposure was sufficient to break glass in a window or door. If the ignition occurred at the deck-to-wall intersection, spread into the building would be more likely. If ignition occurred at a location away from the building, flame spread to the building would have to occur, or sufficient fire growth would have to develop to ignite combustible cladding or break glass.

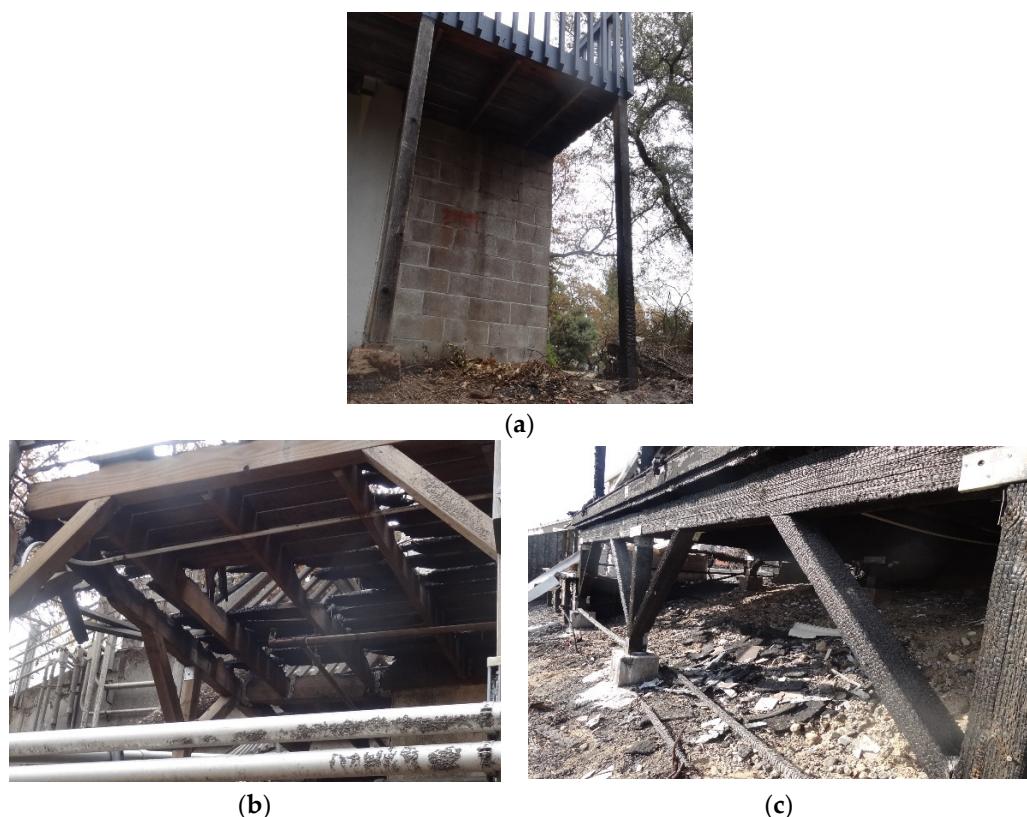
Figure 2. Examples of decks ignited at different locations in the 2020 Glass Fire, (a) ignition at the right footer (suppressed by first-responders during the event), (b) likely above-deck ignition because of uncharred joists, and (c) ignition of combustibles near/below the deck and fire spread to the deck. (Images taken during IBHS's post-event investigation).

Post-wildfire investigations and lab studies have shown that decks can initially be ignited on either top or bottom surfaces [3–6]. Quarles et al. [7] reported that flames from burning trees impinging on the underside of attached decks resulted in deck ignitions and subsequent loss of homes during the Waldo Canyon Fire in Colorado Springs, Colorado. Manzello and Suzuki [8] reported ignition of solid wood decks subjected to ember exposures. The deck-to-wall intersection in a re-entrant (interior corner) was reported to be a vulnerable location, not specifically the gaps between deck boards. Maranghides et al. [6] identified three locations of deck ignitions: (1) near the footers, (2) on the top surface, and (3) on the ground where combustible material had accumulated and ignited. Similar observations were made during the 2018 Camp Fire [9]. IBHS's post Glass Fire investigations 2022, Figure 2, also confirmed similar deck vulnerabilities for decks.

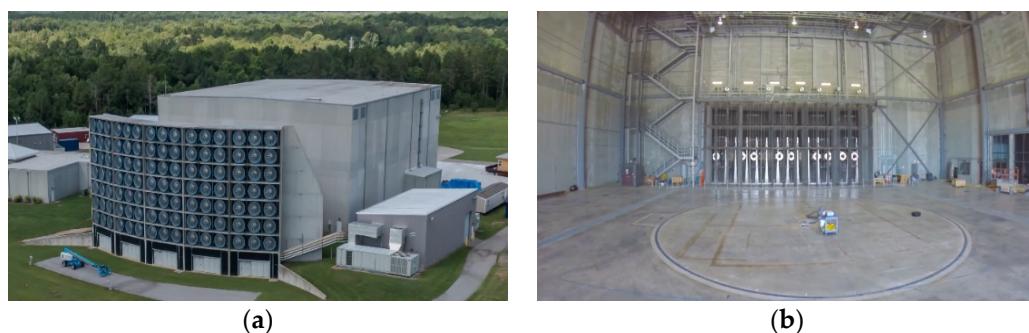
Figure 3. (a) The IBHS Research Center and (b) inside the test chamber.

The IBHS Research Center test chamber can hold a full-scale, one- or two-story residential or small commercial building. The test chamber consists of a wind tunnel, powered by a 105-fan array (Figure 3a). Each fan is 5.5 ft (1.68 m) in diameter and can create a time history of wind speeds from 12 to 120 mph [10,11]. The deck experiments were conducted at the center circle of the chamber against a building with dimensions of 145 ft × 145 ft (44.2 m × 44.2 m).

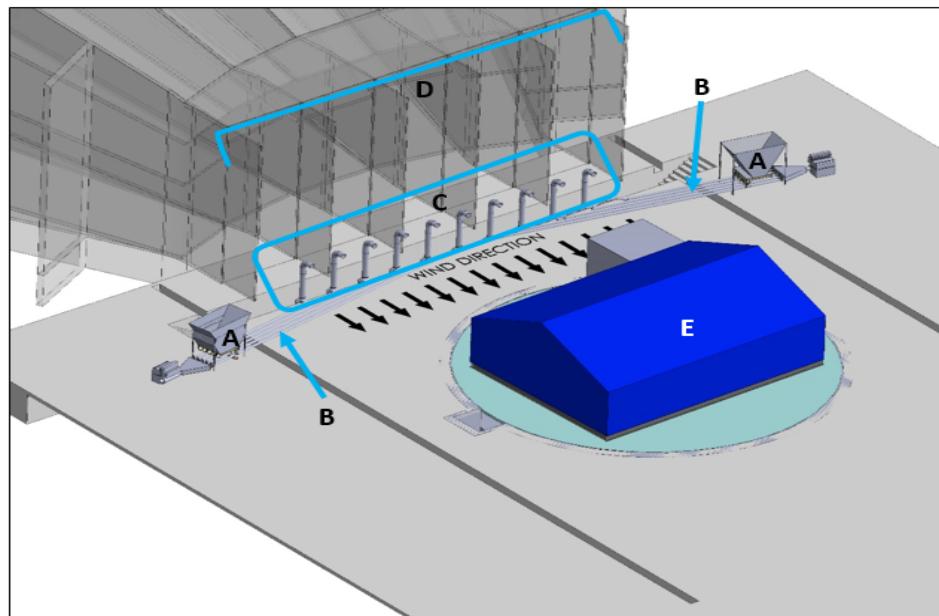
Figure 5. Auger feed and ember generation system, including left and right hoppers (A); auger feed lines (B) for delivery of fuel to generators (C); fan array (D); and test building (E).

Figure 5 shows an overview of the feed system, ember generators, and test building. Prior to testing, fuel was placed in hoppers (A). Five augers (not shown) dropped fuel into the pneumatic feed lines. The feed rate was controlled by powering the augers on and off at defined intervals. The desired feed rate was obtained when individual augers were turned on for 3 to 5 s, and then off for 10 to 20 s. The on/off times for each individual auger were determined by visual inspection of ember output and evidence of elevated temperatures inside the ember generators (red color of the metal burn chambers). The goal of the intermittent fuel-delivery method was to ensure a consistent output of embers by all generators without damage to the generators from excessive heat.

The augers delivered fuel to the pneumatic feed lines (B). These feed lines delivered the fuel to the ember generators (C). As described previously, the ember generators burned the fuel and a fan pushed embers through the vertical exhaust duct. The fan array (D) created the desired wind flow in the test chamber. The test building (E) was then subjected to an ember exposure. Figure 6b shows the ember-generating system operating.

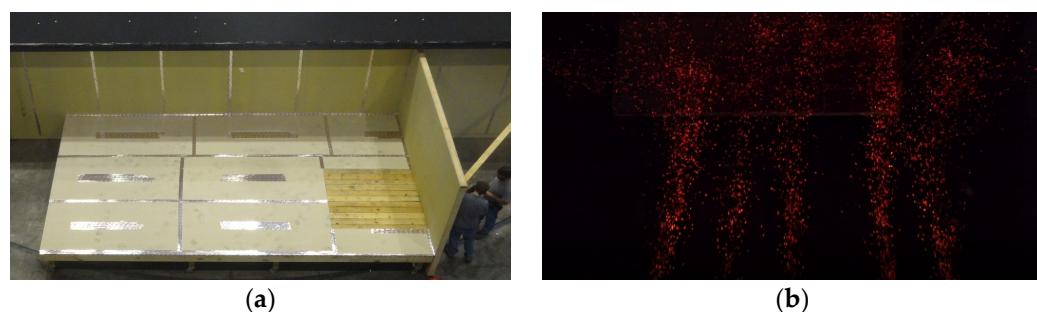
Figure 6. Test setup for ember exposure on decks. (a) test set up. (b) decks exposed to embers.

The main goal for the above-deck ember exposure experiment was to determine whether embers could ignite combustible wood and plastic composite decking without the contribution of other materials. To achieve this goal the decks were monitored using several cameras as well as observations made by individuals in the test chamber. Two replicates for each test configuration were performed. The decking assembly was attached to the test building and a wall positioned at 90-degrees to the building to recreate a re-entrant corner. The turntable was then rotated to determine the location of maximum ember accumulation. This location was visually observed and documented. Based on the results of these tests, the orientation and location of the test deck (within a larger deck structure) was determined. All ignition potential tests were conducted using this configuration (Figure 6a).

Based on results from the preliminary tests, experiments to evaluate the ignition potential of decking to an ember exposure were conducted with the 5 ft × 5 ft (1.5 × 1.5 m) test deck inserted into a larger deck that was 20 ft wide by 12 ft (6 × 3.5 m) deep. The larger deck surface was covered with a panelized, non-paper-faced gypsum product. A framed, movable wall was incorporated into the building design to create a re-entrant corner (Figure 6a). To enhance visual abilities, the lights were turned off during the experiments (Figure 6b).

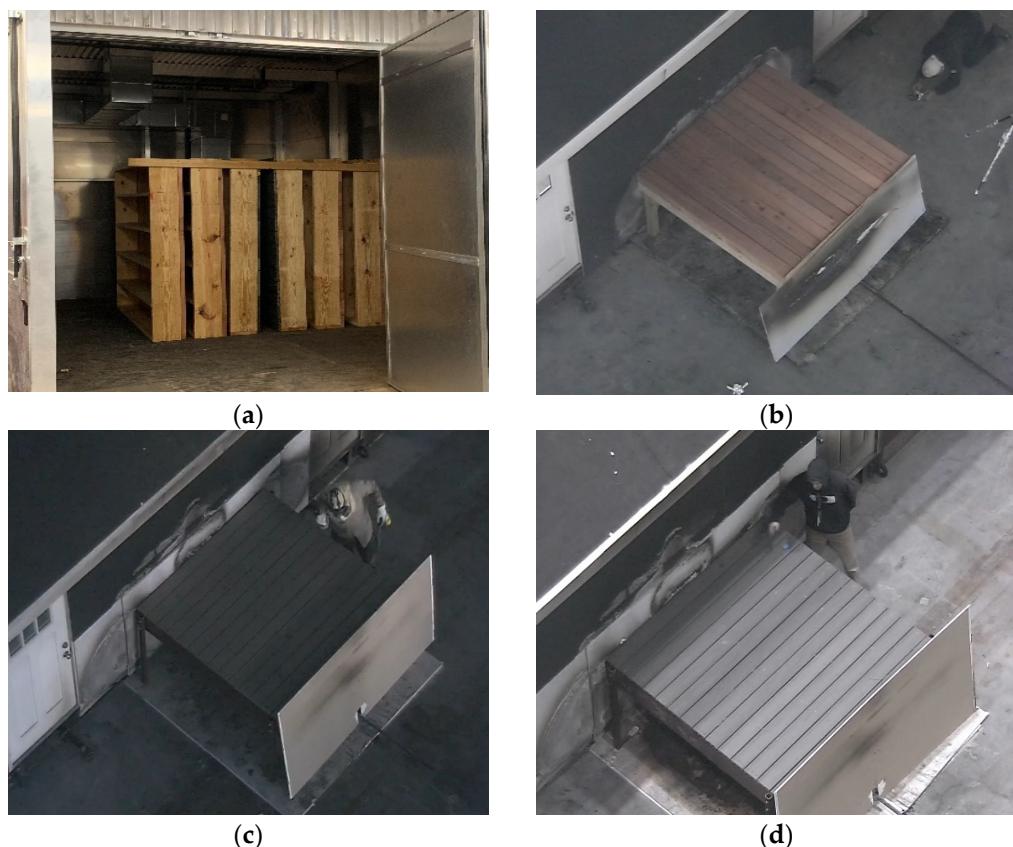
Figure 7. (a) Decks in the kiln. (b) Redwood. (c) Composite A. (d) Composite B.

To replicate the moisture content of the decks similar to decks during red-flag warning events, the decks were placed in a kiln for about two days to reach the moisture content of 5–9%. Figure 7a shows the decks in the kiln room to drive the moisture out, and Figure 7b–d show the decks prior to ignition.

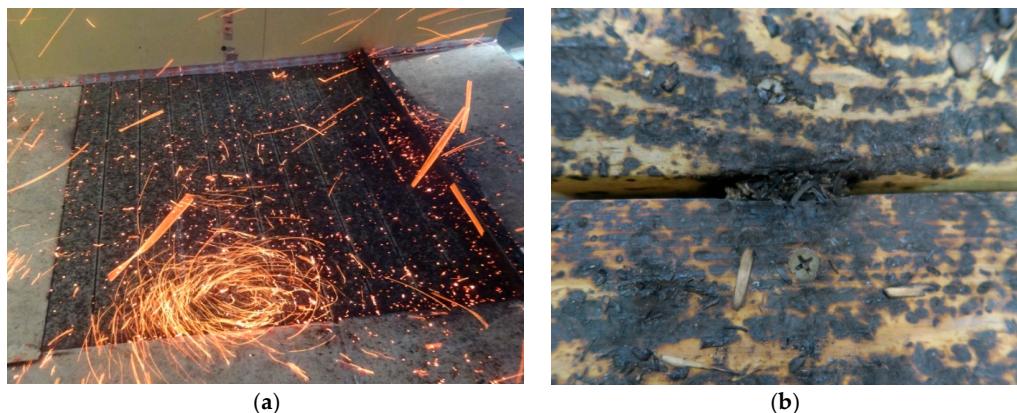
Figure 8. (a) The patterns on the deck resulted in embers dropping into gaps between deck boards. (b) The embers accumulated in the gaps between deck boards on top of the joist.

Ember accumulation patterns and stagnation zones are shown in Figure 8a. The circulation patterns on the deck resulted in embers dropping into gaps between deck

boards. At joist locations, the embers accumulated in the gaps between deck boards on top of the joist (Figure 8b).

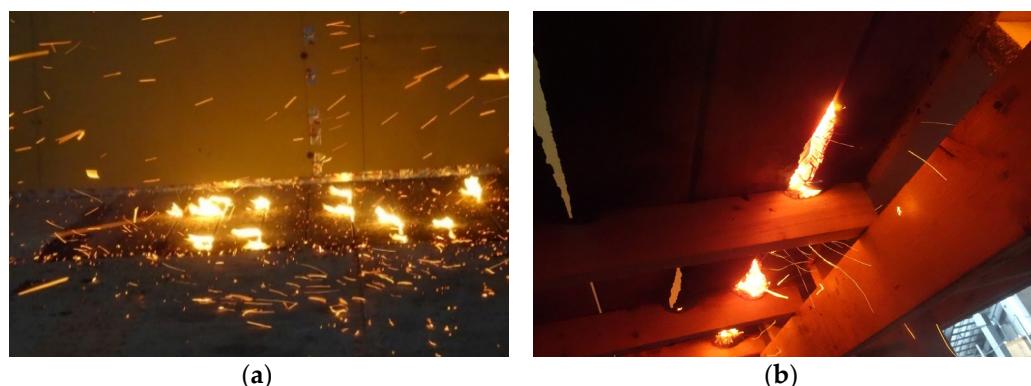
Figure 9. Flame height between the deck boards from (a) above and (b) below.

Flaming and smoldering ignitions consistently initiated in the gaps where deck boards crossed joists, or at the edge of the test decks where there was an underlying horizontal surface where embers could accumulate (Figure 9). Accumulation at these locations occurred regardless of deck board type. Small piles of embers also accumulated at some locations on the deck board surfaces. This finding has been recently tested in a small-scale controlled environment by Richter et al. [13] and it was confirmed that the re-radiation in crevices, between deck boards and the joist–deck board intersection creates a vulnerability for decks. Richter et al. [13] concluded that crevice geometry significantly increases the likelihood for ignition, due to a higher heat flux from a smoldering pile than a flat plate under the same conditions. Manzello and Suzuki [8] reported the deck-to-wall intersection in a re-entrant (interior corner) assembly as a vulnerable location, not specifically the gaps between deck boards.

Flame heights in the medium-density softwood decking were low, never more than a few inches (approximately 60 mm) high, as shown in Figure 9a. Flaming continued until the distance between the deck boards and joists increased to the point where between-member radiant heat transfer decreased (Figure 9b). The effects of wind in keeping the fire growing were predominant in these experiments.

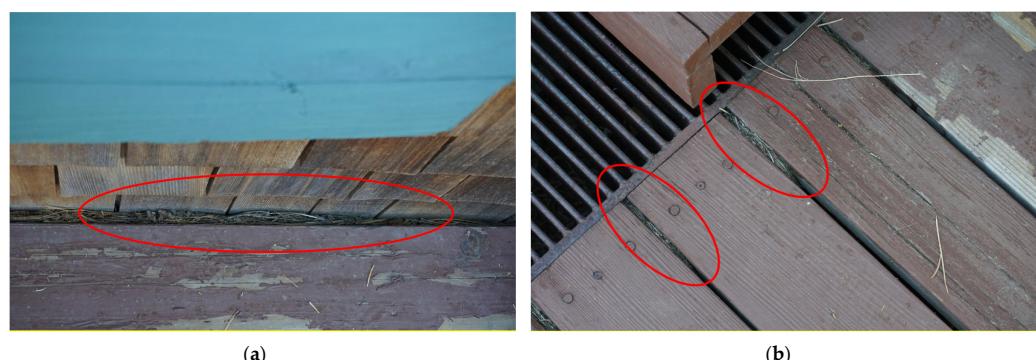
Figure 10. (a) Deck to wall connection, with accumulation of vegetative debris in gap between deck and vertical wall. (b) Debris accumulation in the gap between deck boards [4].

Embers primarily accumulated either on the top of the joists in the gap between deck boards or at the gap between the deck and the wall. These areas are also prone to debris accumulation over time (Figure 10). This can create a fuel ladder effect when exposed to embers.

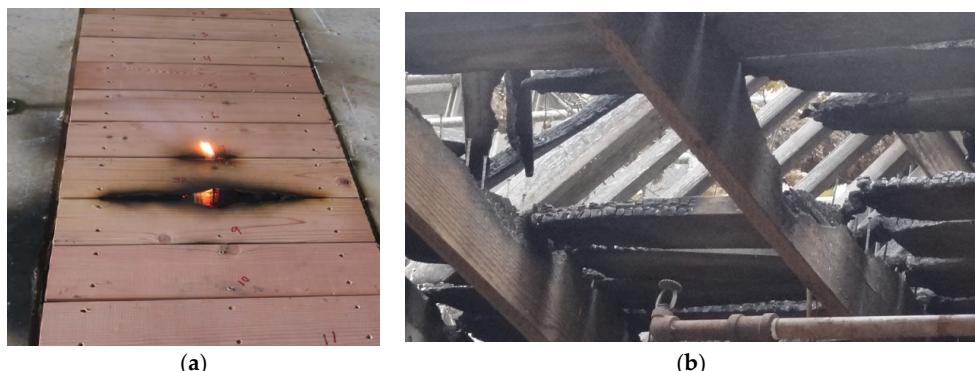
Figure 11. (a) Fire propagation along the joist towards the test building (b) Fire propagation along the joist towards the main building in a commercial wine-tasting room in Napa Valley, California, during the 2020 Glass Fire. (Images taken during IBHS's post-event investigation).

These experiments demonstrated that when enough embers accumulate and generate a certain thermal energy, the deck boards and/or joists ignited. For decks where joists were installed perpendicular to the building, once ignition occurred the fire spread in a smoldering phase along the joist toward and away from the building under an average wind speed of 18 mph. At the deck board gaps, the smoldering combustion transitioned to flaming (Figure 11a) due to the airflow between the deck boards. This allowed fire to continue to propagate all the way to the building. Similar burn pattern was seen during post-event investigations in Glass Fire (Figure 11b).

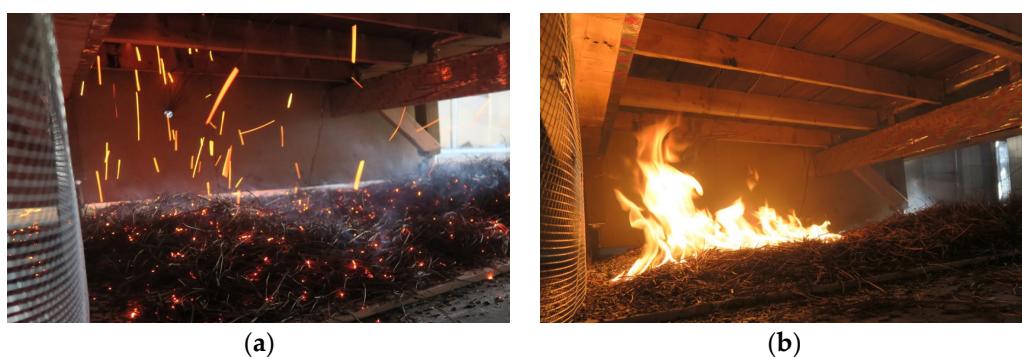
Figure 12. (a) Embers dropping between the boards gaps. (b) Embers igniting the pine needles and causing under-deck flame impingement.

During the above-deck ember tests, it was observed that embers that fell between the deck board gaps can ignite the debris (fine fuels) under the deck that can, subsequently, expose the deck to a flame-impingement exposure, as can be seen in Figure 12. The ignition of the fine fuels from these embers provides additional supporting evidence that storage of combustible materials under the deck should be avoided.

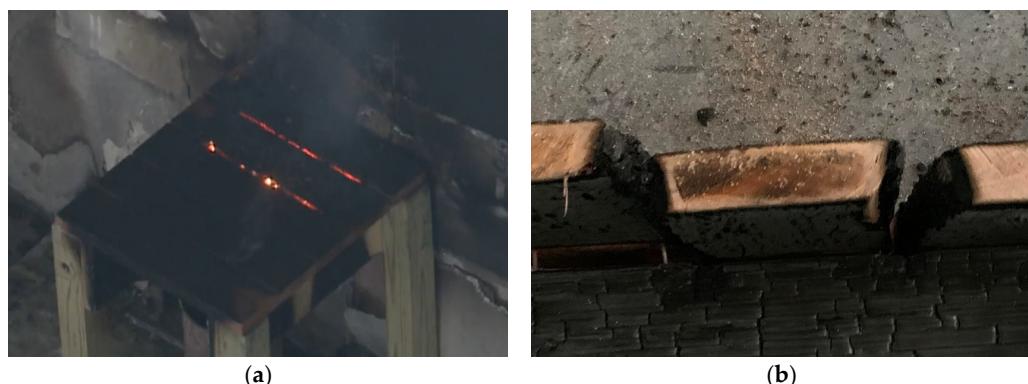
Figure 13. Replicating the current test method. (a) Fire intensity after 15 min (12 min after shutting off the gas burner). (b) Cross-section of the burned deck.

Three replicas (Redwood deck boards and Southern Yellow Pine) were tested following the requirements of SFM 12-7A-4A. Figure 13a shows a sample deck, tested under the current test method procedures, 15 min after the start of the test (12 min after the under-deck burner was extinguished). As shown, there is a thin char layer (Figure 13b) on the boards. A visual observation confirmed that the Peak Heat Release Rate was below the maximum allowable 269 kW/m^2 . The lower thermal conductivity of the char layer acts as an insulator that protects the inner portion of the deck board from thermal-related damage. In addition, the thin charred layer facilitates self-extinguishment of the flames on the surface as it limits the available fuel for the flame to move in any direction, which is one of the acceptance criteria in SFM 12-7A-4. In other words, this thin charred layer causes only a small amount of the material participates in the combustion process.

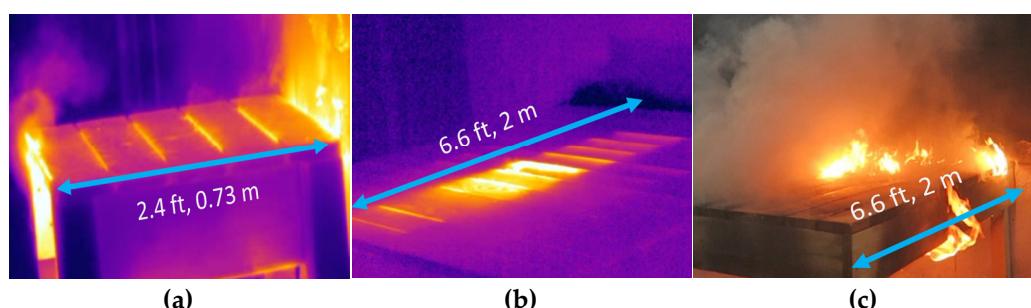
Figure 14. (a) Distribution of heat under a $2 \text{ ft} \times 2.4 \text{ ft}$ deck 90 s after igniting the burner. (b) Distribution of heat under a $6.6 \text{ ft} \times 6.6 \text{ ft}$ deck 90 s after igniting the burner. (c) Intensity of the fire for a $6.6 \text{ ft} \times 6.6 \text{ ft}$ deck 40 min after turning off the burner at no-wind condition.

As previously discussed, decks attached to buildings would be substantially larger than the decks used in SFM-7A-4A. Increasing the deck size showed that the thermal attack from identical under-deck flame is distributed over a larger surface than would occur with a smaller deck. Figure 14a,b show a comparison of the deck temperatures 90 s after burner ignition for the small and large decks, respectively. This distributed heat experienced by the larger deck resulted in a slower burning process and reduced the thickness of the char layer. Hence, eventually a large amount of the available fuel participated in the combustion and caused a more intense exposure from the burning deck to the siding on the building, as shown in Figure 14c. Since this test was under no-wind condition, the smoke accumulated above the deck and limits the visibility of the intense flames behind it.

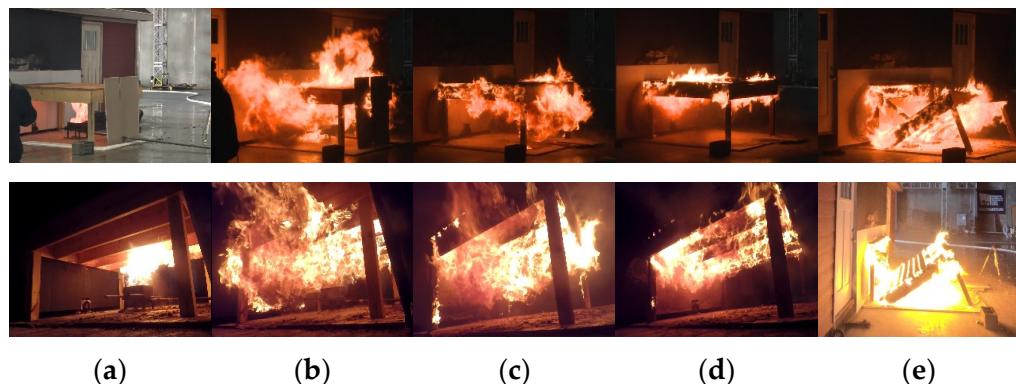
Figure 15. Time-lapse of a redwood deck with Southern Yellow Pine joists test from two angles. (a) After 5 s. (b) After 3 min. (c) After 5 min. (d) After 7 min. (e) After 10 min.

Figure 15 depicts a time-lapse for a large redwood deck exposed to a gusty wind from two different angles; the first row is a corner view, and the second row is an under-deck view.

Columns a and b in Figure 15 show the deck 5 s after igniting the burner and just before turning off the burner at 3 min, respectively. Column c shows the deck almost 7 min after ignition of the burner. During the test, the flame stayed underneath the deck boards for most of the time. The fire started consuming the edges of the combustible boards, widening the spacing between the boards, and, eventually, creating enough space between the boards to allow the flame to rise above the deck. This transition is shown in Column d. Column e shows the collapse of the deck after almost 10 min. Note that in Figure 15e the change in the angle of the last photograph is because the below-deck camera was damaged by the intensity of the fire and an image from a different camera was used. Unlike the case for smaller deck, self-extinguishment did not happen here. To further explore the effects of wind on fire, see [16].

After exposing a 6.6 ft × 6.6 ft deck to an 80 kW under-deck flame for 3 min (as indicated in Figure 15) in the presence of wind, the entire assembly (joists, posts, redwood deck boards, and thermocouples on the deck) burned in less than 15 min. This intense exposure raised the temperature in the area underneath the deck beyond the tolerance of the high-temp thermocouples within minutes of starting the test. Consequently, without losing the generality, the exposure duration was reduced to 2 min in this research.

As discussed in Figure 15, the redwood deck board over SYP structure burned intensely and caused elevated temperatures on the wall, above 800 C for about 400 s. In fact, the temperature is high enough to ignite most of cellulosic materials. When a steel supporting system was used, the elevated temperature on the wall is only associated with the burner and after its removal the temperature rapidly drops. Similar observations were made for composites A and B, but the fire growth happened at a slower rate. The plastic composite burned for a longer time compared to redwood.

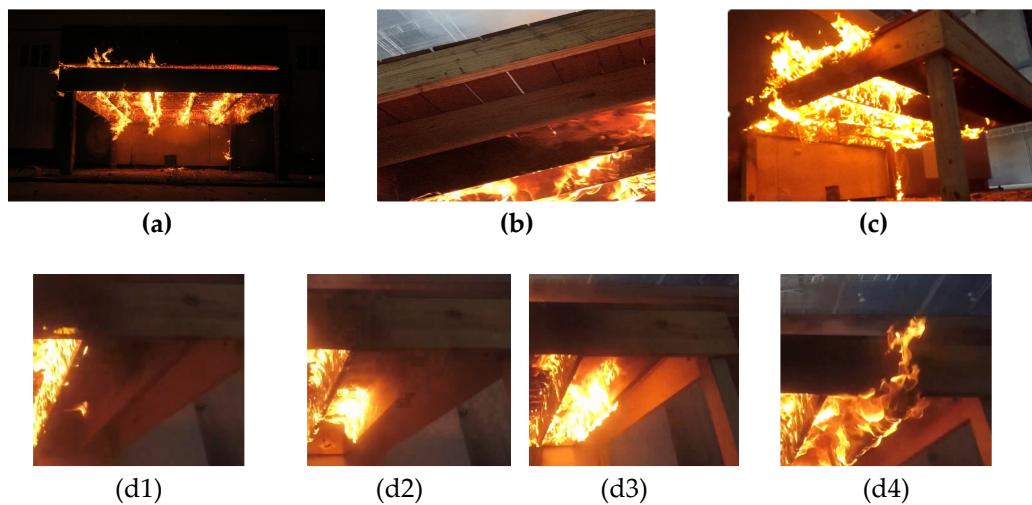
Figure 16. Combustible joists provide a constant heat source to the deck boards, (a–c) are from different experiments, (d1–d4) are taken in one experiment, d1 is taken 6 min after ignition, and (d2–d4) are about 4 min apart.

joists. In other words, a 2 or 3 min exposure from the burner transforms to a much longer exposure to the decking material caused by the burning joists. If a joist was not engulfed in fire, the boards above it did not burn. Figure 16 shows this phenomenon for redwood boards installed over a substructure made from Southern Yellow Pine. Figure 16d1 to 16d4 shows the fire growth in one test in about 15 min. In this test, the gradual growth of fire on the joist caused the entire bay to be involved in the fire. A noncombustible joist in this case would limit, or even self-extinguish, the fire growth.

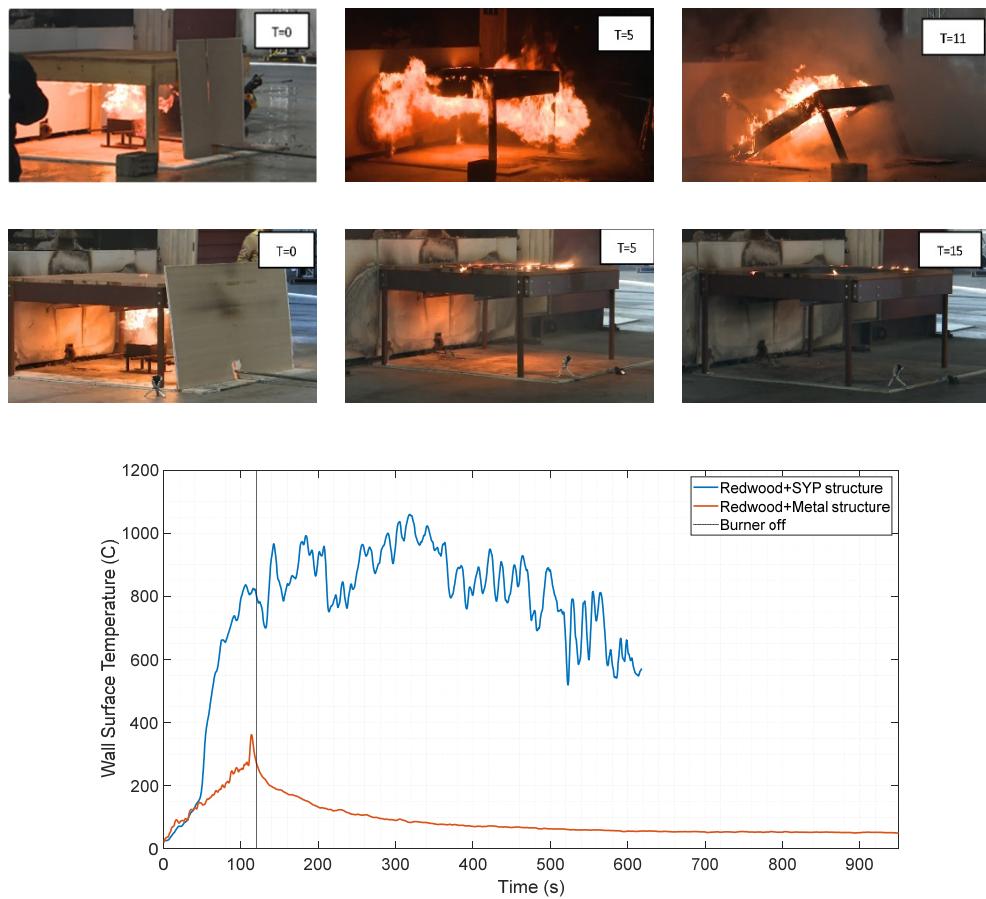
Figure 17. Time-lapse of redwood deck boards with (First Row) Southern Yellow Pine joists and (Second Row) metal supporting system, and the wall temperature.

Board	Sub-Structure	Currently Chapter 7A Compliant ¹	Associated Figure
Redwood	SYP	Yes	Figure 17
Redwood	Metal	Yes	Figure 17
Composite A	SYP	Yes	Figure 18
Composite A	Metal	Yes	Figure 18
Composite B	SYP	No	Figure 19
Composite B	Metal	No	Figure 19
Metal No Gap	SYP	Yes	Figure 20
Metal Gapped	SYP	Yes	Figure 20
Metal No Gap	Metal	Yes	Figure 22
Metal Gapped	Metal	Yes	Figure 22

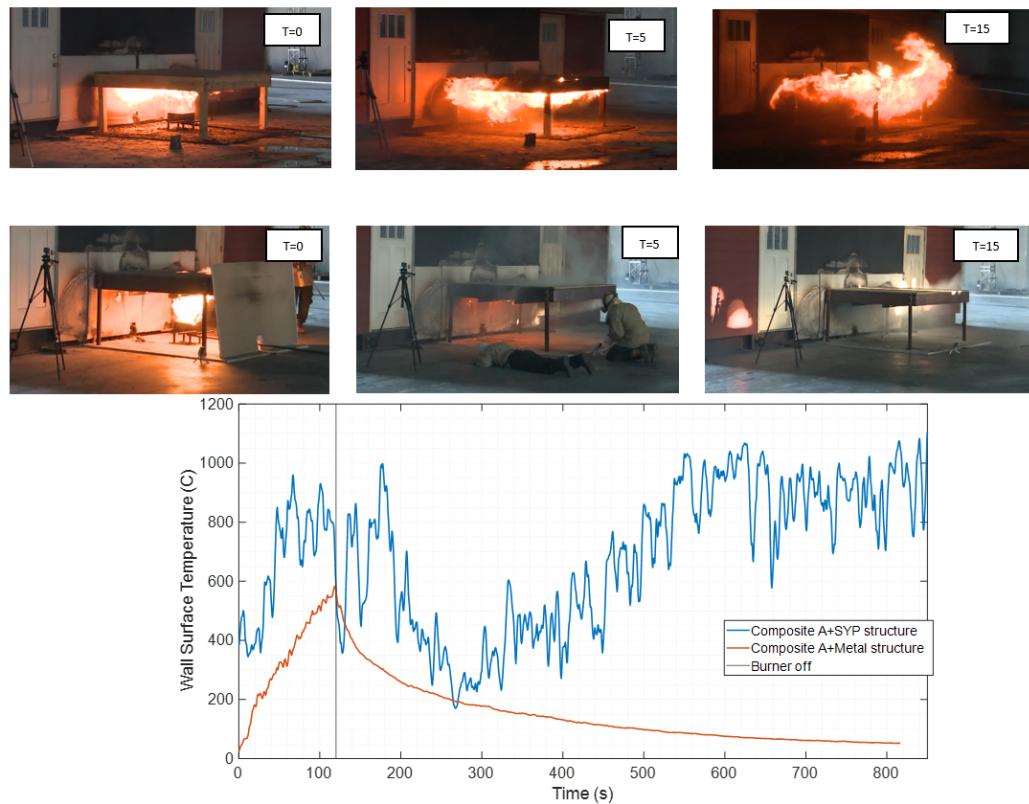
Figure 18. Time-lapse of Composite A deck boards with (First Row) Southern Yellow Pine joists and (Second Row) metal supporting system, and the wall temperature.

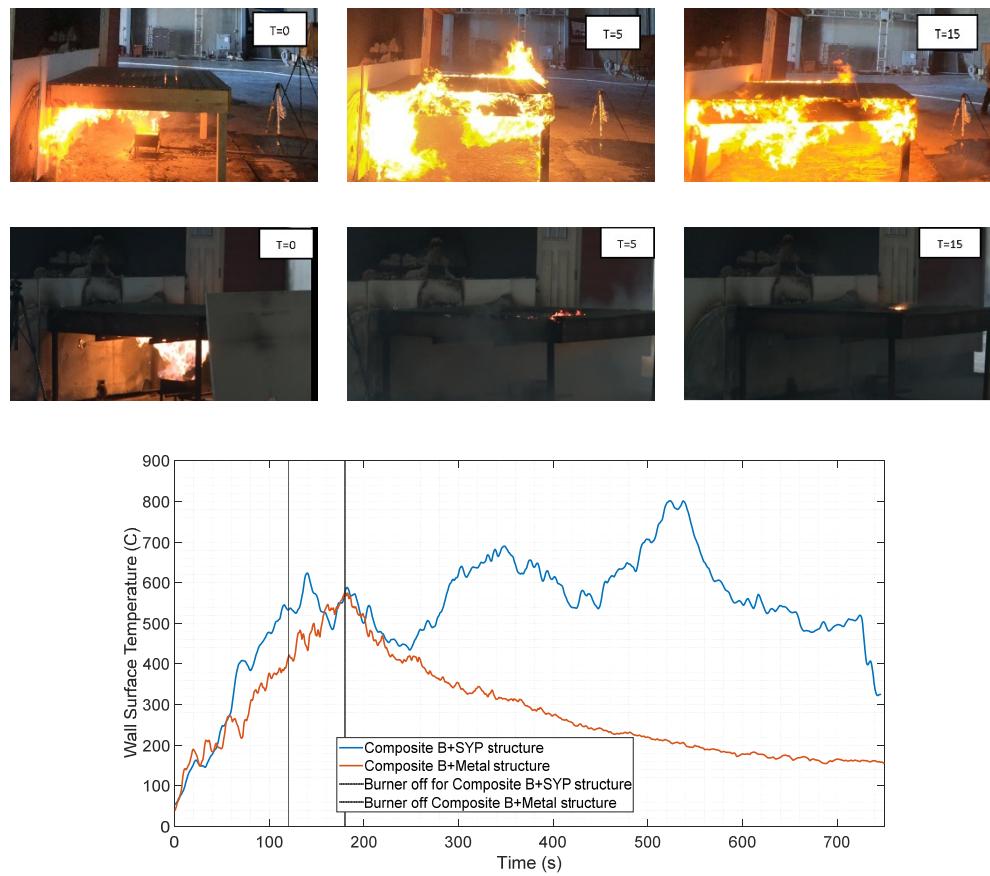
Figure 19. Time-lapse of Composite B deck boards with (First Row) Southern Yellow Pine joists and (Second Row) metal supporting system, and the wall temperature.

The behavior of the wall temperature can be taken as an indicator of the deck assembly's response to a thermal attack. Considering at the temperature behavior after shutting off the burner in these graphs, two patterns are recognizable: (1) the wall temperature maintains the elevated temperature and (2) the wall temperature exhibited a decreasing trend. The extreme case can be seen in Figure 17 where a sudden drop happened after turning off the burner. As can be seen in Figures 17–22, the contribution of joists to the fire performance of the deck assembly overpowered the effect of the walking surface. In other words, regardless of the walking-surface compliance status, the wall temperature can exhibit a decreasing or increasing trend after shutting off the gas burner.

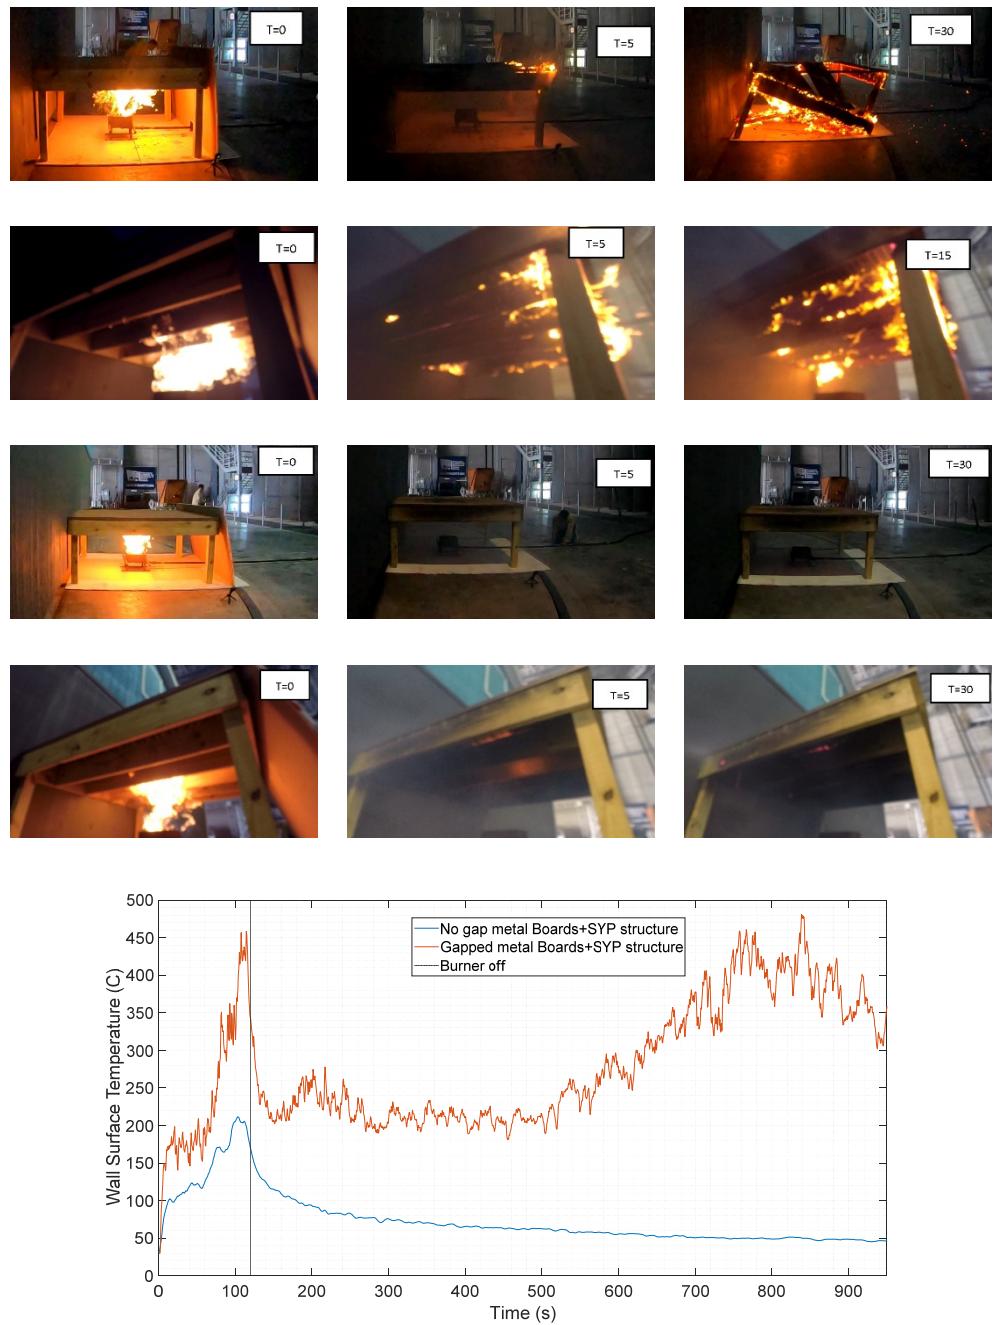
Figure 20. Time-lapse of two types of metal boards installed over SYP supporting system, (First Row) gapped metal boards, and (Second Row) no-gap metal boards, and the wall temperature.

Lastly, we tested two different metal walking surfaces installed over SYP supporting system. The time-lapse is shown in Figure 20. The first two rows are associated with a metal board with gap in between the boards, similar to the traditional boards. The second two rows are associate with a metal board with no gap in between (the installation instructions

for this product specified that there be no spacing between the boards). The graph below shows the variation of wall temperature as well as the fire behavior. Note that the last under-deck footage for the gapped deck is at $t = 15$ min. Beyond this point, the camera was overheated and removed.

In Figure 20, the blue curve is associated with the no-gap metal boards. As can be seen, the temperature rapidly drops after turning off the burner. This is probably because of the limited oxygen for the fire.

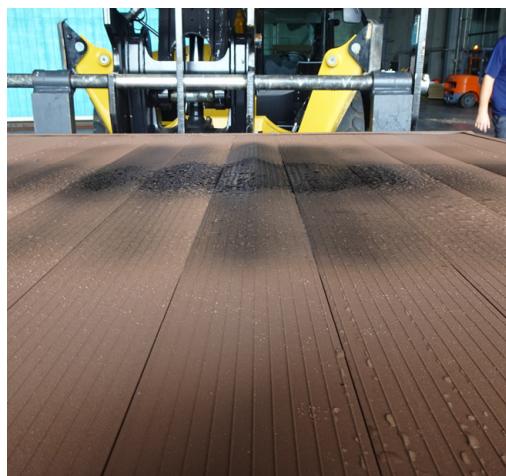
Figure 21. No-gap metal boards on SYP deck assembly after the test.

Figure 21 is associated to the no-gap walking surface installed over SYP supporting structure after the test. As can be seen, the walking surface deformed because of exposure to the heat from the burner flames. Since the airflow between the deck boards is limited, the fire barely got into the flaming phase and, for the most part, the joist was being consumed by smoldering combustion.

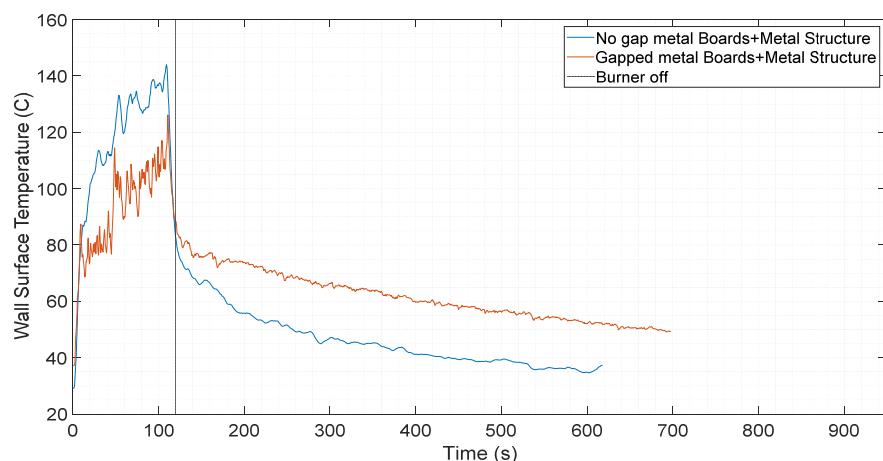
Figure 22. Wall temperature for gapped and no-gap metal boards over a metal substructure.

The metal walking surface and metal joist configuration is depicted in Figure 22. Since none of the components in these tests were combustible, we only present the wall temperature here, representing a base line condition.
