Article

The Plaka Bridge in Epirus: An Evaluation of New Building Materials for Its Restoration

Keywords: bridge; thermal analysis (TG/DTA); microstructure (MIP); Epirus stone; natural hydraulic lime

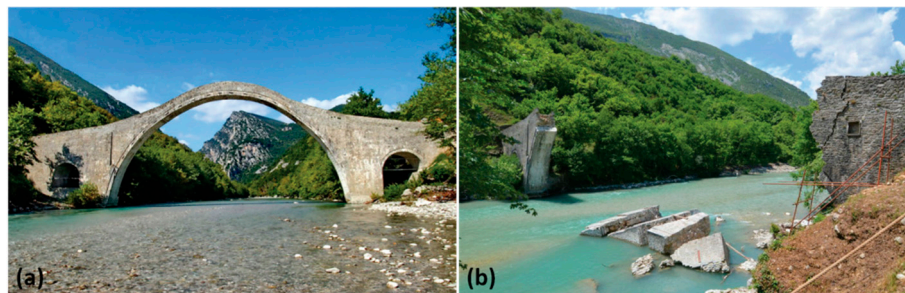
Figure 1. Images of the Plaka Bridge, (a) before its collapse, where one can see the main arch and the two relieving arches on each side, (b) and after its collapse in 2015 (adapted from [15]).

The bridge of Plaka, built over the river Arachthos in Epirus, is a traditional one-arch stone bridge with two relieving arches on each side of the main arch (Figure 1a), protected by law as a landmark monument [14]. In its current position and form, it was built in 1863 and 1866, the latter under the supervision of the famous local builder Constantinos Bekas. It was the longest-span single-arched bridge in the Balkans, until it partially collapsed after a heavy rainfall in February 2015 (Figure 1b). Today, the only remaining non-collapsed parts are the western abutment, including part of the western side of the main arch, as well as a smaller part of the eastern abutment, whereas large fragments of the bridge have been retrieved from the river and are stored in a nearby area.

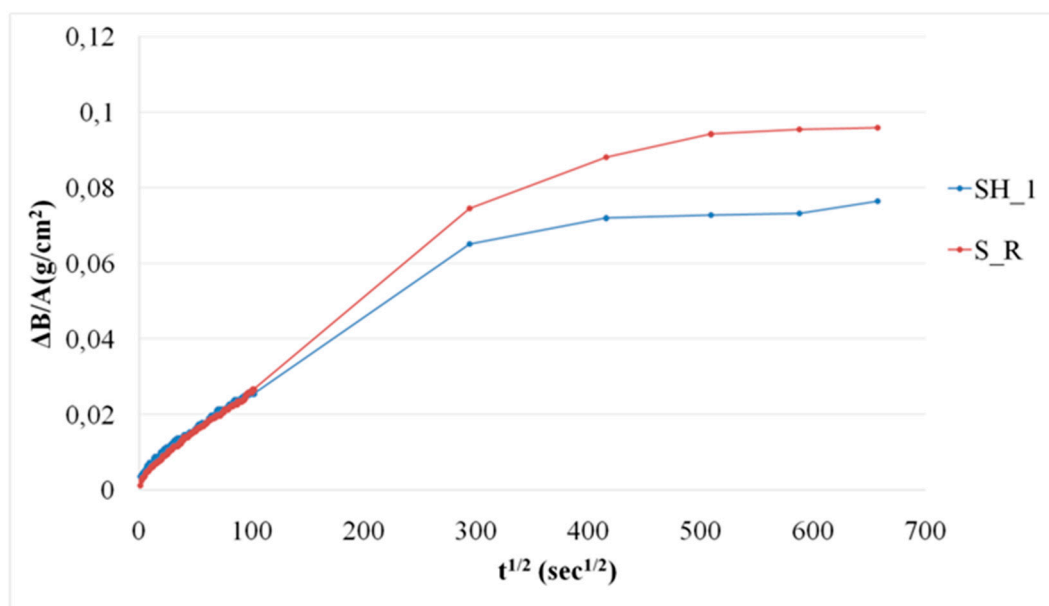
Figure 4. Characteristic capillary rise test results for historical (SH1) and quarry stone (R_S).

The historical and the quarry stone present a similar behavior in relation to capillary rise (Figure 4). The quarry stone presents a slightly higher capillary rise coefficient (C.R.C.) and water absorption capacity through capillary pores (WAC_{cap}) in relation to the historical, though within the same value range ($\sim 2 \cdot 10^{-4} \text{ g}/(\text{cm}^2 \text{ s}^{1/2})$ and $<1\%$, respectively, average of three specimens for each stone type, Table 6).

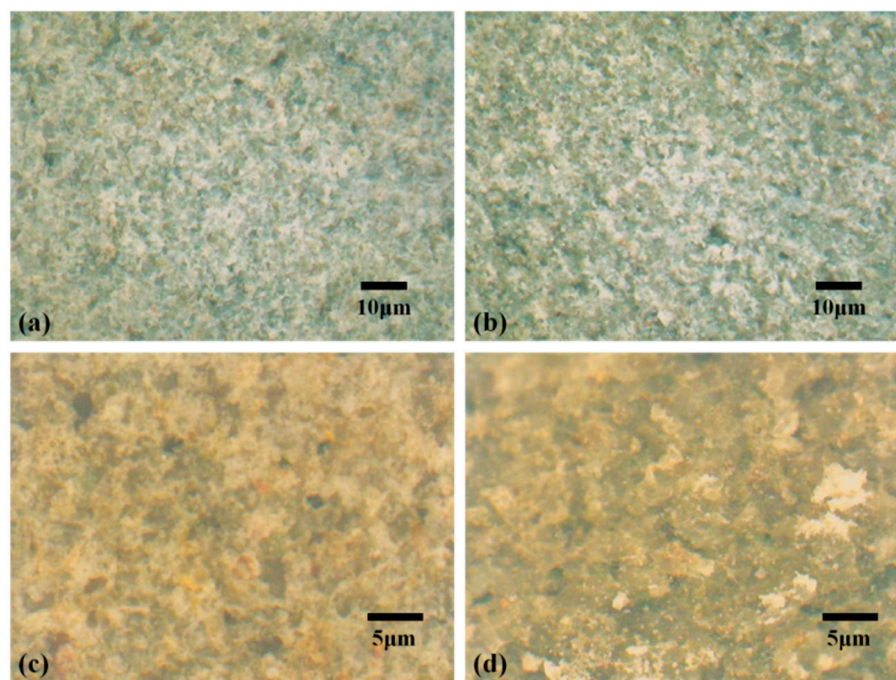
Figure 5. Digital microscopy images of the stone specimens: (a) Surface morphology of the historical stone, SH1, (b) surface morphology of the quarry stone, R_S, (c) surface morphology in area of a differentiated color, probably due to iron oxides and hydroxides, of historical stone, SH1, and (d) surface morphology in area of a differentiated color, probably due to iron oxides and hydroxides, of quarry stone, R_S.

Digital microscopy, implemented to examine the morphology of the surfaces on cut cubic samples of both the historical and the quarry stone, indicated similar surface morphology between the two specimens; this was also the case in areas of discoloration due to the presence of iron oxides and hydroxides, detected microscopically on both the historical and quarry stones (Figure 5).

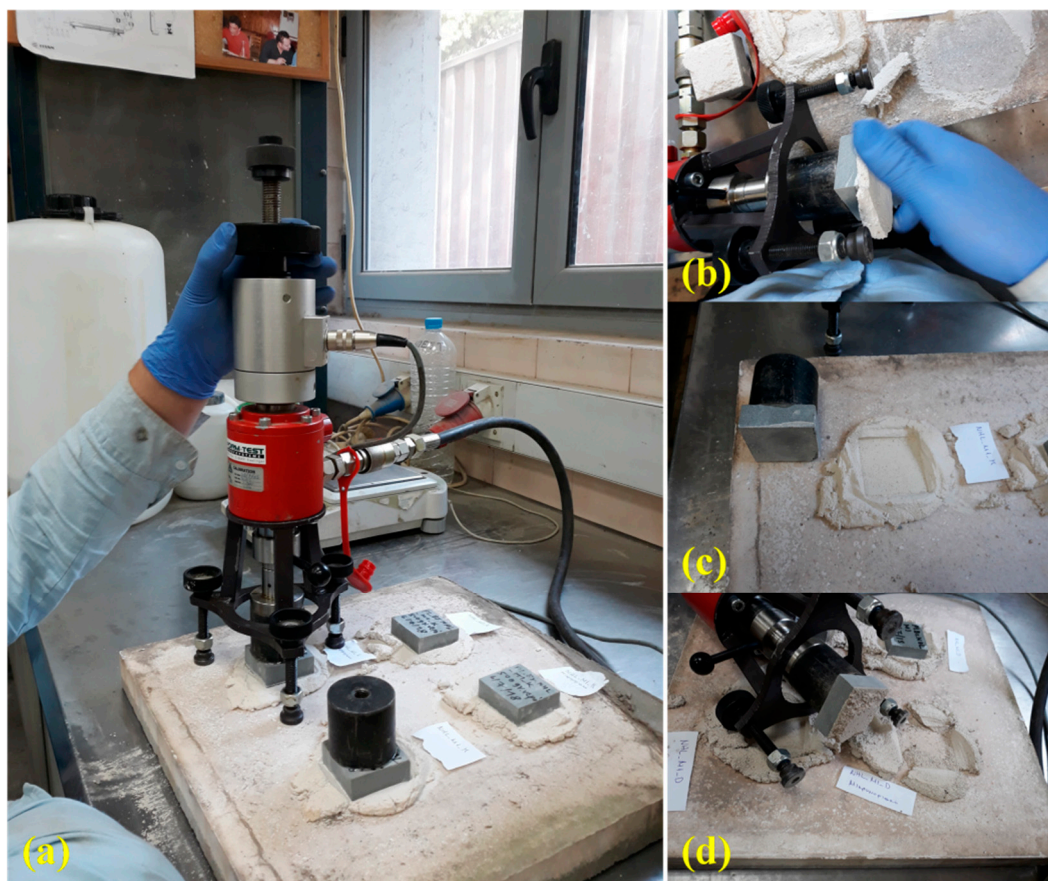
Figure 9. Different pull-off tests results; (a) in the process of the pull-off test, (b) stone-mortar system detached from pavement stone (mortar easily detached from the stone manually indicating no adherence), (c) stone detaching from the mortar completely, indication of no adherence, (d) stone detached with upper part of mortar, lower part of mortar remains on pavement stone.

Pull-off tests were conducted in order to estimate the adhesive strength of the restoration mortars [28]. As described in a previous section, it was decided to use the quarry stone in order to examine this property, in order to be closer to real-time parameters. The different restoration mortars were applied on a pavement stone, and the stone tiles were applied on the restoration mortars, after wetting the surface in contact with the mortar. In this preliminary stage of research, this process was implemented for mortars Pl.Br.1, Pl.Br.2, and NHL_M1, and tests were conducted after 28 days. Thus, at 28 days, special metal cylinders were glued on the top surface of the stone tiles, and the force required to detach the stone tiles from the mortars was measured with a Pruf system instrument (Table 15, Figure 9). The results indicate the better adhesion of NHL_M1 and Pl.Br.2 to the quarry stone.

Mortar	Pull-off Force (kN)	Mortar Adhesive Strength (MPa)	Area of Detachment
NHL_M1	0.229	0.09	Mortar and stone detached from upper surface of pavement stone, mortar presents adhesion to stone tile after detachment (Figure 9d)
Pl.Br.1	0	0	Mortar completely detached from pavement stone – then easily detached manually from stone tile (Figure 9b)
Pl.Br.2	0.371	0.15	Stone tile and upper part of mortar were detached from lower part of mortar and pavement stone (as in Figure 9d)
