Article

Comprehensive Energy Renovation of Two Danish Heritage Buildings within IEA SHC Task 59

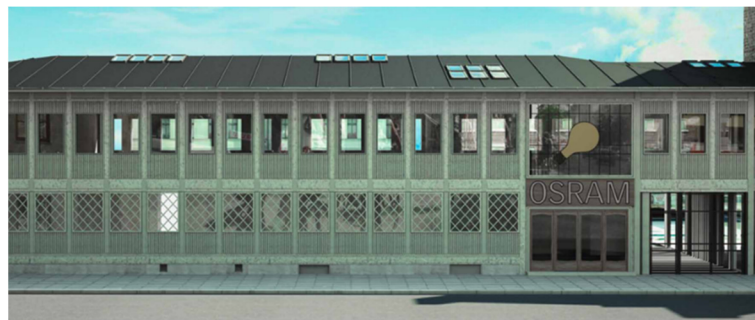
**Figure 3.** Façade facing the main street after renovation.

The Osram Building was built in 1953 as an industrial building. It was the first prefabricated house in Copenhagen, built as an office and warehouse for Nordisk Glødelampe Industri A/S. As part of a Neighbourhood Development Project in a former semi-industrial area of Copenhagen, the City of Copenhagen initiated an energy renovation of the cultural centre “OSRAM”. The facade of the building is listed. The building was renovated in 2009 (see Figures 3 and 4).

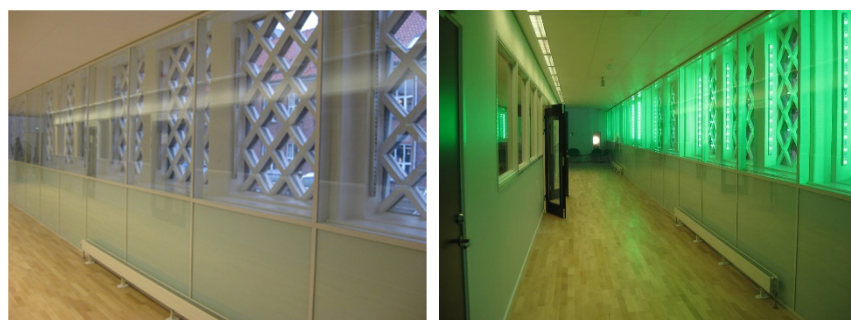
**Figure 4.** Façade facing inside after renovation. LEDs, off (left) and on (right).

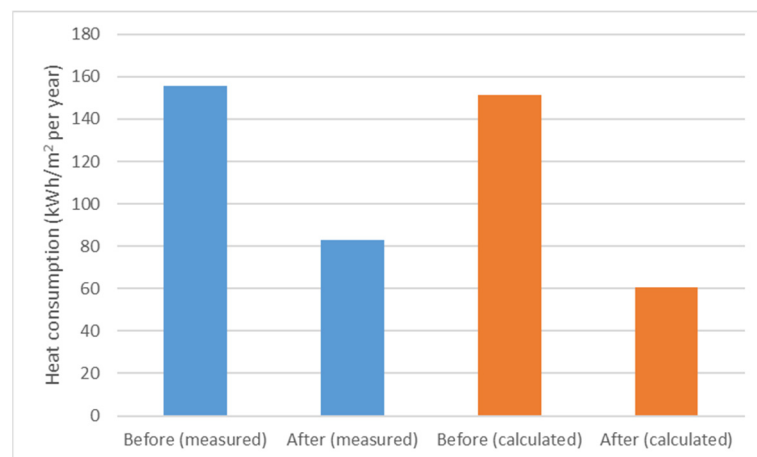
Figure 7. Measured and calculated heat consumption before and after renovation of Ryesgade 30.

After the renovation, the consumption was measured as 83.0 kWh/m² (September 2013 to September 2014), and during the same period the photovoltaic system produced approx. 11,000 kWh, corresponding to 3.3 kWh/m² per year. The electricity production was approx. 20% higher than expected. The IDA ICE model had predicted a heat consumption of 60.6 kWh/m² per year, so the actual consumption was significantly higher than expected. Figure 7 shows the results of measurements and calculations.

One of the main reasons for not achieving the expected savings in heat consumption was the fact that the indoor temperature after the renovation was significantly higher than what is usually used in these types of calculations. The temperature was measured during the heating season of 2013–2014 in blocks A and B (20 different sensors in total), and the result showed an average indoor temperature of 22.5 °C.

If the IDA ICE calculation model is revised to take the actual indoor temperature into account, the expected heat consumption increases from 60.6 to 77.3 kWh/m² per year.

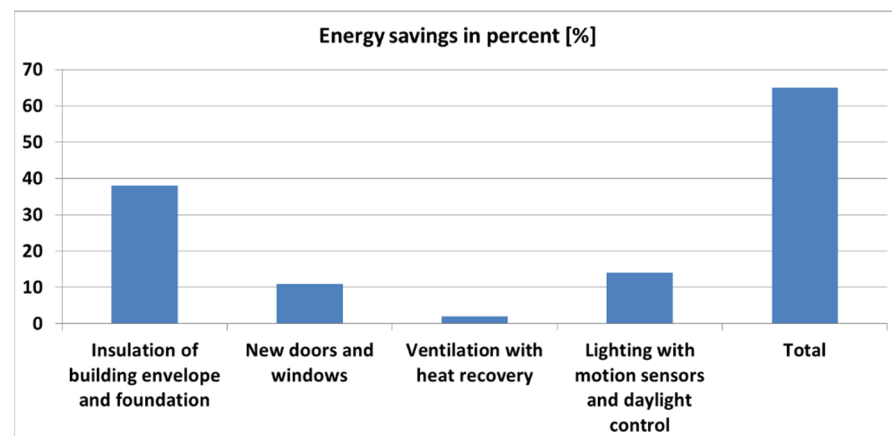
Figure 8. Energy savings in percent divided into the different parts of the renovation.

The energy savings for the building is 9500 and 181,000 kWh per year for electricity and heating, respectively. The savings from the façade insulation and the windows account for 150,000 kWh per year, and the rest are from the heating and lighting systems, the controls and the solar panels (see Figure 8).

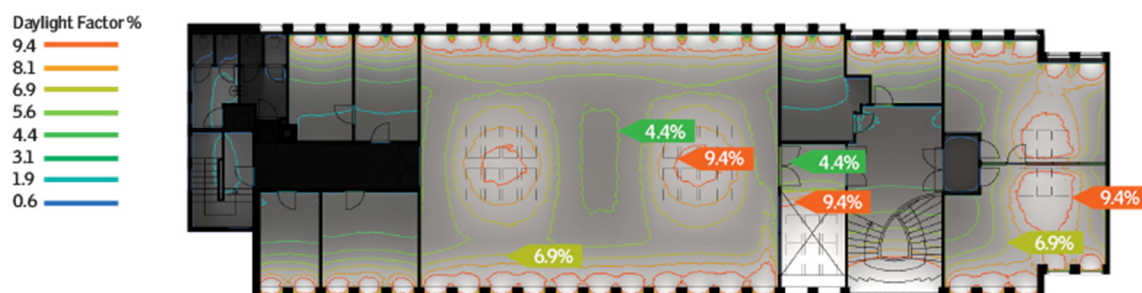
Figure 12. First floor with roof windows.

The daylighting performance of the Osram Building has been specified using the daylight factor (DF) as a performance indicator. The calculations of the daylight given below were performed by Velux [17]. Please note that there are slight differences between the drawings used in the daylight calculations (Figures 12 and 13) and the drawings of the first-floor layout in Figure 11. The daylight calculations were performed at an early stage of the design phase.

The daylight factor analysis has been performed using computer simulations of Radiance. Figures 12–15 show the daylight factor levels obtained on each floor for two different variants evaluating the impact of the installed roof windows on the finalized design.

The comparison of results shows the positive effects of adding roof windows on the daylight conditions of the first floor. The roof windows deliver high levels of daylight in the centre part of the main room, as well as in the meeting rooms at the end of the building. The use of roof windows also contributes to raising the daylight levels on the lower floor via a new opening in the existing structural floor situated below the skylights in the hallway, as shown in Figure 16.

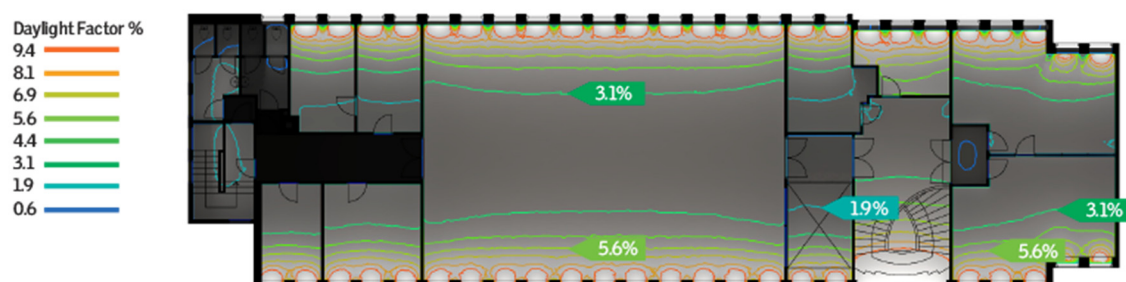
Figure 13. First floor without roof windows.

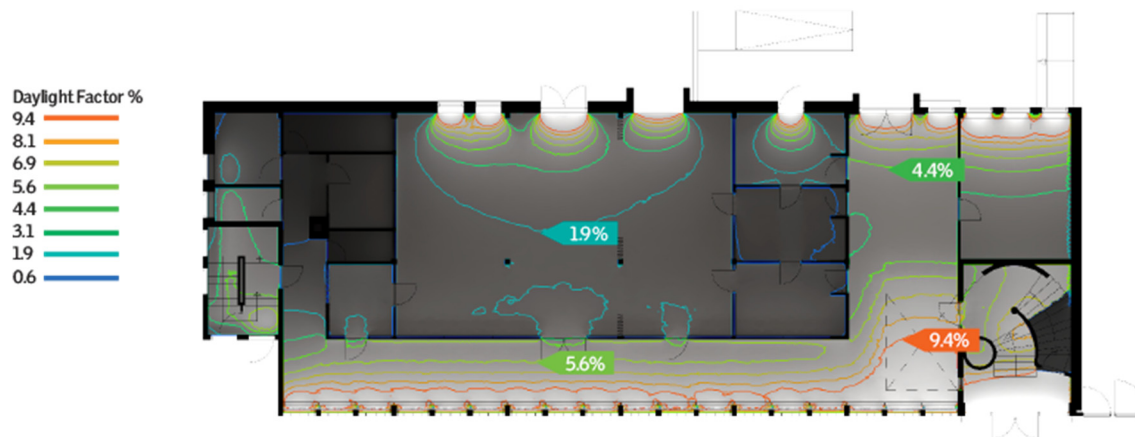
Figure 14. Ground floor with roof windows.

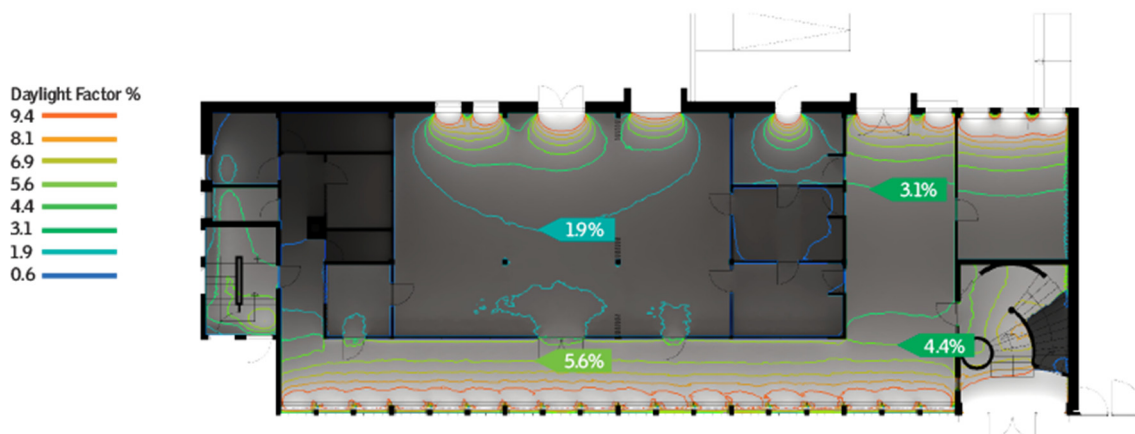
Figure 15. Ground floor without roof windows.
