# Simulation of the Impact of Tyre Damage on Vehicle Travel Safety

This article presents the results of simulation-based research aimed at assessing the impact of tyre damage on vehicle travel safety. The analysis takes into account various influencing factors, including vehicle speed, load conditions, and road surface condition (dry or wet asphalt). Particular emphasis was placed on the dynamic analysis of the vehicle during collision scenarios, including post-impact vehicle positioning, changes in kinetic energy, and the magnitude of the generated impact force. Simulation results indicate that tyre damage significantly compromises vehicle trajectory stability and, in certain cases, makes vehicle control impossible. The conclusions highlight the critical importance of maintaining proper tyre condition in mitigating the consequences of road collisions and emphasise the need for regular tyre inspections as part of routine vehicle maintenance.

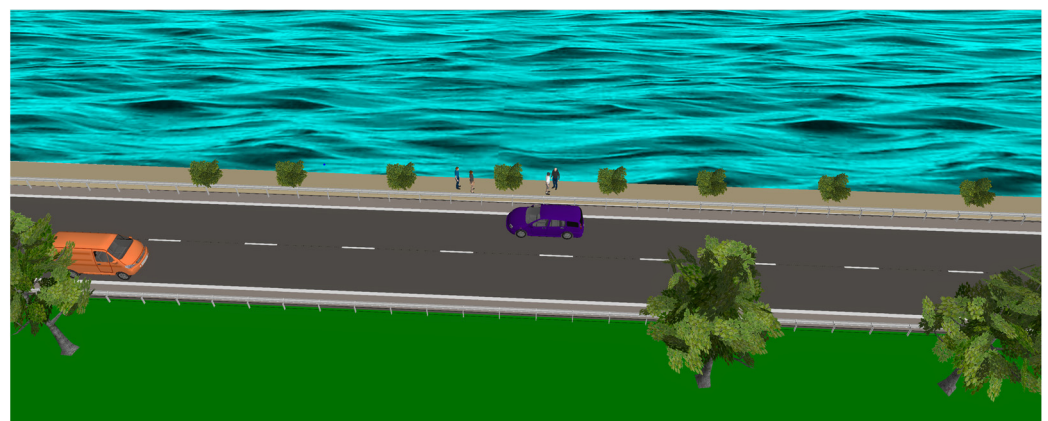
At the moment tyre damage occurred, the vehicles were 89.3 m apart. Figure 7 presents a visual representation of the traffic environment and road conditions used as the basis for simulating the road collision scenario.

**Figure 7.** Traffic environment and road conditions used in the road accident simulation.
