# Supplementary Information

## Investigating the Bond Performance of FRP Bars and Concrete Under Dynamic Loading Conditions

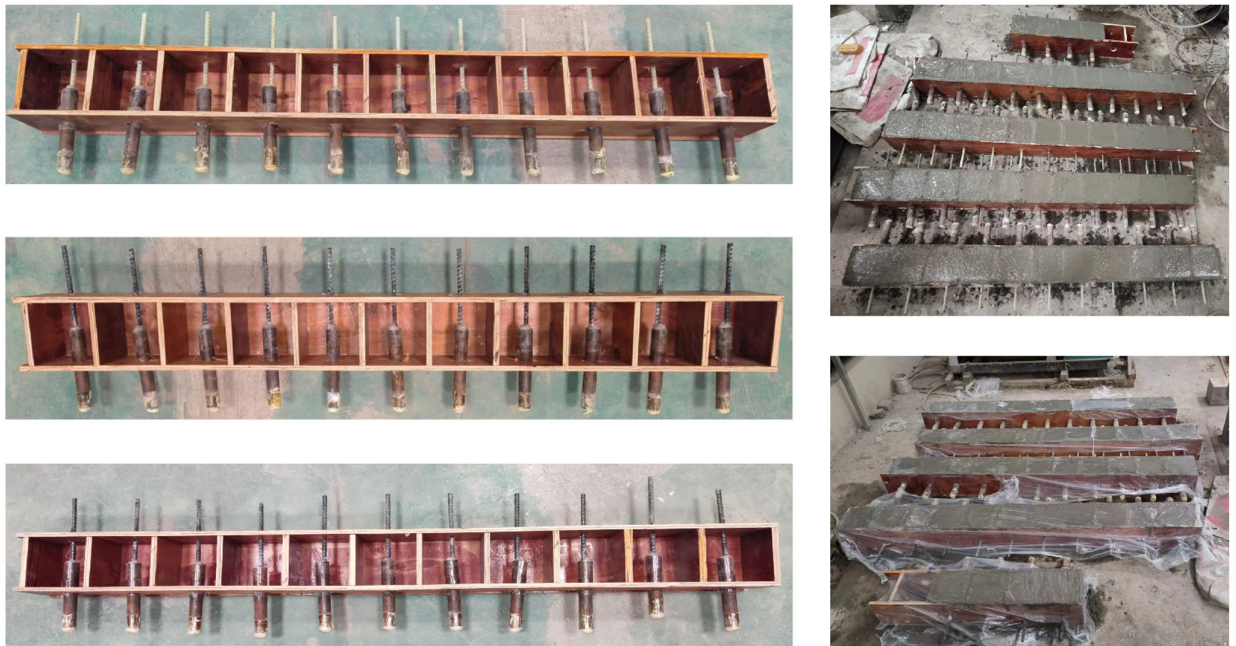
**Figure S4.** Photographs of the specimen preparation process.

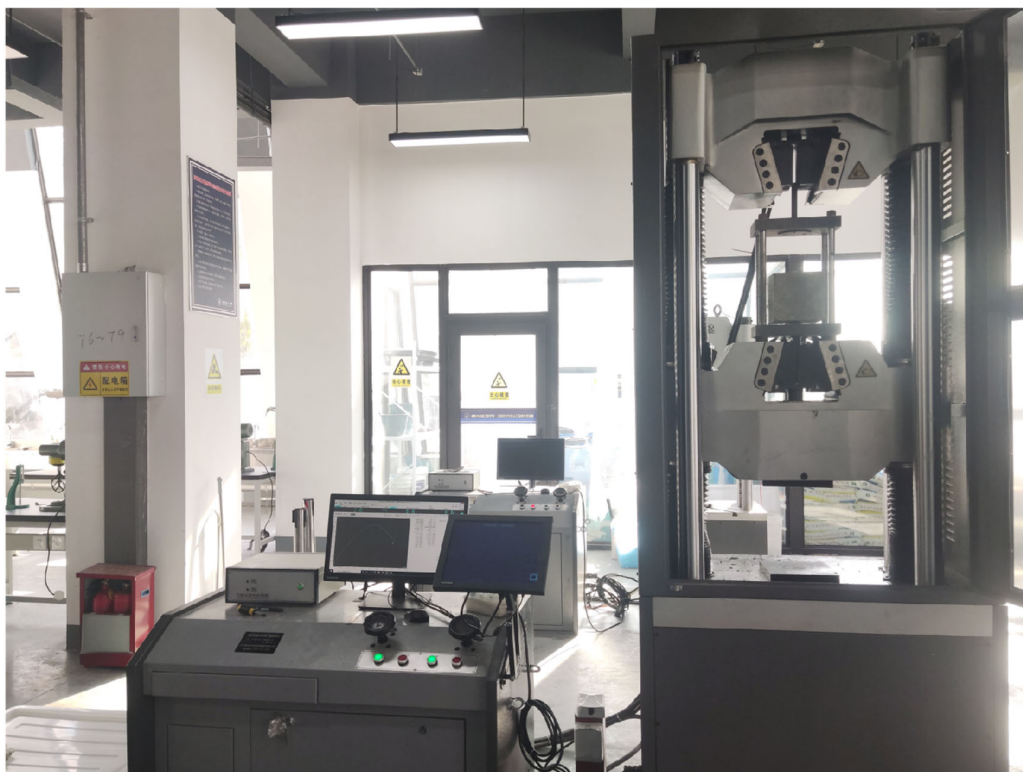
Figure S5. Photograph of the test system.

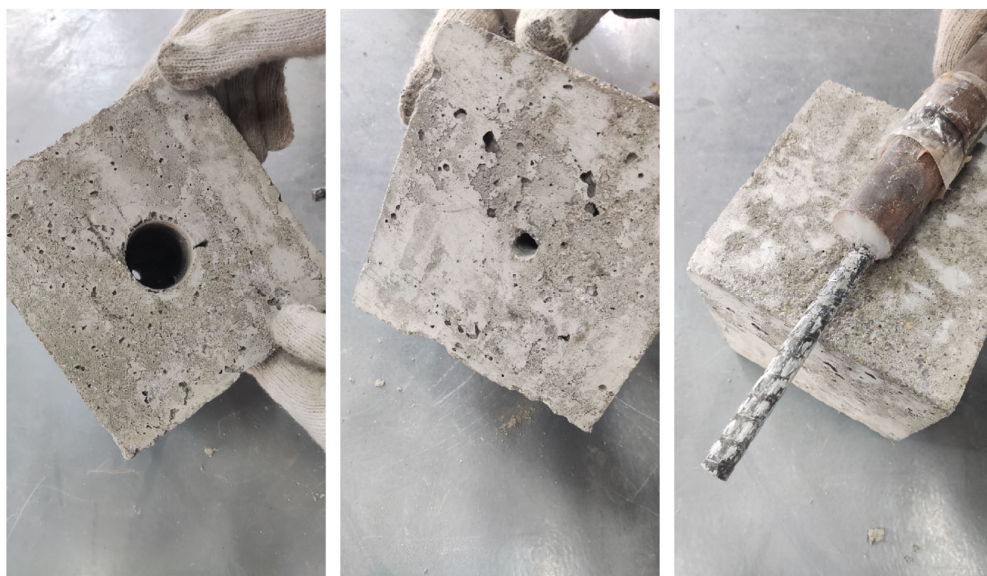
Figure S6. Photograph of the test specimen after pull-out.

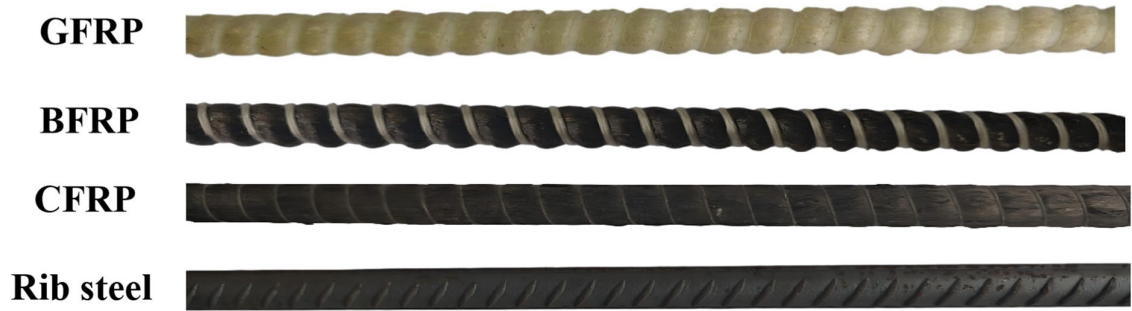
**Figure S7.** Photographs of the four types of bars and a schematic diagram illustrating the geometric parameters of the deformed steel bar.
