Article Improving the Properties of Laser-Welded Al–Zn–Mg–Cu Alloy Joints by Aging and Double-Sided Ultrasonic Impact Compound Treatment

Furong Chen and Chenghao Liu *

School of Materials Science and Engineering, Inner Mongolia University of Technology, Hohhot 010051, China; cfr7075@imut.edu.cn

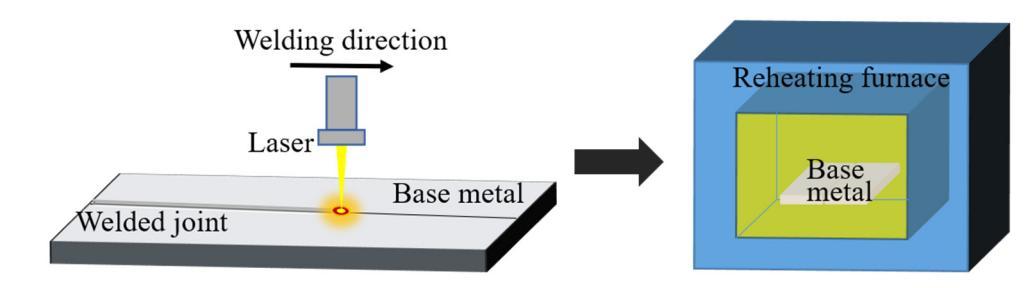
Figure 1. Schematic of laser welding and heat treatment test.

The welding equipment was an IPG YLS-10000 fiber laser (IPG Potonics Corporation, Santa Clara, CA, USA) and a KUKA welding robot (KUKA Roboter GmbH, Augsburg, Bavaria, Germany) was used to conduct butt welding to the $16 \times 8 \times 3 \text{ mm}^3$ base metal. Moreover, T6 heat treatment was adopted for the post-weld heat treatment; the equipment used was a box-type resistance furnace, and the test accuracy was ± 3 °C. The laser welding and heat treatment process parameters are shown in Table 2. The principles of the laser welding and heat treatment test are shown in Figure 1.

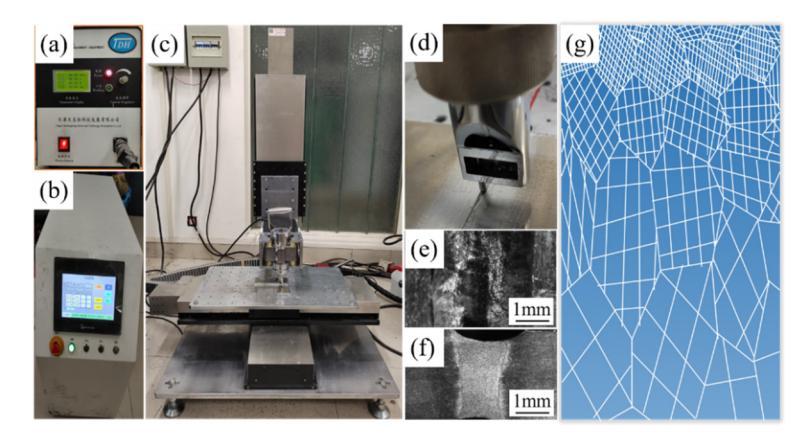
Figure 2. Schematic diagram of DSUIT. (**a**) Ultrasonic impact machine; (**b**) 3D sliding platform controller; (**c**) the composite system of the ultrasonic impact gun head and 3D slide table; (**d**) the working diagram of the welded joint treatment by ultrasonic impact needle; (**e**) the welded joint surface morphology after DSUIT; (**f**) the welded joint cross-section after ultrasonic impact; and (**g**) the schematic of the grain gradient refinement of the welded joint after DSUIT.

In the ultrasonic impact test, a UIT-125 ultrasonic impact machine (Tianjin Dongheng Science and Technology Development Co., Ltd., Tianjin, China) and a self-developed three-dimensional (3D) sliding platform system were combined to treat the welded joints. The DSUIT schematic is shown in Figure 2. The test impacted both the upper and lower surfaces of the welded joints; the movement of the impact needle from the beginning to the end of the welded joint was counted as one impact. The DSUIT test parameters are shown in Table 3.

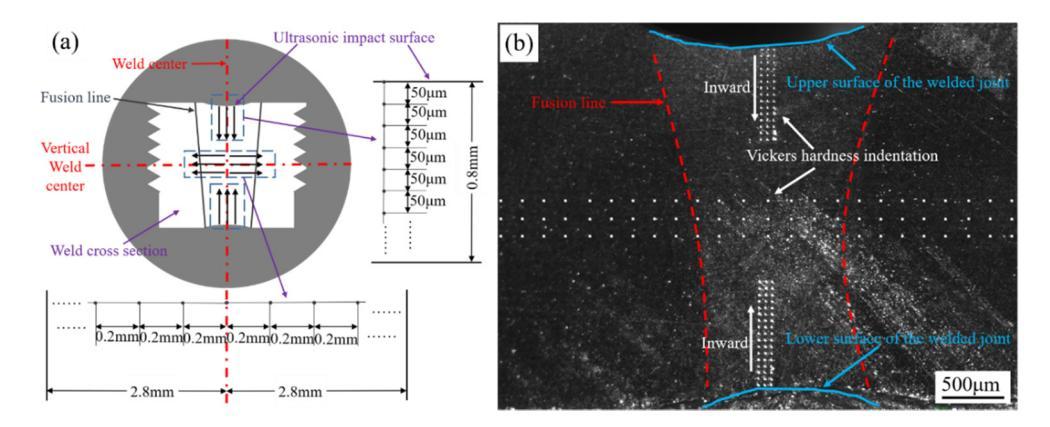
Figure 3. Vickers hardness test. (a) Test principle diagram and (b) schematic diagram of points collected for microhardness tests.

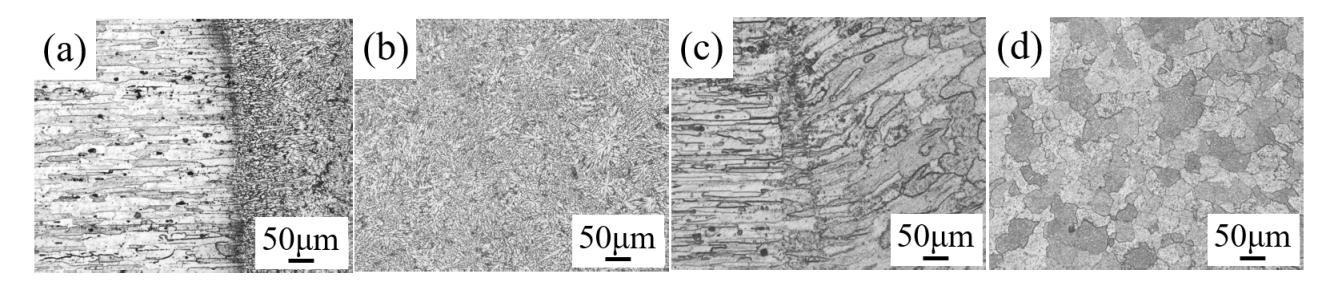
Figure 4. Microstructure of a welded joint before and after aging. (a) Microstructure near the fusion line before aging; (b) microstructure of the weld center before aging; (c) microstructure near the fusion line after aging; and (d) microstructure of the weld center after aging.

Figure 4 shows the changes in the microstructure of a 7075 aluminum alloy fiber laserwelded joint before and after aging. As shown in Figure 4a, the fusion line of the joint was very narrow, and the growth pattern of the fusion line toward the central grain of the weld zone was small columnar grain. It can be observed from Figure 4b that the microstructure of the weld zone of the alloy exhibited the characteristics of an as-cast microstructure, showing a dendritic network structure. The black spots in the figure are non-equilibrium eutectic phase α (Al)+T(AlZnMgCu). Based on the microstructure in Figure 4c, the fusion zone of the joint became wider after the aging and the columnar crystals near the fusion line grew upward. The microstructure in Figure 4d shows that after the treatment, the dendritic reticulated grains in the weld zone grew into an equiaxed grain structure and that most of the non-equilibrium eutectic phases were eliminated.

After the aging treatment, the dendrite structure of the 7075 aluminum alloy laserwelded joint was basically eliminated and transformed into an equiaxed crystal. This was because the solution treatment before the aging treatment recrystallized the dendritic structure of the welded joint and the dendrite segregation homogenized in the process of the solution heat treatment. Simultaneously, the non-equilibrium eutectic phase in the welded joint was eliminated, and the grains in the welded joint again nucleated and grew. The aging treatment following immediately caused the recrystallized grains to continue to grow. After the 24-h aging treatment, the grain structure completely grew from a dendritic structure to an equiaxed structure. The continuous treatment created continuous growth conditions for the fusion zone grains of the welded joint, which made the fusion zone wider and effectively improved the joint's connection properties. In the aging process, the grain growth also improved the microhardness and strength of the welded joint, which effectively improved the joint's mechanical properties.

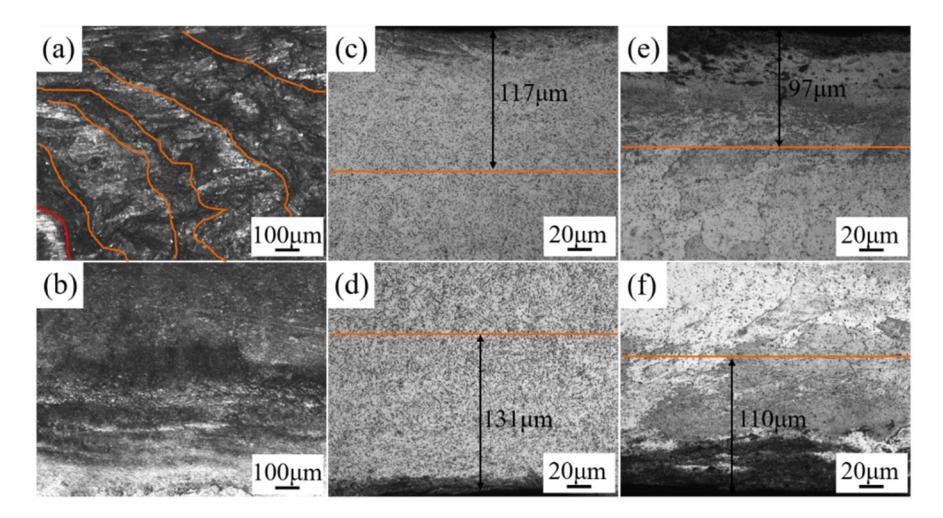
Figure 5. Microstructure of a welded joint after DSUIT. (**a**) As-welded (AW) joint surface morphology; (**b**) welded joint surface morphology of DSUIT; (**c**) plastic deformation layer (PDL) of the upper surface of welded joint after DSUIT; (**d**) PDL of the lower surface of welded joint after DSUIT; (**e**) PDL of the upper surface of welded joint after A–DSUIT; and (**f**) PDL of the lower surface of welded joint after A–DSUIT.

Figure 5 shows the microstructure of the 7075 aluminum alloy laser-welded joint surface before and after DSUIT and the microstructure of the welded joint cross-section after DSUIT.

According to the analysis of the microstructure results in Figure 5, the surface of the AW 7075 aluminum alloy joint demonstrated a regular peak structure that was very uneven. This would cause stress concentration at the joint during its use, which would not be conducive to its service life (Figure 5a). After the UIT on the welded joint, the surface of the weld zone became flat and smooth, and the welding surface defects were significantly reduced (Figure 5b). According to a comparative analysis of Figure 5c,d and Figure 5e,f), the thickness of the PDL on the lower surface of the welded joint after DSUIT was greater than that on the upper surface. This phenomenon was caused by the 7075 aluminum alloy welded joints of Zn and Mg elements at high-temperature volatilization and local depletion of these volatile elements (usually via irregular vaporization), leading to keyhole collapse so that the welded joint was lower than the base metal [25]. Therefore, during the UIT on the upper surface of the welded joint, the weld toe part was impacted first so that the ultrasonic impact strength on the joint's upper surface was lower than that on the lower surface; hence the thickness of the PDL on the upper surface was small. Moreover, the thickness of the PDL of the welded joint after A–DSUIT was smaller than that DSUIT

due to the improvement of the joint microhardness after aging. No phase transformation occurred in the welded joint after DSUIT, which only refined the grain diameter on the joint's surface [26].

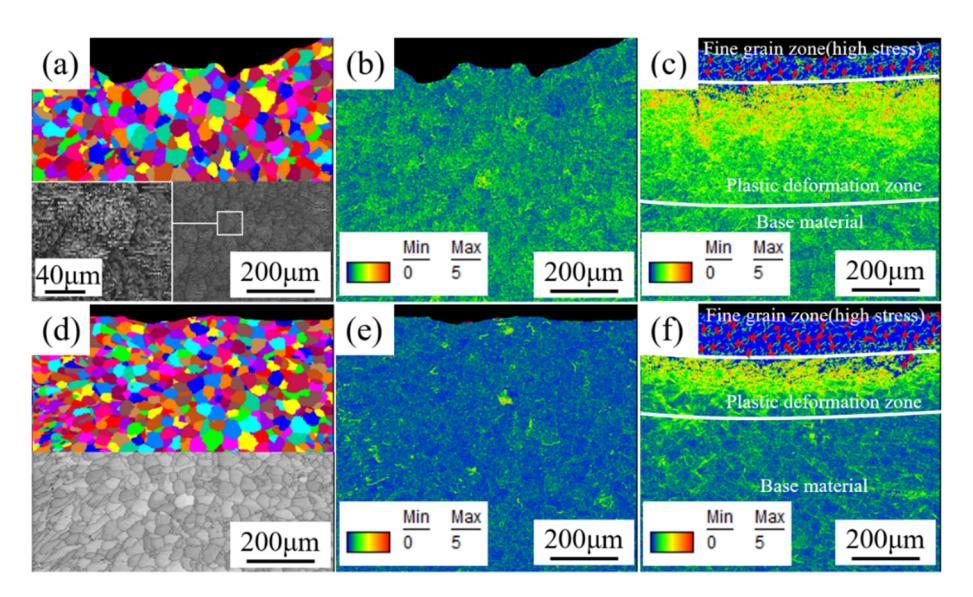
Figure 6. EBSD grain and stress distribution diagrams of the weld zone. (**a**) EBSD grain diagram of weld zone of the AW; (**b**) EBSD stress distribution diagram of weld zone of the AW; (**c**) EBSD stress distribution diagram of weld zone after DSUIT; (**d**) EBSD grain diagram of weld zone after aging; (**e**) EBSD stress distribution diagram of weld zone after aging; and (**f**) EBSD stress distribution diagram of weld zone after A–DSUIT.

To study the microstructure and stress changes of welded joints under the different treatment processes, the EBSD method was used to test the microstructure of the welded zone. TSL OIM Analysis software was used to analyze the EBSD test results, and the grain, stress distribution, misorientation angle distribution, inverse pole and pole figure were obtained. Moreover, the distribution of the grain diameter and misorientation angle in the weld zone was processed using TSL OIM Analysis, and the average grain diameter and average misorientation angle were calculated. The analysis results are shown in Figures 6 and 7.

Figure 6 shows the EBSD grain and stress distribution diagrams of the weld zone. Comparing Figure 6a,b, researchers found that after the aging treatment of the welded joints, the grain diameter of the weld zone became uniform, and the zone's grain structure changed from the original dendritic structure to an equiaxed structure. Moreover, comparing Figure 6b,e, it was clear that the stress at the welded joint was effectively eliminated after the aging treatment (the original stress of the AW joint was actually the residual tensile stress, which was not conducive to its service life). It can be seen from Figure $6c_{r}f$ that certain stress was introduced into the fine grain and plastic deformation zones of the welded joint after DSUIT (the stress introduced here was residual compressive stress, which was beneficial to the service life of the welded component [27]). The fine grain zone displayed red (high) stress (i.e., residual compressive stress), and the residual compressive stress near the welded joint surface was too large, which led to the missing phenomenon in the EBSD analysis process. Meanwhile, it was observed in Figure 6c,f that, because the hardness of the AW joint was lower than that of the aged joint, the PDL thickness of the former was larger than that of the latter, and the residual compressive stress introduced was deeper. However, the zone (base material) of the AW joint not affected by DSUIT showed greater residual tensile stress than that of the aged joint not affected by DSUIT, and the thickness of the stress layer introduced by DSUIT was very different from the overall thickness of the welded joint. Therefore, welded joints treated with A-DSUIT could show better properties in practical application.

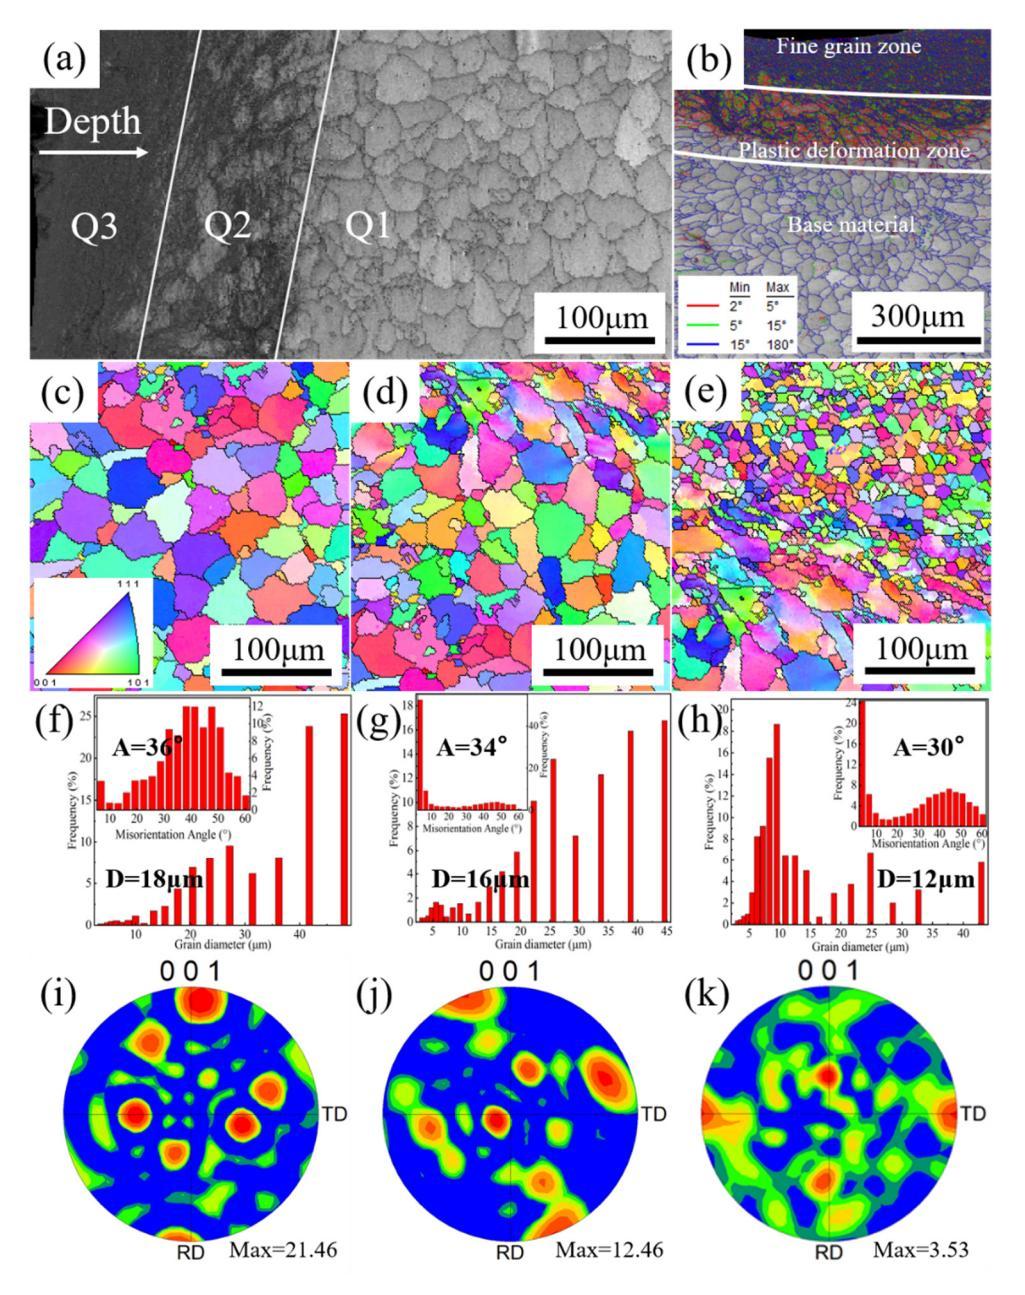
Figure 7. EBSD characterization. (**a**) Microstructure zones of weld zone after A–DSUIT; (**b**) misorientation angle distribution; (**c**–**e**) Q1–Q3 inverse pole figure; (**f**–**h**) Q1–Q3 average grain diameter and misorientation angle statistics; and (**i**–**k**) Q1–Q3 polar Figure.

In view of the microstructure changes in the plastic deformation zone, the A–DSUIT sample was selected as the research object, and the surface layer was further divided into three zones (Q1, Q2, and Q3) according to the grain morphology (Figure 7a). The grain morphology, grain diameter, misorientation angle, and texture strength of the three zones were characterized by EBSD analysis. After the weld zone was ultrasonically impacted, the grains in the near-surface zone were extruded and broken, and a large number of small-angle grain boundaries were formed in the plastic deformation zone of the weld zone (Figure 7b). Figure 7c shows the inverse pole figure of zone Q1; it can be seen that each grain exhibited its own independent orientation information with an equiaxed grain structure. The average grain diameter in Q1 was 18 μ m, the and average misorientation angle was 36° (Figure 7f). According to the polar figure of Q1 in Figure 7i, the texture strength of this region was higher at plane <001>, and the texture strength was 21.46.

Figure 7d is the inverse pole figure of the microstructure of Q2, which was affected by the ultrasonic impact and produced a certain strain between Q1 and Q3. The columnar crystals in the microstructure were deformed and accompanied by the phenomenon of columnar crystal breaking. Compared with the columnar grain diameter and misorientation angle in Q1, the shape and size of the subsurface grains in Q2 changed, and the grain diameter and misorientation angle decreased, with an average grain diameter of 16 μ m and average misorientation angle of 34° (Figure 7g). According to the polar figure of Q2 in Figure 7j, the texture strength of the subsurface zone at plane <001> was lower than that in Q1, and the texture strength was 12.46. Moreover, the texture orientation began to shift under the influence of the ultrasonic impact.

Figure 7e is the inverse pole figure of Q3, where severe plastic deformations occurred near the weld zone surface. The deformed columnar grains in this zone were broken into finer grains; the average misorientation angle in this zone decreased to 30° , while the average grain diameter decreased to $12 \,\mu$ m (Figure 7h. As can be seen from the polar figure of Q3 in Figure 7k, the texture peak of the strong plastic deformation zone on the weld zone surface decreased at plane <001>, and the texture strength decreased to 3.53. The decrease of the texture peak and strength was due to the large grain structure being broken by the impact during the DSUIT of the welded joint, which broke the original texture orientation and reduced the texture strength.

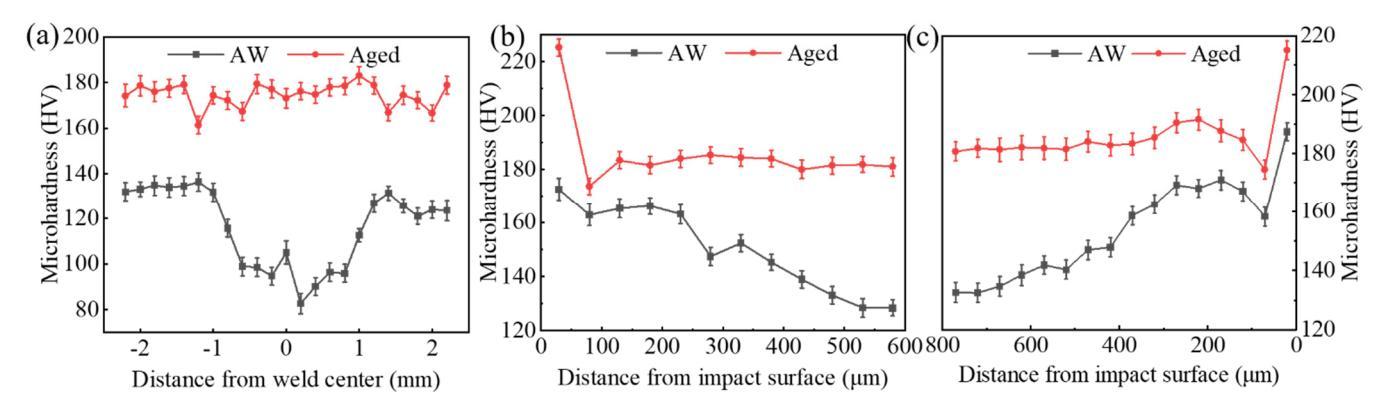
Figure 8. Vickers hardness. (a) Base metal–weld–base metal; (b) the upper surface of the welded joint is inward; and (c) the lower surface of the welded joint is inward.

The Vickers hardness of the welded joints under the different treatment processes was tested. Figure 8a shows the Vickers hardness curves of the vertical weld center from base metal–weld–base metal on the cross-section of the AW and aged joints. Figure 8b,c displays the inward Vickers hardness curves of the upper and lower surfaces of the weld zone after DSUIT of the AW and aged joints.

According to the Vickers hardness curve in Figure 8, the microhardness of the weld zone of the AW joint was lower than that of the base metal. The microhardness at the weld center was the lowest, about 100 HV; the microhardness in the heat-affected zone of the welded joint was the highest, about 140 HV; and the overall average microhardness of the welded joint was about 120 HV. When the welding members were aged, the overall average microhardness was stable around 175 HV, and the microhardness improvement rate of the welded joint was 45.8% (Figure 8a). As shown in Figure 8b,c, based on the microhardness, which gradually decreased inward, and the maximum Vickers hardness of the surface affected by ultrasonic impact reached 180 HV. After aging, the welded joint hardness of the surface layer of fewer than 100 μ m. After the ultrasonic impact of the aging welded joint, the Vickers hardness of the impact surface reached 200 HV. Therefore, the A–DSUIT process significantly improved the microhardness of the welded joint.

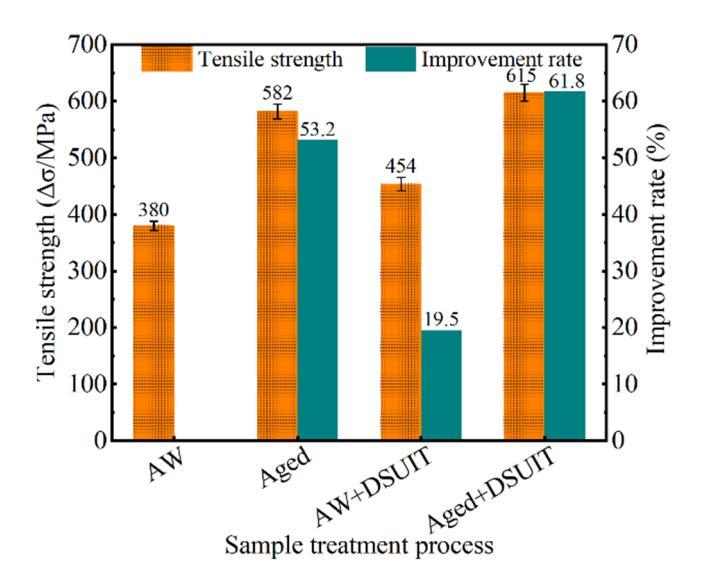
Figure 9. Tensile test results.

A tensile test was carried out on welded components treated by the different processes, and the test results are shown in Figure 9. The tensile strength of the AW joint was 380 MPa, and the joint strength after aging treatment, DSUIT, and A–DSUIT was 582, 454, and 615 MPa, respectively. The improvement rate of the welded joint strength was 29.7%, 19.5%, and 61.8%, respectively. The tensile strength of the welded joints treated by the three different processes was improved, among which A–DSUIT exhibited the most obvious effect. Therefore, the process of A–DSUIT could play an important role in improving the tensile properties of welded components.

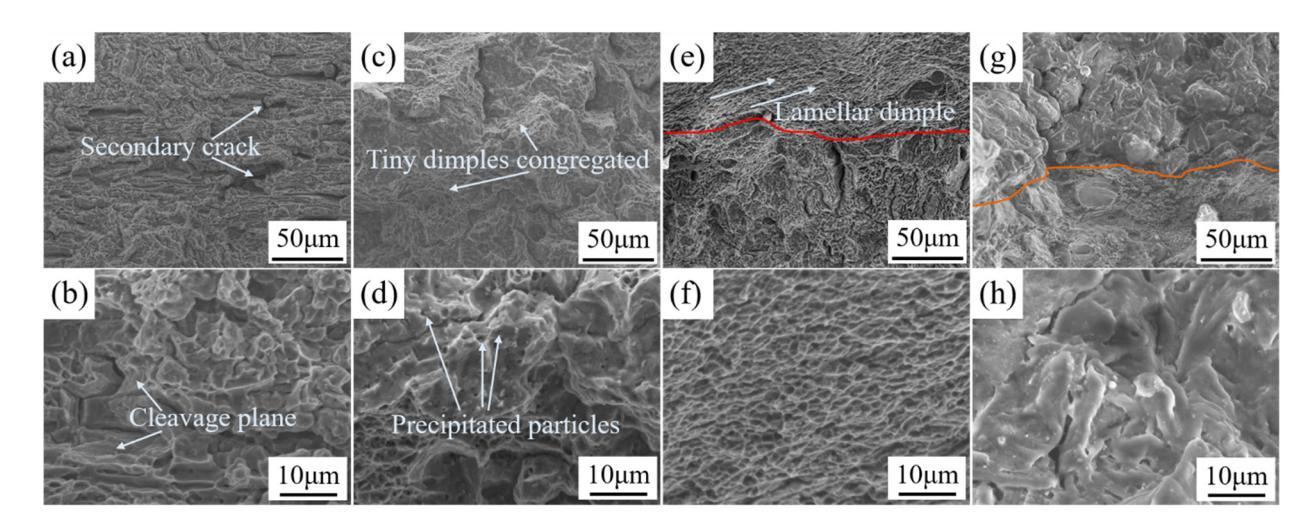
Figure 10. SEM of tensile fractures. (**a**) AW tensile fracture morphology ($500\times$); (**b**) AW tensile fracture morphology ($2000\times$); (**c**) aged tensile fracture morphology ($2000\times$); (**e**) DSUIT tensile fracture morphology ($2000\times$); (**f**) DSUIT tensile fracture morphology ($2000\times$); (**g**) A–DSUIT tensile fracture morphology ($500\times$); and (**h**) A–DSUIT tensile fracture morphology ($2000\times$).

The tensile fractures were observed by SEM, as shown in Figure 10, and researchers found that secondary cracks were generated on the fractured surface of the joints under the different treatment processes. As seen in Figure 10a,b, the tensile fracture morphology of the AW joint was mainly a dimple structure, followed by a partial cleavage plane observed from the fractured surface. As in Figure 10c,d, after the aging treatment, the surfaces fractures mainly comprised cleavage fractures, appearing as a congregation of tiny dimples (due to intensive Guinier Preston zones generated after the aging), and the fractured surface exhibited some precipitated particles (due to the accumulation of impurity elements during the aging process) (Figure 10d). The observation and analysis of the joint fracture morphology DSUIT and A–DSUIT showed that the morphology of the subsurface zone of the welded joints after ultrasonic impact was significantly different (Figure 10e,g). Researchers found that the impact zone of the AW fractured surface presented a regular fine lamellar dimple structure (Figure 10f), while the impact zone of the aged fractured surface presented a large cleavage fracture structure (Figure 10h).

Therefore, the fractures of the 7075 aluminum alloy laser-welded joints in the four states were ductile and brittle mixed fracture forms. The joints before the aging treatment had mainly ductile fractures, and the joints after the aging treatment had mainly brittle fractures. According to the tensile test results in Figure 10, the plastic deformation zone formed by DSUIT on the weld zone surface effectively improved the strength of the welded joints, improved the welding defects on the joint surface, and improved the microstructure and microhardness surface properties. Therefore, A–DSUIT exhibited an obvious effect on the improvement of the comprehensive mechanical properties of the 7075 aluminum alloy-laser welded joints.
