Article Possibilities of Increasing the Durability of Dies Used in the Extrusion Process of Valve Forgings from Chrome-Nickel Steel by Using Alternative Materials from Hot-Work Tool Steels

Abstract: This study refers to an analysis of the dies used in the first operation of producing a valve forging from chromium-nickel steel NC3015. The analyzed process of manufacturing forgings of exhaust valves is realized in the co-extrusion technology, followed by forging in closed dies. This type of technology is difficult to master, mainly due to the increased adhesion of the charge material to the tool substrate as well as the complex conditions of the tools' operations, which are caused by the cyclic thermo-mechanical loads and also the hard tribological conditions. The average durability of tools made from tool steel WLV (1.2365), subjected to thermal treatment and nitriding, equals about 1000 forgings. In order to perform an in-depth analysis, a complex analysis of the presently realized technology was conducted in combination with multi-variant numerical simulations. The obtained results showed numerous cracks on the tools, especially in the cross-section reduction area, as well as sti

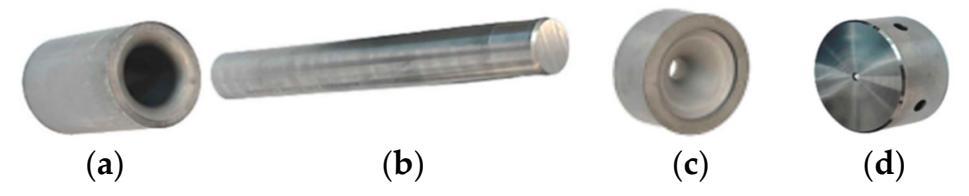
Figure 1. View of (**a**) the die in operation I, (**b**) the punch in operation I, (**c**) the die in operation II, and (**d**) the punch in operation II.

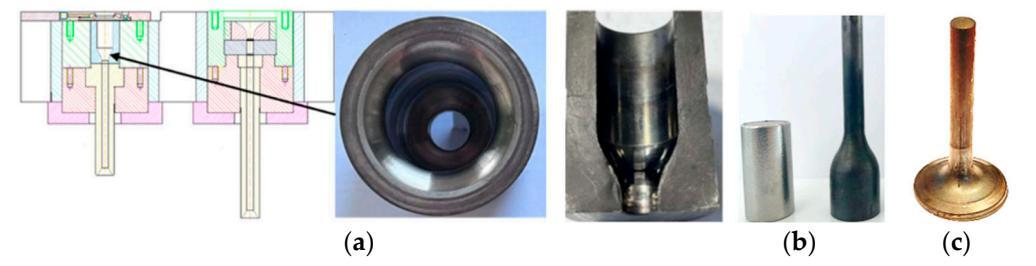
Figure 2. View of (**a**) the lower bench of the press with extrusion and forging, (**b**) the blocking die (top view), the cross-section of the blocking die, (**c**) the initial material, and the forgings after the first and second operation.

The transport of the heated material inside the press takes place by means of a "basket" to the first seat, where the bearing roller is dropped into the blocking die, in which the valve's stem is formed with the use of a hot extrusion process. Next, by means of the manipulator's grippers, the ready slug forging is transported to the die located in the second seat, where the forging process takes place and the disk and profile of the valve are formed, whose shape is close to that of a ready product. In the industrial process, lubrication in the first operation for the analyzed tools (dies) is carried out by a special ring (flat sleeve) mounted in the die housing. The lubricant is a mixture of graphite and oil in the proportions of 1:12 and is fed automatically through a special lubrication device. Due to the lowest durability of all four tools in the set, a detailed analysis was performed on the dies used in operation I, for which the average operation time equals about 1000 forgings. In order to investigation and analysis, the following research techniques/methods were used:

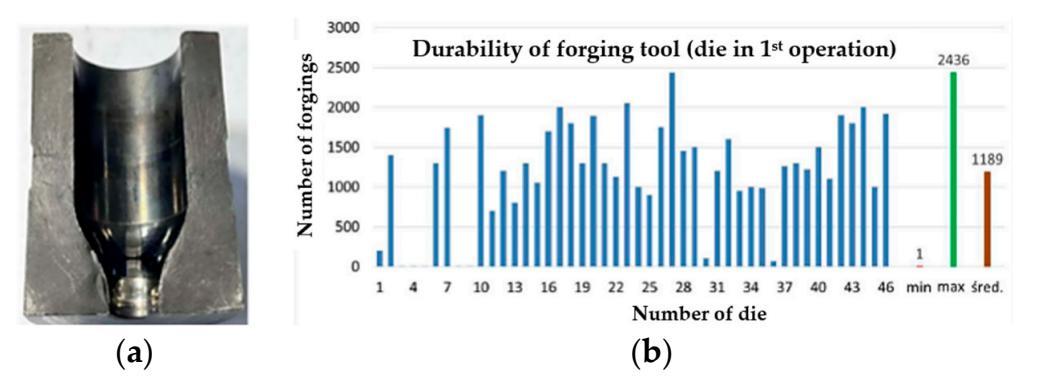
Figure 3. View of (**a**) a cross-section of the die in operation I and (**b**) the diagram of the blocking die's wear [47].

The diagram presents the durability data for 46 tools that were consecutively removed from the production process. The minimal value is at the level of 1 forging, whereas the maximal value equals 2436 items. The average wear is at the level of 1189 forgings. The tools for which the minimal and maximal values were obtained became the subject of analysis and contributed to the selection and evaluation of the method for improving the durability of the blocking die. For the macroscopic analysis, next to the typical tools used for macroscopic tests, the 3D scanning technique was applied, which is at present successfully used for the evaluation of the wear of tools removed from the process, mainly owing to their easy analysis and interpretation of results. In the analysis of the wear of the blocking die, over 50 tools were scanned, and the obtained scan images were compared with the CAD model of the tool. On this basis, a color map of deviations was created, from which it is possible to determine the areas of the biggest wear. Additionally, for a selected group of tools, every 100th forging was collected from the process in order to precisely track the wear mechanisms occurring on the tool during the operation. The studies conducted so far make it possible to divide the analyzed dies in operation I into two groups. The first group includes those that became worn during the process initiation—during the attempt at extrusion of the charge material, the forging was blocked in the tool without the possibility of continuing the production process. The other group of tools is constituted by the blocking dies that have been worn, and the destructive mechanisms occurring on them run according to a specific and repeatable pattern. In order to better present the wear mechanisms of the blocking dies, one tool was selected, which had produced the minimal number of items, i.e., 1, and one die represented the maximal tool wear, i.e., one that had made 2350 items. The tool that had produced one item, i.e., T1, was removed from the process as the forging became stuck in the blocking die. In the presented scan of the tool, we can clearly see the sticking of the material (probably of the forging) up to the thickness of 0.04 mm (Figure 4a). In the same scan image of the slug forging, we can clearly notice material loss up to a thickness of even 0.95 mm on the formed stem, where the whole stem surface has a wavy texture. On the tool's cylindrical section, no wear traces were recorded.

The technology of forging in closed dies applied in the analyzed process, despite its obvious advantages referring to the quality and performance properties of the forging, is rarely used because it is a process that is very difficult to master and that requires the preparation of the charge material mass with the precision of ± 1 –2% and maintaining a constant charge heating temperature as well as a proper design of the geometry of the die working impressions, ensuring their proper filling. The biggest problems of the analyzed technology of forging in closed dies are, however, the very high pressures occurring in the forging process, which cause problems with the low durability of the die (in some cases, even up to a few tens of forgings and in extreme cases, up to one forging) and the creation of faulty products resulting from the difficulties in the forming of steel with a high nickel content as well as the selection of the optimal process parameters. One of the biggest difficulties is the increased adhesion of the charge material made of nickel-chromium steel (nickel content up to 25–35%, chromium content of about 15–20%) to the substrate of the tool made of tool steel WLV during the process of forward extrusion. Another important problem is the lack of dissolution of the carbides in the charge material in the case of improper charge heating (for this steel, the temperature should be within the scope of 1040–1080 °C; a temperature that is too low causes a lack of dissolution of the hard carbide fractions and a temperature that is too high causes burning of the material). The high pressures and temperatures as well as the long friction path cause blocking of the extruded material in operation I in the eye of the die. Based on the data collected from the real production process, the average minimal and maximal durability for the blocking die was determined (Figure 3).

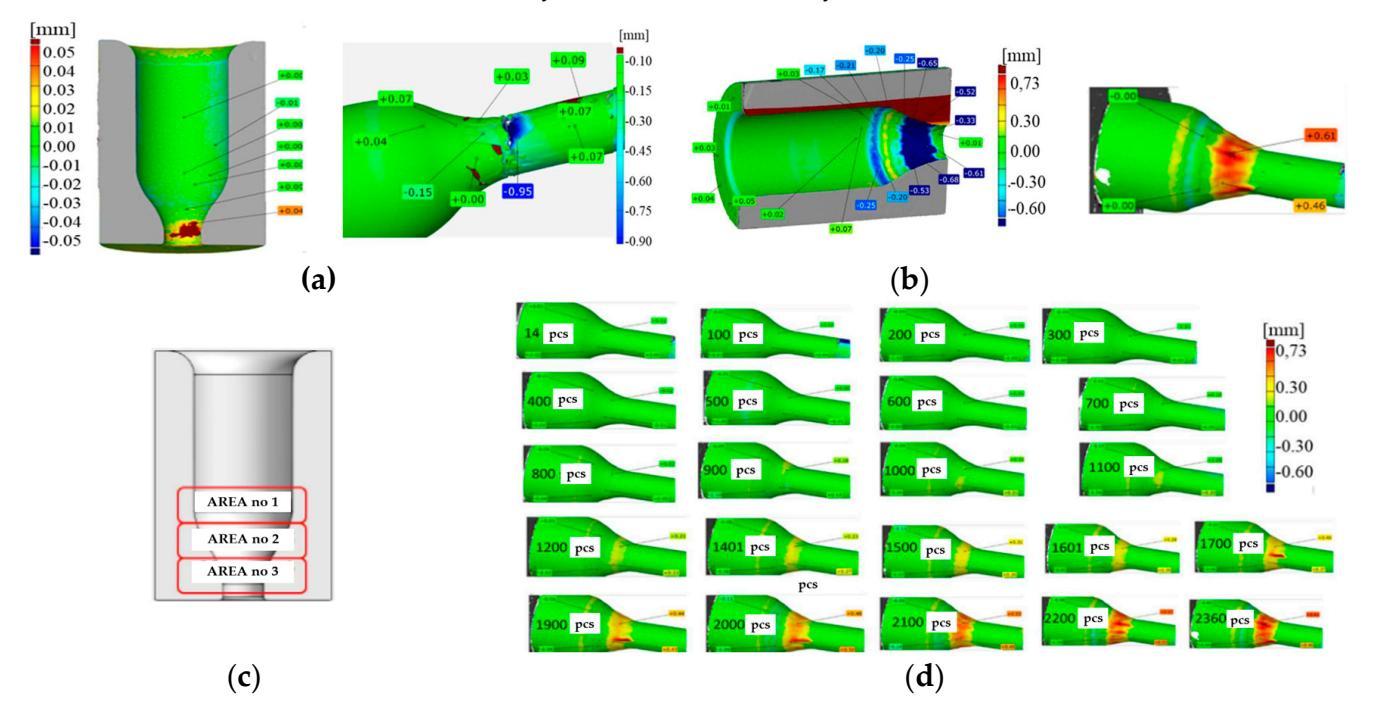
Figure 4. View of (**a**) the result of the comparison of the 3D scan of the T1 tool's half with the CAD model, (**b**) the scan image of the last forging from the T2350 tool, (**c**) the tool with marked characteristic zones, and (**d**) 3D scans of periodically sampled forgings for subsequent stages of tool wear [47].

The tool representing the second group of blocking dies is T2350, which made 2350 items (Figure 4b). While analyzing the particular sections of the tool, we can notice that, in the cylindrical part, the material loss is the smallest. Next, at the bottom of the cylindrical part, we can see a ring with a negative deformation value up to -0.25 mm. Shifting downwards, there is a ring with a positive deformation reaching 0.3 mm. The biggest material loss is in the section forming the stem, which even reaches -0.68 mm, on the measured half of the tool. The pattern of the wear occurring on blocking die T2350 was used to introduce a division into three zones, characterized by different wear mechanisms—Figure 4c shows the assumed division. In zone no. 1, plastic deformation and thermo-mechanical wear are dominant. Zone no. 2 represents material growth (resulting from the sticking of the forging material) as well as thermo-mechanical fatigue. Zone no. 3 is characterized by abrasive wear and plastic deformation. Figure 4d presents the results of the so-called reverse 3D scanning, consisting of scanning every 100th forging, consecutively collected from the production process. Such a compilation enables an analysis of the history of the tool's operation based on the change in the forgings' geometry. On the final forging, a big material growth occurs on the stem (over 0.7 mm), which, in this case, decides to remove the tool from further operation.

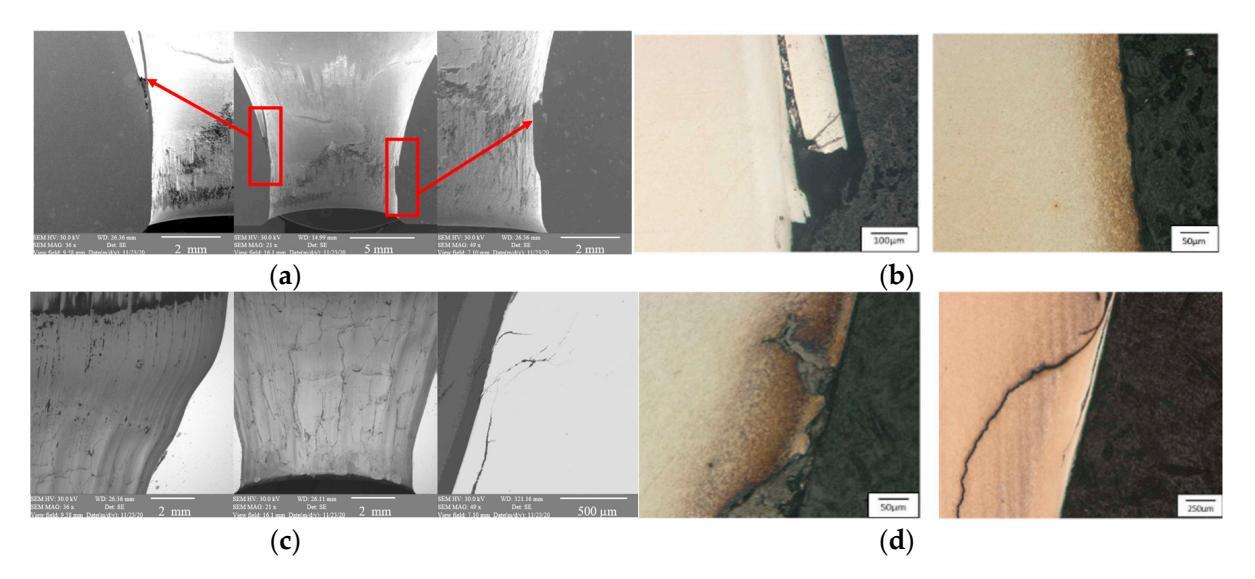
Figure 5. View of (**a**) the microstructure of the blocking die with the Nireva material stuck in the stem-forming area (zone no. 3), (**b**) the microstructure of the blocking die in the upper part of the tool (zone no. 1), (**c**) the SEM image of the selected working areas of T235, (**d**) the microstructure of the blocking die using light microscopy and in its etched state.

The wear analysis performed on a light microscope confirmed numerous cracks in the tool material at the surface reaching as much as 0.8 mm into the blocking die T2350 (Figure 5c,d). The biggest cracks are in the area where the stem is formed (zone 3)—in some areas in this zone, the phenomenon of shearing of the formed material parallel to the direction of its flow was also observed during forging. This is also an effect of the strong adhesion of the forging material to the die surface. Additionally, there is no visible nitrided layer. Probably, after its removal, the tool's degradation process proceeded very rapidly. In zone 2, there are also visible cracks, but they are much shallower, and their insides probably contain oxides, which were formed as a result of the presence of high temperatures, as well as deformations on the tool surface.

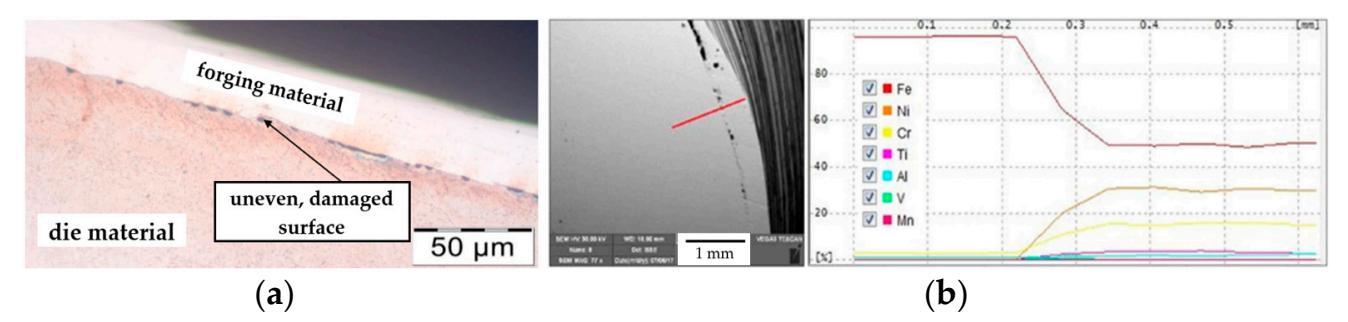
Additionally, an evaluation of the microstructure was made by means of a light microscope (Figure 6a), which revealed the thick sticking of the Nireva material in the stem-forming area (zone no. 3 according to Figure 4). During the forging process, the phenomenon of the shearing of the formed material parallel to the direction of its flow can be observed. This is a result of the predominance of the material that will adhere to the die surface over the internal cohesion of the formed material. The microstructure at the top of the tool, in area no. 1, points to the presence of a thin nitrided layer below 100 μ m. There is no recorded wear in the remaining part of the tool. Next, on blocking die T1, an EDS analysis was completed in order to confirm the presence of the forging material on the tool (Figure 6b). The presence of Ni at the level of 30%, 15% Cr, and 2% Ti unequivocally points to the Nireva material.

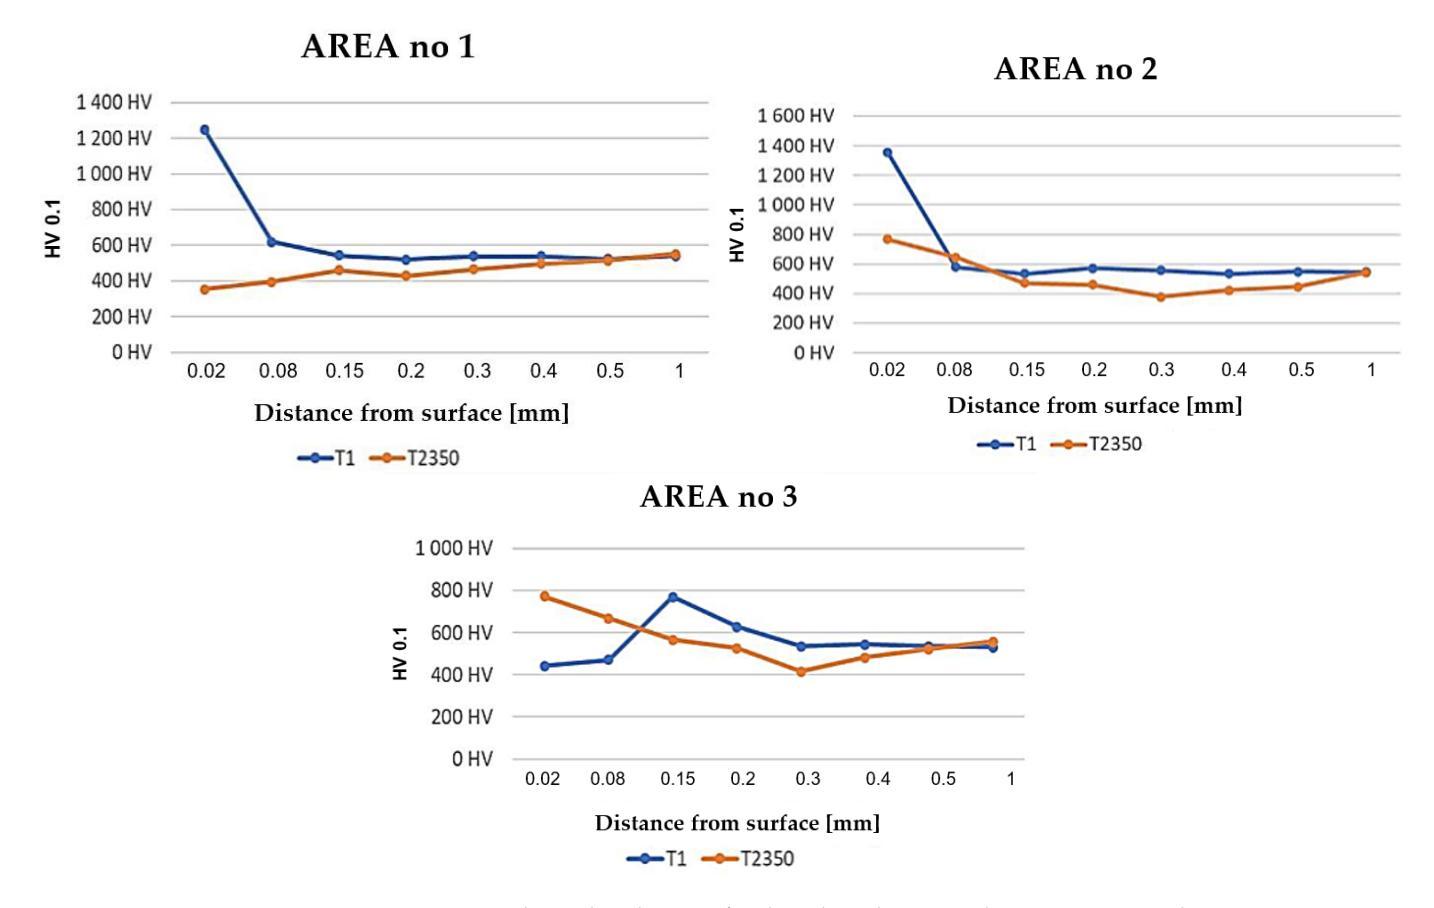
For tools T1 and T2350, the hardness distributions were made by the Vickers method with a load of 0.1 in the indicated areas on the sample (Figure 7). The blue diagram presents the results for blocking die T1, whereas the orange one is made for tool T2350.

For zone 1 and tool T1, we can determine the thickness of the nitrided layer at the level of up to 0.1 mm. In turn, in the case of tool T2350, the nitrided layer was probably removed during operation. Additionally, the substrate material underwent tempering to a hardness below 400 HV0.1. For zone 2, the hardness of tool T1 is over 1300 HV0.1, and in the consecutive measurement points, the hardness is at the level of that of the native material, which is about 550 HV0.1. In the case of die T2350, the nitrided layer was probably sheared, as the first measurement point, falling to the depth of 0.02 mm from the tool surface, has the value of 800 HV0.1. A similar situation is presented in the case of zone 3 for this tool. In zone 3, for tool T1, the first two hardness values are 440 HV0.1. This is the hardness of the forging material, which became stuck in the area where the stem was formed.

Figure 7. Hardness distributions for the selected areas in the representative dies.

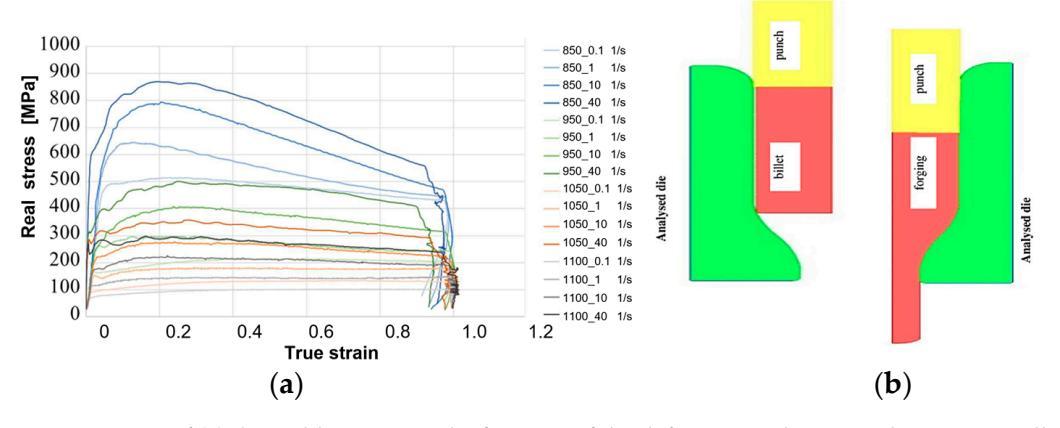
The yield stresses in the function of deformation were determined experimentally for the Nireva material. By means of a non-linear estimation, owing to the specific curves on the Gleeble 3800 device, the Spittel equation was determined (1), which assumes the following form [48]:

Figure 8. View of (**a**) the yield stresses in the function of the deformation determined experimentally for the Nireva material and (**b**) the FE model before and after one forging operation.

In order to perform a more thorough analysis and determine the parameters and physical quantities difficult to determine experimentally, numerical modeling was conducted. By means of a program for numeral simulations, Forge NxT 3.0, and based on the measurements and tests performed under the conditions of the real production process, a model was constructed to be used in the analysis of tool wear. The forging material from which motor truck engine valves are made is Nireva, and, since the material database of the Forge program does not contain this steel, a very similar grade was chosen, X5NiCrAlTi31-20/1.4958, for which the material data were assumed. The boundary conditions necessary for the numerical simulations include the strength properties, which, for the Nireva steel, were experimentally determined in a universal simulator of metallurgical processes, i.e., the Gleeble 3800 device (DSI Europe GmbH, Tatschenweg 1, D-74078 Heilbronn, Germany). In the deformation scope of 0-1, for the deformation rates of 0,1; 1; 10; and 40 [1/s] and at the four temperatures of 850; 950; 1050; and 1100 [°C], the yield stress dependence curves were determined in the function of the deformation of the Nireva material (Figure 8a). For the analysis of the first operation, an axisymmetrical model was made, which was used for the numerical simulations (Figure 8b).

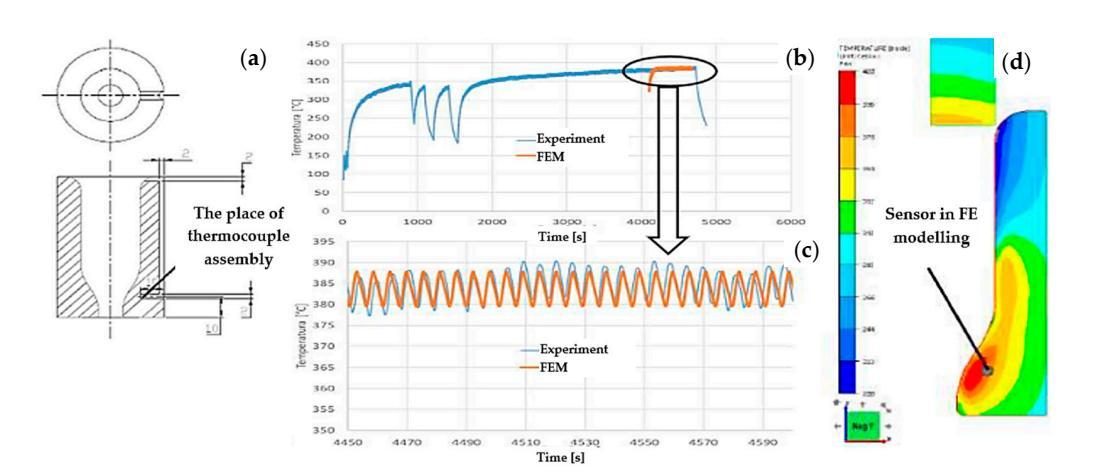
Figure 9. View of (**a**) the draft of the blocking die with a drilled opening for the thermocouple, (**b**) the real measurements of the temperature on the die, (**c**) the temperature distribution after 70 cycles with the marked area of the temperature measurement, and (**d**) the FEM results of the temperature field distribution.

The Spittel equation determined the material data describing the mechanical properties of Nireva in the Forge program under the conditions of hot forging. The bodies deformable in the simulation, that is, those that enable the determination of stresses on the tool as a result of contact, e.g., with the forging, are the forging, the punch, the die, and the casing. In turn, the slide, the base, and the clamping ring are non-deformable bodies. Next, the heat exchange coefficients between the forging and the punch were assumed to be $8 \text{ kW/m}^2 \cdot \text{K}$, between the forging and the die 2 kW/m²·K, and between the tools 1.5 kW/m^2 ·K. As the tool material, steel X0CrMoV5-1/1.2344 from the Forge database was selected. The initial temperature of the forging was 1050 °C. For the die, the determined temperature was at the level of 380–390 °C, and these data were compared with the measurements made under the real process conditions. The entire deformation process took 0.1 s. The program specified a complete displacement of the punch, dividing the entire distance of several millimeters into a single computational step of 0.5 mm. The program divides the time steps in such a way as to count the entire deformation process in the stages of the punch movement every 0.5 mm. The simulation was created as axisymmetric with trio elements. The size of the elements is 1 mm, but in the zone of intense deformation, their size is 0.6 mm. The initial number of elements for the sample (input material) was 22,684 and changed during the calculations due to deformation and also due to the reconstruction of the mesh. Additionally, in order to obtain more accurate calculations, automatic remeshing for smaller elements was adopted, which was activated at an element deformation of 0.2. A blocking die was constructed (Figure 9a) with a drilled opening in the lower part of the tool for the thermocouple. Next, the production process was carried out with the thermocouple introduced into the tool, and the temperature results in the die were recorded (Figure 9b), which are analogical to those in the numerical simulation (Figure 9c). During the calculation of individual forging cycles (temperature changes), a more accurate simulation of one cycle is first calculated, and then the remaining cycles are calculated on its basis until the process temperature is established. This type of simulation is only for temperature calculations.

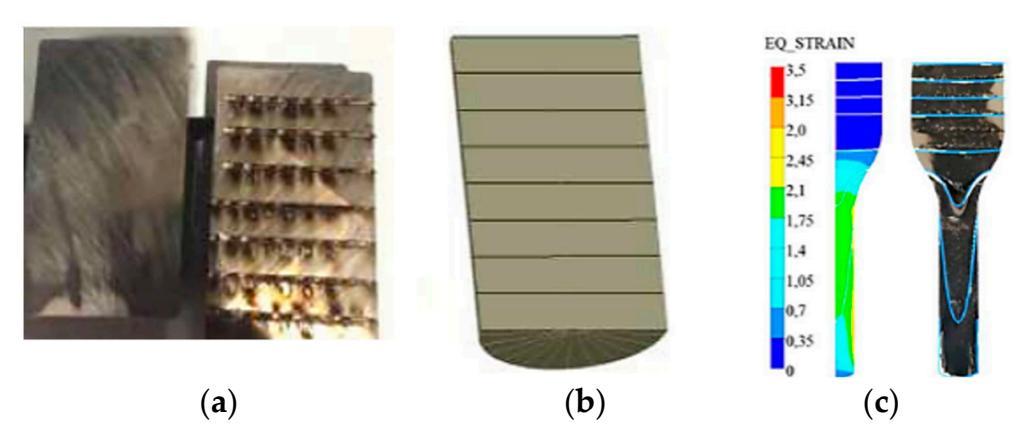
In order to select the proper friction coefficient in the numerical simulation program, a roller/preform was prepared and cut in half. On one half, horizontal lines at even distances of 5 mm were grooved by means of a laser (Figure 10a).

Figure 10. View of (**a**) the cut preform and real sample, (**b**) the sample prepared in the simulation program, and (**c**) FEM—the plastic deformation distribution with the plotted flow lines on the forging, the flow lines from the simulation (blue) plotted on the photograph of half of the forging with the drilled grooves after 1 deformation operation.

Both halves were welded together and then introduced into the production processes. After the extrusion of the stem in the first seat, clear flow lines were formed on the slug form, which were compiled with the numerical model. Based on the obtained results, a numerical model with analogical flow lines was prepared (Figure 10b,c), for which the determined friction coefficient was at the level of 0.3. For the preparation of the model of tools used in the simulation program, ready geometrical tool models were used. The data of the Maxipres 700 E press were assumed as follows: a crank length of L = 576 mm and double cranks of R = 127 mm, which were considered in the numerical modeling. By means of the numerical simulation program, the reduced stresses as well as the normal stresses on the die surface were determined (Figure 11). In the case of reduced stresses, the highest value is 1400 MPa and falls in the area that begins the forming of the stem. For normal stresses, the highest value equals 1200 MPa and also falls in the area where the narrowing of the tool begins. For both distributions, the highest stresses occur in the same area. We can presume that this area can be dominated by two destructive mechanisms, i.e., thermo-mechanical fatigue and plastic deformation. In order to confirm this, another model was constructed, where the die material behaves like an elastic-plastic body. Additionally, the contact time of the forging after the first deformation operation was determined (Figure 11).

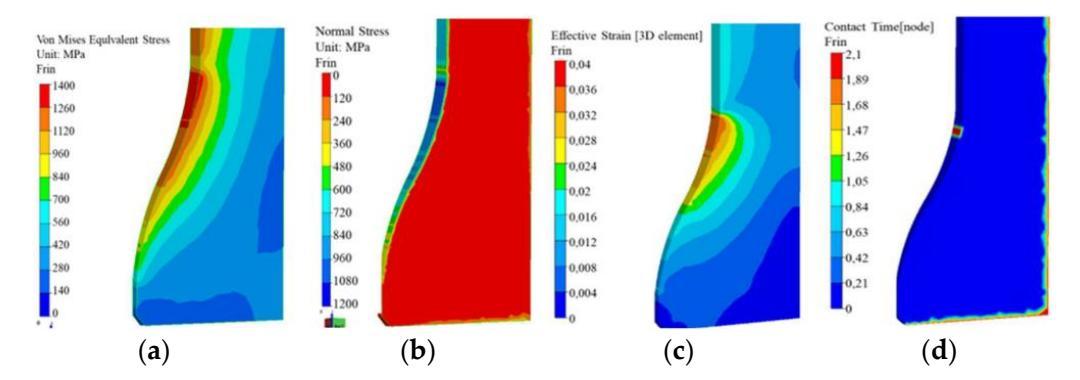
Figure 11. Distribution of the stresses: (**a**) reduced, (**b**) normal on the blocking die, (**c**) the plastic deformations on the die, (**d**) the contact time after one operation of forging a valve.

For both distributions—of the plastic deformation and the forging's contact with the tool—after the first forging operation, we can confirm that the area where the highest values were obtained overlaps with the maximal values of the reduced stresses and normal stresses. During the analysis of the wear mechanisms on the tool removed from the production process, we can expect that the area dominated by wear mechanisms, such as thermomechanical fatigue and plastic deformation, is the area in which the forming of the valve stem begins. The next distribution determined in the numerical simulation program is the distribution of the abrasive wear according to the Archard model as well as the friction path (Figure 12).

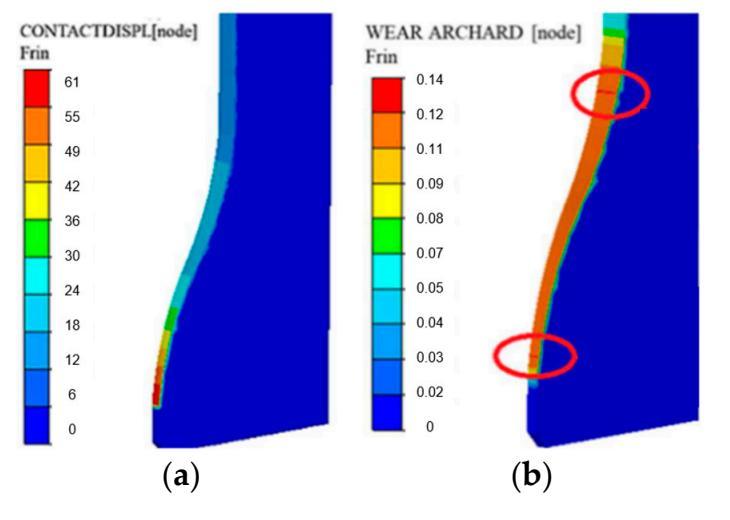
Figure 12. View of (**a**) the friction path and (**b**) the abrasive wear distribution according to the Archard model (the highest values are marked with red circles).

We can see that the high friction path from the FE simulation falls in the area of the biggest narrowing on the tool, where the stem is already shaped. The friction path in this area equals 60 mm and the abrasive wear is 0.15. The results presented above should be treated as the assumed initial state of the process (what should be obtained if the assumed conditions were ensured). Due to the low repeatability and stability of the industrial process, numerical models were constructed, which can show what can happen if the assumed conditions are different. To that end, five different variants were assumed, which, in the authors' opinion, can significantly contribute to premature wear of the forging dies. The following variants were assumed: I. Nominal process; II. Increased friction from f = 0.4 to f = 0.6; III. Lowered charge temperature up to 950 °C; IV. Increased charge temperature up to 1150 °C; V. Increased tool temperature up to 300 °C. Figure 13 shows the global results of the numerical modeling in the above-listed variants.

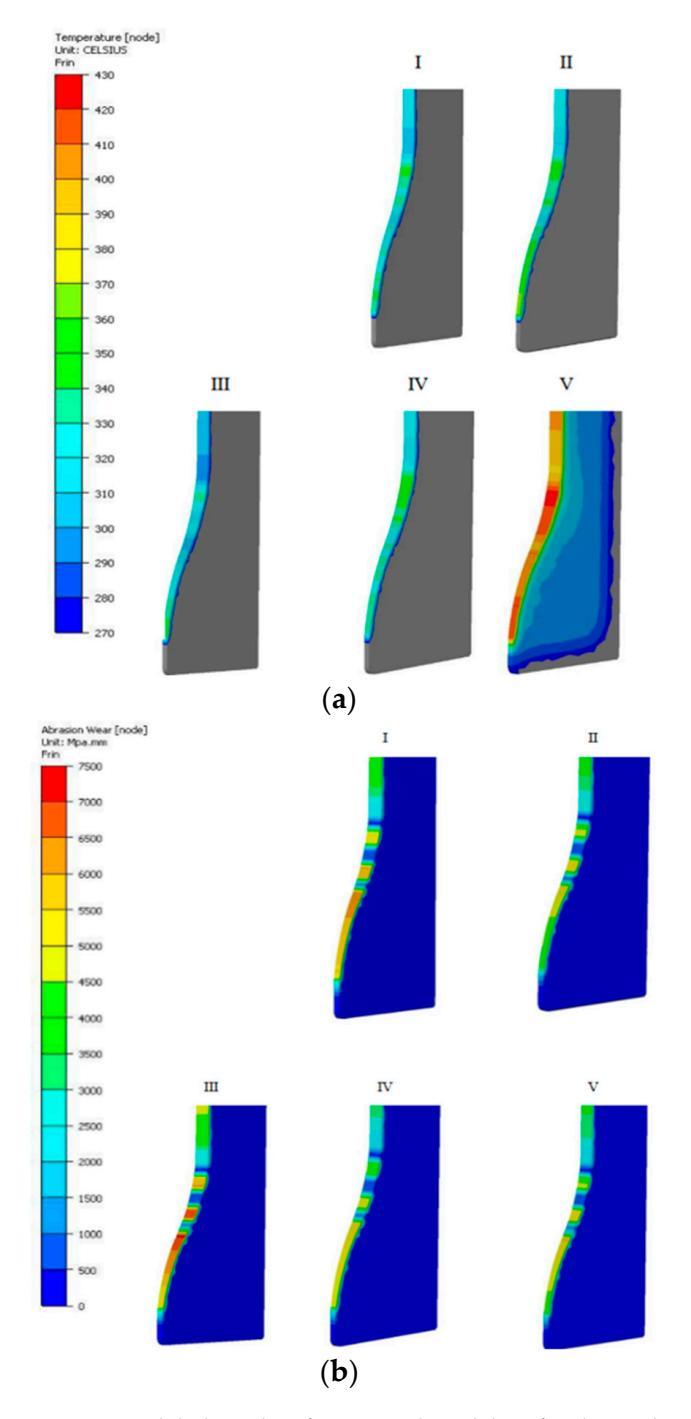
Figure 13. Global results of numerical modeling for the 5 selected variants: (**a**) the temperature field distributions and (**b**) the wear distributions according to the Archard model.

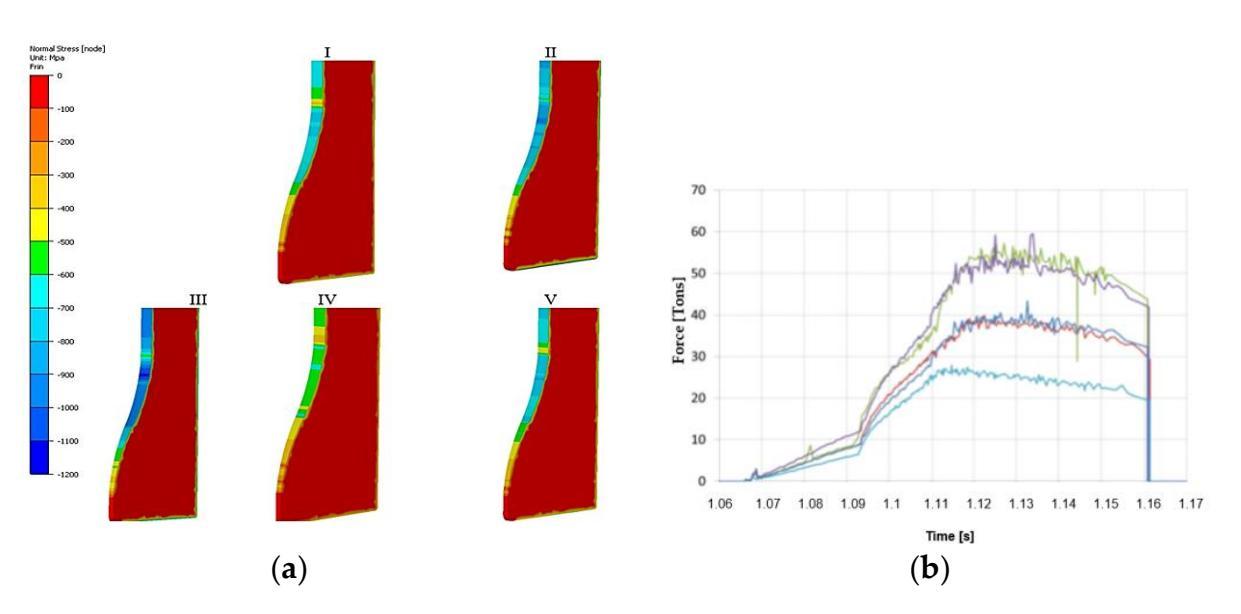
Among the variants selected for further analysis, i.e., the normal stresses, the most advantageous seems to be the distribution for the nominal variant (at the level of 650 MPa), whereas high pressures occur for variant III, that is, for the temperature of the charge lowered to 950 °C, which, with a raised yield point for such a material, can really cause increased stresses (about 950 MPa) as well as a hindered material flow (Figure 14a). In turn, the tool temperature is, of course, most affected by the increase in the tool's initial temperature from 200 °C to 300 °C. With this said, the "net" difference with respect to the initial value for variant V equals about 100 °C. In turn, among the remaining variants, for which the initial temperature was 200 °C, the biggest "net" difference is for variant II, where the temperature in the working area increased by over 150 °C, that is, by about 350 °C.

Figure 14. The view of (**a**) the normal stress distributions and (**b**) the forging force courses as a function of time for the particular variants.

Increasing the input material temperature by 100 $^{\circ}$ C also raised the temperature of the tool by about 120 $^{\circ}$ C. Probably it had a positive effect in that it lowered the forging forces in this variant (Figure 14b).

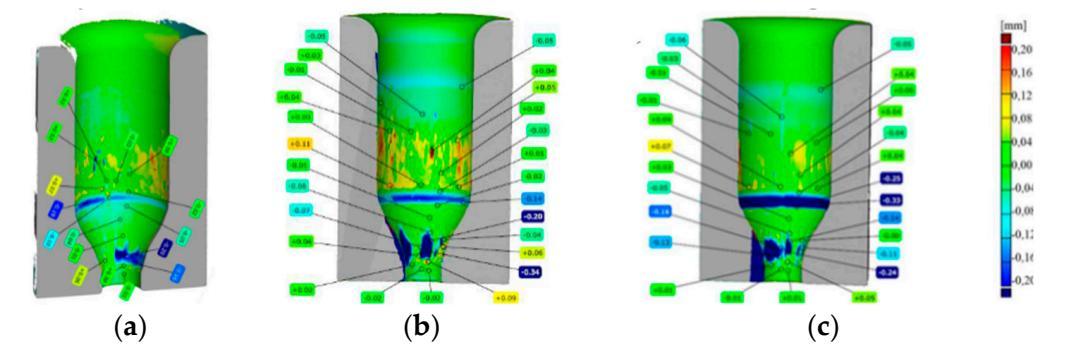
Dies made of the three steel grades, after the standard thermal treatment., i.e., hardening and two-fold tempering as well as nitriding to a diffusion layer thickness of 0.15 mm, were introduced into the production process. The tools before the process were heated to 200 °C in a chamber furnace and then mounted in the seat of the press. The charge material had a temperature of about 1050 °C, and the blocking dies were lubricated and cooled with a lubricant based on graphite. Each test was performed on ten tools. A detailed analysis was conducted on the wear mechanisms examined on a representative tool from the given group. Figure 15 shows scan images of the blocking dies after the operation, where each of the analyzed tools had worked over about 2000 items, which is near the average value.

Figure 15. A comparison of the scans with maps of geometrical deviations for the dies made of (a) QRO90 Supreme, (b) Unimax, and (c) W360 [47].

The average wear values for the applied tools are similar, where slightly better results were obtained for QRO90 Supreme. This can be caused by a better adjustment of the chemical composition to the conditions of the process. For each area on the tool, the material loss as well as the growth looked similar, where, in the cylindrical part, the biggest growth was recorded on Unimax, reaching over 0.11 mm. Next, a clear blue ring, proving a material loss in the analyzed area, the highest value (-0.33 mm) was obtained on the blocking die made of W360. This ring is formed as a result of the gravitational fall of the charge material into the tool. The last analyzed area of stem formation has clear grooves and furrows, where the biggest material loss falls on the tool made of Unimax and reaches -0.34 mm. Table 2 presents the global results referring to the performed tests.

The applied QRO90 Supreme material, with a nitrided layer thickness of 0.2 mm, is characterized by better performance properties at elevated temperatures, causing better durability for the tools made from this material. The technological tests performed under industrial conditions demonstrated that the average die durability after the introduction of this durability-improving method (QRO90 Supreme) increased by 1000 items and equals 2200 forgings, compared to the data presented in the diagram in Figure 3b. The maximal value possible to obtain for the given blocking die also increased and equaled 2900 items. On this basis, it was decided that the best solution would be the use of the QRO90 Supreme material for the blocking dies.

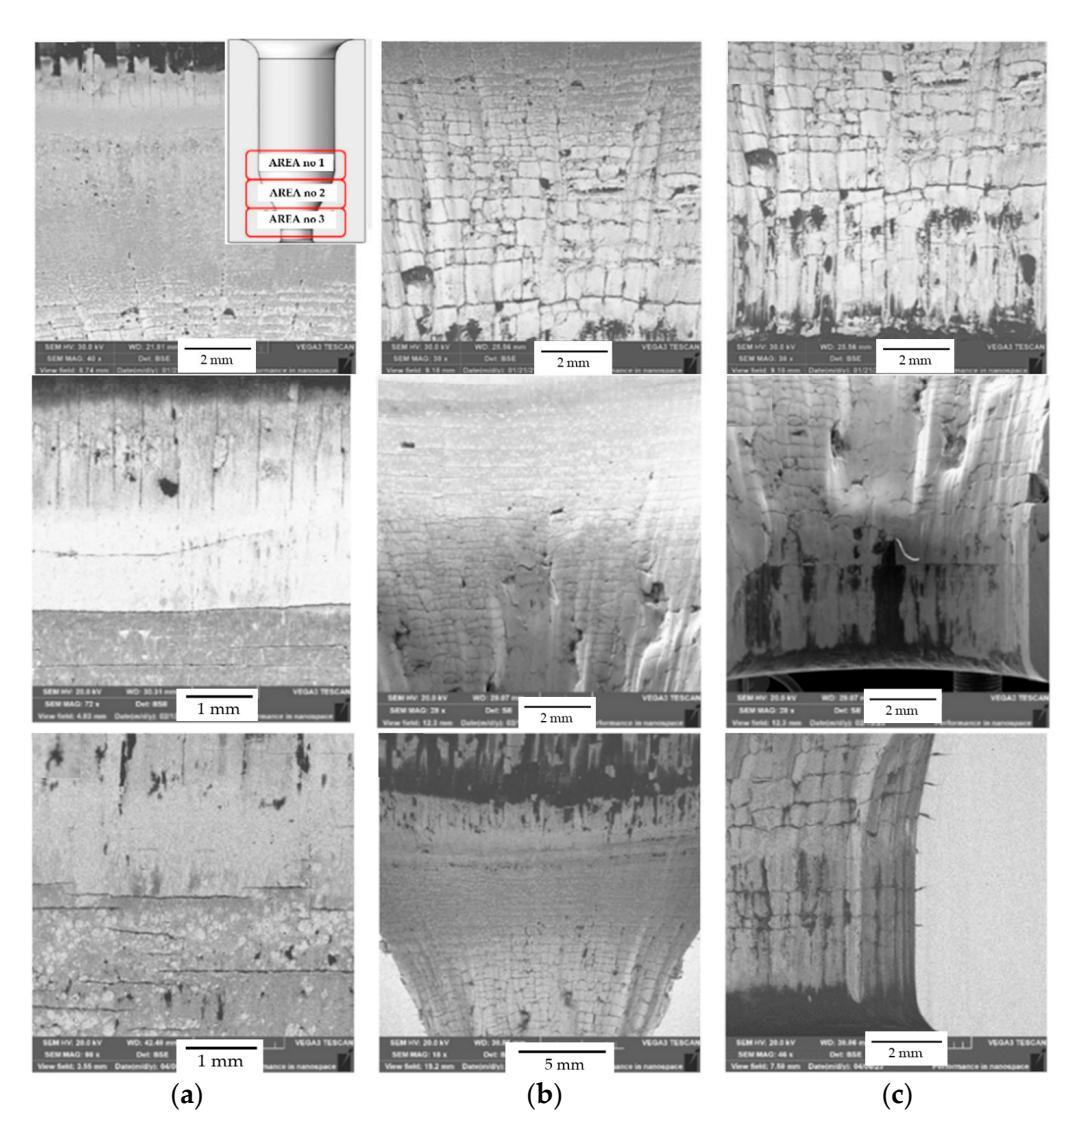
The selected tools underwent an analysis with the use of a scanning electron microscope in order to evaluate the state of the surface. The analysis showed similar wear mechanisms for all the introduced tools. Figure 16 illustrates the consecutive blocking dies made of QRO90 Supreme, Unimax, and W360. In turn, the successive images (a), (b), and (c) are areas 1, 2, and 3, as shown in Figure 4.

Figure 16. The results of the SEM images in the sub-surface area of a cross-section made on the blocking die after the operation for the successively selected materials: QRO90 Supreme; Unimax; W360: (**a**) area 1, (**b**) area 2, (**c**) area 3, SEM [47].

Area 1 is mainly characterized by radial cracks running around the tool. Area 2 is dominated by a network of thermo-mechanical cracks with numerous spallings of the tool material. The visible dark spots are the remains of the graphite after the carried-out process. In the narrowing, i.e., area 3, there are visible traces of abrasive wear as well as the dark stickons of the lubricant and minor cracks. Additionally, for the tool made of Unimax, in areas 2 and 3, we can observe plastic deformations of the tool material. Tests with the use of a light microscope point to numerous and diversified wear mechanisms, especially in the tool's surface layer. Starting from area 1, according to Figure 4, that is, the lower cylindrical part of the tool, there are visible microstructural changes characterized by intensive etching—this is connected with the presence of a nitrided layer (Figures 17a, 18a and 19a). The lightcolored area at the surface is the decarburization of the material. The numerous spallings and cracks in area 1 lead to the mechanical removal of the diffusive layer. The observed cracks are localized only in the area of the nitrided layer. Another area subjected to analysis, that is, no. 2, is the area on the tool in which there is a change in the diameter and that is, for all the applied hot operation steels, characterized by relatively uniformly distributed cracks, typical of thermal fatigue, parallel to the working surfaces (Figures 17b, 18b and 19b).

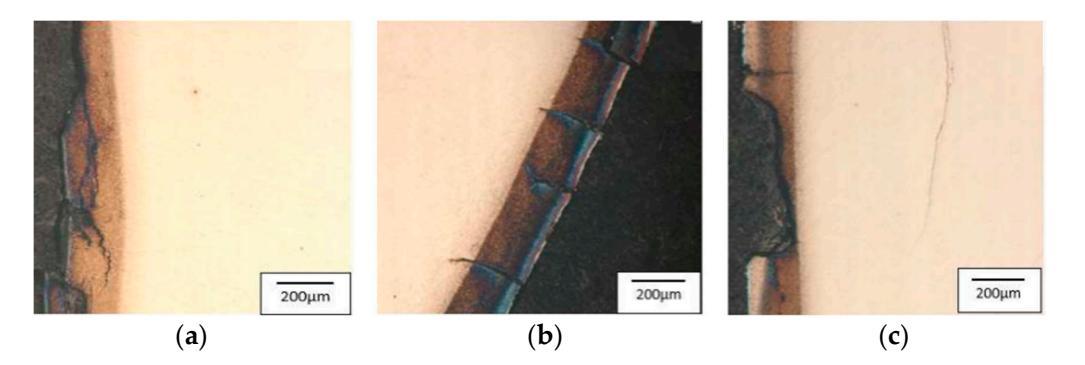
Figure 17. Photographs of the blocking die surface after the operation for QRO90: (**a**) area 1, (**b**) area 2, (**c**) area 3. Light microscopy, etched state.

In the cracks, there are products of oxidation and the remains of the lubricant. The cracks have a transcrystalline character. There is also an area of intensive etching, analogical to area 1. Additionally, for the blocking die made of Unimax for area 2 (Figure 18b), a narrow band parallel to the working surface was observed, which was etched more intensively. This is probably caused by the presence of tensile and shear stresses. Area 3, the area with the most intensive wear, underwent the strongest degradation, with numerous cracks and spallings (Figures 17c, 18c and 19c). There is a visible decarburization at the surface, especially for Unimax and W360. Stick-ons of the forging material were also observed.

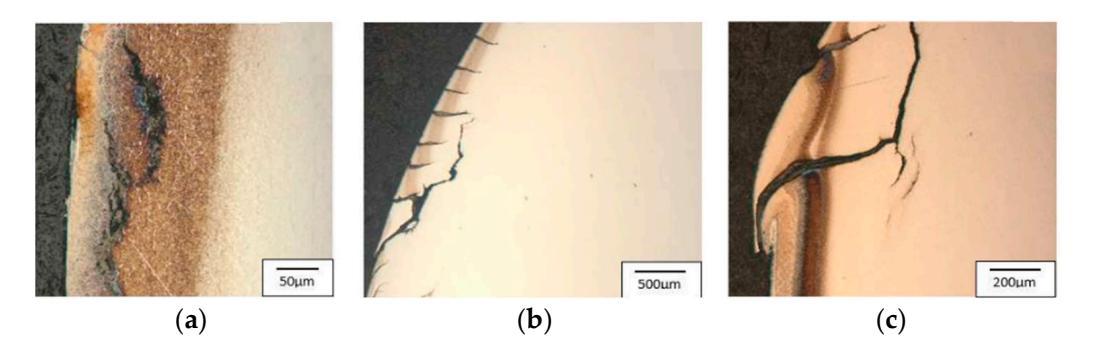
Figure 18. Photographs of the blocking die surface after the operation for Unimax: (**a**) area 1, (**b**) area 2, (**c**) area 3. Light microscopy, etched state.

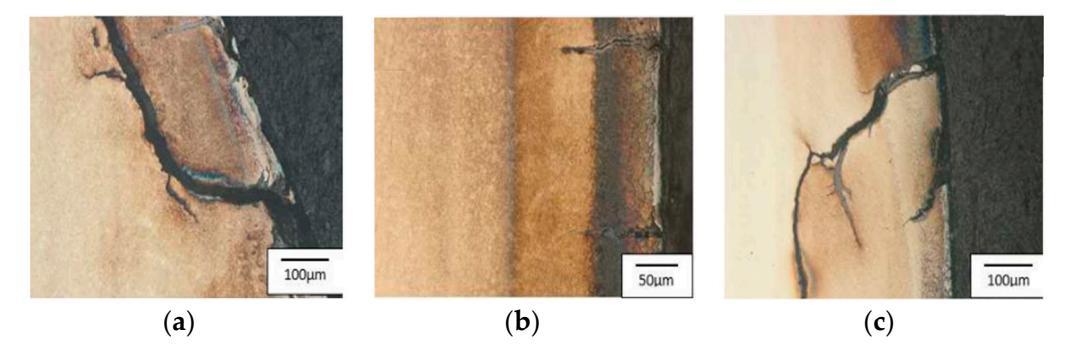
Figure 19. Photographs of the blocking die surface after the operation for W360: (**a**) area 1, (**b**) area 2, (**c**) area 3. Light microscopy, etched state [47].

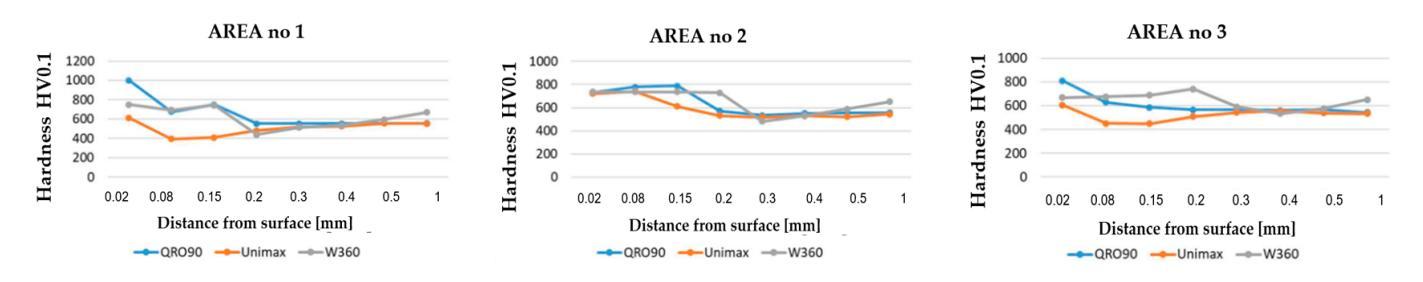
Microhardness tests were conducted for the selected areas, i.e., 1, 2, and, 3, as shown in Figure 4, for the blocking dies made from QRO90 Supreme, Unimax, and W360 and coated with a nitrided layer to the diffusive layer thickness of 0.2 mm (Figure 20).

Figure 20. The hardness distribution of the blocking dies made from the three different materials for areas 1, 2, and 3.

The biggest differences can be seen in area 1. The QRO90 Supreme material, in the first point, still has the hardness of the nitrided layer. For the Unimax material, a clear drop of hardness was observed to have a value lower than the core material, which is caused by the disintegration of the nitrided layer as well as material decarburization. In turn, the lowered hardness of W360 in area 1 is caused by material tempering. For area 2, a similar trend was observed for each applied material, with a local drop in hardness of the nitrided layer caused by the cyclic heating of the tool material. The course of hardness in area 3 for QRO90 and Unimax is similar in character, its drop being probably caused by material decarburization, whereas the hardness of W360 in area 3 has a character that is analogical to that in areas 1 and 2. After the analysis of the results for the three applied materials, QRO90 Supreme was selected, with a nitrided layer thickness of 0.2 mm, as it has the highest average durability, and the number of extruded forgings in the die has the smallest scatter.
