# **Optical Sensing of the Fatigue Damage State of CFRP under Realistic Aeronautical Load Sequences**

**Abstract:** We present an optical sensing methodology to estimate the fatigue damage state of structures made of carbon fiber reinforced polymer (CFRP), by measuring variations on the surface roughness. Variable amplitude loads (VAL), which represent realistic loads during aeronautical missions of fighter aircraft (FALSTAFF) have been applied to coupons until failure. Stiffness degradation and surface roughness variations have been measured during the life of the coupons obtaining a Pearson correlation of 0.75 between both variables. The data were compared with a previous study for Constant Amplitude Load (CAL) obtaining similar results. Conclusions suggest that the surface roughness measured in strategic zones is a useful technique for structural health monitoring of CFRP structures, and that it is independent of the type of load applied. Surface roughness can be measured in the field by optical techniques such as speckle, confocal perfilometers and interferometry, among others.

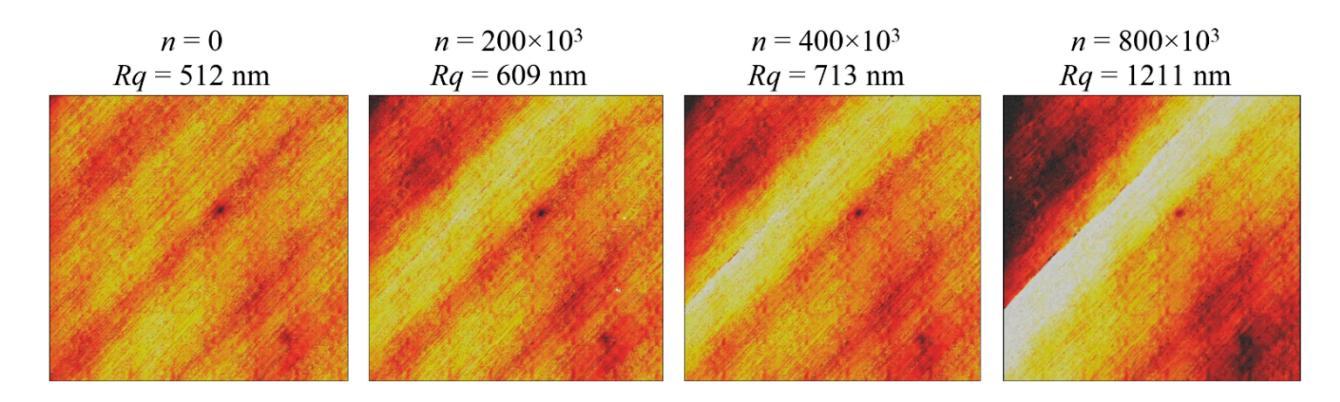
Figure 1. Evolution of the surface topography due to fatigue damage of a CFRP specimen.

Previous studies [17,18] have shown that the magnitude of the surface roughness increases due to changes in the topography that have been induced by the damage. The changes of the surface start at the beginning of the life of the structure with matrix micro-cracks. With increasing cycles, the cracks become bigger and produce local delaminations. At the end of the life the local delaminations become deeper. Figure 1 shows the evolution of the surface topography for a particular and representative case of a CFRP specimen after different numbers of fatigue cycles. From previous studies we have established that the roughness parameter which has a better correlation with the accumulated damage of the material is the root mean square (standard deviation), commonly known as Rq, which is determined by the next equation, where  $z_i$  is the value of the height of the measured point *i* respect to the mean plane of the surface, and *P* is the total number of measured points (pixels) per surface [19,20]:

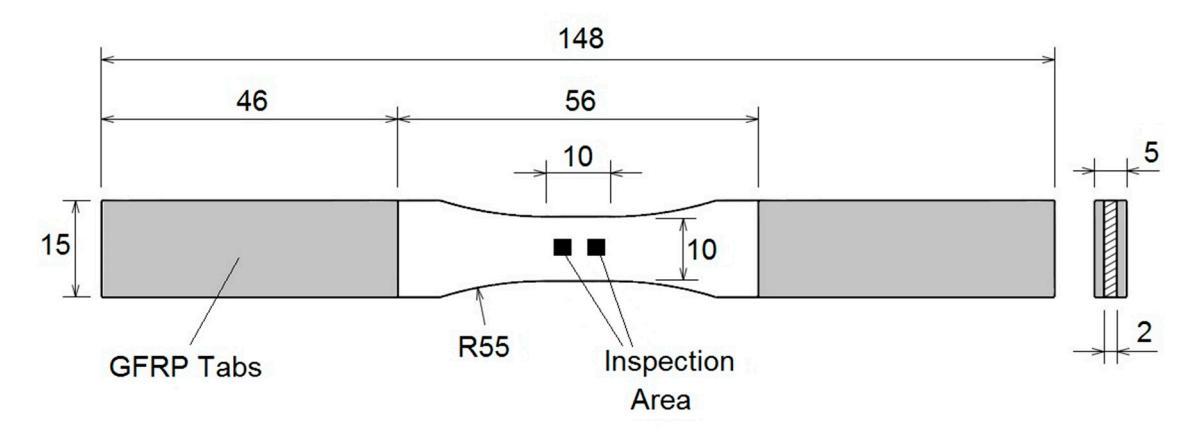
Nine coupons with "dog bone" geometry have been manufactured from the panel (see Figure 2). This geometry is selected to guarantee that the damage of the coupon is produced in a controlled zone, (gage zone) which corresponds to a volume of  $10 \times 10 \times 2$  mm<sup>3</sup>. Tabs made of GFRP were bonded on the specimen ends in order to avoid spurious stresses due to the gripping force of the test machine clamps.

**Figure 2.** "Dog bone" geometry of the CFRP coupons used for tensile variable amplitude tests. Inspection area of one of the faces of the coupon.

Measuring the surface roughness in several points is recommended in order to obtain an adequate statistic of the damage. In the present work, the surface roughness of each coupon was measured in four points in the gage zone, two points in the front face and two points in the back face (see Figure 2). Each test point has an area of  $1.55 \times 1.49 \text{ mm}^2$ , which has been established in order to evaluate a similar area and scale than the used in laser speckle techniques. The topography of the surface at each area of evaluation is obtained by confocal microscope by measuring the heights of the surface in a discretized area of  $4675 \times 4478$  pixels, where each pixel has an area of  $0.33 \times 0.33 \ \mu\text{m}^2$ . To present the results of roughness evolution, the four points of examination have been averaged with the aim to present one value of evolution per coupon.

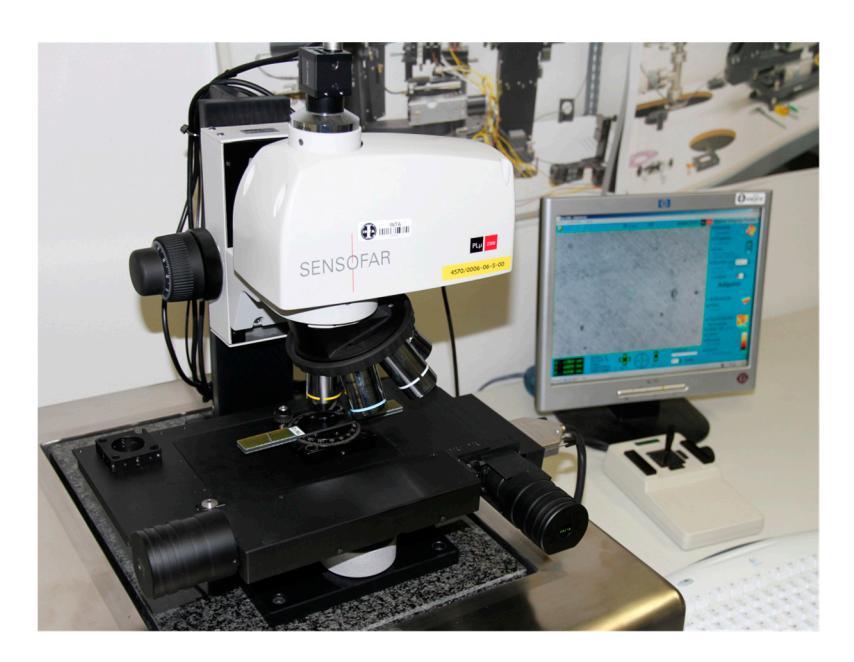
A hydraulic test machine (MTS 810 from MTS Systems Corporation, Eden Prairie, MN, USA), under load controlled conditions, was used for the fatigue tests. The surface topography was obtained by a confocal microscope (PL $\mu$  Confocal Imaging Profiler, from Sensofar, Barcelona, Spain) with an objective zoom of 50× and an axial resolution of 5 nm. The experimental setup to measure the surface roughness of the coupons with the confocal microscope is shown in the Figure 3.

Figure 3. Experimental setup to measure the surface roughness by the confocal microscope.

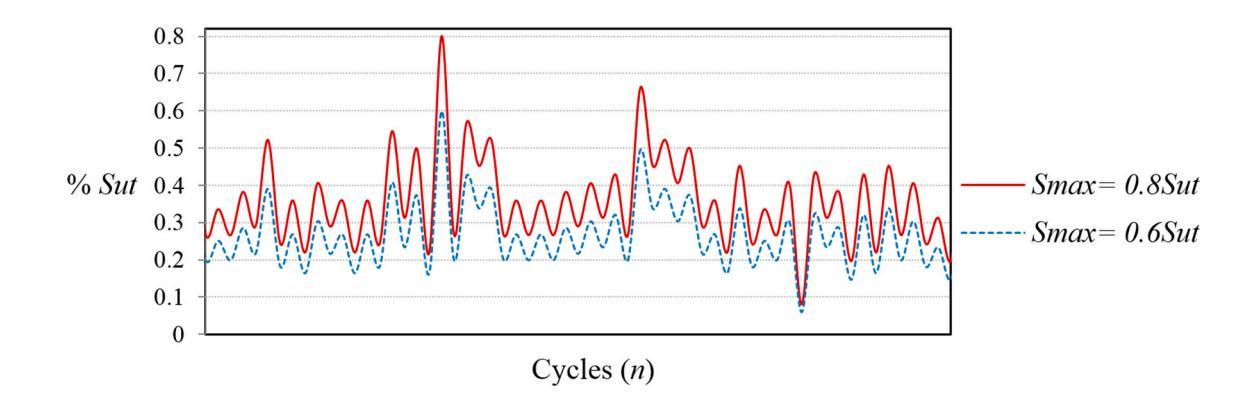
VALs have been applied at 10 Hz with an R = 0.1, where the relation of the maximum peak load of the sequence and the minimum valley of the sequence is 10:1. In order to evaluate load sequences of different severity, FALSTAFF has been scaled to different magnitudes of maximum peak load. Table 1 shows the load sequences applied to the coupons and Figure 4 illustrates a fragment of the load history applied to the coupons with two different magnitudes of maximum peak load. If the coupon did not fail within the load history, the sequence was repeated until failure, with a limit of 10 million of cycles. The fatigue tests have been interrupted periodically before failure in order to perform the measurement of the surface parameters.

**Figure 4.** Fragment of the FALSTAFF load sequence with two different magnitudes of maximum peak load.

The FALSTAFF load sequence is a standardized representation of the loads supported by the wing roots of fighter aircrafts during 200 flights (1 year of typical usage), under the combinations of different types of missions and maneuvers [23]. The total number of cycles of the FALSTAFF load sequence is  $1.054 \times 10^6$  cycles of different magnitude, and has been applied to the coupons in order to evaluate the fatigue damage under VAL.

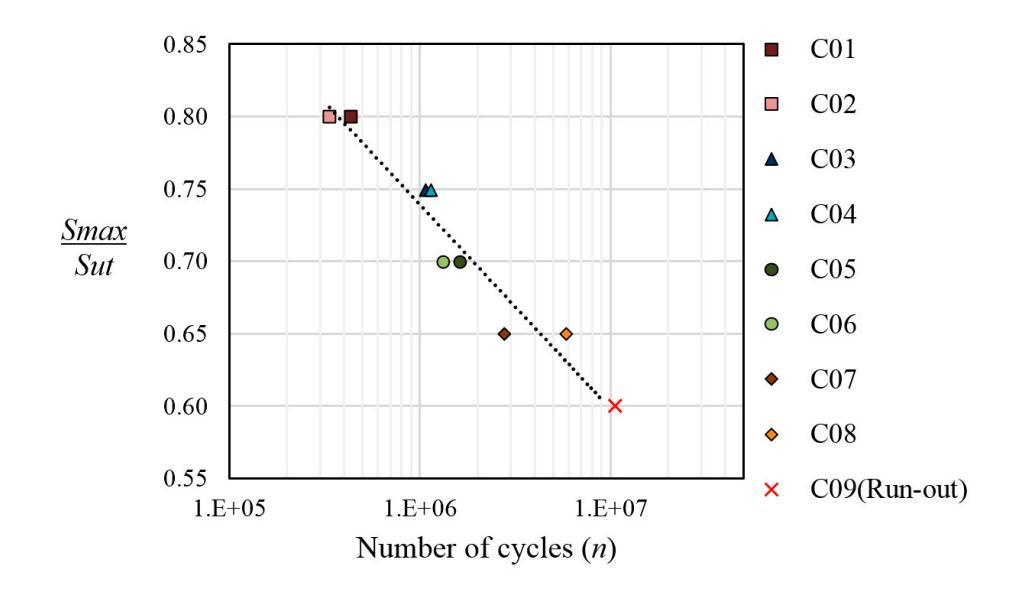
The classical stress-life curve (S-N) which is used to characterize the fatigue properties at CALs, can be used in a modified version for VALs to present life results, by plotting the maximum peak stress (*S<sub>max</sub>*) versus the number of cycles until failure (N). The resultant curve is known as Gassner curve [3]. Figure 5 shows the Gassner curve for the coupons cycled at different levels of maximum peak load. The trend line shown in the graphic has been adjusted using the failure data of the coupons C01 to C08. The coupon C09 loaded at  $S_{max} = 0.6S_{ut}$  survives  $10.5 \times 10^6$  cycles and its failure cycle is unknown.

**Figure 5.** Gassner curve in semi-log graphic, for the coupons cycled with the FALSTAFF load sequence at different levels of maximum peak load.

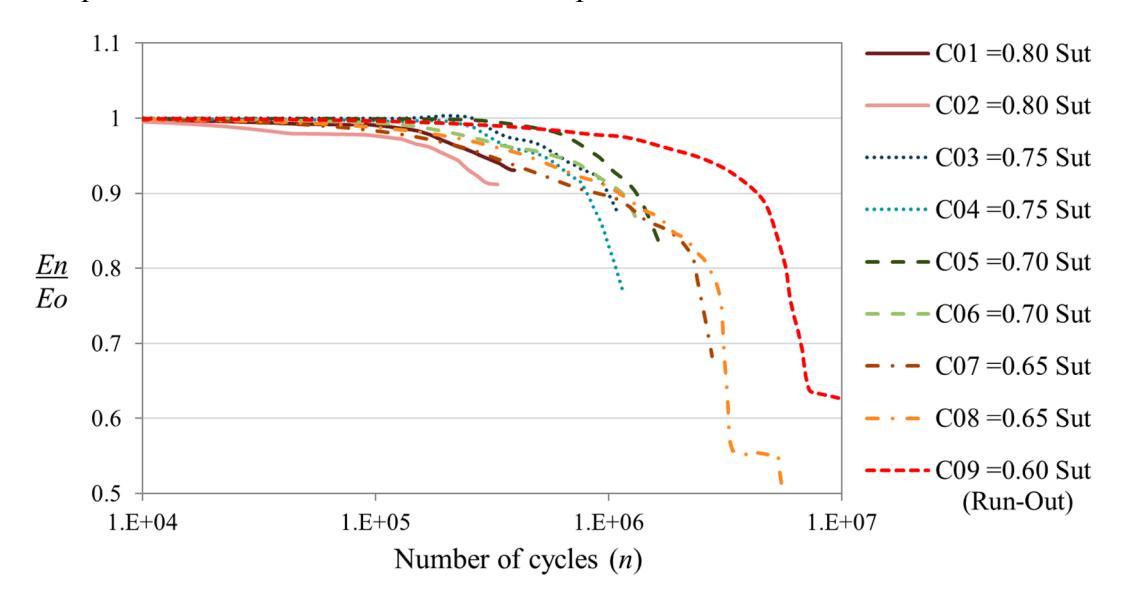
The stiffness degradation of the coupons has been measured during the fatigue cycles. The value of the stiffness has been calculated taking into account the displacement of the test machine and the applied load. The stiffness measurements have been treated in order to obtain normalized values and to quantify the stiffness degradation in terms of percentage of the initial stiffness. Figure 6 shows the degradation of the stiffness due to the accumulated damage of the coupon. The plot shows that the coupons cycled with VALs of higher severity presents a faster degradation of the stiffness, because higher loads produce more damage in the composite material. This behavior was expected and is in accordance with the results obtained when CALs are applied [18] and confirms that the stiffness degradation can be used as a metric to determine the damage state due to fatigue loads.

**Figure 6.** Stiffness degradation in semi-log graphic, for the coupons cycled with the FALSTAFF load sequence at different levels of maximum peak load.

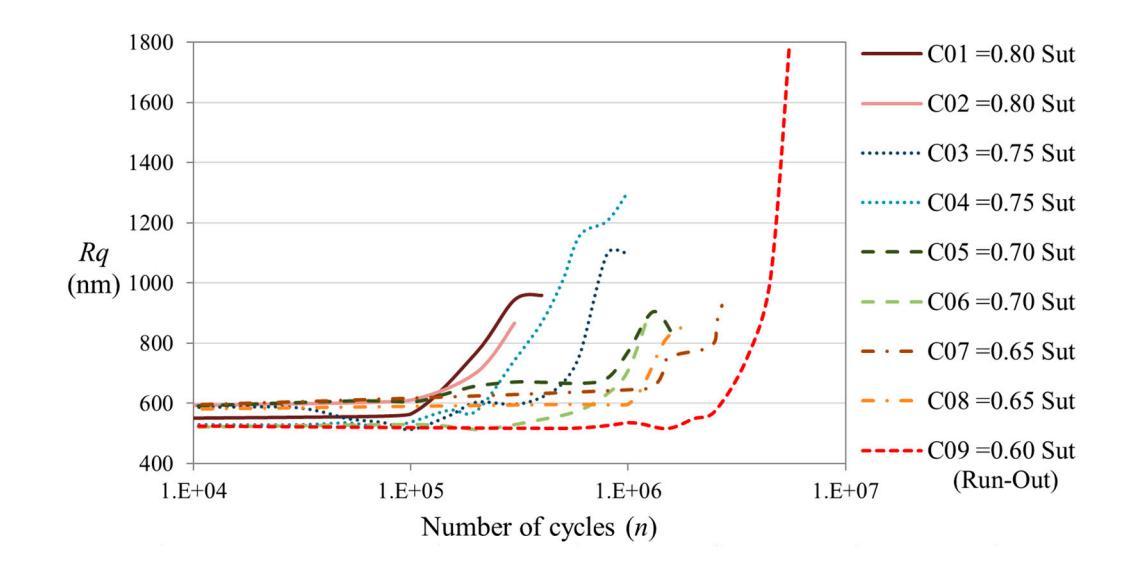
Figure 7 shows the evolution of the surface roughness magnitude due to damage accumulation in the material. The magnitude of the roughness has been quantified by the parameter Rq, Equation (1). The graphic shows that the magnitude of the roughness increases due to the accumulation of damage on the material. The rate of increment is highly dependent on the applied load level. The roughness grows faster when the applied load spectra is more severe. This is because a faster growing of the damage is produced in the material when is cycled at higher loads. This behavior is similar to the results of stiffness degradation.

Figure 7. Evolution of the surface roughness magnitude quantified by the parameter Rq during the VALs.

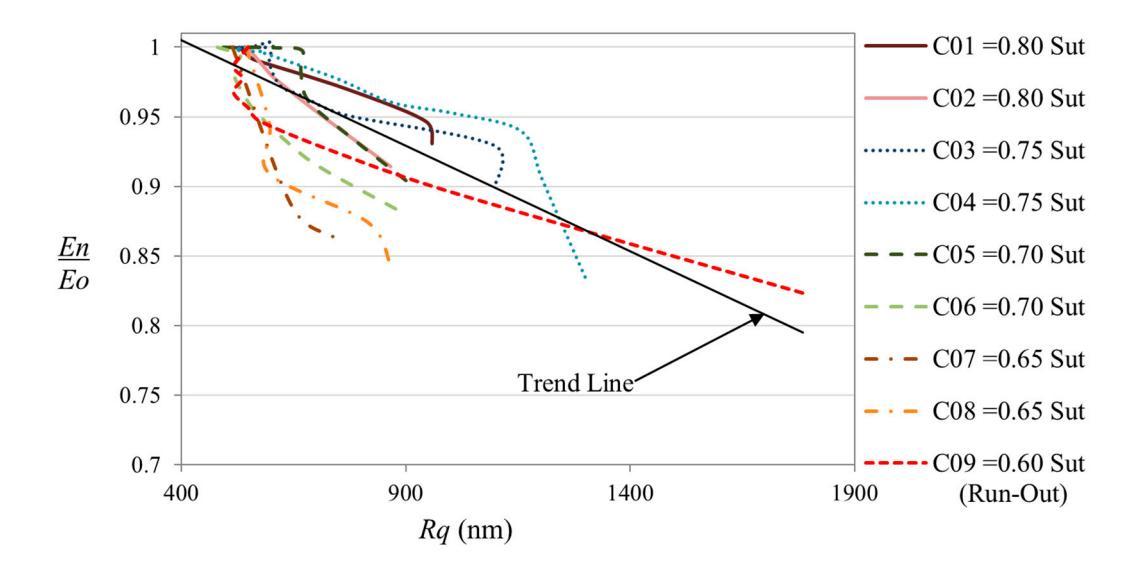
Figure 8 shows the relation between the structural damage measured by the roughness magnitude Rq and the damage measured by the stiffness degradation. The graphic shows that the surface roughness tends to increase with the degradation of the stiffness. A linear Pearson correlation between both parameters has been determined with a magnitude of 0.75. We consider this correlation as good for the case of evaluate fatigue damage by non-destructive methods. This is because the fatigue is a stochastic phenomenon. The scattering in the life results for the evaluated material when the same geometry and the same level of load is applied, could be around one decade in the logarithmic scale [6]. This scattering is due to manufacturing process of the CFRP that could produce different type of imperfections in each coupon.

Figure 8. Correlation between stiffness degradation and surface roughness magnitude (Rq) at VALs. The trend line is obtained combining the roughness and stiffness data of all the coupons.

The results show that the fatigue loads produce significant changes of the surface topography that increases the magnitude of the surface roughness. The increment on the surface roughness has been correlated with the internal damage of the material by comparing the measurements with the stiffness degradation obtaining a linear relation, with a Pearson correlation coefficient of 0.75.

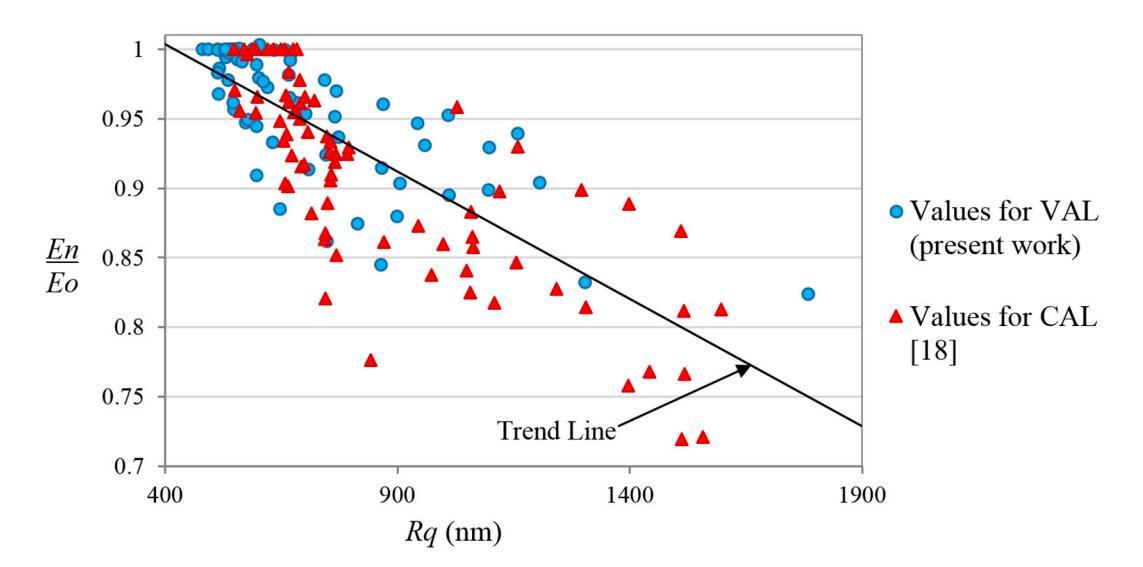
The results of the correlation between the stiffness degradation and the increment of the roughness magnitude, obtained in the present work with realistic in-service loads (VAL), have been compared with results reported in previous studies obtained with the same methodology for CAL [18]. Figure 9 shows both data superimposed. The results for both studies show similar tendencies and similar statistics and scattering. Taking into account both data (CAL and VAL), the Pearson correlation coefficient between stiffness degradation and roughness magnitude is 0.80. We can conclude from this comparison that the results obtained by the present methodology are independent of the load type applied, and can be used for applications where the in-service loads are known and controlled (such as pressure vessels) and for applications where the loads are of random or variable nature (wings, automotive components, *etc.*).

**Figure 9.** Comparison between the data obtained for VAL in the present work, and the data obtained for CAL in a previous study [18]. The trend line is obtained for the combination of both studies.

The results obtained by the present work under realistic in-service loads have been compared with results obtained in a previous work for constant amplitude loads obtaining similar tendencies and statistics. Taking into account both data (CAL and VAL), the Pearson correlation coefficient between stiffness degradation and roughness magnitude is 0.80. We can conclude from this comparison that the results obtained with the present methodology are independent on the load type applied, and can be used for applications where the in-service loads are known and controlled (such as pressure vessels) and for applications where the loads are of random or variable nature (wings, automotive components, *etc.*).
