Experimental Study on Rebar Corrosion Using the Galvanic Sensor Combined with the Electronic Resistance Technique

Abstract: In this paper, a new kind of carbon steel (CS) and stainless steel (SS) galvanic sensor system was developed for the study of rebar corrosion in different pore solution conditions. Through the special design of the CS and SS electronic coupons, the electronic resistance (ER) method and zero resistance ammeter (ZRA) technique were used simultaneously for the measurement of both the galvanic current and the corrosion depth. The corrosion processes in different solution conditions were also studied by linear polarization resistance (LPR) and the measurements of polarization curves. The test result shows that the galvanic current noise can provide detailed information of the corrosion processes. When localized corrosion occurs, the corrosion rate measured by the ER method is lower than the real corrosion rate. However, the value measured by the LPR method is higher than the real corrosion rate. The galvanic current and the corrosion current measured by the LPR method shows linear correlation in chloride-containing saturated Ca(OH)₂ solution. The relationship betw

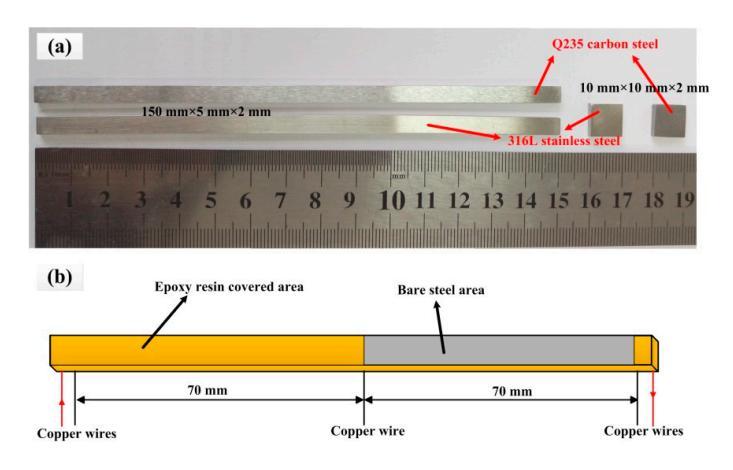
Figure 1. Electronic coupons and electrodes used in tests (**a**) the photo of electronic coupons and electrodes (**b**) the structure of the electronic coupon.

The materials used in the test were Q235 carbon steel and 316L stainless steel. The chemical compositions of the steels are shown in Table 1. The specimens with different dimensions used in the tests are shown in Figure 1a. The specimens machined in the dimensions of 150 mm \times 5 mm \times 2 mm were used as electronic coupons. The detailed structure of the electronic coupon is shown in Figure 1b. It is seen that the electronic coupon was divided into two parts with the same lengths. A half part of the electronic coupon was completely sealed with epoxy resin and the other half part had a 70 mm long bare steel area on the front face. Five copper wires were welded at the back side of the electronic coupon. The two copper wires on the edges of the electronic coupon were used for current injecting and the other three coppers were used for voltage measurements. The small specimens used for electrochemical tests were made in a dimension of 10 mm \times 10 mm \times 2 mm. The specimens were sealed with epoxy resin with the end face exposed to the solution. A copper wire was welded at the back side of the specimen and it was also sealed in the epoxy. Before the test, the working surface of the electronic coupons and electrodes were ground consequentially from 600 to 1200 grit silicon carbide paper, rinsed with deionized water and degreased in acetone.

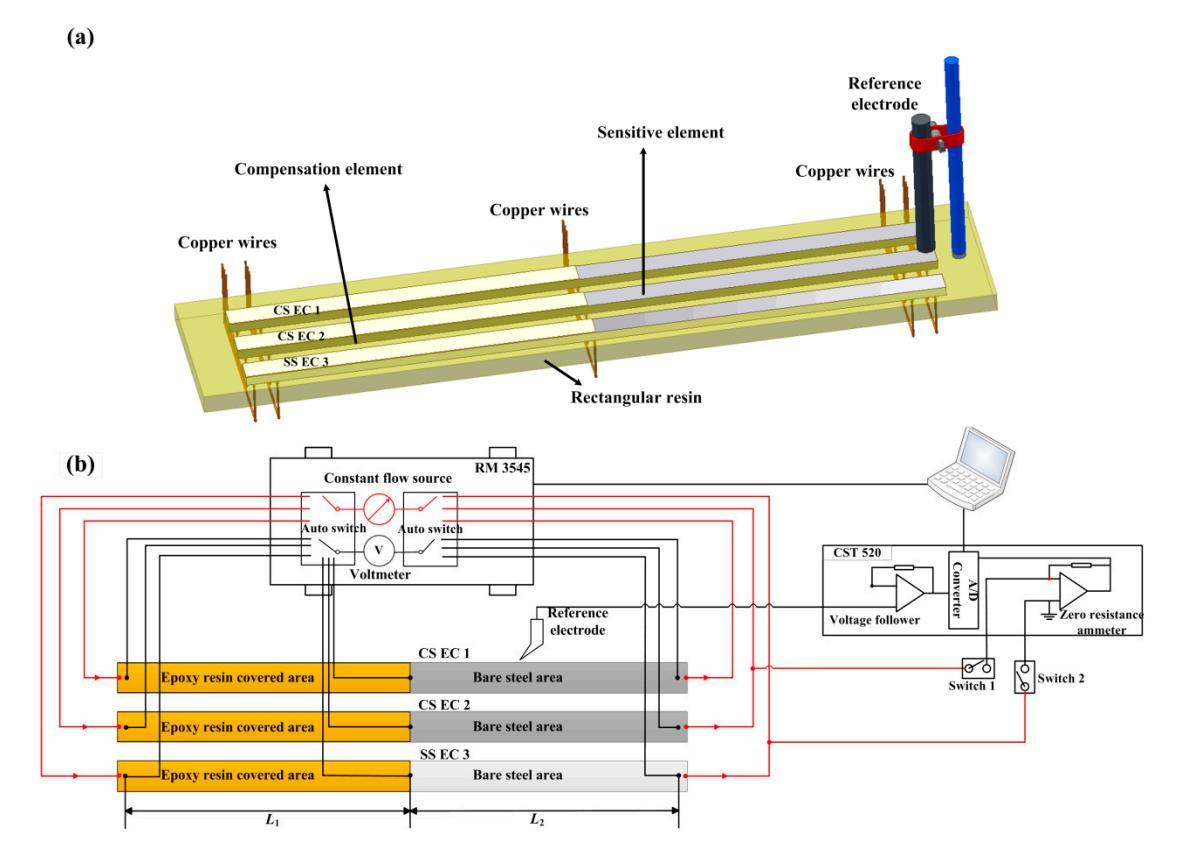
It is seen from Figure 2a that the sensor system consists of three electronic coupons. Two of the coupons were carbon steel electronic coupons (CS EC 1 and CS EC 2) and one of the coupons was a stainless steel electronic coupon (SS EC 3). The electronic coupons were embedded in a rectangular resin with their measurement wires passing through the back of the rectangular resin. Excepting half parts of the front faces of the electronic coupons, which were kept bare, the other sections of the electronic coupons were all sealed by epoxy resin. A reference electrode was fixed on the bare steel sides of the coupons. The measurement circuit of the galvanic sensor system is shown in Figure 2b. It can be seen that the galvanic sensor system was composed of two monitoring parts, i.e., the corrosion depths monitoring of the electronic coupons by using the RM 3545 Micro Resistance measurement device (HIOKI, Ueda, Japan) and the galvanic current and coupled potential monitoring by using the zero resistance ammeter (ZRA) and high resistance voltage follower (CST 520, CorroTest, Wuhan, China).

Figure 2. The galvanic sensor system (a) scheme of the sensor (b) measurement circuit of the sensor system.

The measurement principle of the corrosion depth for each electronic coupon is the same as the thin film ER sensors and the ER probes [18]. The half part of the coupon sealed by epoxy was used as a temperature compensation element and the other bare half part was used as a sensitive element. Because of the measurement error and the size of the weld point, the lengths of the two parts on the electronic coupon may have a tiny difference. Supposing that the length of the compensation element was L_1 , the electronic resistance R_c of this element can be expressed as:

During the corrosion depths measurements, Switch 1 and Switch 2 were kept open. The ER of the elements on the three electronic coupons can be measured in sequence through the autoswitch system of RM 3545. CS EC 1 was only used for corrosion depth measurement. For the galvanic current and coupled voltage measurements, the autoswitch system of RM 3545 was kept open and Switch 1 and Switch 2 were switched on. The CS EC 2 and SS EC 3 were coupled during this period. The galvanic current between the two coupons and the coupled potential of the coupons can be measured. The monitoring frequency was 1 Hz in the test. The cycle periods for corrosion depth measurements were 2 h and the measurement duration was less than 10 s. For the other time, galvanic current and coupled potential signals were kept for continuous monitoring. Since the variation of the ER signal is only a correlation to the change of the cross-section area [33], the corrosion depths of the electronic coupons can be actually reflected without considering other interferences such as the conductivity of the concrete medium or the reaction of the rust layer on the steel surface. In the long-term rebar corrosion monitoring test, due to the short duration of the ER measurements, the galvanic current can seem to be continuously monitoring without interruption. Thus, the corrosion depths and the galvanic current can be thought approximately to be measured synchronously by the new design galvanic sensor system.

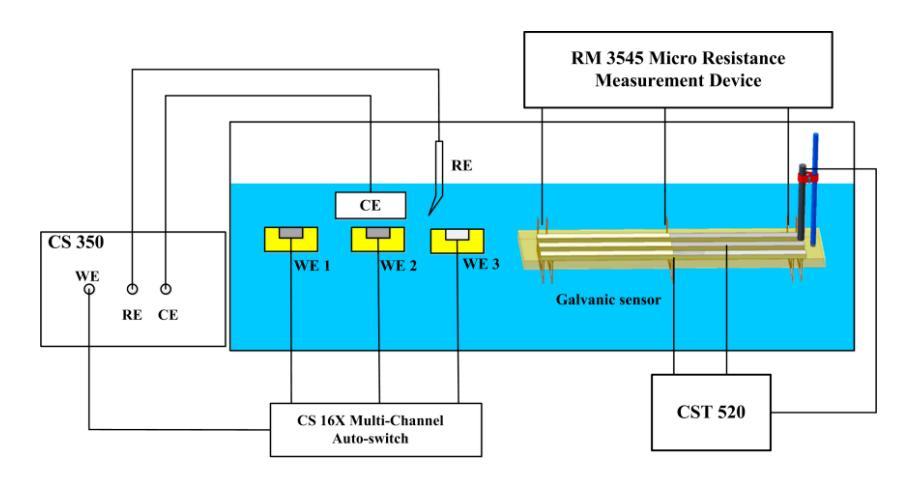
The corrosion monitoring system in the test cell is shown in Figure 3. Besides the galvanic sensor system, a traditional three-electrochemical cell was used for the LPR and polarization curves measurements. Three working electrodes (WEs) were used in the tests. WE 1 and WE 2 were CS electrodes and WE 3 was an SS electrode. WE 1 was used for the LPR measurement and WE 2 and WE 3 were used for polarization curves measurements. A platinum plate was used as a counter electrode and a saturated calomel electrode was used as the reference electrode. LPR measurements were performed by applying anodic voltage scans at the rate of 0.1 mV/s over a range of ± 10 mV around the stabilized open-circuit potential (OCP). Polarization curves were measured by scanning the potential, approximately from -500 mV to 750 mV (vs. SCE). The three working electrodes were alternately connected to the electrochemical station CS 350 (CorroTest, Wuhan, China) for the LPR and polarization curves measurements through the CS 16X (CorroTest, Wuhan, China) multi-channel auto switches.

Figure 3. Test cell of the corrosion monitoring system.

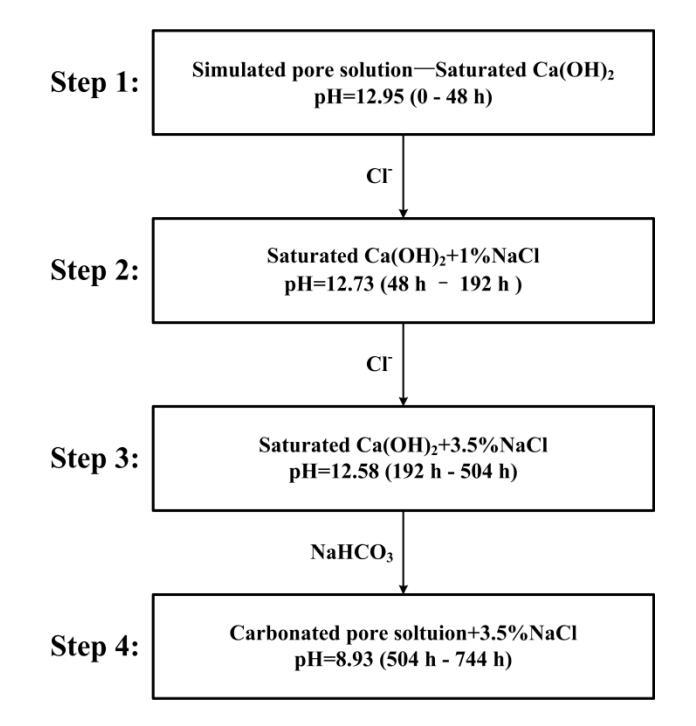
Figure 4. Scheme of the experimental procedures.

The test cell was placed in an air-conditioned room with temperature fluctuation at 19 ± 1.5 °C. The test solution was directly exposed to the air and the pH of the solution was monitored by a TDS YM 2712 pH monitor. The saturated Ca(OH)₂ aqueous solution with pH = 12.95 was firstly used as a simulated pore solution and then successively modified by the addition of chloride ions (1% and 3.5% NaCl solution). Following, the pH of the simulated pore solution was adjusted to 8.93 by the introduction of sodium bicarbonate solution to simulate the carbonated pore solution. Figure 4 presents the scheme of the four experimental procedures:

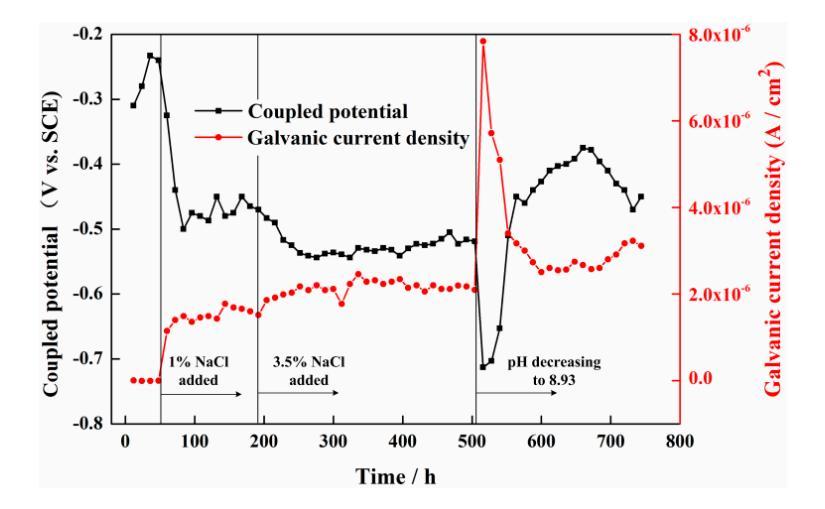
The coupled potential and galvanic current density variations between the CS EC 2 and SS EC 3 are shown in Figure 5. It is seen that the coupled potential reached -240 mV_{SCE} after the sensor was immersed in pure Ca(OH)₂ solution for 48 h. The galvanic current was negative, which means the CS EC 2 had a higher potential than the SS EC 3 and acted as a cathode. The galvanic current density was close to -1.17×10^{-8} A/cm², which nearly had no influence on the corrosion processes. After 1% NaCl was added to the solution, the coupled potential had a significant decrease from $-240 \text{ mV}_{\text{SCE}}$ to $-480 \text{ mV}_{\text{SCE}}$ in 36 h and came to a stable value of $-470 \text{ mV}_{\text{SCE}}$. The galvanic current also changed to positive and had a large increase to 1.6×10^{-6} A/cm². It indicates that the breakdown of the passive film on the CS EC 2 and it turned into an anode after the introduction of chloride ions. The coupled potential of the sensor had a further decrease to $-530 \text{ mV}_{\text{SCE}}$ after the concentration of NaCl increased to 3.5%. The galvanic current density also had a slight increase to 2.3×10^{-6} A/cm². When the pH of the solution decreased to 8.93, the coupled potential had a sudden reduction to $-713 \text{ mV}_{\text{SCE}}$ in 12 h and the galvanic current density also had a dramatic increase to $7.8 \times 10^{-6} \text{ A/cm}^2$. Following, the coupled potential gradually recovered and became stable at -400 mV_{SCE} , which was even higher than that in high pH conditions with NaCl added. The galvanic current density also decreased to a stable value of 3.13×10^{-6} A/cm², which is higher than that in the previous condition.

Figure 5. Time dependence of the coupled potential and the galvanic current density variations between the CS EC 2 and SS EC 3.

The previous studies revealed that the galvanic current between CS and SS had a strong linear correlation to the corrosion current measured by the LPR method [28]. Through the comparation of the galvanic current shown in Figure 5 and the corrosion rate shown in Figure 11, it can be found that the galvanic current in pure saturated pore solution is negative and the corrosion rate is close to zero. They have no obvious correlation in this solution condition. It is seen from Figure 5 that the galvanic current density comes to a stable value of 3×10^{-6} A/cm² at the end of test in a low pH solution condition. However, the corrosion rate measured by the LPR method has a large fluctuation from 0.13 mm/a to 0.16 mm/a, indicating there is also no obvious correlation during this period. The corrosion rate and the galvanic current only have similar variation trends with the introduction of

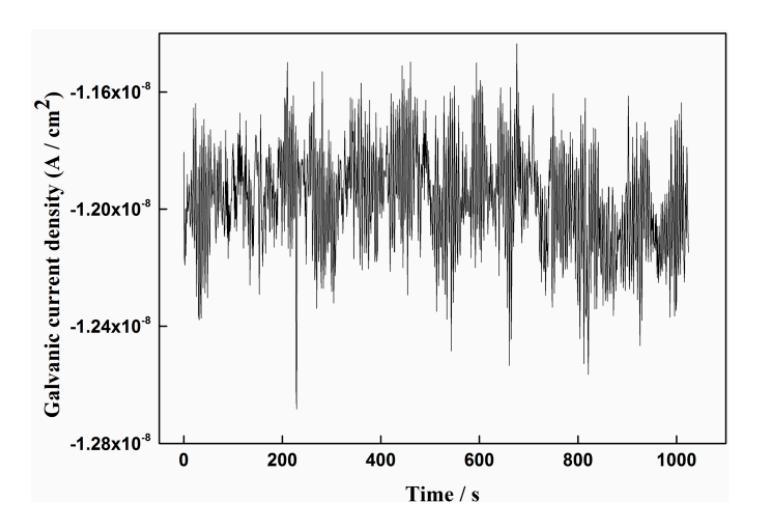
More detailed information of the galvanic current noise during different test periods is shown from Figure 6 to Figure 8. It can be seen from Figure 6 that the current fluctuations were small and no current transients are found, which means the passive film is integrated. As shown in Figure 7a, the current transients can be clearly observed after 1% NaCl was added for 5 h. The fluctuations of the current spikes reached nearly 4×10^{-8} A/cm². It is seen from Figure 7b that the galvanic current density increased to 1.53×10^{-6} A/cm² after 1% NaCl was added for 120 h. However, the current fluctuation had a slight decrease, which might indicate the forming of a rust layer or stable pits on the CS EC 2 [34]. The same phenomenon can be seen from Figure 7c,d, that the fluctuation of the current became intensive and frequent after the concentration of NaCl increased to 3.5% at the initial 15 h and that the current fluctuations became smaller after 3.5% NaCl was added for 252 h.

Figure 6. Galvanic current density monitored by the sensor after immersed in pure $Ca(OH)_2$ solution for 36 h.

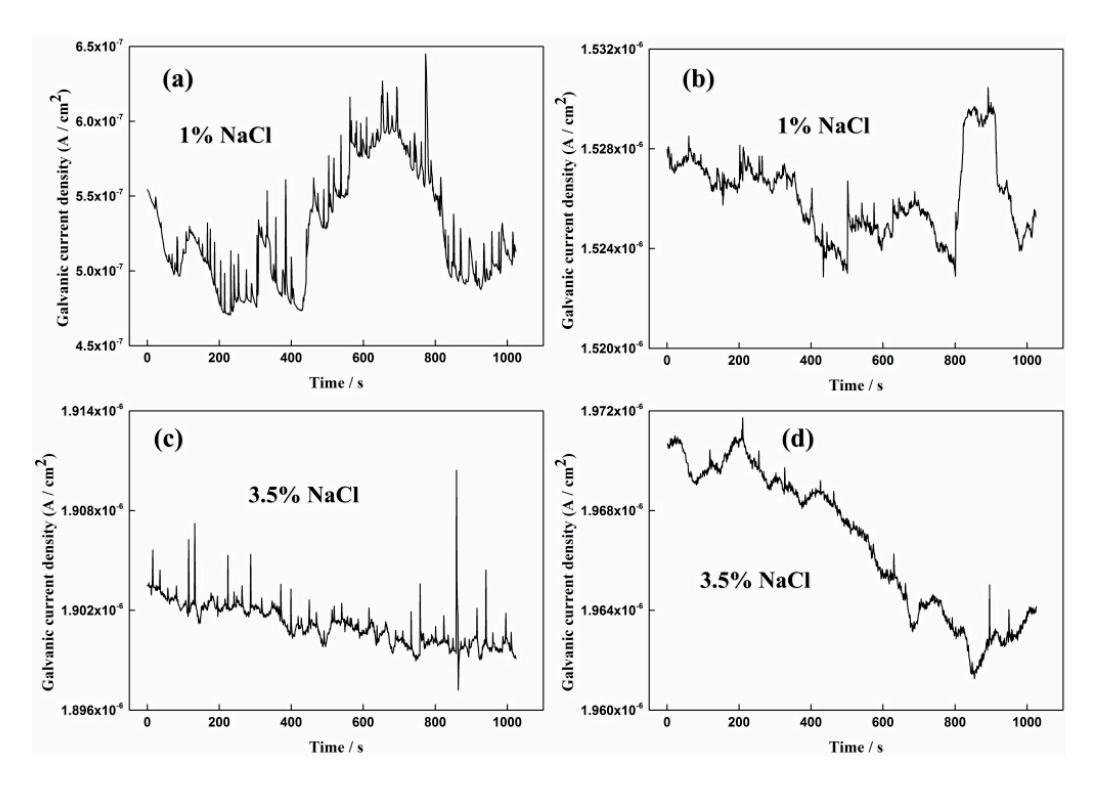
Figure 7. The galvanic current density in different concentrations of solutions containing chloride ions (a) after 1% NaCl added for 5 h (b) after 1% NaCl added for 120 h (c) after 3.5% NaCl added for 15 h (d) after 3.5% NaCl added for 252 h.

The corrosion processes of the rebar in different pore solution conditions were quite different. As shown in Figure 7a, the frequent current transients reveal a metastable pitting corrosion process in 1% NaCl-containing pore solution. The tiny pits shown in Figure 13b verify the corrosion process. When the concentration of the NaCl reaches 3.5%, metastable pitting corrosion will become active again at the initial period, which can be seen from Figure 7c. The stable localized corrosion will soon form on the steel surface and it can also lead to the decrease of the current transients [34]. The serious localized corrosion on the surfaces of the corrosion coupon and the CS EC 2 also shows the stable pitting corrosion process during this period. When the pH of the solution decreases to 8.93, the disappearance of the current spikes reflects the corrosion patterns changing into general corrosion. The corrosion rates measured by both the ER and LPR methods have significant increases at the initial period with pH decreased to 8.93. The passive film on the CS EC 2 cannot be maintained in the low pH solution. Due to the overall destruction of the passive film, the galvanic current had an intensive increase. A new corrosion product layer will soon form on the steel face due to the high corrosion rate. The new corrosion product layer is more dense than that in high pH solution conditions and it will perform a mitigation effect on the corrosion rate. However, the crevice and default on the layer shown in Figure 12d indicate the inhomogeneity of the new corrosion product film. It leads to the metastable pitting corrosion happening again, which can be deduced from the reappearance of the current transients. The small pits shown in Figure 13d have a good correlation with the galvanic current noise changes. The test results show that the corrosion processes can be well-revealed by the galvanic sensor.

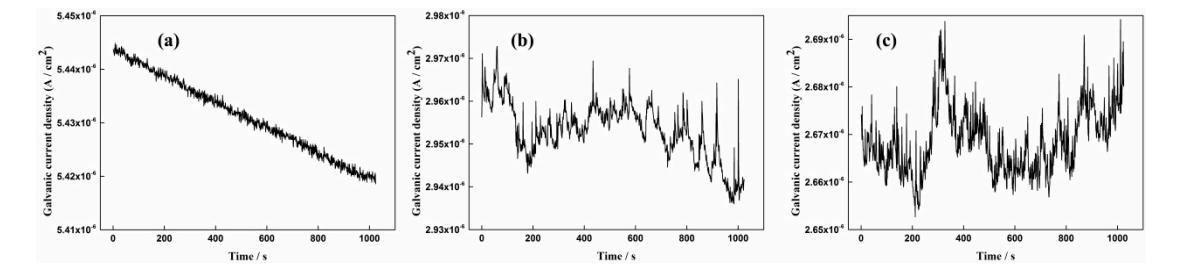
It is seen from Figure 8a that current transients disappeared after pH was decreased to 8.93 for 24 h, which indicates that pitting corrosion might change into general corrosion on the CS EC 2 during this period. However, with the decrease of the galvanic current density and the rise of the coupled potential after pH was decreased for 82 h, current spikes are observed again from Figure 8b, which means localized corrosion re-emerging on the CS EC 2. It can be seen from Figure 8c, after the pH was decreased for 180 h, the frequency of the current spikes had a decrease and the fluctuations of the galvanic current had nearly no changes compared with that shown in Figure 8b.

Figure 8. The galvanic current density monitored by the sensor with pH decreased to 8.93; (**a**) after pH decreased for 24 h; (**b**) after pH decreased for 82 h; (**c**) after pH decreased for 180 h.

occurs on the steel surface. However, when metastable pitting corrosion or localized corrosion happen on the steel surface, a much higher corrosion rate will be measured by the LPR method. It can be found that, with the reappearance of the metastable pitting corrosion on the steel surface, the LPR measurement result increases to 0.16 mm/a. The corrosion rate has a large fluctuation due to the unstable corrosion behavior on the steel surface, which can be deduced from the noise signal shown in Figure 8c,d.

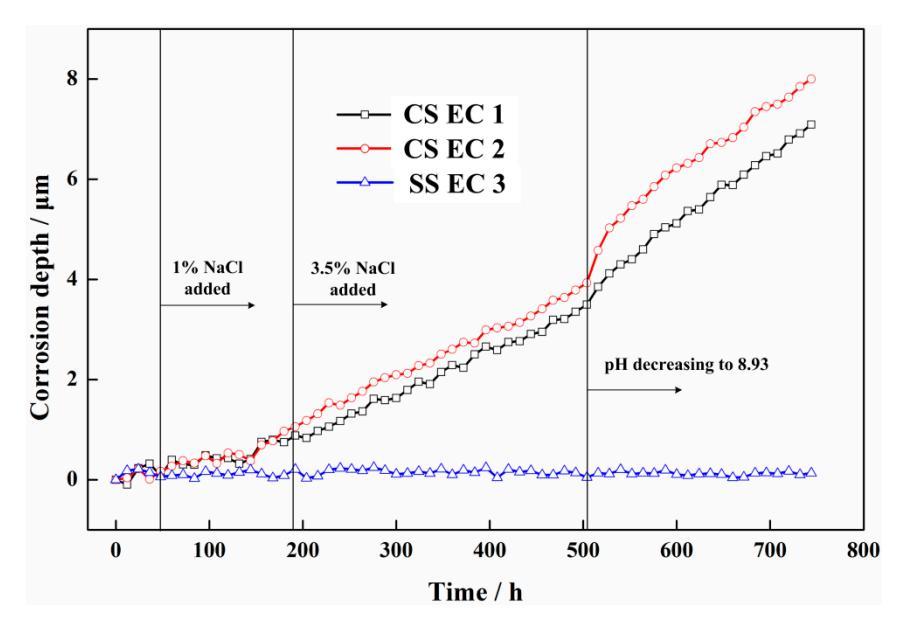
Figure 9 shows the corrosion depths of the three electronic coupons measured by the sensor system. It is seen that no corrosion happened on the SS EC 3 through the whole test. The corrosion rates of the CS EC 1 and CS EC 2 were close to zero in pure Ca(OH)₂ solution, and the initial period in 1% NaCl contained pore solution. After 1% NaCl was added for 156 h, obvious corrosion depth increase of the CS EC 2 can be seen. The corrosion rate of the CS EC 2 reached 0.022 mm/a. Though the corrosion depth of the CS EC 1 also had a slight increase with 1% NaCl added, the corrosion process was not stable during this period. Significant corrosion processes can be found after the concentration of the NaCl increased from 1% to 3.5%. The corrosion depth curves of both the CS EC 1 and 2 showed a linear growth, suggesting the corrosion rates measured by the ER signal were stable. The corrosion rates of the CS EC 1 and EC 2 were 0.077 mm/a and 0.081 mm/a, respectively. The corrosion rate of the CS EC 2 coupled with the SS EC 3 was slightly higher than that of the CS EC 1. After the pH of the solution decreased to 8.93, the corrosion rate of the CS EC 2 had a sudden increase to 0.211 mm/a in the first 24 h and gradually reduced to a stable value of 0.114 mm/a. The corrosion rate of the CS EC 1 also had an increase to the peak value of 0.162 mm/a and came to a stable value of 0.102 mm/a. It can be found from the ER measurement results that the corrosion rates of the two CS ECs only had obvious differences at the end of the 1% NaCl added period and the initial period of the decreasing of the pH to 8.93. The stable corrosion rates of both the CS ECs were very close during different test conditions, indicating the galvanic current seemed to be having no obvious impact on the corrosion process of the carbon steel.

Figure 9. The corrosion depths of the three electronic coupons measured by the ER technique.

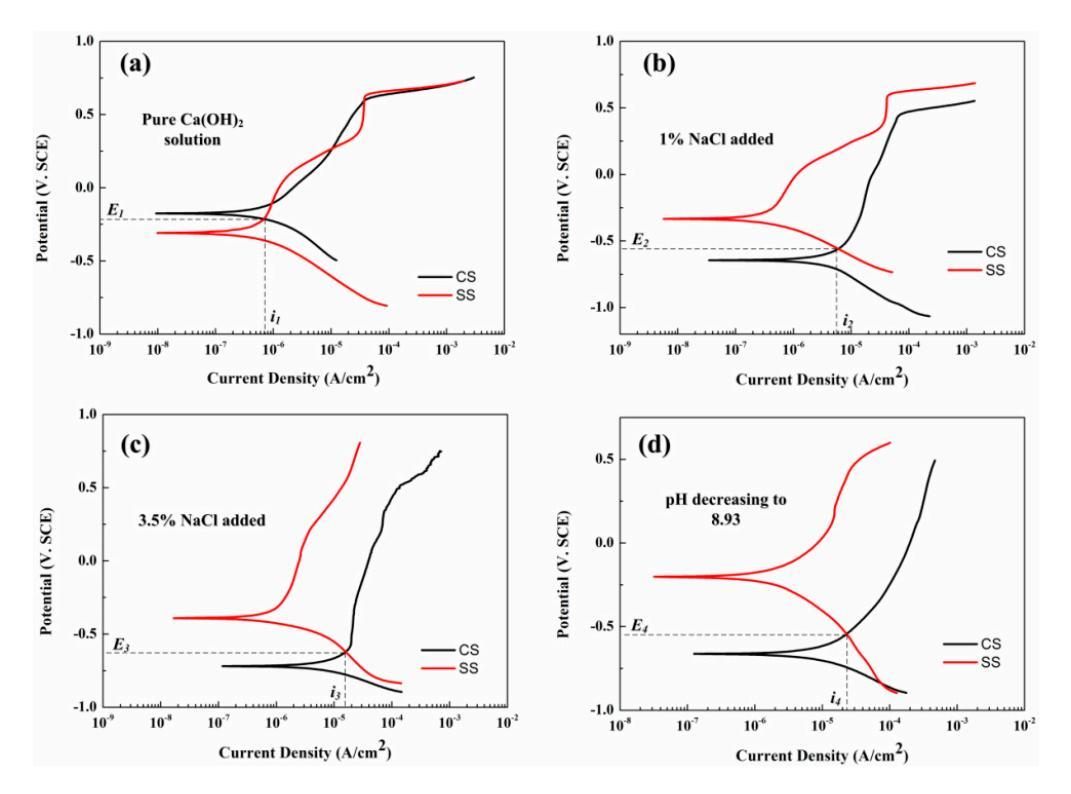
Figure 10 shows the polarization curves of the CS and SS WEs in different solution conditions. The corrosion potential and corrosion rates of the working electrodes fitted from the polarization curves are listed in Table 2. The corrosion potential and corrosion current were obtained by the Tafel extrapolation method. It can be seen from the polarization curves of the SS that only a slight change can be observed with 1% NaCl added to the solution. However, the corrosion potential of the CS decreased from -0.18 V_{SCE} to -0.64 V_{SCE} after 1% NaCl was added, indicating the breakdown of the passive film on the steel surface. When the concentration of NaCl rose to 3.5%, the corrosion potential of the CS and SS both had dramatic decreases to -0.71 V_{SCE} and -0.31 V_{SCE}, respectively. The corrosion rates of the CS and SS also increased to 0.17 mm/a and 0.0071 mm/a. With the decreasing of the pH, the corrosion potentials of both steels recovered to -0.66 V_{SCE} and -0.26 V_{SCE}, respectively. The corrosion rates of the CS working electrode nearly had no changes with the decreasing of pH. Nevertheless, the corrosion rate of the SS increased to 0.019 mm/a in this situation.

In the pure saturated Ca(OH)₂ solution, the corrosion potential of SS was lower than CS, suggesting that CS will work as a cathode and SS will act as an anode when they are coupled. With the introduction of chloride ions, the passive film on the CS surface was broken. The corrosion potential of CS became much lower than SS showing the exchange of the anode and cathode. If the two kinds of steel are coupled in chloride-containing pore solutions, the potentials of both steels will be polarized to the same coupling potential [35]. The galvanic current and coupled potential can be estimated through the intersections of the polarization curves. The coordinates of the intersections, shown in Figure 10a–d, are listed in Table 1. It is seen from Figure 10 and Table 2, that the galvanic currents increased in turn following the changes of the solution conditions ($i_4 > i_3 > i_2 > i_1$). The coupled potential firstly had a significant decrease after the introduction of chloride ions, however, the coupled potential had a slight recovery after the pH decreased to 8.93 ($E_3 > E_4 > E_2 > E_1$). The variations of both galvanic current and coupled potential deduced from the intersections had the same trends as the galvanic sensor measurement results.

Figure 10. The polarization curves of the CS and SS WEs in different test conditions (**a**) pure saturated Ca(OH)₂ solution (**b**) with 1% NaCl added (**c**) with 3.5% NaCl added (**d**) with pH decreasing to 8.93.

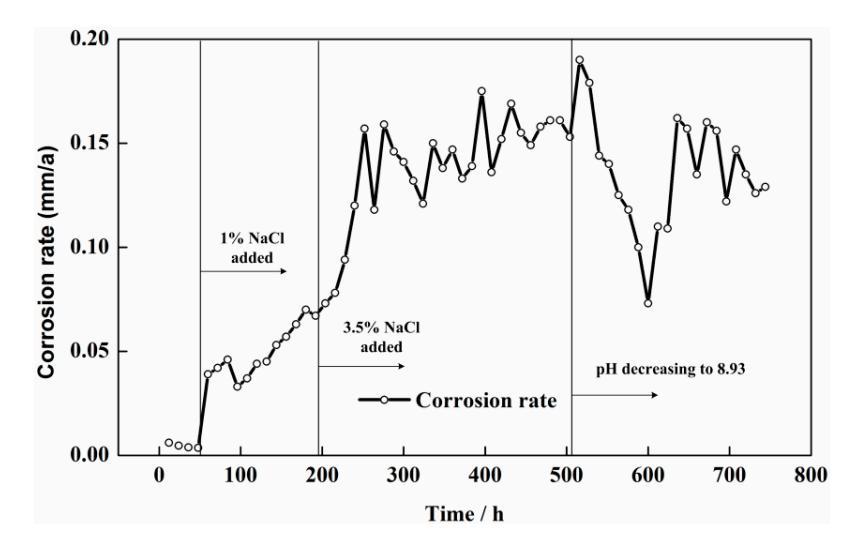
Figure 11 shows the corrosion rates of CS measured by the LPR method in different solution conditions. The corrosion rate was calculated through the Stern–Geary equation [36]:

where i_{corr} is the corrosion current density, B is the Stern constant (52 mV for passive state and 26 mV for active state) [37,38], and R_p is calculated from the slope of the linear polarization curve. It can be seen from Figure 11 that the corrosion rate measured by LPR was close to zero in pure saturated Ca(OH)₂ solution. The corrosion rate of the CS electrode had a sudden increase to 0.042 mm/a and gradually increased to 0.067 mm/a. The LPR measured results was nearly 3 times higher than that measured by the CS EC 2. A dramatic increase of the corrosion rate from 0.067 mm/a to 0.15 mm/a can be seen, with the concentration of NaCl increased to 3.5% for 60 h. The measurement result was still 2 times higher than the data measured by the corrosion coupons. The LPR measurement result had a large fluctuation, with the pH of the solution decreased to 8.93. The corrosion rate firstly reached the highest value of 0.19 mm/a and soon decreased to 0.08 mm/a. The corrosion rate measured by the LPR method was close to the results measured by electronic coupons during this period. Following, the corrosion rate measured by the LPR method recovered to a stable value of 0.13 mm/a at the end of the test, which was still higher than the ER measurement results.

Figure 11. Time dependence of the corrosion rates measured by the LPR method.

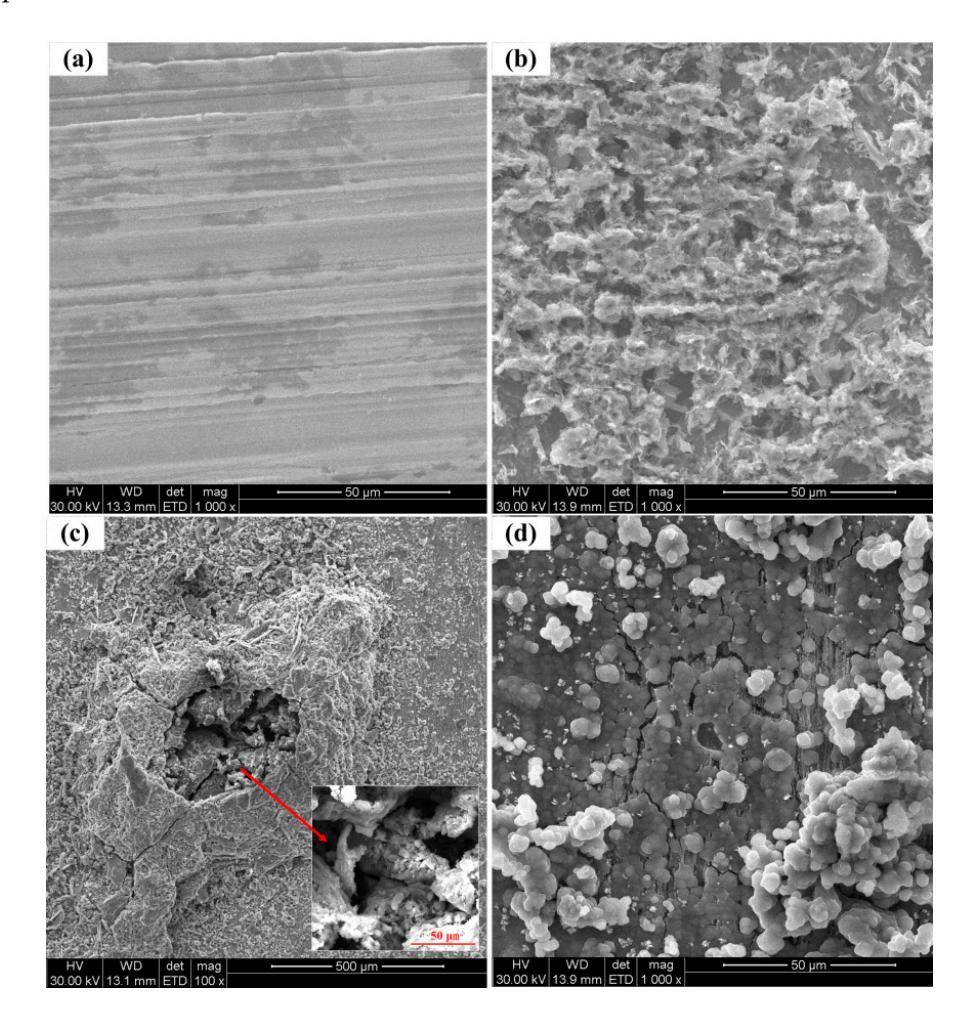
Figure 12 shows the SEM views of the surface morphologies of the corrosion coupons. The corrosion coupons were independently immersed in different solution conditions and carried out before the changes of the solution conditions. As seen from Figure 12a, the surface of the corrosion coupon is smooth, and the scratches can be clearly seen, indicating the steel was well-protected in the saturated $Ca(OH)_2$. As shown in Figure 12b, a porous rust layer was formed on the steel surface, which means the breakdown of the passive film and obvious corrosion happened after 1% NaCl was added. The porous rust layer can also be seen from Figure 12c, and serious localized corrosion is found on the steel surface. It suggests that the steel will suffer stable pitting corrosion in 3.5% NaCl-containing pore solution. As shown in Figure 12d, a more dense corrosion product film can be seen on the steel surface with the pH of the solution decreased to 8.93.

Figure 12. SEM images of the corrosion coupons' surfaces after corrosion in different solution conditions, (**a**) pure saturated $Ca(OH)_2$ solution (**b**) saturated $Ca(OH)_2$ solution with 1% NaCl (**c**) saturated $Ca(OH)_2$ solution with 3.5% NaCl (**d**) with pH decreasing to 8.93.

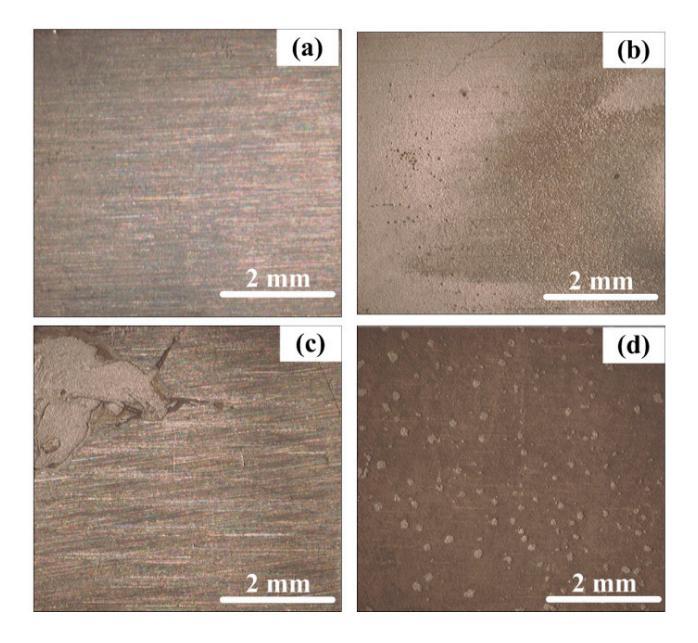
Figure 13 shows the surface morphologies of the corrosion coupons after the porous rust layers were removed by rubber. Tiny pits can be seen from Figure 13b, indicating a metastable pitting corrosion process happened on the steel surface in 1% NaCl-containing pore solution. However, the whole surface of the steel also became rough, suggesting general corrosion also occurred on the steel surface. Obvious localized corrosion behavior can be found from Figure 13c. It demonstrates that stable localized corrosion is liable to form in a 3.5% NaCl solution condition. It is seen from Figure 13d that the rust layer cannot be completely removed by rubber, which means the corrosion product layer had

a well-adsorptive performance. However, tiny pits can also be found on the steel surface, suggesting that the metastable pitting corrosion also occurred along with the general corrosion when the pH decreased to 8.93.

Figure 13. The surface morphologies of the corrosion coupons in different solution conditions after the rust layers were removed by rubber (**a**) pure saturated $Ca(OH)_2$ solution (**b**) saturated $Ca(OH)_2$ solution with 1% NaCl (**c**) saturated Ca(OH)_2 solution with 3.5% NaCl (**d**) with pH decreasing to 8.93.

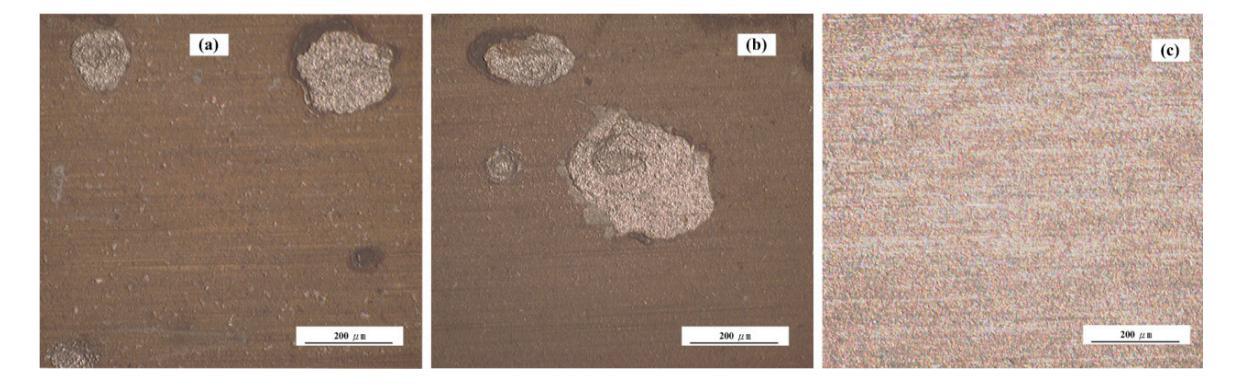
Figure 14 shows the surface morphologies of the three electronic coupons after corrosion for 744 h. The porous rust layers on the CS EC 1 and CS EC 2 were also removed. Significant localized corrosion patterns can be found on both CS WEs. Larger pits can be found on the CS EC 2, indicating the localized corrosion on the CS EC 2 was a more serious than that on the CS EC 1. The surface of the SS EC 3 was smooth and flat, suggesting the low corrosion rate of the stainless steel. Figure 15 shows the surface morphology of the electrode used for the LPR test. The surface of the electrode was rough and serious pitting corrosion can be seen from the SEM image, as shown in Figure 15b. It reveals that slight polarization may lead to the acceleration of localized corrosion in chloride-containing pore solution.

Figure 14. Surface morphologies of the electronic coupons (a) CS EC 1 (b) CS EC 2 (c) SS EC 3.

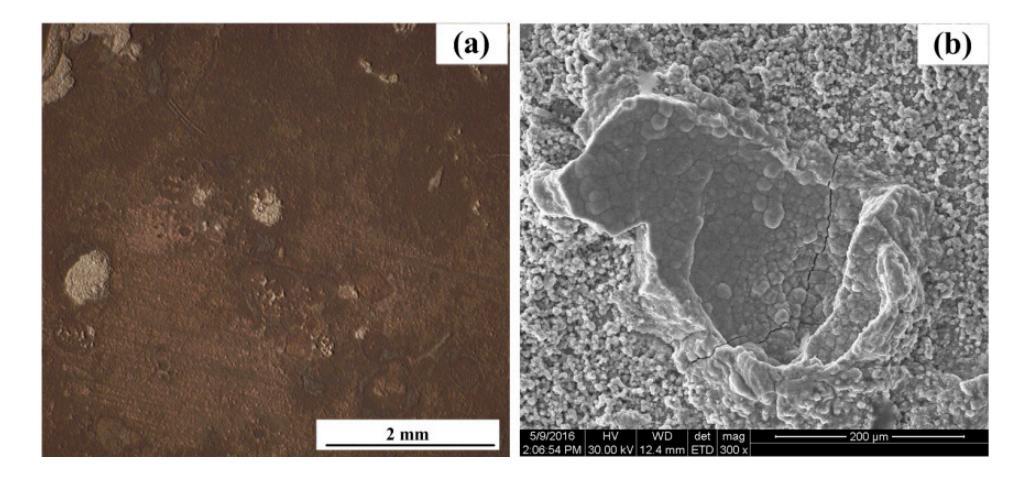
Figure 15. The surface morphology and SEM image of the WE used for the LPR measurement (**a**) the surface observed by optical microscope (**b**) SEM image of pitting corrosion area.

Through the observation of the morphologies, more serious pitting corrosion can be seen on the electrode used for the LPR test. It indicates that the WE used for the LPR test will suffer more serious localized corrosion with an anodic polarization process. As it is well known that, with the introduction of the chloride ions into the solution, the FeOOH passive layer will be reduced into Fe_3O_4 or Fe_2O_3 , which is less protective. The reduction of the FeOOH will cause the local breakdown of the passive film and lead to the initial pitting corrosion process [24]. Once a pit is initiated on the steel surface, the aggressive ions will soon come into the occluded site and cause continuous localized corrosion due to the self-sustaining effect [39]. The occluded pit area will have a more negative potential than the other areas on the steel surface. However, during the LPR measurement period, the applied potential is based on the open circuit potential of the whole electrode. Therefore, the pitting area may suffer more serious anodic polarization, and performs high anodic current in this situation. It will result in the corrosion current measured by the LPR method being higher than the real corrosion current. Consequently, the real corrosion rate of the steel is between the ER and LPR measurement results.

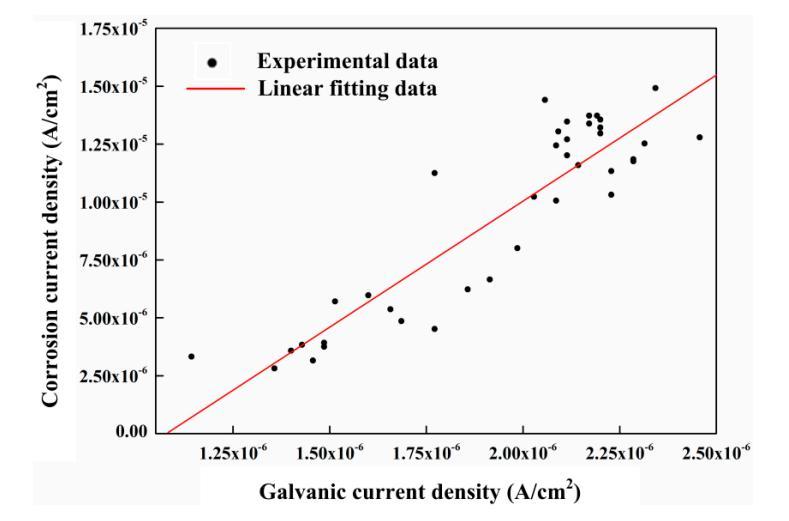
chloride ions in saturated $Ca(OH)_2$ solution. The relationship of the corrosion current density and the galvanic current density during this period is shown in Figure 16. The corrosion current density and the galvanic current density can be expressed as:

where i_{corr} is the corrosion current density and i_g is the galvanic current density. The R^2 (R is the correlation coefficient) of the linear fitting data is 0.84, indicating an excellent linear correlation between the galvanic current and corrosion current. It shows the corrosion current can be calculated from the galvanic current in chloride-containing saturated Ca(OH)₂ solution. The corrosion rate also can be represented by the galvanic current in this condition. However, it is not suitable for the carbonated concrete conditions.

Figure 16. The relationship between the corrosion current density measured by LPR and the galvanic current density between CS and SS in chloride-containing saturated Ca(OH)₂ solution conditions.

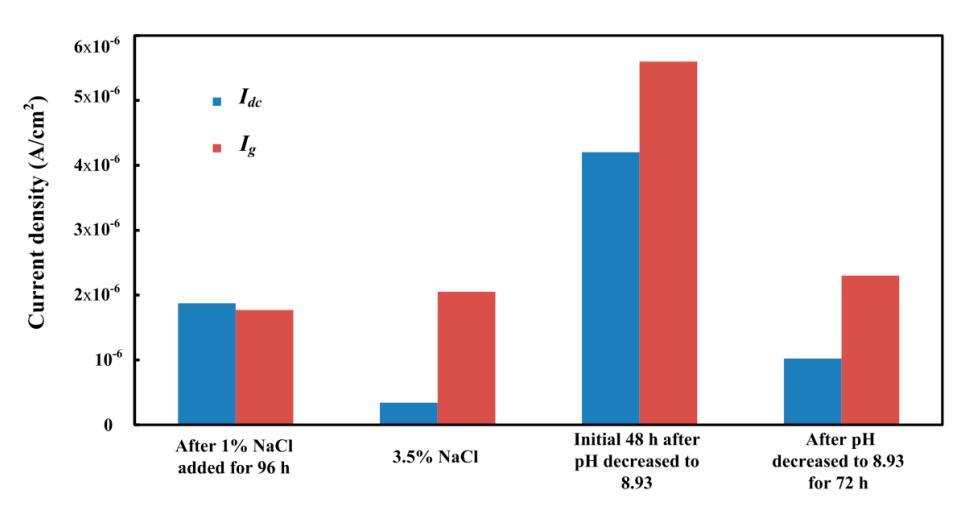
The acceleration effect of the galvanic corrosion between CS and SS can be further studied by the relationship between the galvanic current density and the corrosion rate difference between the CS EC 1 and CS EC 2. The difference of the corrosion current density (I_{dc}) can be calculated from the corrosion rates difference [40] between the CS EC 1 and CS EC 2:

where Δv is corrosion rate difference between the CS EC 1 and CS EC 2, *n* is valence, F is Faraday constant and ρ is the density of the metal. It is noted that the corrosion rate difference is measured by the ER method. Thus, the corrosion current difference is only used to represent the corrosion current difference on general corrosion behavior. Due to the resolution of the ER method, the corrosion rate cannot be monitored in pure saturated Ca(OH)₂ solution. After 1% NaCl was added for 96 h, the I_{dc} was nearly the same as I_g , suggesting that the galvanic current also contributes to the general corrosion on the CS EC 2. However, because the corrosion rate measured by the CS EC 1 is not stable during this period, the comparison between I_{dc} and I_g may not be accurate. As shown in Figure 17, it can be clearly seen in 3.5% NaCl-containing pore solution that only less than one fifth galvanic current contributed to the general corrosion rate. It is known that the CS is suffering localized corrosion during this period, which indicates that the galvanic current is not provided by the whole surface of the CS EC 2. Most of the galvanic current should be provided by the pitting corrosion area. When the corrosion process transferred to uniform corrosion after the pH of the solution decreased to 8.93, it can be seen that I_{dc} occupied three quarters of I_g , suggesting that most of the galvanic current will contribute to the general corrosion. Following, with localized corrosion reappearing on the steel surface, the proportion of I_{dc} decreased to 44 percent. The test results reveal that, when localized corrosion happens on the steel surface, most of the galvanic current will come from the pitting corrosion area. In other words, the galvanic corrosion behavior between CS and SS may lead to the acceleration of localized corrosion in some conditions. It also well explains why more serious pitting corrosion appeared on the surface of the CS EC 2. The monitoring data provided by the new design galvanic sensor shows a new analytical method for the evaluation of localized corrosion.

Figure 17. The comparison diagram of the calculated corrosion current density difference and the galvanic current density in different solution conditions.
