Article Corrosion of Hydrogen Storage Metal Alloy LaMm-Ni_{4.1}Al_{0.3}Mn_{0.4}Co_{0.45} in the Aqueous Solutions of Alkali Metal Hydroxides

Abstract: Corrosion of pristine AB₅-type metal alloy LaMm-Ni_{4.1}Al_{0.3}Mn_{0.4}Co_{0.45} in the aqueous solutions of alkali metal hydroxides of diverse composition and concentration was tested. Correlation was observed between the alloy corrosion intensity in various hydroxide solutions, and its electrochemical capacity in these electrolytes. Mm(OH)₃, CoO(OH), and nickel metal aggregates were detected among the products of selective oxidation of the alloy. High intensity corrosion of the alloy was observed in RbOH and CsOH solutions leading to formation of ternary oxides at the surface of the alloy. Presence of rubidium and cesium ions in the electrolyte were found to create an additional driving force for lanthanides (La and Ce) to leave the lattice of the alloy, thus, enhancing its corrosion. Corrosion, together with mechanical degradation, were found to be the main reasons of deactivation of LaMm-Ni_{4.1}Al_{0.3}Mn_{0.4}Co_{0.45} alloy upon elongated electrochemical treatment.

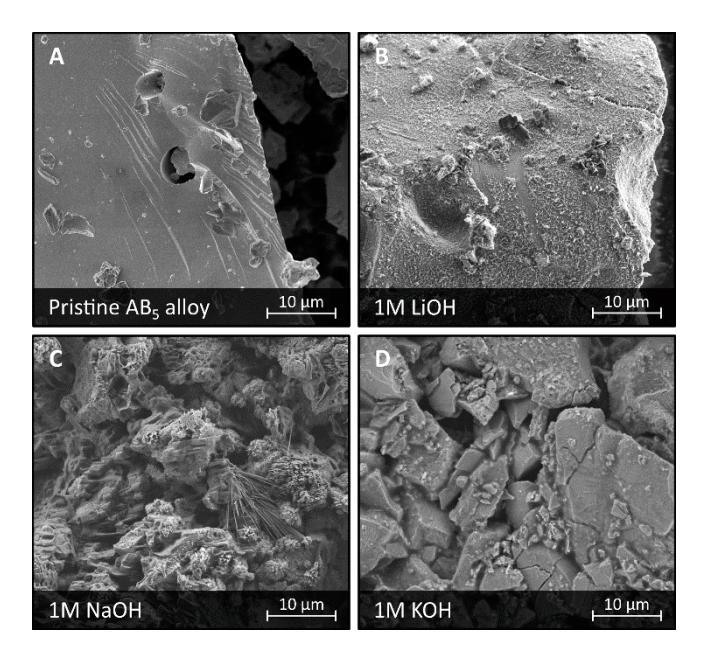
Figure 1. SEM images of a surface of LaMm-Ni_{4.1}Al_{0.3}Mn_{0.4}Co_{0.45} alloy not subjected to any treatment (**A**), and after electrochemical treatment in 1 M LiOH (**B**), 1 M NaOH (**C**), and 1 M KOH (**D**).

The surface of LaMm-Ni_{4.1}Al_{0.3}Mn_{0.4}Co_{0.45} alloy was investigated with SEM imaging after electrochemical treatment in electrolytes containing light alkali metal hydroxides, as shown in Figure 1A–D. The alloy was activated with a standard CV procedure and subjected to several cycles of charging/discharging before the surface investigation. In general, rather minor surface modifications were observed after electrochemical treatment in light alkali metal hydroxides. Only small and medium size needle-shape crystals, not fully covering the surface of the alloy, were found. Shape, size, and composition determined by EDS allowed us to identify these crystals as Mm(OH)₃, as shown in Figures S8 and S9. No other crystalline corrosion formations nor amorphous corrosion structures were found.

The largest Mm(OH)₃ needle-shape crystals, of a length reaching ca. 10 µm, were observed at the surface of the alloy treated in NaOH electrolytes (1 M NaOH, 6 M NaOH). We found also that treatment in NaOH results in the relatively largest coverage of the alloy surface by Mm(OH)₃ among all the light metal hydroxide solutions. Corrosion in LiOH and KOH electrolytes (1 M LiOH, 1 M KOH, 6 M KOH) was ongoing with significantly lower intensity resulting in lower surface coverage with Mm(OH)₃ needles. These observations are in very good agreement with the results of the electrochemical test showing the largest capacities of the alloy observed in 6 M LiOH/KOH and 6 M KOH, with slightly lower capacities at 6 M NaOH/KOH [22].

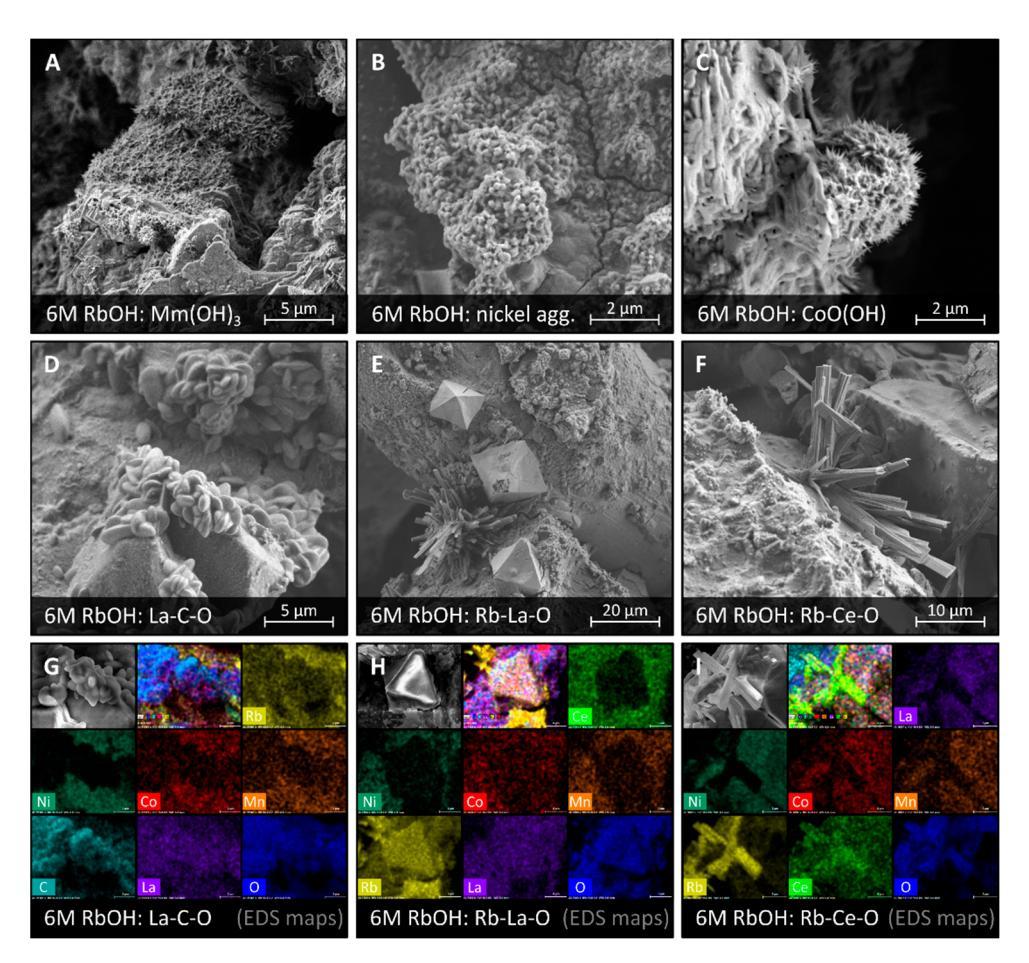
Figure 2. SEM images of a surface of LaMm-Ni_{4.1}Al_{0.3}Mn_{0.4}Co_{0.45} alloy after electrochemical treatment in 6 M RbOH showing surface formations of: Mm(OH)₃ (**A**), nickel aggregations (**B**), CoO(OH) (**C**), La-C-O (**D**), Rb-La-O (**E**), and Rb-Ce-O (**F**). EDS maps showing elemental distribution in the areas where corrosive surface formations were found: La-C-O (**G**), Rb-La-O (**H**), and Rb-Ce-O (**I**).

We have discovered the three new crystalline corrosion products, as shown in Figure 2D–F, not described before to appear at the surface of the AB₅-type alloy. Attempts of their identification was performed using elemental EDS analysis, as shown in Figure 2G–I, Figures S12–S19 and Tables S5–S8, supported by a search in a crystallographic database [31]. Unfortunately, our attempts to isolate these corrosion products and investigate them with X-ray diffraction were unsuccessful due to the small size of their crystals and relatively low number of well-formed corrosion sites.

Round-shaped small crystals most likely might be one of the hydrogenated lanthanum carbonates or oxalates, as shown in Figure 2D,G. The EDS elemental analysis showed high content of lanthanum, oxygen, and carbon within the crystals, while concentration of all other possible elements was much lower: Ni, Co, Mn, Al, Ce, Nd, Pr, Au, as shown in Figures S5 and S6 and Table S5. Ten crystalline La-C-O compounds were found in the Inorganic Crystal Structure Database (ICSD) [31], all of which were lanthanum carbonates and oxalates at various levels of hydration, as shown in Table S10. It is impossible to judge which of those compounds were observed in our samples. La-C-O crystals were relatively small, not exceeding 2 μ m in diameter, and they were appearing in a larger formation of 80–100 crystals.

Crystals in the shape of bipyramids are most likely rubidium-lanthanum oxide, as shown in Figure 2E,H. EDS elemental analysis showed simultaneous high content of rubidium, lanthanum, and oxygen within the crystals, with depletion of all other elements possible to be found in this sample: Ni, Co, Mn, Al, Ce, Nd, Pr, Au, as shown in Figures S14 and S15 and Table S6. RbLaO₂ was the only compound found in the ICSD crystallographic database, as shown in Table S10 [31], to contain exclusively rubidium, lanthanum, and oxygen [32]. Rb-La-O crystals observed were well-formed, having 15–20 μ m in diameter, and appearing in groups of 5–10.

The elongated rectangular crystals are most likely rubidium-cerium oxide, as shown in Figure 2F,I. High concentration of rubidium, cerium, and oxygen was detected within the crystals with EDS, as shown in Figures S16 and S17 and Table S7. Rb_2CeO_3 was the only compound containing Rb-Ce-O elements [33] found in the crystallographic database [31]. Purity of these crystals may result from inaccessibility of the +IV oxidation state by other lanthanides than cerium. The observed crystals were of various sizes starting from 2–3 µm in length, fully stuck to the surface, up to the crystals of 10–16 µm long, growing perpendicularly to the surface. Most often, the larger formations of Rb-Ce-O were found comprising 20–30 crystals growing from a common broader base.

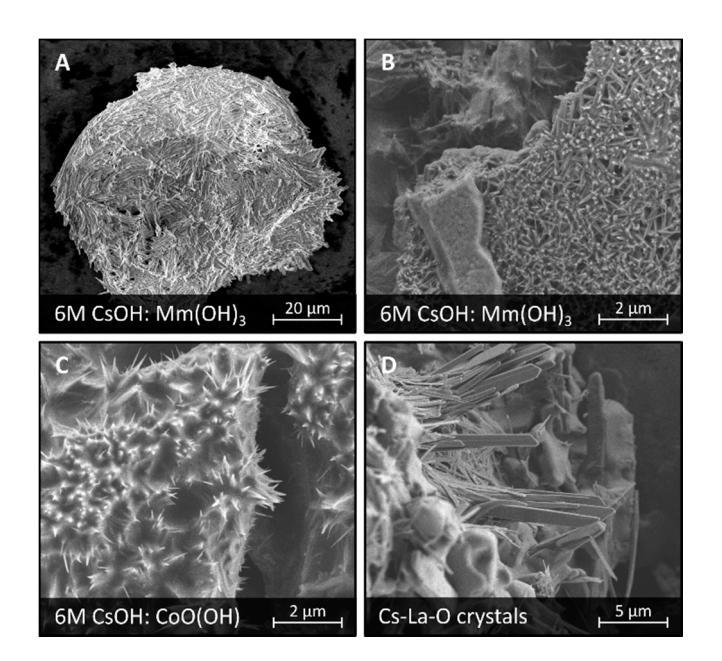
Figure 3. SEM images of a surface of LaMm-Ni_{4.1}Al_{0.3}Mn_{0.4}Co_{0.45} alloy after electrochemical treatment at 6 M CsOH showing surface formations of: Mm(OH)₃ (**A**,**B**), CoO(OH) (**C**), and Cs-La-O (**D**).

The surface of LaMm–Ni_{4.1}Al_{0.3}Mn_{0.4}Co_{0.45} alloy was covered with the products of its corrosion after treatment in CsOH solutions (1 M CsOH, 6 M CsOH). The surface was mostly covered by a thick continuous corrosion layer of crystalline Mm(OH)₃, as shown in Figure 3A,B, and small spiky crystals of CoO(OH), as shown in Figure 3C, described before [15]. However, areas of uncovered surface were noticed.

We observed one corrosion product which was not reported earlier in similar systems, as shown in Figure 3D. This compound forms elongated crystals of a morphology reminiscent of the Rb-Ce-O crystals described above. However, the EDS analysis showed that the only elements present in these crystals are cesium, oxygen, and lanthanum (instead of cerium), with depletion of all other elements which might be present in this sample: Ni, Co, Mn, Al, Ce, Nd, Pr, Au, as shown in Figure S20 and Table S9. Thus, the elongated crystals are most likely cesium-lanthanum oxide. No Cs-La-O compounds were found in the ICSD, as shown in Table S10 [31], however, one compound of this composition, mainly CsLaO₂, was previously mentioned in the literature [34]. Cs-La-O crystals having an average length of $5-15 \mu m$, appear in large formations of 20–30 crystals growing from a common base. CsOH electrolyte enhances the rate of corrosion of the AB₅ alloy, similarly to RbOH, but leading to more uniform surface coverage resulting in a capacity decrease of the alloy. It is worth mentioning that CsOH is a very aggressive medium, which causes corrosion of various materials, including glass. Cesium is able to form crystalline ternary compounds with lanthanum and oxygen, which provides an additional driving force for lanthanum to migrate to the surface of the alloy.

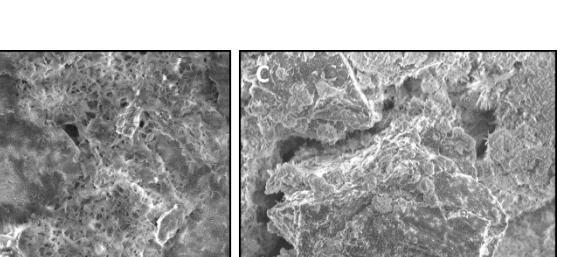
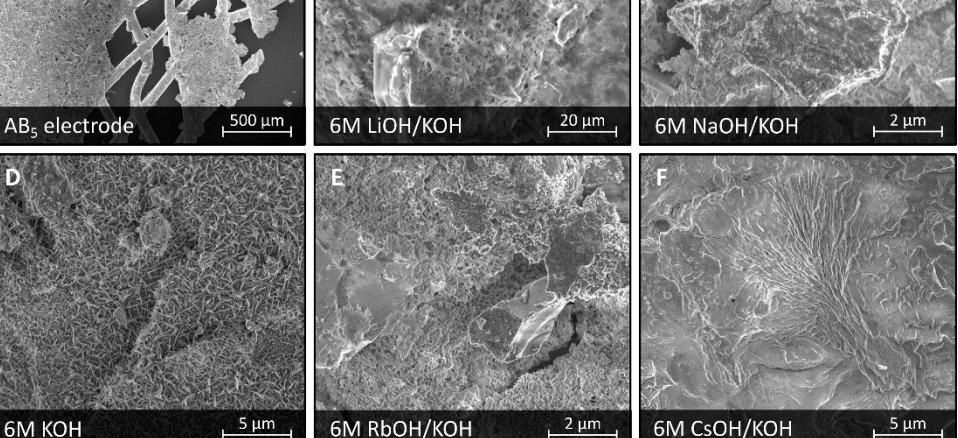
Figure 4. SEM images of a surface of LaMm-Ni_{4.1}Al_{0.3}Mn_{0.4}Co_{0.45} alloy not subjected to any treatment (**A**), and after electrochemical treatment at 6 M electrolytes: 6 M LiOH/KOH (**B**), 6 M NaOH/KOH (**C**), 6 M KOH (**D**), 6 M RbOH/KOH (**E**), and 6 M CsOH/KOH (**F**).

Surprisingly, corrosion of LaMm-Ni_{4.1}Al_{0.3}Mn_{0.4}Co_{0.45} alloy, electrochemically treated in 6 M mixed electrolytes containing 4 M KOH and 2 M additive of another component (LiOH, NaOH, RbOH, or CsOH), is much less dependent on composition of the electrolyte than in the case of single component electrolytes, and it is similar to corrosion occurring solely in 6 M KOH, as shown in Figure 4. In all cases of pristine 6 M KOH and bimetallic 6 M MOH/KOH electrolytes, corrosion goes in a direction of selective oxidation of lanthanides, as described before [15]. No other large corrosion formations, even in electrolytes containing RbOH and CsOH, were observed, as shown in Figure 4E,F.
