Corrosion and Residual Strength Analysis of High Pressure Die Casting AM Series Mg Alloys

Abstract: Higher pressure die casting (HPDC) AM series (Mg-Al-Mn) Mg alloys have wide application potential in the automobile industry. To promote its application, systematic investigation on the corrosion performance and corrosion residual strength of HPDC AM50+1Ce and AM60 was carried out. The corrosion of HPDC AM50+1Ce was more uniform, while the pitting corrosion of AM60 was more severe, and the mechanical properties of HPDC AM60 was more sensitive to corrosion. The residual strength of AM50+1Ce and AM60 after corrosion of 648 h was 199 MPa and 183 MPa, respectively. The findings can contribute to a better understanding of the corrosion and residual strength of HPDC AM series Mg alloys.

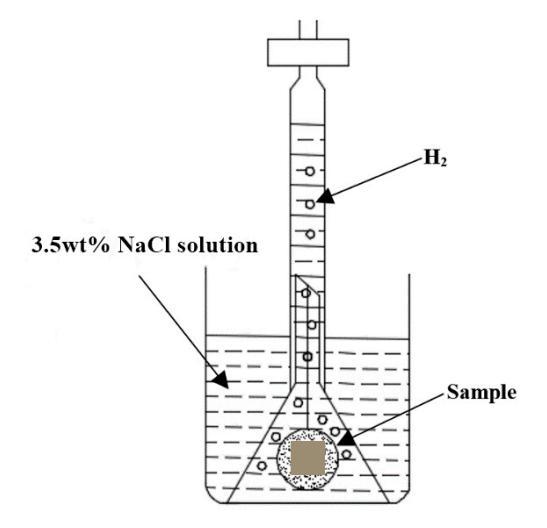
Figure 1. Schematic illustration of hydrogen evolution apparatus.

The HPDC AM60 and AM50+1Ce were processed into square samples with a dimension of 10 mm \times 10 mm \times 5 mm. Firstly, the surface of the sample was ground with SiC sandpaper (up to 200 grit), and cleaned with ethanol in an ultrasonic cleaner for 10 min. Then the samples were sealed with resin to expose only the working surface of 10 mm \times 10 mm, and the working surface of the sample was sequentially polished with SiC sandpaper (up to 1000 grit). After being cleaned with ethanol in the ultrasonic cleaner again, the samples were taken out and dried with cold air. The schematic diagram of the hydrogen evolution test is illustrated in Figure 1. The samples were tied with a thin wire, then put into a beaker containing 200 mL 3.5 wt% NaCl solution, an inverted burette with a funnel were used to collect and measure the evolved hydrogen, and the data was collected over 132 h. In addition, much attention was paid to make sure the working surface of the sample was vertical to the bottom of the beaker during the experiment.

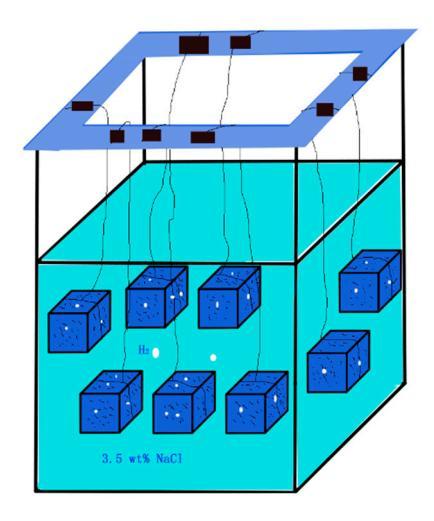
Figure 2. Schematic diagram and actual picture of the weight loss experiment.

Samples for weight loss were cut from the samples provided and machined into a cuboid with a dimension of 10 mm × 10 mm × 5 mm. Before the immersion experiment, the six faces of the weight loss sample were first grounded with SiC sandpaper (up to 1000 grit). Then cleaned with anhydrous alcohol in an ultrasonic cleaner for 5 min, and rinsed with anhydrous alcohol again, then dried with cold air. The actual dimension of the weight loss samples was measured with a Vernier caliper, and the actual surface area S_0 of each sample was calculated, then the initial weight was measured and recorded as m_0 . Each weight loss sample was labeled and sealed. The weight loss test was performed at time junctures of 24 h (1 day), 72 h (3 days), 168 h (7 days), 264 h (11 days), 456 h (19 days) and 648 h (27 days). As presented in Figure 2, the samples were tied with a thin wire and immersed in a 3.5 wt% NaCl solution during the experiment. After the immersion test, silver nitrate combining with chromic acid solution was used to clean the corrosion product, then the samples were rinsed with anhydrous alcohol and dried with cold wind, finally the weight after corrosion was measured and recorded as m_t .

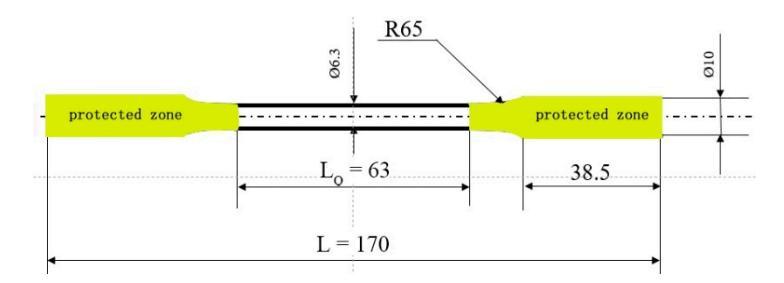
Figure 3. The tensile sample for the corrosion residual strength test.

The tensile samples as shown in Figure 3 were immersed in 3.5 wt% NaCl aqueous solution at room temperature for six sets of time, 24 h (1 day), 72 h (3 days), 168 h (7 days), 264 h (11 days),

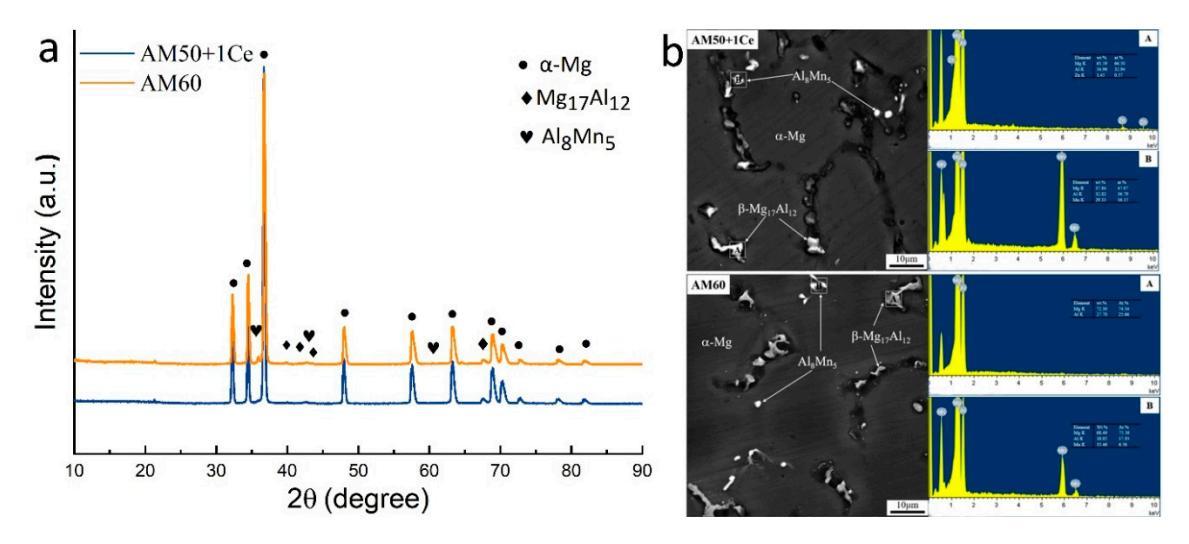
Figure 4. (a) XRD pattern and (b) SEM with EDS of higher pressure die casting (HPDC) AM50+1Ce and AM60 magnesium alloys.

Looking at the XRD pattern (Figure 4a), both alloys were composed of α -Mg, Mg₁₇Al₁₂ and Al₈Mn₅ phases, the result was further confirmed from Energy Dispersive Spectrometer (EDS) (Figure 4b). The actual composition of the tested alloy is presented in Table 1. Figure 5 shows the hydrogen evolution curves of HPDC AM50+1Ce and AM60 immersed in 3.5 wt% NaCl solution for 132 h. As immersion time extended, the amount of hydrogen evolution increased continuously. At 132 h, the hydrogen evolution of HPDC AM50+1Ce reached 2.05 mL/cm², while the hydrogen evolution of AM60 was 1.41 mL/cm², which was 0.849 mm·y⁻¹ and 0.584 mm·y⁻¹, respectively. The hydrogen evolution of HPDC AM50+1Ce was much larger than that of AM60, indicating that the self-corrosion rate of AM50+1Ce was greater than AM60. Looking at Figure 5b, the hydrogen evolution rate of HPDC AM50+1Ce was always greater than that of AM60 during the 132 h period of immersion test. In the initial stage, the corrosion rate of both alloys increased quickly, then the corrosion media, a large

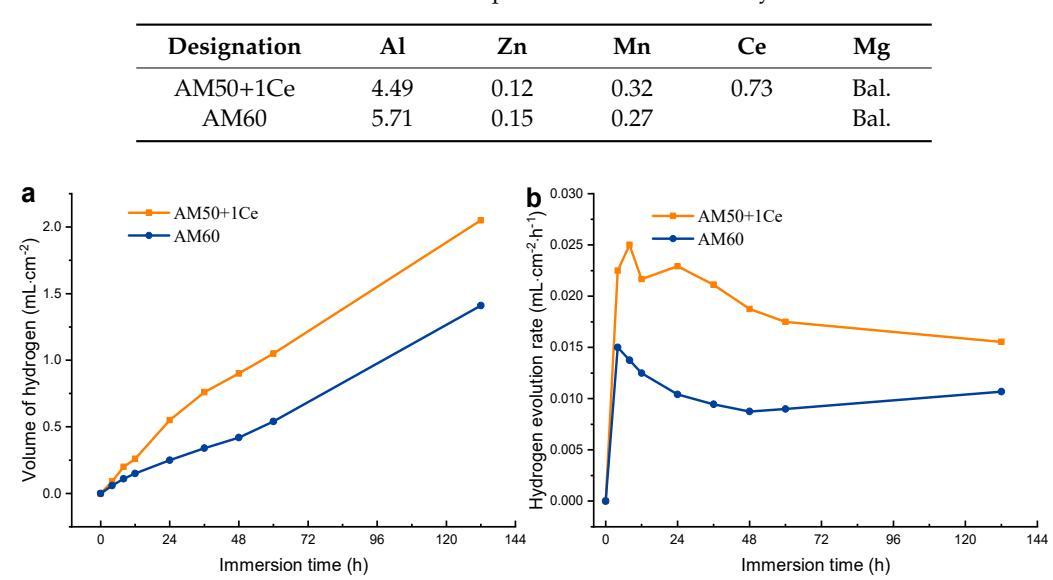
Figure 5. Volume of hydrogen evolved (**a**) and hydrogen rate (**b**) for HPDC AM series Mg alloys during 132 h immersion in 3.5 wt% NaCl solution.

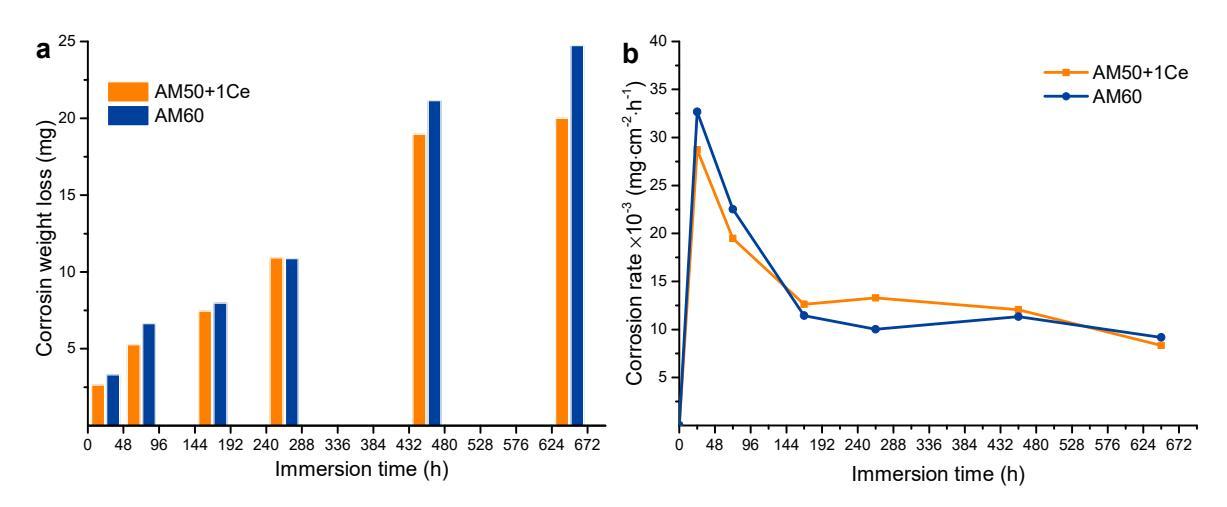
Figure 6. The weight loss (**a**) and corrosion weight rate (**b**) of HPDC AM50+1Ce and AM60 during immersion in 3.5 wt% NaCl solution for 648 h.

in 3.5 wt% NaCl solution for 648 h. As the immersion time extended, the corrosion loss of the two samples both increased. It can be observed from Figure 6b that the weight loss rate of HPDC AM50+1Ce and AM60 rose sharply during the 0–24 h immersion stage, the weight loss rate of AM60 ($9.162 \times 10^{-3} \text{ mg} \cdot \text{cm}^{-2} \cdot \text{h}^{-1}$) was greater than AM50+1Ce ($8.342 \times 10^{-3} \text{ mg} \cdot \text{cm}^{-2} \cdot \text{h}^{-1}$), indicating that in the whole process of immersion for 648 h in 3.5 wt% NaCl solution, the average corrosion of HPDC AM60 was more serious. According to Equation (2), the annual average corrosion rates of HPDC AM50+1Ce and AM60 were calculated to be 0.406 mm·y⁻¹ and 0.446 mm·y⁻¹, respectively. The data from mass loss was close, and the data of mass loss was easily influenced in the corrosion product clean process, so a corrosion test through other methods was further conducted to compare the corrosion of these two alloys.

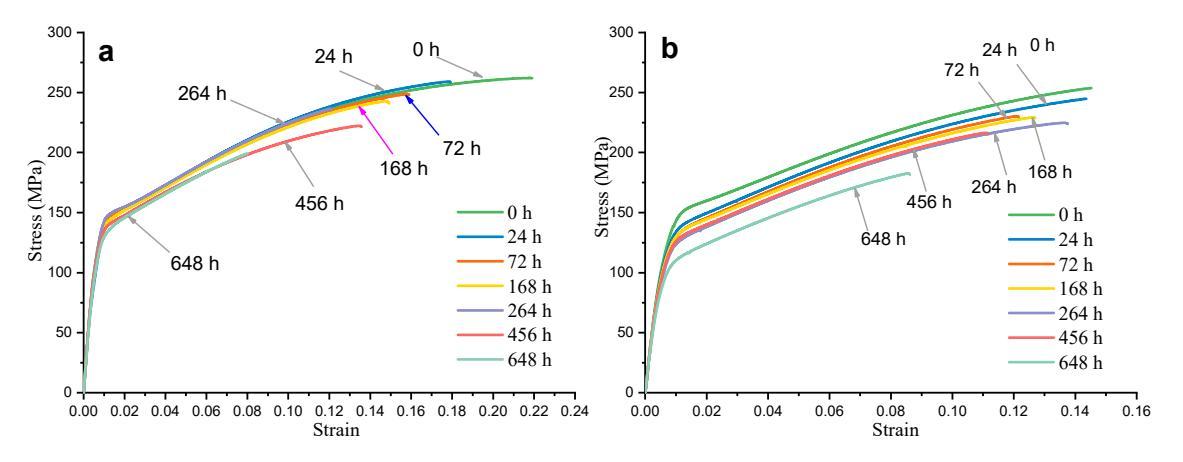
Figure 7. The engineering stress–strain curve of HPDC (**a**) AM50+1Ce and (**b**) AM60 magnesium alloys after corrosion test for different time immersing in 3.5 wt% NaCl solution.

Figure 7 shows the engineering stress-strain curves obtained after corrosion of HPDC AM50+1Ce (a) and AM60 (b) in 3.5 wt% NaCl solution for 24 h, 72 h, 168 h, 264 h, 456 h and 648 h, respectively. The stress-strain curves at different corrosion time points all included the elastic deformation stage, the plastic deformation stage and the fracture. Corrosion did not change the deformation form of the magnesium alloy during the tensile process. It can be seen from Figure 7 that the yield strength, tensile strength and elongation of the two magnesium alloys tended to decrease with the extension of corrosion time. Figure 8 compares the corrosion residual strength of HPDC AM50+1Ce and AM60 immersed in 3.5 wt% NaCl solution for different times. During the immersion period of 0-72 h, the tensile strength of the two magnesium alloys declined significantly. In this process, the corrosion had just spread throughout the tensile specimen surface. During the subsequent 72–456 h period, the tensile strength of AM60 decreased little. In this process, a protective oxide film formed, but after immersion for 456 h, the oxide film was broken or damaged, which accelerated the corrosion of the magnesium alloy, resulting in a significant decrease in tensile strength. However, for HPDC AM50+1Ce magnesium alloy, there was no formation of a stable protective film after immersion for 72 h, the film layer fell off, the magnesium substrate was exposed, the corrosion aggravated, and the tensile strength showed a continuous decline. The corrosion residual strength of the two sets of samples after immersion for 648 h in 3.5 wt% NaCl solution was 199 MPa and 183 MPa, respectively, which were 63 MPa and 71 MPa lower than the immersion strength of 0 h, respectively. A simple comparison of the influence of corrosion on the strength shows that the greater the corrosion rate, the greater the rate of weight loss, and the more the cross-sectional area of the gauge section of the tensile specimen was reduced, the more the tensile strength decreased. The variation of the weight loss rate of HPDC AM50+1Ce and AM60 could reflect the corrosion rate of the alloy to some extent. However, many studies have shown that pitting corrosion is much more destructive to the substrate

than uniform corrosion. The corrosion weight loss method is an average evaluation method for the corrosion rate, so it cannot accurately characterize the degree of local corrosion or pitting corrosion on the substrate, thus underestimating the harm of pitting. For Mg alloy under working load, pitting corrosion has significant influence on the mechanical properties of the alloy. Therefore, pitting depth is often used to evaluate the pitting corrosion. Therefore, experimental results of corrosion residual strength could only show that the pitting corrosion of AM60 was more serious, and its tensile strength was more likely to be influenced in the corrosion process in 3.5 wt% NaCl solution.

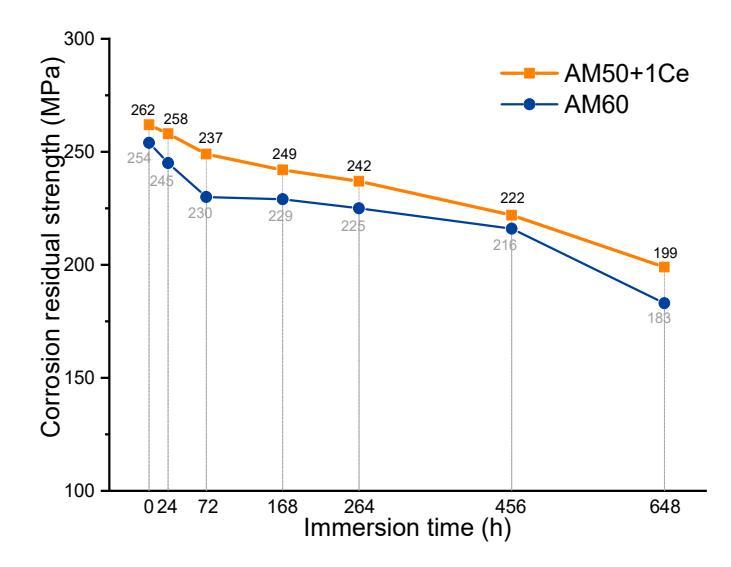
Figure 8. The corrosion residual strength comparison of HPDC AM50+1Ce and AM60 magnesium alloy for different corrosion times.

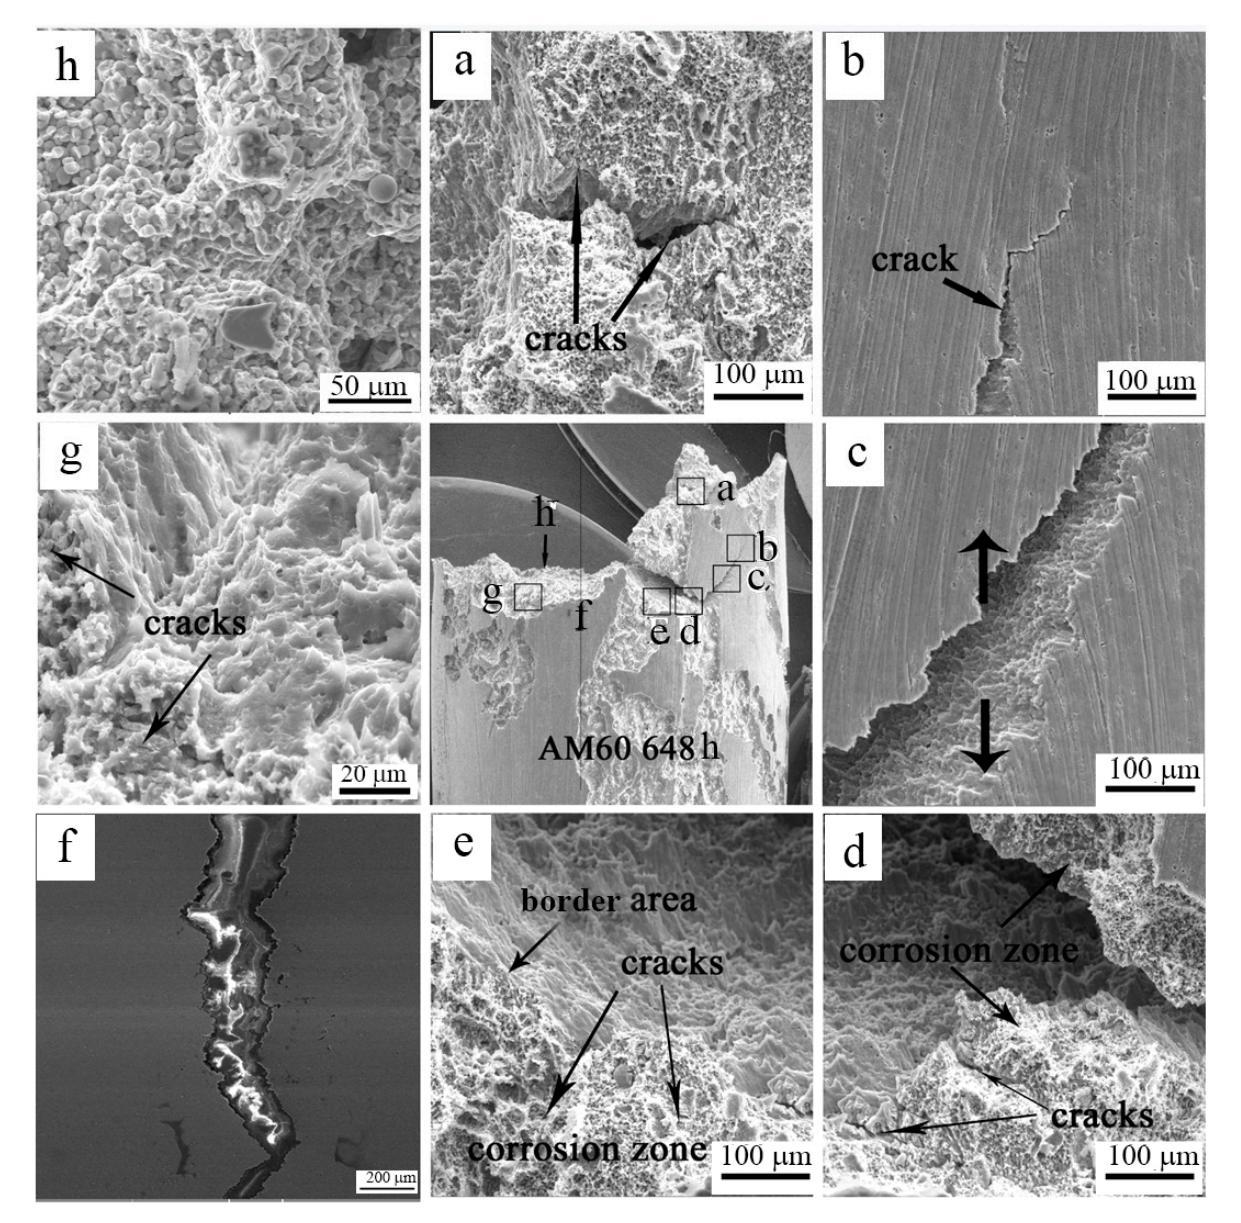
Figure 9. The tensile fracture surface of different zone (**a**–**h**) of HPDC AM60 magnesium alloy immersed in 3.5 wt% NaCl solution for 648 h.

To further investigate the effect of corrosion on the strength of HPDC AM60, after immersion in 3.5 wt% NaCl aqueous solution for 648 h, the fracture surface of AM60 was observed under scanning electron microscopy. As can be seen from (a), (d), (e) and (h) in Figure 9, a large number of micro cracks were formed at the interface between the corroded area and the intact matrix. Under the load condition, these micro cracks were preferentially formed in the pitting area and extended to the inside of the magnesium matrix. Fracture morphology near the corrosion zone (e) is different from the morphology in the interior (g) of the matrix. The fracture morphology of the transition zone has no dimples and no tearing edges, which was a brittle fracture. Due to the formation of a large number of micro cracks in the corrosion zone of the surface layer, the crack propagation grew and joined together, and it is easy to form a highly harmful tear pattern on the surface of the alloy, as shown in Figure 9b,c. Cracks

expand rapidly, causing the material to break. Although the corrosion did not change the main plastic deformation mechanism and the final fracture mechanism inside the matrix, the appearance of a large number of cracks on the surface layer had a great influence on the fracture of the alloy.

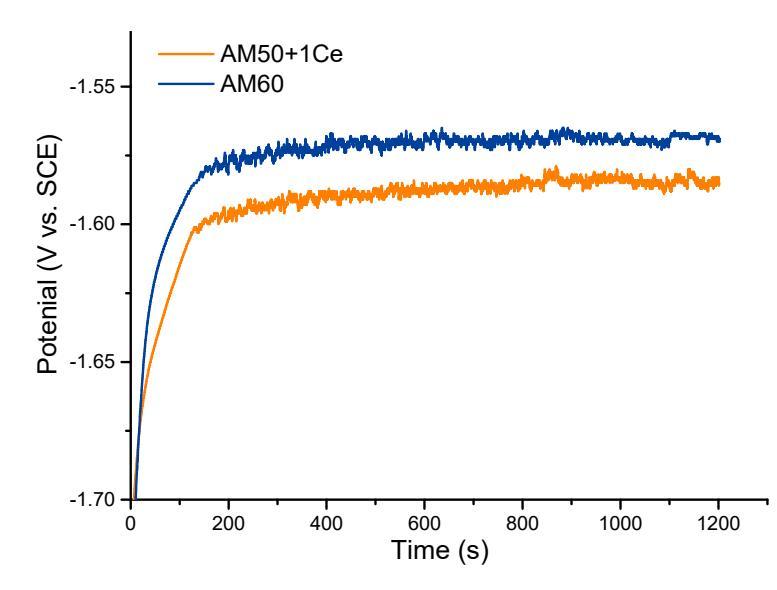
Figure 10. The open circuit potential of HPDC AM50+1Ce and AM60 magnesium in 3.5 wt% NaCl solution.

Figure 10 compares the open circuit potential (OCP) of HPDC AM50+1Ce and AM60 in 3.5 wt% NaCl solution. In the initial stage, the evolution of the OCP was closely related to the growth of the local corrosion of the alloy [34]. In the first 200 s, the OCP of the two in the 3.5 wt% NaCl aqueous solution was different, the surface of the working electrode was constantly polarized over time, the potential shifted towards positive direction and then the two reached the potential stable platform almost simultaneously. This was the result of dynamic balancing between the local corrosion and corrosion product. When AM50+1Ce reached steady state, the potential was around -1.585 vs. SCE, and the stable platform potential of AM60 was about -1.557 vs. SCE. The AM50+1Ce had more active electrochemical activity.

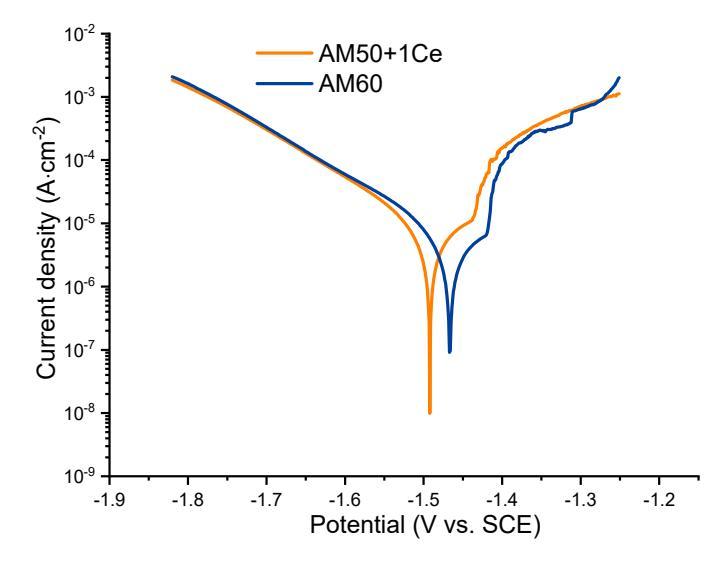
Figure 11. Potentiodynamic polarization behavior of HPDC AM50+1Ce and AM60 magnesium alloys in 3.5 wt% NaCl solution.

Figure 11 presents the polarization curves of HPDC AM50+1Ce and AM60 in 3.5 wt% NaCl solution. It was obvious that the cathode branch and the anode branch of the polarization curve were asymmetrical. In the process of anodic polarization, there was a small platform and a curve jump phenomenon, indicating the pitting and collapse of the passivation film, in the later stage, the AM60 anodic polarization branch fluctuated greatly, which relates to the pitting corrosion [23,35,36]. Moreover, in the anodic polarization process, the current density of AM50+1Ce was greater than that of AM60, indicating that the former was more severely corroded. Corresponding electrochemical parameters were calculated through the cathode branch of polarization curve by the Tafel extrapolation method, the corrosion current density (i_{corr}) and corrosion potential (E_{corr}) are summarized in Table 2. According to the fitting results, HPDC AM50+1Ce sample had a more negative corrosion potential (-1.522 V vs. SCE) and a larger corrosion current density (79.63 μ A·cm⁻²), indicating a higher electrochemical activity. The corrosion potential (-1.497 V vs. SCE) of AM60 was more positive, and its corrosion current density ($69.57 \ \mu$ A·cm⁻²) was also smaller, indicating that it had better corrosion resistance than the former one. This was consistent with the hydrogen evolution results. The corrosion rate of HPDC AM50+1Ce was larger than that of AM60.

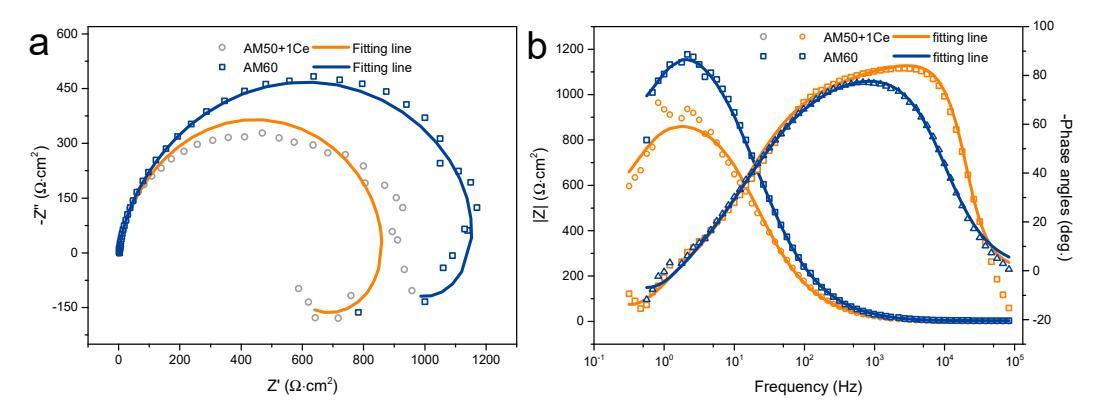
Figure 12. The Nyquist (**a**) and Bode plots (**b**) of EIS data of HPDC AM50+1Ce and AM60 magnesium alloys in 3.5 wt% NaCl solution.

The results of the EIS are set out in Figure 12. In the Nyquist plot, it is clear that AM60 had a larger capacitive arc than AM50+1Ce, indicating that AM60 had a better corrosion resistance than AM50+1Ce. Similar results could also be obtained from the Bode plot, in which the impedance modulus of AM60 was apparently higher than that of AM50+1Ce. The higher impedance modulus in the low frequency range indicates better corrosion resistance [8,9]. The impedance modulus (2 Hz) of AM60 and AM50+1Ce was about 1150 $\Omega \cdot cm^2$ and 850 $\Omega \cdot cm^2$, respectively. For both of them, the impedance modulus turned to decline after reaching the peak with a positive shift in phase angle in low frequency range, which is the character of inductive behavior. The EIS data was further analyzed by fitting the raw data using the equivalent circuit (Figure 13), Table 3 summarizes the value of all the element used to fit the EIS data. What stood out in this table was the difference between the two alloys, AM60 shows larger values in all resistance values. R_s is the solution resistance between the working electrode and the reference electrode [37], $R_{\rm CT}$ is the charge transfer resistance of the electrical double layer near the surface, which is a key parameter related to the corrosion performance of magnesium alloys. To fit the capacitive property of the interface, constant phase element (CPE) was introduced. CPE can both fit the capacitive property and enhance the fitting quality, which has been used widely in fitting EIS data [8]. $R_{\rm CP}$ represents the resistance characteristic of the corrosion products that cover part of the substrate surface, in the present study, the value of this element was quite small, which indicated the poor protective property of the passivation film. The $R_{\rm CT}$ combined with CPE₂ represents the cathode reaction process of magnesium alloy, which was why the charge transferring in this process was a key parameter related to the corrosion. On the contrary, R_L and L_A represent the resistance and inductance related to the anode process of the corrosion [38]. Comparing the corrosion rate from weight loss, hydrogen evolution, corrosion current and EIS, we could see that the result was consistent excluding weight loss. As we mentioned above, the data of weight loss was close and easily influenced in the cleaning process, so according to the hydrogen evolution and electrochemical test, we came to the conclusion that the corrosion rate of AM50+1Ce was larger than AM60.

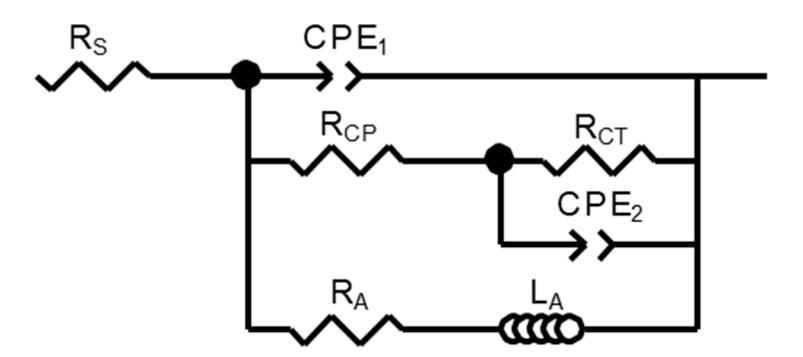
Figure 13. Equivalent electrical circuit used to fit the EIS spectra of HPDC AM50+1Ce and AM60 magnesium alloys.

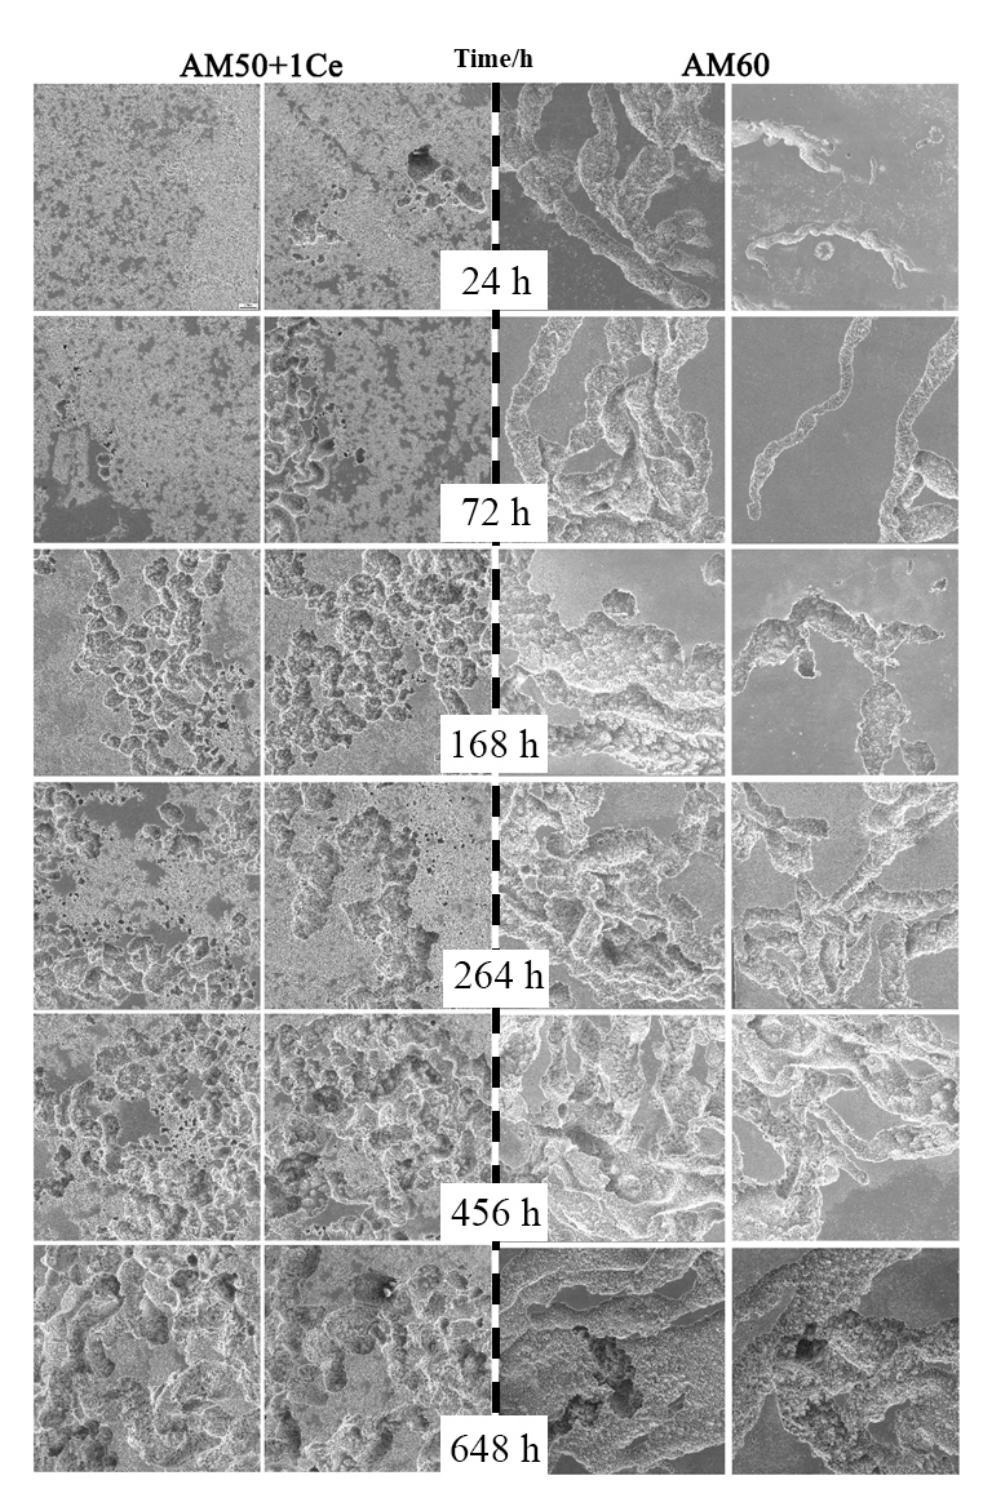
Figure 14. The corrosion morphology of HPDC AM50+1Ce and AM60 in 3.5 wt% NaCl solution for immersion of 24 h, 72 h, 168 h, 264 h, 456 h and 648 h.

The morphology and corrosion propagation of HPDC AM50+1Ce and AM60 after immersion for 24 h, 72 h, 168 h, 264 h, 456 h and 648 h in 3.5 wt% NaCl solution is displayed in Figure 14. Corrosion of both alloys began with pitting, but there was a noteworthy difference in corrosion propagation behavior. Local corrosion of AM60 was more obvious, and its macroscopic corrosion morphology was similar to the filamentous corrosion pit of AZ91. As the immersion time progressed, the corrosion progressed toward the two sides of the filament corrosion, the tip and the inside of the matrix, and the filamentous corrosion pits were connected to each other, continuously eroding the magnesium matrix. Local corrosion of HPDC AM50+1Ce was lighter, showing more corrosion nucleation points, more uniform corrosion spread and more uniform corrosion morphology, but there was still some local corrosion in the alloy. Moreover, as the immersion time prolonged, the etch holes continued to expand, the corrosion pits continued to grow, and the corrosion pits were connected to each other, thereby eroding the entire alloy surface, and finally forming corrosion appearance with different sizes, different depths, and uneven distribution. The main reason was that the solidification process of die-cast magnesium alloy is a non-equilibrium solidification process. There are components such as segregation and uneven structure in the alloy, which leads to different corrosion potentials in different parts. The protective film formation was different, and finally the difference of corrosion morphology presented.

Figures 14 and 15 show the surface corrosion characteristics of the AM50+1Ce and AM60, but the corrosion to the inside of the matrix was not clear. For this reason, weight loss samples of AM50+1Ce and AM60 after immersion time of 456 h and 264 h in 3.5 wt% NaCl solution were selected for cross-section observation, as presented in Figure 16. The results show that the corrosion of AM50+1Ce was more uniform to the whole of the matrix; while the local corrosion of AM60 was severe, indicating that the pitting effect was stronger, it can be observed that the corrosion pit was in the favorable direction during the expansion process. In particular, casting defects inside the alloy extend to form three-dimensional corrosion pits of various shapes. The area where the corrosion has not occurred was

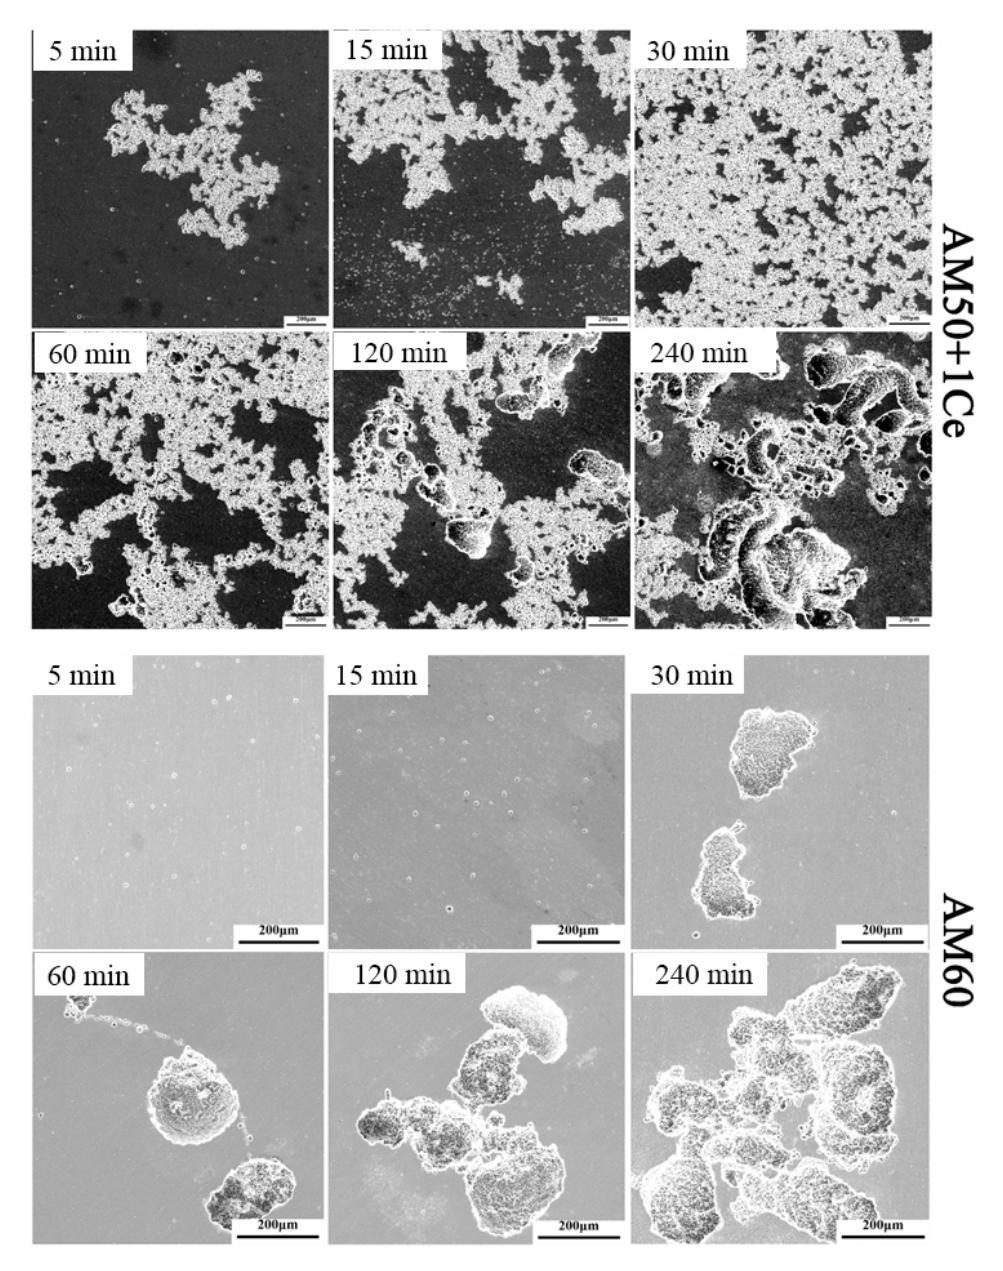
Figure 15. The corrosion morphology for HPDC AM50+1Ce and AM60 in immersion for different times.

To further investigate the corrosion behavior and expansion of two alloys, two sets of samples were immersed in the corrosion media for 5 min, 15 min, 30 min, 60 min, 120 min and 240 min, then the corrosion products were cleaned and observed. As shown in Figure 15, in the initial stage, AM50+1Ce corroded in a large area, the distance between each pitting was small, and the expansion speed of corrosion pit was faster. Corrosion pits quickly merged into larger corrosion pits, gradually eroded the surface layer of magnesium alloy, and the overall corrosion rate was faster, which was consistent with the previous hydrogen evolution results. The AM60 corroded very slowly in the initial stage,

mainly concentrated in a small area, especially in casting defects such as shrinkage cavities and pores. It can be seen from Figure 15 that the pitting in the AM60 magnesium alloy continuously enlarged and deepened, the corrosion pits connected and merged, and the corrosion was still not observed in the area where no corrosion had occurred before, thus indicating local corrosion of AM60 was severe, which was consistent with previous electrochemical tests and corrosion residual strength results.

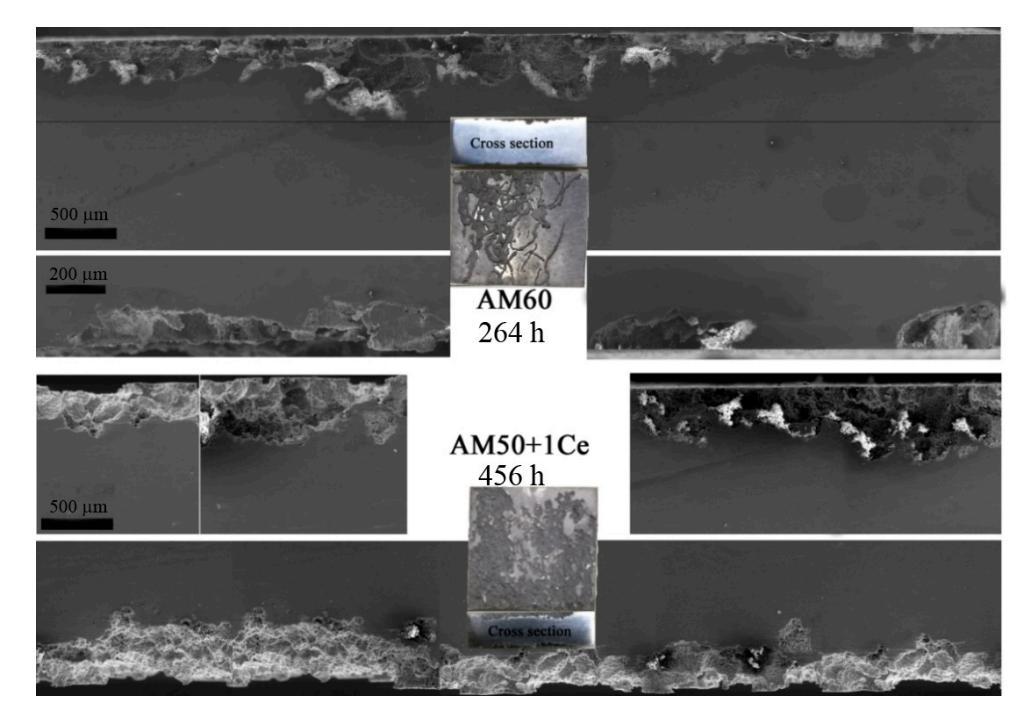
Figure 16. The cross-section corrosion morphology of HPDC AM50+1Ce and AM60 magnesium alloys immersed in 3.5 wt% NaCl solution for 456 and 264 h.

gradually eroded, and was removed during the cleaning process. At the same time, it can be observed that micro cracks were formed in the corroded areas, which was consistent with the observation in Figure 9, which would adversely affect the mechanical properties of the magnesium alloy.

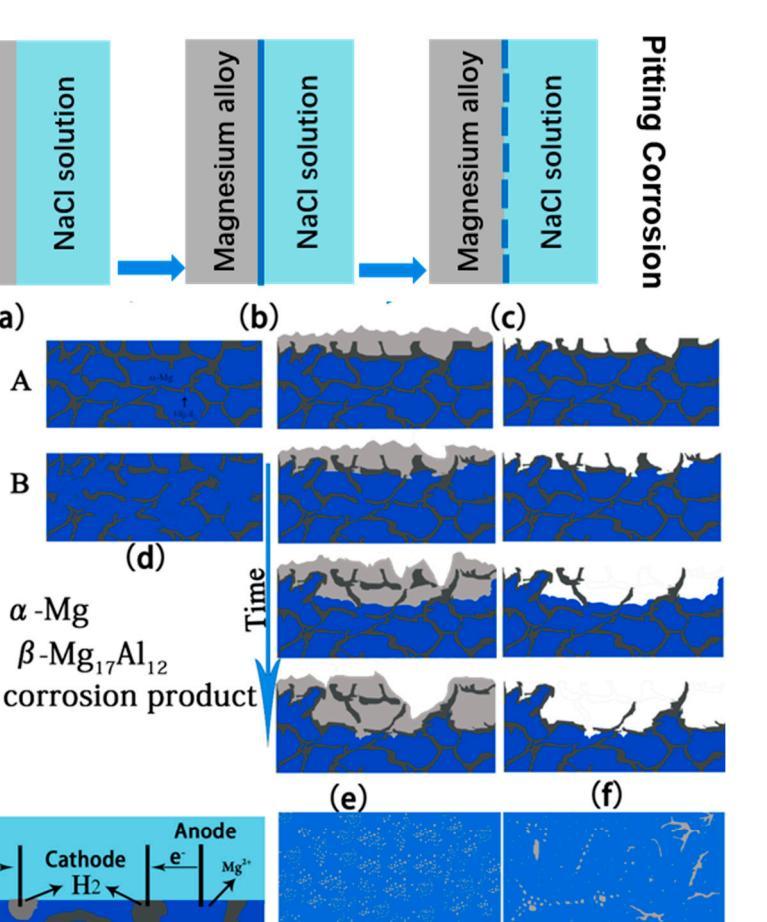
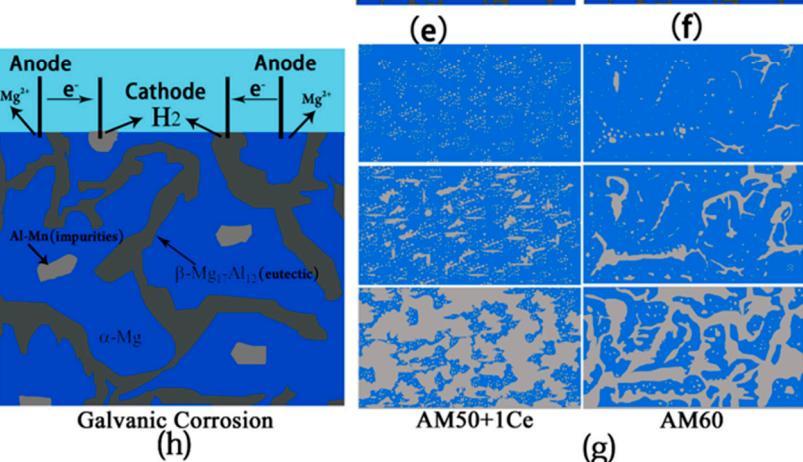
Figure 17. The schematic diagram of corrosion mechanism and morphology expansion model of HPDC AM50+1Ce and AM60 magnesium alloys in 3.5 wt% NaCl solution. (a-c) pitting process; (d) two type of second phase structure; the corrosion model before (e) and after (f) corrosion products cleaning; (g) corrosion propagation behavior of these two alloys and schematic diagram of galvanic corrosion.

Based on the analysis of corrosion behavior and corrosion morphology of HPDC AM50+1Ce and AM60, a corrosion mechanism and morphology extension model were established. As shown in Figure 17, a thin film formed when magnesium alloy came into contact with the corrosion solution. For HPDC Mg alloy, the defect such as gas pore can lead to the local corrosion and destruct the film, pitting corrosion occurs. With the dissolution of Mg, the concentration of Mg ions in the solution increases continuously. Due to the slow diffusion rate of Mg ions in the solution under static conditions, the concentration of Mg ion is very high near the surface of the sample, and the Mg easily reacts with OH^- to form Mg(OH_{2} , attaching to the surface of the magnesium alloy. However, this corrosion product layer is not dense enough, and Cl^- has the characteristics of small dimension, low hydration degree and fast moving speed, which makes it easy to pass through the Mg(OH_{2} film. In addition, the film easily drops off from the surface, then the magnesium matrix is again exposed, and as the concentration of Cl^- increases, the damage is more serious, thereby aggravating the corrosion of the magnesium alloy.
