Article Laser Surface Hardening of Gun Metal Alloys

Abstract: The effect of laser irradiation with different numbers of laser shots on the microstructure, the surface, and the hardness of gun metal alloy was studied by a KrF pulsed excimer laser system, X-ray diffraction, Raman spectroscopy, scanning electron microscopy, and Vickers hardness test. The influence of 100–500 laser shots was irradiated on the surface hardness profile and on the microstructure of gunmetal alloy. XRD results showed the maximum 20 shift, the maximum full width of half maximum FWHM, the maximum dislocation density, and the minimum crystallite size for the sample irradiated with 300 laser shots. The hardness was measured in three different regions at the laser irradiated spot, and it was found that maximum hardness was present at the heat affected zone for all samples. The hardness value of the un-irradiated sample of gun metal was 180, and the value increased up to 237 by raising the number of laser shots up to 300. The peak value of surface hardness of the laser treated sample was 32% higher than the un-irradiated sample. The Raman shift of the un-exposed sample was 605 cm⁻¹ and shifted to a higher value

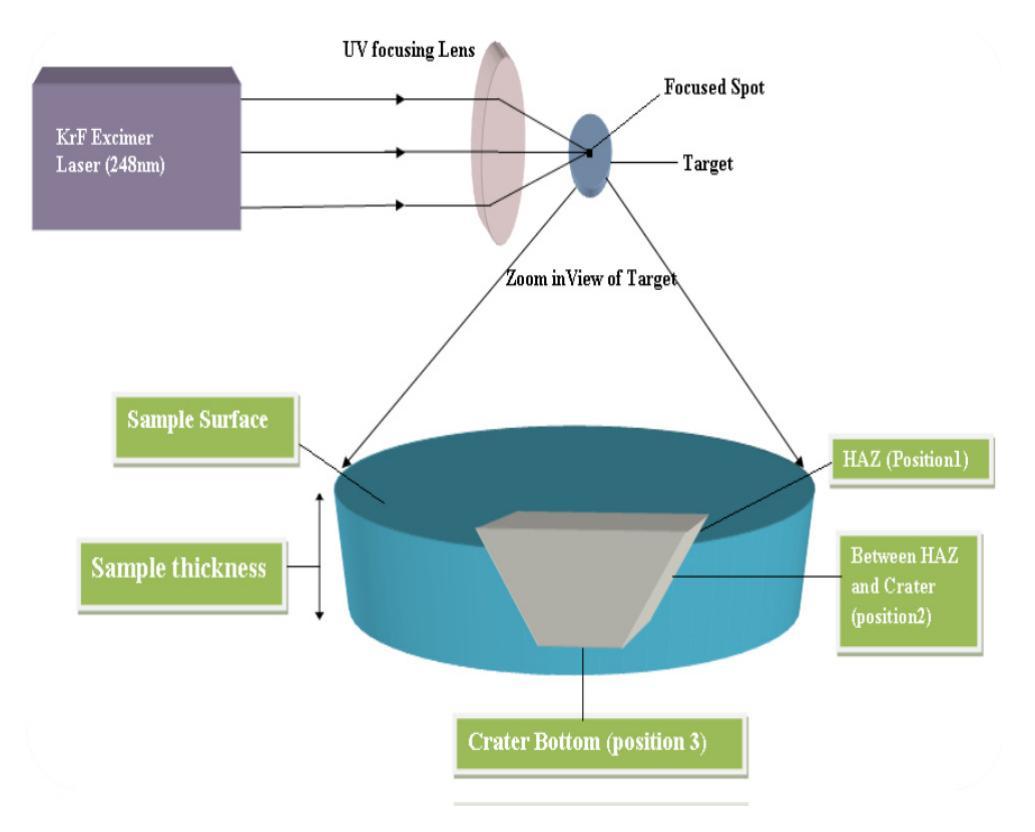
Figure 1. Schematic of the experimental setup used for laser irradiation.

Six circular shaped discs (diameter = 16 mm, thickness = 7 mm) were cut from the cylindrical rod of gunmetal copper alloy (C90300). The elemental analysis of this alloy was done using an optical emission spectrometer (Model: J 75/80, Italy). The composition of the alloy was: 88.5 wt% copper, 8 wt% tin, and 3.2 wt% zinc with traces of iron and sulfur. All the samples were annealed at T = 550 °Cfor 2 hours before laser irradiation and characterization inside the electrical furnace (NeytechQex, USA). The samples surfaces were made rough by rubbing them gently with sandpaper for higher laser absorption. After this, samples were ultrasonically cleaned in isopropyl alcohol to remove dirt and impurities. The KrF pulsed excimer laser (Ex50, GAM LASER INC, USA) was used to irradiate the samples with parameters (E_l = 18 mJ, λ = 248 nm, v_l = 20 Hz, τ_l = 20 ns, \emptyset = 1 J/cm²). The unfocussed laser beam $(9 \times 4 \text{ mm}^2)$ was passed through a circular aperture and focused through a UV quartz lens in the image plane to a circular spot of area 1.8 mm². The previous work reported that the higher hardness was observed when the samples were irradiated in the air as compared to a vacuum. Therefore, all the samples in the present work were irradiated in the air at room temperature. One sample was kept un-irradiated for reference, and the other five samples were irradiated by 100, 200, 300, 400, and 500 laser shots. The lattice of the laser irradiated spots was achieved with 1 mm separation of each spot. The elemental analysis of the gunmetal samples was again done and was found to be the same composition as it was before laser irradiation. The XRD (D8 Discover, Bruker, Germany) and the Raman spectroscopy (BX 41, Lab RAM, HR, Horiba, France) were used to study the structural properties. Vickers hardness test (SUNTEC, CLARK, Model: CV-700AT, SER#CV 70546, Japan) with 300 g load was used for the hardness measurement. The surface morphology of the irradiated spot was studied using SEM (Jeol-JSM-6480 LV, Japan). The schematic of the experimental setup used for laser irradiation is shown in Figure 1.

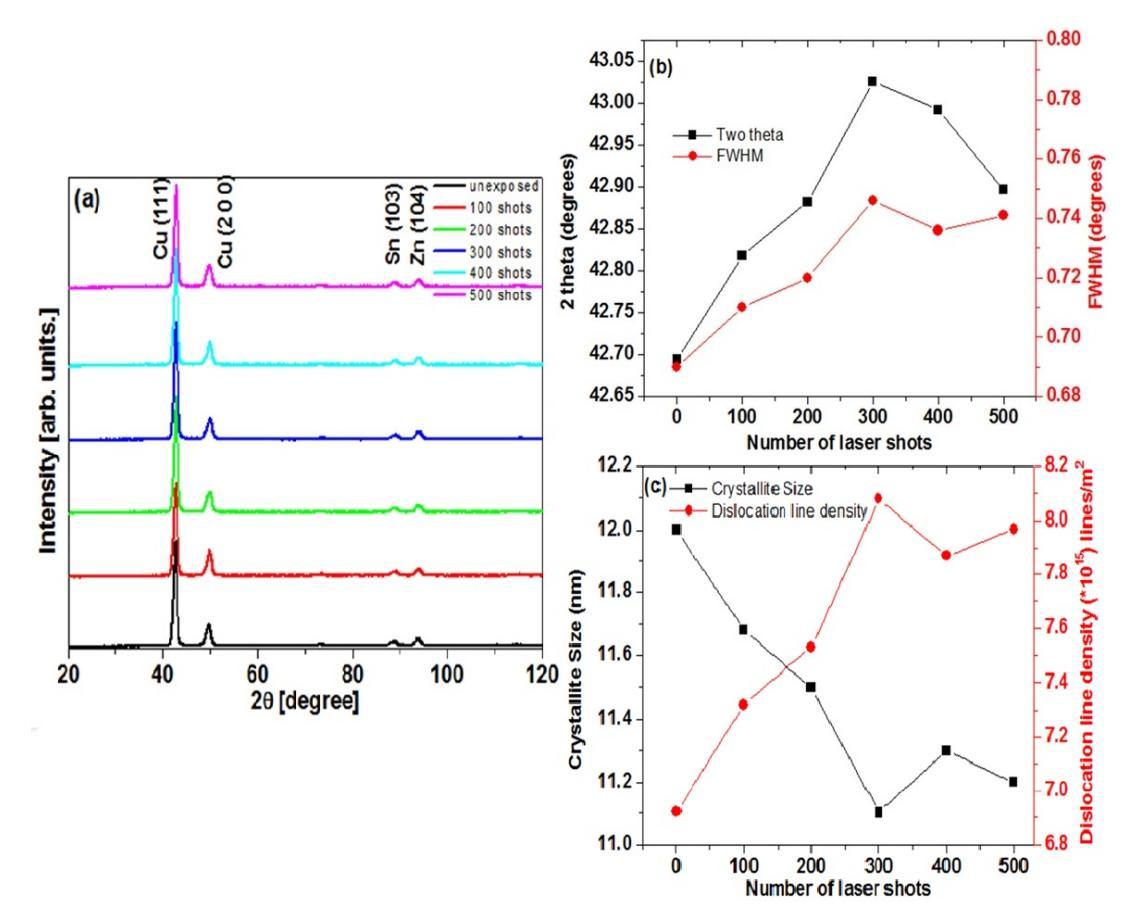
Figure 2. The XRD results of gun metal samples. (a) XRD spectra of unirradiated sample; (b) 2θ shift and FWHM of Cu (111) with respect to the number of laser shots; (c) the crystallite size and the dislocation line density with respect to the number of laser shots.

Figure 2a shows the XRD results of the un-irradiated and the laser irradiated gunmetal alloy samples at 100, 200, 300, 400, and 500 laser shots. The four peaks of Cu (111), Cu (200), Sn (103), and Zn (104) were found at 2θ values of 42.69°, 49.69°, 88.64°, and 94.14°, respectively, and were in agreement with the standard peak diffraction pattern Cu (00-004-0836), Zn (00-004-0831), and Sn (00-004-0673).

The intensity of peaks for Cu, Zn, and Sn was observed in decreasing order and in the same manner as the untreated gun metal alloy, i.e., 88.5% of Cu, 8% of Zn, and 3.2% of Sn. The laser irradiation at different numbers of laser shots appeared to change the XRD parameters, which included 2θ and FWHM values. The 2θ and the FWHM values changed remarkably for the Cu (111) peak but only slightly for the Cu (200), the Sn (103), and the Zn (104) peaks. Thus, the most intense peak [Cu (111)] may have acted as a probe in order to study the microstructural changes in the gun metal alloy after laser irradiation. The shifts in 20 and FWHM of the Cu (111) plane with respect to the number of laser shots are presented in Figure 2b. It is evident from Figure 2b that the 20 degrees value of the un-irradiated sample was 42.695°. This value was observed to increase consistently with the number of laser shots and reached the maximum value of 43.026° for the sample irradiated by 300 shots. However, the 2θ degrees value was observed to decrease with a further increase in the number of shots up to 500. The shift in the 20 degrees value from its standard value was an indication of an increase in the defect density in the material [19–21]. The sample irradiated with 300 shots therefore had the highest defect density. The decrease in the 20 shift—and hence the defect production—at 400 and 500 laser shots was of considerable importance. It was therefore stated that 400 and 500 shots produced a sort of annealing of the samples, which caused a re-crystallization process in the samples.

The FWHM values of Cu (111) peaks were extracted from XRD results using Gaussian profile fitting analysis. Figure 2b shows that the FWHM value (0.69°) for the un-irradiated sample increased consistently with number of shots and reached a maximum value of 0.746° for the sample irradiated at 300 laser shots. The value of FWHM decreased with a further increase in the number of laser shots up to 500. FWHM is used to characterize structural disorder [22]. The laser shots dependence of FWHM indicated that the samples irradiated with 300 shots had the highest disorder in the crystalline structure. The decrease in FWHM value at 400 and 500 laser shots was once again assigned to the re-crystallization process that possibly happened due to some annealing process. The crystallite (grain) size for the samples was also determined for the study of structural analysis of the laser irradiated materials. The well-known Scherer's formula [23] was used for this purpose and is given in Equation (1):

The increase of crystal dislocation depicted the quantification of work hardening related to the work done on the material or the addition of energy to the material. The added energy transferred existing dislocations and promoted a large number of new dislocations. The values of the dislocation line density versus the number of shots for irradiated samples calculated by the above equations are plotted in Figure 2c. The figure shows that, by increasing the number of shots, the dislocation line density increased, but beyond 300 shots, it slightly decreased [12]. Furthermore, it was explained that the dislocation line density was the inverse square of the grain size [21], thus the dislocation density increased from the un-irradiated sample to 300 laser shots. The dislocation line density then decreased upon further increase in the number of laser shots up to 500. The results of grain size and dislocation density therefore indicated that the samples irradiated with 300 shots contained the maximum structural disorder.

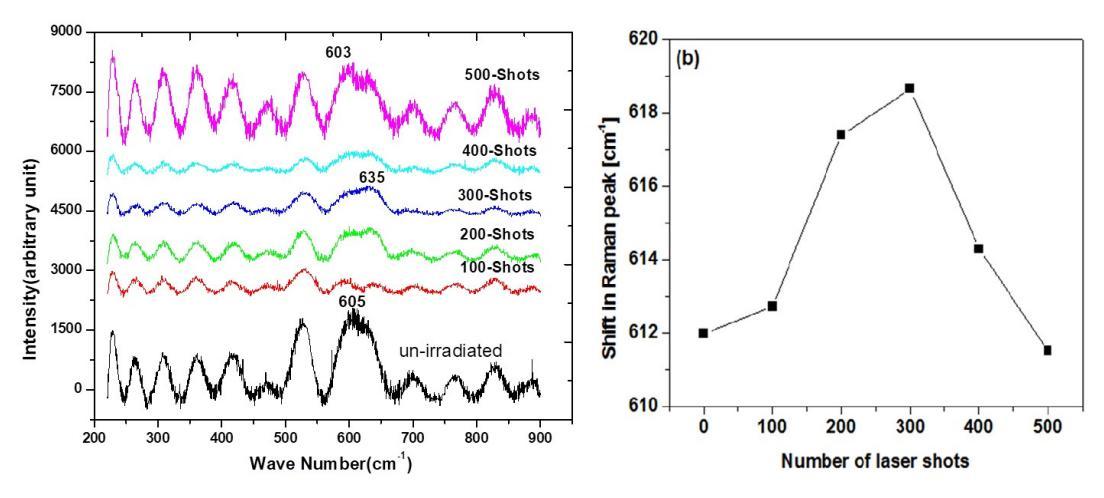
Figure 3. The Raman spectra of gun metal samples. (**a**) Raman spectra of unirradiated and laser irradiated gun metal samples at different numbers of laser shots. (**b**) Shift in most intense Raman peak at different numbers of laser shots.

In order to get further insight into the structural modifications induced by laser irradiation in gun metal alloy, Raman scattering measurements were carried out. Figure 3a shows Raman spectra recorded at different numbers of laser shots. The highest intensity Raman peak of gun metal alloy was found in the form of a band in the range of 558 to 673 cm⁻¹. The Raman spectra for all samples were Gaussian fitted. The peak position of the prominent Raman band versus the number of laser shots is plotted in Figure 3b.

The Raman shift of the un-exposed sample was 605 cm⁻¹. The position of this Raman mode was blue and shifted to a higher value of wave number at 635 cm⁻¹ by increasing the number of laser shots to 300. Upon increasing the number of laser shots to 500, the same Raman mode was red and shifted to a lower value of wave number until it reached 603 cm⁻¹. Since the shift in the Raman mode from its original position indicated the presence of stress [25,26] induced by structural disorder in the lattice [16], we determined that the gun metal alloy irradiated by 300 laser shots had the maximum disorder in the microstructure by confirming the XRD results.

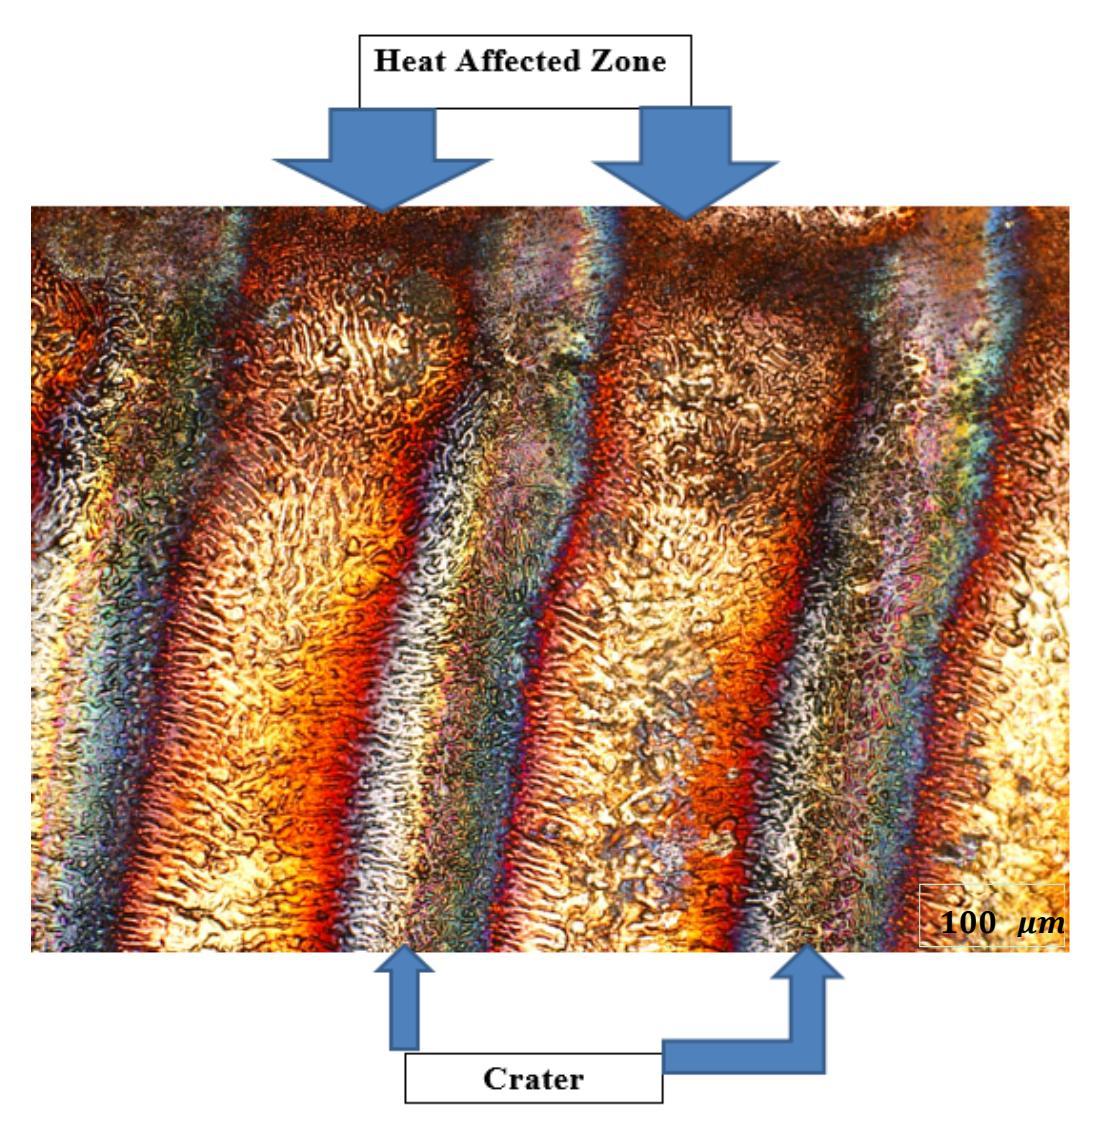
Figure 4. Optical micrograph of laser irradiated sample.

The optical micrograph of an array of the laser irradiated area is shown in Figure 4. The morphology at three different positions—around the crater [at heat affected zone (HAZ), position 1], between HAZ and the crater bottom (position 2), and the bottom of the crater (position 3)—is shown. The hardness at HAZ (position 1) and between HAZ and the crater (position 2) increased with an increased number of laser shots.

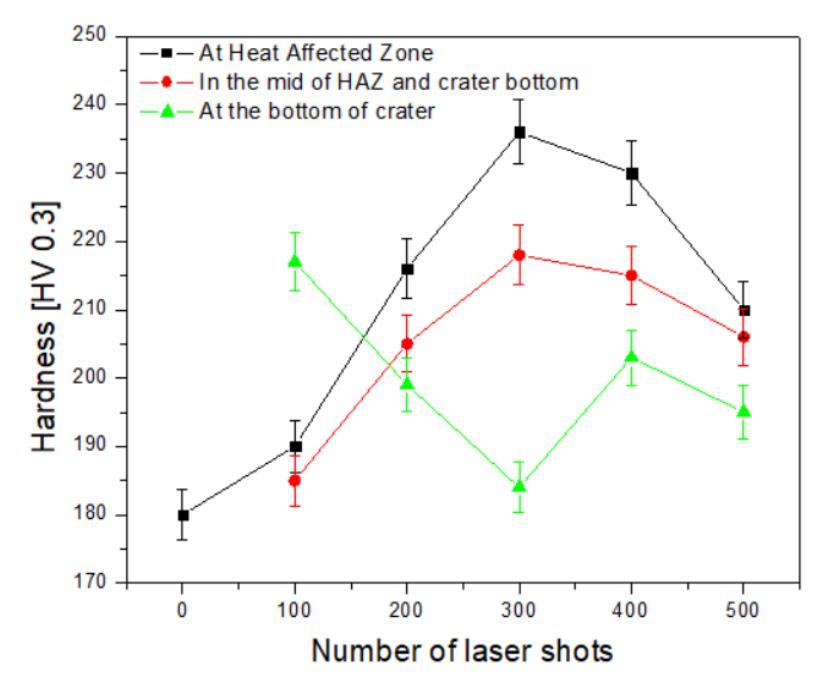
Figure 5. Hardness of gun metal alloy in different regions of the laser irradiated spot at different numbers of laser shots. Hardness comparison at the crater, the heat affected zone (HAZ), between the crater and the heat affected zone versus the number of laser shots.

Figure 5 shows that at 300 laser shots, maximum hardness was attained at positions 1 and 2. This in turn decreased the hardness at the bottom of the crater (position 3). Following this, by increasing the number of laser shots further, the hardness of position 1 and position 2 started to decrease, while the hardness of position 3 started to increase. The hardness value of the un-irradiated sample of gun metal was 180. This value increased up to 237 by raising the number of laser shots up to 300.

The hardness value decreased by increasing the number of laser shots to 500. The utmost hardness obtained at 300 laser shots was 32% higher than the un-irradiated sample of gun metal.

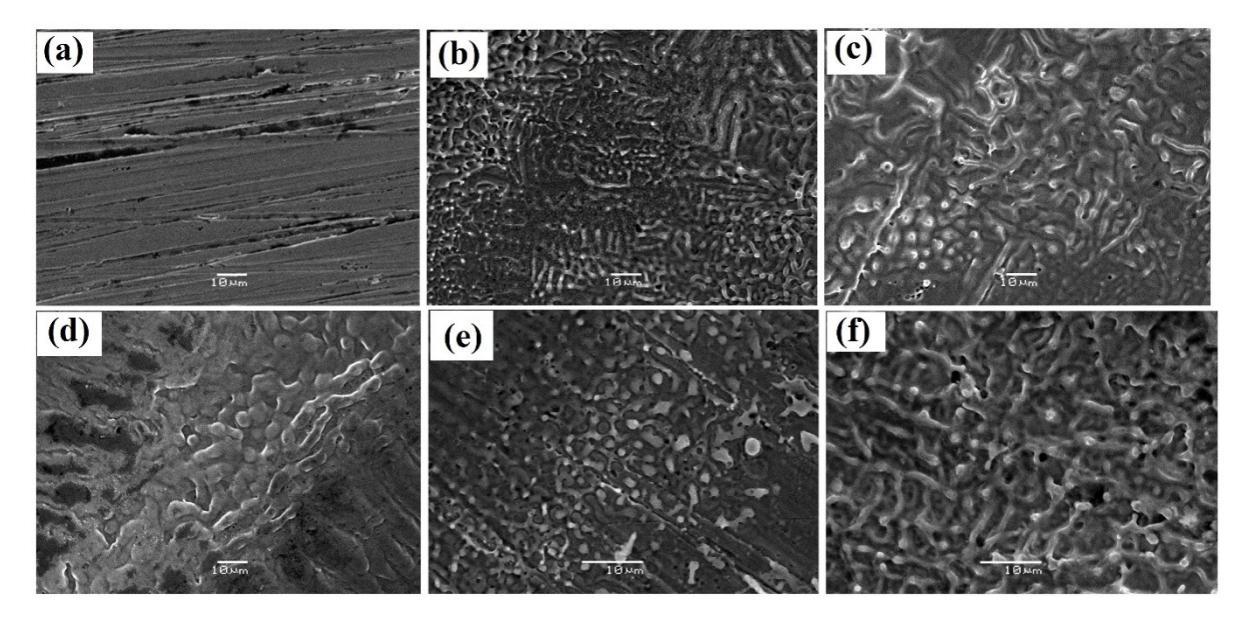
Figure 6. SEM images of gun metal alloy: (**a**) un-irradiated and irradiated with (**b**) 100, (**c**) 200, (**d**) 300, (**e**) 400, and (**f**) 500 laser shots.

The surface modification of gun metal alloy after irradiation at different numbers of laser shots was also studied by using SEM. The SEM micrographs of laser produced craters at a diverse number of laser pulses are shown in Figure 6. The SEM micrographs were taken from the bottom surface of the crater.

Figure 6a shows the plain surface of the untreated sample, which was made rough with sandpaper for higher laser absorption and then ultrasonically cleaned in isopropyl alcohol to remove dirt and impurities. The presence of a small number of scratches in the micrograph was due to the polishing of the gun metal surface. Laser produced structure formation was observed [31,32] when the gun metal was irradiated with a laser from 100-500 laser shots. Figure 6b shows the re-solidification of the melt surface, due to which some oblong structures and cone formations were observed. Figure 6c shows the formation of a long, spaghetti-like structure along with cone formation (greater than that of Figure 6b). Figure 6d shows the circular, the oval, and the banana-like structures with larger sizes than all others. In Figure 6e, the structure split again into smaller sizes. The melting and the long structure with high ablated materials were observed in Figure 6f. From SEM analysis, it could be seen qualitatively that, as the number of shots increased from 100–300, the particle size also increased; the particle size decreased at 400 laser shots and again increased slightly at 500 laser shots. Subsequently, the hardness data inside the crater could be very well correlated with the particle size. As the particle size increased for 100–300 laser shots, the hardness decreased. The particle size again increased when the number of laser pulses was increased to 500; hence, the hardness slightly increased. It was previously observed [33] that the hardness was higher at the edge of the laser irradiated spots as compared to the center of the
