Article

Effect of Ageing on the Tracking Characteristics of High-Temperature Vulcanized Silicone Rubber Hybrid Composites for High Voltage Insulation

Mohamed Ghouse Shaik * D and Vijayarekha Karuppaiyan

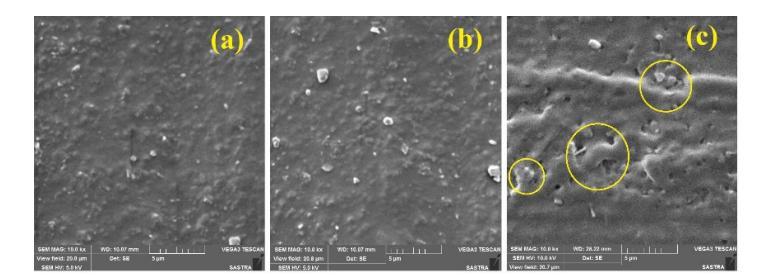
Figure 1. Scanning electron microscope images of (**a**) 5%; (**b**) 10%; (**c**) 15% Nano SiO₂ filled silicone rubber.

SEM analysis was used to ensure uniform dispersion of nanoparticles in the silicone rubber matrix. The SEM images of nanoparticles filled silicone rubber samples are shown in Figure 1. It shows the change in morphology of the rubber sample for different concentration of nanofillers. It was observed that for 5% and 10% by weight filled nano SiO₂ samples, the dispersion of fillers was in nanometric scale. But it was found that for higher filler concentration, i.e., 15% by weight, micro-sized agglomerated nanoparticles were observed. The circles in Figure 1c indicate the micro-sized agglomeration of SiO₂ nanoparticles. Hence it is evident from the SEM analysis that using two roll mill technique the samples with lower concentration can be fabricated without much agglomeration of nanoparticles. In contrast, with higher nanofiller concentration, it was challenging to prepare samples without micro-sized agglomeration of rancoparticles. Hence in this work, 10% by weight filled samples were used for tracking studies.

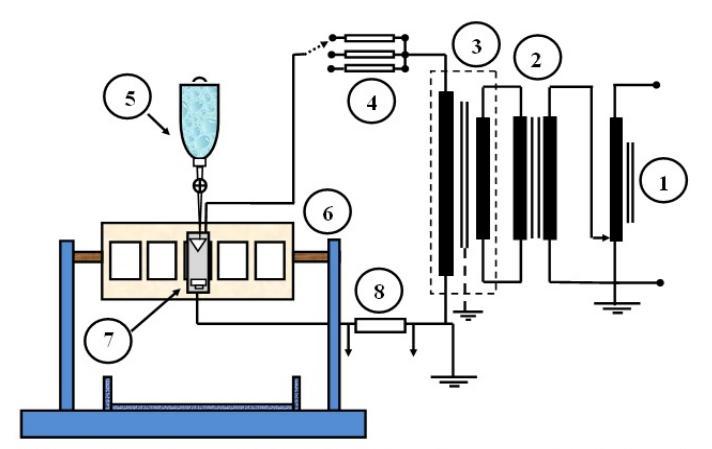
1- Variable AC supply, 2- 1:1 Isolation Transformer, 3- Test Transformer, 4- Current Limiting Resistors, 5- Contaminant Solution, 6- Inclined Plane Test setup, 7- Test Sample, 8- Resistor for Leakage current measurement

Figure 2. Experimental setup for the inclined plane test.

Single-phase AC supply 230 V, 50 Hz was applied to single-phase variac of rating 240 V/(0–270)V and the output of the variac was connected to the 1:1 isolation transformer. The output of the isolation transformer was connected to the 5 kV, 500 VA high voltage test transformer. A series current limiting resistance of 10 k Ω /22 k Ω /33 k Ω was connected to the secondary of the test transformer, and the other end of the resistance is connected to the HV electrode. The LV electrode is connected to a 25 W, 500 Ω resistance across which the leakage current is measured, and the respective waveforms are recorded in digital storage oscilloscope (DSO) (Keysight make DSO: Model no-DSO X1102, CA, USA). Figure 2 shows the experimental arrangement of the work.

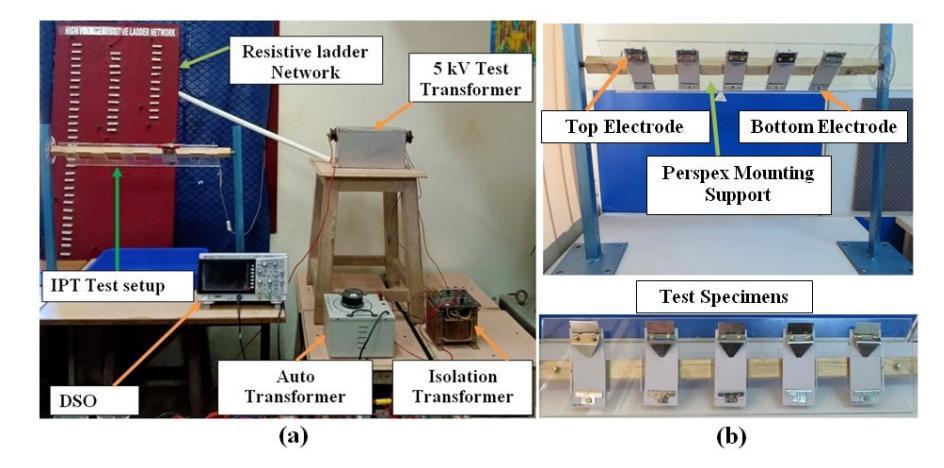
Figure 3. Photograph of the experimental setup and mounting support: (**a**) Experimental set up, (**b**) mounting support.

paper, and the flow rate was adjusted to 0.3 mL/min as per IEC 60,587 standard which is equivalent to 5 drops per minute [33]. Figure 3 shows the photograph of the experimental arrangement.

The drops per minute were adjusted carefully to achieve 0.3 mL/min. A 4.5 kV of AC supply was applied across the electrodes and series resistance of 33 k Ω is connected as recommended in IEC 60,587 [33]. The primary voltage of 204 V is set to get 4.5 kV at the secondary side of the test transformer. The design of this low-cost indigenous tracking setup was reported in our previous tracking studies on micro ATH filled silicone rubber insulation [37].

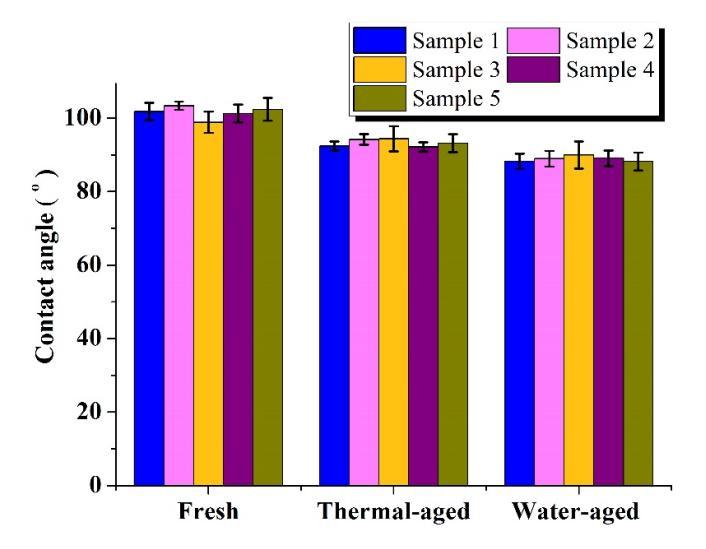
Figure 4. Contact angles of fresh, thermal- and water-aged samples.

Figure 4 shows that the hydrophobicity of the thermally aged and the water-aged samples decreased due to the effect of ageing. For every sample, the given contact angle is the average of eight measurements carried out at different locations of the sample. For fresh hybrid composites samples, the average contact angle was 101.56°. In contrast, for thermally aged samples, the average contact angle was reduced to 93.28°, and for water aged samples, the contact angle was further reduced to 88.91°.

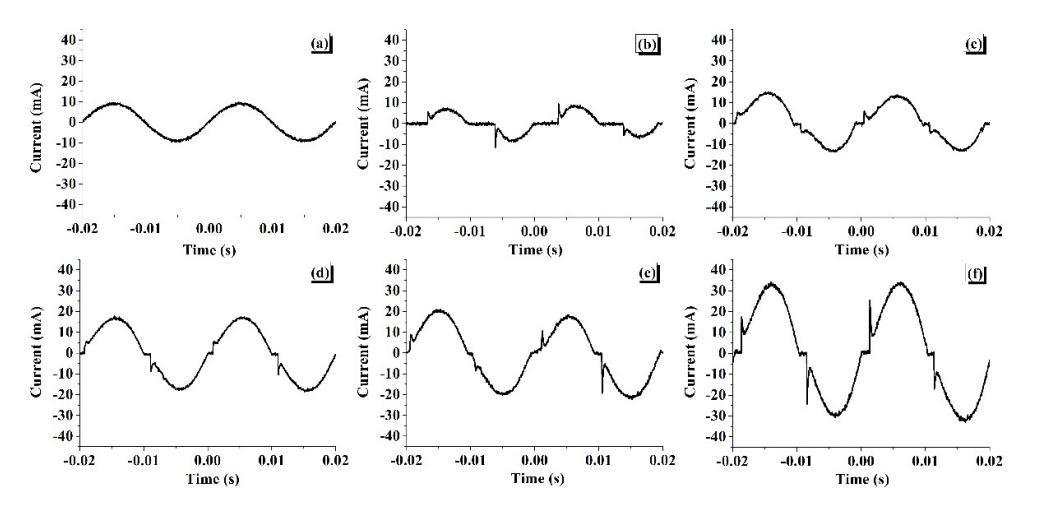
Figure 5. Variation of instantaneous leakage current of the fresh sample at different stages: (**a**) initial period, (**b**) dry band arcing period, (**c**) and (**d**) continuous arcing period, (**e**) hot spot initiation period, (**f**) carbonisation period.

Figure 5 shows the variation of instantaneous leakage current patterns recorded during the tracking of a fresh sample at different time intervals throughout the tracking test duration. Figure 5a shows the initial leakage current during the starting period of the test. It was minimum and continuous. Later, due to leakage current, the wet surface evaporated, and dry band regions were formed. Figure 5b shows the typical current pattern during the dry band arcing period. In this case, the current was discontinuous. Due to continuous rewetting and the dry band arcing the leakage current magnitude

was increasing, as shown in Figure 5c,d. As time progressed, the magnitude of leakage current was raised, and a hotspot was observed near the bottom electrode. Figure 5e shows the leakage current pattern recorded during the initiation of the hotspot. With time, the erosion process was aggravated with carbonisation at the bottom region of the sample. Continuous arcing was observed during this period, and the leakage current pattern was as shown in Figure 5f.

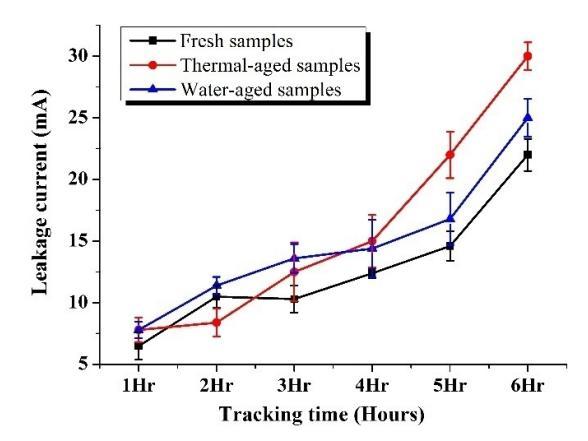
Figure 6. Variation of leakage current of fresh, thermal-aged and water-aged samples during tracking.

Figure 6 shows the variation of the root mean square (RMS) values of the leakage current (LC) of the fresh and aged samples during the tracking test. The instantaneous leakage current patterns and the RMS values were noted continuously, in the DSO. For the calculation purpose, the RMS values of leakage currents were noted at the end of each hour, ten times (last ten frames of the LC waveform, with two cycles covered per frame). Similar observations and calculations were made for all the five samples of a particular category (five samples each per the fresh, the thermal aged and the water aged category). Thus for each sample category, 50 RMS values were noted at the end of each hour. Then the mean and standard deviation were calculated for every hour. The mean RMS values were considered to represent the variation of leakage current against the time.

For fresh samples, the RMS values of leakage current (LC) was very minimum during the initial period of the test. It slowly increased after 4 h, and after that, the increase in current was almost

linear. However, for thermal-aged samples, the current was almost constant during the initial period. After 2 h, a higher magnitude of current was observed compared to fresh samples. For water aged samples, initially higher leakage currents were observed due to the low value of hydrophobicity. However, from the third hour to the fourth hour, the current value was steady and almost constant. After 4 h, the current increase linearly. During the end of the test, the LC magnitude was highest for thermal-aged samples compared to the fresh and the water-aged samples. But up to 4 h of the test period, all the samples showed almost similar LC patterns, and the LC magnitude variations were minimum among the fresh and the aged samples. This could be due to the effect of the addition of nanofillers. It is reported in recent literature that the addition of a small amount of nanofiller improves the tracking resistance of polymeric insulations [25–28].

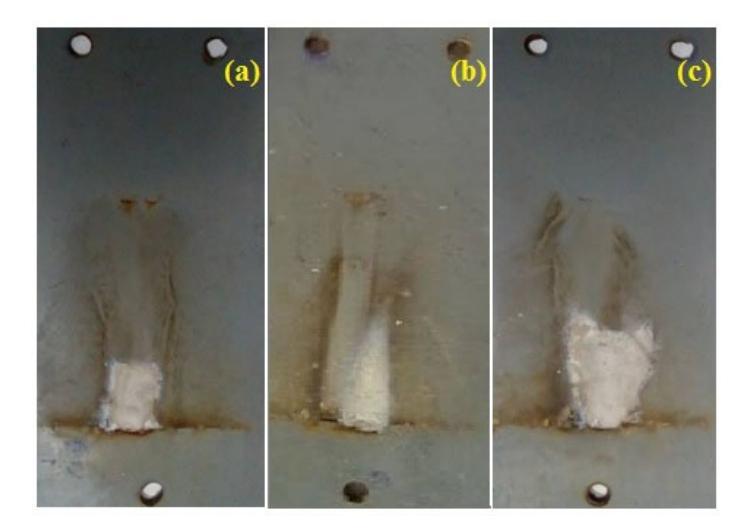
Figure 7. Images of the highly eroded and tracked samples: (a) Fresh, (b) thermal-aged, (c) water-aged.

After tracking tests, the tracked specimens were removed carefully. Figure 7 shows the images of such highly eroded and the tracked samples from the fresh, thermal-aged and water-aged groups.

The average tracking length and average percentage weight loss of the thermal-aged and water-aged samples were comparatively higher than those of the fresh samples. The difference in the average weight loss between thermal aged and water aged sample was minimum. This ensures that the addition of nanofillers improves the tracking resistance performance of the hybrid composite samples even after ageing.

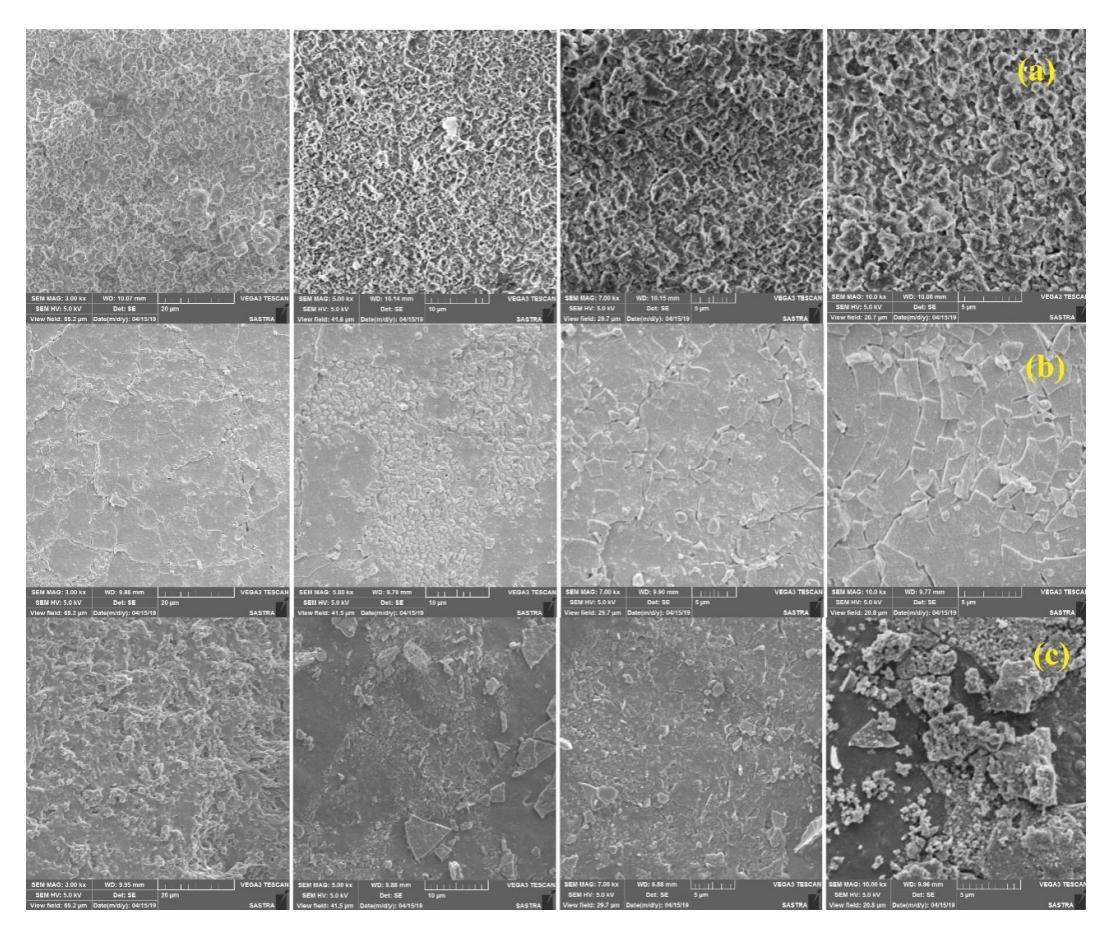
Figure 8. SEM micrographs of the eroded samples after the tracking with the magnification level of 3000, 5000, 7000, 10,000×: (a) Fresh, (b) thermal-aged, (c) water-aged.

SEM analysis was carried out to study the surface roughness, cracks, and surface morphology after tracking, and to understand the extent of degradation of the samples. ImageJ software was used to carry out the surface morphological studies. SEM images of the highly eroded region of the fresh, the thermal aged and the water-aged samples with a magnification level of 3000, 5000, 7000, 10,000× are shown in Figure 8. From the figures, it is clear that the surface morphology after tracking is different for the fresh sample and aged samples.

At different magnification, distinct differences were observed at the surface of the tracked samples. Due to electrical tracking, oxidation at the surface of the silicone rubber occurs. Due to this, the hydrophobicity recovery process is retarded [28]. Figure 8a shows the SEM images of the fresh samples. The morphological changes in the highly eroded area were analysed. A rupturing pattern was observed with uniform degradation. The presence of voids and pits were found. This pattern was different in the thermal-aged and the water-aged samples. In the case of thermal-aged tracked samples, as shown in Figure 8b, uniform cracks and surface splitting was observed. Compared to the SEM images of the fresh samples, more surface cracks were found. This could be due to the loss of its hydrophobicity due to thermal ageing before electrical tracking [28]. After electrical tracking, the surface morphology was affected in the aged samples. In the case of water-aged samples, instead of the crack formation, more craggy irregular morphology was observed, as shown in Figure 8c. In the water-aged samples, the continuous steady leakage current was observed for a longer duration compared to fresh and thermal aged samples, as discussed in Section 3.2. Due to this continuous leakage current, ATH released water and alumina, which might have settled over the surface as

residues. This may be the reason for the irregular shapes at the surface of the water-aged samples. Such irregular cracked surface may provide speedy transportation of the low molecular weight (LMW) components as reported in recent articles [7,23]. Figure 9 shows the schematic illustration of the

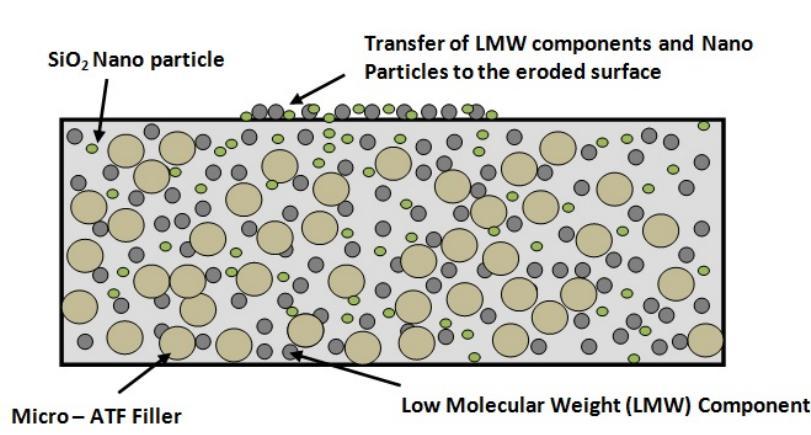
Figure 9. Schematic illustration of the transfer of the LMW components and the nanoparticles to the eroded surface.

Electrical tracking has altered the physical and chemical structure of the base polymer surface. Due to oxidation, the hydrophobic methyl group was changed to a hydrophilic hydroxyl group. However, after a certain time, the recovery of hydrophobicity was observed due to the reorientation of the LMW component from the bulk polymer matrix [7,23]. During this process, the nanoparticles were also transferred to the eroded surface. The migration of nanoparticles over the surface can effectively improve the tracking resistance of the nano filled composites. It is reported that the recovery of hydrophobicity is slower compared to the unfilled samples, because it offers resistance to the transport of the LMW from the bulk structure to the polymer surface [23]. The improved corona discharge activity due to nano alumina was recently reported in [23]. The formation of alumina oxide (Al₂O₃) as the decomposition of ATH fillers might have settled over the surface of the water aged sample. From this study, it is clear that the addition of nano and microparticles in the polymer matrix has significantly improved the tracking resistance, even after the thermal and water ageing.

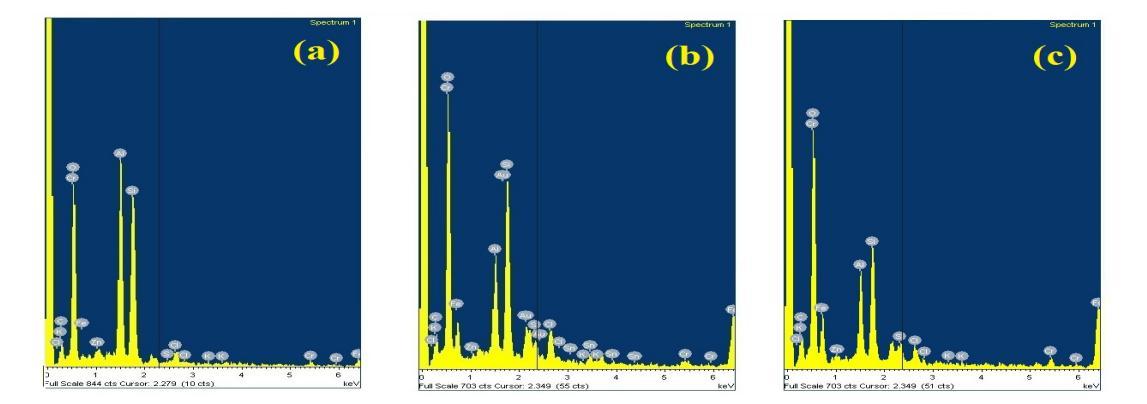
Figure 10. EDAX spectra of tracked samples: (a) Fresh, (b) thermal-aged, (c) water-aged.

EDAX was used in our study to know about the changes happening in the chemical composition of the tracked samples. Figure 10 shows the EDAX spectrum of the fresh, thermal-aged and water-aged samples after electrical tracking test. The results of EDAX will be in weight percentage (weight%) or atomic percentage (atomic%). Weight% is the function of the atomic weight of the elements present in the sample, whereas atomic% is the function of the number of atoms present in the sample [28].

The major elements C, O, Al and Si, were found on the surface of the fresh, thermal-aged and water-aged samples, as indicated from the EDAX spectrum. In Table 3, the comparison of both weight% and atomic% for different elements present in the fresh, thermal-aged and water-aged sample were presented. As atomic% gives the percentage of one kind of atom relative to the total number of atoms in the sample, the change in atomic% was analysed in detail. It was clear from the table that the atomic% of C had reduced and the atomic% of O had increased due to ageing. The reduction in atomic% in C and the increase in the atomic% of O were due to the deformation of Si-CH₃ chain, which might have changed to Si-OH [28]. The elemental changes indicated that the aged samples degrade more compared to fresh samples.

A decrement in the atomic% of the aluminum was observed, due to ATH micro-fillers decomposition. An increase in the atomic% of Fe was found in the aged samples, which might have released due to the degradation of bottom electrodes due to a high magnitude of leakage current in the aged specimen. From the EDAX analysis, it was clear that several elemental changes had occurred in the aged samples. However, the atomic% change in the elemental composition was not too high. This could be the effect of high resistance against electrical tracking due to the addition of a small percentage of nanofillers in the base polymer matrix.

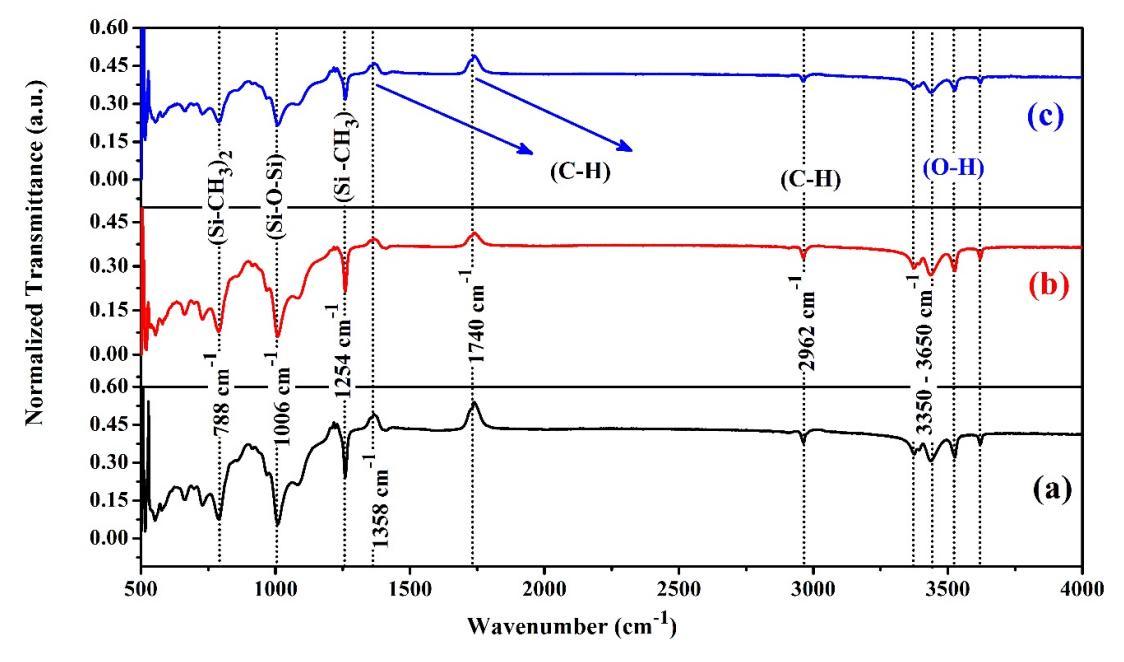
Figure 11. FTIR-Spectrum of the highly eroded and tracked samples: (a) Fresh, (b) Thermal-aged, (c) Water-aged.

The FTIR spectra of the fresh, thermal-aged and water-aged samples are shown in Figure 11. The obtained results were interpreted based on similar observations in our previous work and other literature [31,37]. The FTIR spectrum of the fresh tracked hybrid composite sample was shown in Figure 11a. This spectrum was used to compare the FTIR spectrum of the thermal aged and the water- aged samples, as shown in Figure 11b,c. For understanding the change in the transmittance value, all the patterns were normalised, and a stacked pattern was given for better clarity. In the FTIR

The dips observed in the transmittance plot at 3350–3650 cm⁻¹ indicated the formation of the O-H hydroxyl bond. For the thermal-aged and the water-aged samples, similar dips were observed. There was not much difference in the transmittance spectrum in this region. Slightly higher transmittance value was found in the water aged sample, which indicated a higher degree of hydroxylation in the water aged sample. The higher transmittance was due to the dehydration of ATH fillers and the sustained- leakage current, as discussed in Section 3.2.

The dip observed at 2962 cm⁻¹ indicated the decrease in the intensity of the C-H stretch in CH₃ bond. This indicates C-H symmetric stretching, which affects the polymer chain. Due to this, shrinkage of the polymer chain occurs, and it hardens the surface of the polymeric sample. This results in less vibration of C-H bond, and consequently, C-H stretch intensity decrease. In the aged sample, a similar dip was observed, but, the ageing did not affect the transmittance value much. The introduction of inorganic nanoparticles in the polymer matrix offered a better barrier against surface ageing [22–25]. This could be the reason for the similar transmittance pattern for the fresh and the aged samples. The thermal and water ageing did not influence much on the hybrid composite materials.

There was an increase in the transmittance spectrum at 1740 cm⁻¹ and 1358 cm⁻¹. This is due to the formation of carbonyl degradation products due to electrical tracking.

At 1254 and 788 cm⁻¹, the changes in the transmittance peaks for the thermal-aged and water-aged sample were almost the same. There was not much change in the intensity of the Si-C bond. This is because the skeleton of the polymer matrix is made up of the Si-C Bond.

In the region 1006 cm⁻¹, there was a difference in the peak intensity of the thermal-aged and the water-aged samples, due to Si-O stretch vibration. There was not much difference between the fresh and aged samples.
