Article

MDPI

Lamb-Wave-Based Tomographic Imaging Techniques for Hole-Edge Corrosion Monitoring in Plate Structures

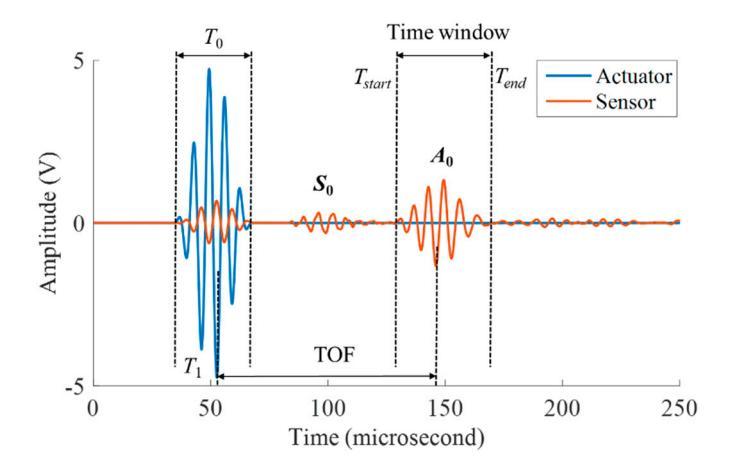
Figure 1. Schematic illustration for the time window calculation.

where T_1 represents the wave excitation time of an actuator, *ToF* is the time of flight from an actuator to a receiver, and T_0 is the period of excitation wave envelope. The time window is illustrated in Figure 1.

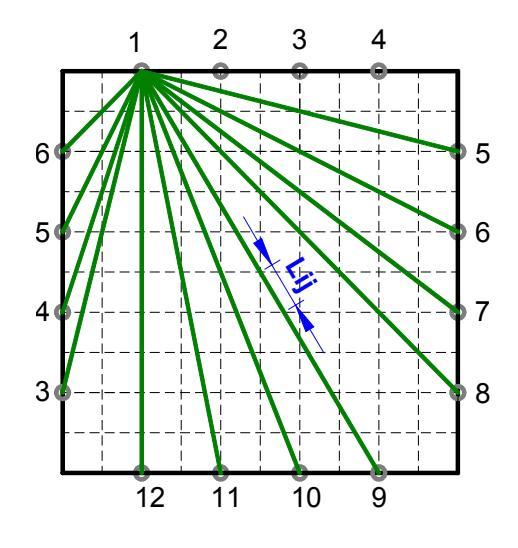
Figure 2. The illustration of the grids and paths in the specimen.

The plate under study was divided into grids, and the sensor recording the data at a receiver location (named projection data) can be expressed as a sum of the contributions from grids that lie on the straight path connecting the sensor to the actuator. Figure 2 illustrates a specimen divided into 100 grids with 16 PZT sensors, and 12 paths are illustrated when No. 1 PZT is regarded as the actuator. The contribution of each grid is proportional to the path length in that grid, which is regarded to be its weight. Thus, a weight matrix is constructed as a rectangular array whose size is equal to the number of paths multiplied by the number of grids. From the projections (measured data) and the weight matrix (created from sensor locations and ray geometry), the field value (correlation coefficient in this study) was obtained using the ART method as below:

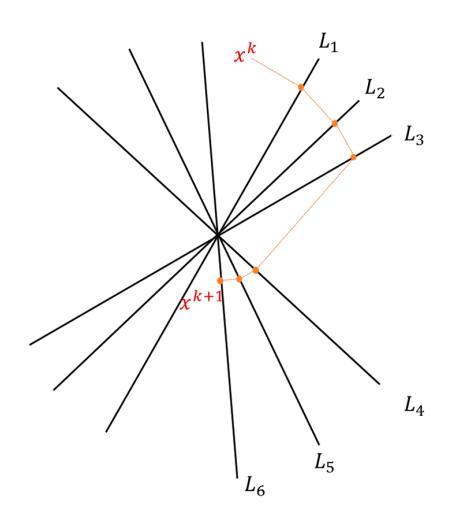
Figure 3. Kaczmarz's Method.

Figure 3 shows an example of a sweep for the consistent case with the relaxation parameter $\lambda_k = 1$.

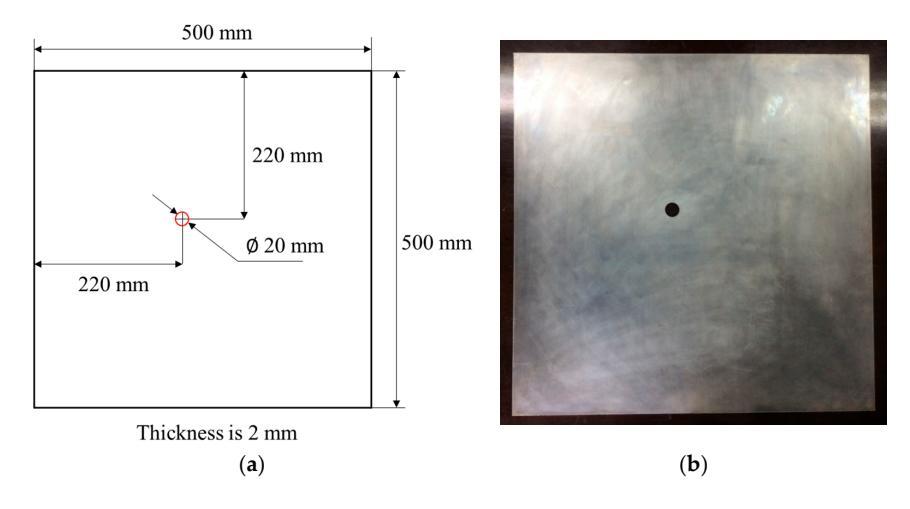
Figure 4. (a) The geometry of the specimen and (b) the real specimen.

In the experiment, the material is Al-2024-T3; its density, Young Modulus, and Poisson's rate are 2.78 g/cm^3 , 73.1 GPa, and 0.33, respectively. The geometry of the material is 500 mm \times 500 mm \times 2 mm, as illustrated in Figure 4. The piezoelectric sensor used in the study was manufactured by Stem, Inc. (Millbrae, CA, USA). The geometry and outline of the PZT is illustrated in Figure 5. The properties of the PZT are shown in Table 1.

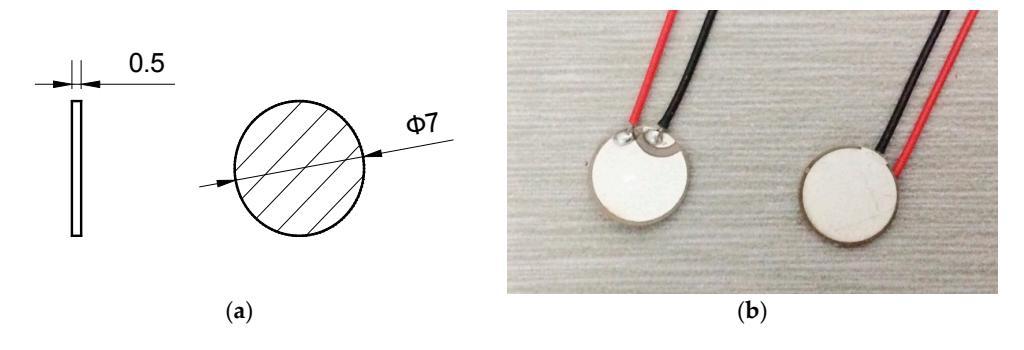
Figure 5. (a) The geometry of the PZT and (b) the outline of the PZT.

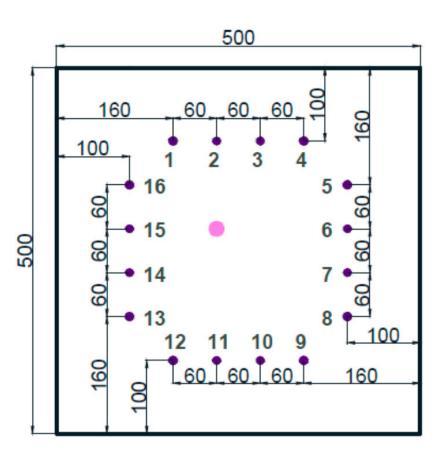
Figure 6. The layout of the PZT sensors. (The unit in the figure is mm.)

In the field of structural health monitoring, there are two configurations for PZT sensors, namely, pulse-echo configuration and pitch-catch configuration. The pitch-catch configuration was chosen in this study. In the pitch-catch configuration, the actuator and the receiver are placed across the potentially damaged region. When damage exists in the potentially damaged region, the discontinuities in the wave propagation paths will alter the characteristics of the wave. The layout of the PZT sensors is illustrated in Figure 6. This kind of layout is more efficient with limited sensors [13]. Based on this layout, 96 actuator-sensor paths for each actuator and sensor are shown in Figure 7.

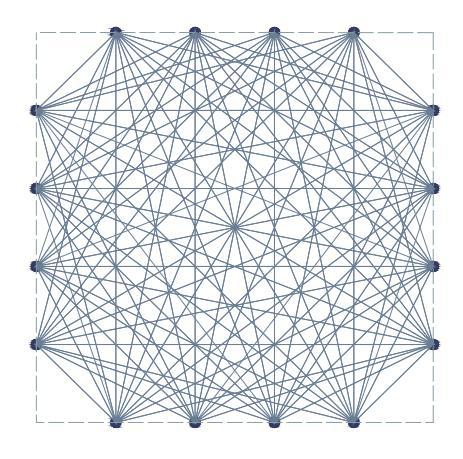
Figure 7. The 96 signal paths for the PZT sensors layout.

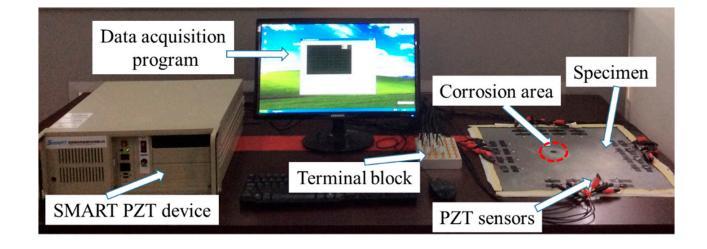
Figure 8. The experimental setup.

The overall experimental setup of the structural health monitoring system for hole-edge corrosion damage included the SMART PZT device, data acquisition, terminal block, PZT sensors, and specimen. A schematic of the overall procedure is illustrated in Figure 8. SMART PZT device manufactured by Nanjing SMART Company generates an excitation signal and senses the wave propagation through the specimen. The excitation signal was a five cycles tone burst generated by SMART, and the SMART is used to record both the received signals and the excitation signals.

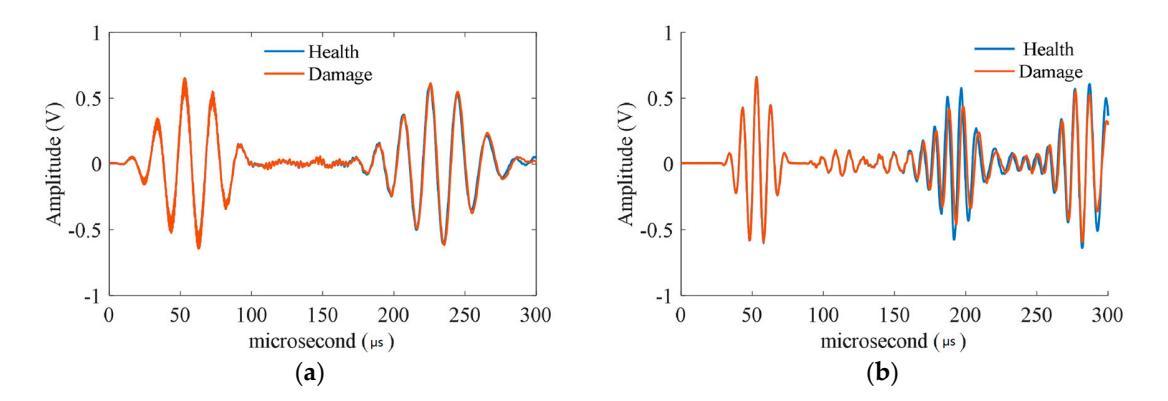
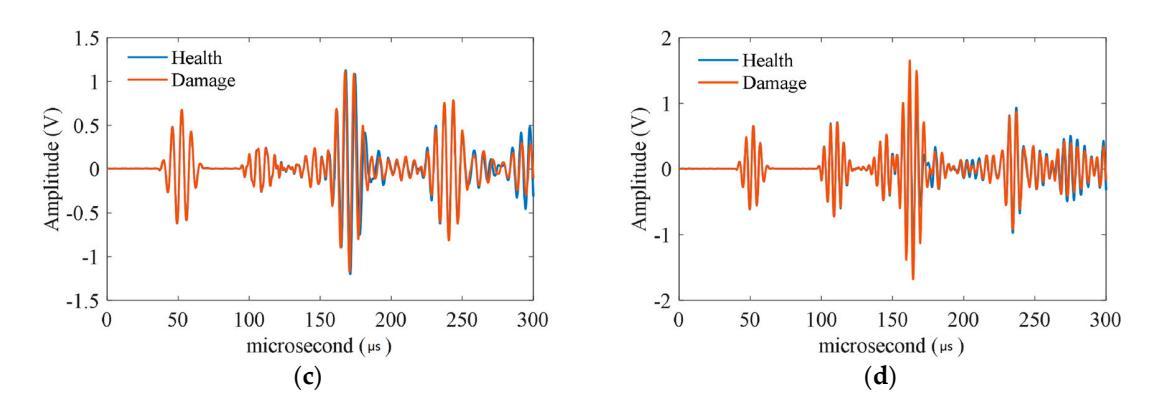
Figure 9. Cont.

Figure 9. The different frequencies of the Lamb wave in a specific path based on hole-edge corrosion damage. (a) 50 kHz; (b) 100 kHz; (c) 150 kHz; and (d) 200 kHz.

Based on the sensor layout, the excitation signal should be designed. For the A_0 mode of the Lamb wave, the phase velocity is varied by the product of frequency and thickness. In this study, the thickness of the specimen was 2 mm, and four different frequencies (50 kHz, 100 kHz, 150 kHz, and 200 kHz) of Lamb waves were compared, as shown in Figure 9, for a specific actuator-sensor path. When the frequency-thickness was 0.2 MHz·mm, the received A_0 signal was sensitive to the varying thickness. Thus, the central frequency of the excitation signal was set to 100 kHz.

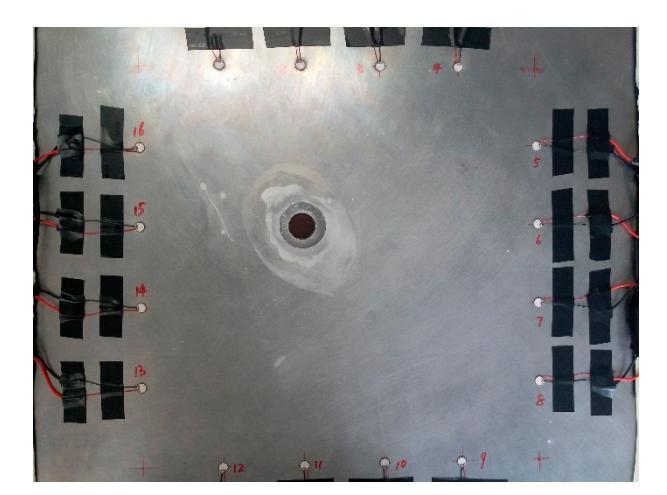
Figure 10. The specimen corroded by hydrofluoric acid.

Based on the setup of the experiment, the Lamb wave signals for 96 actuator-sensor paths without corrosion damage (namely healthy condition) were obtained by the SMART PZT device. Then the hole-edge damages were made artificially. In order to manufacture the artificial corrosion damage, hydrofluoric acid was used on the plate at the edge of the hole. Hydrofluoric acid (400 mL) with the concentration of 20% was used to corrode the Al-2024-T3. The detailed information of the hydrofluoric acid is illustrated in Table 2. The specimen corroded by hydrofluoric acid is shown in Figure 10.

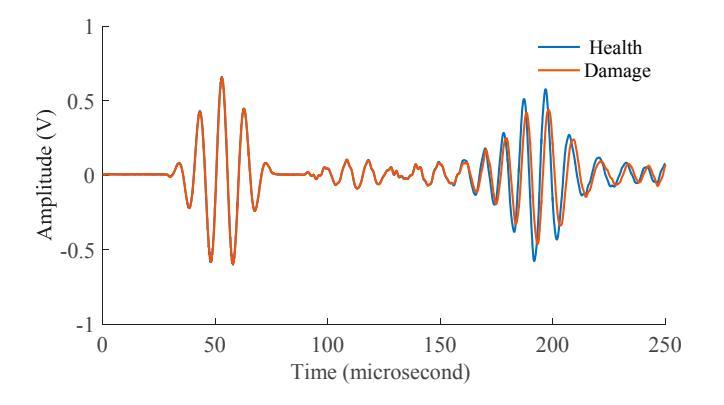
Figure 11. The Lamb wave signals without damage and with damage.

errors caused by the external environment, the Lamb wave signals of each actuator-sensor path were obtained three times, and the average value of signal features (the correlation coefficient was used in the study) for each set of data was used. For illustration, the signals based on the healthy and damaged conditions of one actuator-sensor path of the Lamb wave, which is across the hole-edge corrosion damage area, are shown in Figure 11. Based on the thickness-loss of aluminum, the *fd* (the product of frequency and thickness of the specimen) of the Lamb waves decreased, and the phase velocity of A_0 mode was changed. The corrosion damage is a kind of discontinuity that can disperse and reflect energy of the original Lamb wave and cause changes in wave characteristics.

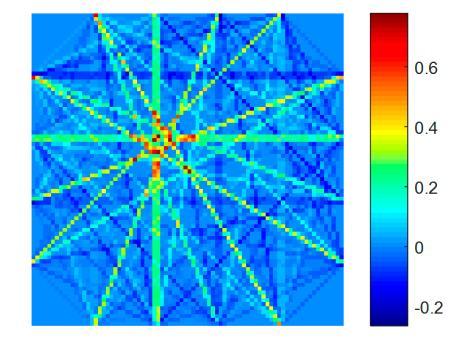
Figure 12. The original tomographic imaging.

Based on the signals of the healthy condition and the signals of the damaged condition, the ART method was used to locate and quantify the hole-edge corrosion damage. In order to obtain a detailed image, 6400 square grids of the same size were divided. Based on the 96 paths, a tomographic image was obtained. The ART method was used to find the optimal solution for the ill-posed equation. Because the matrix *A* is sparse, the original image (as shown in Figure 12) is strengthened or weakened in the specific path. In order to make the tomographic image describe the real condition of the damage, a homogenization method was designed to make the image smoother. As illustrated in Figure 13, there are three situations: the grid in the green area, blue area, and yellow area.

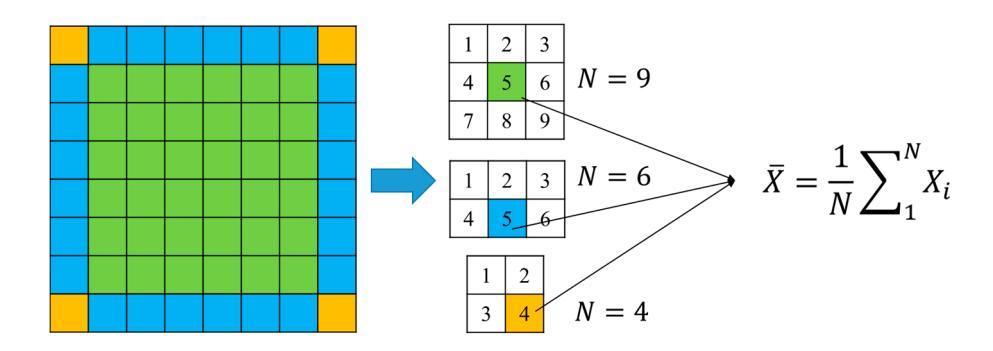
Figure 13. The method of homogenization to make the image smoother.

- (a) When the grid is in the green area, the updating step is to average the value of the surrounding eight grids with its own value.
- (b) When the grid is in the blue area, the updating step is to average the value of the nearby five grids with its own value.
- (c) When the grid is in the yellow area, the nearby three grids' value are included with its own value to calculate a new value, which is regarded as updated.

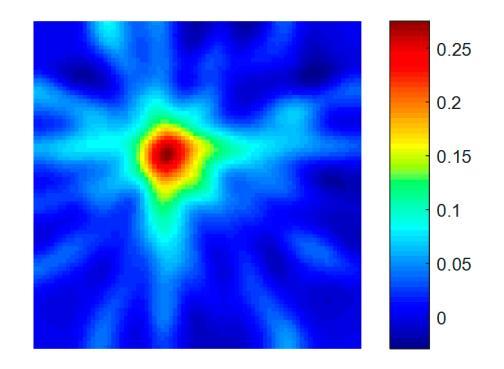
Figure 14. The tomographic imaging results with homogenization.

The tomographic images based on the homogenization method are illustrated in Figure 14, and it shows that the homogenization can depict the corrosion damage more accurately.

In Figure 14, the red area is highlight and the threshold is set to 0.2, when the value of the grid is larger than 0.2, the grid is regarded as the corrosion damage area. After calculating, the predicted corrosion area based on the tomographic method is 768.65 mm², and the real corrosion damage area in the specimen is 647.95 mm². The relative error between the predicted corrosion damage and the real corrosion damage is 18.63%. The real corrosion damage and the predicted corrosion damage are illustrated in Figure 15. The relative error is less than 20% and confirms that the proposed method can locate the corrosion damage at a hole in the plate and can predict the area of the corrosion damage around the hole accurately.

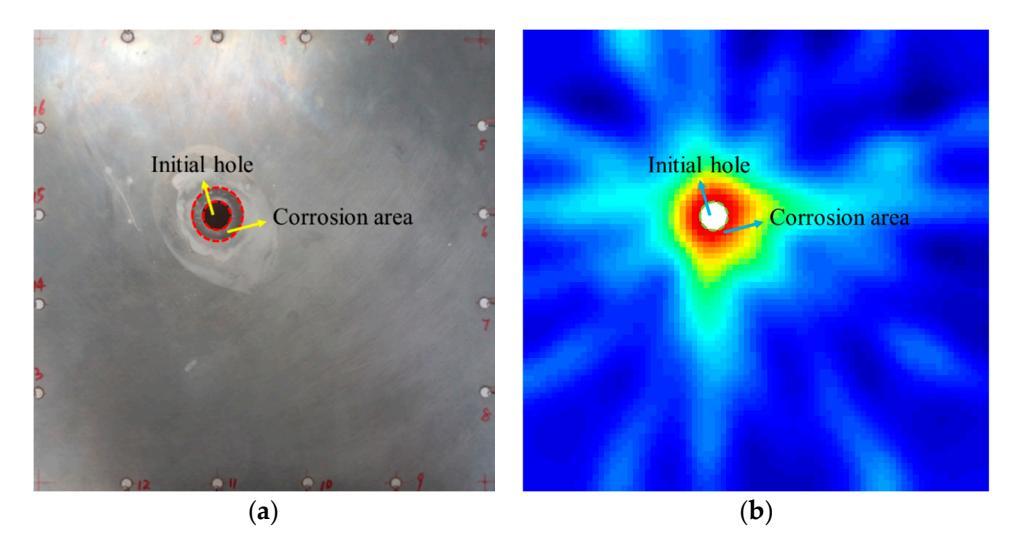
Figure 15. (a) The area of real corrosion damage and (b) the area of predicted corrosion damage.
